# **REPORT OF COMPLIANCE EVALUATION INSPECTION**

AT  
City of Salina Public Water Supply  
300 West Ash Street  
Salina, Kansas 67402

October 7-9, 2025

BY  
U.S. ENVIRONMENTAL PROTECTION AGENCY  
Region 7  
Enforcement and Compliance Assurance Division (ECAD)

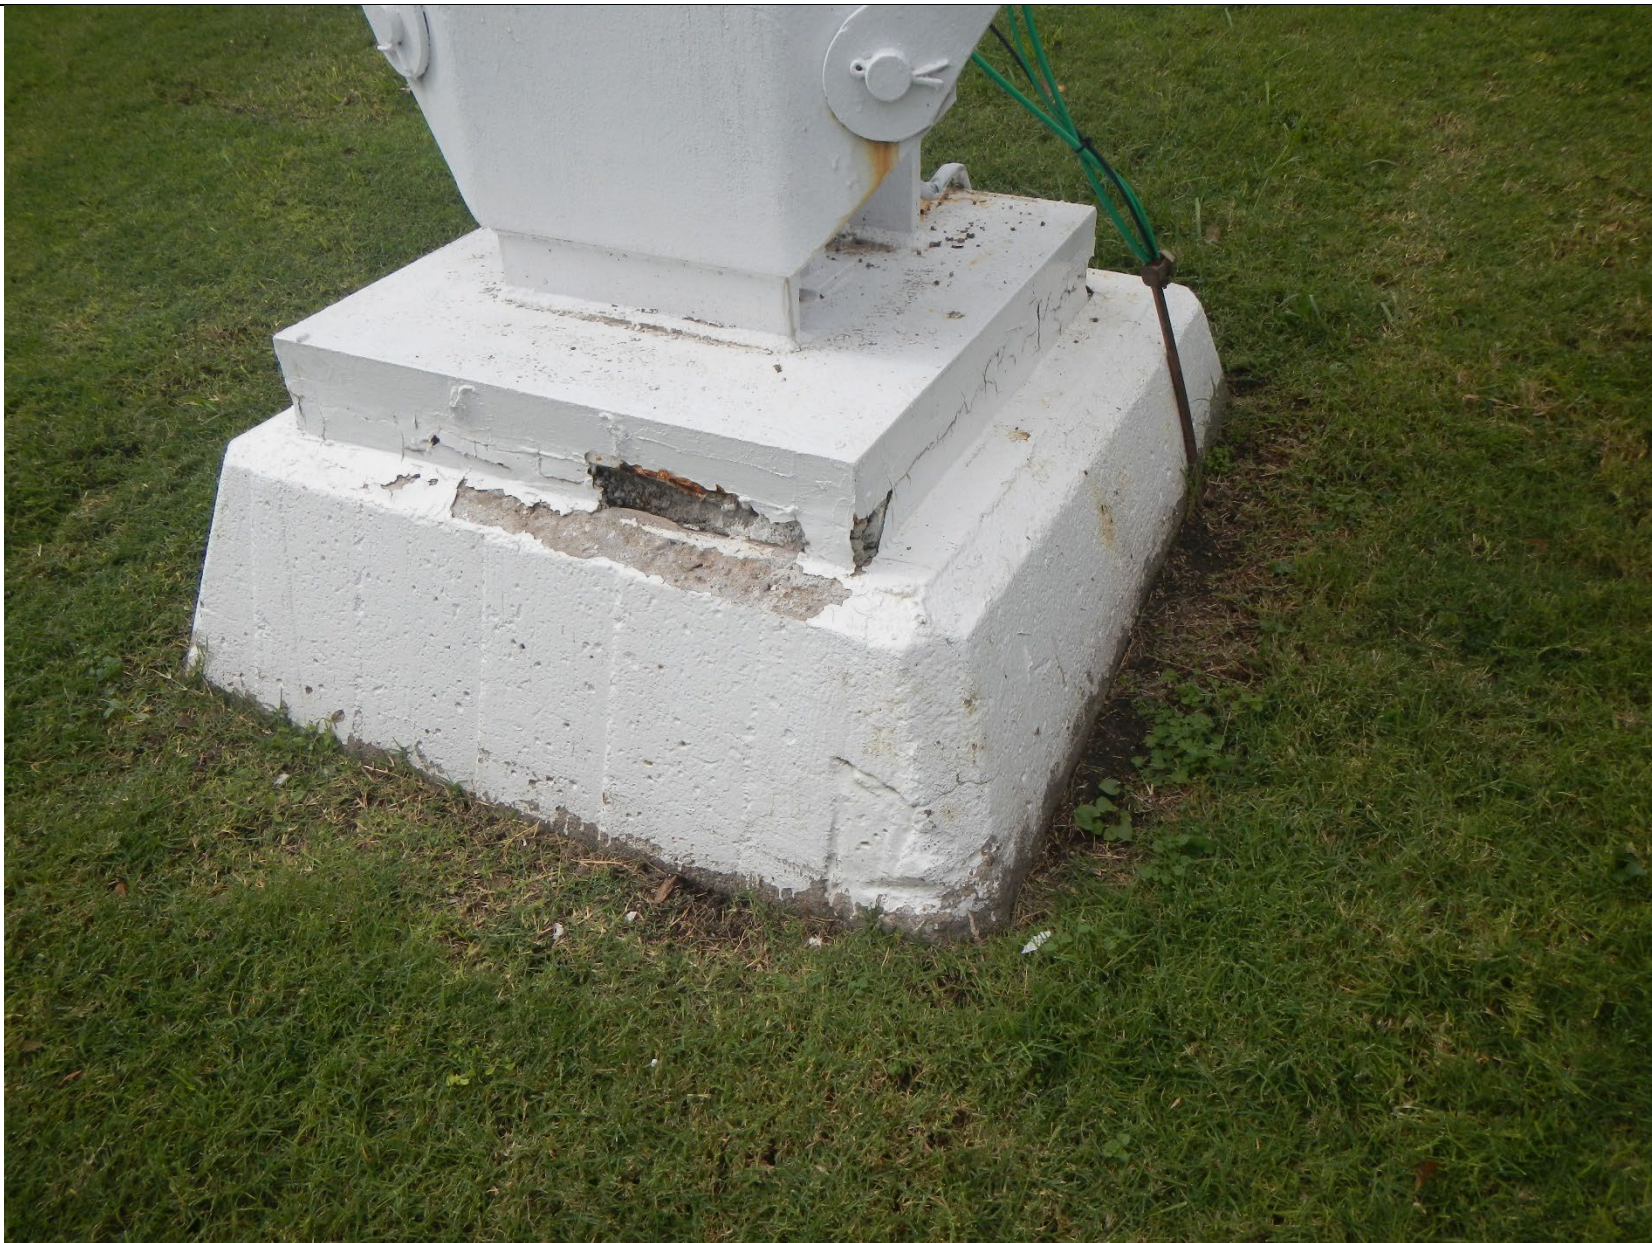
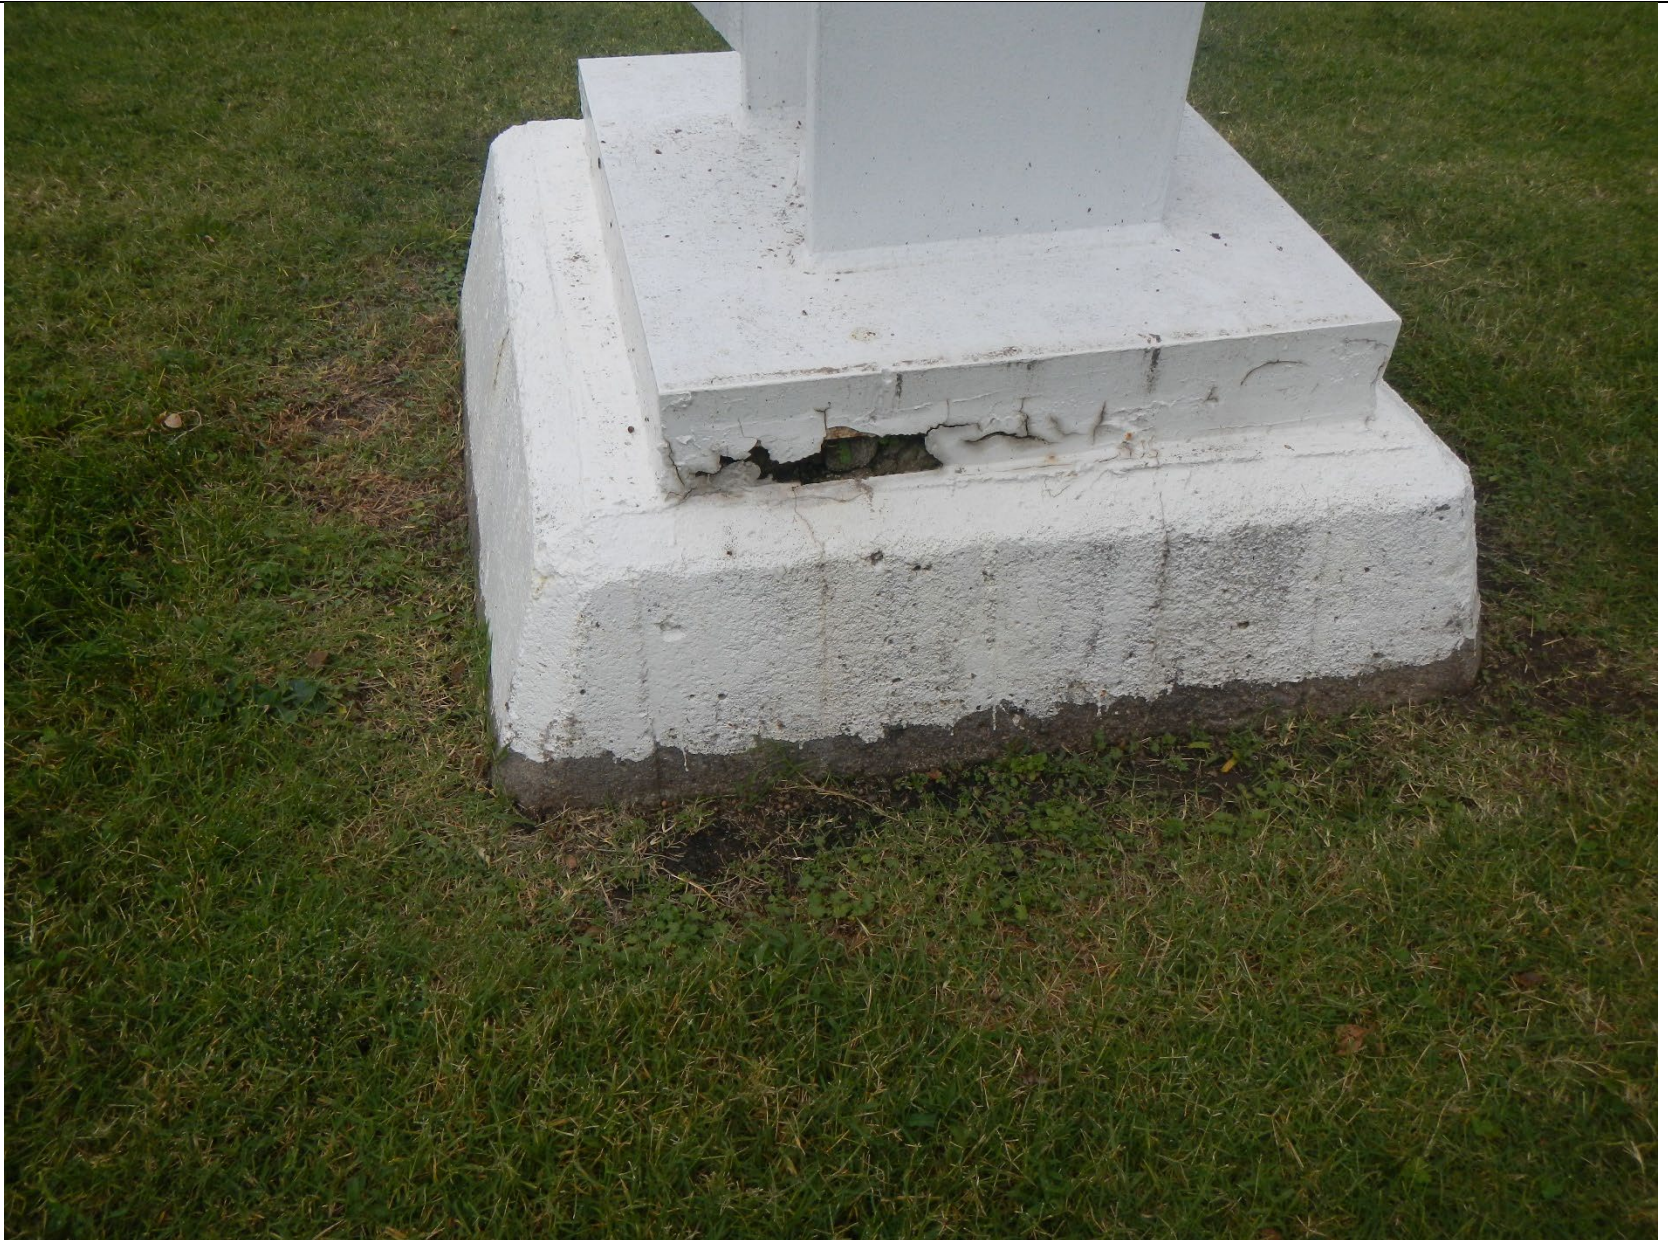
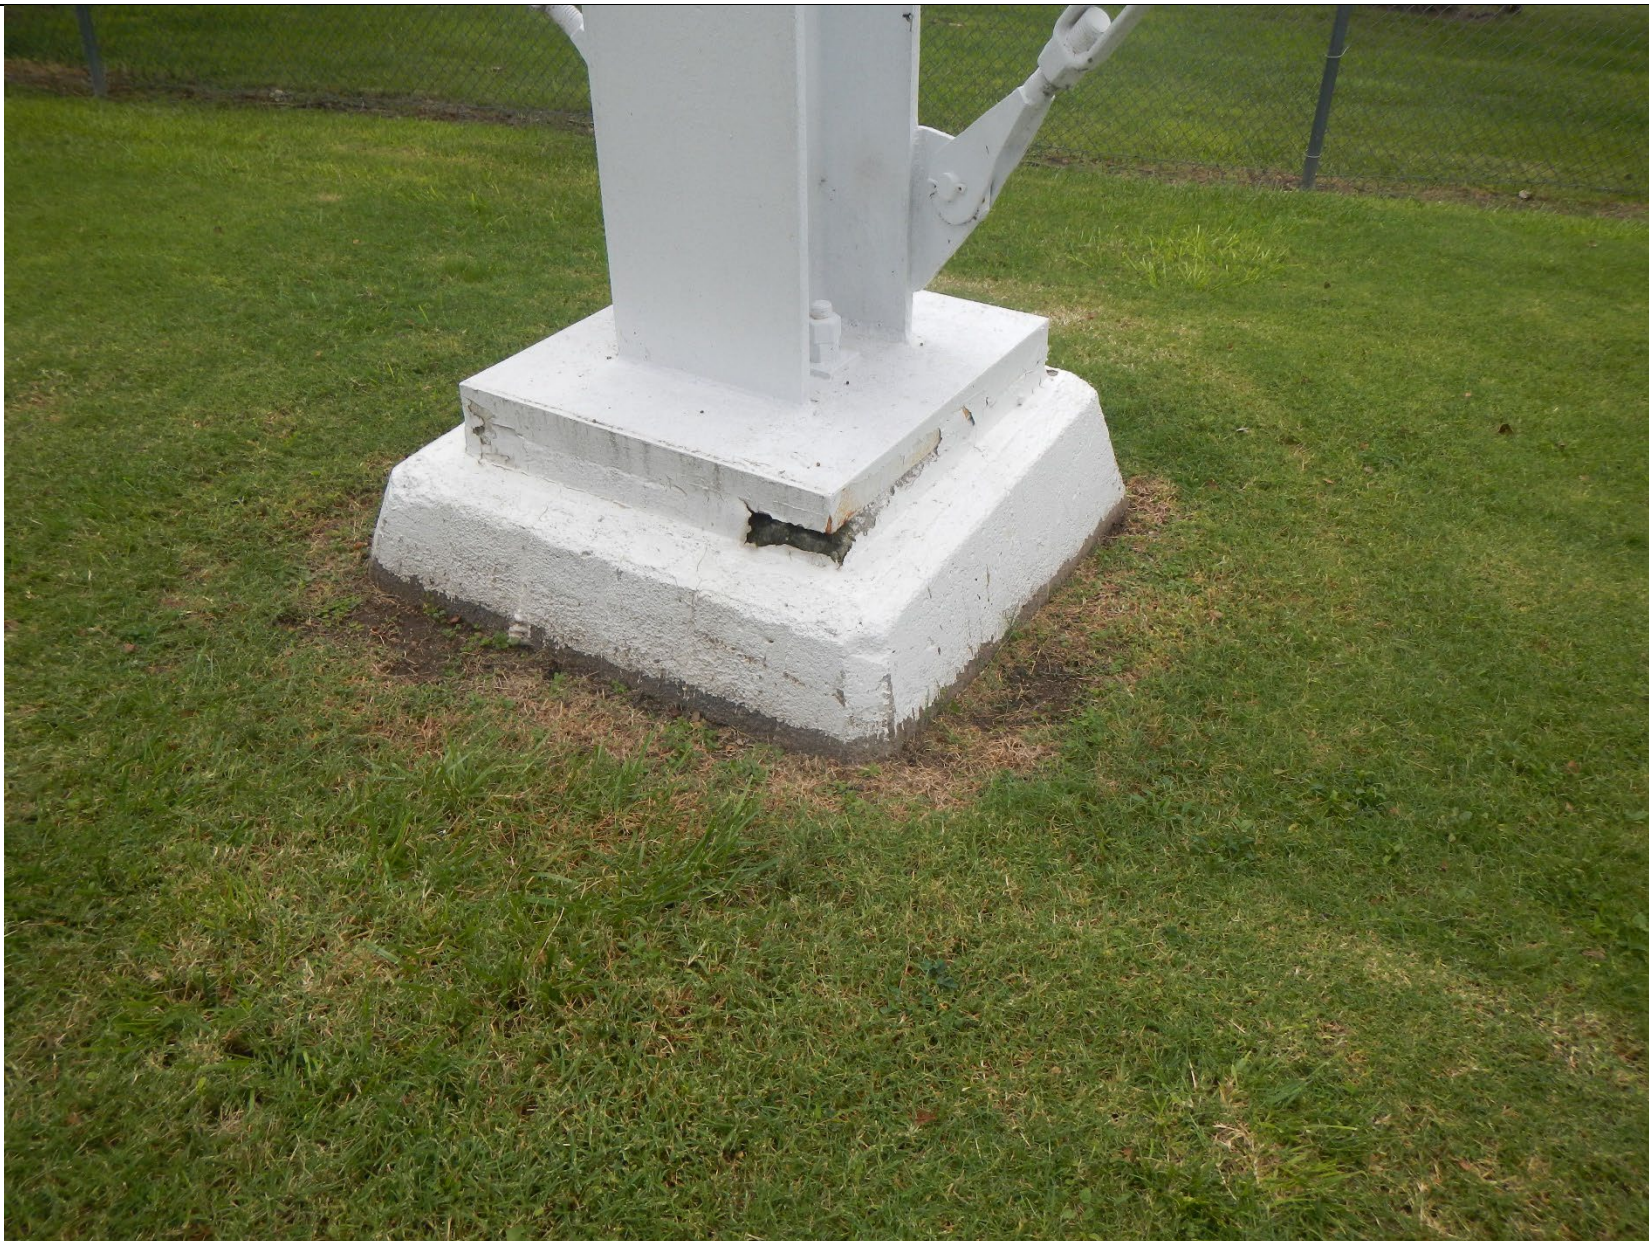
| 40 | DSCN5147.JPG | Minor degradation of the support concrete at Sunset Tower. | 2025:10:08 10:53:29 |

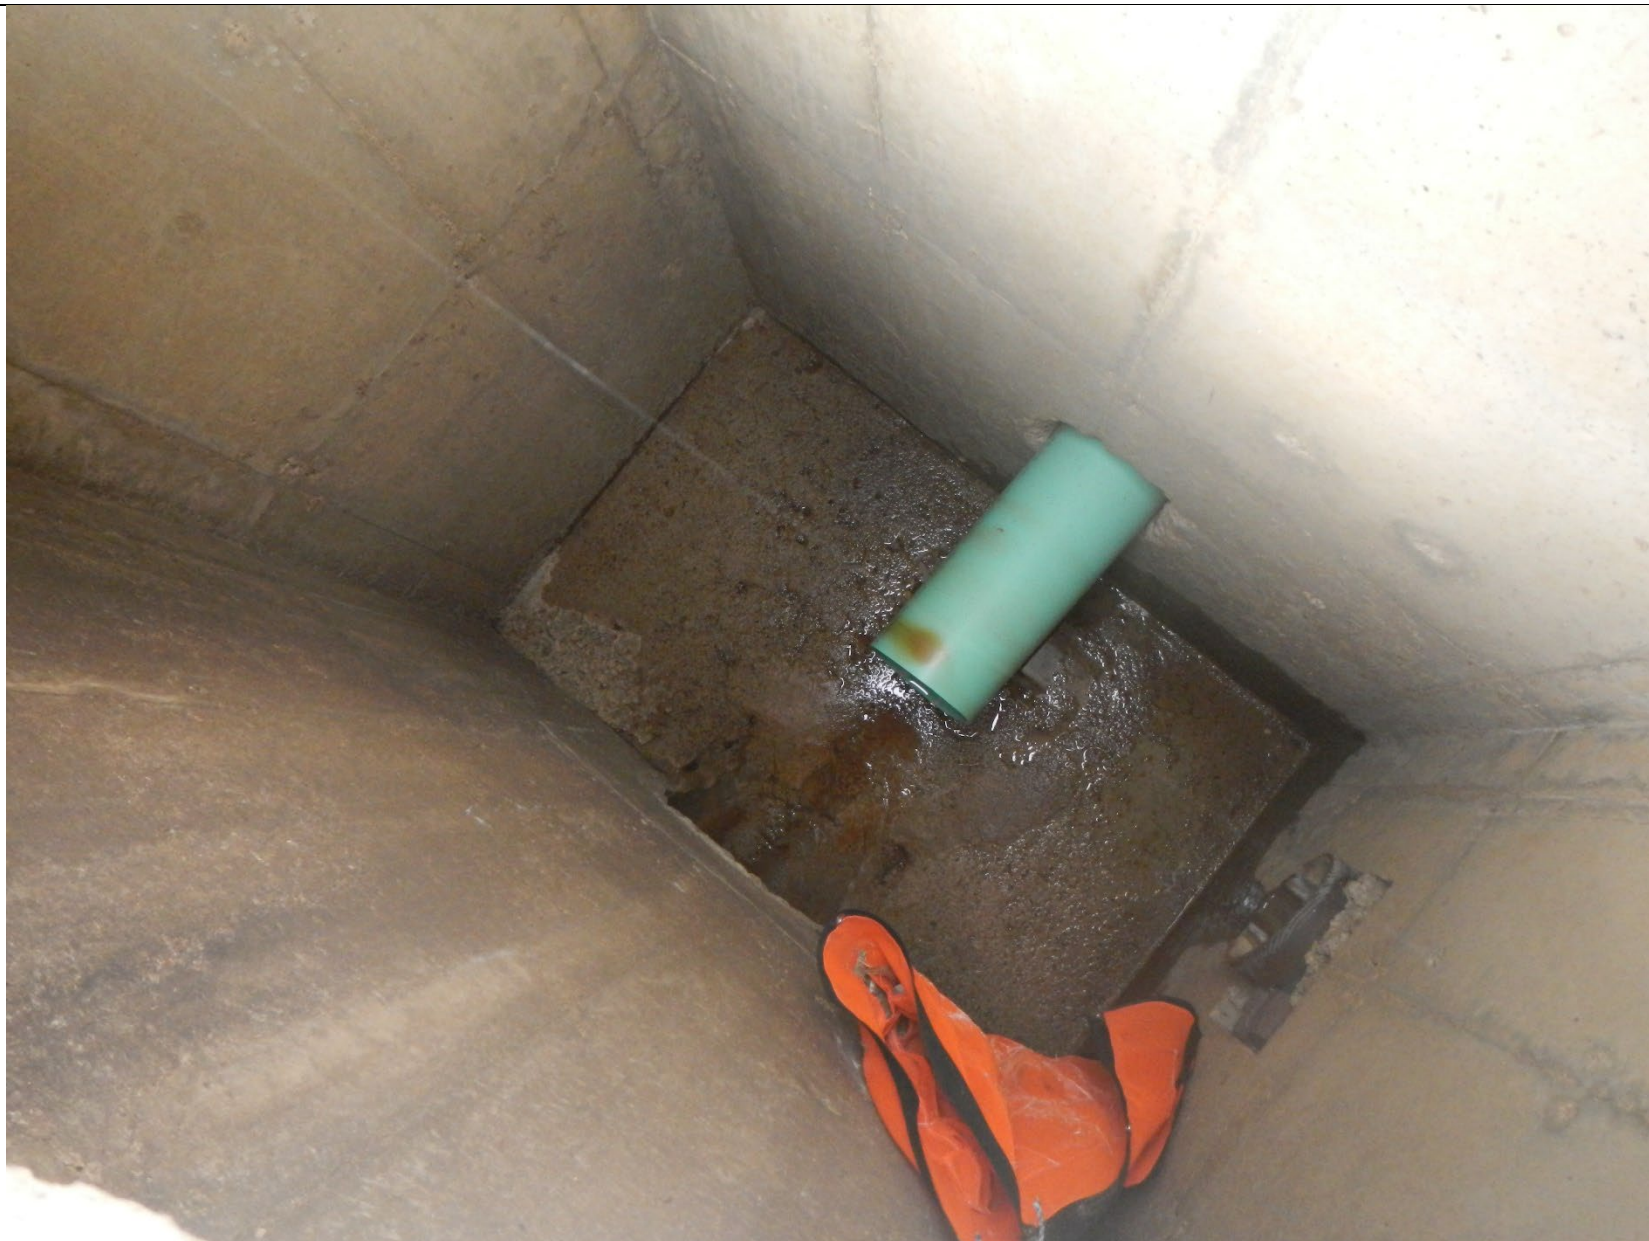
Also, while inspecting the system’s finished water storage structures, I observed that the system’s Gold Tower overflow appeared to be directly connected into the city’s storm sewer system without a visible screen or other backflow prevention (photo 44). This was noted as preliminary finding #5 on the NOPF that was left on-site. After the inspection, I found that the Gold Tower overflow is properly air-gapped and screened inside the tower. This can be seen in the 2023 inspection report for the Gold Tower (attachment 8).

| 44 | DSCN5151.JPG | Gold Tower overflow pipe in the city stormsewer. | 2025:10:08 11:31:28 |

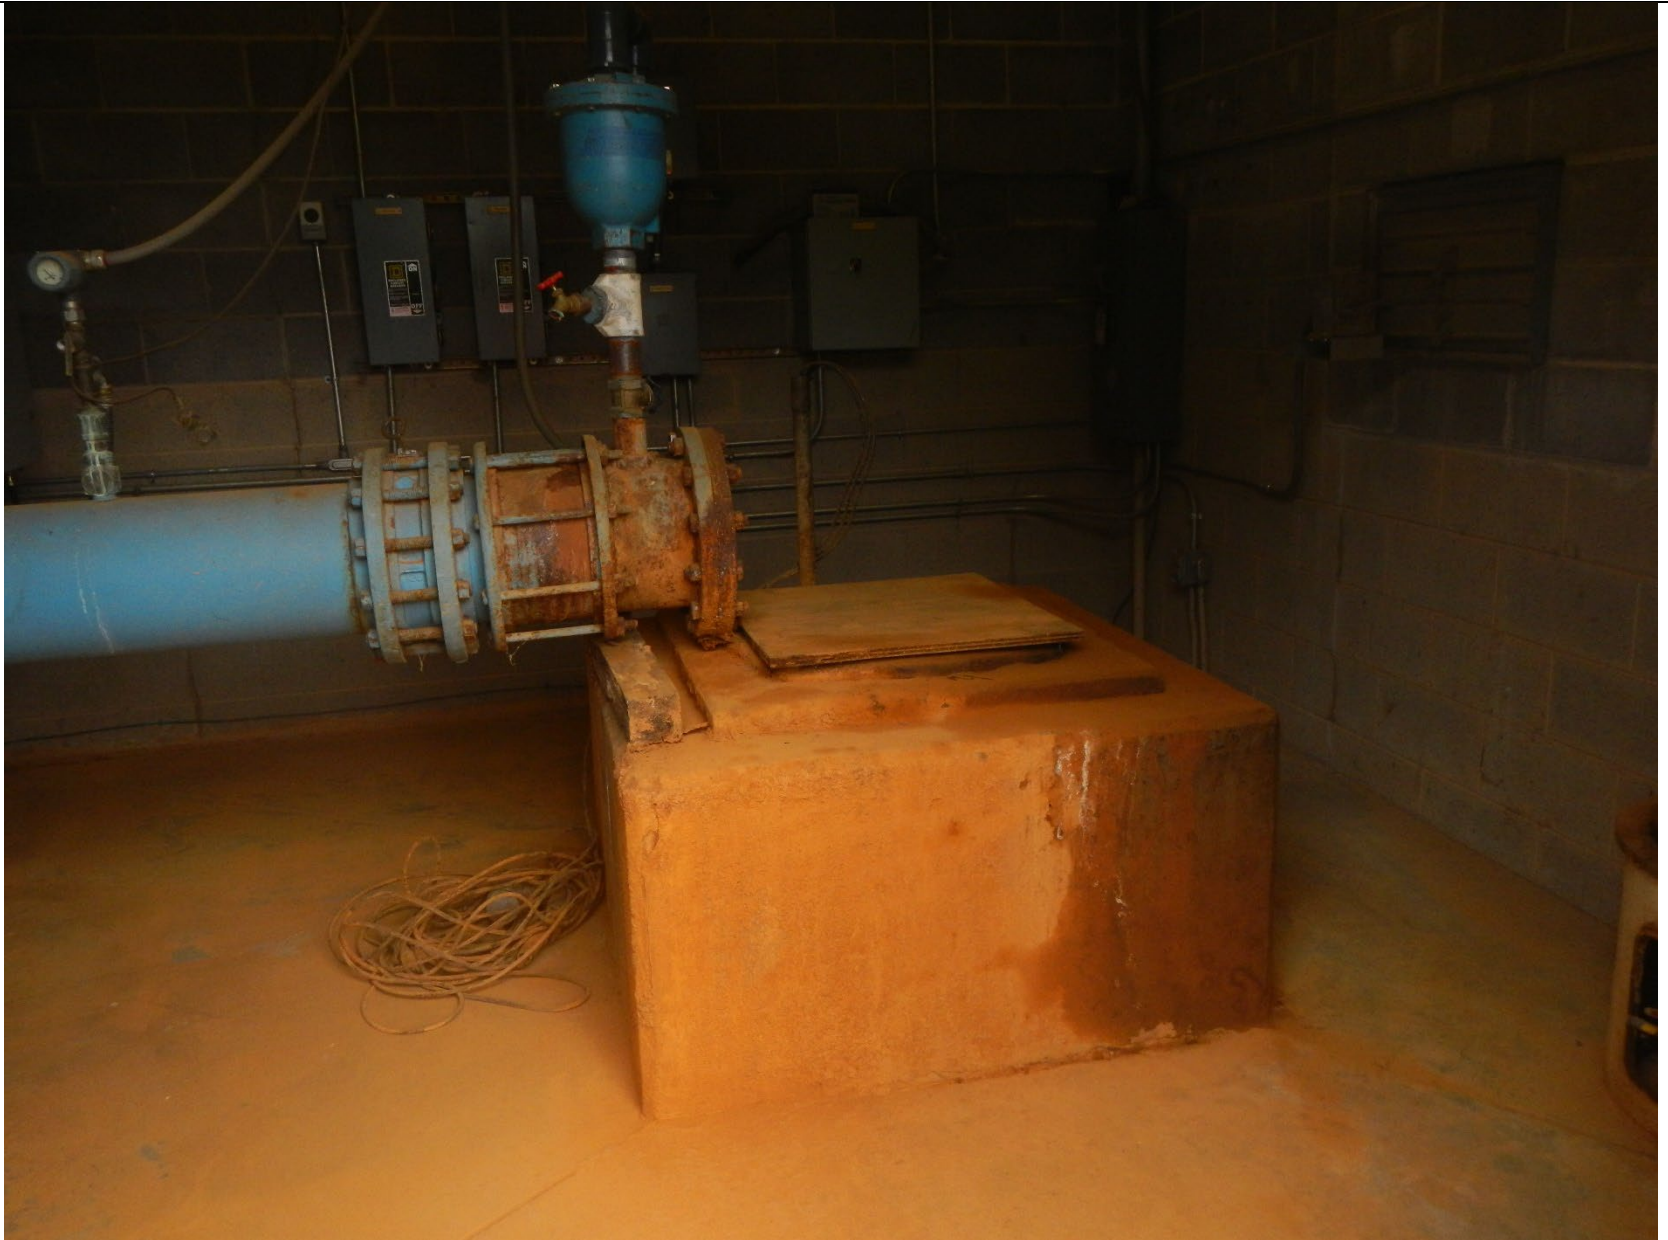
14 and 15) have had their motors and pumps pulled out of the wells and had pieces of plywood set over the well hole at the time of inspection. System personnel explained that they were currently evaluating the wells to determine the best way to put them back in service, and they were most likely not going to abandon the wells. The plywood pieces were not bolted down and had portions of the well open to possible contaminations (photos 48, 50, and 53-55). This was noted as preliminary finding #2 on the Notice of Preliminary Findings that was left with the system after the inspection. In the system's October 10, 2025, response to the two of the initial findings on the NOPF, the system showed that they had secured the plywood boards, properly covering the wells (attachment 5), and no further actions were taken.

| 48 | DSCN5155.JPG | Well #15, no motor or pump, with plywood covering the well opening. | 2025:10:08 13:20:18 |

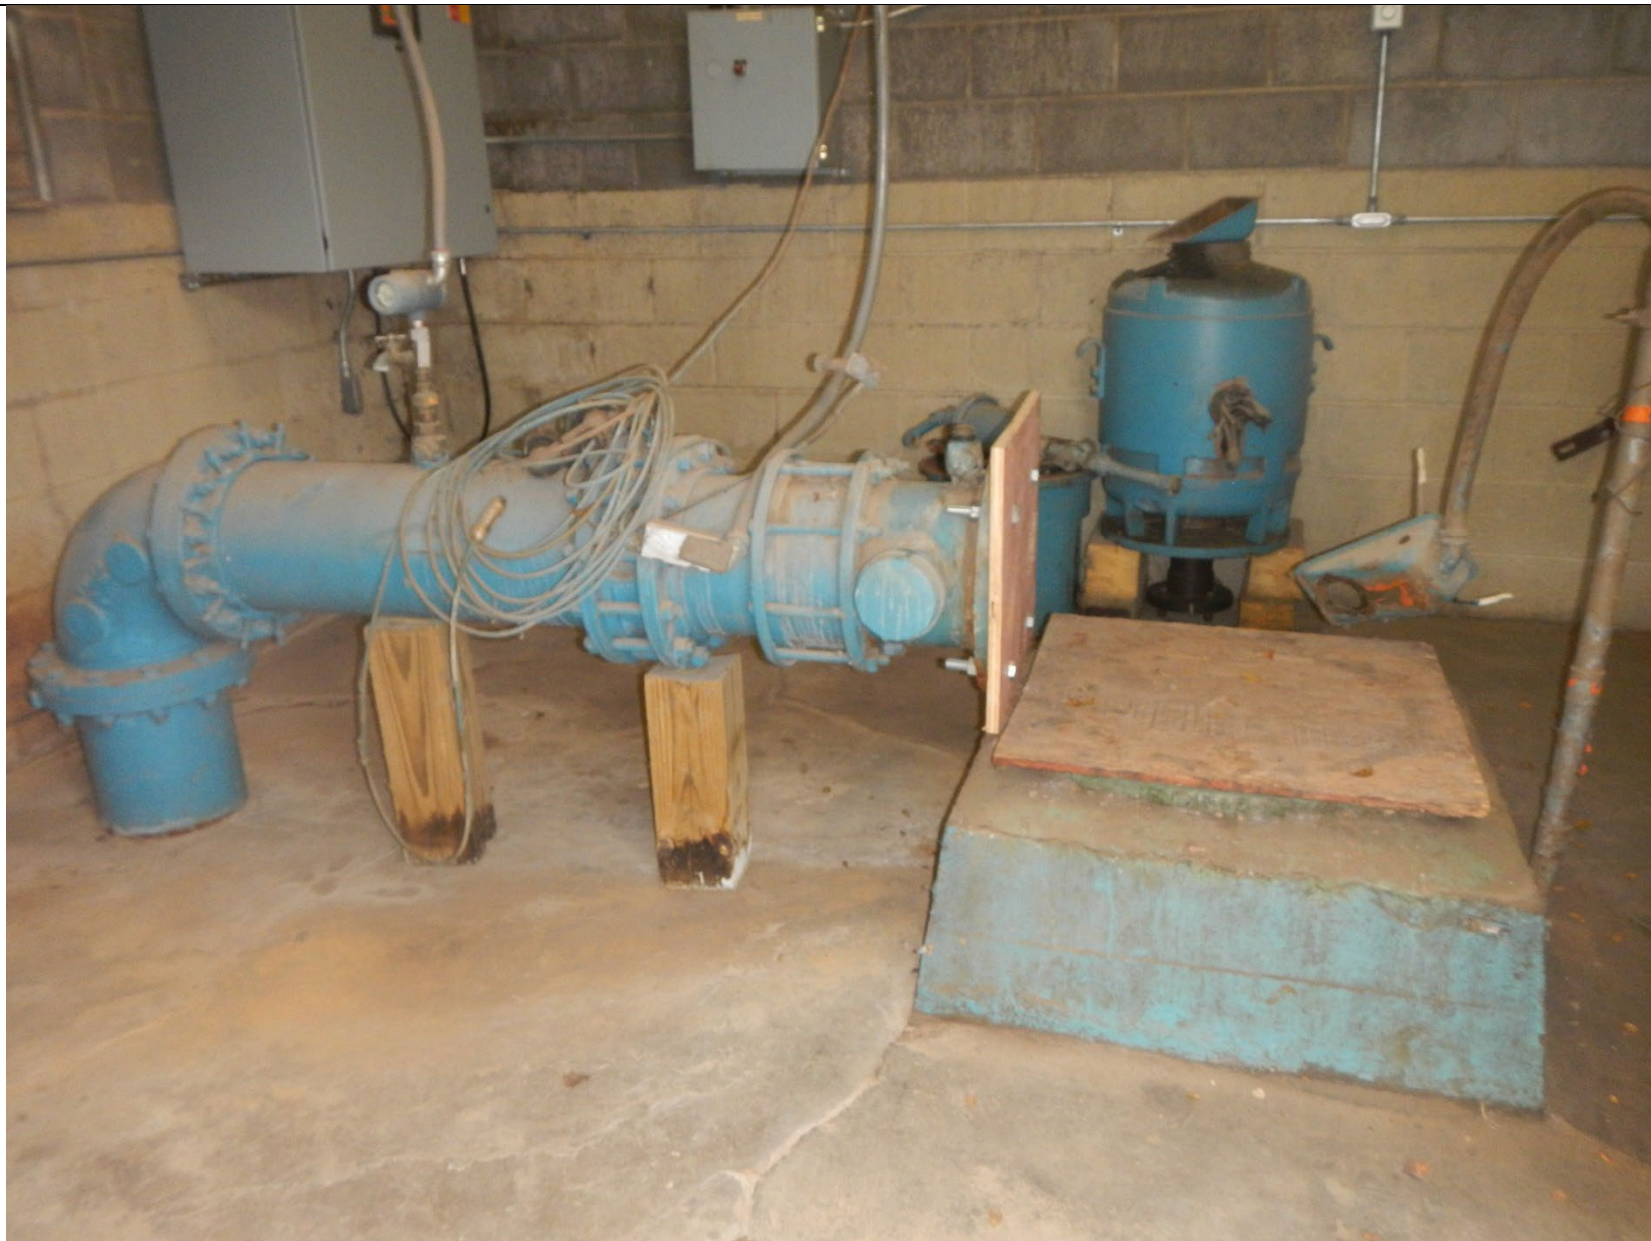
| 50 | DSCN5157.JPG | Well #14, no motor or pump, with plywood covering the well opening. | 2025:10:08 13:39:51 |

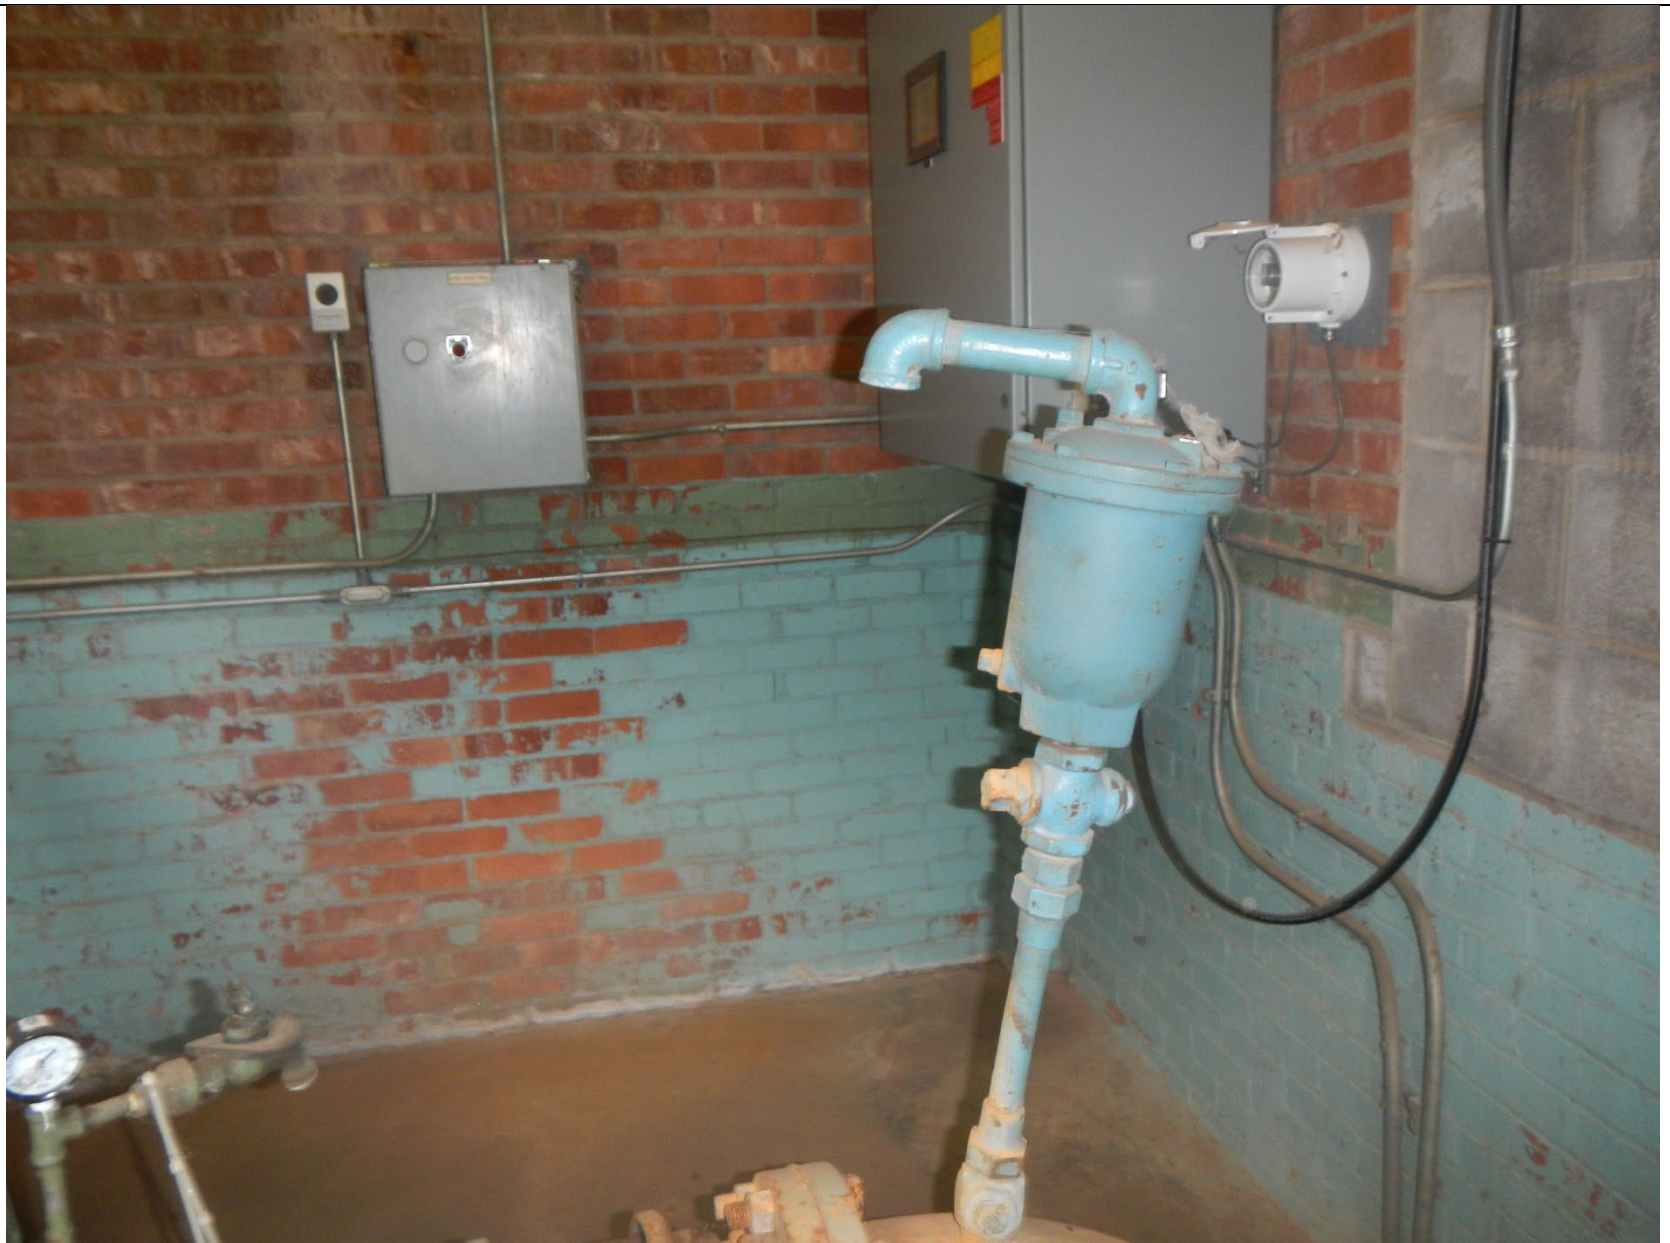
I also observed that the air relief valve (ARV) overflow pipe on multiple wells that were not screened and were open to possible contamination (photos 51, 52, and 60). This was noted as part of preliminary finding #4 on the NOPF provided to the system. The wells appeared to be well maintained and in proper working condition during my inspection.

| 51 | DSCN5158.JPG | Well #7, no screen on the ARV discharge pipe. | 2025:10:08 13:44:44 |

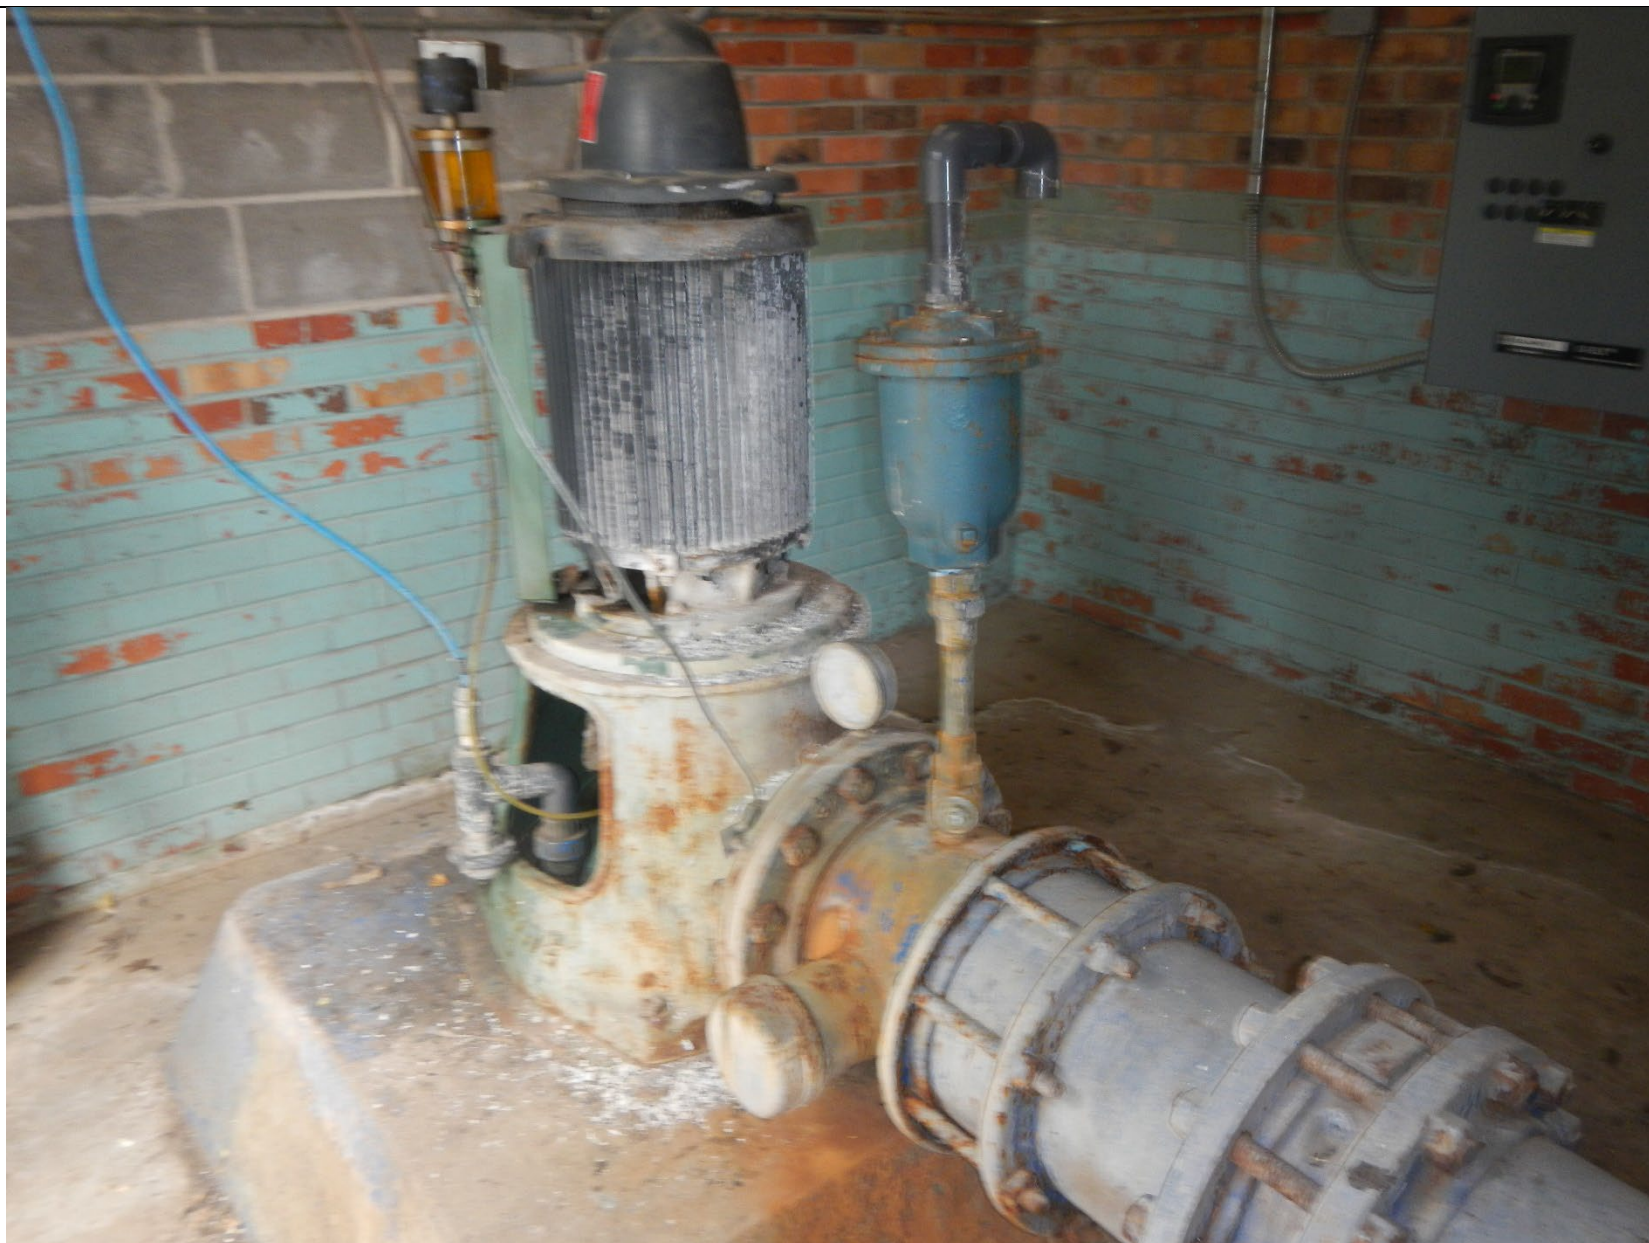
| 52 | DSCN5159.JPG | Well #11, no screen on the ARV discharge pipe. | 2025:10:08 13:52:46 |

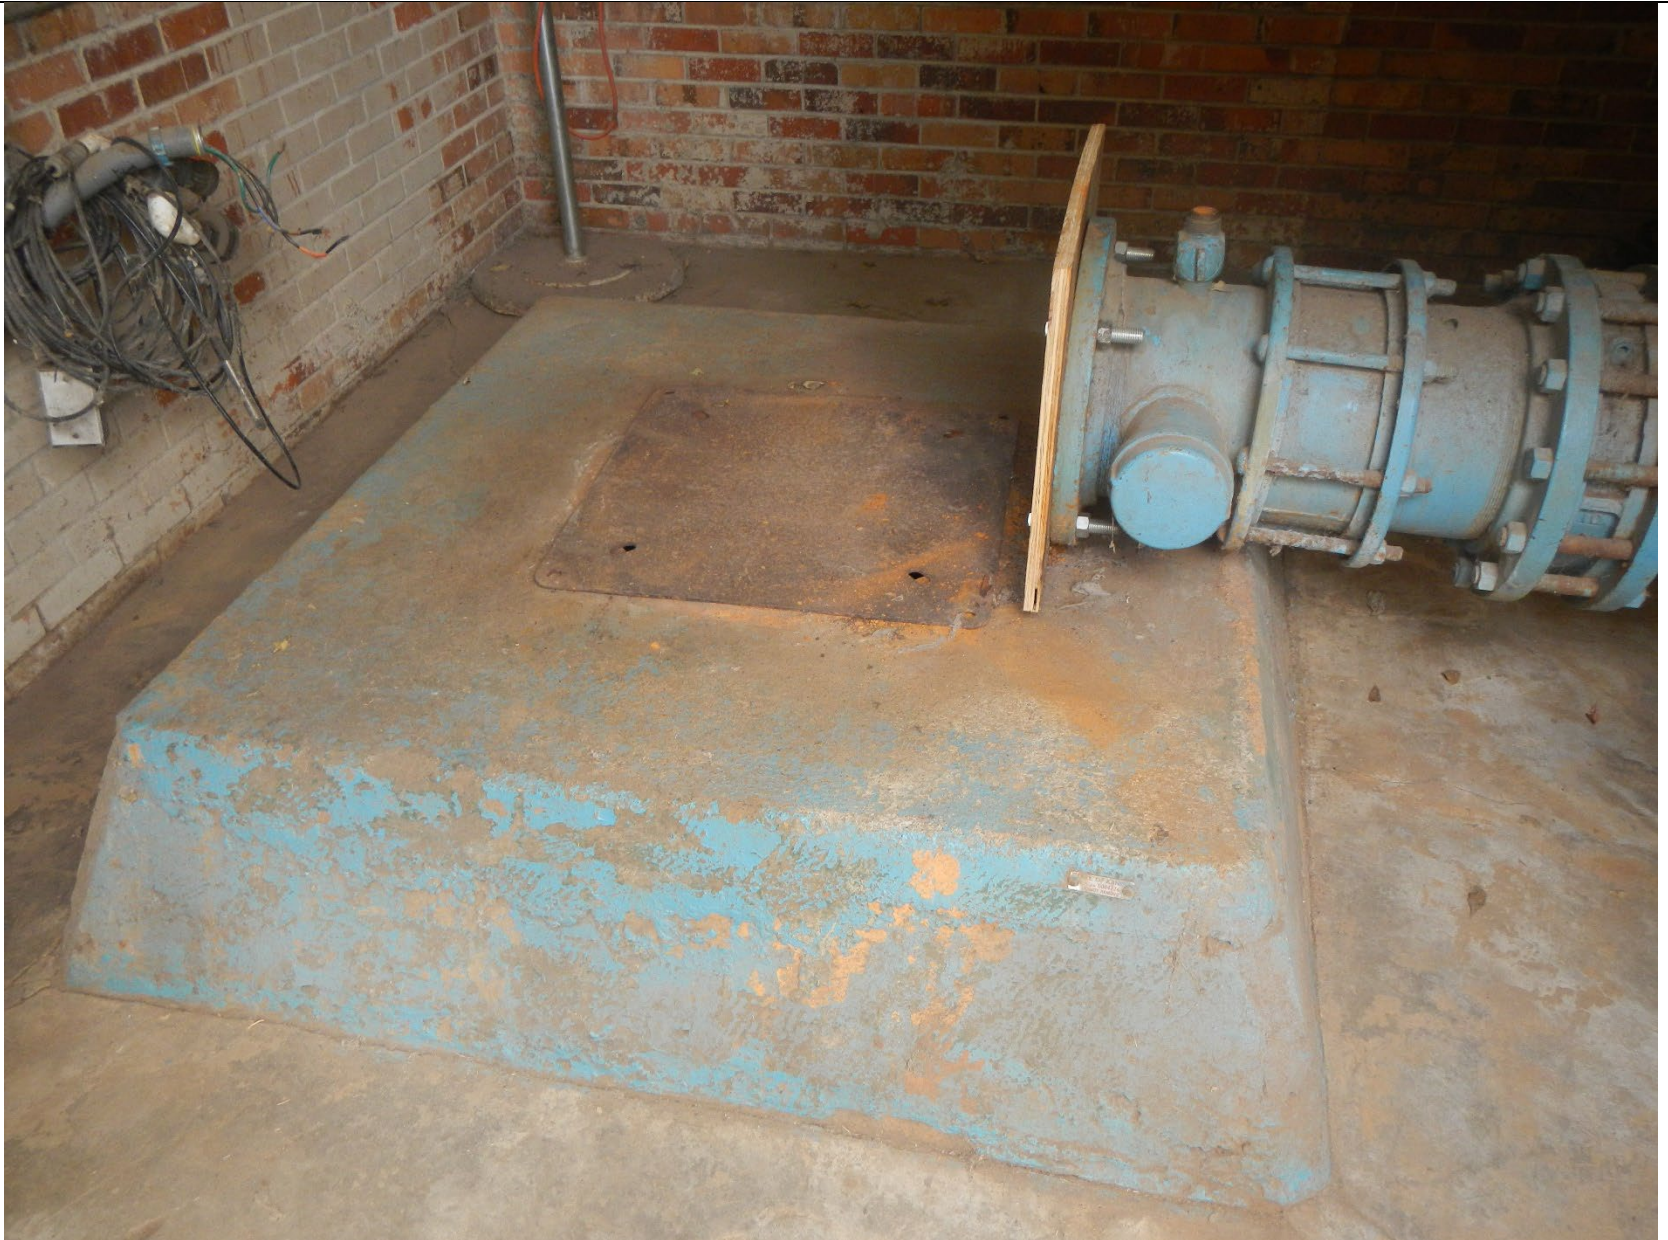
| 53 | DSCN5160.JPG | Well #12, no motor or pump, with plywood covering the well opening. | 2025:10:08 13:58:15 |

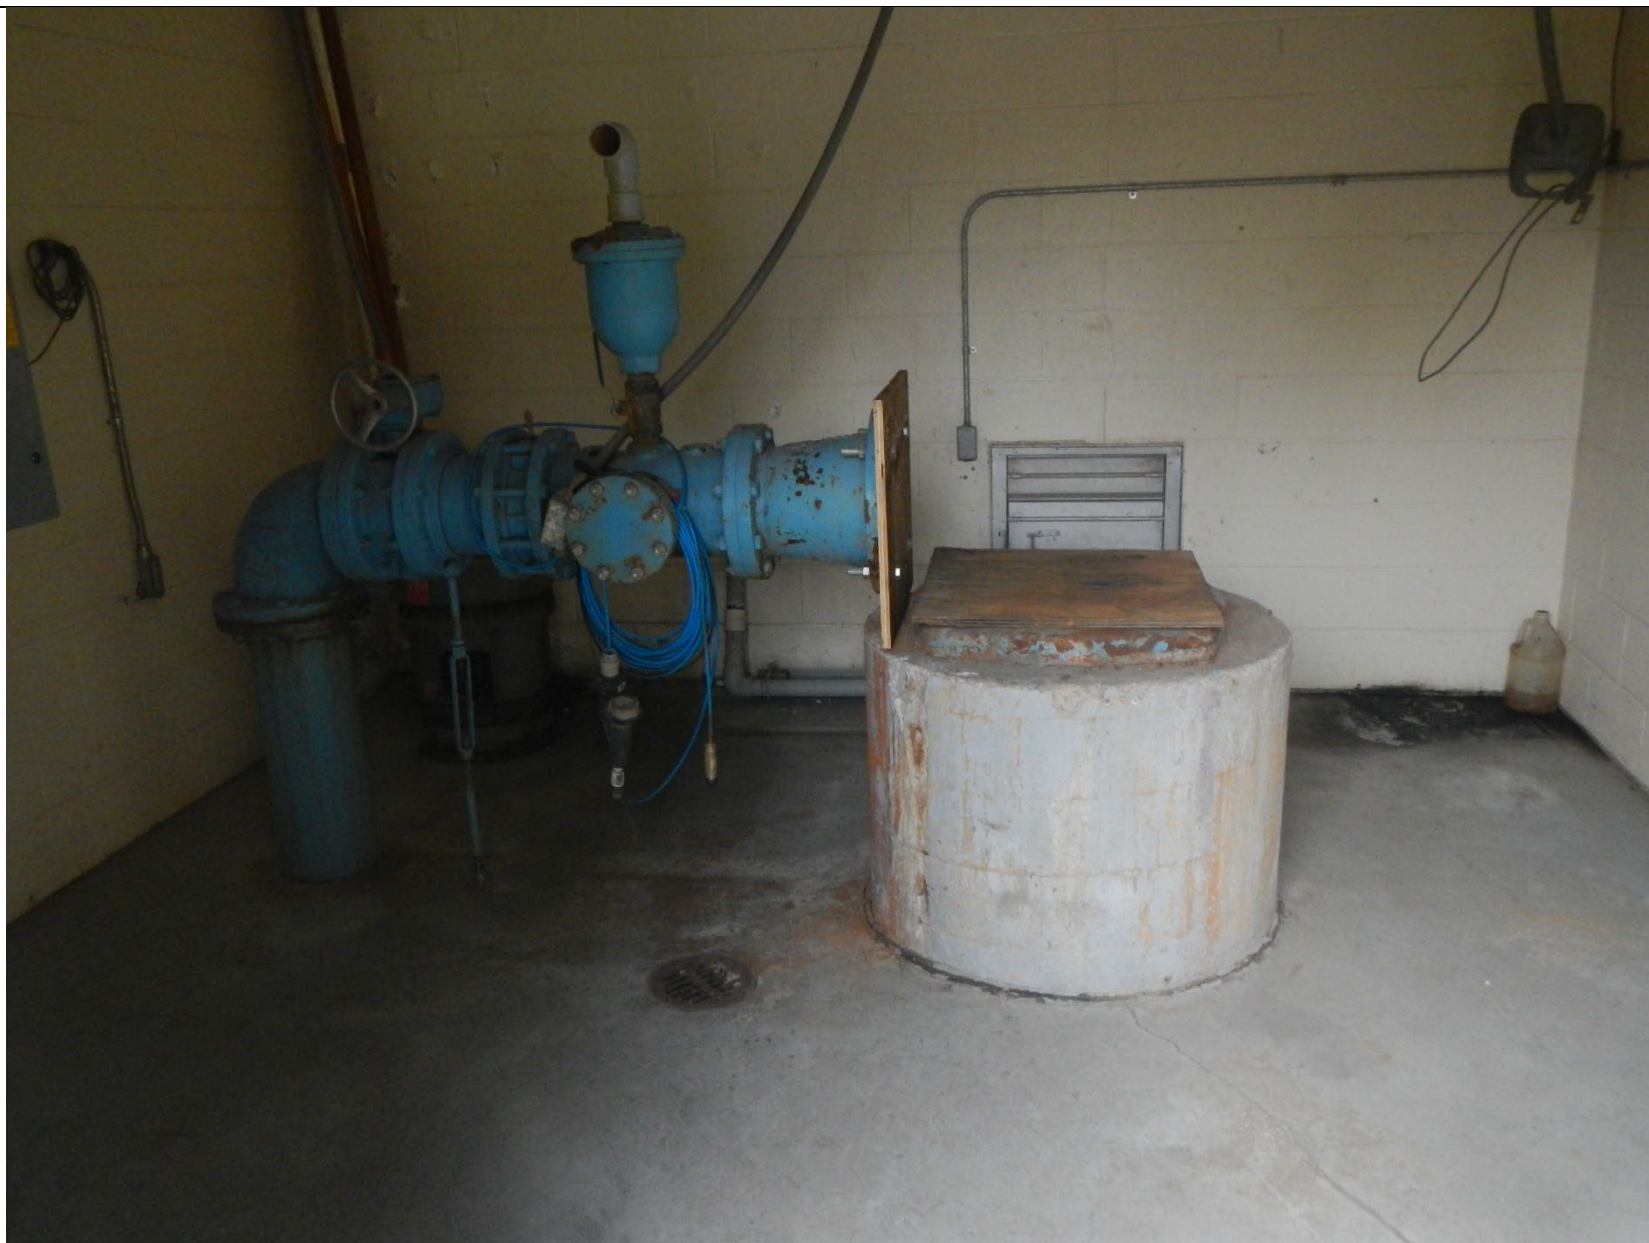
| 54 | DSCN5161.JPG | Well #13, no motor or pump, with plywood covering the well opening. | 2025:10:08 14:04:26 |
