# **REPORT OF COMPLIANCE EVALUATION INSPECTION**

AT  
City of Salina Public Water Supply  
300 West Ash Street  
Salina, Kansas 67402

October 7-9, 2025

BY  
U.S. ENVIRONMENTAL PROTECTION AGENCY  
Region 7  
Enforcement and Compliance Assurance Division (ECAD)

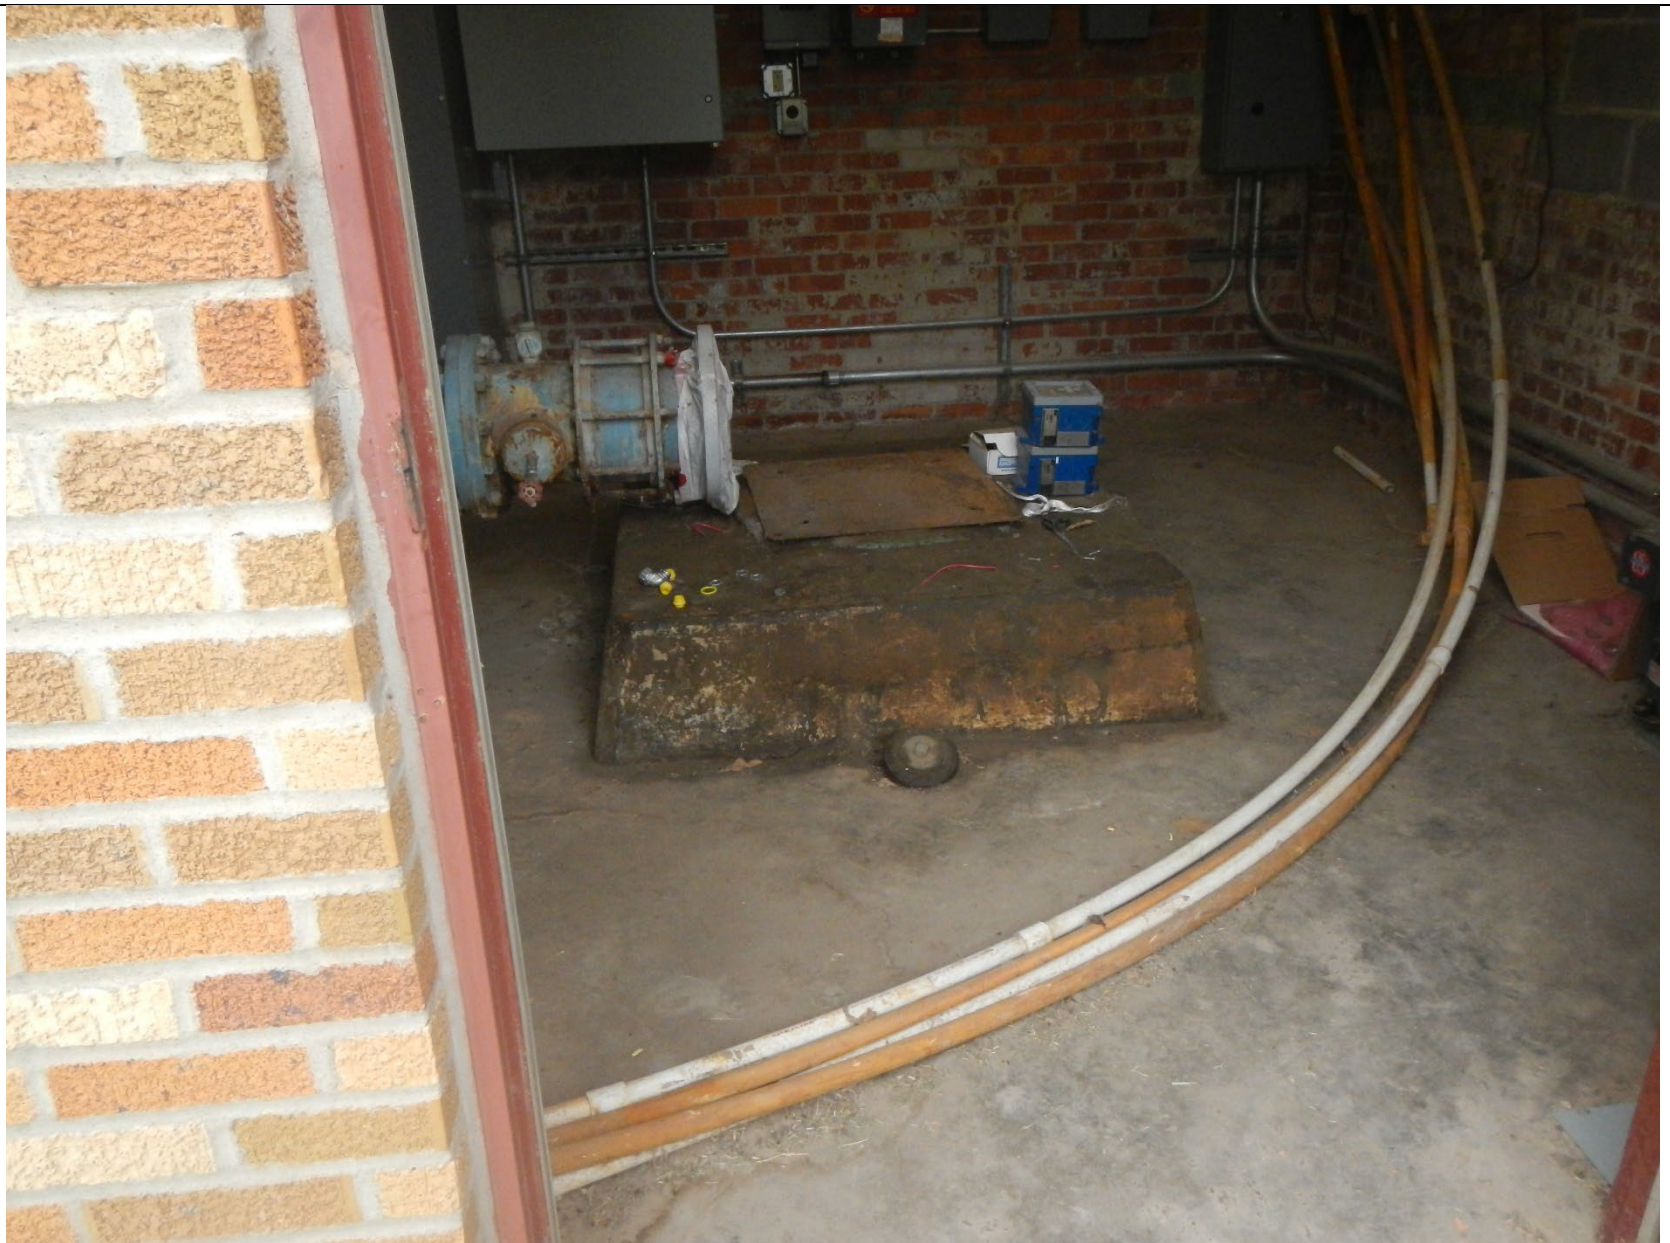
14 and 15) have had their motors and pumps pulled out of the wells and had pieces of plywood set over the well hole at the time of inspection. System personnel explained that they were currently evaluating the wells to determine the best way to put them back in service, and they were most likely not going to abandon the wells. The plywood pieces were not bolted down and had portions of the well open to possible contaminations (photos 48, 50, and 53-55). This was noted as preliminary finding #2 on the Notice of Preliminary Findings that was left with the system after the inspection. In the system's October 10, 2025, response to the two of the initial findings on the NOPF, the system showed that they had secured the plywood boards, properly covering the wells (attachment 5), and no further actions were taken.

| 55 | DSCN5162.JPG | Well #8, no motor or pump, with plywood covering the well opening. | 2025:10:08 14:11:16 |

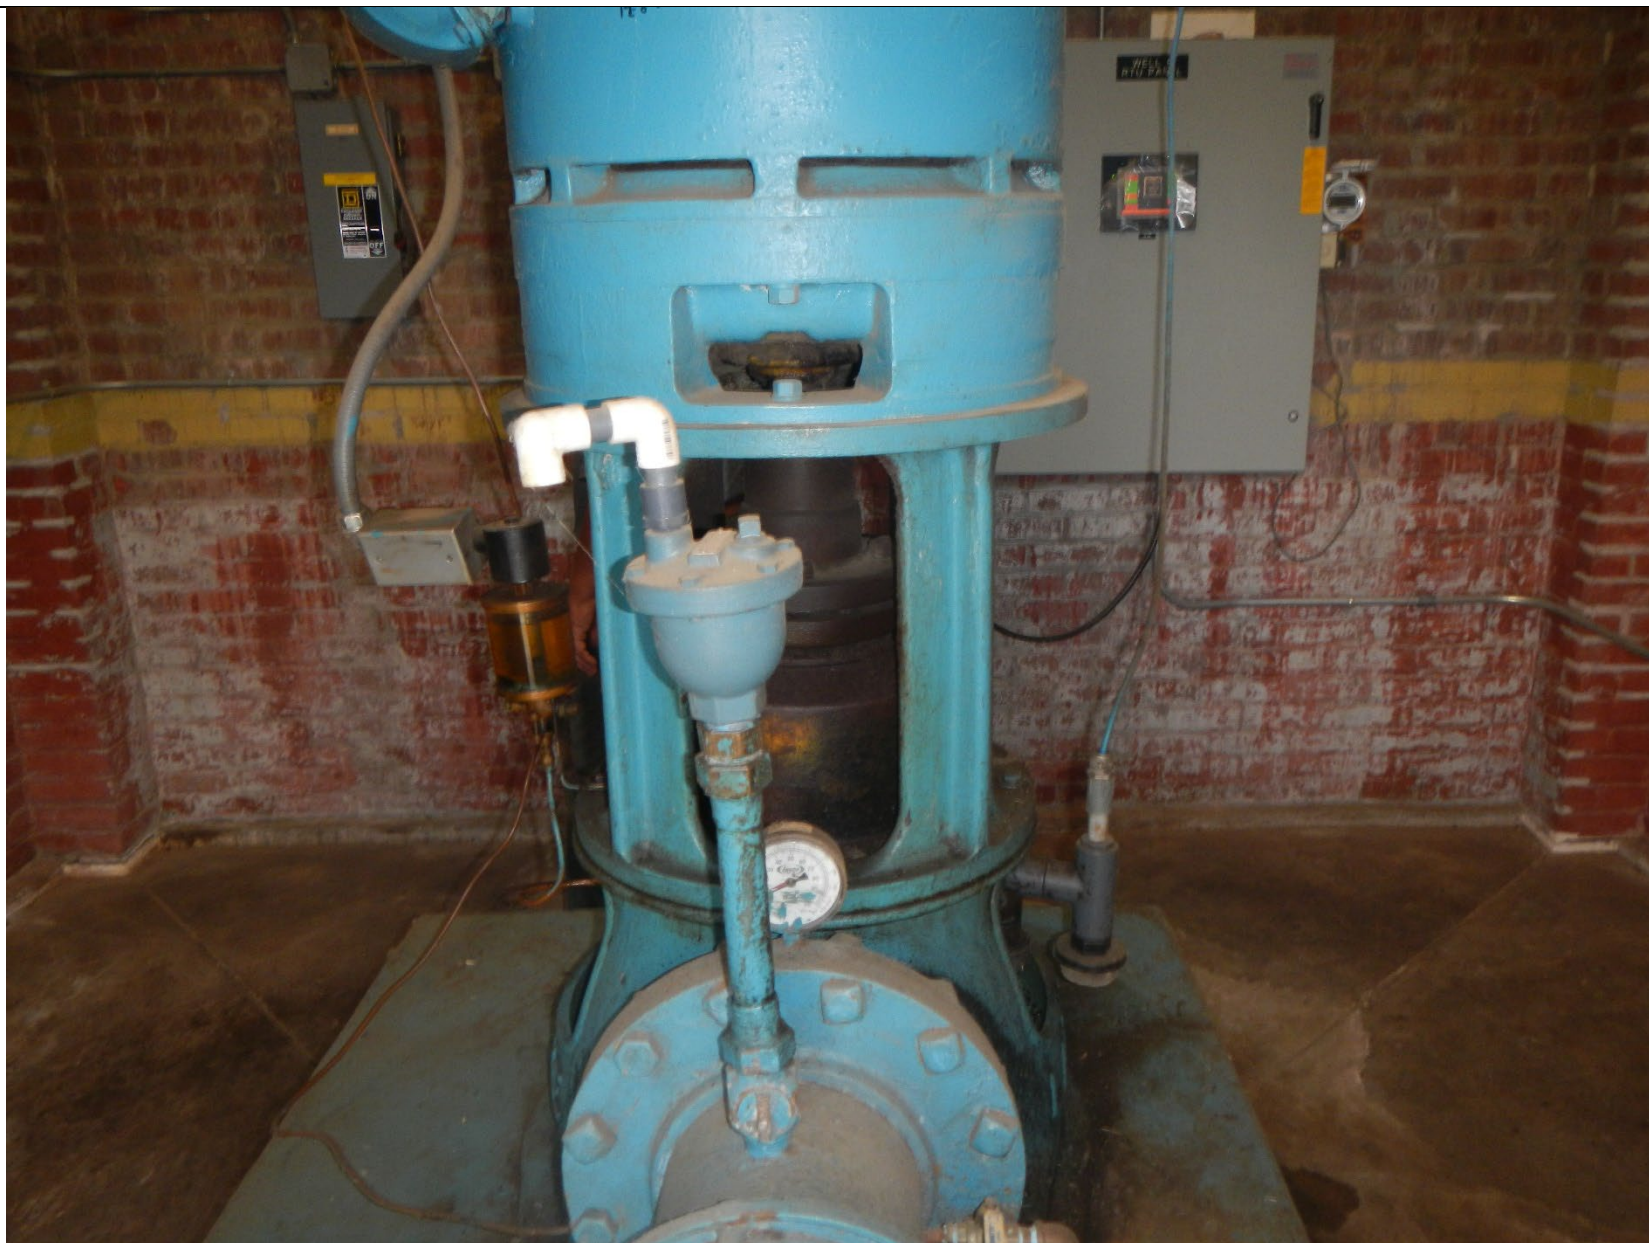
I also observed that the air relief valve (ARV) overflow pipe on multiple wells that were not screened and were open to possible contamination (photos 51, 52, and 60). This was noted as part of preliminary finding #4 on the NOPF provided to the system. The wells appeared to be well maintained and in proper working condition during my inspection.

| 60 | DSCN5167.JPG | Well #5, no screen on the ARV discharge pipe. | 2025:10:08 14:53:15 |

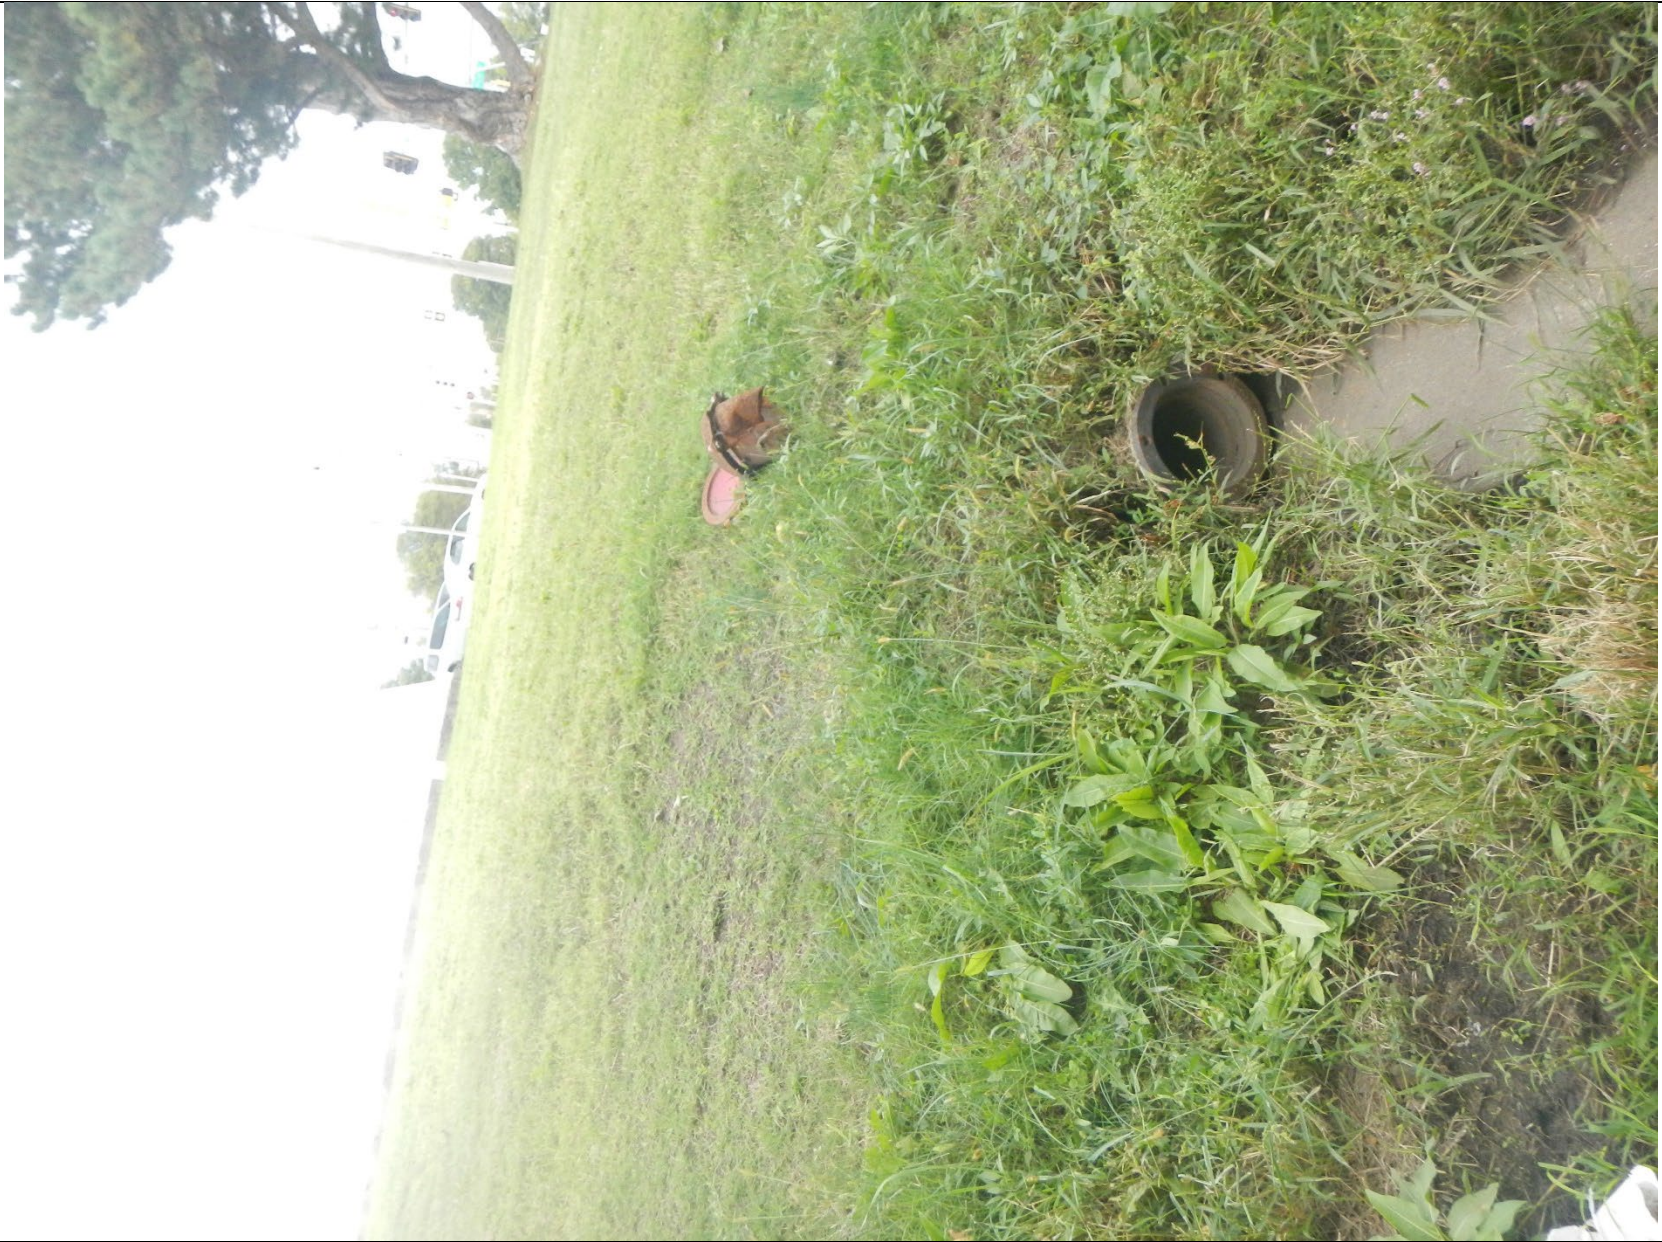
While inspecting the system’s finished water storage structures, I also observed that multiple overflow pipes were screened with mesh larger than 24-mesh (photo 39) or were missing a screen (photos 19, 21, 36, and 61). This was noted as preliminary finding #3 on the NOPF that was left on-site. In the system’s October 10, 2026, response, they noted that KDHE minimum design standards (MDS) required screens to have openings less than 0.25-inch (4-mesh) on overflow pipes. System personnel asked if Region 7 recommended the less than 0.25-inch screen or the 24-mesh screen. While the system would only be required to use the less than 0.25-inch screen in KDHE’s MDS, EPA highly recommends system’s use 24 mesh screen or smaller. Also, KDHE’s MDS requires that if the overflow pipe has a flap gate, it must be self-closing and have an integral screen.

| 61 | DSCN5168.JPG | Key Acres tower overflow discharge. Flapper was missing and had no screen. | 2025:10:08 15:14:18 |
