**U.S. ENVIRONMENTAL PROTECTION AGENCY, REGION III  
ENFORCEMENT AND COMPLIANCE ASSURANCE DIVISION  
WATER BRANCH – NPDES SECTION (3ED32) CLEAN WATER ACT  
COMPLIANCE INSPECTION REPORT**

**Name of Facility:** Lancaster Township MS4  
**Facility Address:** 1240 Maple Avenue, Lancaster, PA 17603  
**Mailing Address:** 1240 Maple Avenue, Lancaster, PA 17603

Report Prepared on: April 9, 2022 By: Taylor Fontaine  
*Date* Taylor Fontaine, Environmental Scientist  
(PG Environmental, EPA Contractor)

| <b>Type of Inspection:</b> | MS4 Compliance Inspection |

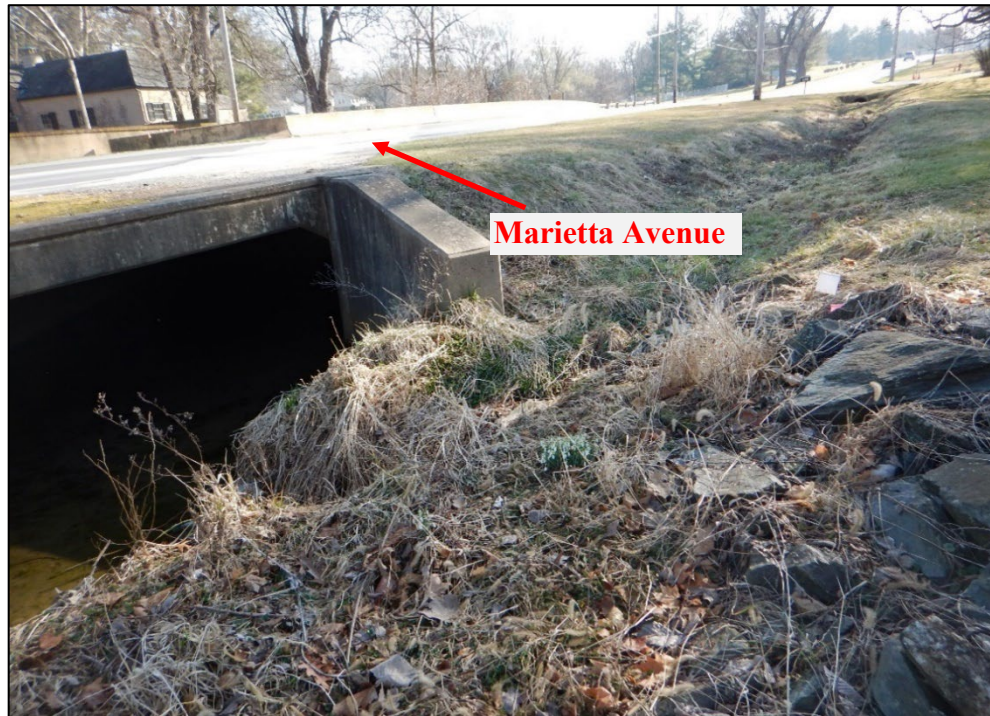
**Photograph 1.** Township Site for Potential Floodplain Restoration BMP: (DSCN2823) View, facing northeast, upstream of the site along Marietta Avenue. The pictured stormwater conveyance is located within the Pennsylvania Department of Transportation (PennDOT) right-of-way and is maintained by PennDOT.

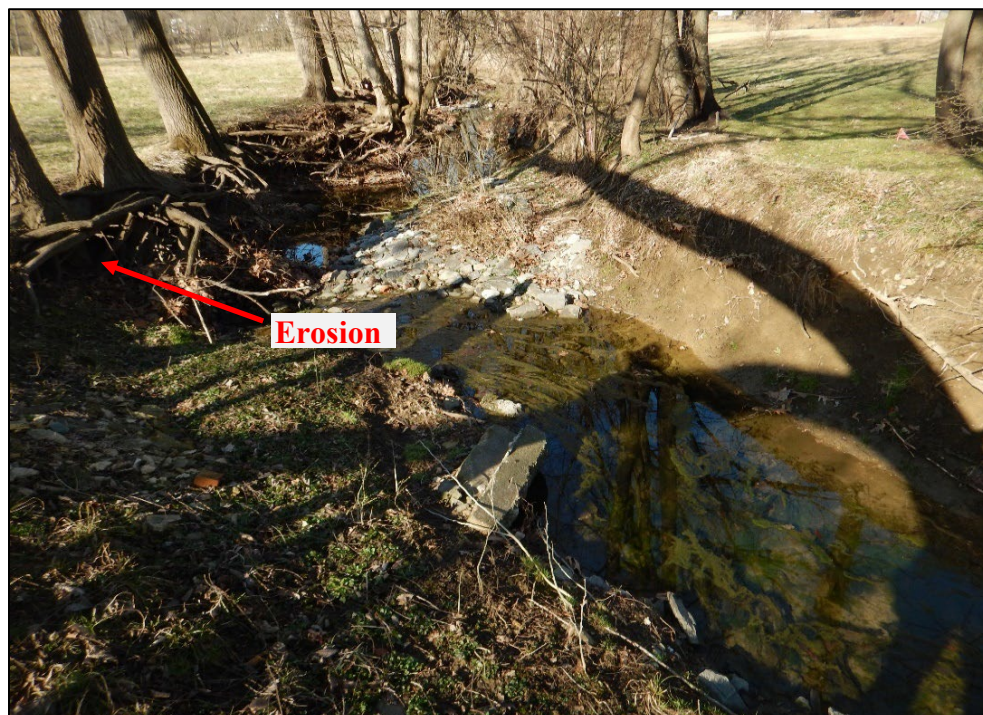
- 1) The EPA Inspection Team observed the planned location for a floodplain restoration BMP. The Township representative stated that the goal of the project is to restore the streambank that had become eroded (refer to [Photographs 1 through 4](#)), and to reduce sediment and nutrient loadings to Little Conestoga Creek. The approximate planned development timeline of the project was not confirmed at the time of the inspection.

**Photograph 2.** Township Site for Potential Floodplain Restoration BMP: (DSCN2823) View, facing west, of observed streambank erosion that has exposed the adjacent tree roots.

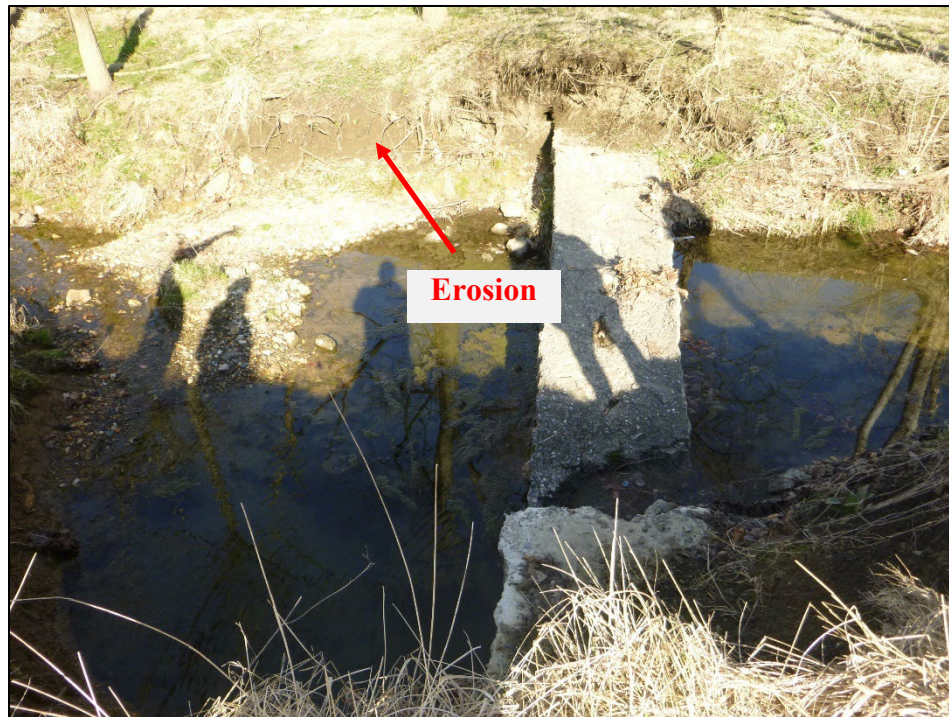
**Photograph 3.** Site for Potential Floodplain Restoration BMP: (DSCN2828) View, facing north, of observed streambank erosion and an exposed concrete encasement for a sanitary sewer pipe.

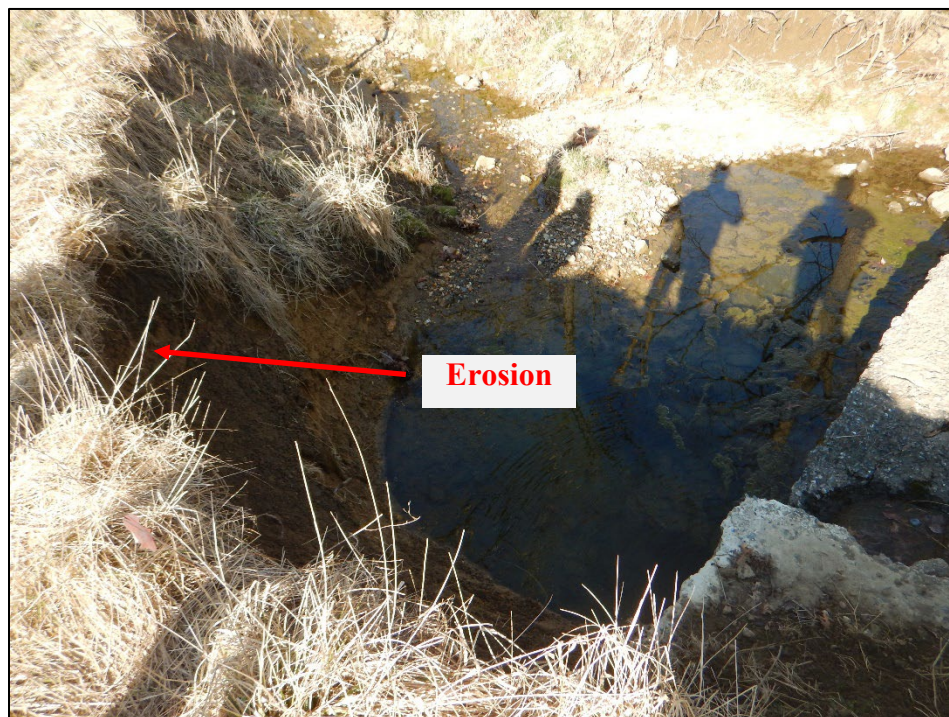
**Photograph 4.** Site for Potential Floodplain Restoration BMP: (DSCN2829) Additional view of observed streambank erosion.

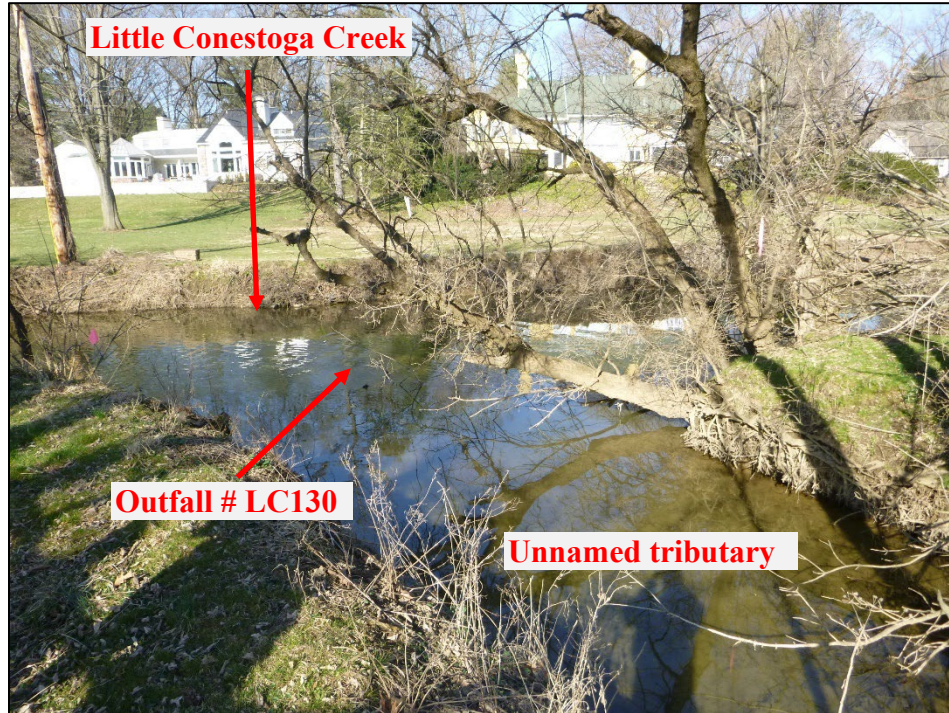
- 1) Outfall #LC130 is identified on the Township’s MS4 mapping, and there were no observations of note with respect to the outfall (refer to Photograph 5).

**Photograph 5.** Township MS4 Outfall # LC130: (DSCN2832) View of the approximate location for Township Outfall #LC130, located at the confluence of an unnamed tributary and Little Conestoga Creek.

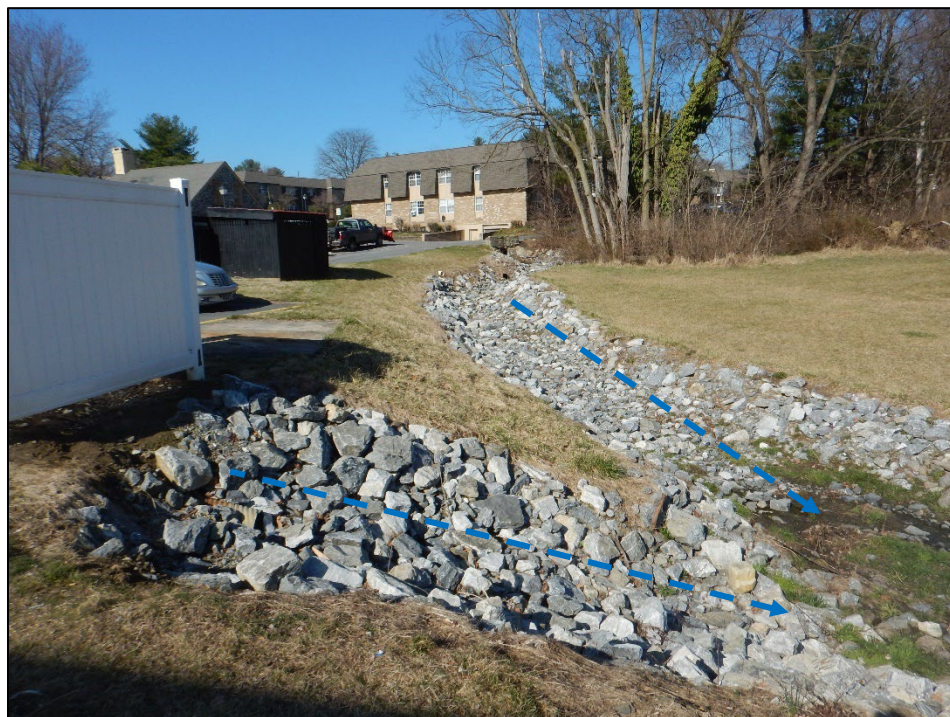
**Photograph 6.** Kensington Club Basin Rehabilitation Project: (DSCN2835) View, facing west, of a drainage inflow area located west of the basin. Adjacent parking lots drain into the basin. Note the blue arrows indicating the directions of flow.

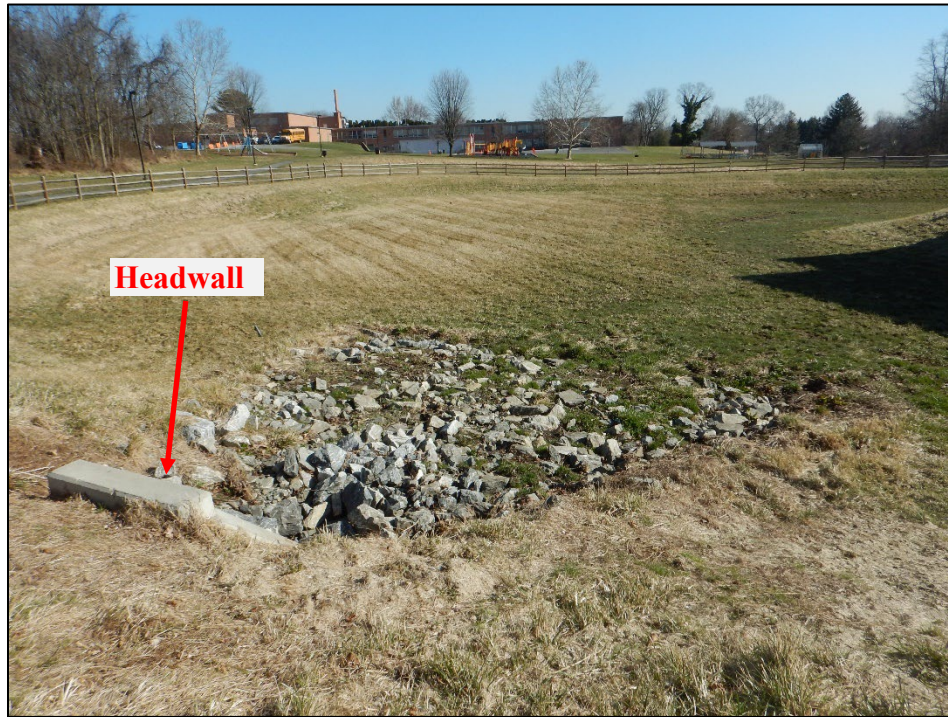
**Photograph 7. Kensington Club Basin Rehabilitation Project: (DSCN2836)** View, facing northeast, of the detention basin. Note the inflow headwall in the left side of the photo.

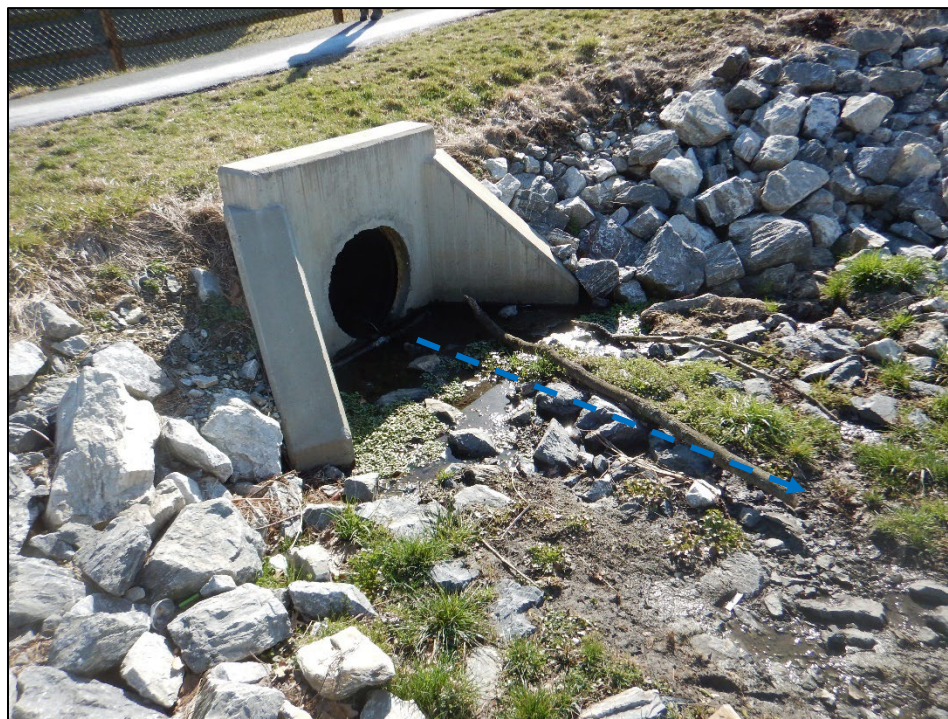
**Photograph 8. Kensington Club Basin Rehabilitation Project: (DSCN2838)** Closer view of the inflow headwall and pipe, as shown in Photograph 7. Note the blue arrow indicating the direction of flow.

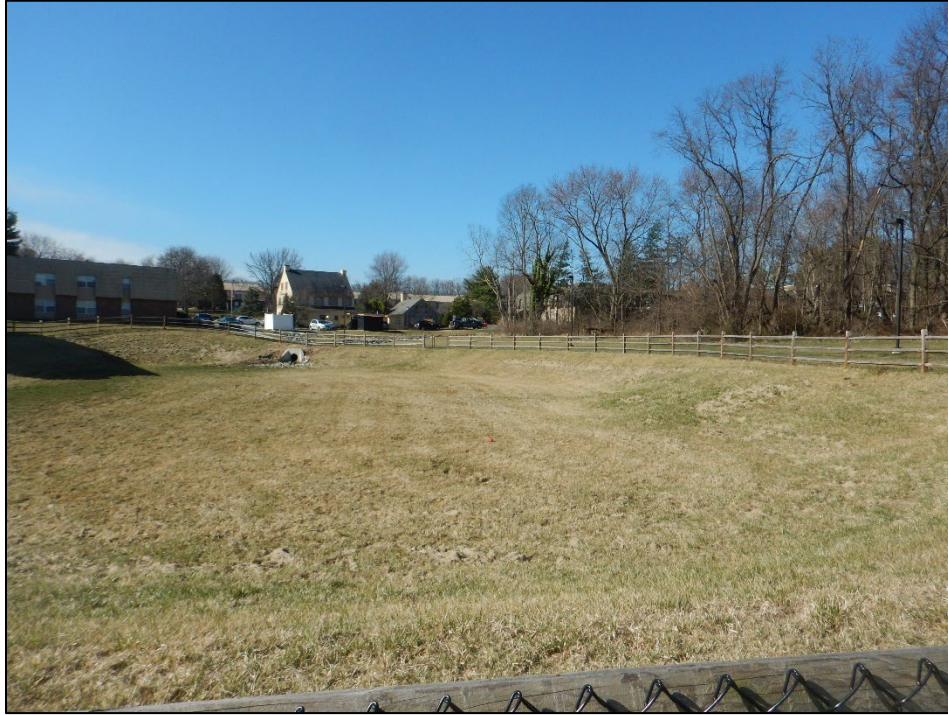
**Photograph 9.** Kensington Club Basin Rehabilitation Project: (DSCN2840) Additional view, facing west, of the basin that was observed to be mowed and largely trash free at the time of the inspection.

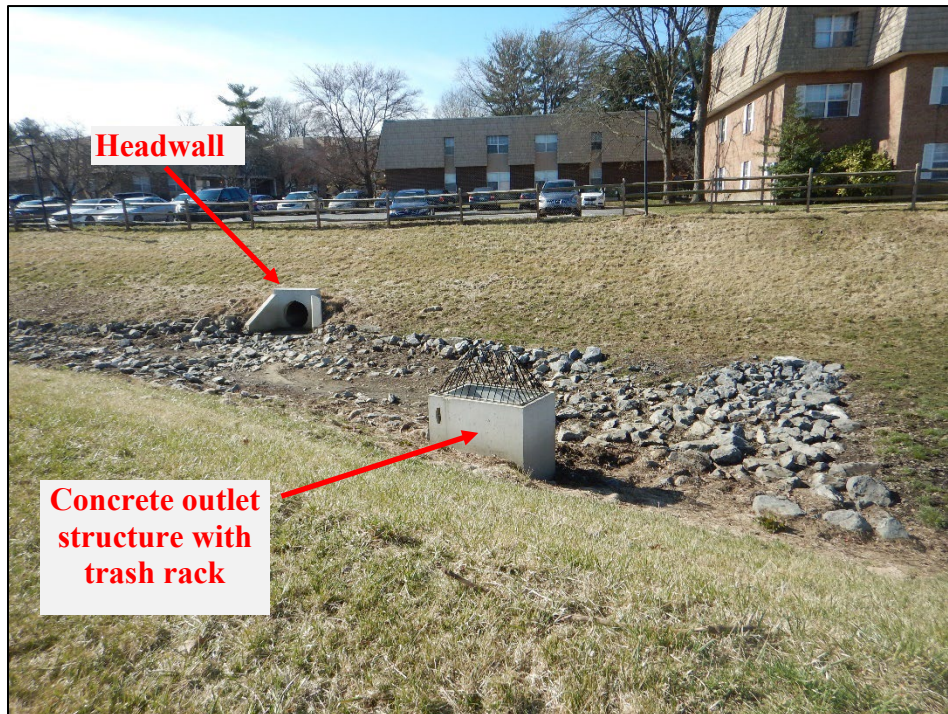
**Photograph 10.** Kensington Club Basin Rehabilitation Project: (DSCN2842) View, facing south, of another inflow headwall and the basin's concrete outlet structure, equipped with a trash rack.

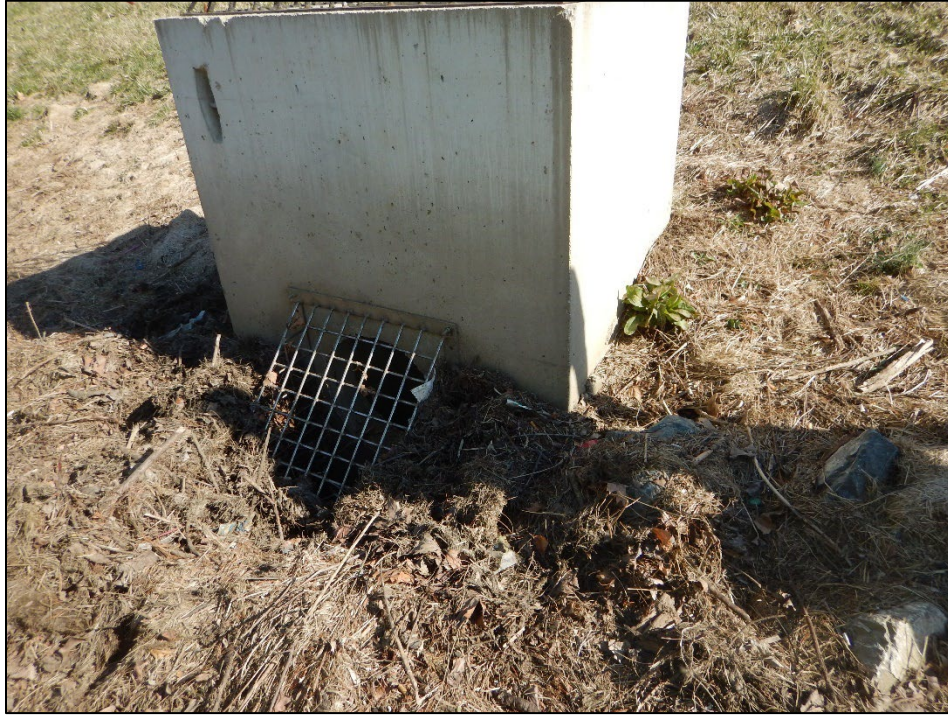
- 3) The EPA Inspection Team observed the detention basin perimeter was adequately mowed. From what was visible, the structures within the basin appeared to be in good condition and no trash was observed (refer to [Photographs 9 and 10](#)). However, there was observed debris and sediment build up around the basin trash rack (refer to [Photograph 11](#)). There was no observed trash inside the outlet structure (refer to [Photograph 12](#)).

**Photograph 11. Kensington Club Basin Rehabilitation Project: (DSCN2848)** Closer view of the basin's concrete outlet structure, as shown in Photograph 10. The lowest outlet, behind the visible trash rack, was inundated with sediment and debris.

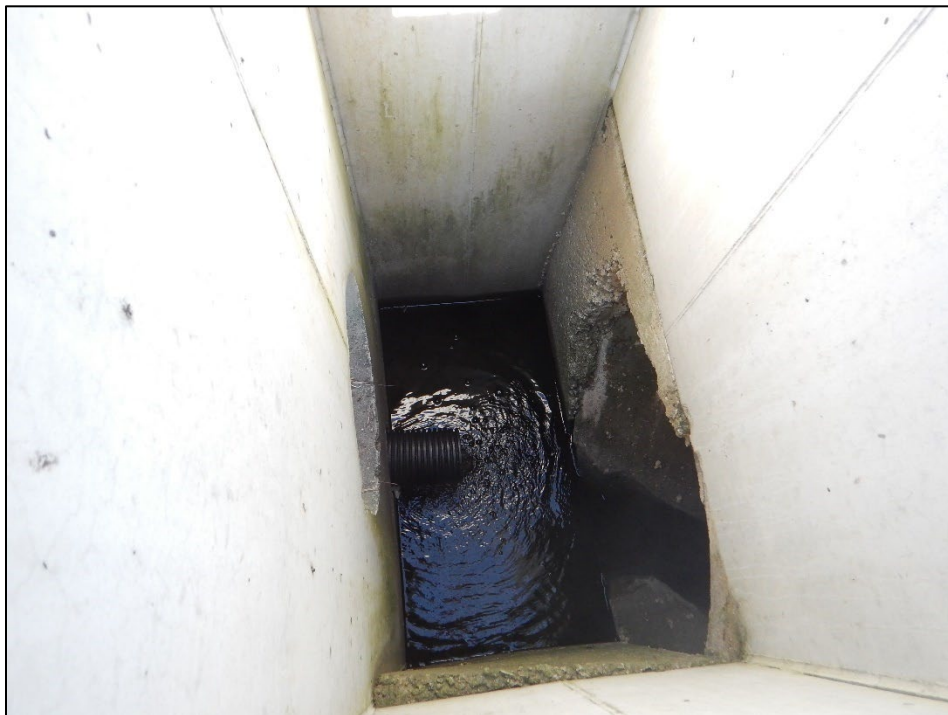
**Photograph 12. Kensington Club Basin Rehabilitation Project: (DSCN2849)** View inside the basin's concrete outlet structure as shown in Photographs 10 and 11. There was no observed trash inside the outlet structure, and the Township representative stated there were groundwater sources contributing to the observed flow.

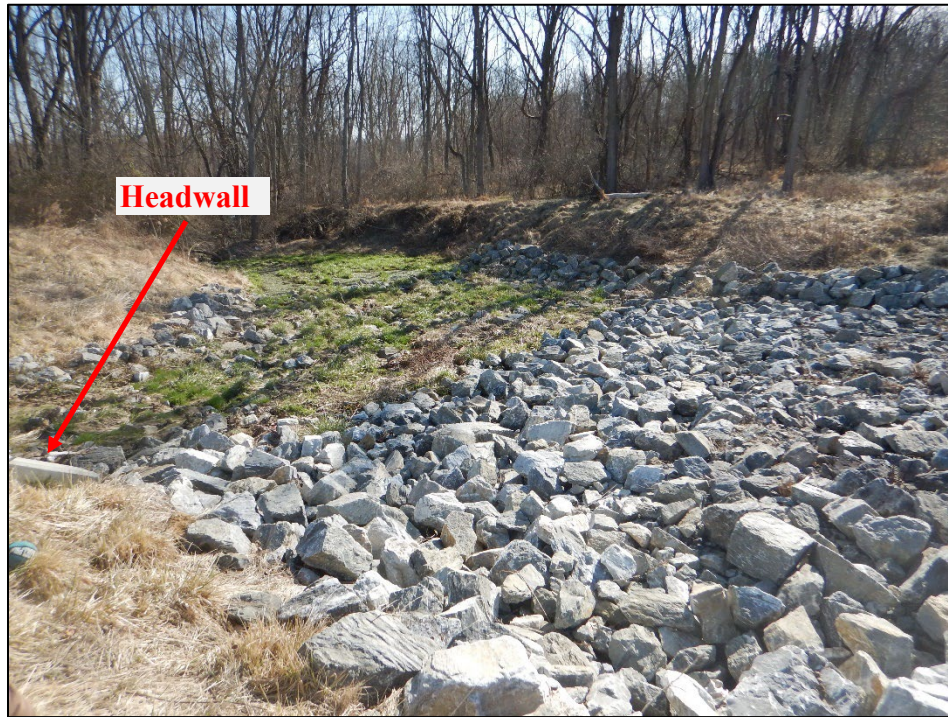
**Photograph 13. Kensington Club Basin Rehabilitation Project: (DSCN2844)** View, facing east, of the armored emergency spillway, basin outflow headwall, and drainage area towards an unnamed tributary to the Conestoga River.

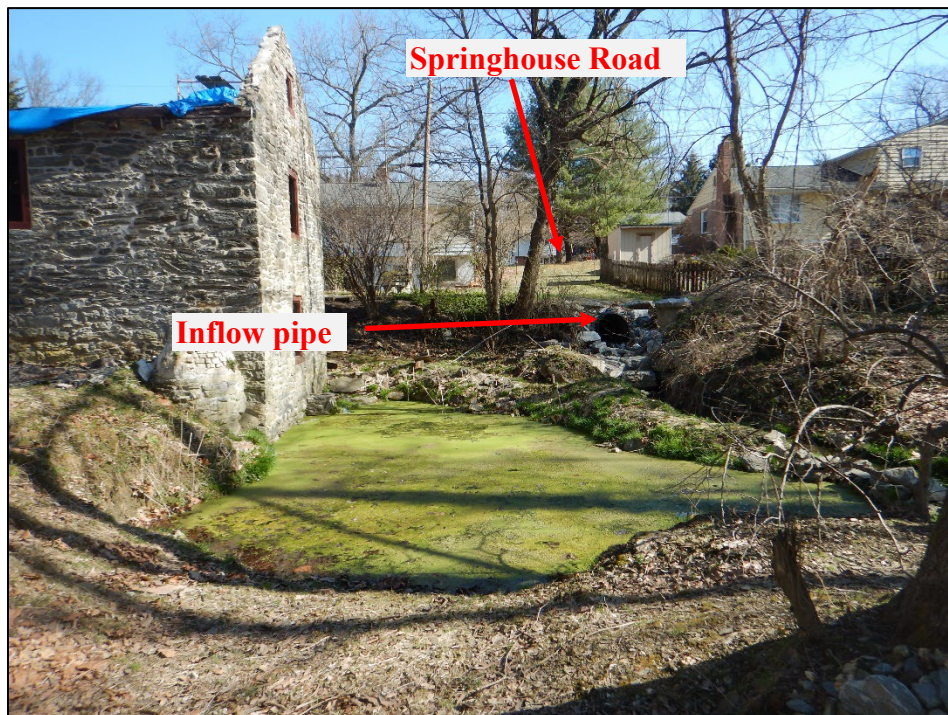
- 1) The EPA Inspection Team observed that the Springhouse Road Swale had become channelized. The Township representative stated that the owner had made modifications to the swale starting in 2018-2019, reducing its efficiency. These modifications included walling off a portion of the swale to create a pond and removing the installed check dams designed to slow the stormwater flow (refer to Photographs 14 through 16).

**Photograph 14. Springhouse Road Swale: (DSCN2850)** View, facing north, of the swale inflow pipe, channel, and proximity to Springhouse Road.

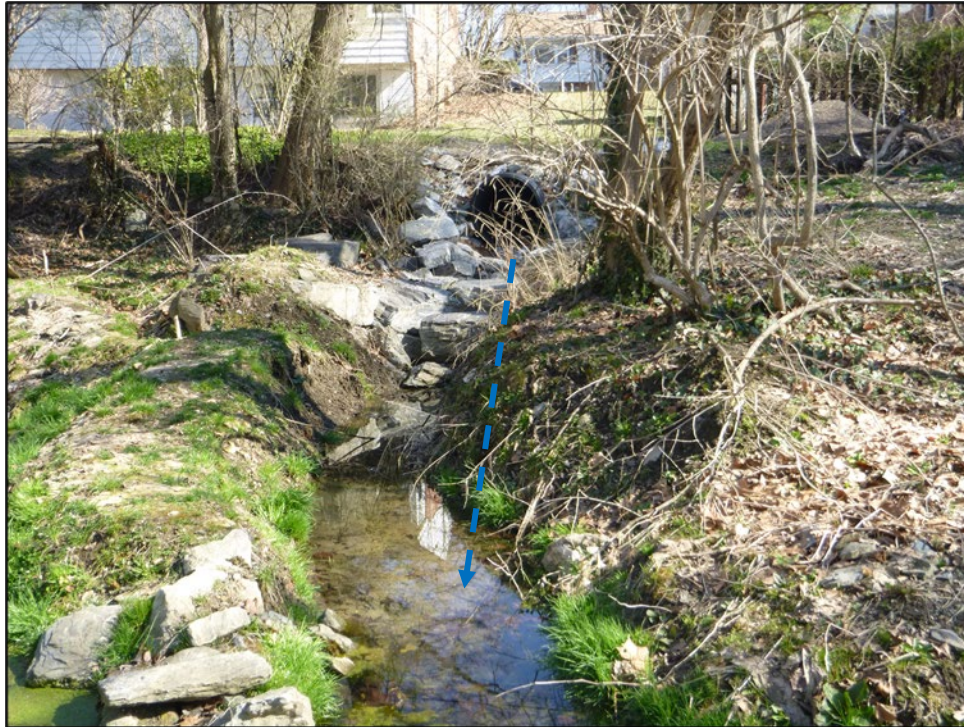
**Photograph 15.** Springhouse Road Swale: (P1060574) Closer view of the swale's inflow pipe and main channel, as shown in Photograph 14. Note the blue arrow indicating the direction of flow.

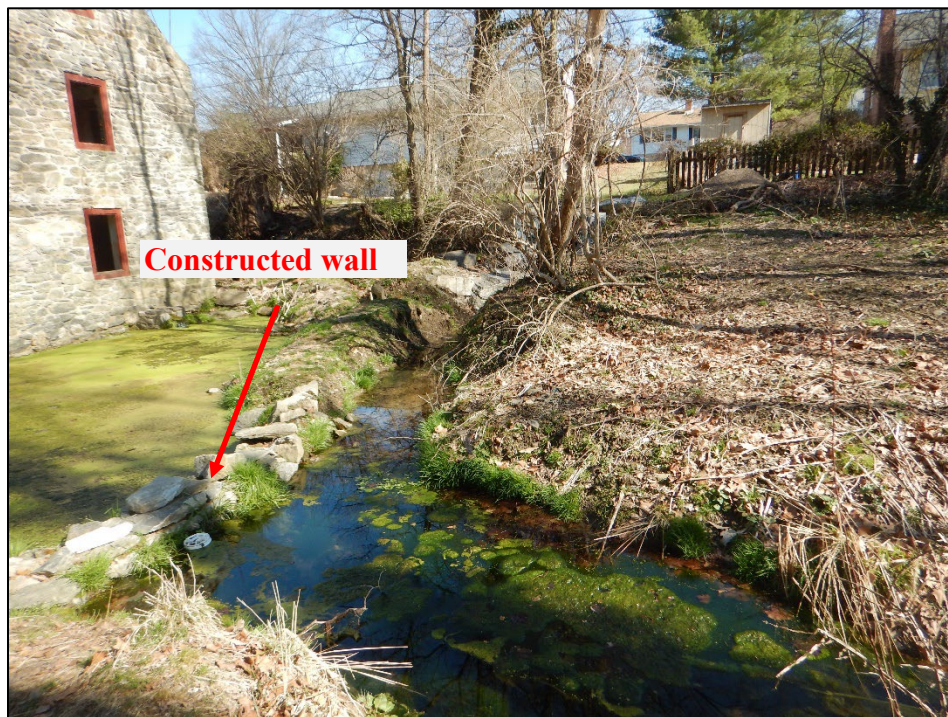
**Photograph 16.** Springhouse Road Swale: (DSCN2851) View, facing north, of where the owner of the land had removed stones installed for a check dam and walled off part of the swale, creating a pond.

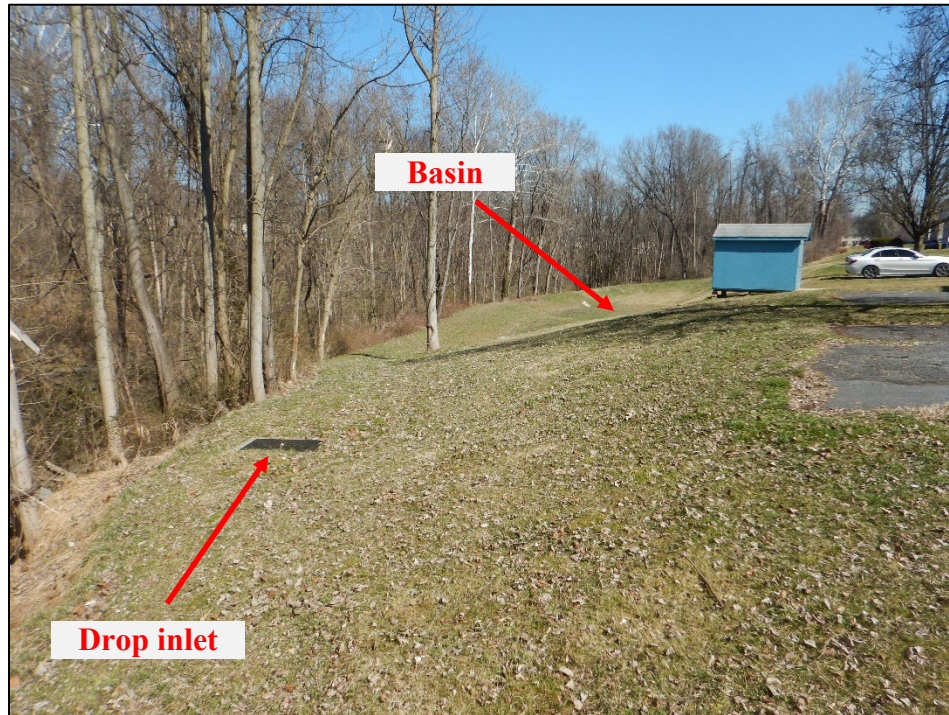
**Photograph 17. Chadwick Circle Detention Basin: (DSCN2861)** View, facing northeast of a drop inlet that conveys stormwater to the shown basin.

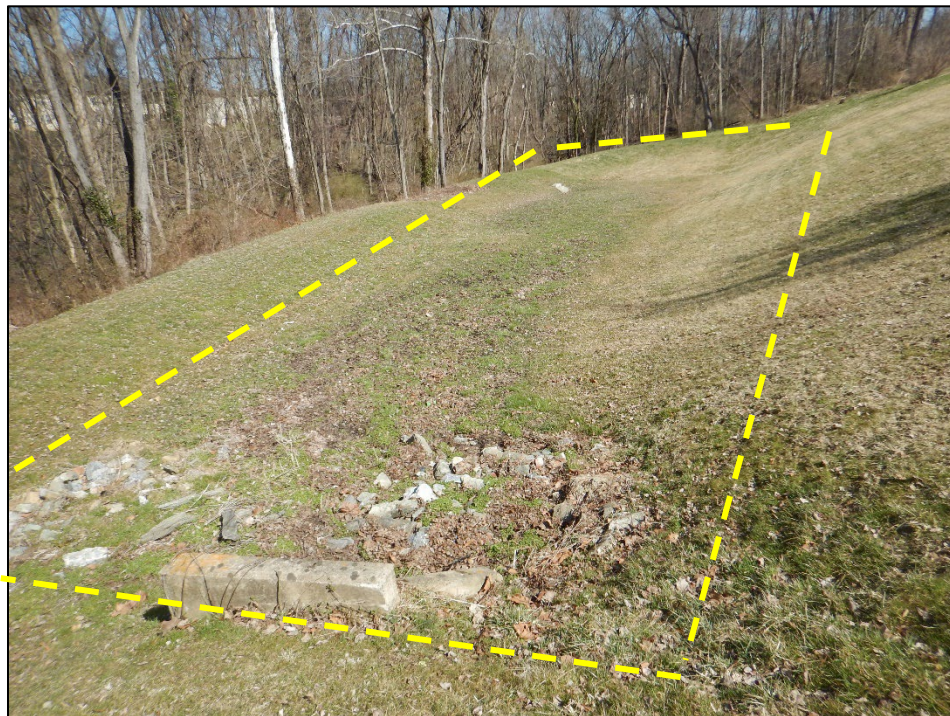
**Photograph 18. Chadwick Circle Detention Basin: (DSCN2864)** View, facing northeast, of the basin. The basin was mowed and largely free of trash and debris. Note the yellow dotted lines indicating the approximate boundary of the basin.

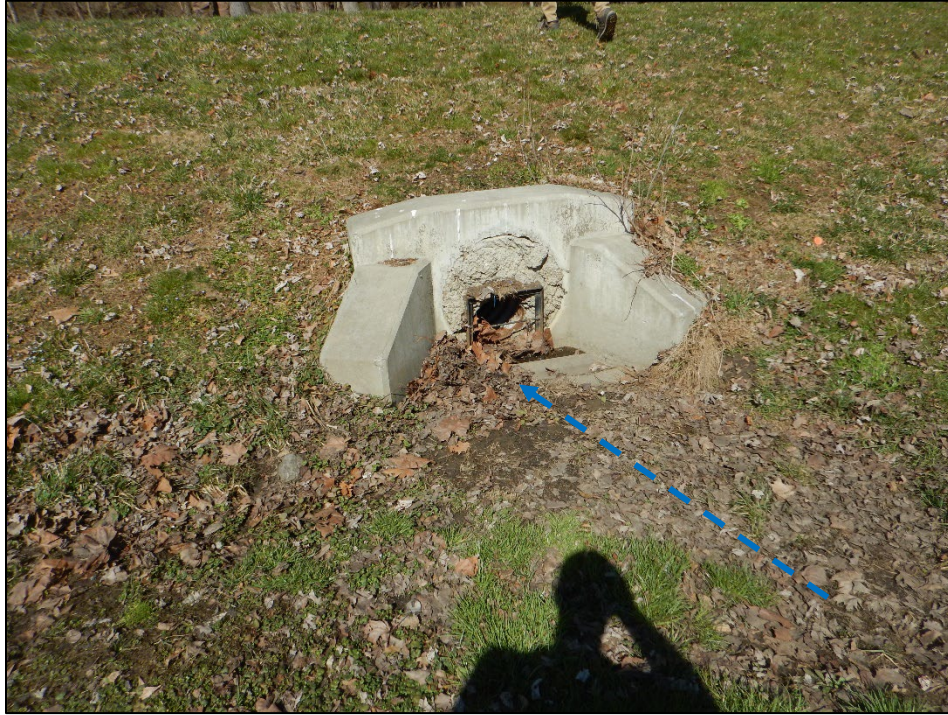
**Photograph 19. Chadwick Circle Detention Basin: (DSCN2869)** View, facing northwest, of the outflow headwall that conveys stormwater to an adjacent vegetated ravine. Note the blue arrow indicating the direction of flow.

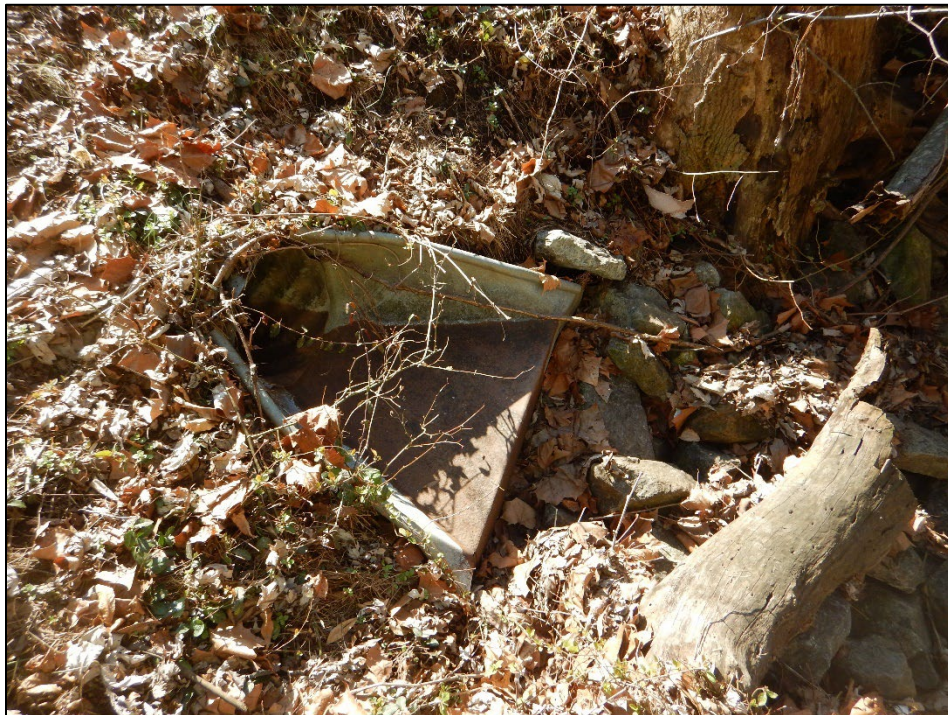
**Photograph 20. Chadwick Circle Detention Basin: (DSCN2873)** View of the basin's outlet pipe that conveys stormwater to a vegetated ravine that flows into the Gable Park Basin.

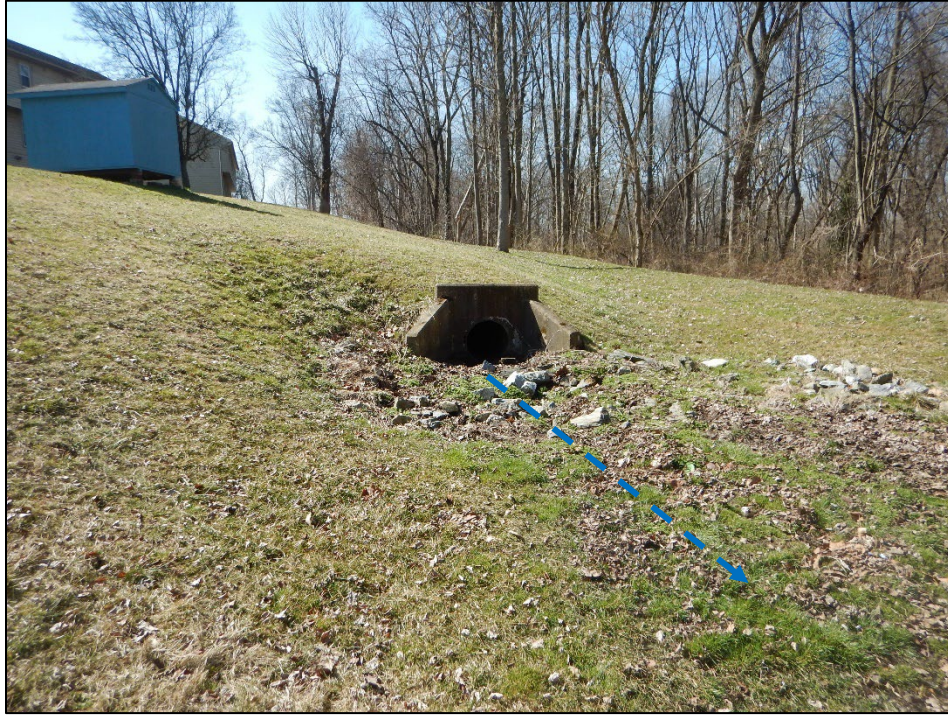
- 1) The EPA Inspection Team observed the basin forebay, inflow headwall, outflow headwall, and outlet pipe (refer to Photographs 17 through 20). The basin was mowed and largely free of trash and debris. However, the riprap in the forebay needed maintenance and replacement (refer to Photograph 21).

**Photograph 21. Chadwick Circle Detention Basin:** (DSCN2866) View, facing southwest, of the basin inflow headwall. The riprap in the forebay needed maintenance and replacement. Note the blue arrow indicating the direction of flow.

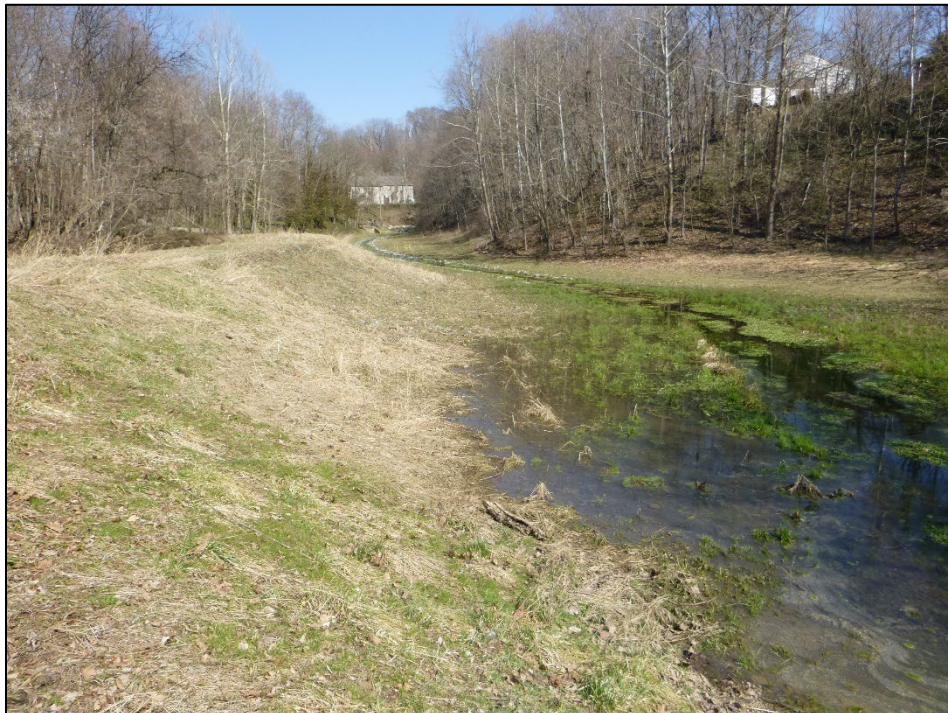
**Photograph 22. Gable Park Basin:** (P1060586) View, facing north, of the basin that receives stormwater from the Chadwick Circle Detention Basin and Springhouse Road Swale drainage areas.

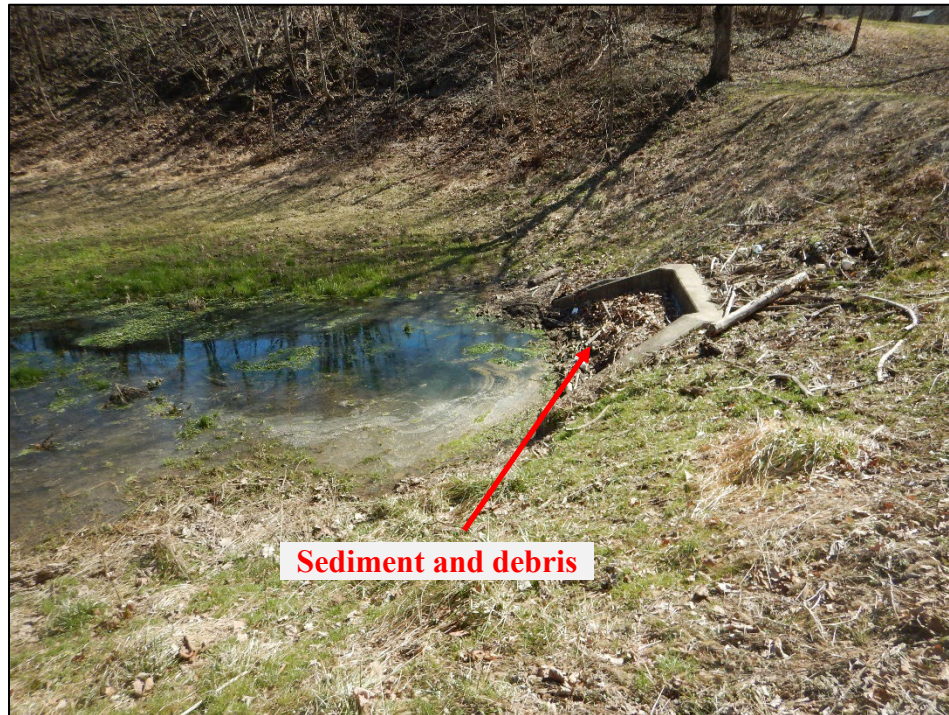
- 1) The EPA Inspection Team observed the basin and outflow headwall (refer to Photograph 22). The basin’s principal outlet pipe was inundated with sediment and woody debris and needed maintenance (refer to Photograph 23).

**Photograph 23. Gable Park Basin:** (DSCN2880) View, facing east, of the basin's outflow headwall and outlet pipe that were inundated with sediment and woody debris, and needed maintenance.

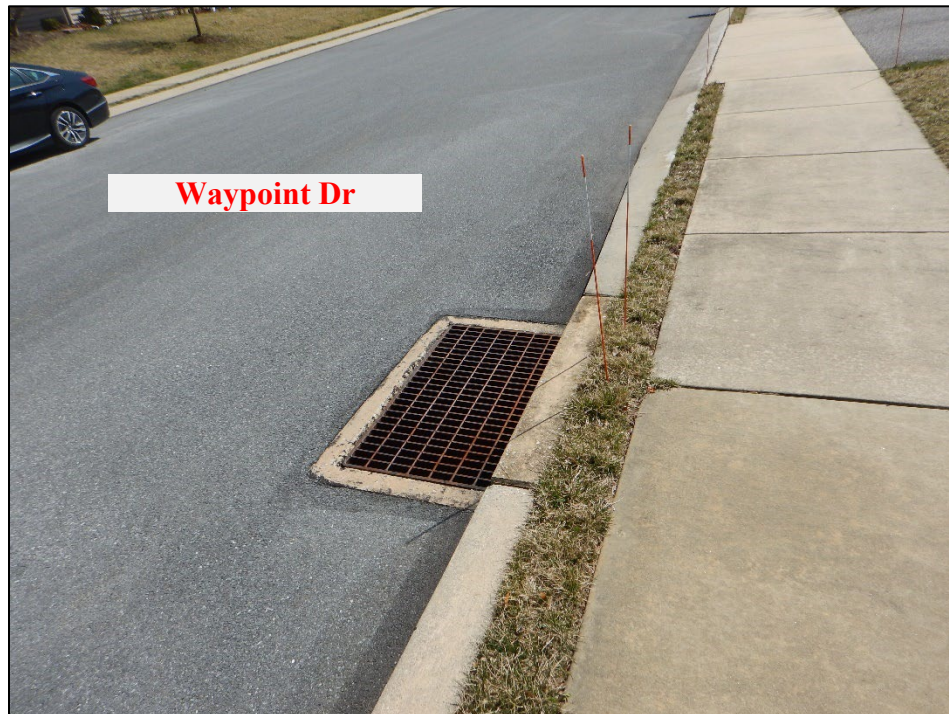
**Photograph 24. Southern Village Detention Basin:** (DSCN2881) View, facing southwest, of a drop inlet located on Waypoint Dr. that conveys stormwater to the basin.

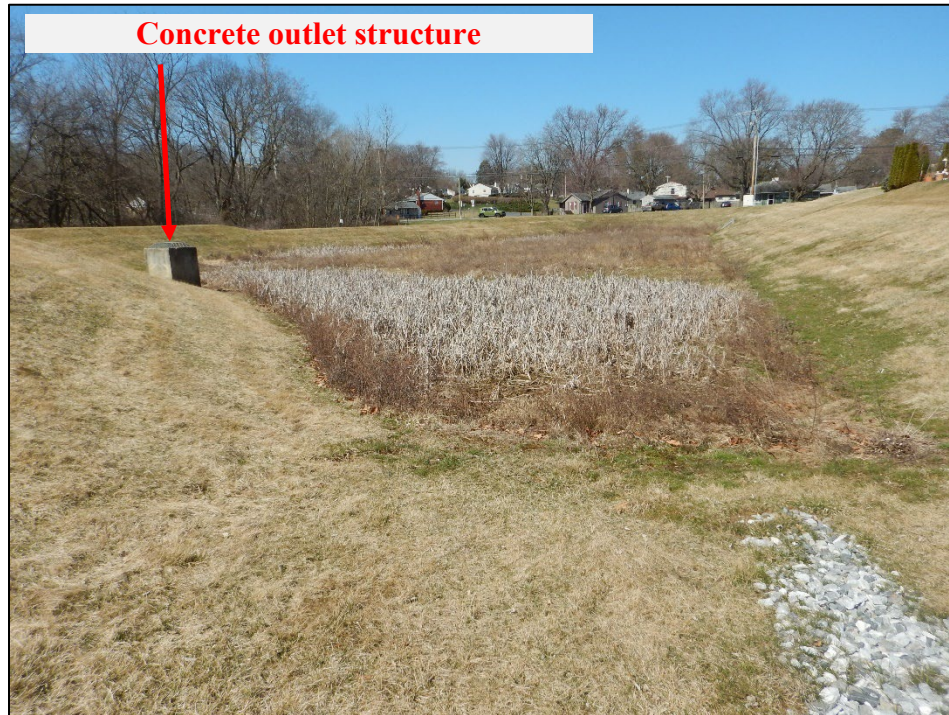
**Photograph 25. Southern Village Detention Basin:** (DSCN2885) View, facing northwest, of the detention basin and concrete outlet structure. The basin appeared to be well maintained.

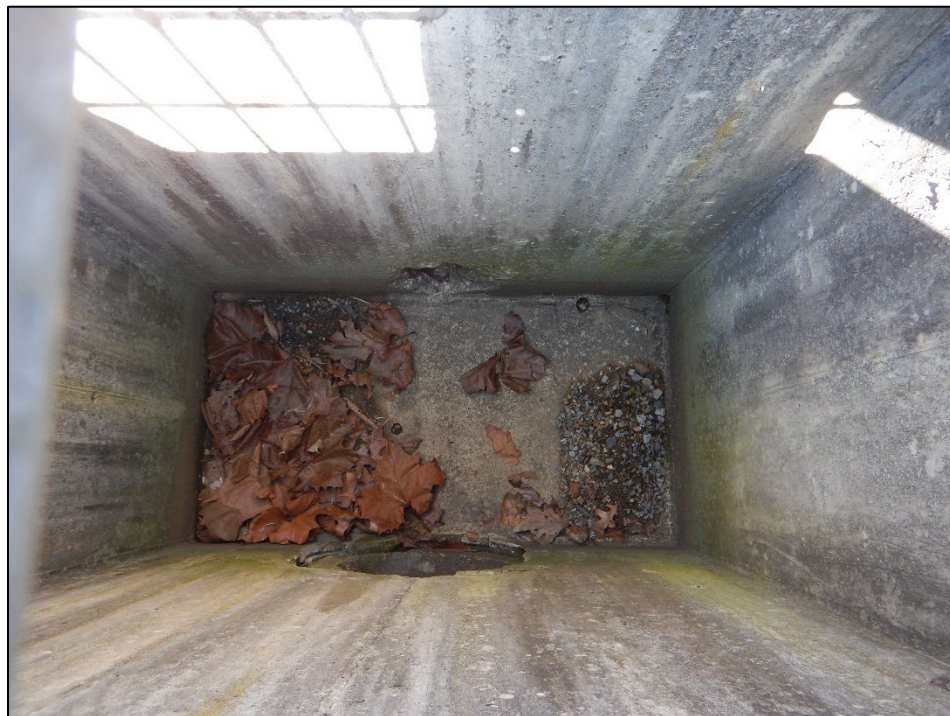
**Photograph 26. Southern Village Detention Basin:** (DSCN2888) View inside the basin's outlet structure, as shown in Photograph 25. There was no observed trash or flow at the time of the inspection.

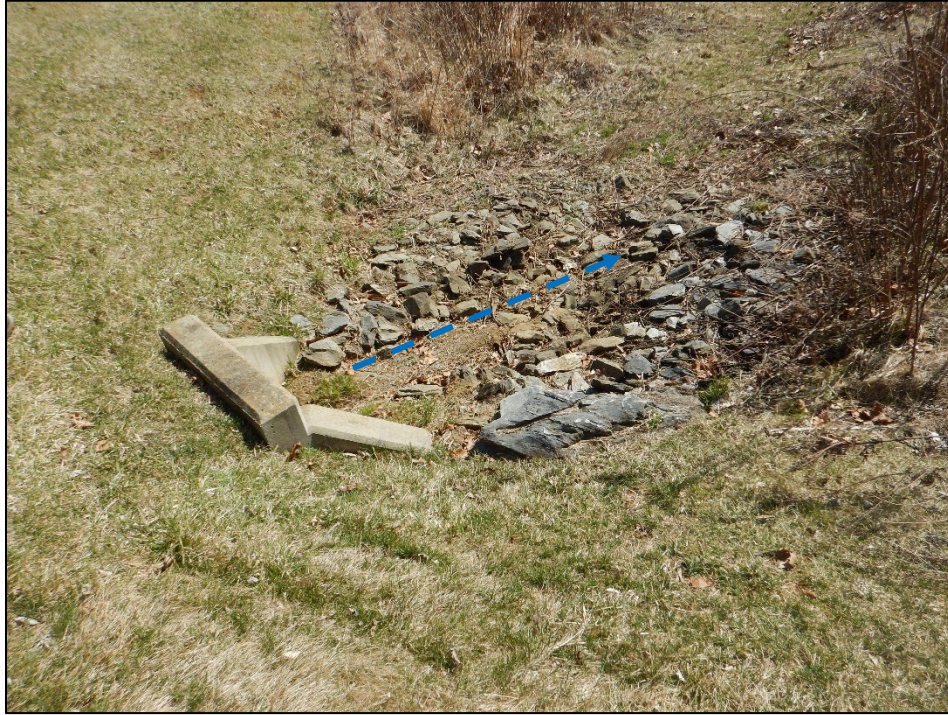
**Photograph 27. Southern Village Detention Basin:** (DSCN2890) View of the basin’s outflow headwall and drainage area that conveys stormwater to an unnamed tributary of the Conestoga River. Note the blue arrow indicating the direction of flow.

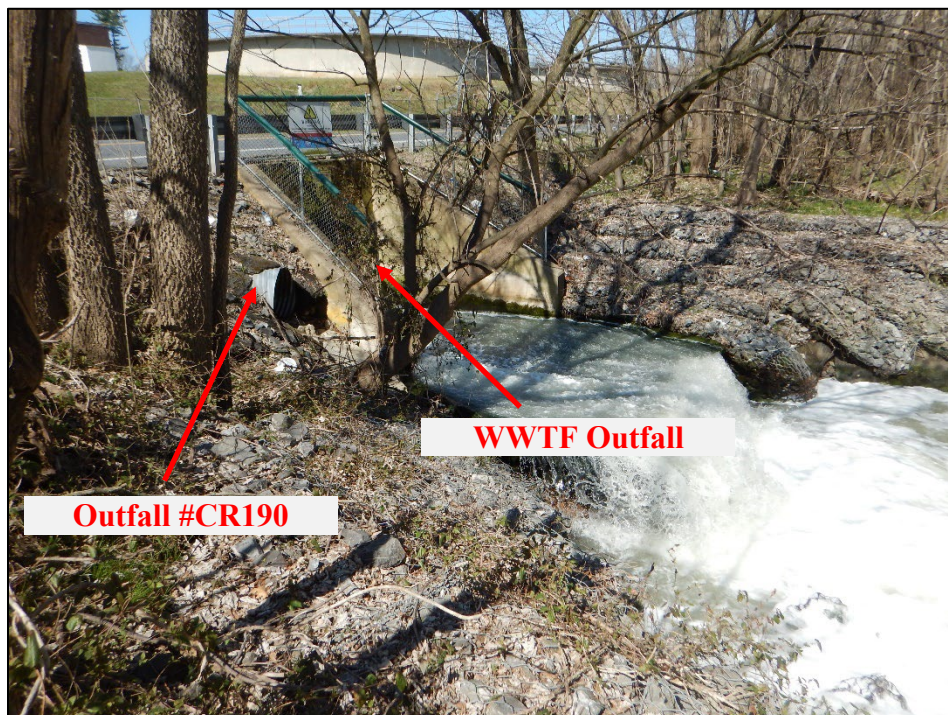
**Photograph 28. Township Outfall #CR190:** (DSCN2895) View, facing west, of Township Outfall #CR190 to the Conestoga River. Note the location of the outfall directly adjacent to the outfall for the City of Lancaster’s WWTF.

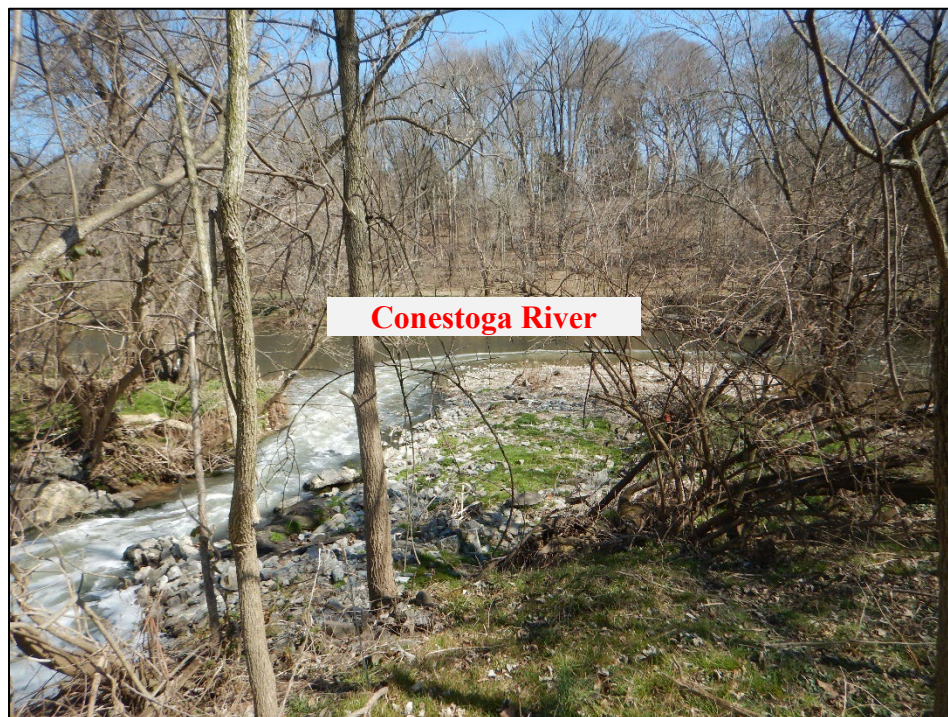
**Photograph 29. Township Outfall #CR190:** (DSCN2898) View, facing east, of the drainage area for the outfall into the Conestoga River.

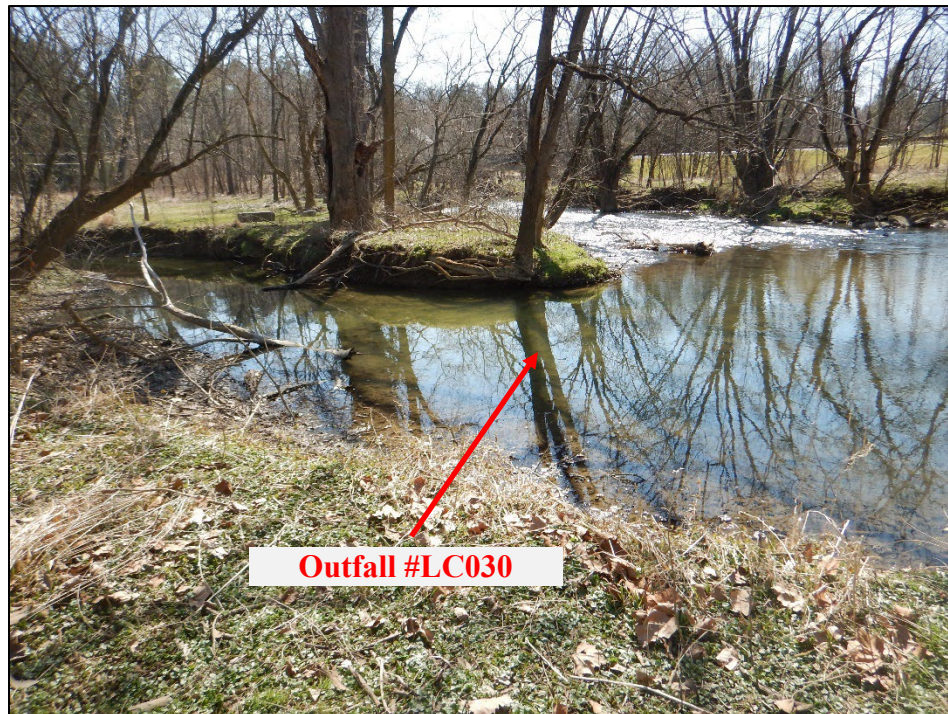
**Photograph 30. Township Outfall #LC030:** (DSCN2906) View, facing west, of the approximate location for Township Outfall #LC030 located west of the Township Public Works Campus.
