**U.S. ENVIRONMENTAL PROTECTION AGENCY, REGION III  
ENFORCEMENT AND COMPLIANCE ASSURANCE DIVISION  
WATER BRANCH – NPDES SECTION (3ED32) CLEAN WATER ACT  
COMPLIANCE INSPECTION REPORT**

**Name of Facility:** Lancaster Township MS4  
**Facility Address:** 1240 Maple Avenue, Lancaster, PA 17603  
**Mailing Address:** 1240 Maple Avenue, Lancaster, PA 17603

Report Prepared on: April 9, 2022 By: Taylor Fontaine  
*Date* Taylor Fontaine, Environmental Scientist  
(PG Environmental, EPA Contractor)

| <b>Type of Inspection:</b> | MS4 Compliance Inspection |

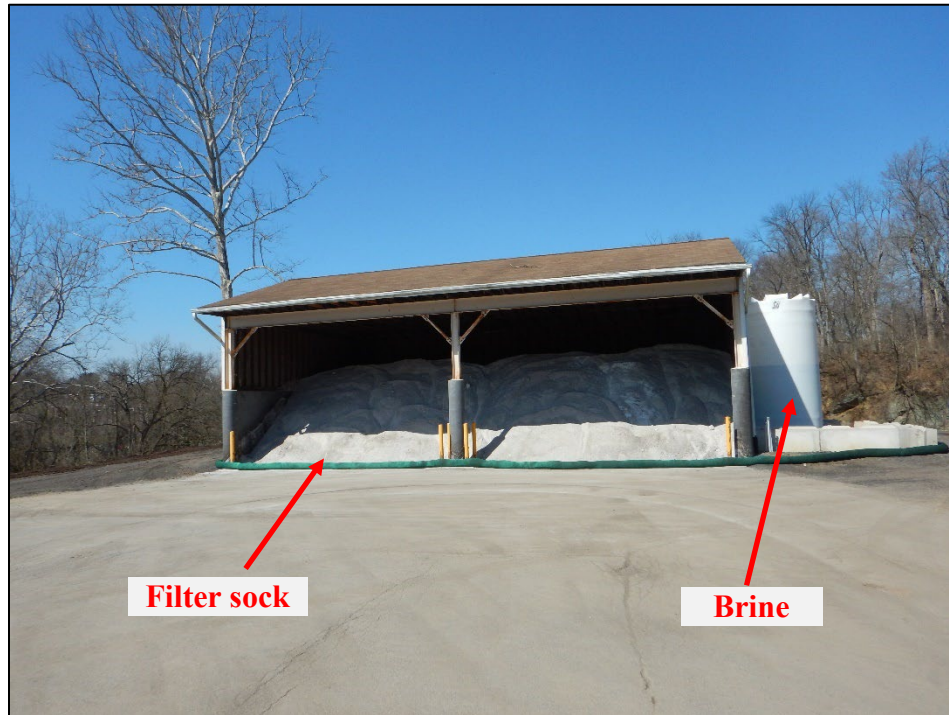
- 1) The EPA Inspection Team observed the covered salt storage building located in the northern portion of the site (refer to [Photographs 31 and 32](#)). The building was enclosed on three sides. At the time of the inspection, there was a filter sock on the ground surrounding the exposed side and no materials were observed migrating from the building.

**Photograph 31. Township Public Works Campus:** (DSCN 2910) View, facing north, of the Campus's salt storage building, attached to the upper garage. The building was enclosed on three sides and had a filter sock placed along the open side. There was no observed salt migration from the building from the building. Note the Campus' brine storage on the right side.

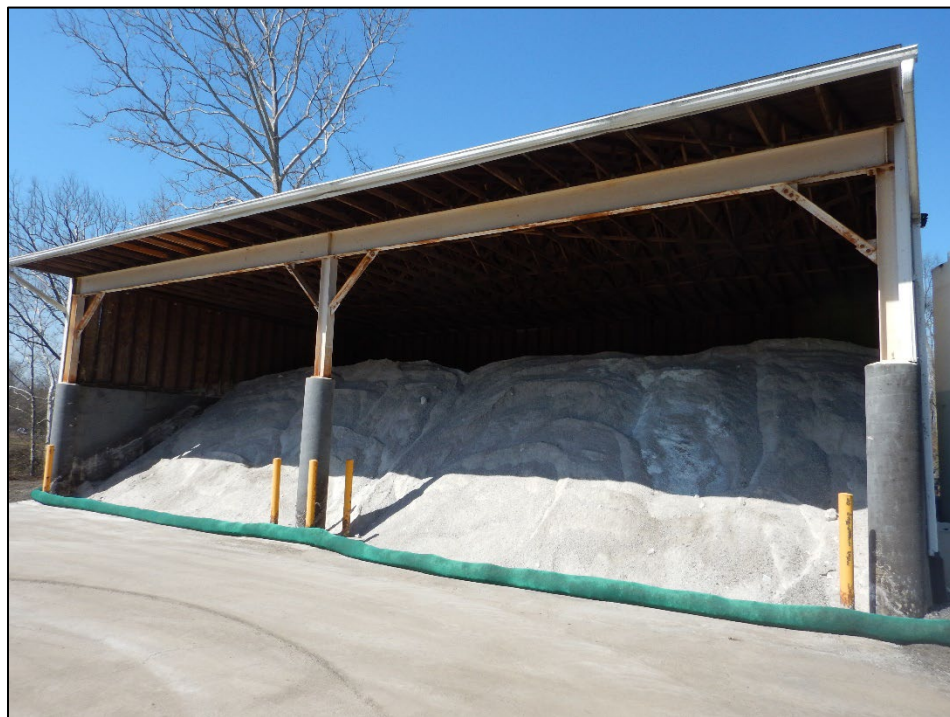
**Photograph 32. Township Public Works Campus:** (DSCN 2911) Closer view of the salt storage building and filter sock, as shown in Photograph 31.

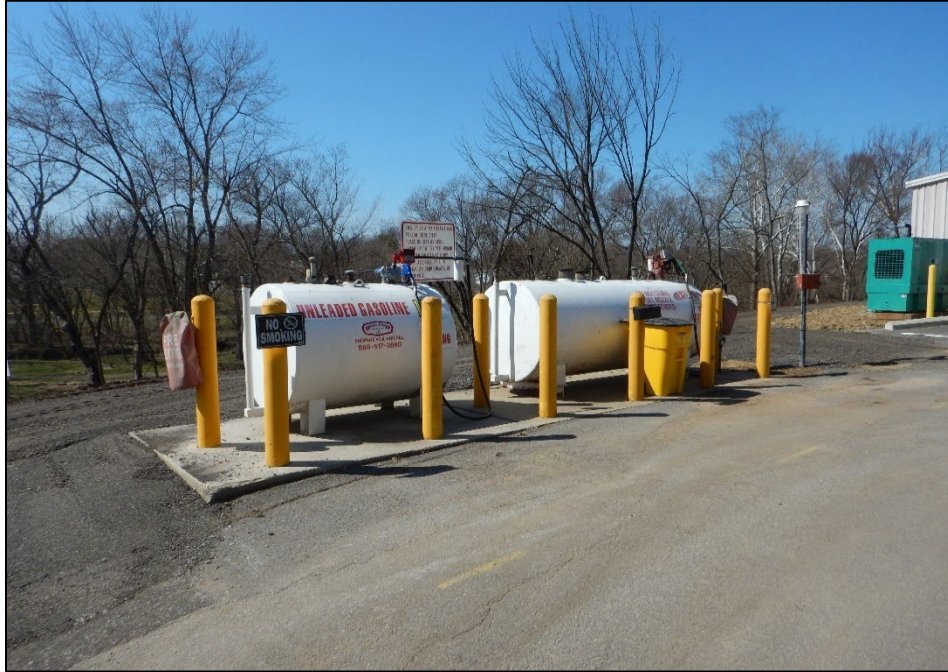
- 2) The EPA Inspection Team observed two aboveground fuel tanks (one 1,000-gallon diesel, one 500-gallon regular unleaded gasoline). The tanks were in good condition (refer to [Photograph 33](#)). The EPA Inspection Team did not observe spills or staining at the fuel tanks. Spill kits/materials were observed in the adjacent building.

**Photograph 33. Township Public Works Campus:** (DSCN2909) View, facing northwest, of the two aboveground fuel tanks (one 1,000-gallon diesel, one regular 500-gallon unleaded gasoline). The EPA Inspection Team observed spill kits in the adjacent building.

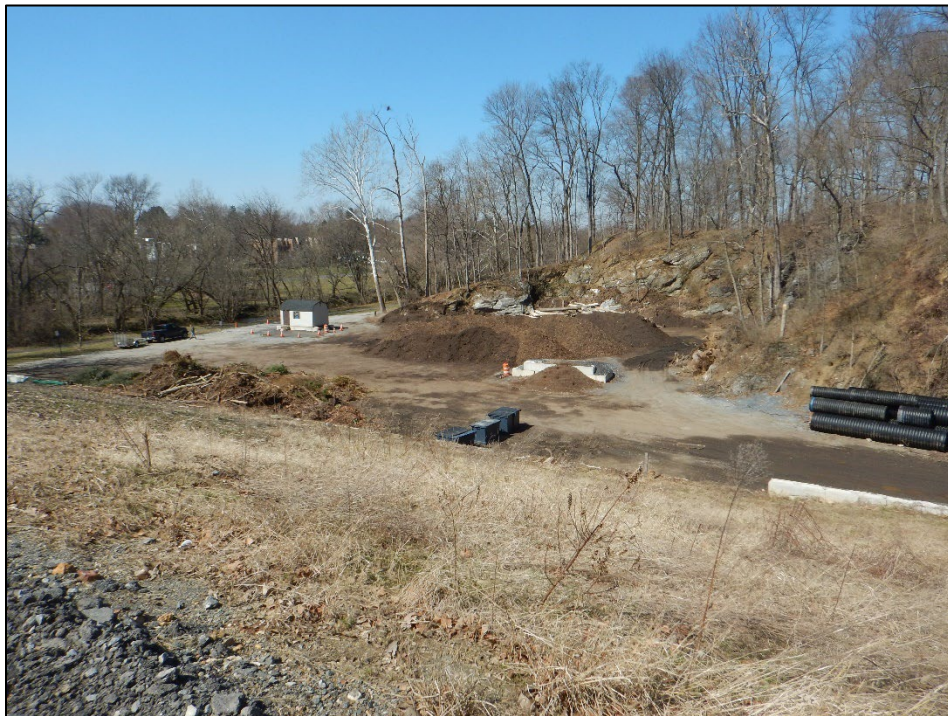
**Photograph 34. Township Public Works Campus:** (DSCN2914) View, facing northwest, of the Township's wood waste recycling center that also serves as material and aggregate storage.

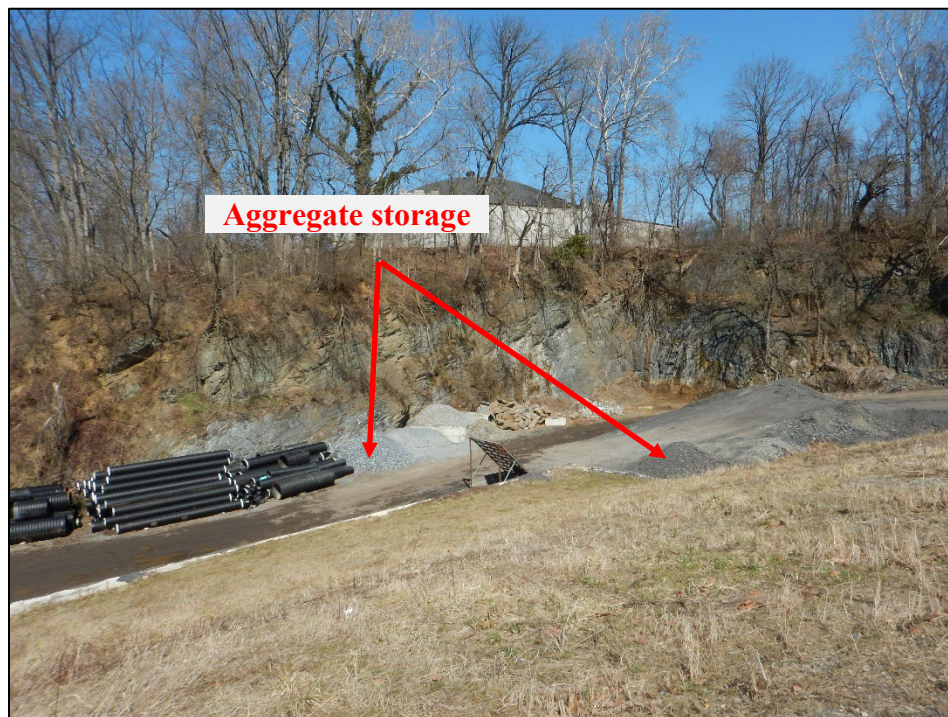
**Photograph 35.** Township Public Works Campus: (DSCN2917) View, facing north, of the materials and aggregate storage mostly consisting of gravel and dirt.

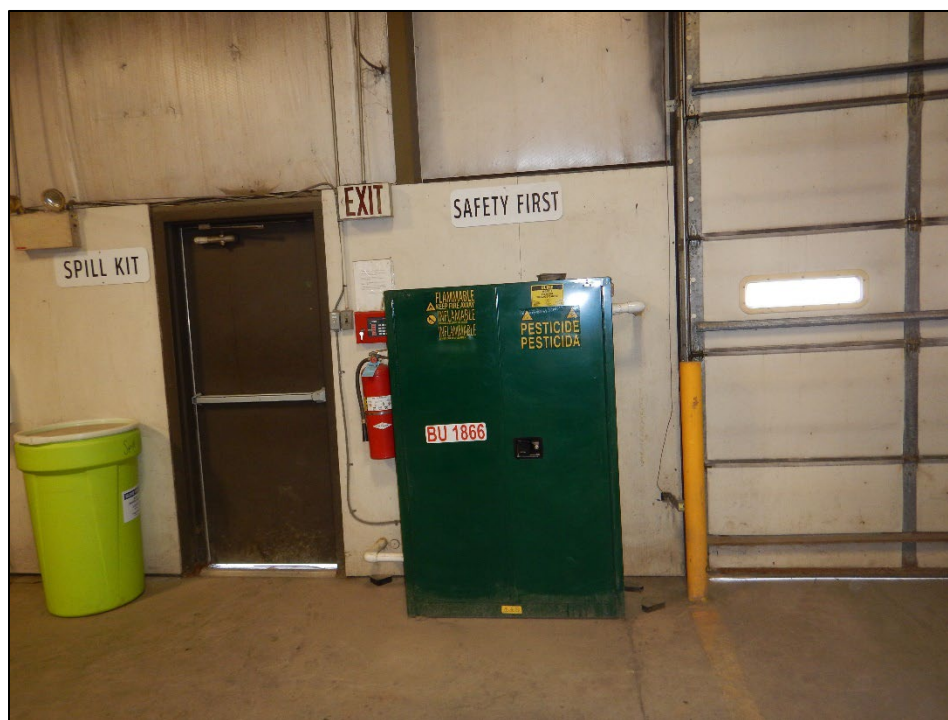
**Photograph 36.** Township Public Works Campus: (DSCN2920) View of pesticide storage inside the upper garage.

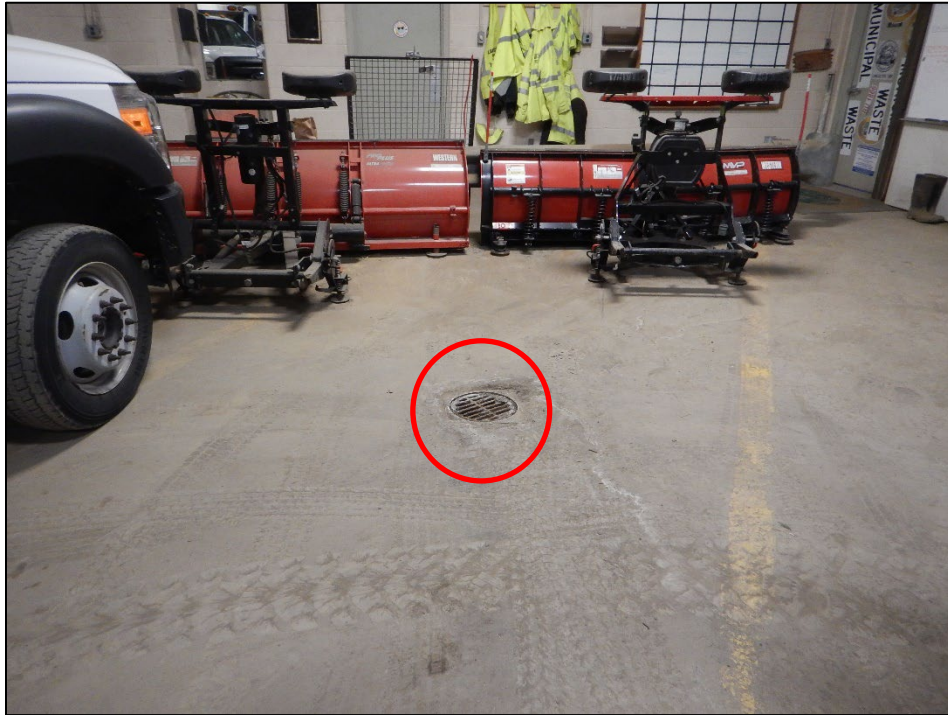
**Photograph 37.** Township Public Works Campus: (DSCN2921) View, inside the upper garage, of a floor drain connected to an underground OWS which then conveys to the City of Lancaster’s sanitary sewer.

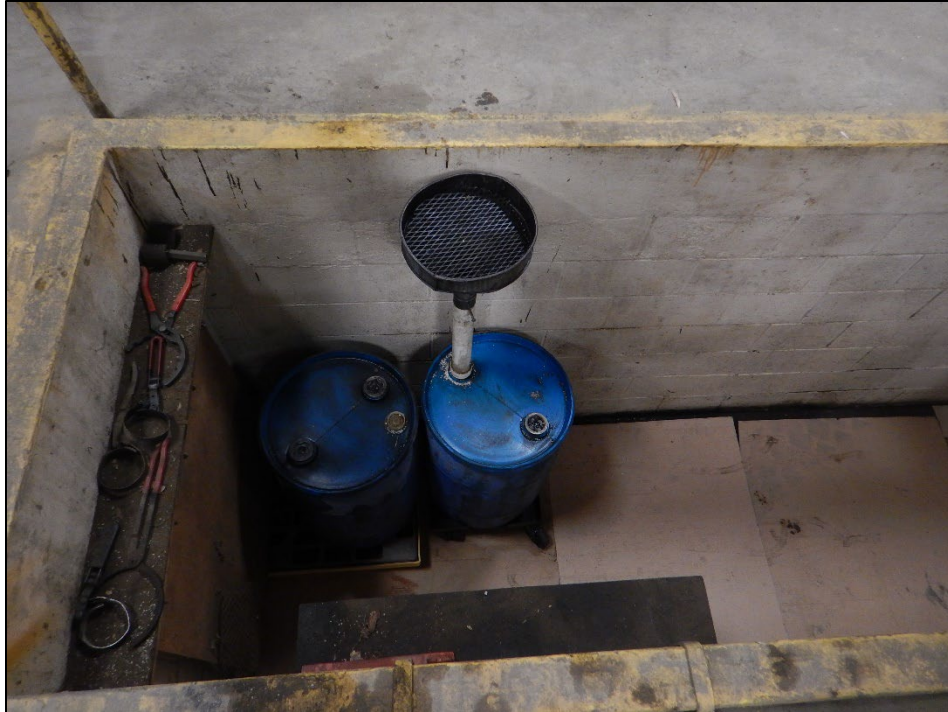
**Photograph 38.** Township Public Works Campus: (DSCN2922) View, inside the upper garage, of the fluid draining pit that the Public Works staff use for servicing vehicles. There were no drains in the pit.

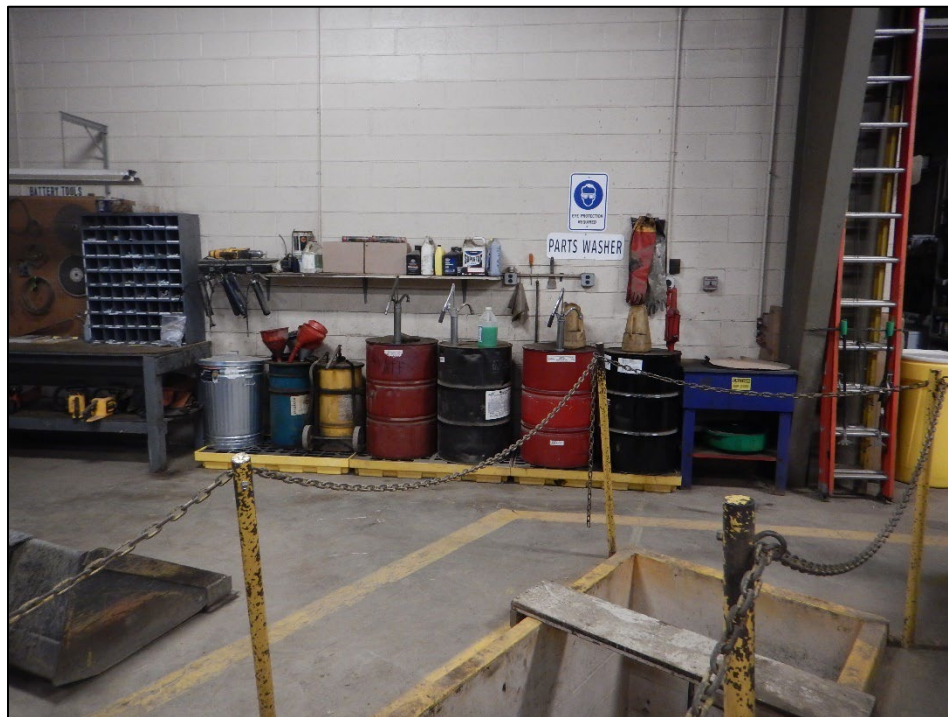
**Photograph 39. Township Public Works Campus: (DSCN2922)** View, inside the upper garage, of waste oil storage barrels stored on spill pallets.

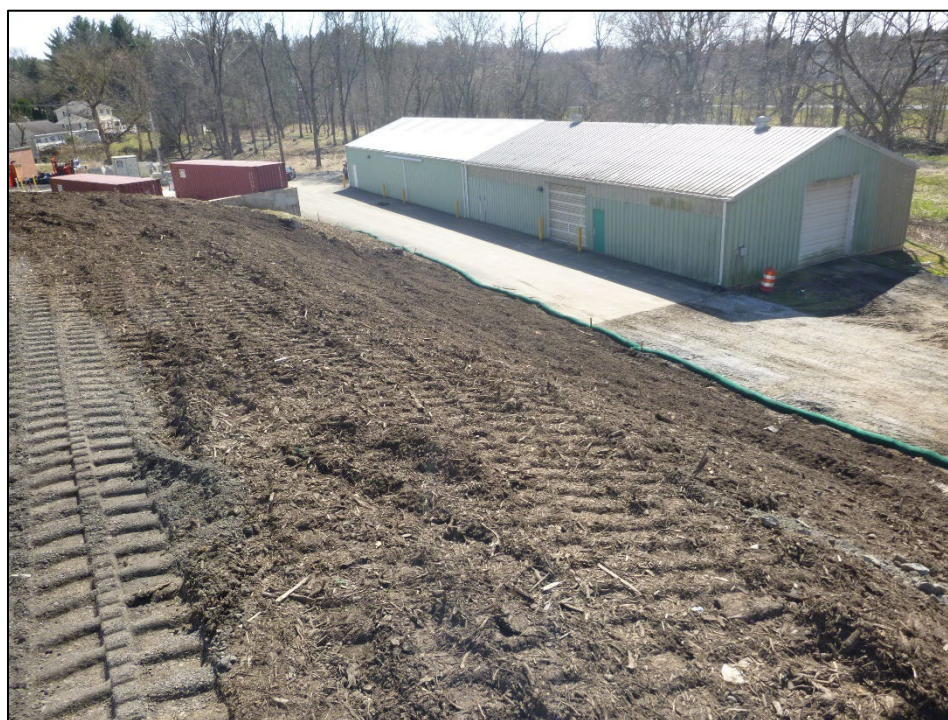
**Photograph 40. Township Public Works Campus: (P1060610)** View, facing west, of the lower garages at the Campus primarily used for vehicle and materials storage.

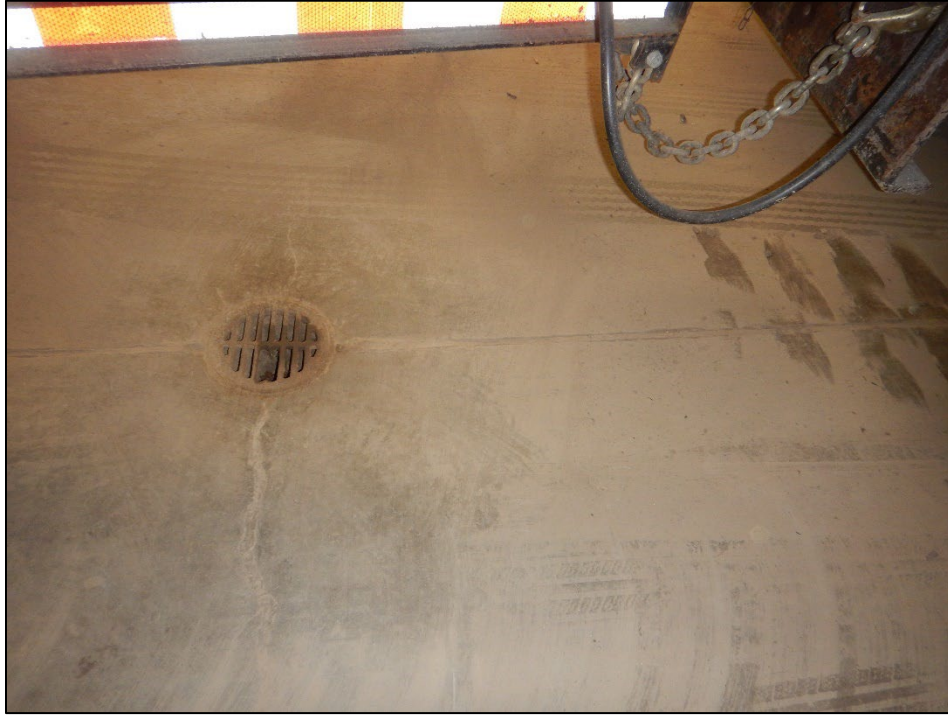
- 7) The EPA Inspection Team observed the lower garages which are primarily used for vehicle and materials storage (refer to [Photograph 40](#)). These garages contain approximately two (2) floor drains, but Township representatives were unsure what the connections to these drains were, nor where these drains discharged (refer to [Photograph 41](#)). After the inspection, on March 28, the Township stated and provided documentation that they had capped the floor drains (refer to [Appendix B, Exhibit 3](#)).

**Photograph 41. Township Public Works Campus: (DSCN2934)** View of one of the two (2) floor drains located in the lower garage. At the time of the inspection, Township representatives were unsure as to what these drains were connected to.

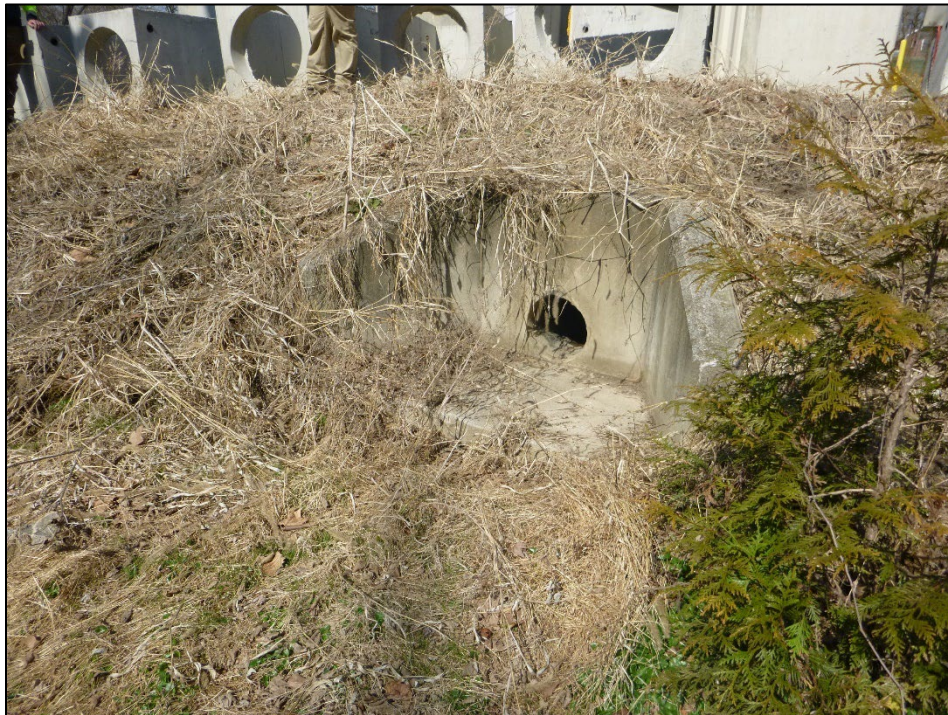
**Photograph 42. Township Public Works Campus: (P1060613)** View, facing north, of the stormwater headwall and outlet pipe that receives stormwater flow from the adjacent Campus parking lots/roads. Stormwater flows from this outlet pipe into a vegetated area.

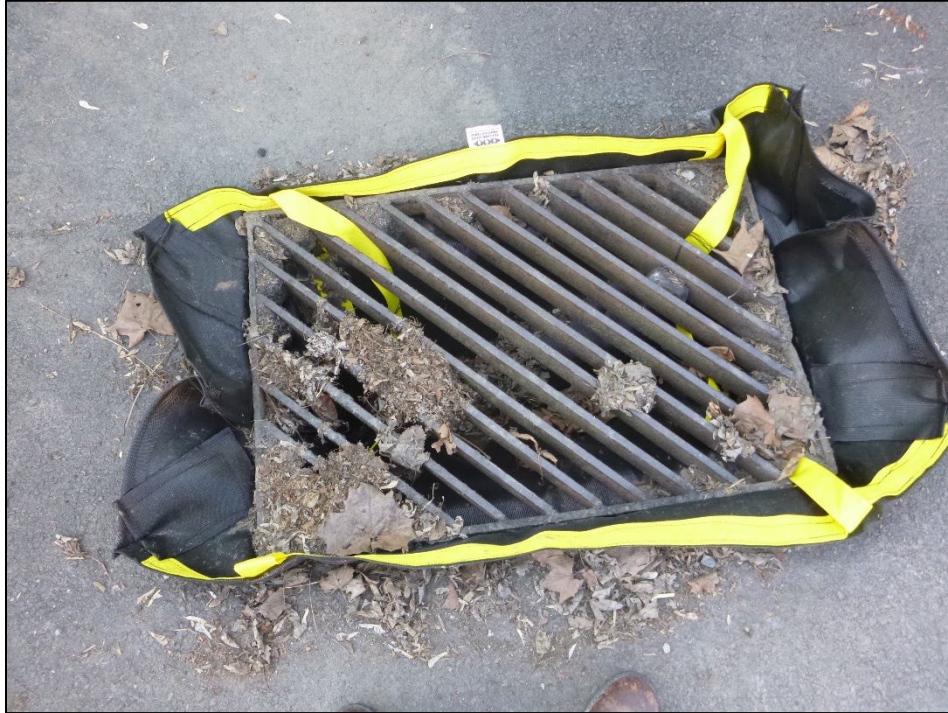
**Photograph 43. Township Public Works Campus: (P1010614)** View of a drop inlet with filter insert located in the parking area for the Campus. Stormwater conveys through the inlet and out the headwall, as shown in Photograph 42.

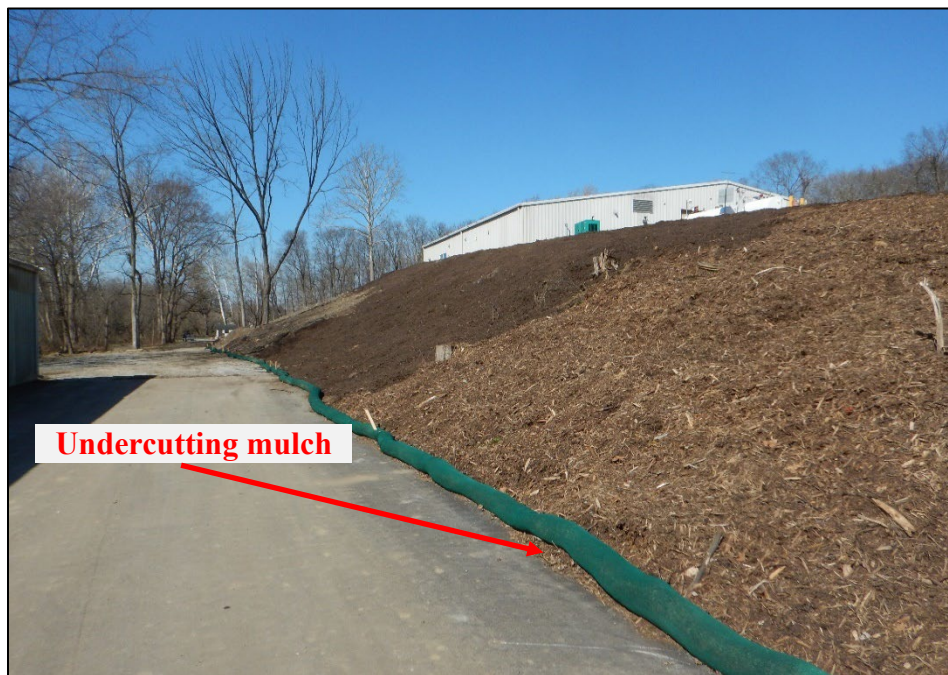
- 9) The EPA Inspection Team observed a steep slope between the upper garage and lower garages. The Township had placed mulch on the slope to assist with erosion and had staked filter socks at the toe of the slope. However, the filter socks were not installed correctly (e.g., sock ends were not overlapping, not staked at proper intervals, and the mulch was undercutting) (refer to [Photograph 44](#)). After the inspection, on March 28, the Township stated and provided documentation that they had further stabilized the filter socks (refer to [Appendix B, Exhibit 3](#)).

**Photograph 44. Township Public Works Campus: (DSCN2938)** View, facing north, of the steep slope in between the upper garage and lower garages. The Township had placed mulch on the slope to assist with erosion and had staked filter socks at the toe. However, the mulch was undercutting the filter sock, which was also not staked.
