**UNITED STATES ENVIRONMENTAL PROTECTION AGENCY**  
**New England Regional Laboratory**  
**Laboratory Services and Applied Science Division**  
**11 Technology Drive, North Chelmsford, MA 01863**

**Report Memorandum**

**Subject:** Observation Report – Trelleborg Coated Systems US, Inc.

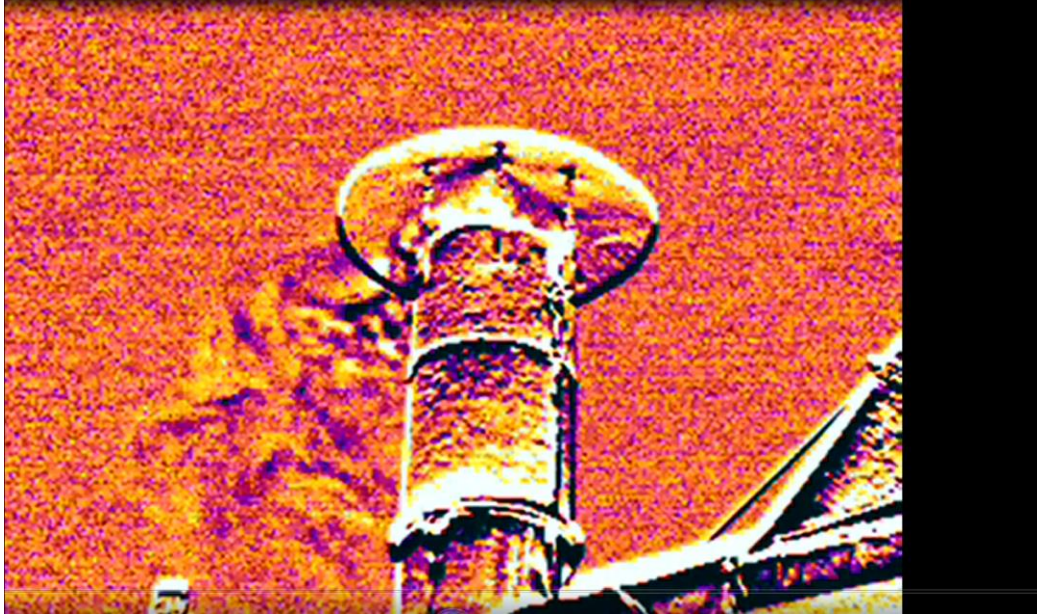
The first test run took place from 10:05 AM -11:05 AM. A series of FLIR videos were recorded by EPA during the first test run that demonstrated the main bypass stack connected to the oxidizer's ventilation was leaking uncontrolled VOC emissions to the environment. Screenshots from these FLIR videos can be found in Attachment A of this report. FLIR videos clearly demonstrating emissions will be retained by the EPA team and will be available upon request.

### **Photo 1: Main Bypass Stack Demonstrating Leaks on Camera's High Sensitivity Mode**

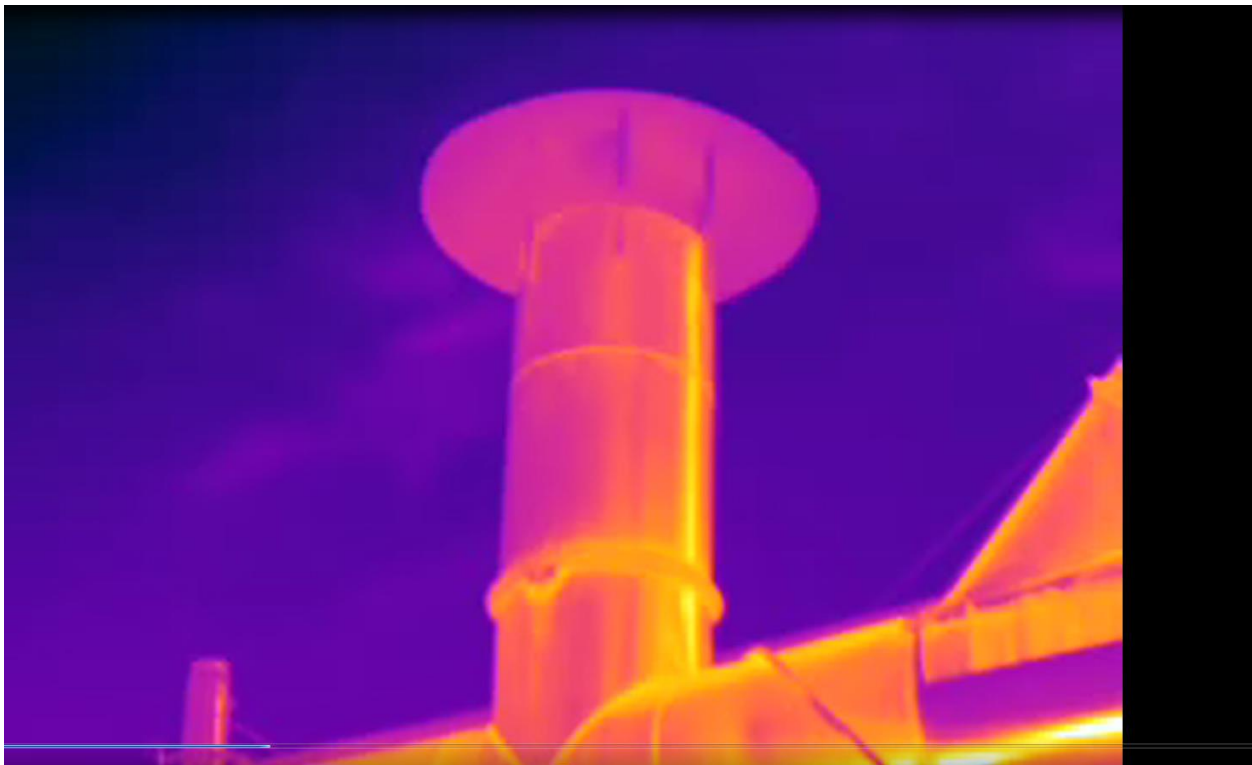
**Photo 2: Main Bypass Stack Demonstrating Leaks on Camera's Auto Mode**

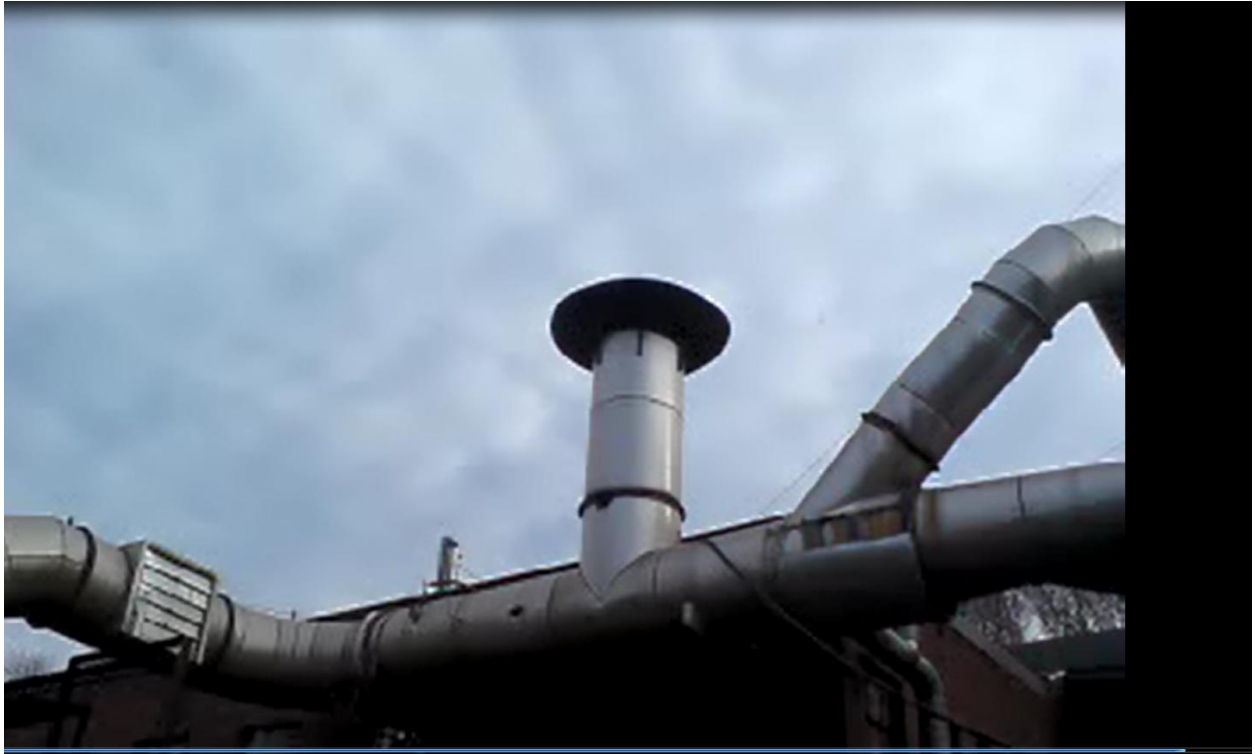
**Photo 3: Main Bypass Stack Demonstrating Leaks on Visible Light Mode**
