## Region 6 Compliance Assurance and Enforcement Division

### INSPECTION REPORT

| Inspection Date(s): | 06/07/2022 | | |
| Company Name: | <b>Bright Start Dairy</b> | | |

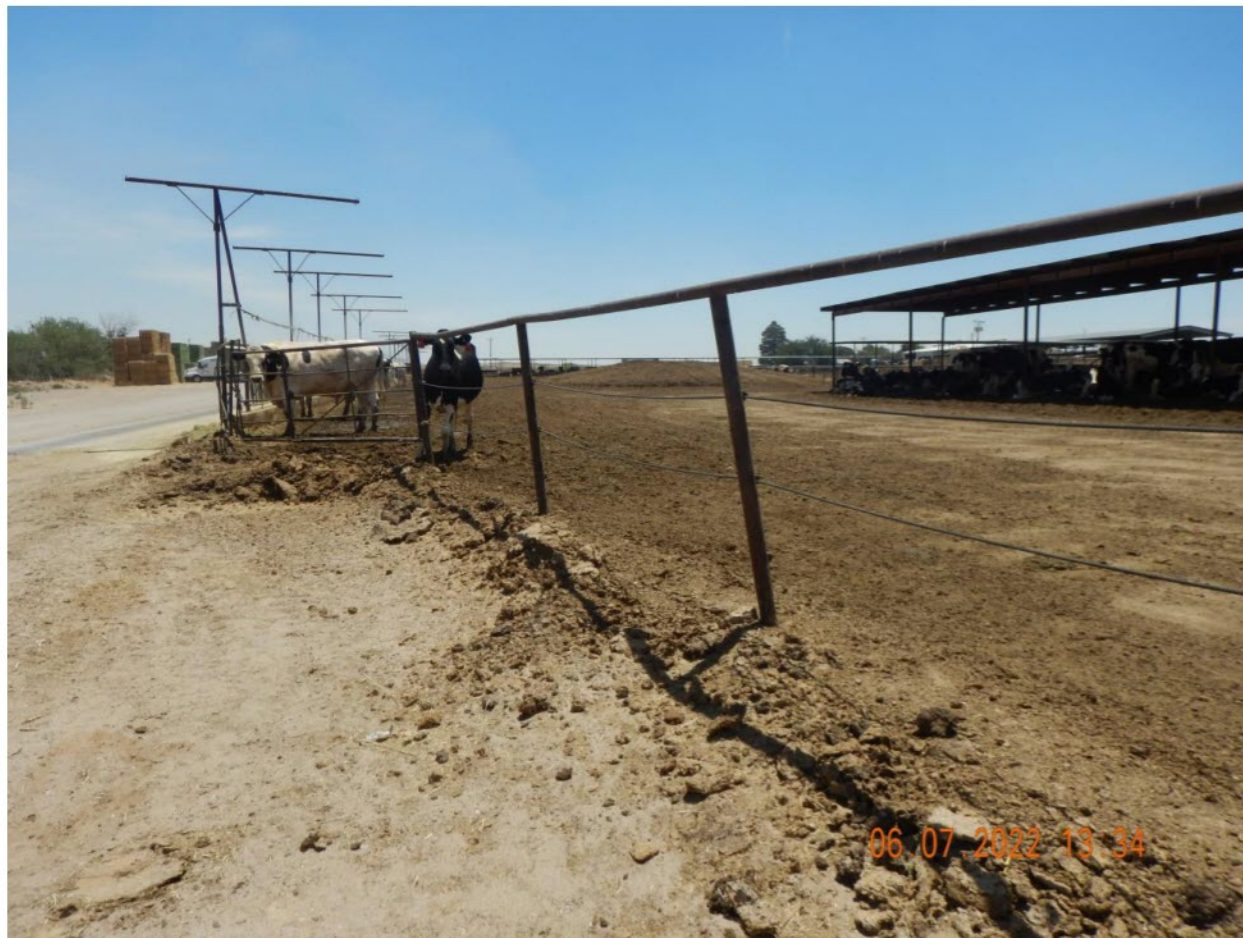
Photo No. 1

We observed that at the NW and NS sides of the facility, berms were not properly designed, constructed, operated, and maintained to contain the 25-yr/24-hr rain event of 4". The slope of the berms at pens were insufficient and almost at the same level of the slope of the pen's surface. Any wastewater or runoff would come in at these locations and discharge to open areas and ditch systems located near the NW and NS areas. We observed erosion, manure, marks of precipitation, run off and marks of accumulation of water at these locations. Areas should be regraded and level to allow proper runoff (See Photo Nos. 1-10 in Appendix 1).

Description: This image shows part of the dairy facility confined and open pens, piles of manure, low berms, rain roof and potential run off flowpath.

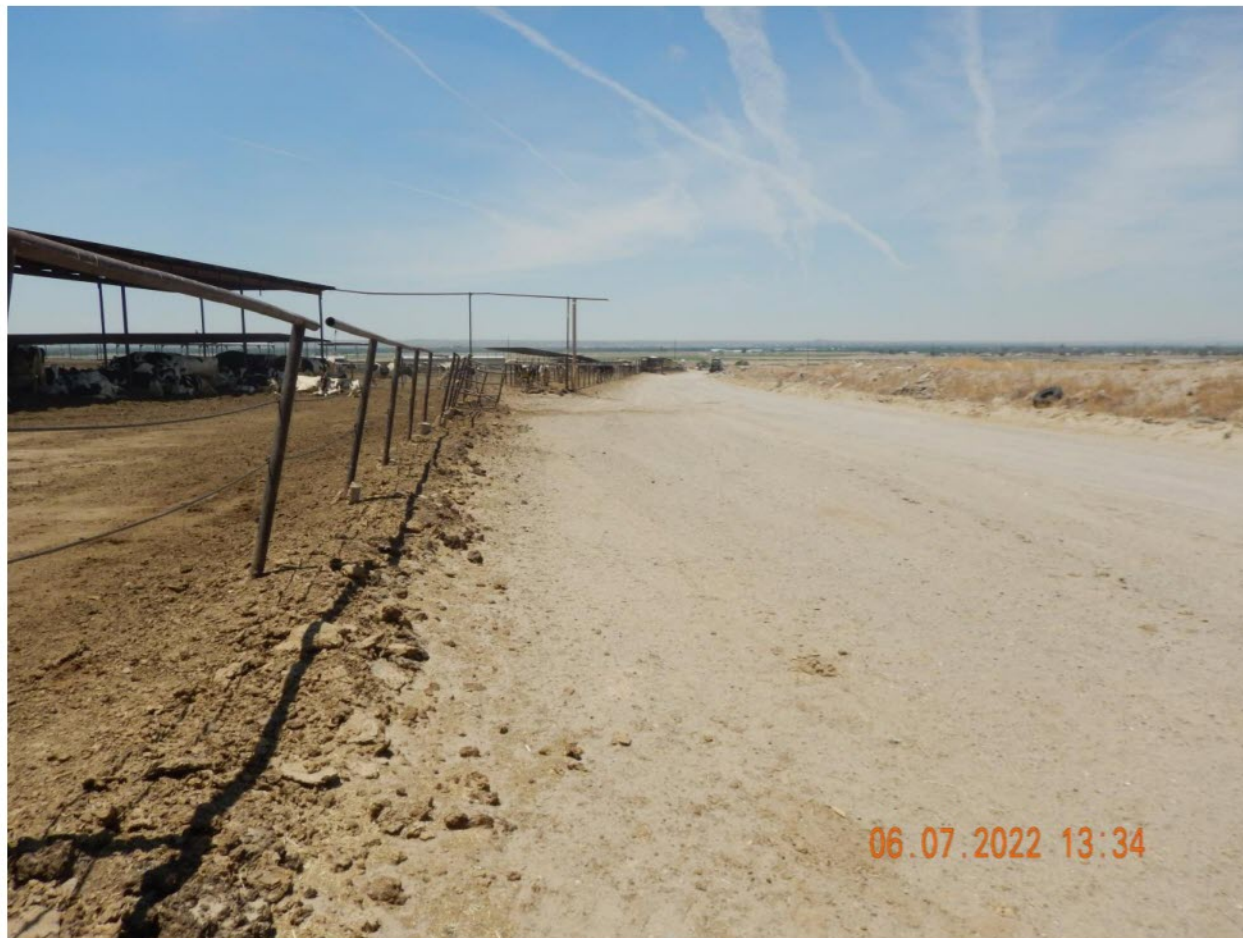
Photo No. 2

Description: This image shows part of the dairy facility confined and open pens, piles of manure, low berms, ditch, rain roof and potential run off flowpath.

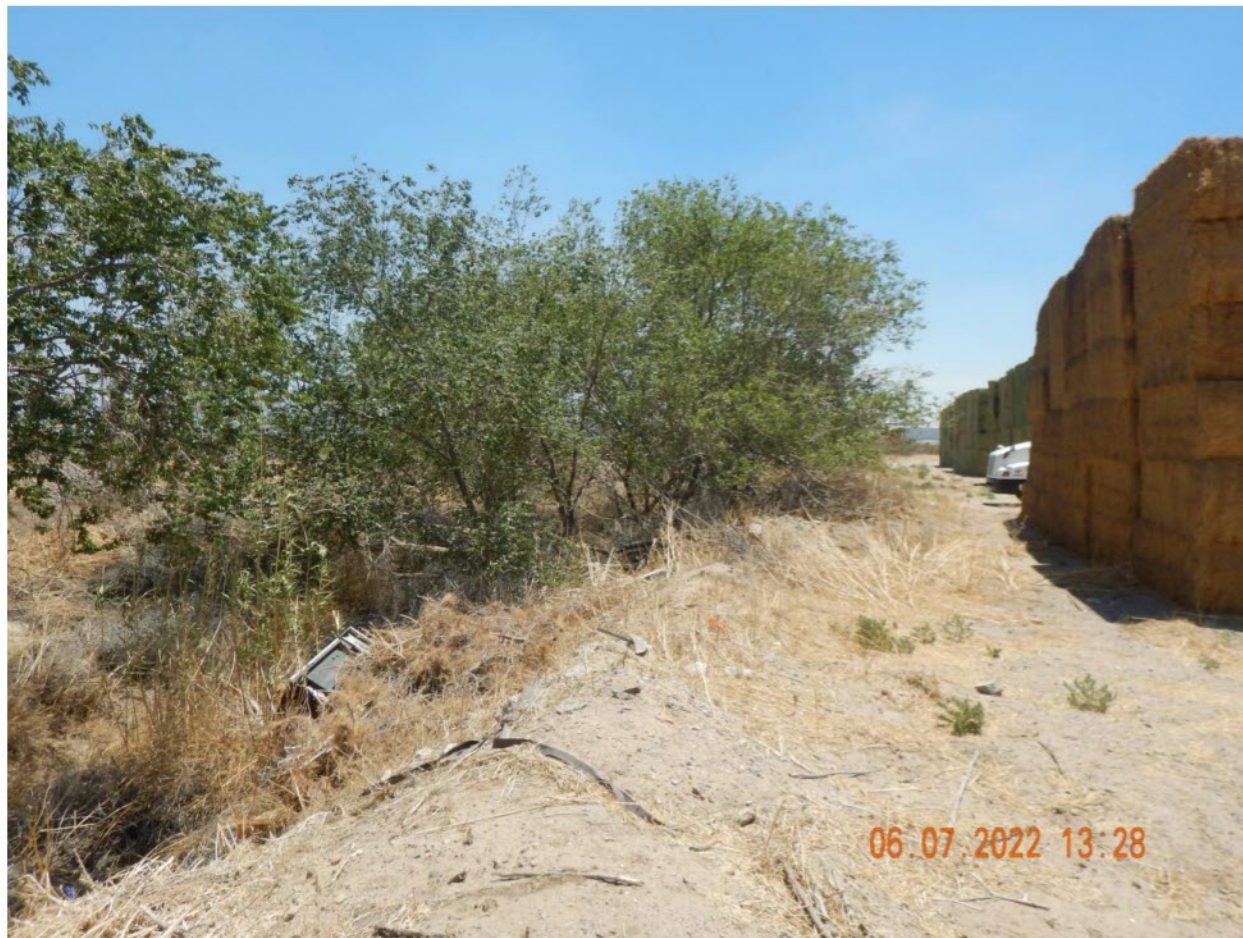
Photo No. 3

We observed that hay was stored without cover barn area approximately 10 feet from a ditch system and next to impoundment #1 (See Photo Nos. 1 – 3 in Appendix 1).

Photograph File Name: DSCN0868.JPG  
Date of Photograph: 06/07/2022  
Latitude and Longitud: 32.157421, -106.659281  
Orientation: NS  
Map Datum: WGS-84  
Time of Photo: 1:28 PM  
Photographer: Jack Arias  
Description: This image shows stored hay without covered barn area approximately 10 feet from the ditch.

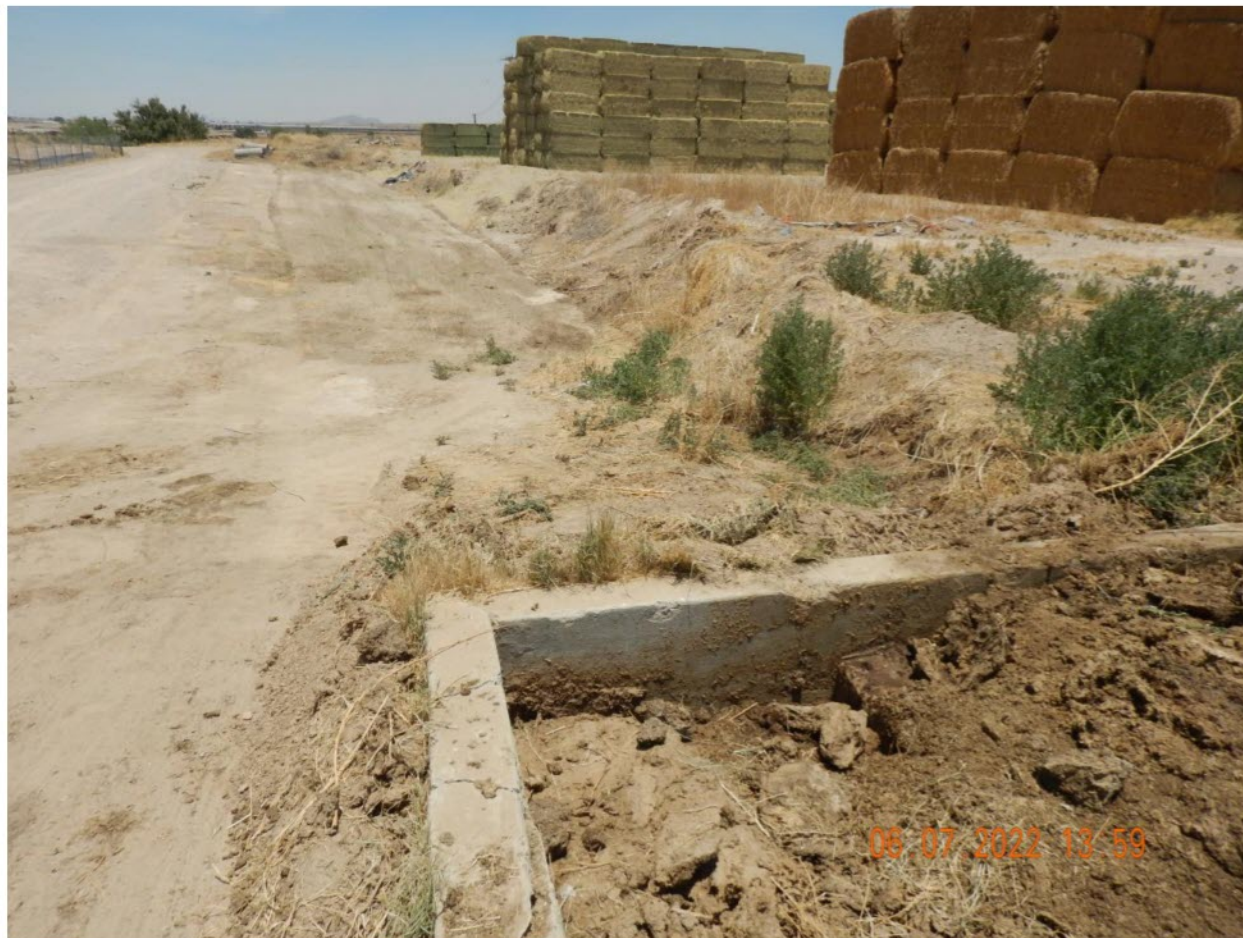
Photo No. 4

Photograph File Name: DSCN0885.JPG  
Date of Photograph: 08/07/2022  
Latitude and Longitude: 32.156890, -106.668190  
Orientation: W  
Map Datum: WGS-84  
Time of Photo: 1:59 PM  
Photographer: Jack Arias  
Description: This image shows stored hay without covered barn area approximately 100 feet from impoundment # 1.

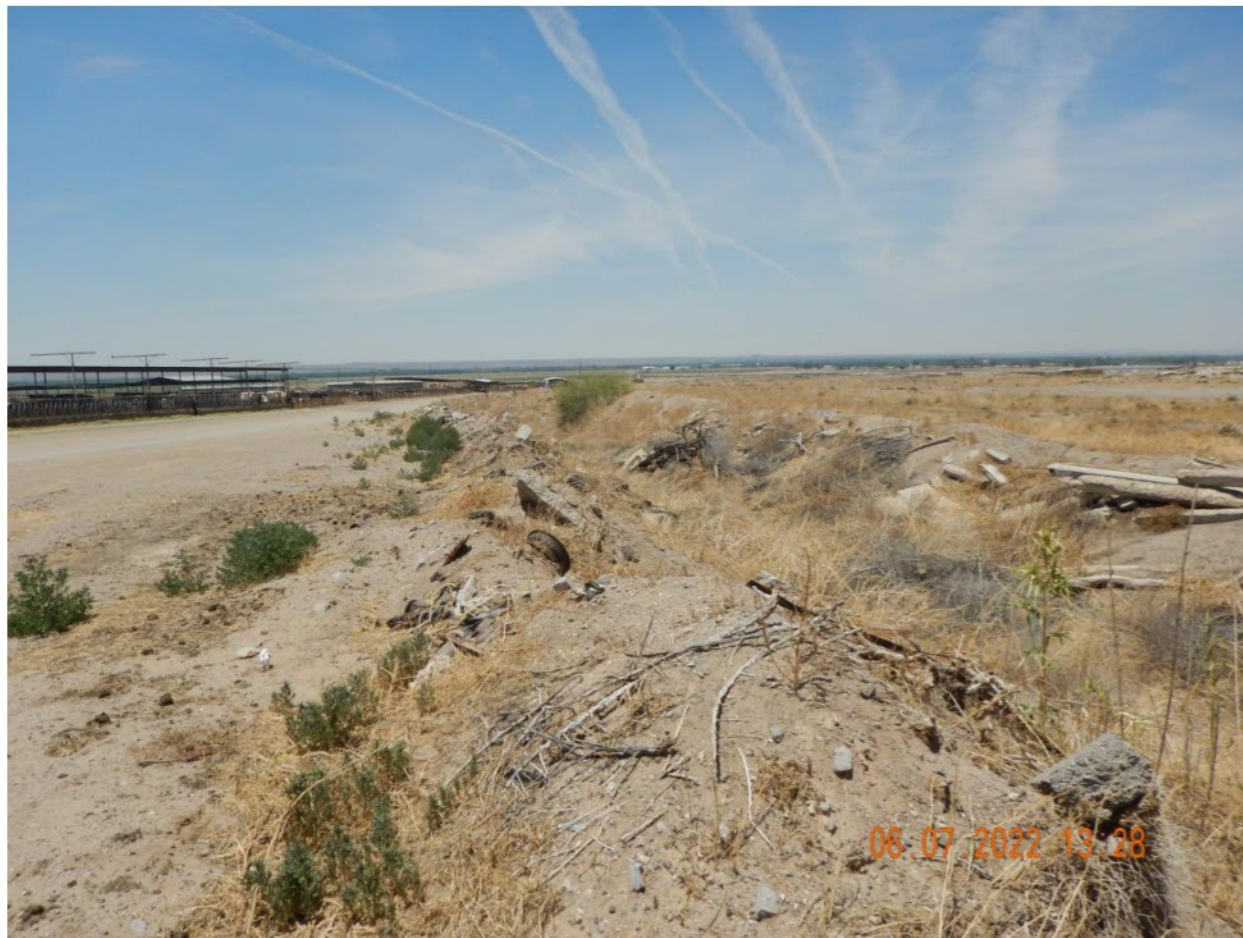
Photo No. 5

Photograph File Name: DSCN0869.JPG  
Date of Photograph: 06/07/2022  
Latitude and Longitude: 32.157421, -106.659281  
Orientation: NW  
Map Datum: WGS-84  
Time of Photo: 1:40 PM  
Photographer: Jack Arias  
Description: This image shows a ditch approximately 10 feet from stored hay and 80 feet from pens.

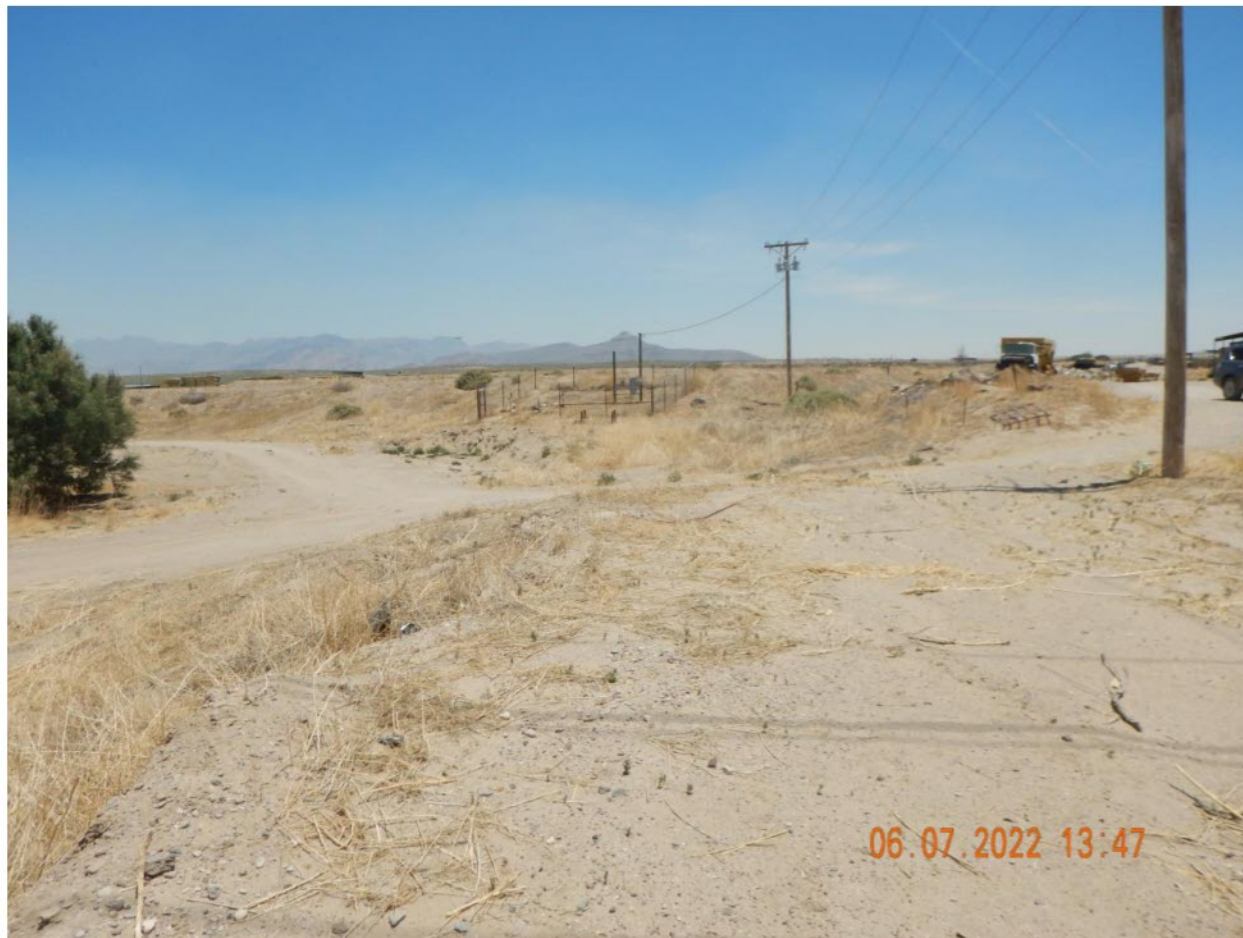
Photo No. 7

Description: This image shows an open area where wastewater or runoff could come in and potentially discharge to a mesquite drain near the facility.

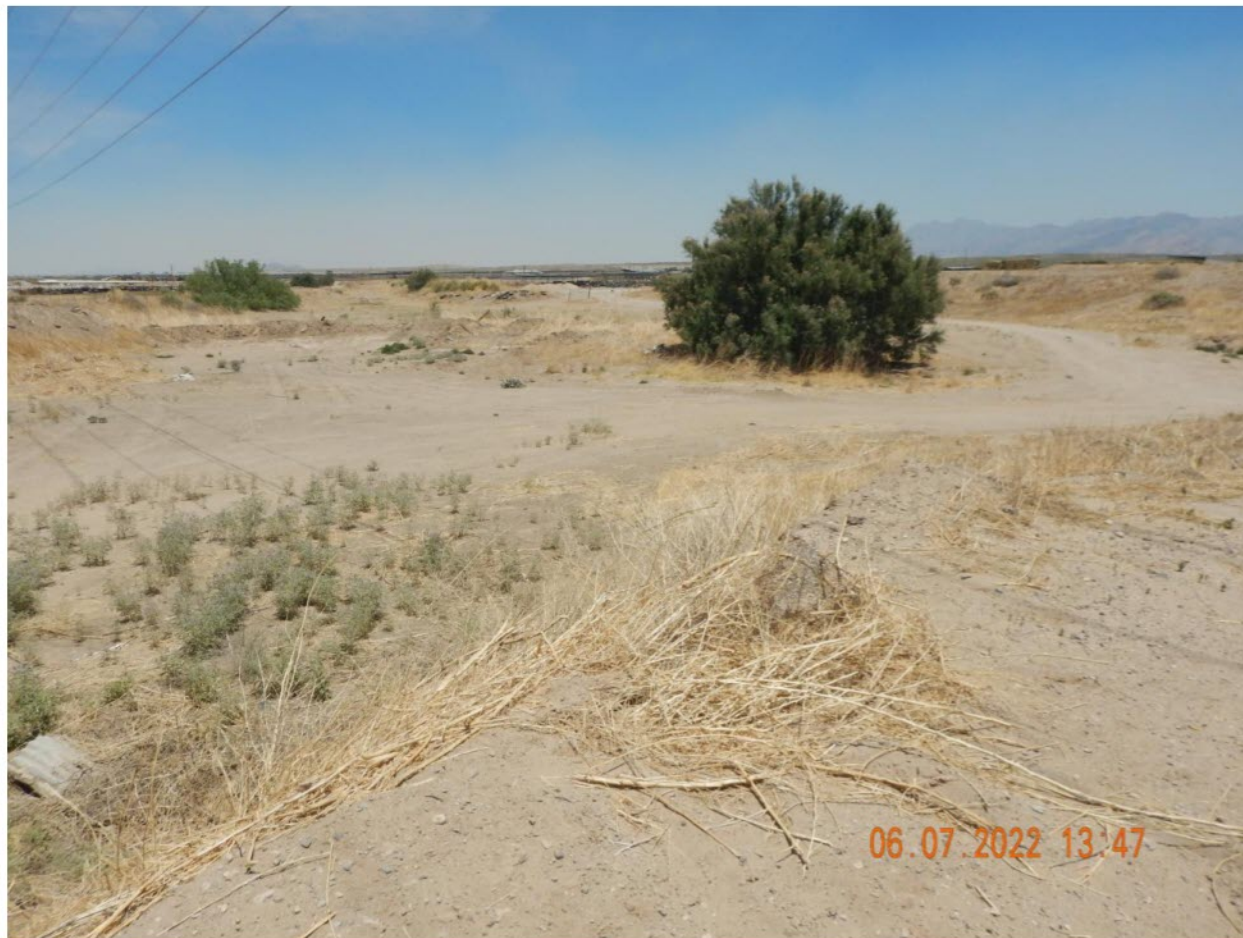
Photo No. 8

Description: This image shows an open area where wastewater or runoff could come in and potentially discharge to mesquite drain near the facility.

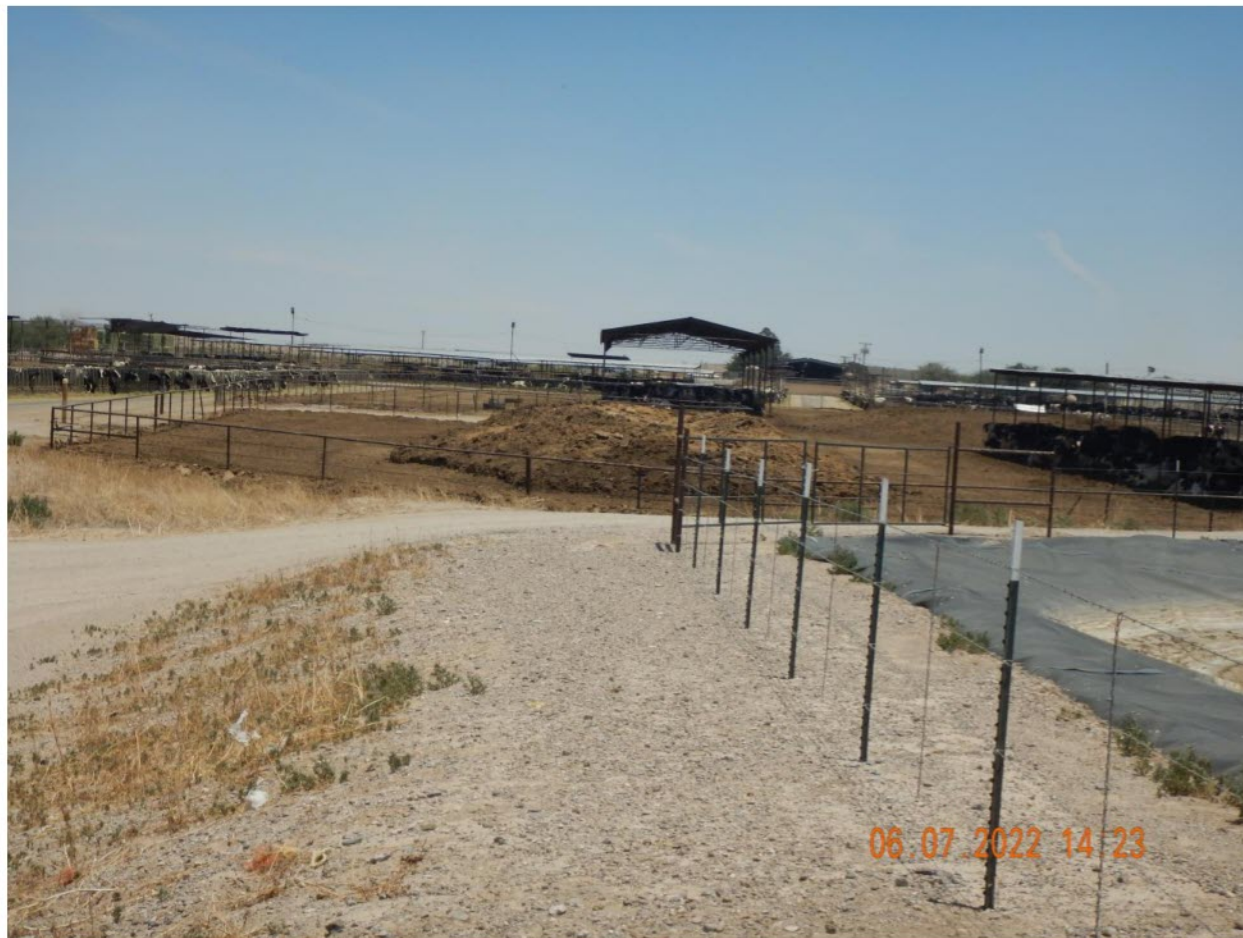
Photo No. 9

We observed large amounts and accumulation of manure solids inside pens. Manure solids should be removed, and area regraded and leveled to allow proper runoff (See Photo Nos. 9 - 10 in Appendix 1).

Description: This image shows large amounts and accumulation of manure and debris inside pens. Manure solids should be removed, and area regraded and leveled to allow proper runoff.

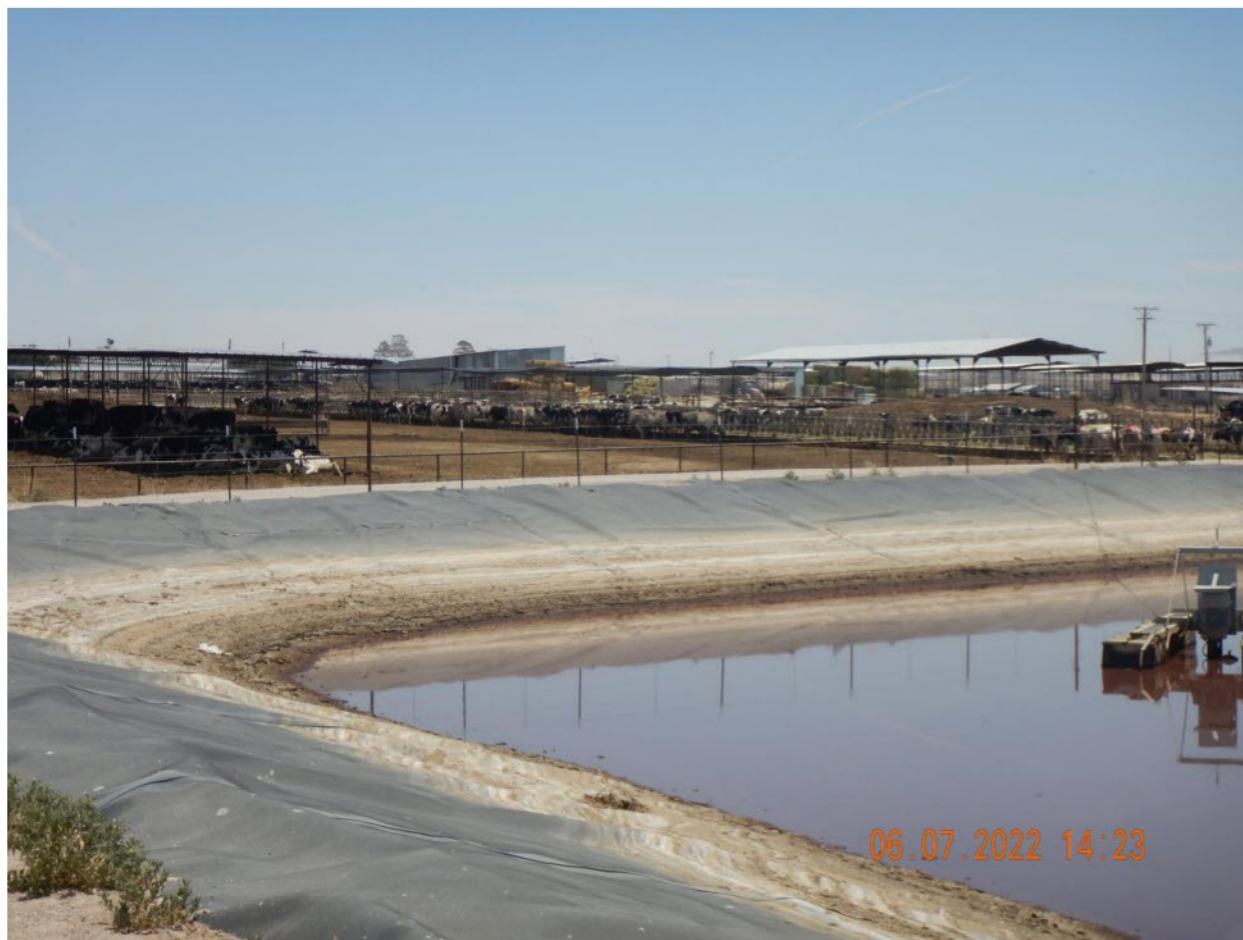
Photo No. 10

This image shows large amounts of manure and debris inside pens. Manure solids should be removed, and area regraded and leveled to allow proper runoff.

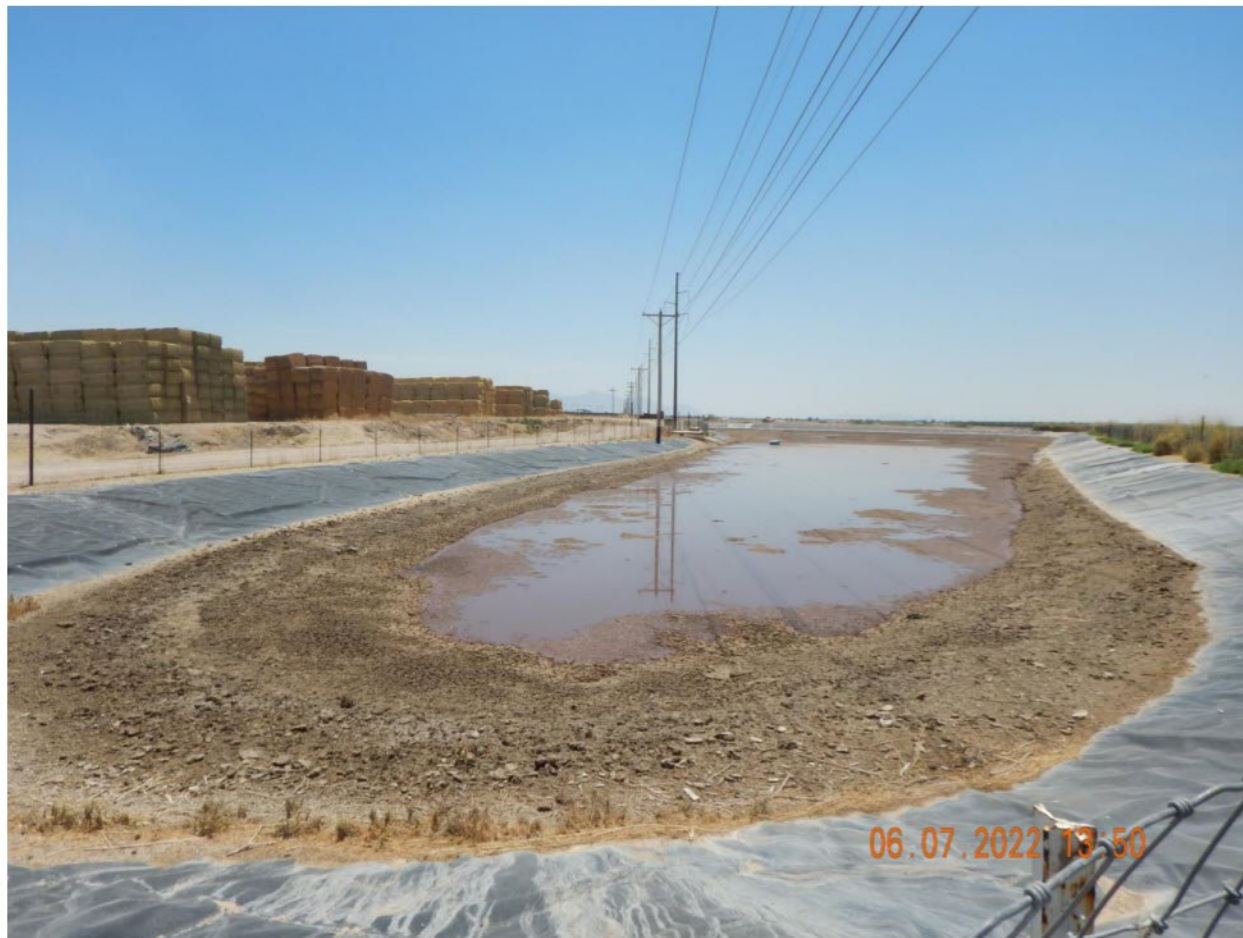
Photo No. 11

Bright Start Dairy consisted of two synthetically lined process wastewater lagoons or impoundments (#1 and #2) that formed part of the watershed retention control structures (RCS). Impoundment #1 showed large amounts of manure solids (approximately 40% capacity) inside its perimeter. Also, we did not observe a pool depth marker and observed a discharge into impoundment #1 of manure solids and wastewater coming from pens and concrete separators. (See Photo Nos. 11 - 13 in Appendix 1).

Additionally, we observed that the impoundment #1 did not have a screen separator system that could potentially reduce accumulation of manure solids inside the perimeter of the impoundment #1. This could potentially affect the integrity of impoundment #1 and its capacity to contain wastewater and runoff from the cow milking parlor, pens, feed lanes, and concrete separators. Impoundment #1 is located at the northwest corner of the facility and impoundment #2 near NS side of facility (See Photo Nos. 11 – 13 in Appendix 1).

This image shows impoundment #1 containing large amounts of Manure solids (manure) inside its perimeter. This could impact the integrity of impoundment #1 and its capacity to contain wastewater and runoff from the cow milking parlor, pens, feed lanes, and concrete separators.

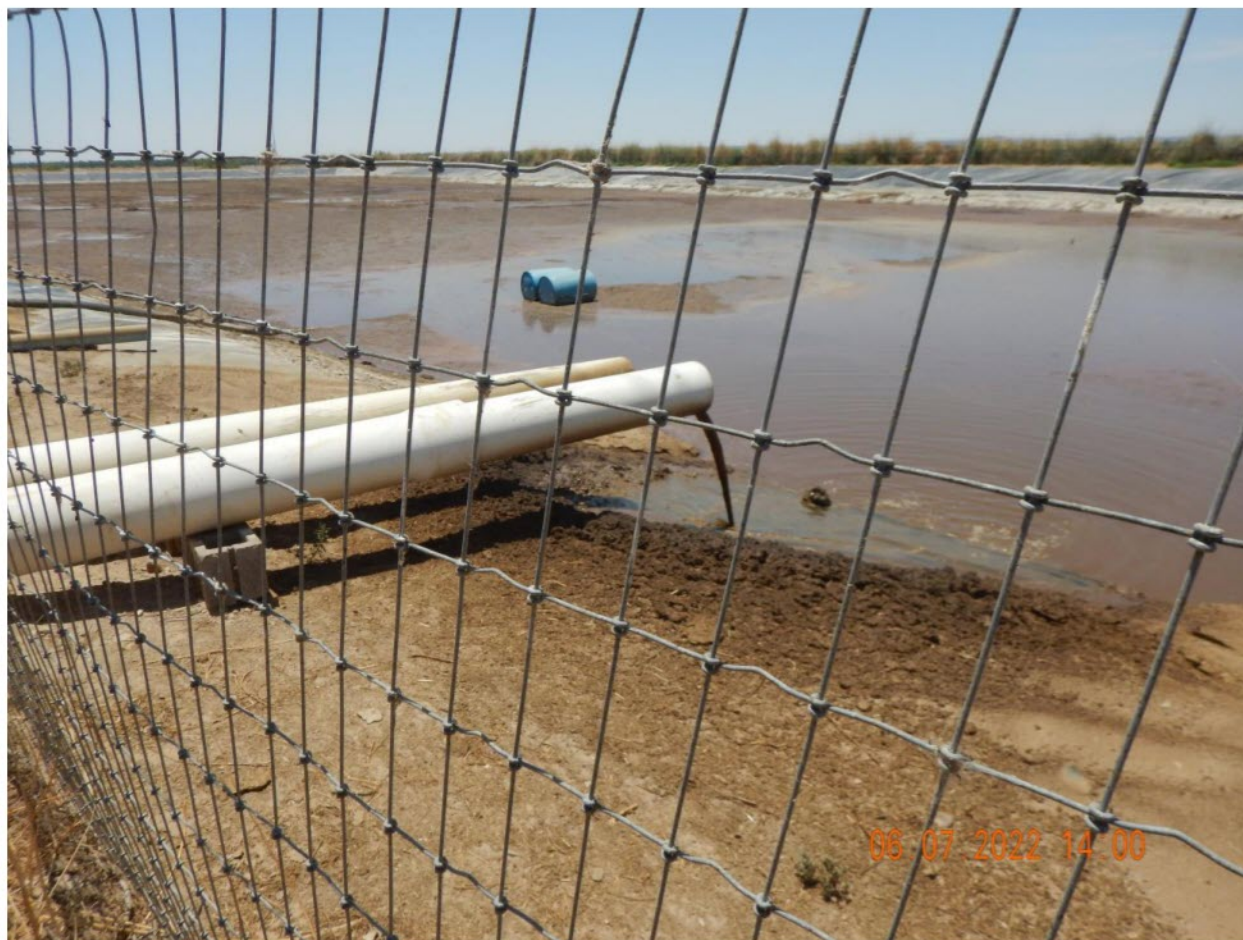
Photo No. 12

Description: This image shows a discharge into impoundment #1 of sediments and wastewater coming from pens and concrete separators.

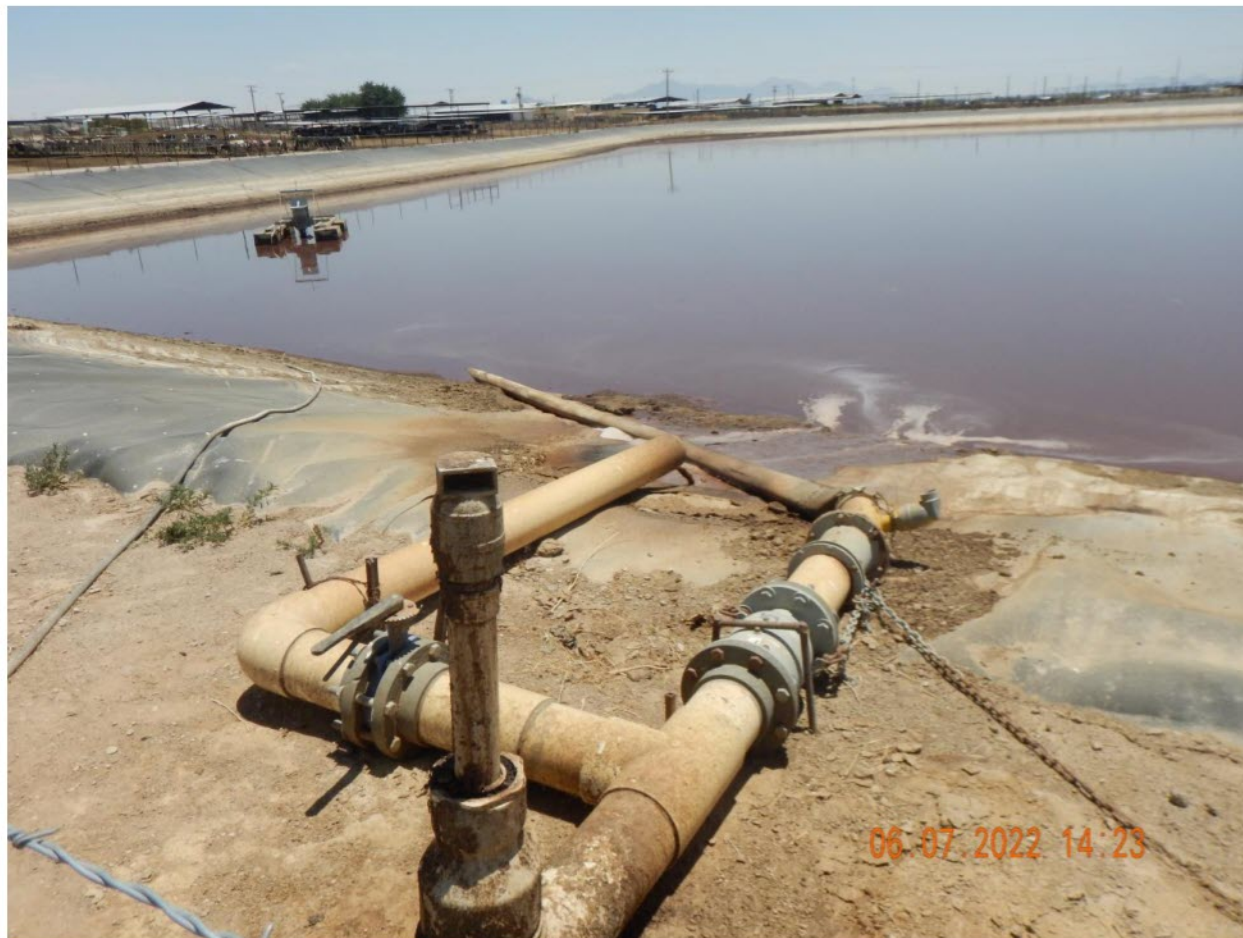
Photo No. 13

Description: This image shows a lined process wastewater lagoon/impoundment #2 that formed part of the watershed retention control structures (RCS).

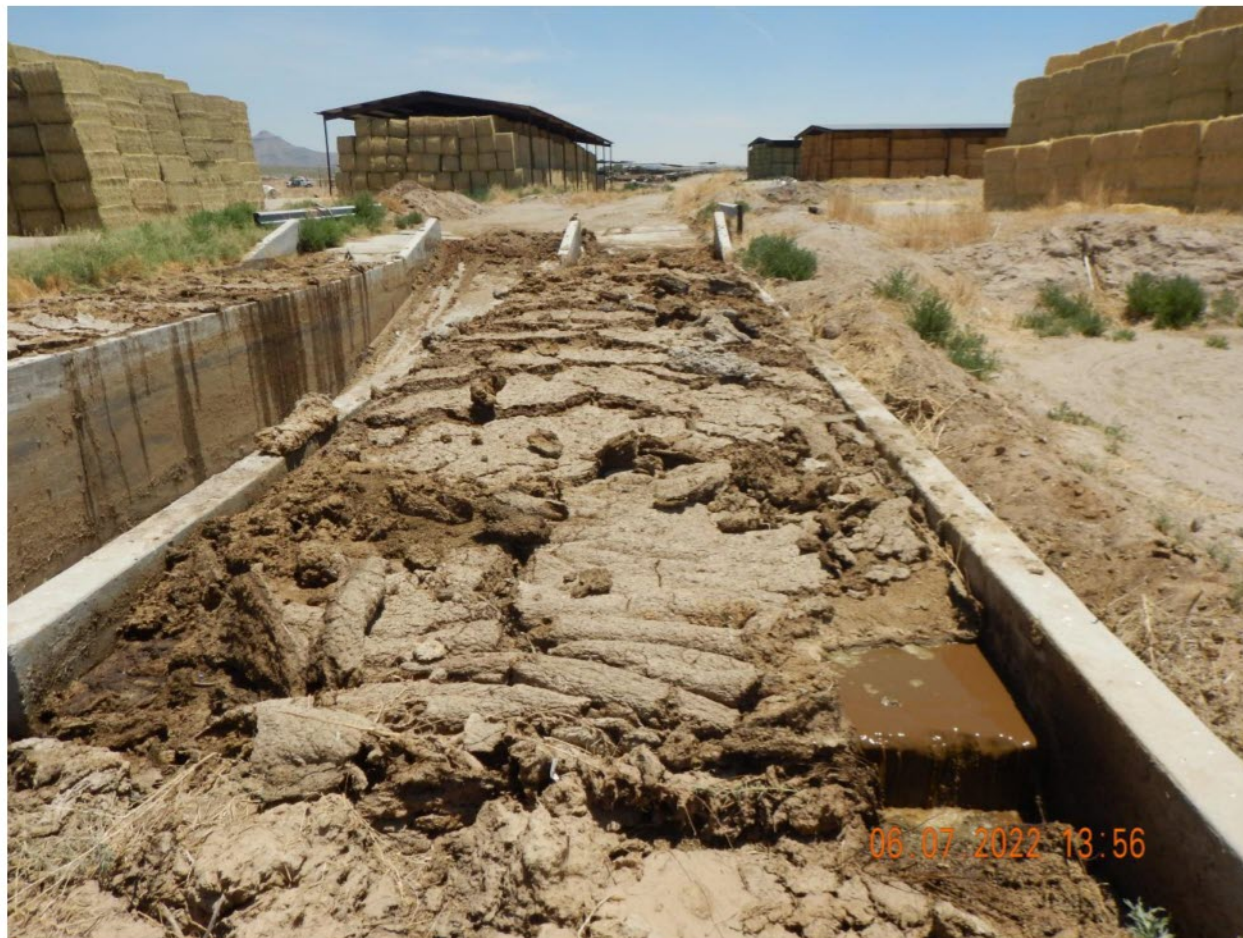
Photo No. 14

Concrete separator # 1 and #2 showed large amounts and accumulation of manure solids inside the perimeter of the separators. We observed manure solids blocking aggressively the flow of wastewater coming from milking parlor, pens, and feed lanes into impoundment #1. Also, we observed overflows and accumulation of manure solids outside of the concrete separators, near the NW ditch, and stored outside of the impoundment #1. (See Photo Nos. 14 - 18 in Appendix 1).

This image shows large amounts and accumulation of Manure solids inside the perimeter of concrete separators #1. We observed sediments blocking the flow of wastewater from coming from milking parlor, pens, feed lanes, and pens into impoundment #1.

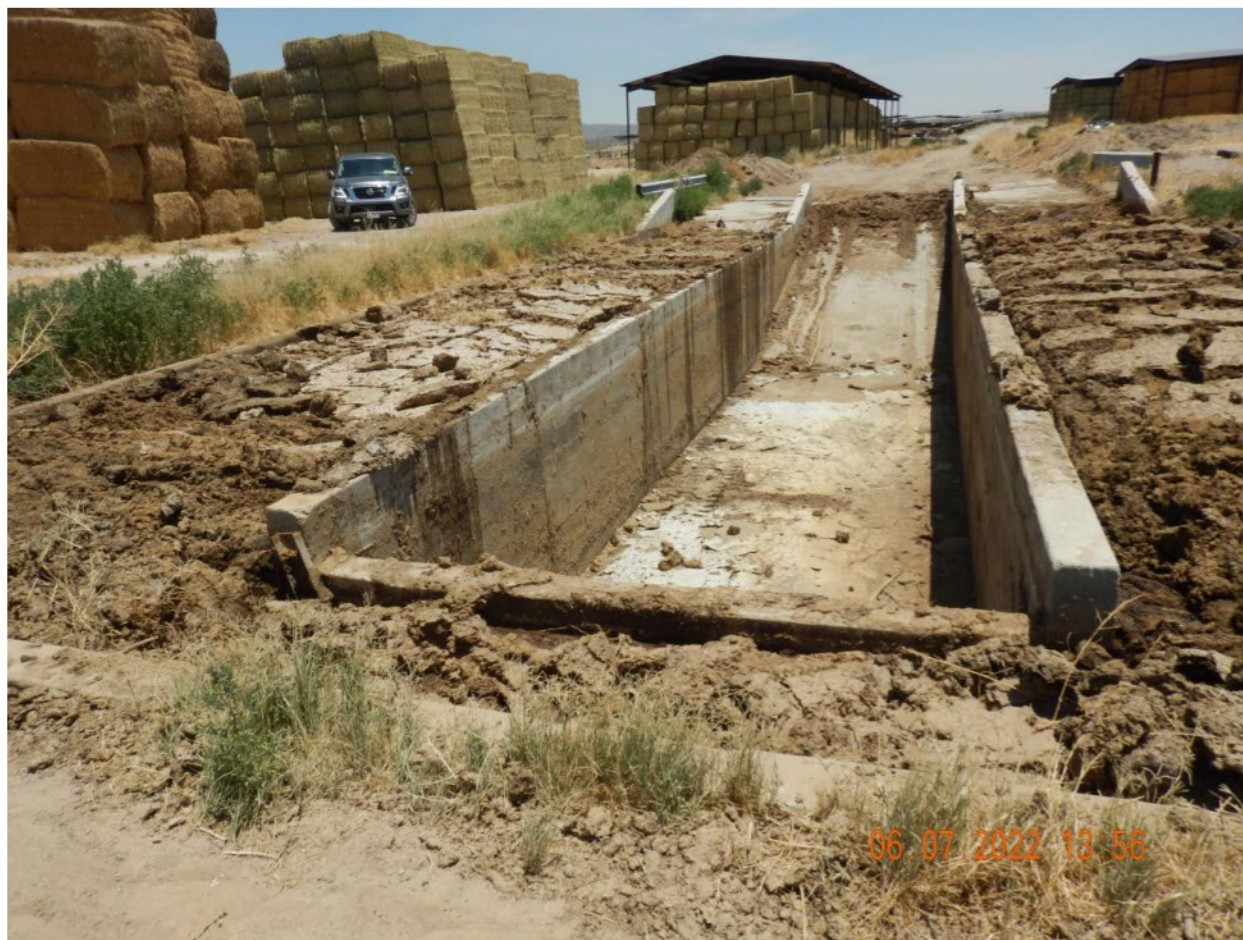
Photo No. 15

This image shows large amounts and accumulation of manure solids inside the perimeter of concrete separators #1. We observed manure solids blocking the flow of wastewater from coming from milking parlor, pens, feed lanes, and pens into impoundment #1.

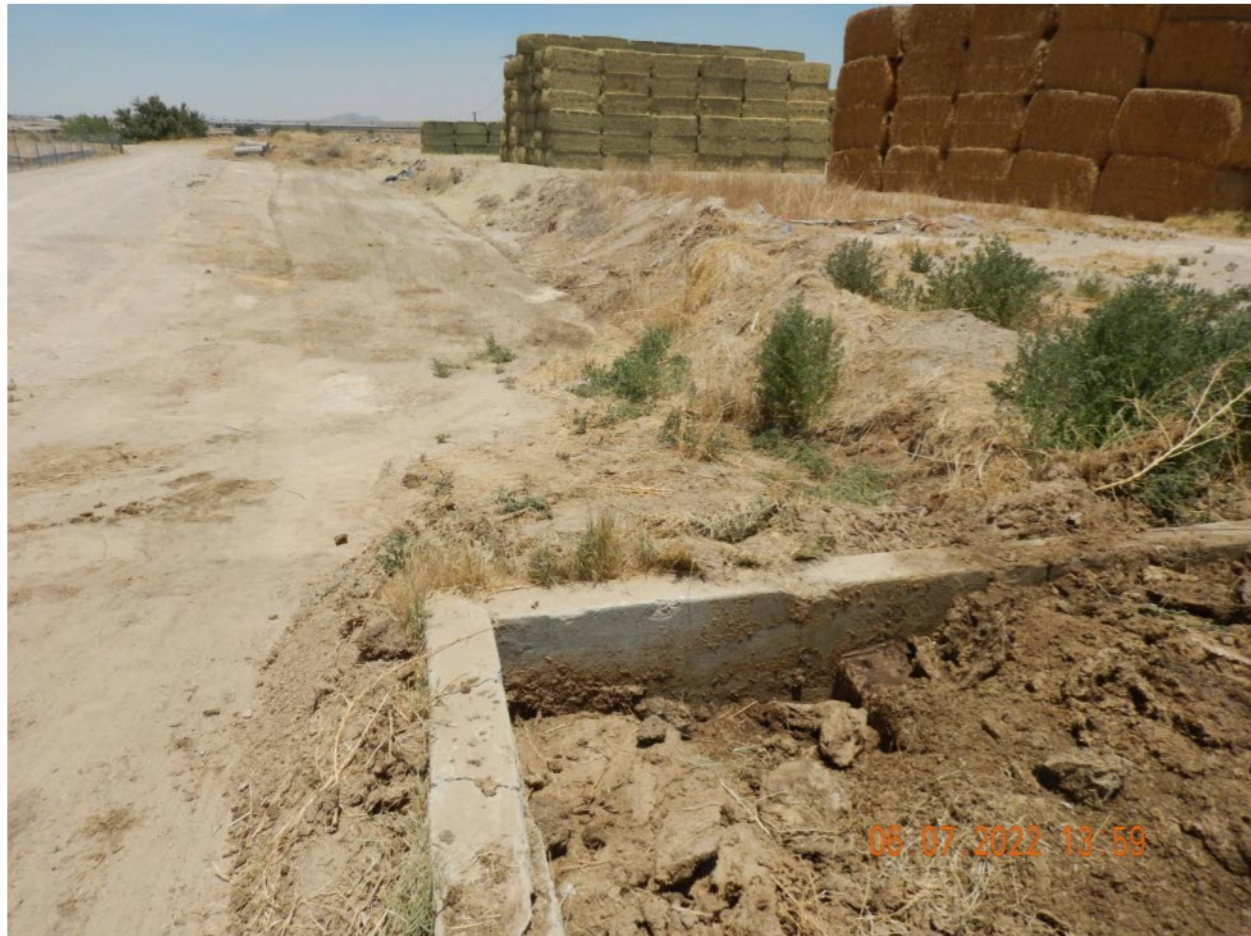
Photo No. 16

This image shows overflows and accumulation of manure solids outside of the concrete separator #1. Sediments are near the NW ditch and been stored outside of the impoundment #1.

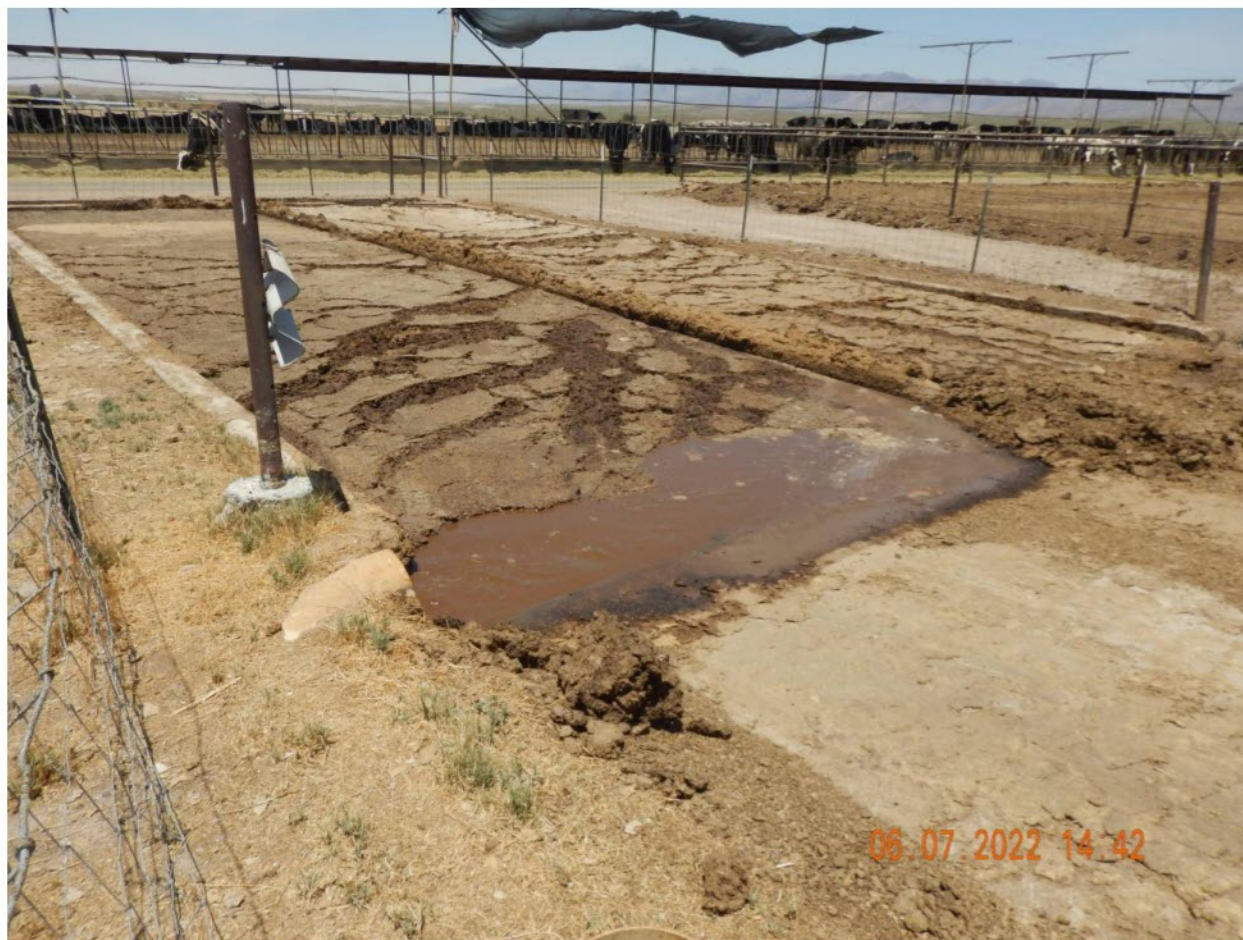
Photo No. 17

Photograph File Name: DSCN0907.JPG  
Date of Photograph: 06/07/2022  
Latitude and Longitude: 32.156970, -106.664432  
Orientation: N  
Map Datum: WGS-84  
Time of Photo: 2:42 PM  
Photographer: Jack Arias  
Description: This image shows overflows and accumulation of manure solids inside and outside of the concrete separator #2.

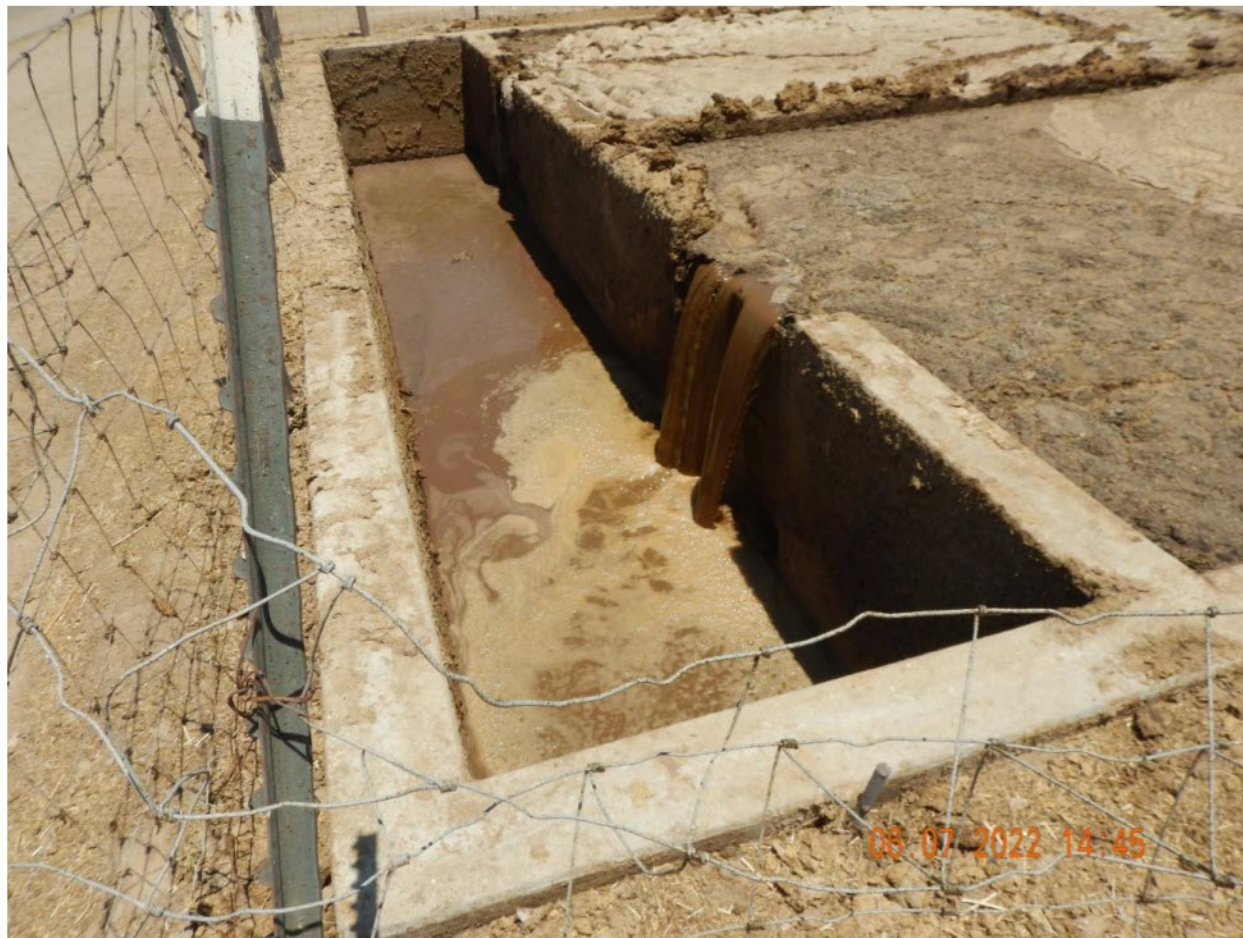
Photo No. 18

This image shows wastewater coming from accumulation of manure solids in separator #2. This wastewater will discharge in concrete separator #1 (which showed evidence of overflows of manure solids inside and outside its perimeter).

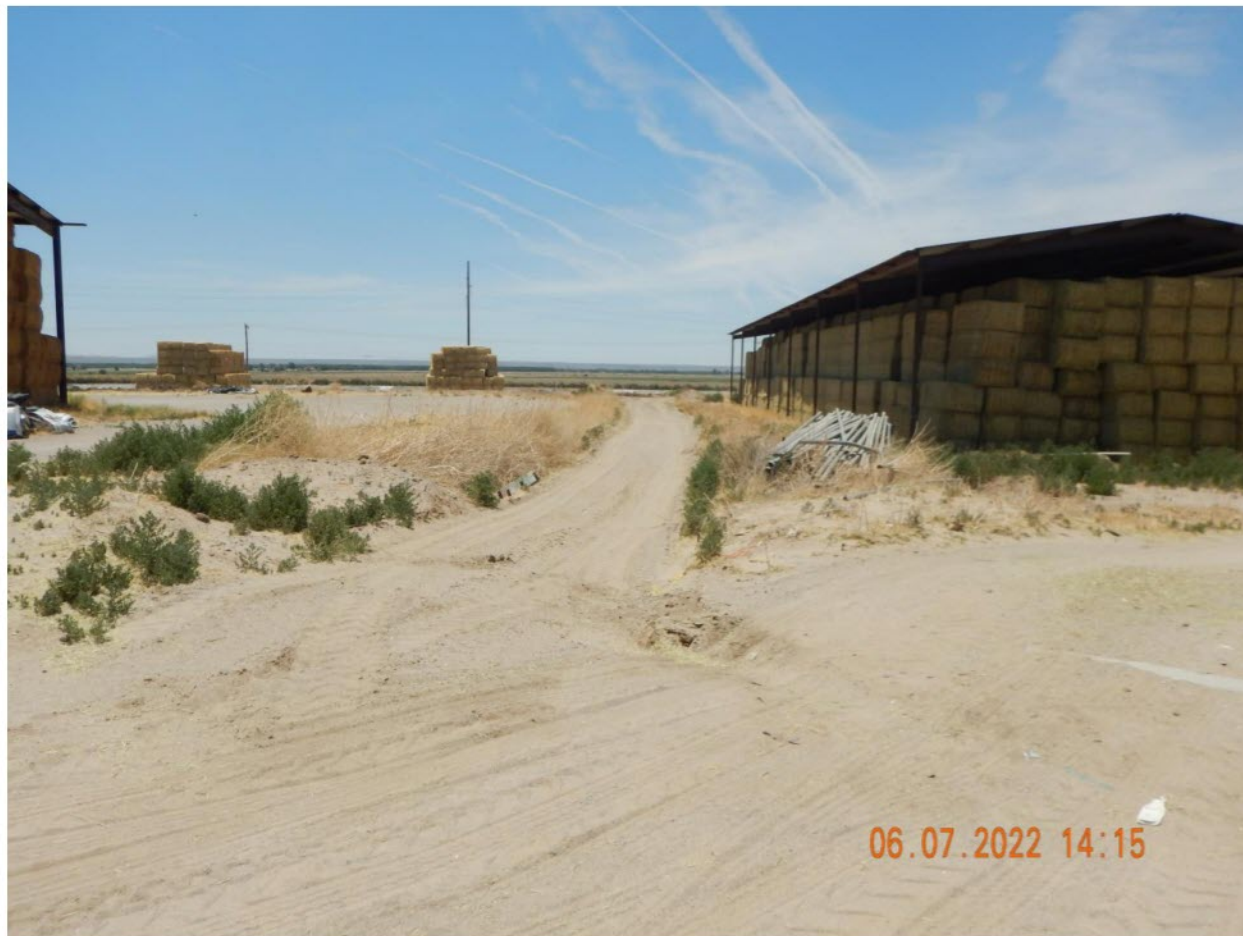
Additionally, we observed an undefined flowpath of a ditch that transport wastewater coming from milking parlor, pens, feed lanes, and concrete separator #2. Also, we found that 100% of the wastewater from milking parlor, pens, feed lanes, concrete separator #2, and ditches discharging into concrete separator #1. This undefined discharge system is producing large accumulation of manure and blocking flow of wastewater into impoundment #1. Proper maintenance, reinforcement of walls of separators, removal of sediments, and improvement of discharge systems reduce overflows and accumulation of sediments inside and outside the perimeter of concrete separators and impoundment #1 (See Photo No. 19 in Appendix 1).

This image shows an undefined flowpath of a ditch that transport wastewater coming from milking parlor, pens, feed lanes, and concrete separator #2.
