## Region 6 Compliance Assurance and Enforcement Division

### INSPECTION REPORT

| Inspection Date(s): | 06/07/2022 | | |
| Company Name: | <b>Bright Start Dairy</b> | | |

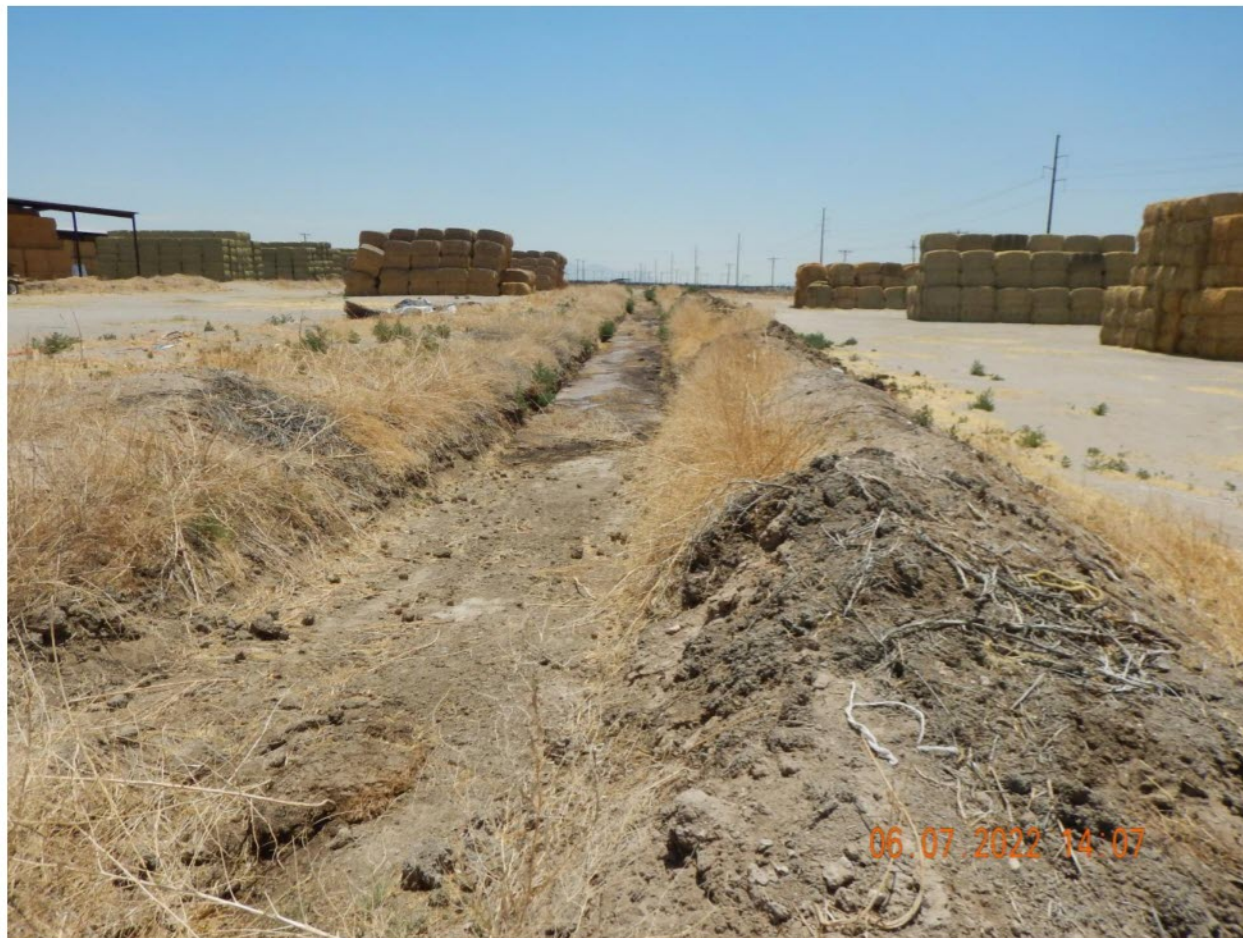
Photo No. 20

We observed a large undefined trench with a significant amount of solids buildup inside the perimeter of the trench. Also, we observed flow paths of manure solids coming from pens to the trench (See Photo Nos. 20 - 21 in Appendix 1).

The transportation and accumulation of manure solids in this trench system is producing inappropriate accumulation of manure and discharge of wastewater that is directly affecting the discharge of wastewater and accumulation of sediment in concrete separator #1 and impoundment #1. Proper planing, maintenance, removal of sediments, and improvement of discharge system reduce accumulation of sediments inside the perimeter of concrete separators and impoundment #1 (See Photo Nos. 20 - 21 in Appendix 1).

Description: This image shows a large undefined trench with large amounts manure solids (manure and debris) inside the perimeter of the trench. Also, we observed flow paths of manure solids coming from pens to the trench.

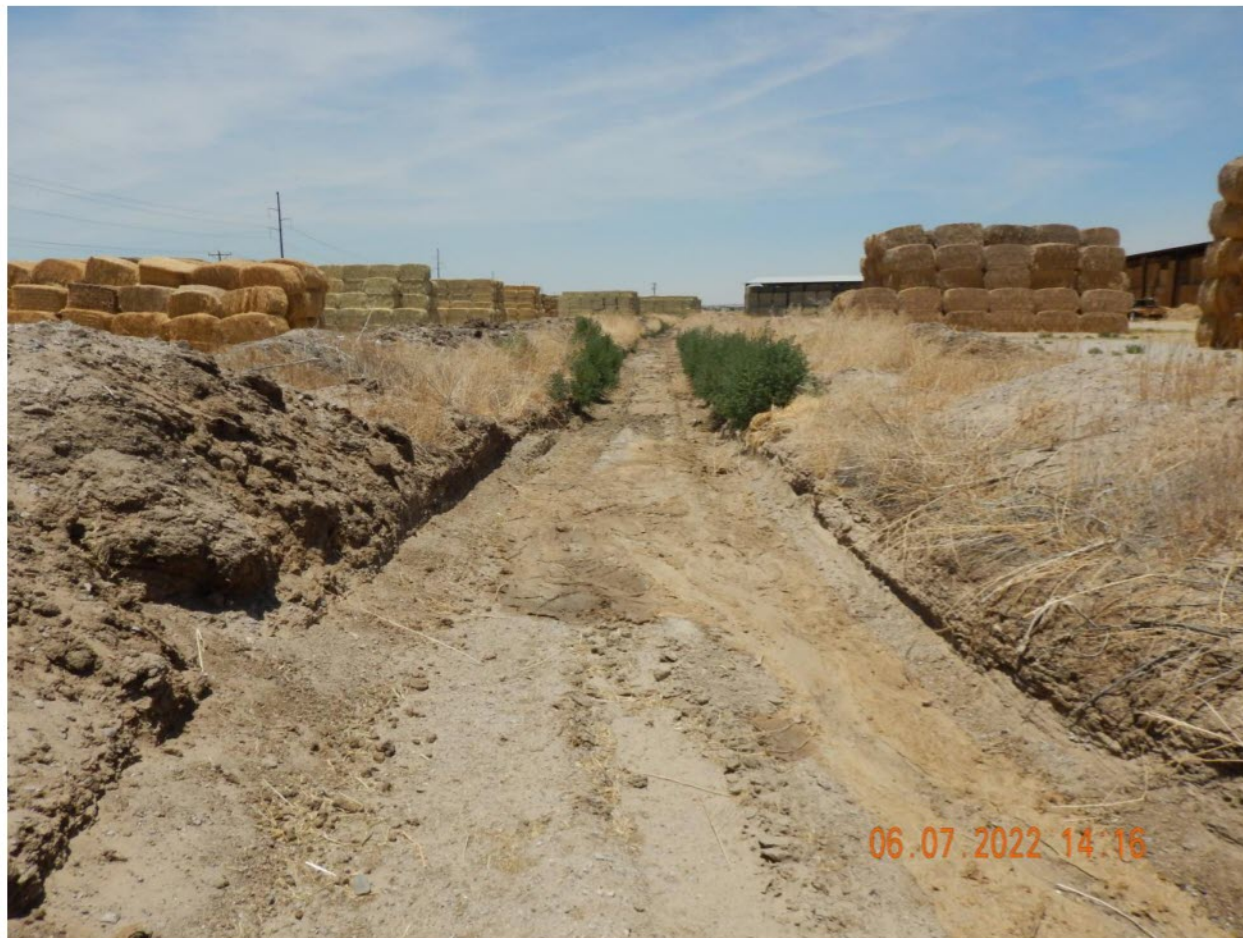
Description: This image shows a large undefined trench with large amounts of sediments (manure and debris) inside the perimeter of the trench. Also, we observed flow paths of sediments coming from pens to the trench.

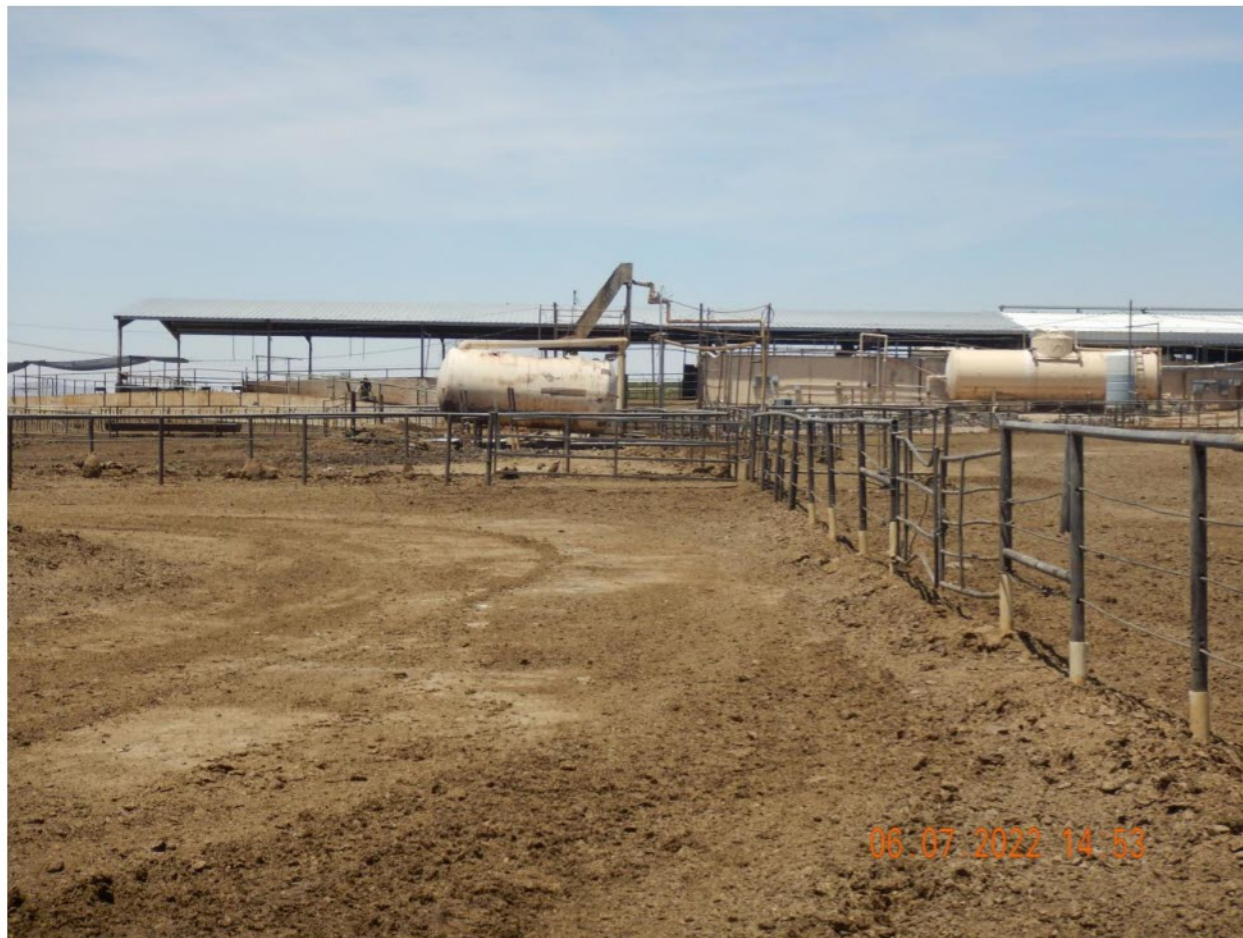
Bright Start Dairy has consisted of one screen separator system that formed part of the watershed retention control structures (RCS) for the milking parlor area. We observed accumulation of manure solids around the screen separator system that could lead to overflows, obstructions, and improper discharge of wastewater from milking parlor area (See Photo No. 22 in Appendix 1).

Description: This image shows potential accumulation of sediments around the screen separator system that could lead to overflows, obstructions, and improper discharge of wastewater from milking parlor area.

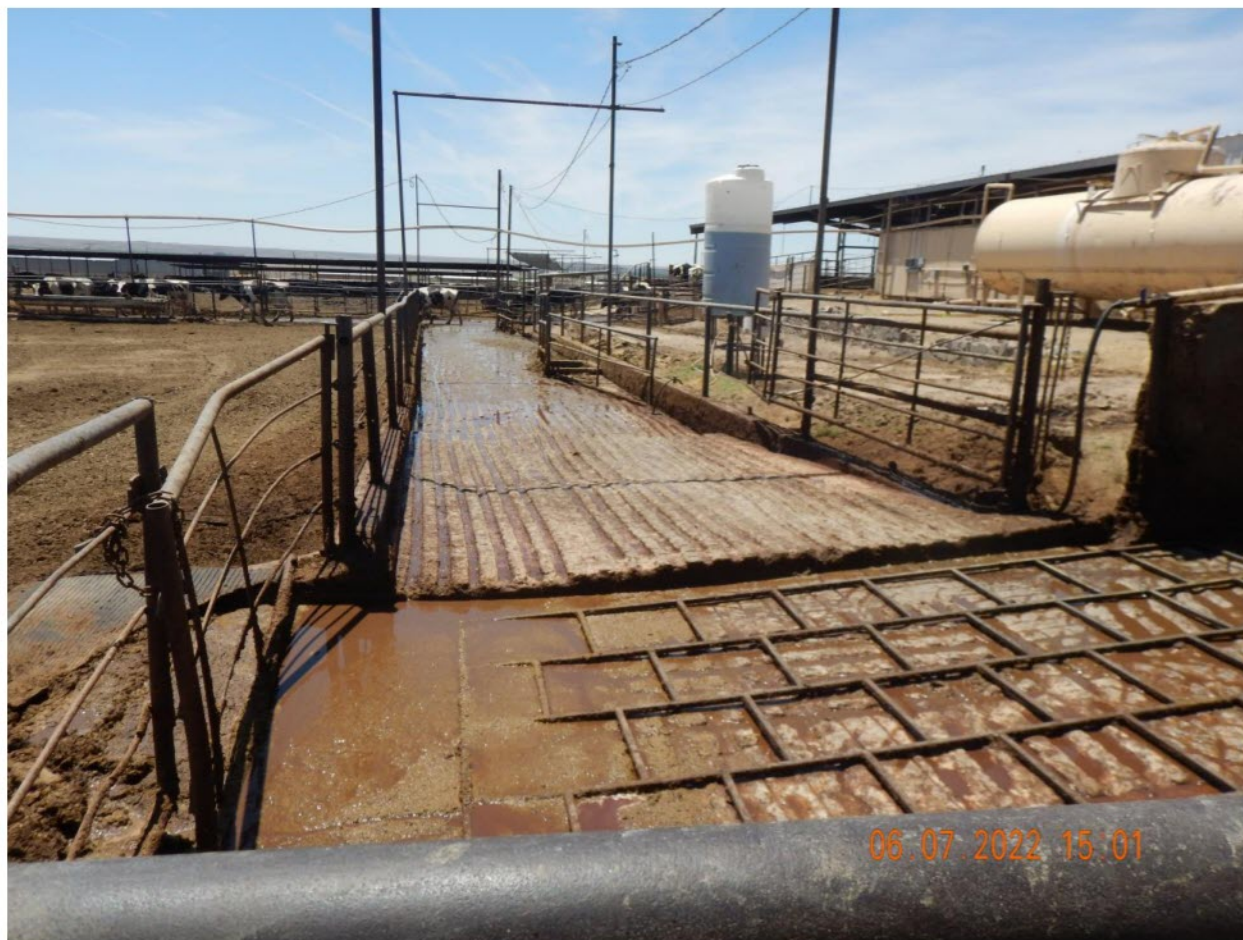
We observed pools and flowpath areas around the milking parlor system. Also, we observed (next to the entrance of the milking parlor area and a storm drain system) 7 barrels (each 60-gallon capacity) containing Advance Corrosive Acid and Liquid Santex Soups 5 feet from a storm water system and without a proper containment area. The lack of a containment system will lead to improper overflows and discharges (See Photo Nos. 23 - 24 in Appendix 1).

Photograph File Name: DSCN0920.JPG  
Date of Photograph: 06/07/2022  
Latitude and Longitude: 32.156597, -106.659798  
Orientation: S  
Map Datum: WGS-84  
Time of Photo: 3:01 PM  
Photographer: Jack Arias  
Description: This image shows pools and flowpath areas around the milking parlor system.

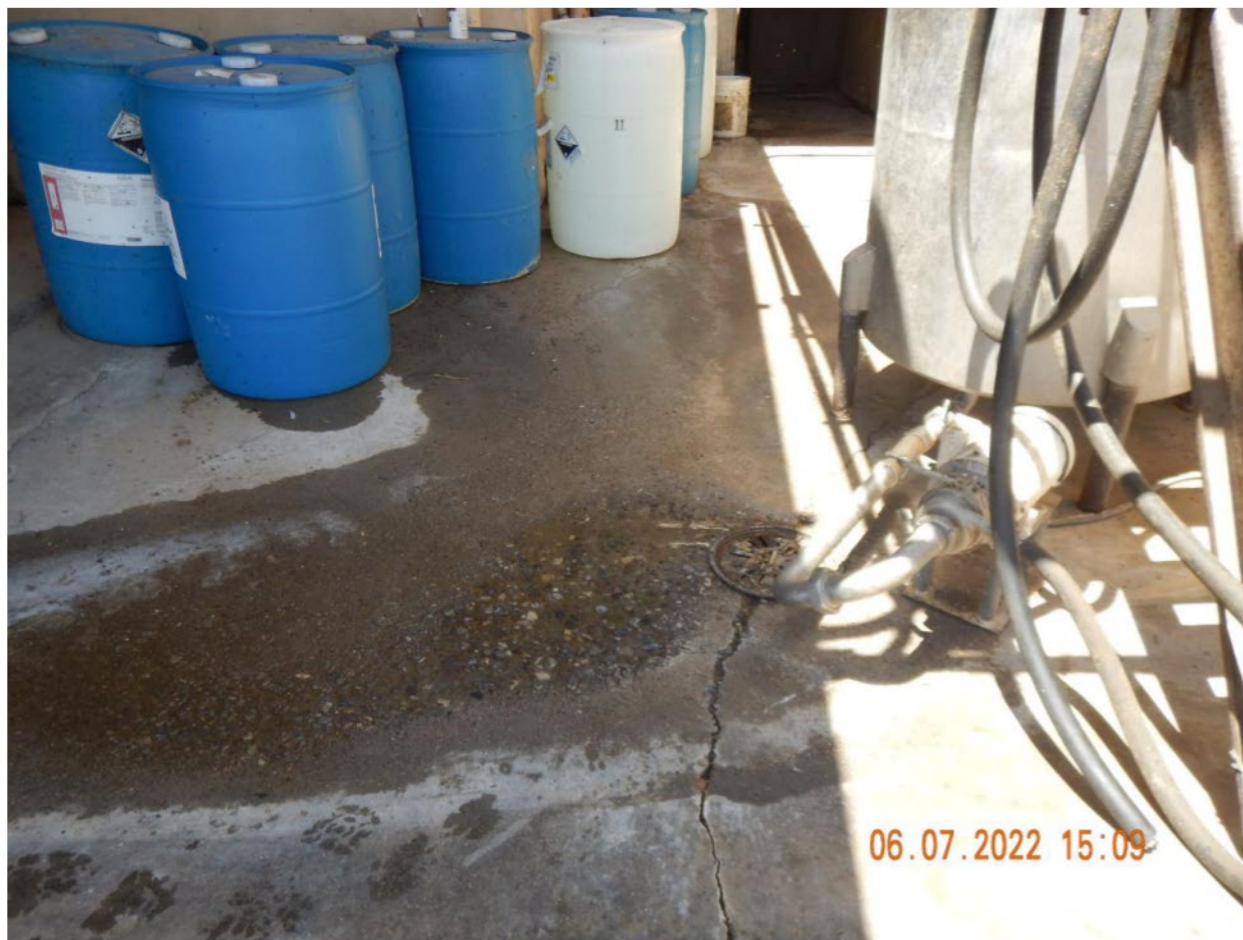
This image shows 7 barrels (each 60-gallon capacity) containing Advance Corrosive Acid and Liquid Santex Soups to 5 feet of a storm water system and without a proper containment area. The lack of a containment system will lead to improper overflows and discharges.
