**Region 6 - Enforcement & Compliance Assurance Division**  
**INSPECTION REPORT**

| Inspection Date(s): | 09/21/22 | |
| Media Program: | Water | |
| Company Name: | Luckey Custom Feedlot, Inc. | |

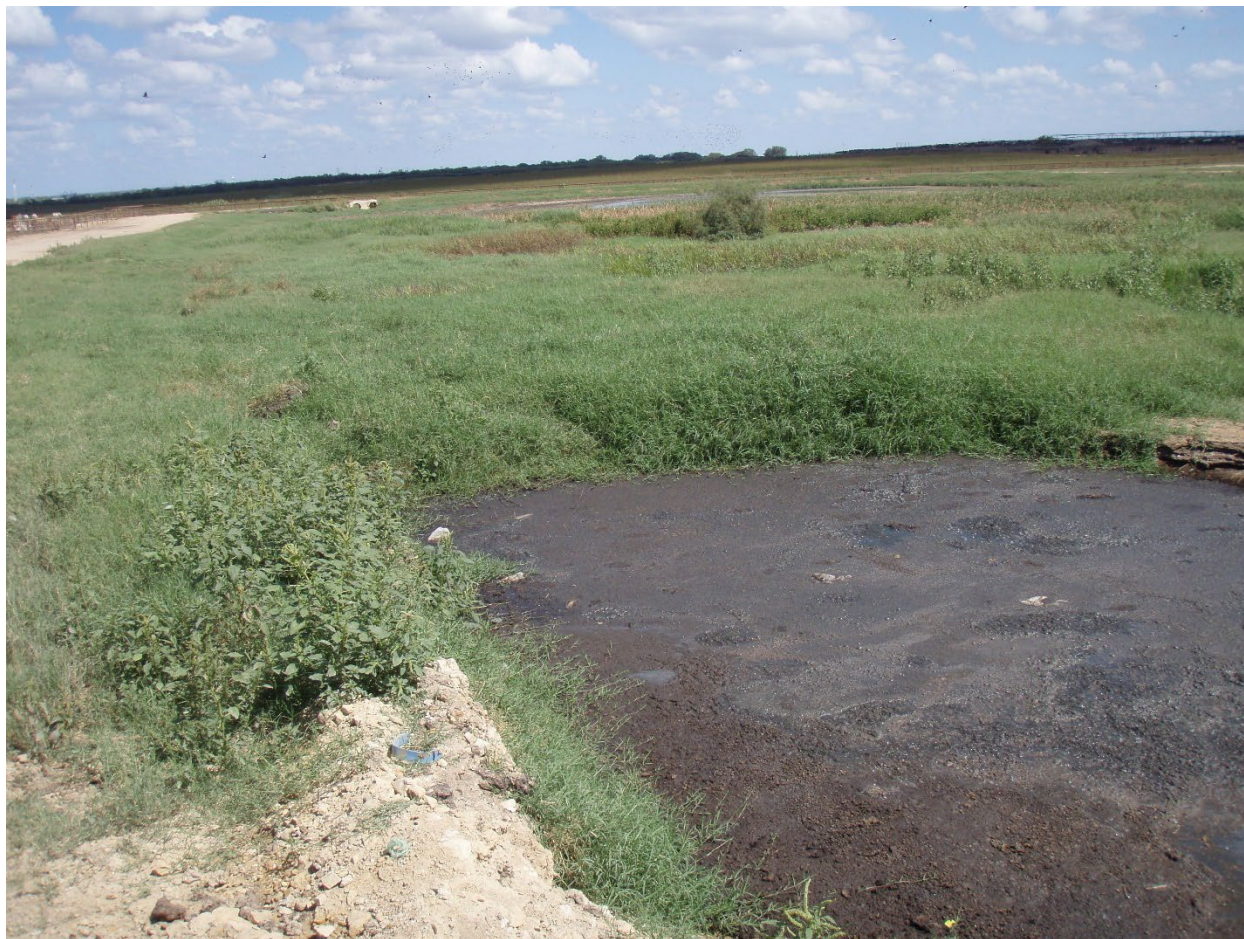
*Photo No. 1*

*Description: Photo is of the clay solid settling basin. There is one tree shown. The RCS is in the distant background. Note the culvert that signifies the drainage channel connecting the two structures. View is to the north.*

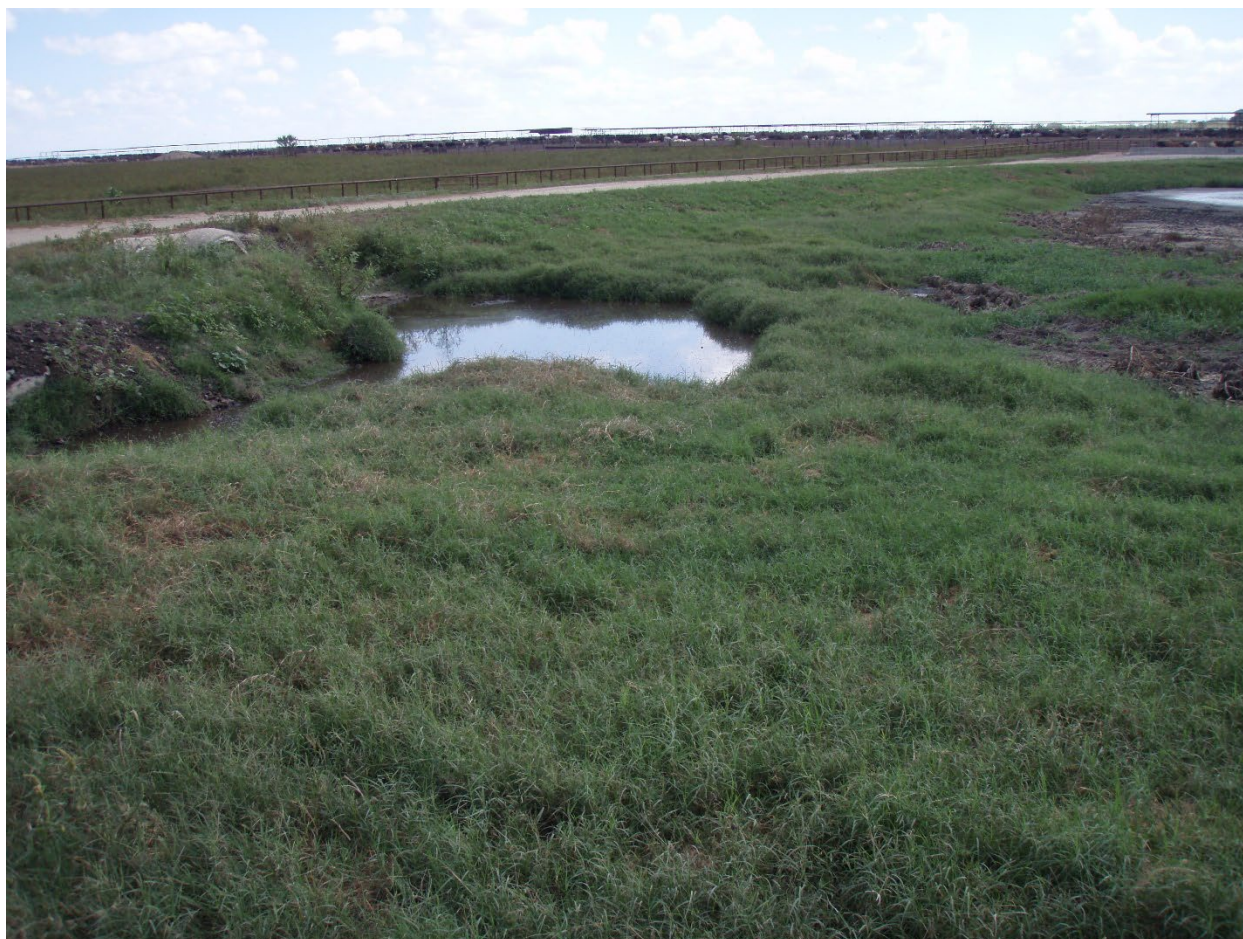
*Photo No. 2*

*Description: This is a close-up shot of the flow from pens and settling basin meeting at the drainage channel and being directed to the RCS. View is to the northeast.*

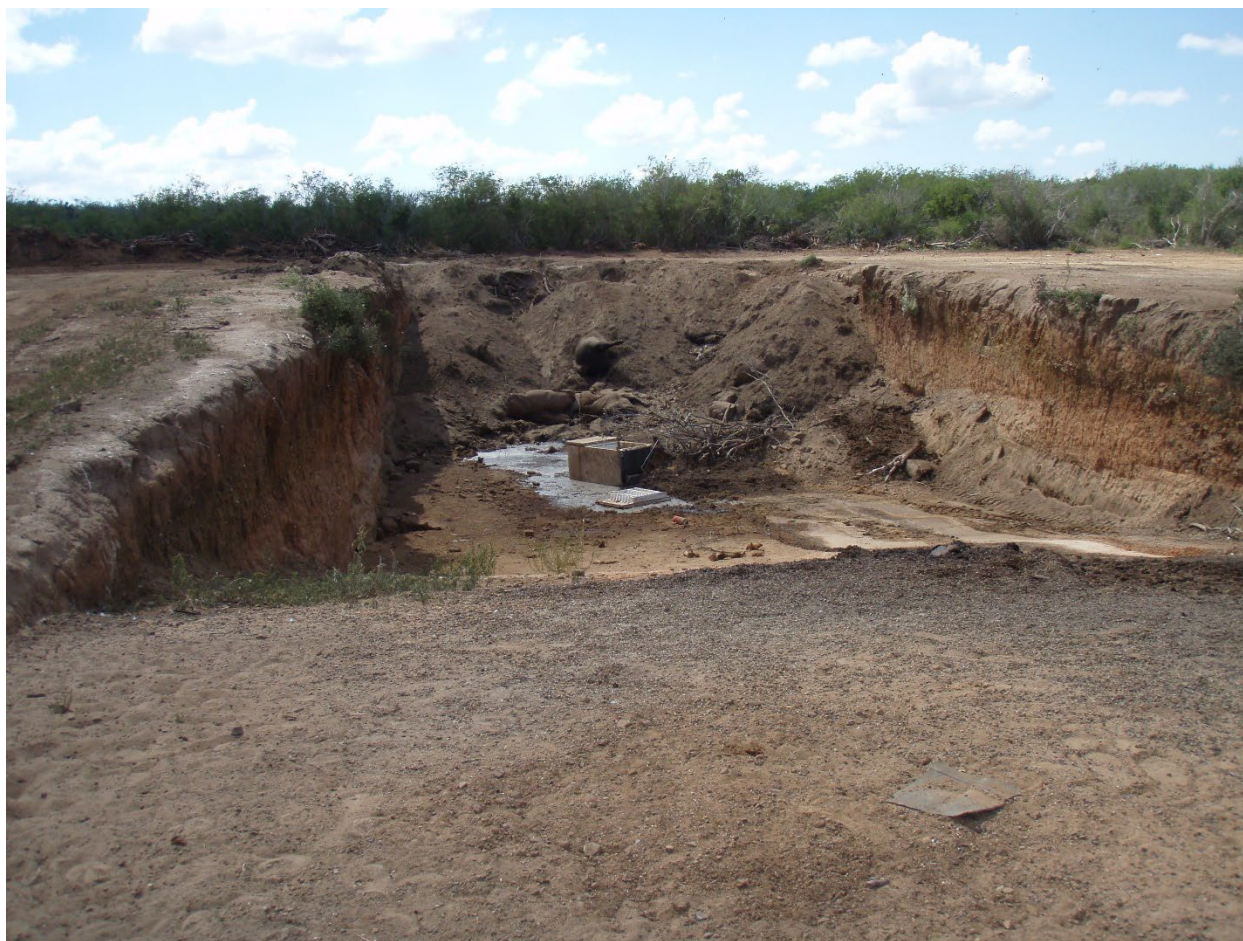
*Photo No. 3*

AOC 1: There are around five exposed carcasses in the mortality pit at the time of the inspection. Part III.A.11.c of the TPDES CAFO general permit requires “Carcasses shall be collected within 24 hours of death and properly disposed of within three (3) days of death in accordance with the Texas Water Code Chapter 26, Texas Health and Safety Code Chapter 361, and 30 TAC Chapter 335 (relating to Industrial Solid Waste and Municipal Hazardous Waste) unless otherwise provided for by the Commission. Animals must not be disposed of in any liquid manure or process wastewater system. Disposal of diseased animals shall also be conducted in a manner that prevents a public health hazard in accordance with Texas Agriculture Code §161.004 and 4 TAC §§31.3, 58.31(b) and 59.12. The collection area for carcasses shall be addressed in the potential pollutant sources section of the PPP with management practices to prevent contamination of surface or groundwater; control access; and minimize odors.”

*Description: Photo shows the mortality pit and exposed carcasses. View is to the south.*

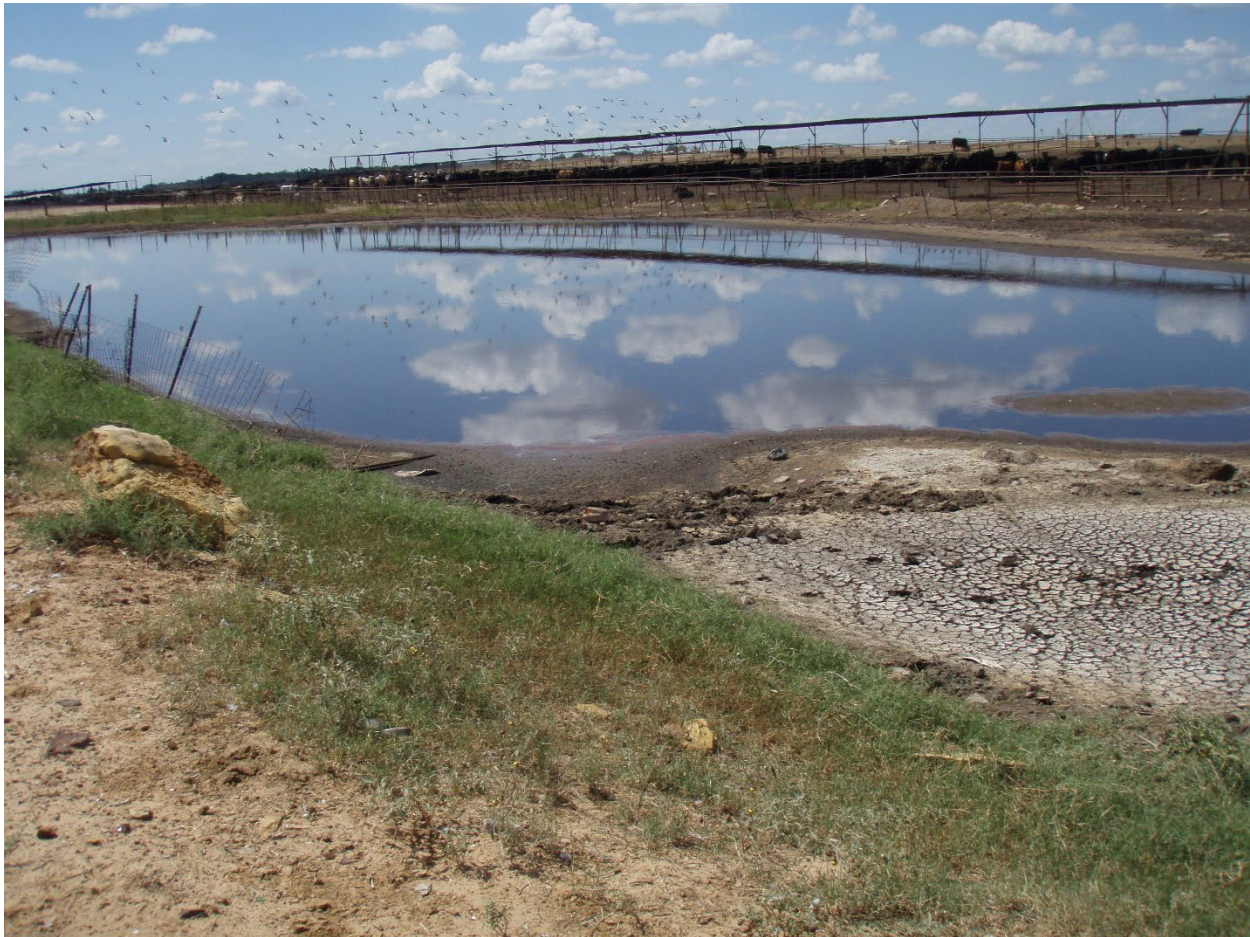
*Photo No. 4*

*Description: Photo shows the second clay solid settling structure. The cattle pens are shown in the background. The freshwater pond is directly northeast of this structure. View is to the southwest.*

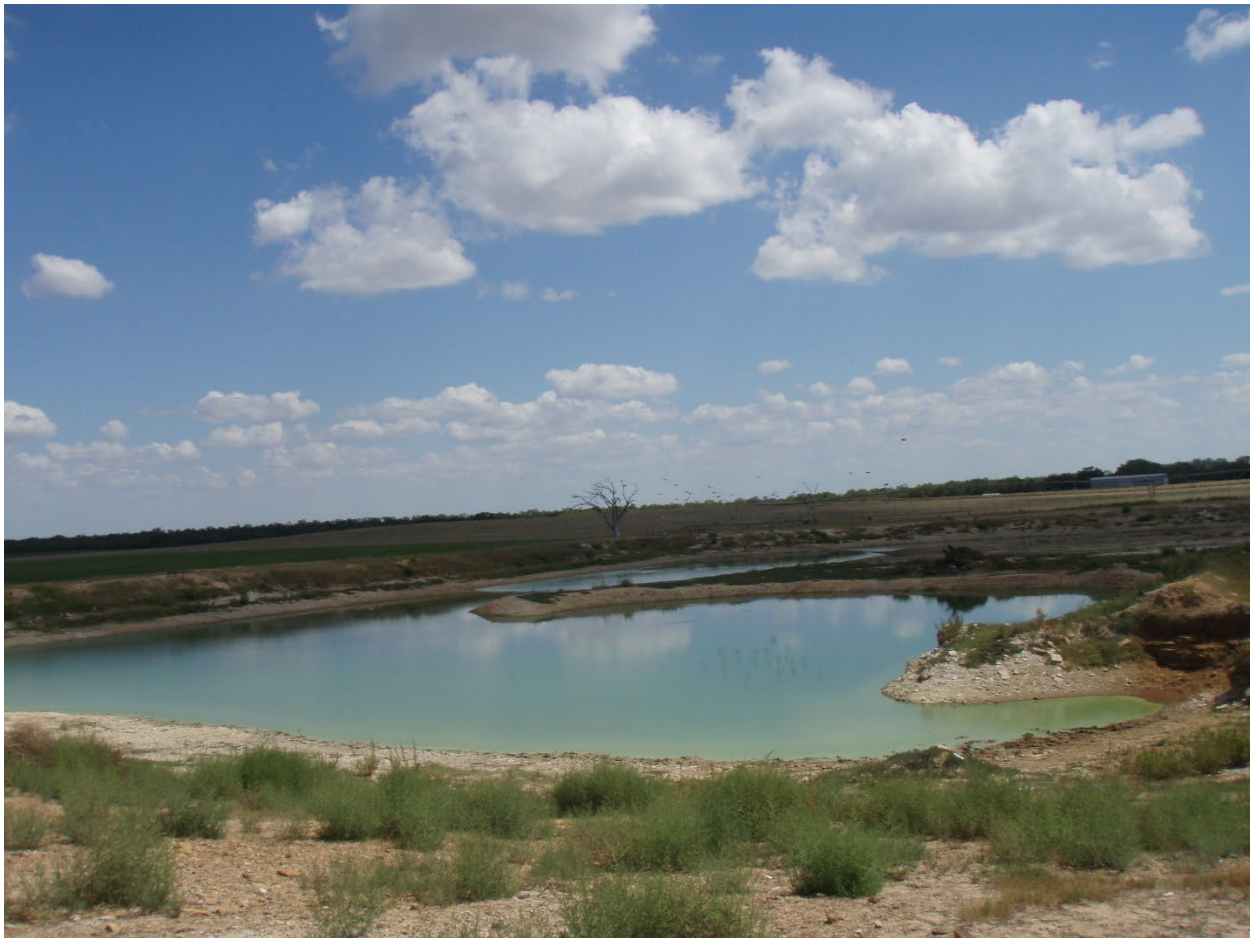
*Photo No. 5*

*Description: Photo shows the freshwater pond. This is directly northeast of the second solid settling structure. View is to the northeast.*

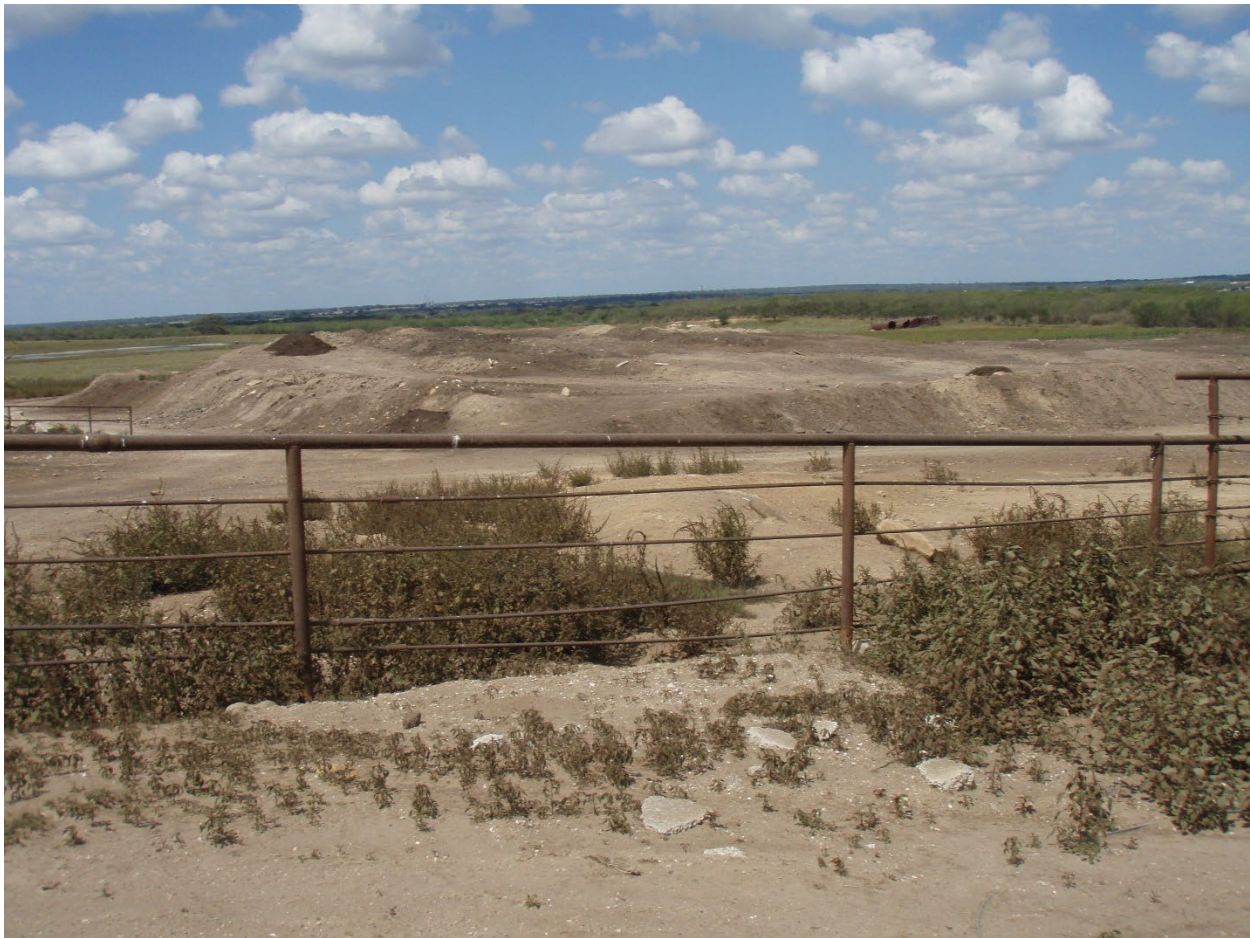
*Photo No. 6*

*Description: This photo shows the manure stockpile with the RCS in the background. View is to the northwest.*

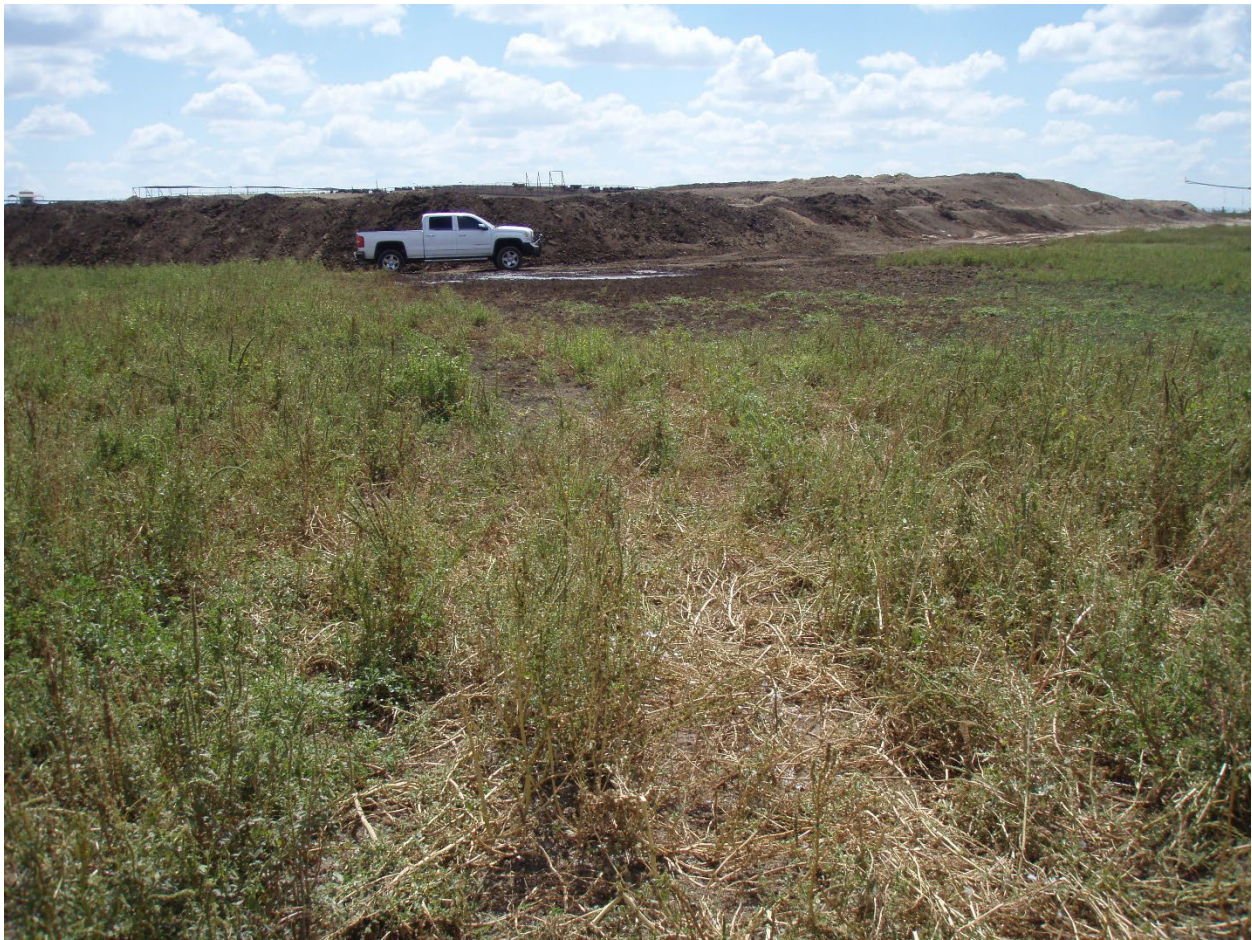
*Photo No. 7*

AOC 2: There is a low spot behind the manure stockpile that allows runoff to leave the production area and not enter the RCS. Part III.A.9.b of the TPDES CAFO general permit requires “Manure or sludge stored for more than 30 days must be stored within the drainage area of a RCS or stored in a manner (i.e. storage shed, bermed area, tarp covered area, etc.) that otherwise prevents contaminated stormwater runoff from the storage area. All storage sites and structures located outside the drainage area shall be designated on the LMU map. Storage for more than 30 days is prohibited in the 100-year floodplain.”

*Description: This photo shows the manure runoff at a low spot of the stockpile that is not being captured and directed to the RCS. The runoff can flow out freely into the nearby LMU. View is to the southeast.*

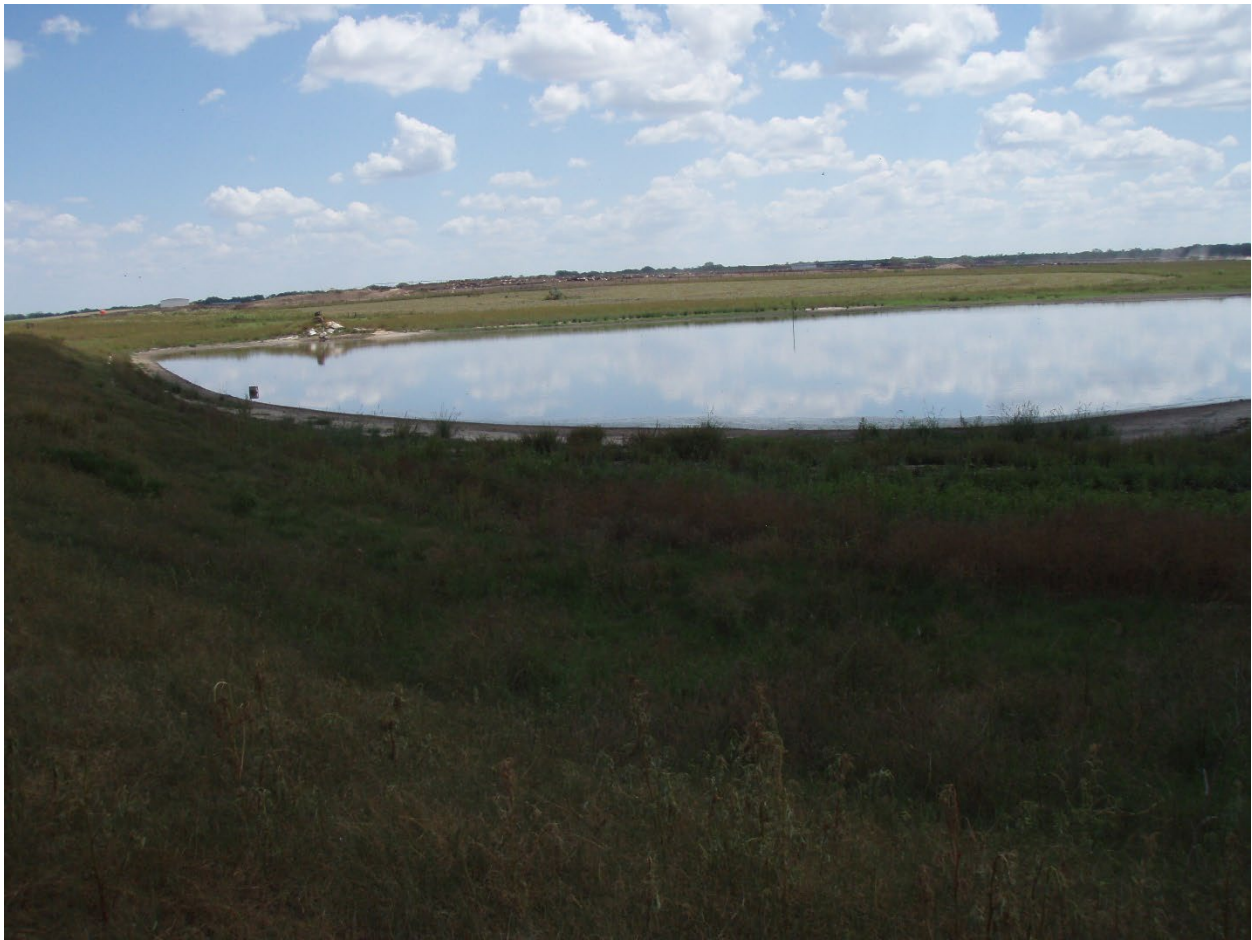
*Photo No. 8*

*Description: This photo shows the RCS with pole marker in the middle and pen and manure in the background. View is to the east.*
