**Well Inspection**  
**Osage DNR / Environmental Protection Agency**  
**1201 Elm Street, Suite 500**  
**Dallas, Texas 75270**

| <b>Operator Info</b> | Park WM | <b>Inventory ID</b> OS2455000 | | | | |
| <b>Inspection Reason</b> | Plugging Witnessed | <b>Responsible Company at</b> | | Park WM | | |

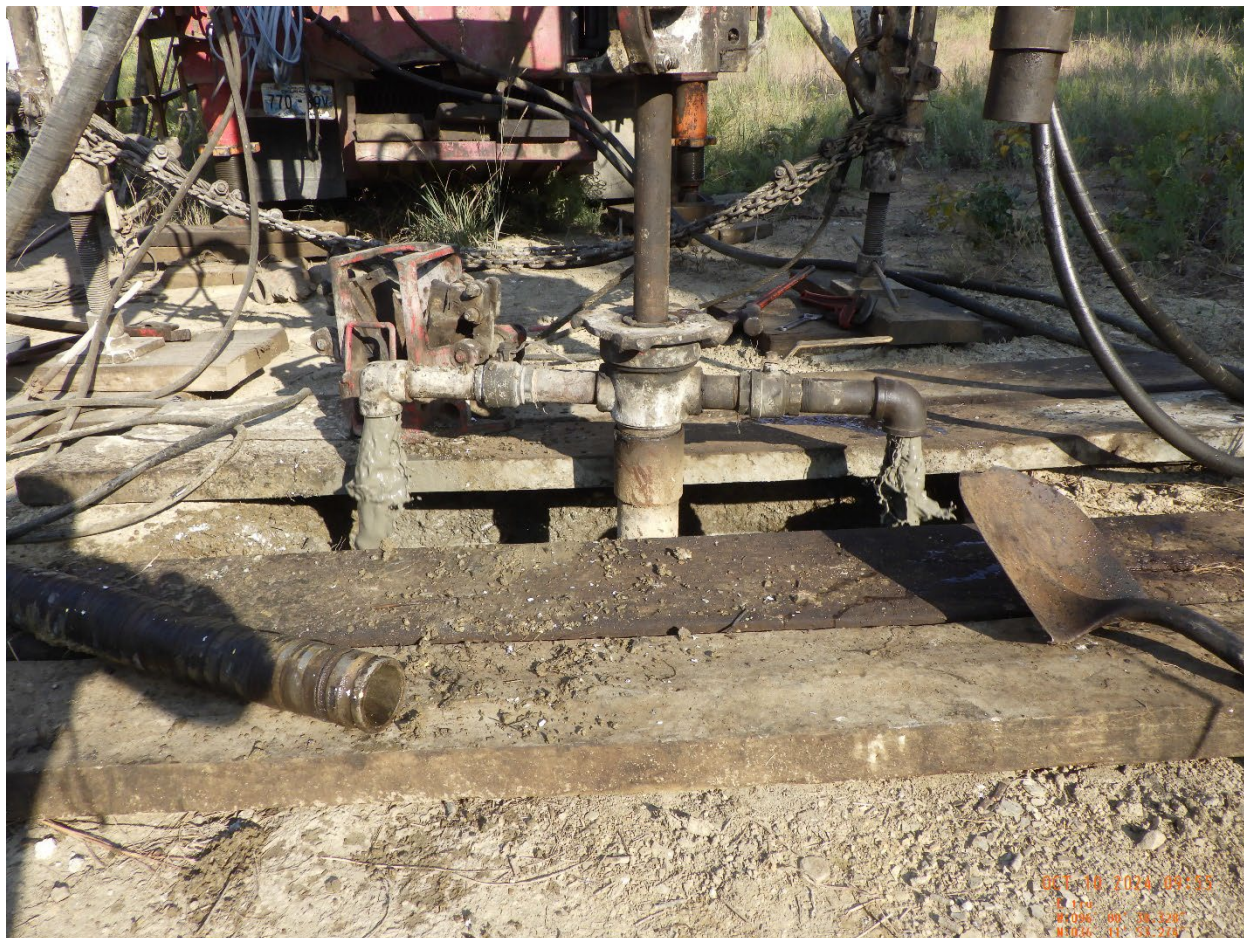
Photo No. 1

**Description:** This was well OS2455000 with cement circulating to the surface.

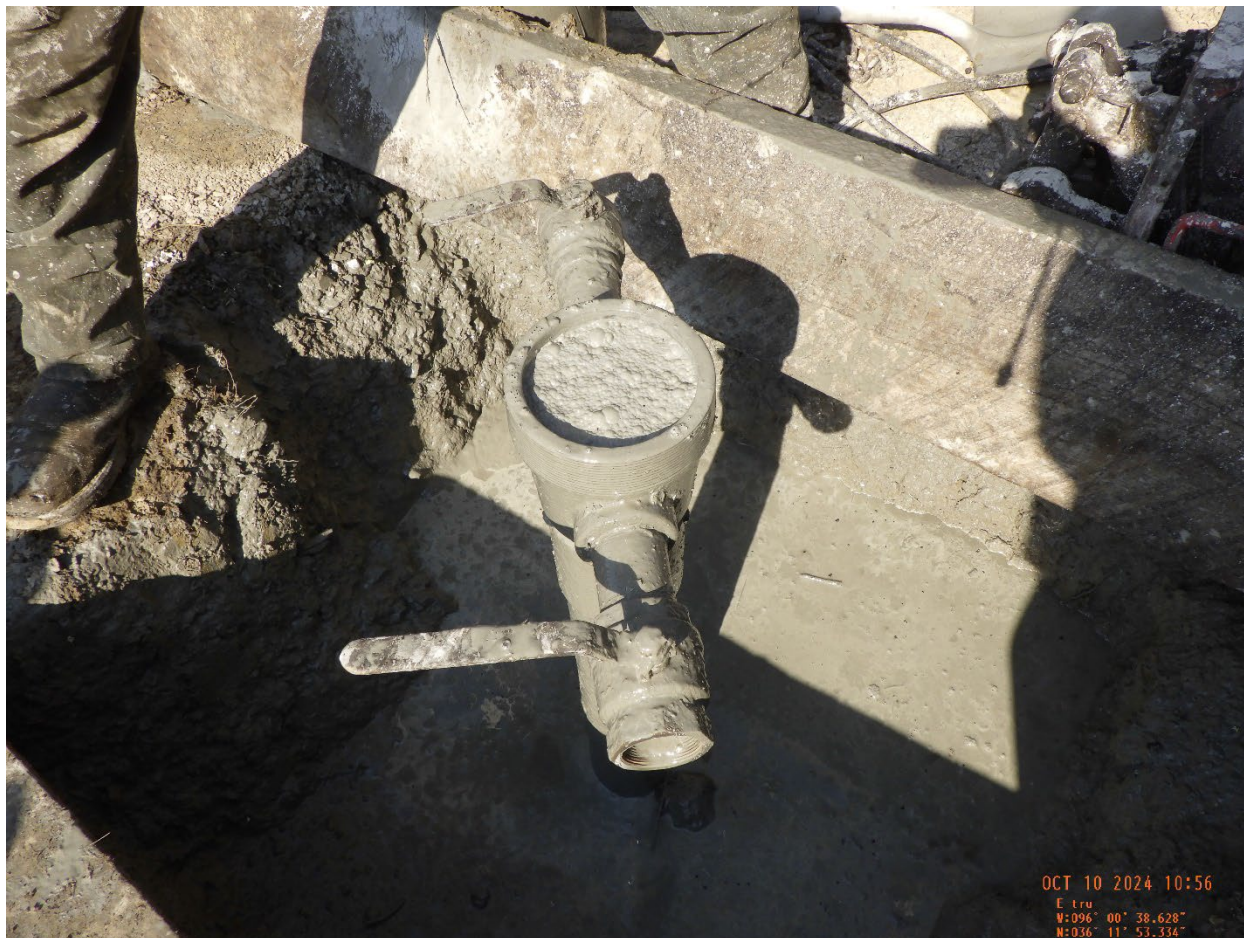
Photo No. 2

| <b>Inspection Comments</b> | | EPA inspector observed Lester Well Service run 1385 feet of tubing into well OS2455000 and circulate 120 sacks of class A cement to the surface. Inspector observed the well standing full of cement with no fallback. Well successfully plugged. BIA inspector Ira Lookout and Osage Nation DNR inspector Stephen Wynn were also present during the inspection. | | | | |

**Description:** This was well OS2455000 standing full of cement with no fallback.
