**Region 6 - Enforcement & Compliance Assurance Division**  
**INSPECTION REPORT**

| Inspection Date(s): | 5/22/2024 | |
| Company Name: | <b>MidAmerica Environmental Holdings, LLC</b> | |
| Facility Name: | <b>USA Disposal – El Dorado</b> | |

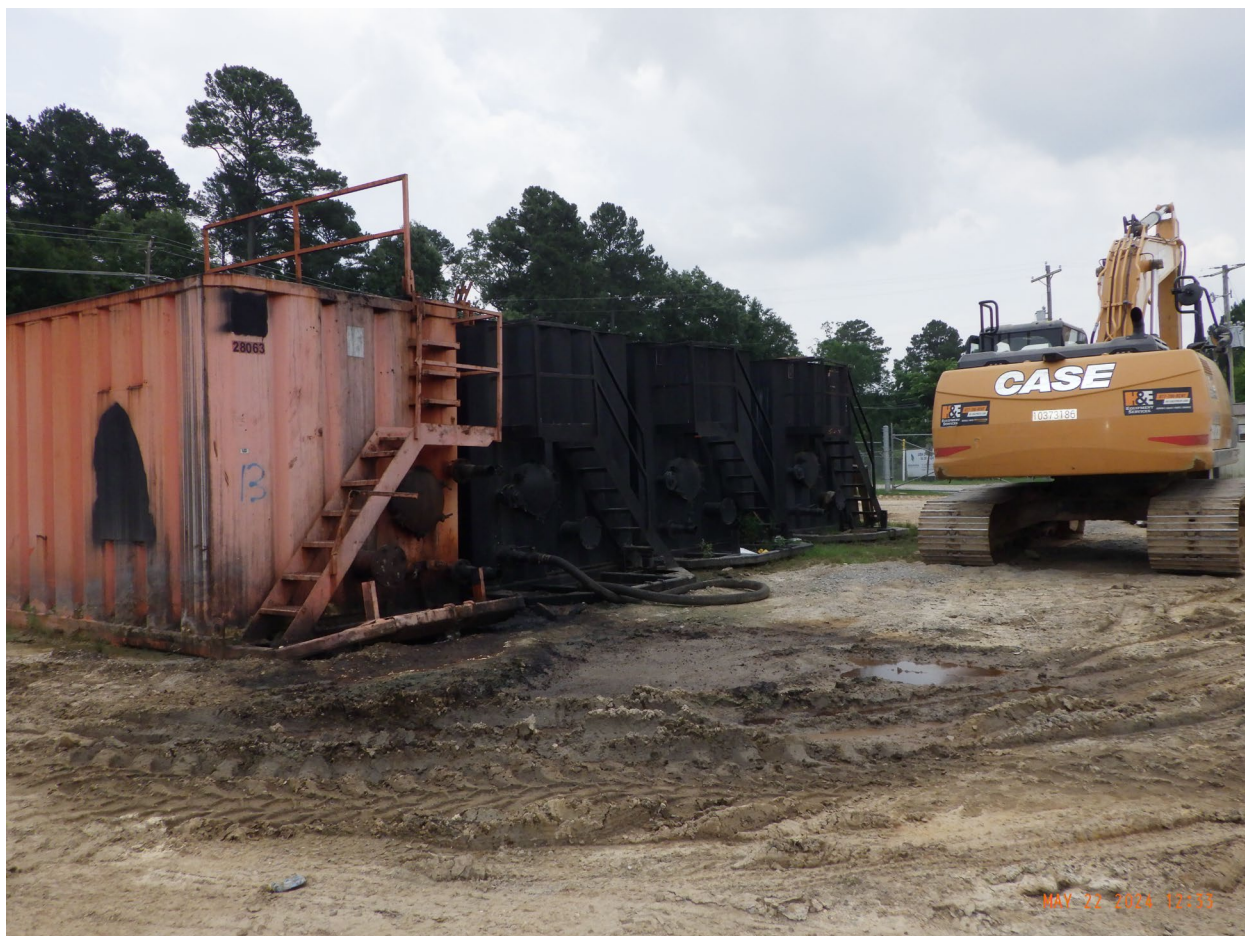
**Photo File Name:** R0010155

**Description:** Looking SE, this photo showed the opposite view from Photo No. 3. A spill was observed in front of the red frac tank.

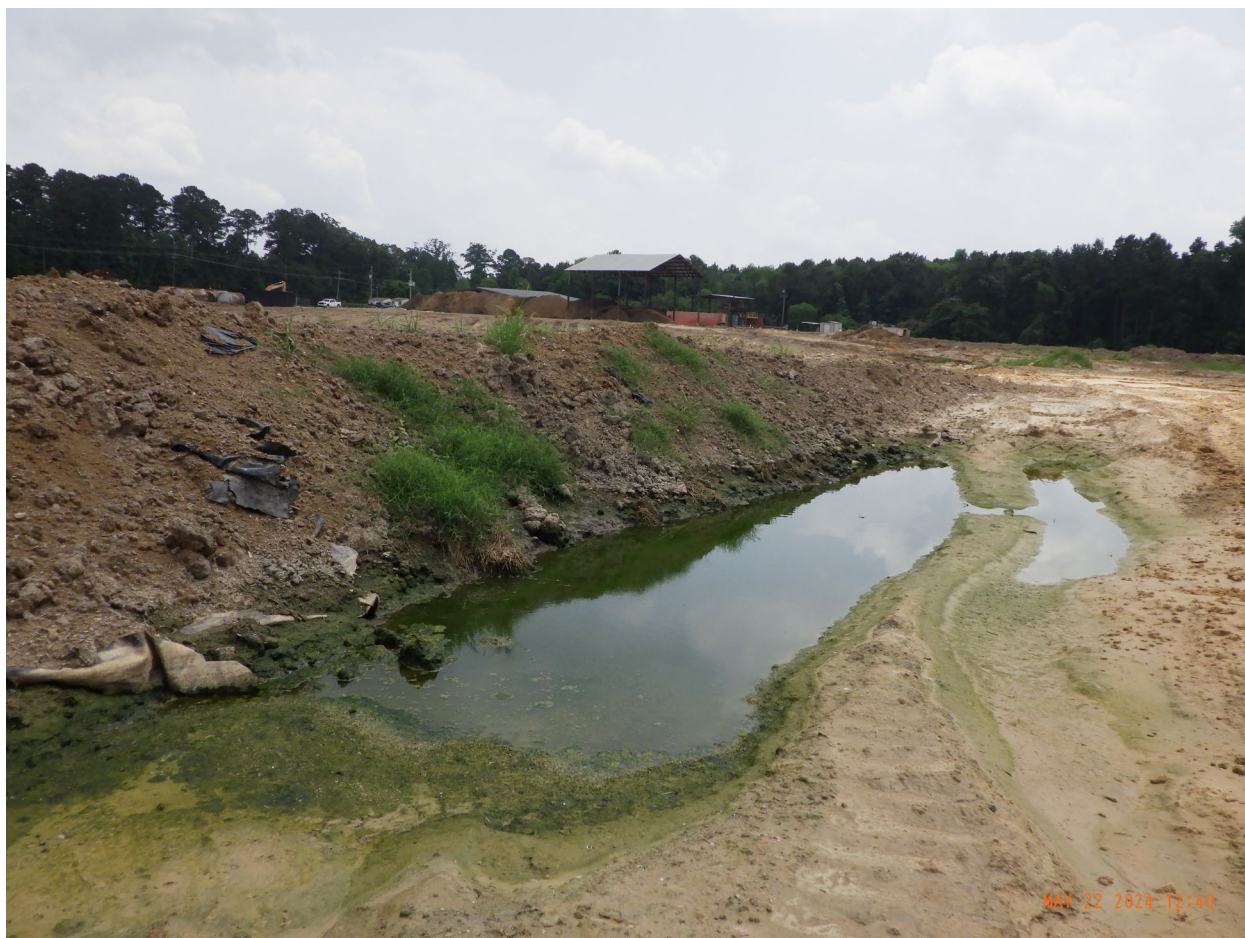
**Photo File Name:** R0010163

**Description:** Looking S-SE, this photo showed bulked waste material (liquid waste blended with sawdust) with runoff adjacent to the stockpile. Synthetic liner pieces were observed in the bulked material, and algal growth was noted in the adjacent runoff.

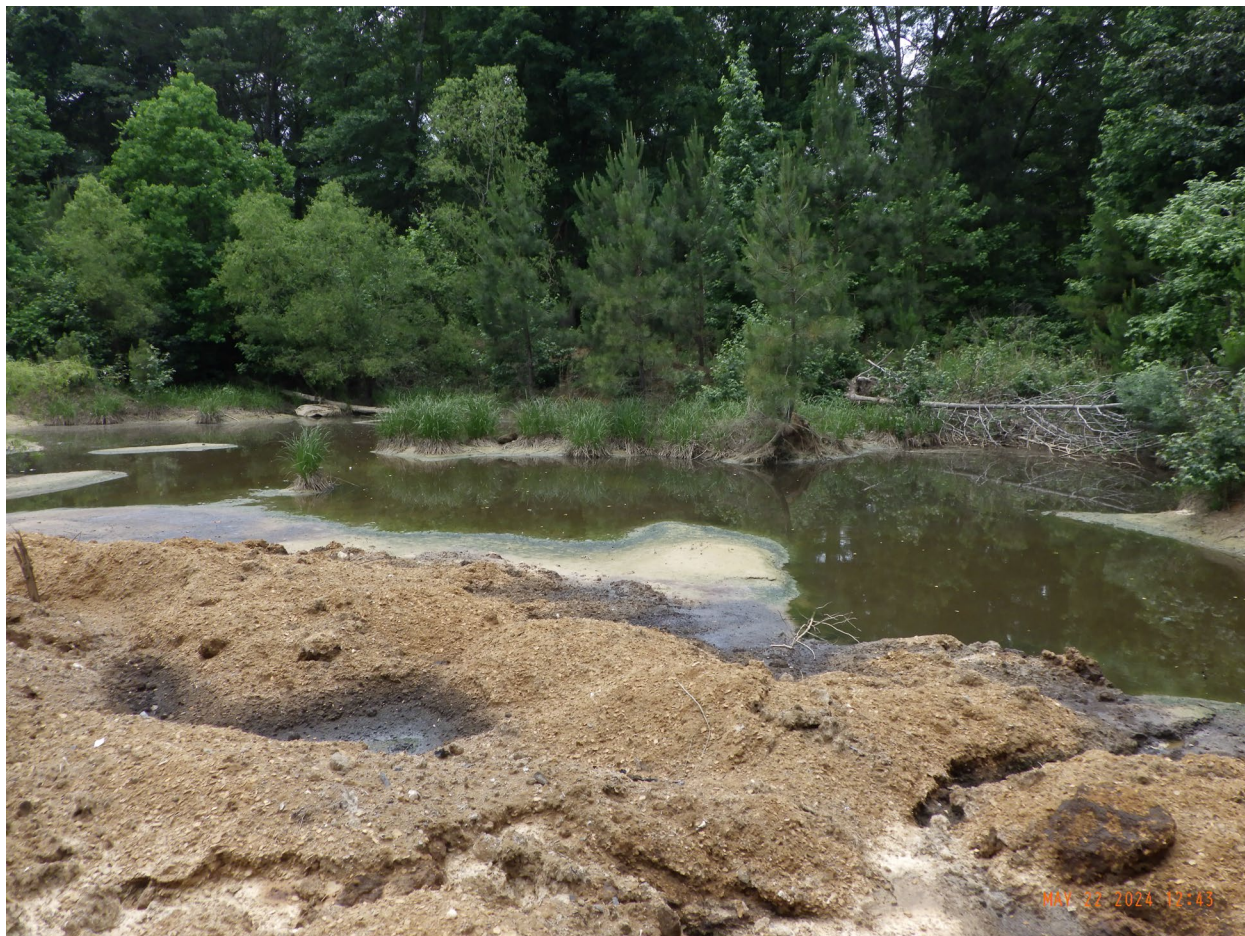
**Photo File Name:** R0010169

**Description:** Looking SW, this photo showed bulked material and leachate discharged into the wetland at the facility. Algal growth was noted in the surface water.

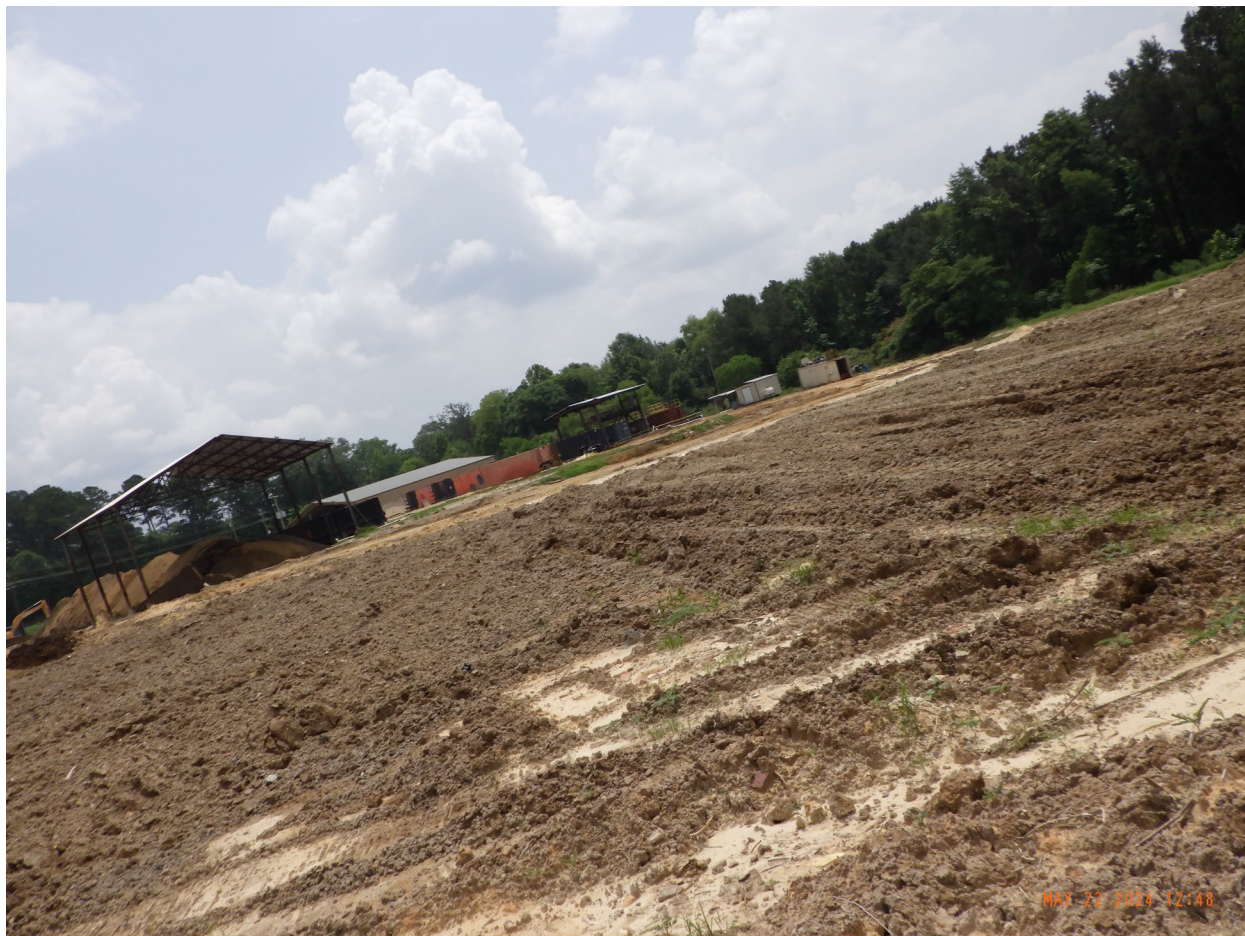
**Photo File Name:** R0010174

**Description:** Looking SE, this photo showed bulked material land applied on top of bare soil at the facility. The process area was observed in the background.

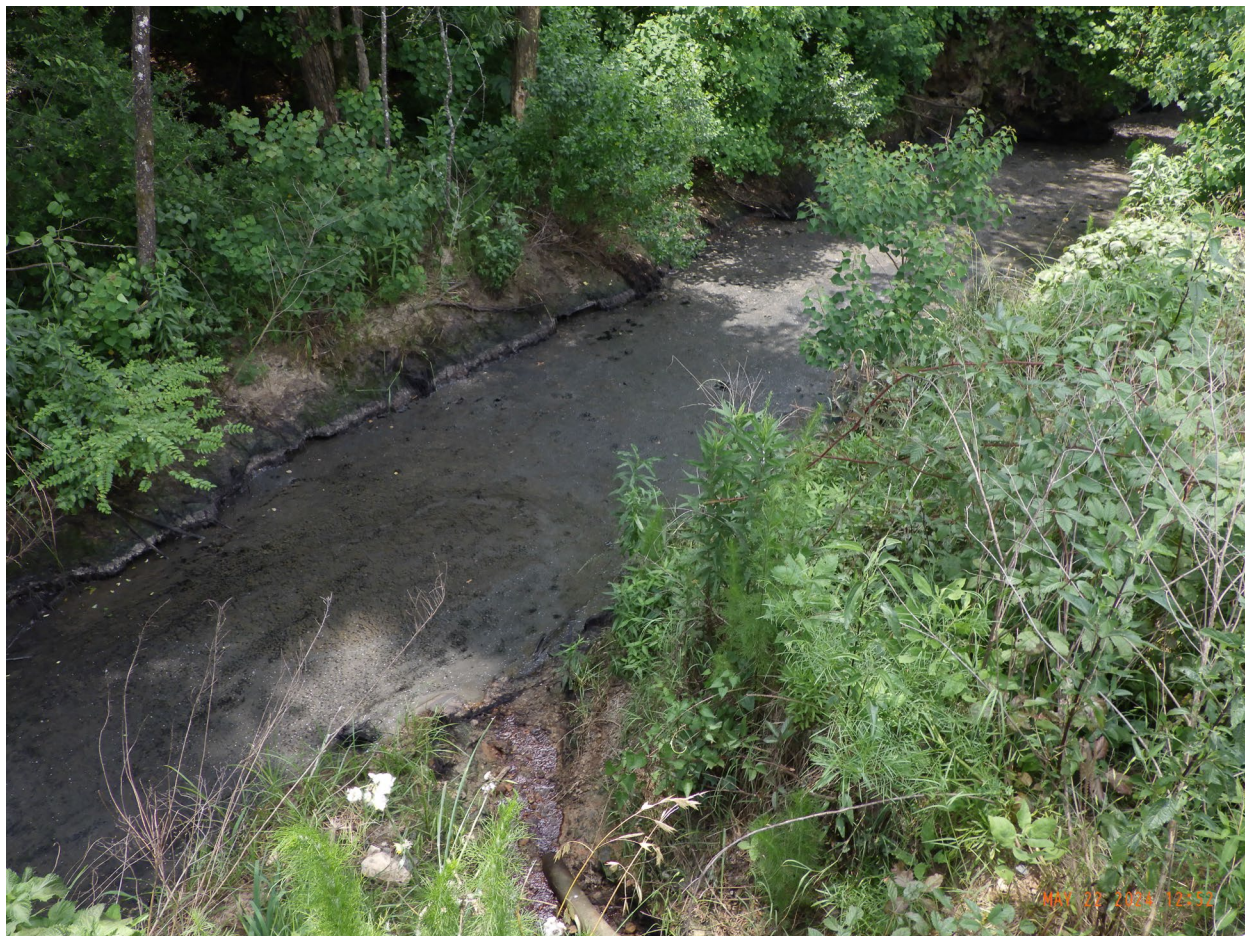
**Photo File Name:** R0010182

**Description:** Looking W-SW, this photo showed the receiving stream (UT of Boggy Creek) at the erosion gully in Photo No. 20 and No. 21. Unknown material, black staining, and odor were noted at the receiving stream.

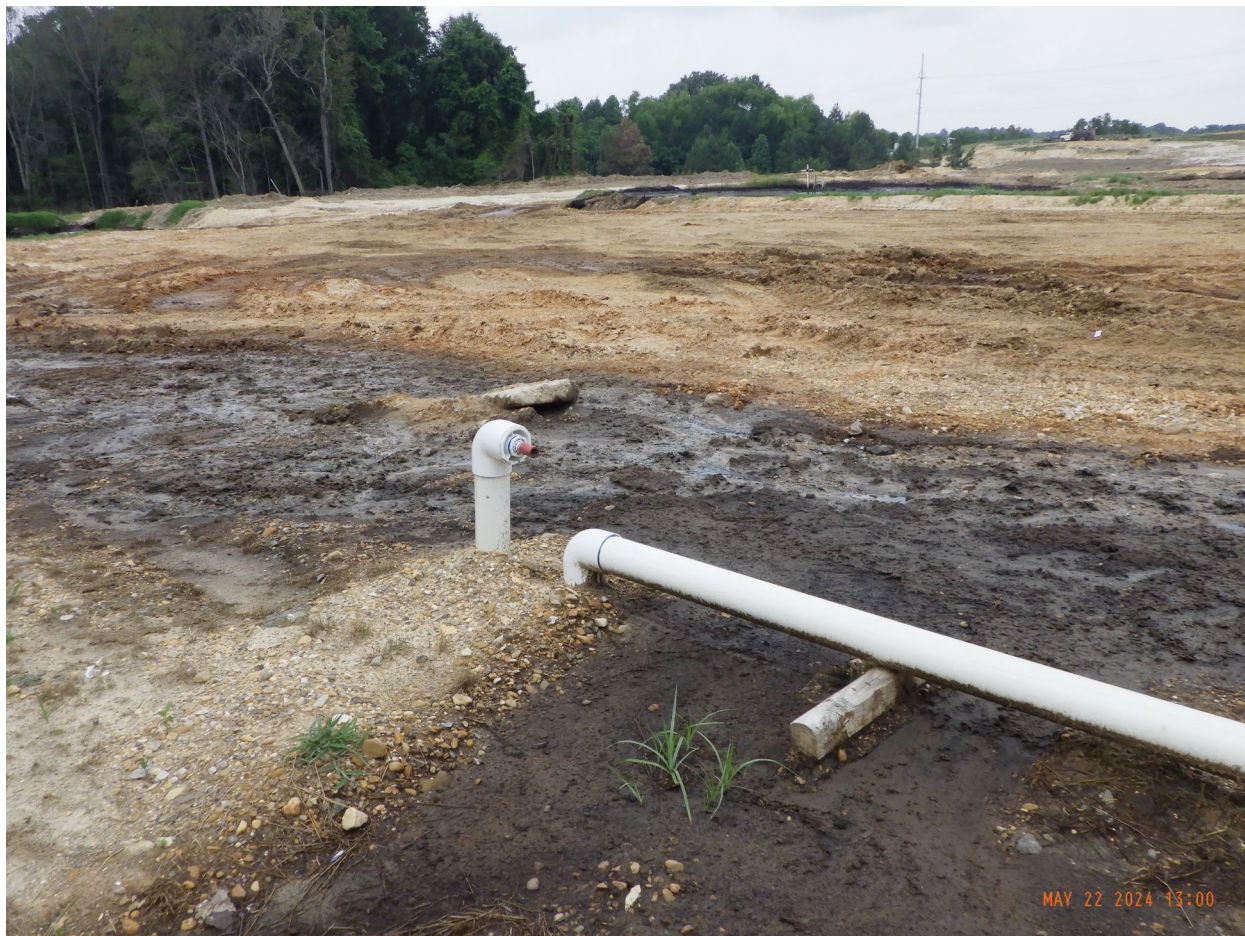
**Photo File Name:** R0010199

**Description:** Looking NW, this photo showed the piping at the holding pit viewed in Photo No. 30. Black staining, hydrocarbon sheen, and flow indicators were noted in the process area.

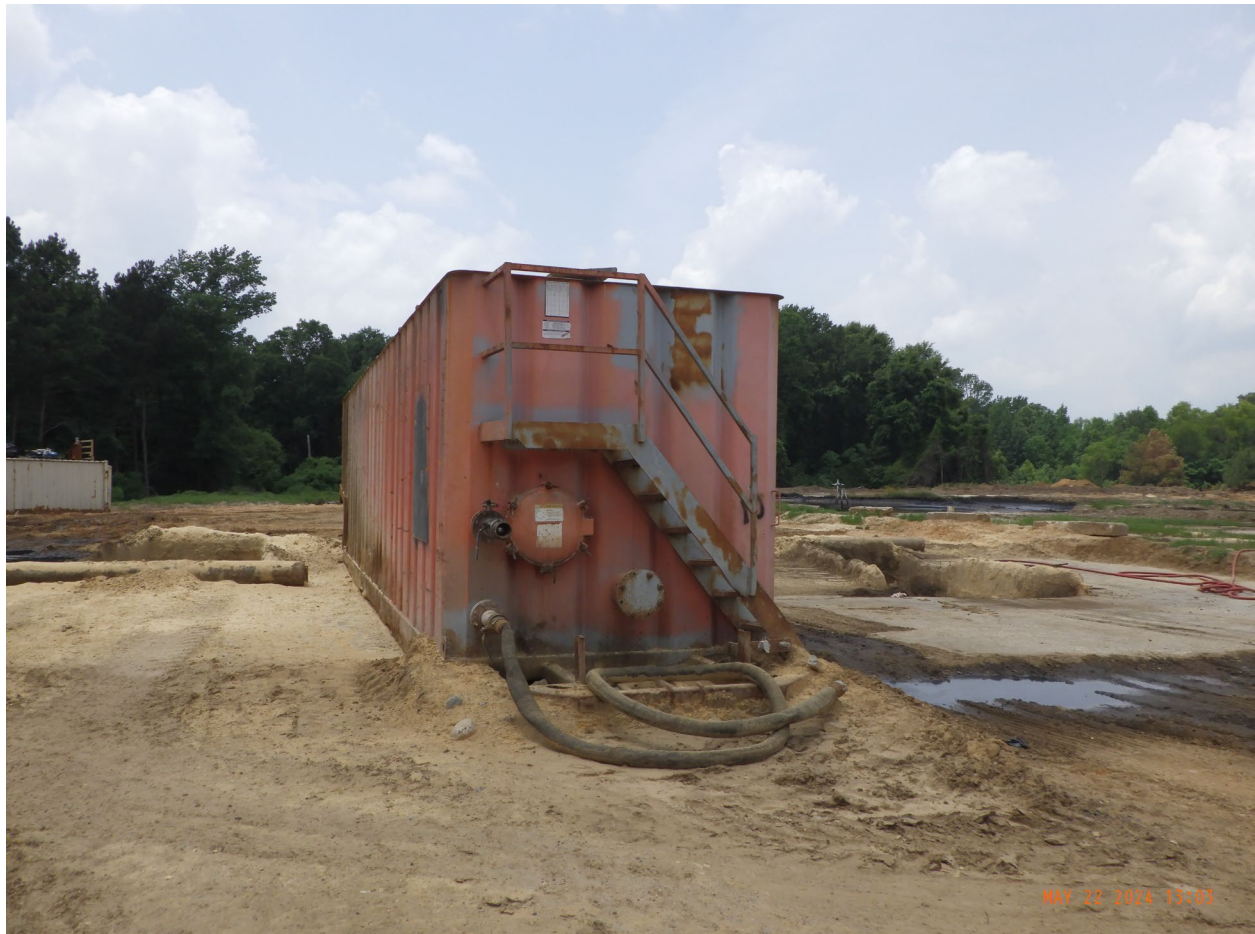
**Photo File Name:** R0010203

**Description:** Looking W-NW, this photo showed a frac tank stored between two (2) subsurface, concrete pits. Sawdust (bulking material) and unknown liquid wastes noted around the area.

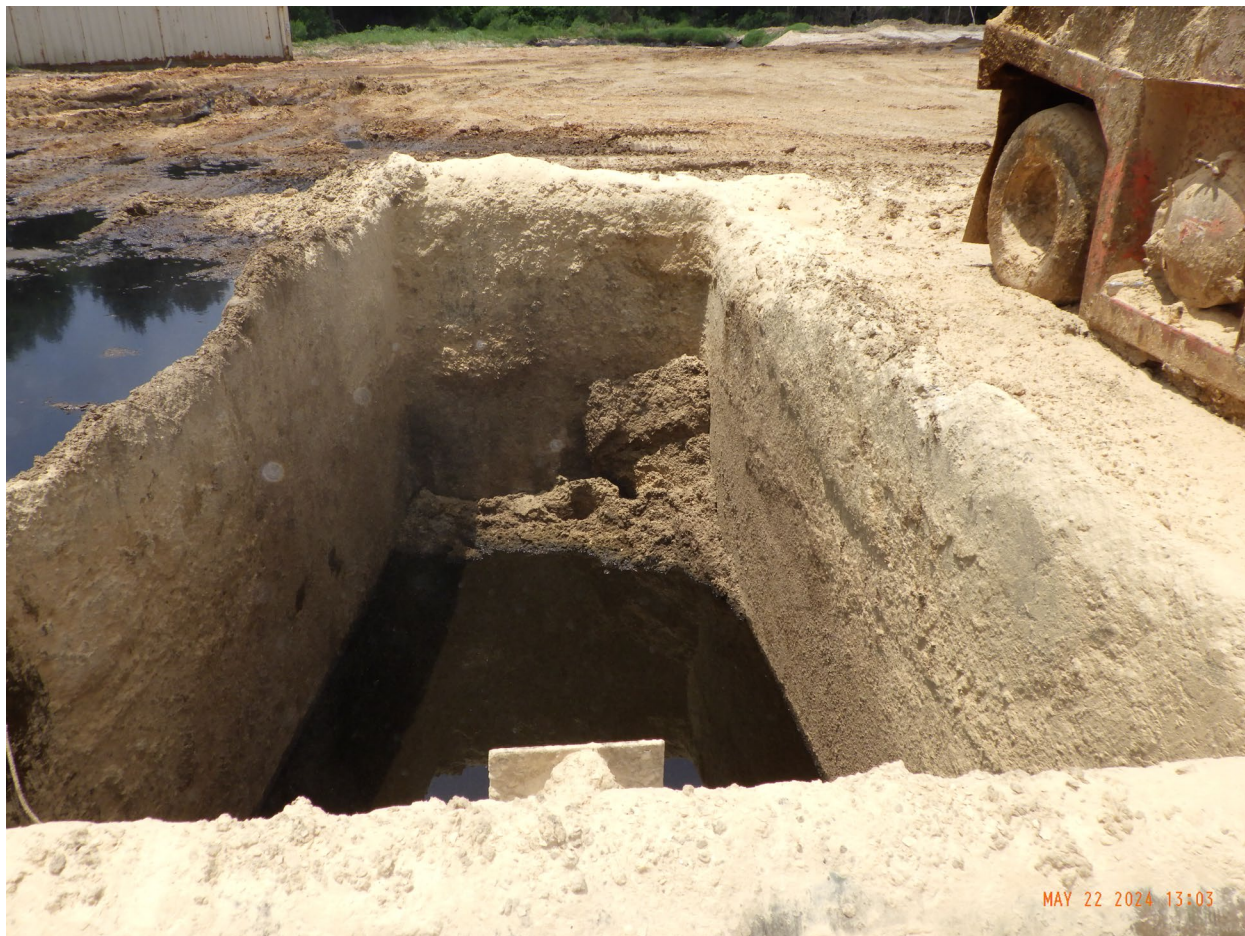
**Photo File Name:** R0010204

**Description:** Looking W, this photo showed the subsurface, concrete pit to the left of the frac tank in Photo No. 34. Unknown liquid wastes and sawdust (bulking material) were noted around the area.

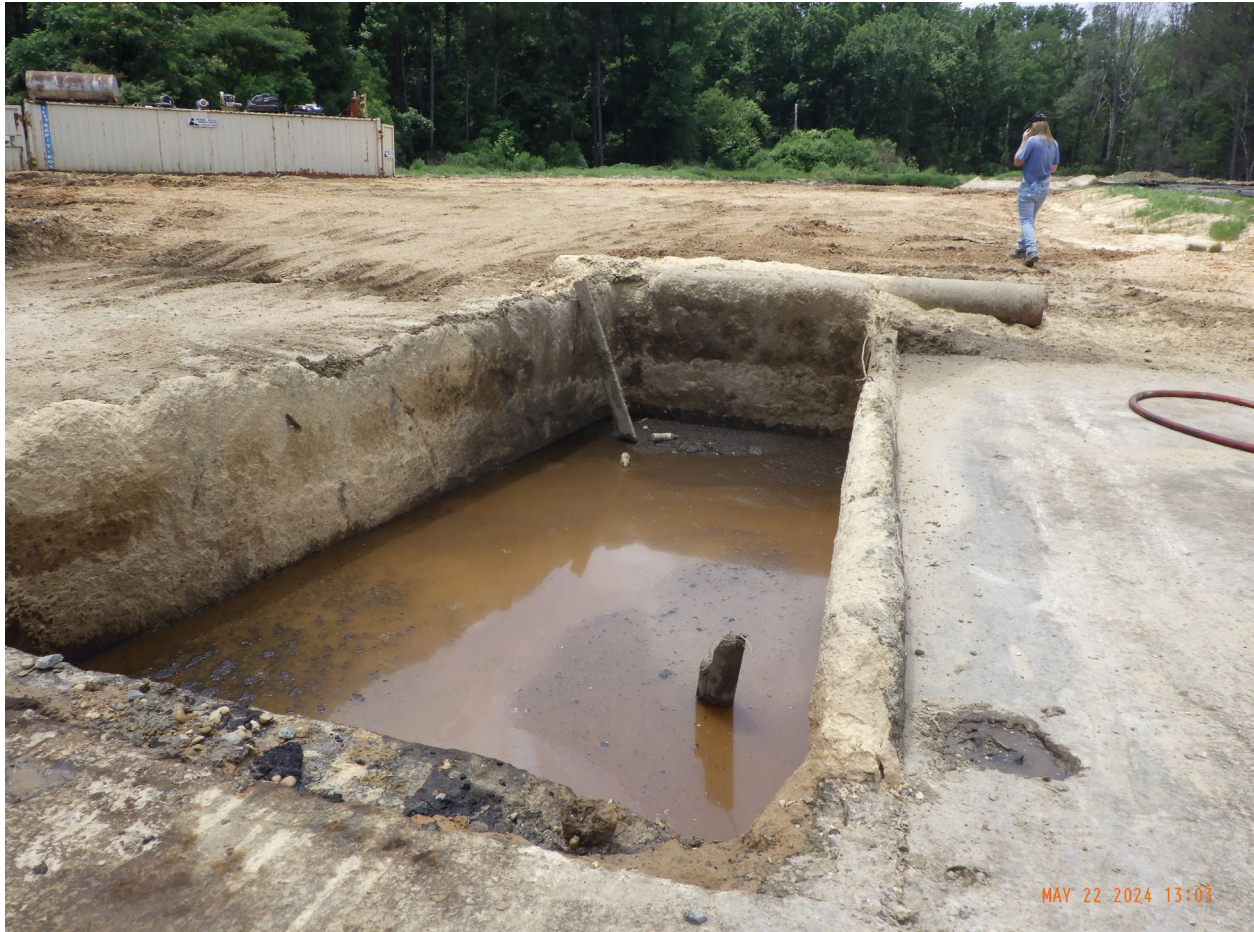
**Photo File Name:** R0010205

**Description:** Looking W-SW, this photo showed the subsurface, concrete pit to the right of the frac tank in Photo No. 34. Unknown liquid wastes were observed in the pit.

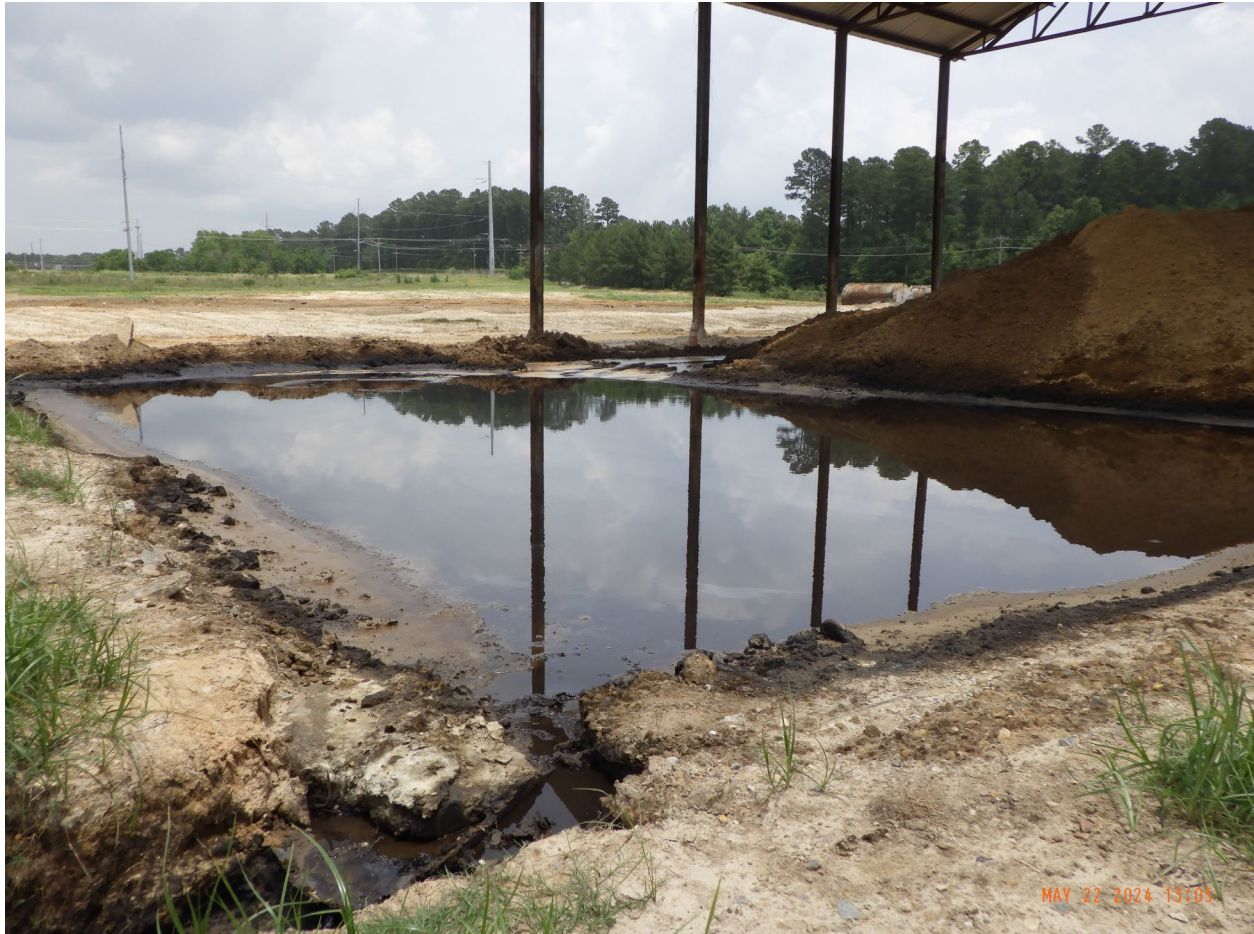
**Photo File Name:** R0010209

**Description:** Looking N-NE, this photo showed another large, concrete pit used to catch leachate from the bulked material. Soil used to make an earthen berm. An erosion gully was noted in the earthen berm with overflows directed toward the concrete pit in Photo No. 37.

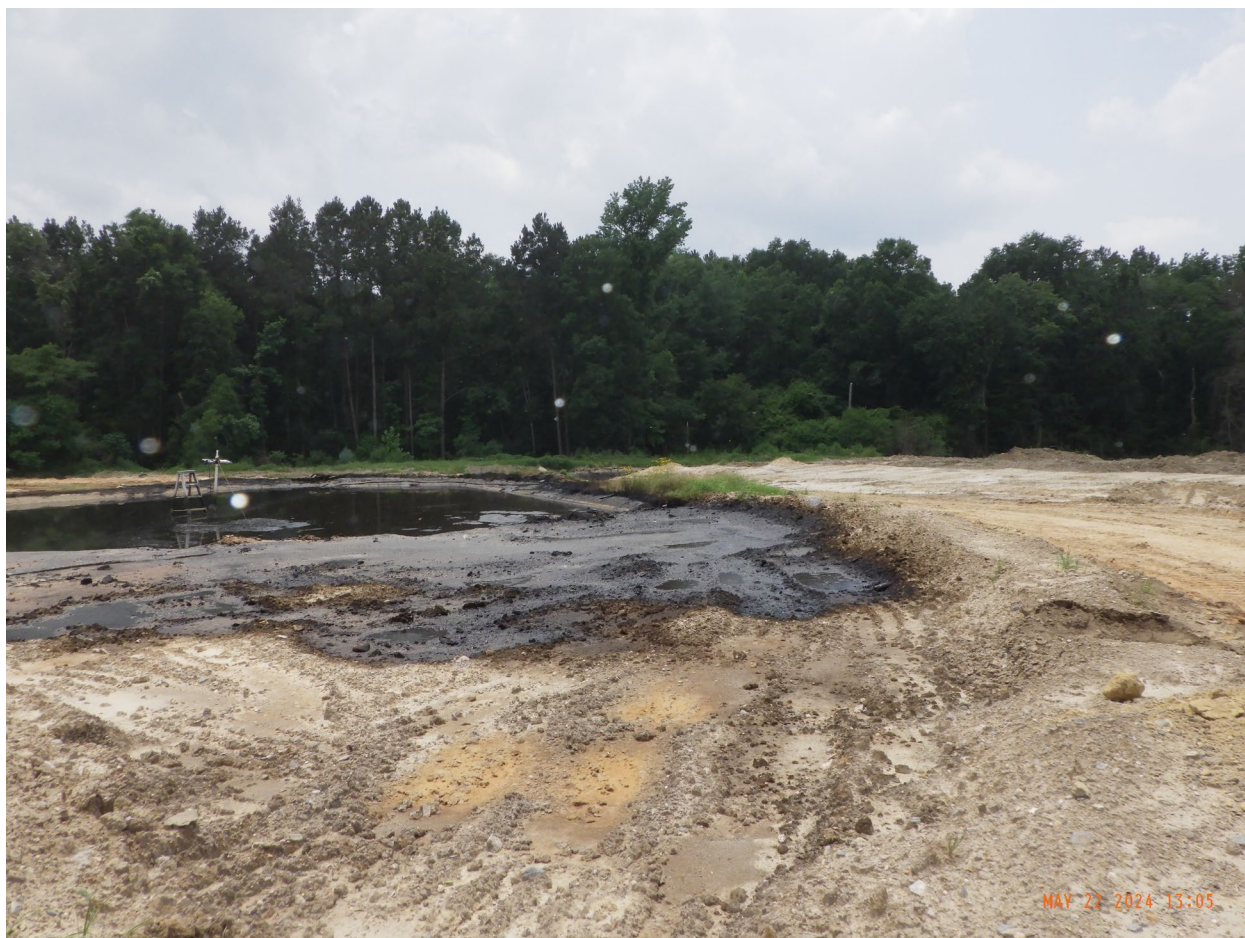
**Photo File Name:** R0010212

**Description:** Looking SW, this photo showed an additional view of the large, concrete pit in Photo No. 37. Black staining was noted outside the concrete pit.
