INSPECTION REPORT

| Type of Inspection | Compliance Evaluation Inspection (CEI) | |
| Facility or Site Name | Sherwin-Williams #708176 | |
| Facility/Site Physical Address | 245 Post Rd | |

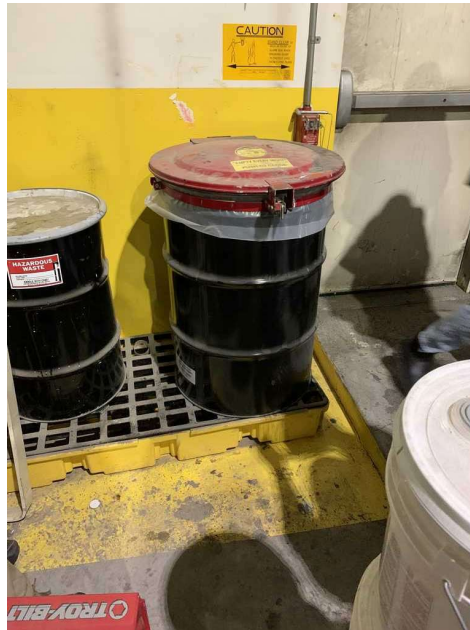
| SAA | | | IMG_2186.jpg |

| <p>At the time of inspection, we observed two SAA accumulation drums: one 35-gallon drum had a “Hazardous Waste” label and an aerosol can inside but was not marked or labeled with an indication of the hazards of the contents. The second 55-gallon drum contains cleanup materials such as spilled paint and epoxy rags. Ms. Trujillo told us that this is a SAA hazardous waste container and is managed as such. This drum was not labeled with the words “Hazardous Waste” and an indication of the hazards of the content.</p> <p>A small propane tank was found on the floor next to the SAA, Ms. Trujillo placed it into the hazardous waste drum after we photographed and documented it. We also observed a closed cardboard cylindrical drum that contained two universal waste lamps. This drum was not labeled or marked with the words “Universal Waste Lamps” or “Used Lamps” and was not marked with an accumulation start date. This drum was labeled with the words “Universal Waste.”</p> | | | |

| A photo of the SAA. | | | |

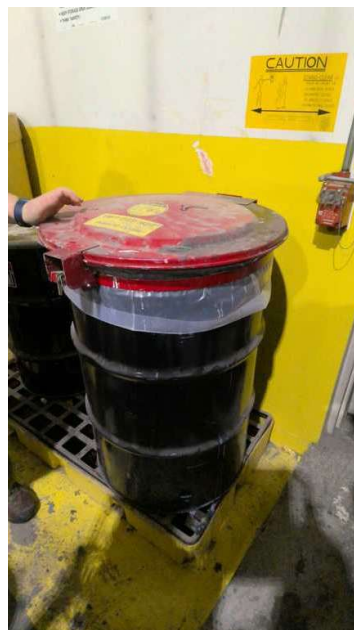
| Hazardous Waste Drum | | | IMG-2024070808592059201125611.jpg |

| Two hazardous waste accumulation drums improperly labeled. One had only a “Hazardous Waste” label, but no hazardous waste indicator or accumulation start date. One had no labeling at all. | <b>Citations:</b> | <b>Sections:</b> |

| This 55gal drum was not full, and it was missing a "hazardous waste" label and hazard indicator. The drum was closed. | | | |

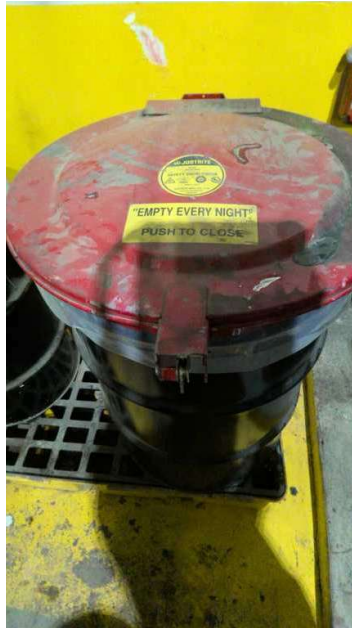
| 55 Gallon drum | | | IMG-2024070808595259521236339.jpg |

| Closer photo of the label on the 55-gallon drum. | | | |

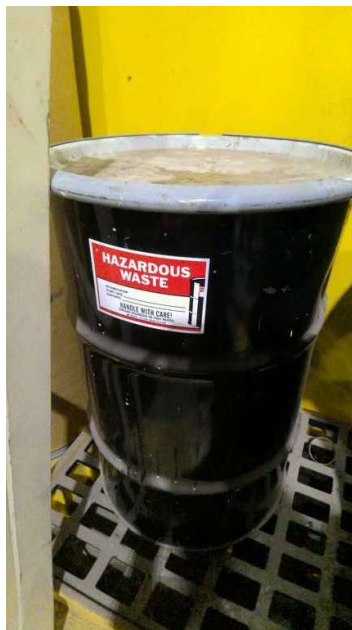
| 55 Gallon hazardous Waste drum | | | IMG-20240708090009091196538.jpg |

| This drum was not full and did not have a hazard indicator or accumulation start date. | | | |

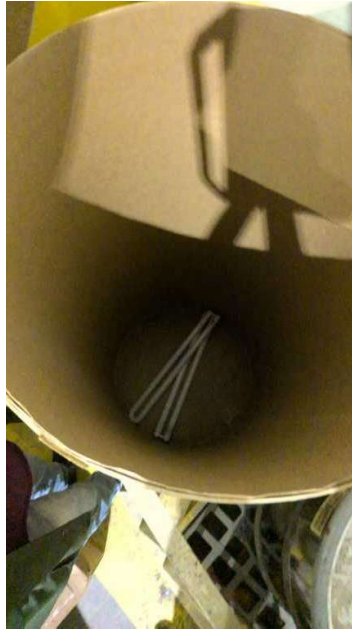
| Cardboard universal waste box | | | IMG-202407080900550551082801.jpg |

| This photo shows the interior to the cylindrical cardboard box containing lamps within the SAA. | | | |

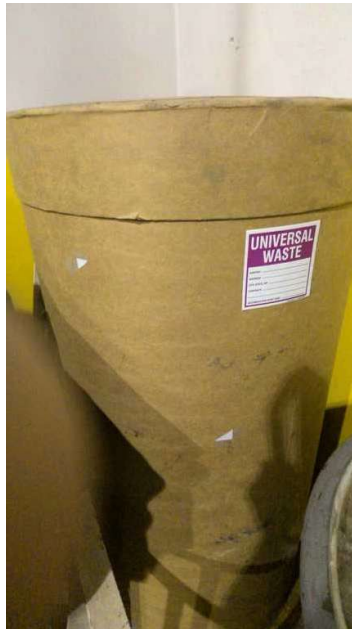
| Cardboard universal waste box | | | IMG-20240708090104141174780.jpg |

| A third cylindrical cardboard box contained lamps. It was labeled with "Universal Waste" but did not include "Lamps" in the label, or have an accumulation start date. | | |

| This photo shows the "universal waste" label on the cardboard box, but it lacks a "lamp" label and accumulation start date. | | | |

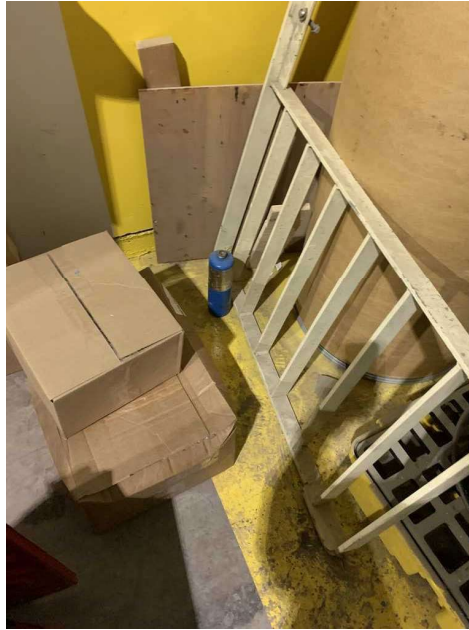
| Propane tank on the floor | | | IMG_2189.jpg |

| A Butane tank was sitting on the floor adjacent to the SAA, and this was an AOC. Ms. Trujillo put it in a sealed hazardous waste drum after this was pointed out. (Correction: the small tank was a propane tank). | <b>Citations:</b> | <b>Sections:</b> |

| Propane tank as it was found before being placed in the drum. | | | |

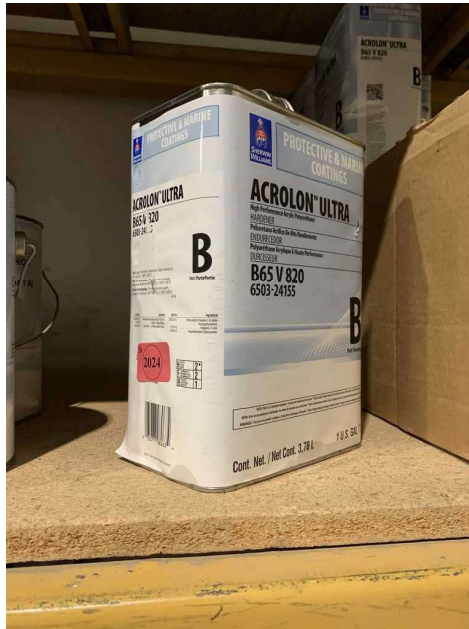
| Expired Acrolon | | | IMG_2191.jpg |

| <p>At the time of the inspection, we observed one shelf next to the SAA that contained new and full Acrolon gallon containers that were expired. We asked if Ms. Trujillo had a written inventory of these products indicating awareness and a plan for the expired items, and she did not. We found five that were confirmed expired. Ms. Trujillo told us that these expired products were not determined to be a waste because they can still be sold or donated via the Sherwin Williams program called “Ready To Go.” Expired products are placed on a separate pallet when the manager has time, but there is no set review schedule to do this. Ms. Trujillo told me that the last inventory review was on October 22, 2023. We advised her to move forward in selling or donated this material to avoid it becoming a waste.</p> | | | |

| This is a photo of one of the expired Acrolon containers. It is unopened and unused. | | | |

Inspector Chu then covered the AOCs from the inspection. Additionally, she advised Ms. Trujillo to pursue donating or selling the expired materials that were found to avoid them becoming a hazardous waste.

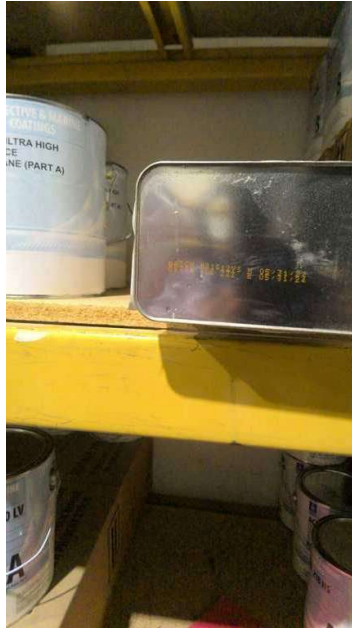
| Expired Acrolon Date | | | IMG-20240708090704741348324.jpg |

| The expiration date on a container of Acrolon | | | |

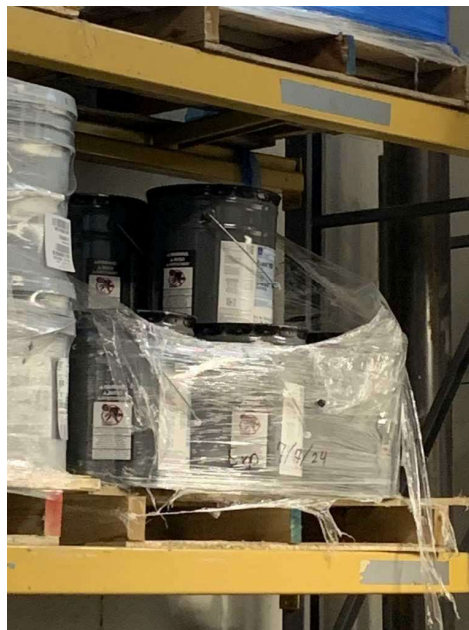
| Expired Paint | | | IMG_2197.jpg |

| Expired cans of paint on the shelf. | | | |
