## Region 6 - Enforcement & Compliance Assurance Division

### INSPECTION REPORT

| Company Name: | <b>Waters Materials Co. LLC</b> | |
| Facility Name: | <b>Gilmore-Wilcoxon Lease</b> | |

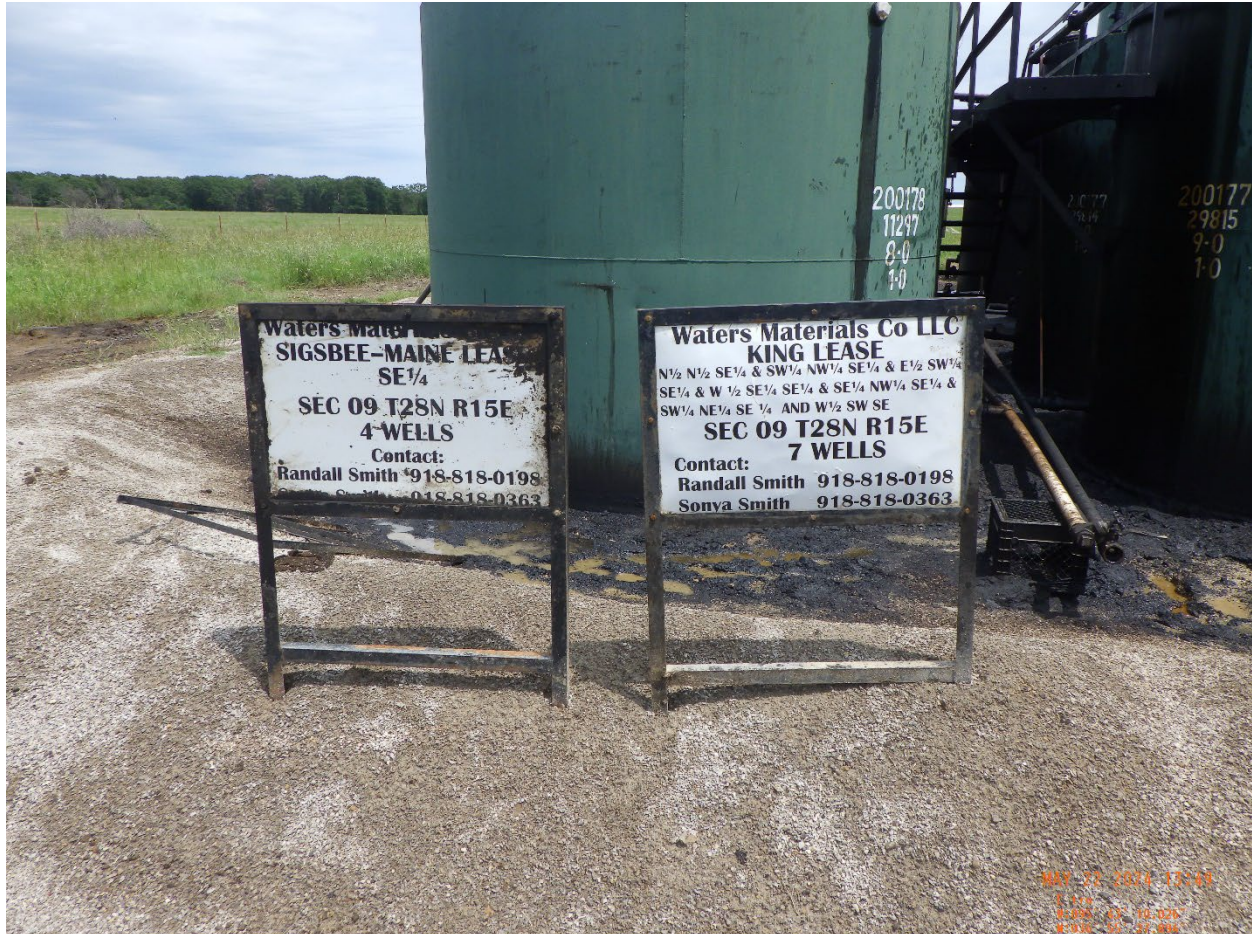
Photo No. 1

I observed the facility signage, which was believed to be inaccurate at the time of the inspection. See photo No. 1 of Appendix 1 (photo log). The facility was believed to be the Gilmore-Wilcoxon tank battery. At the time of the inspection, EPA inspector met an oil purchasing driver who stated he was loading oil from the Gilmore lease. For additional location information and photo metadata, see Appendix 1.

**Description:** This was a photo of the facility signage which was present at the time of the inspection. This facility was believed to be the Gilmore-Wilcoxon tank battery. During the inspection, the EPA inspector did speak with the oil purchaser who was loading oil from the facility, the purchaser stated he was purchasing a load from the Gilmore Lease.

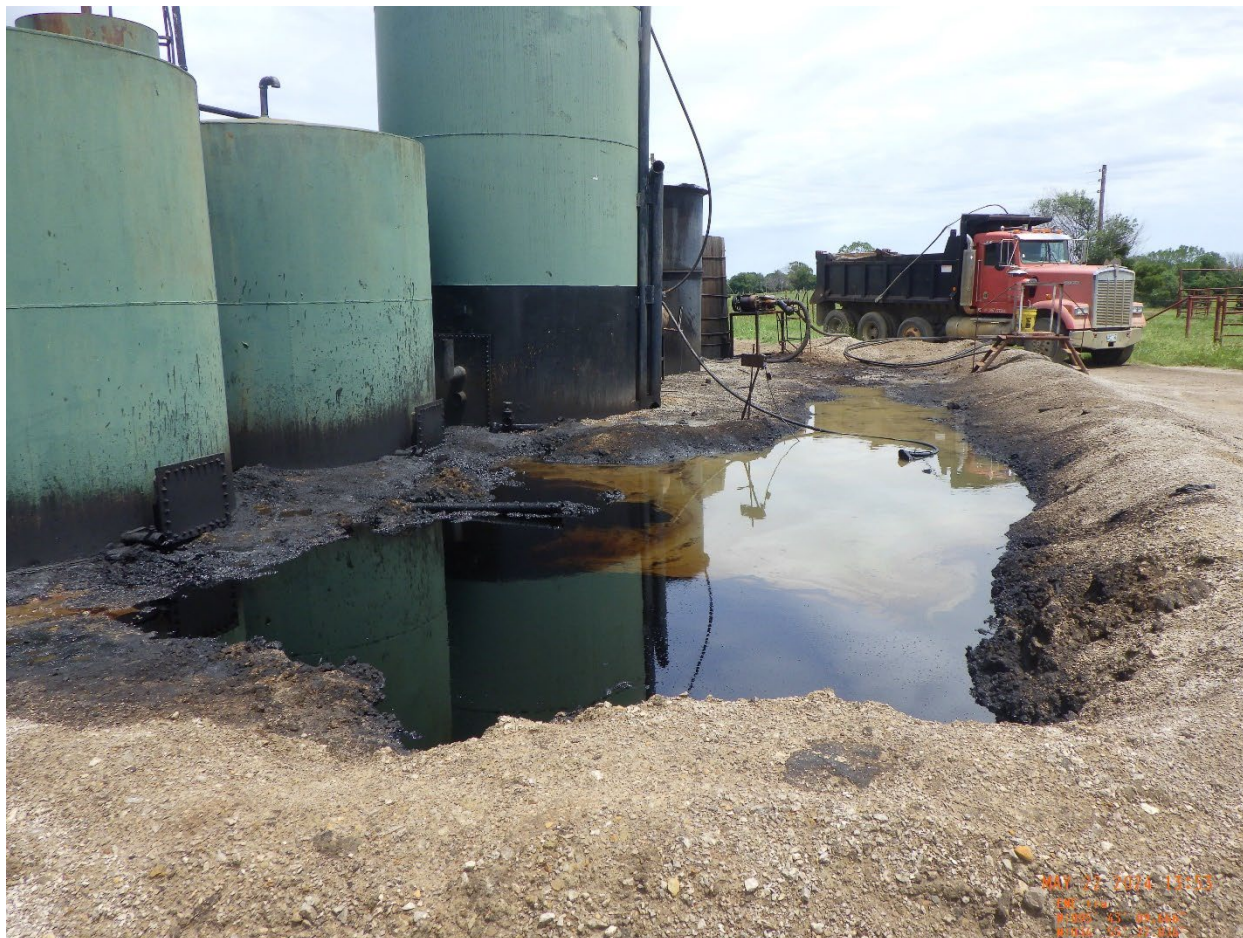
Photo No. 2

I observed large quantities of loose oil on the floor of the facility, including the “pit” area, on the soil/gravel and on the tanks. I also observed drain valves without a plug/cap. See photos No. 2, 3, and 4.

**Description:** This was a photo showing loose crude oil floating inside the secondary containment berm on the floor of the facility.

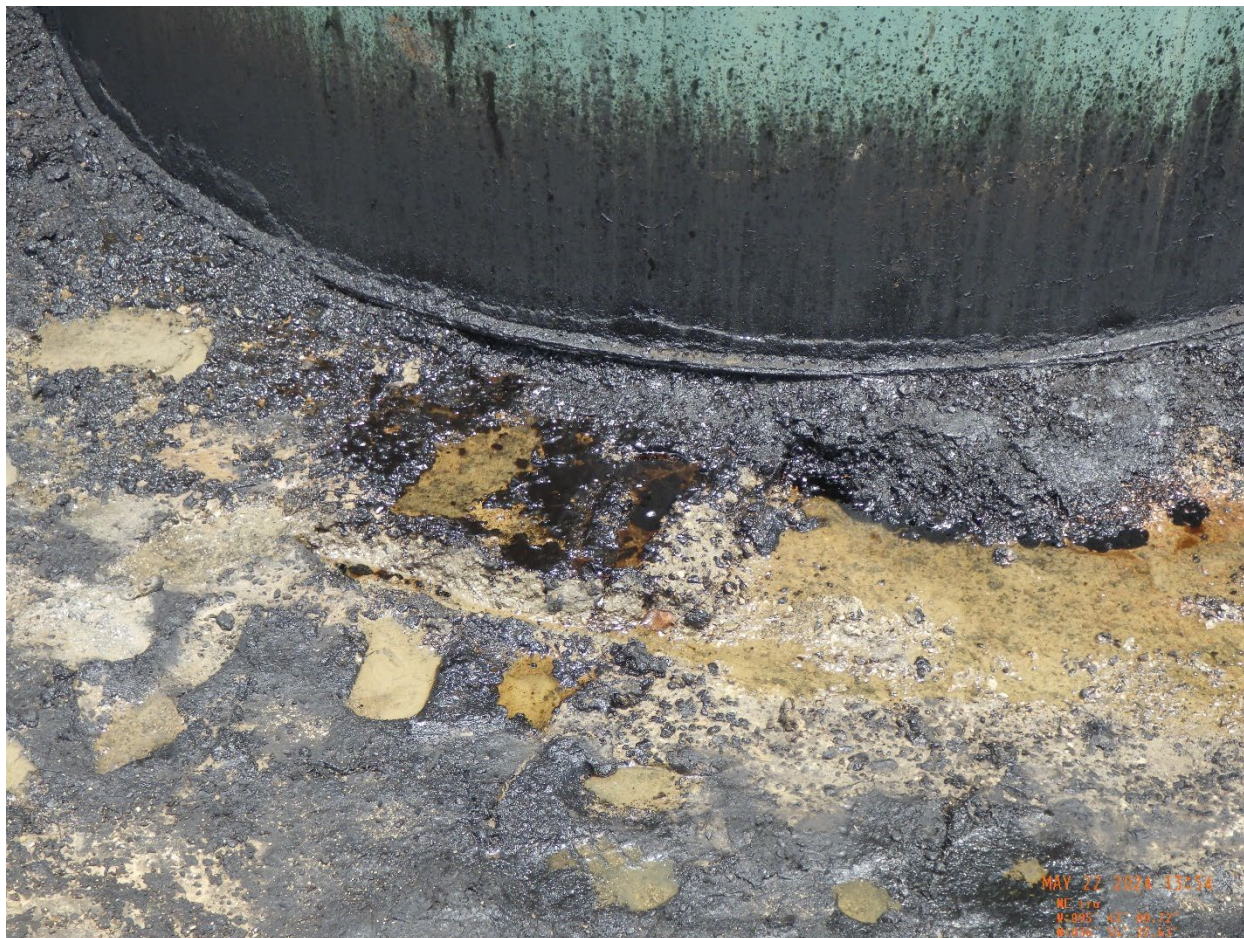
Photo No. 3

**Description:** This was a photo showing oil-stained soil and free oil on the floor of the facility inside the secondary containment.

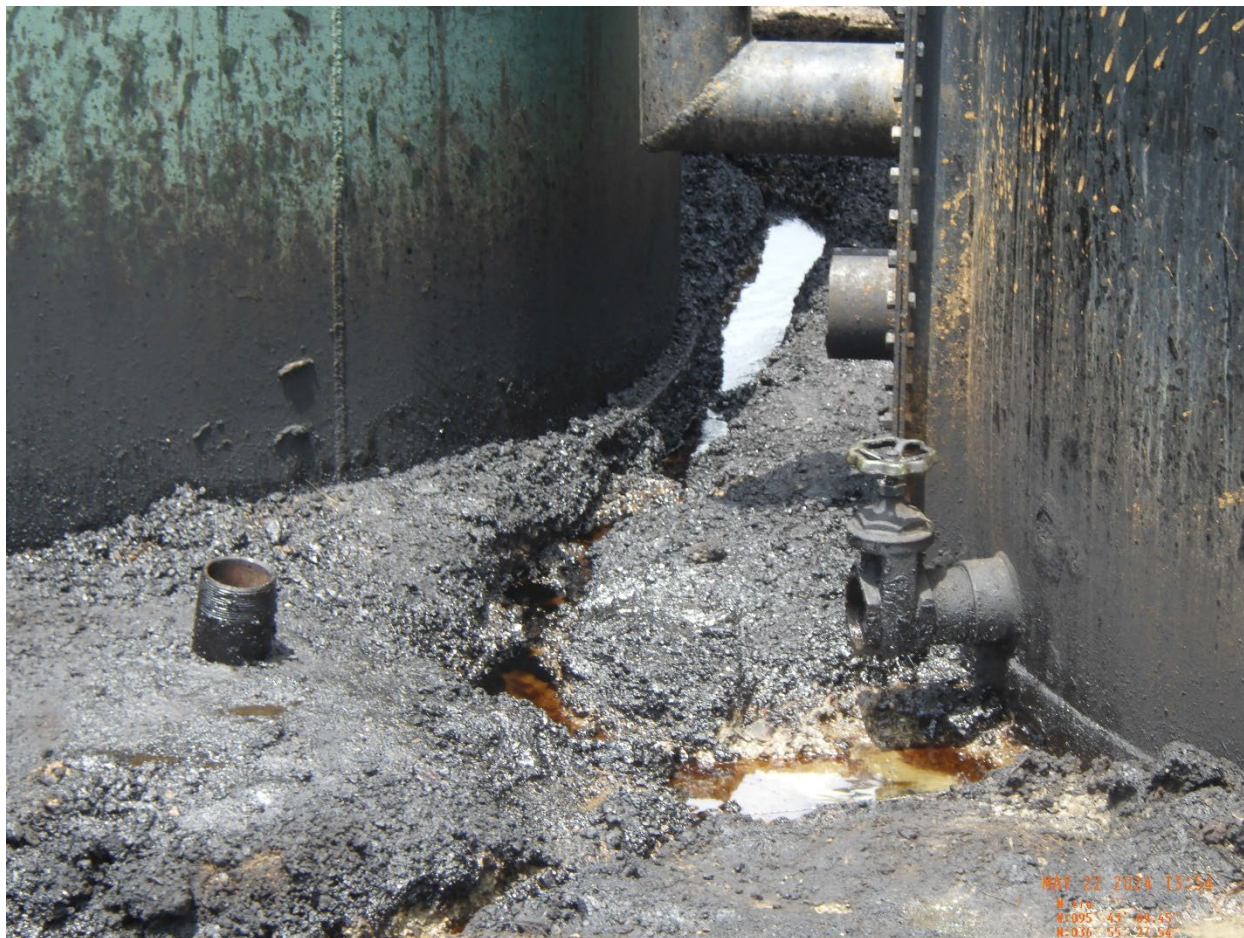
Photo No. 4

**Description:** This was a photo showing loose oil, oil-stained soil, and a tank drain valve without a cap/plug.

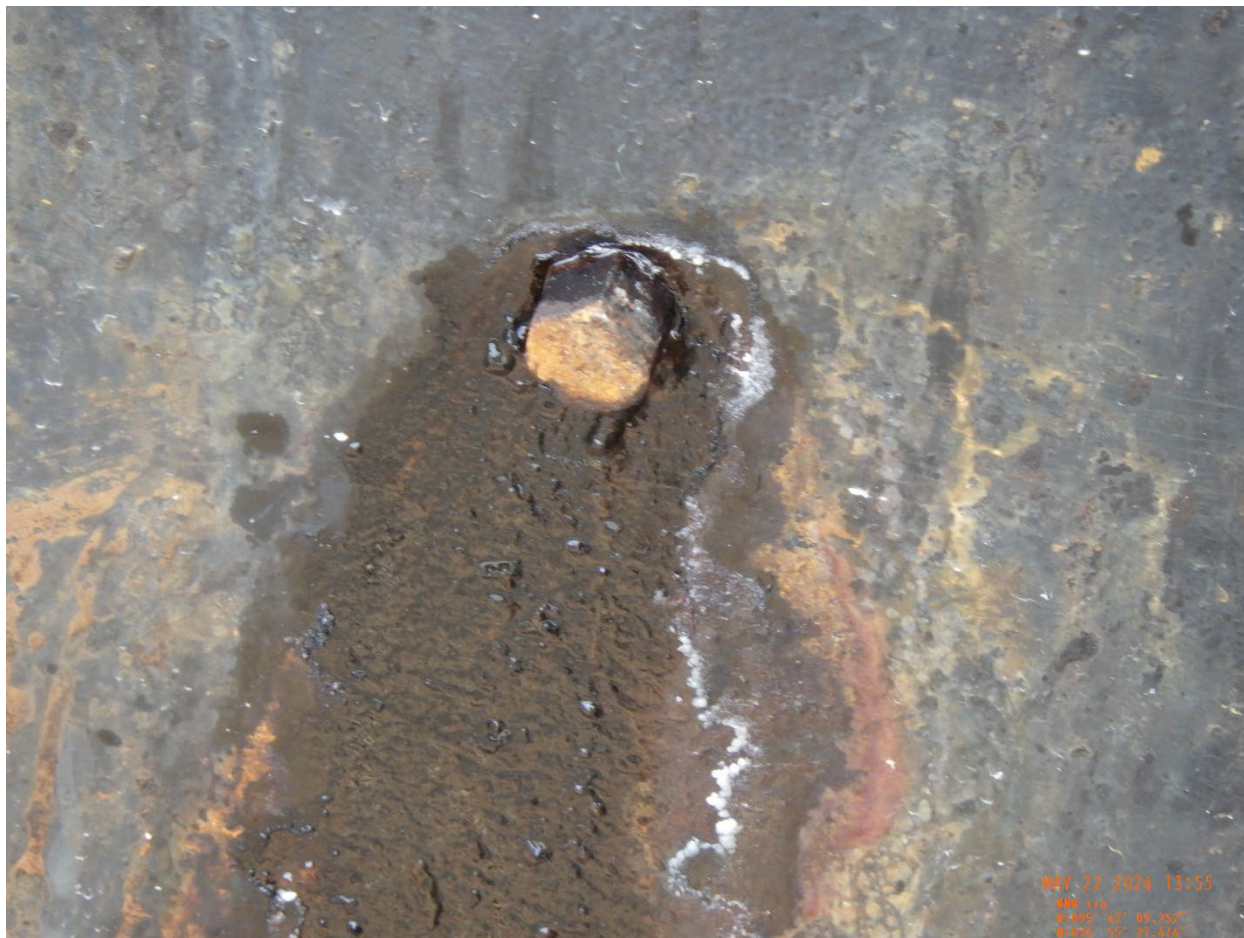
Photo No. 5

I observed a temporary repair plug installed into one of the facilities’ steel tanks. At the time of the inspection, the temporary repair was leaking. See photo No. 5.

**Description:** This was a temporary repair plug which had been installed in one of the steel tanks at the facility. The plug was leaking at the time of the inspection.

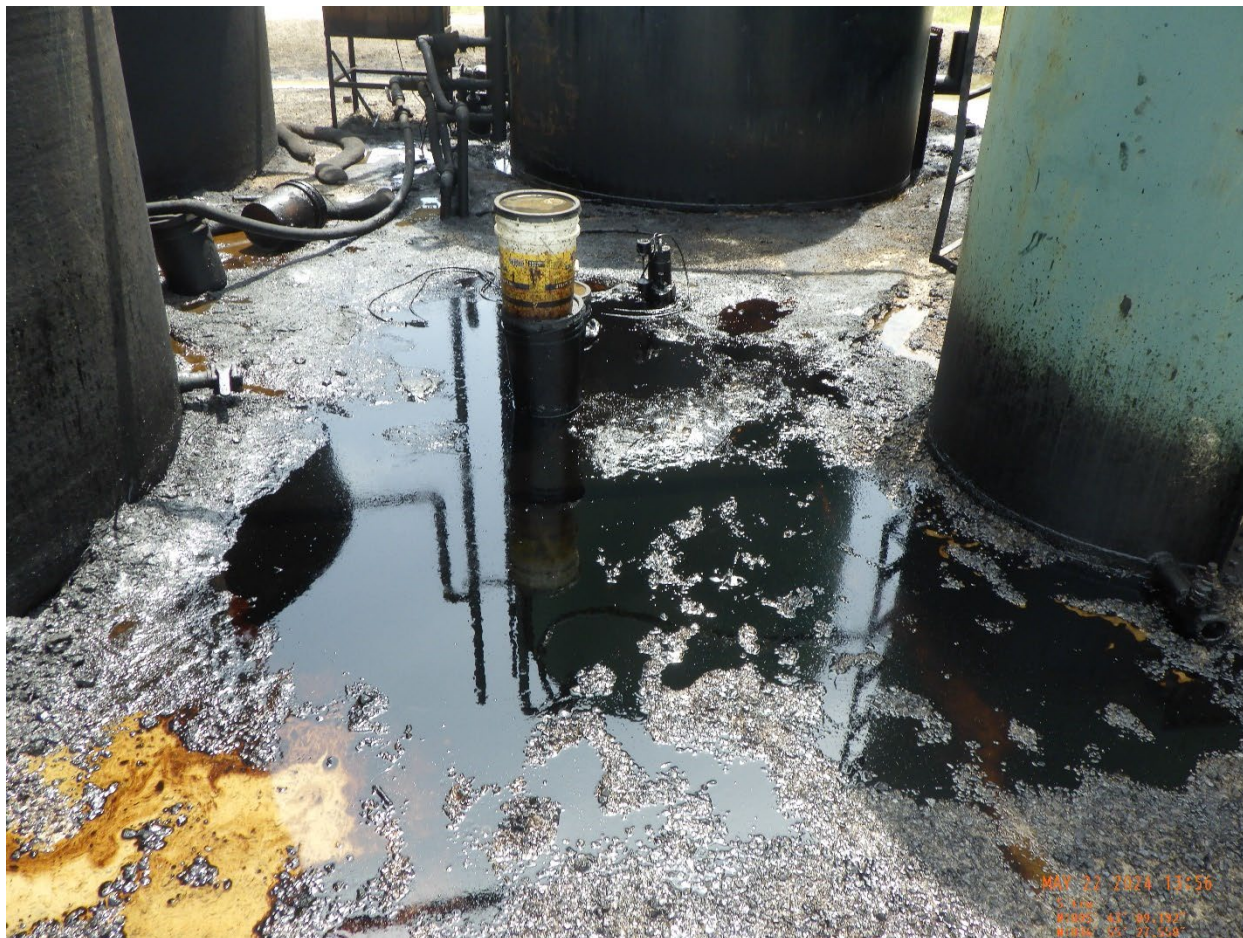
Photo No. 6

I observed additional oil on the floor of the facility which can be seen in photo No. 6.

**Description:** This was a photo showing free oil and oil staining on the floor of the facility as well as tank drain valves without a plug/cap.

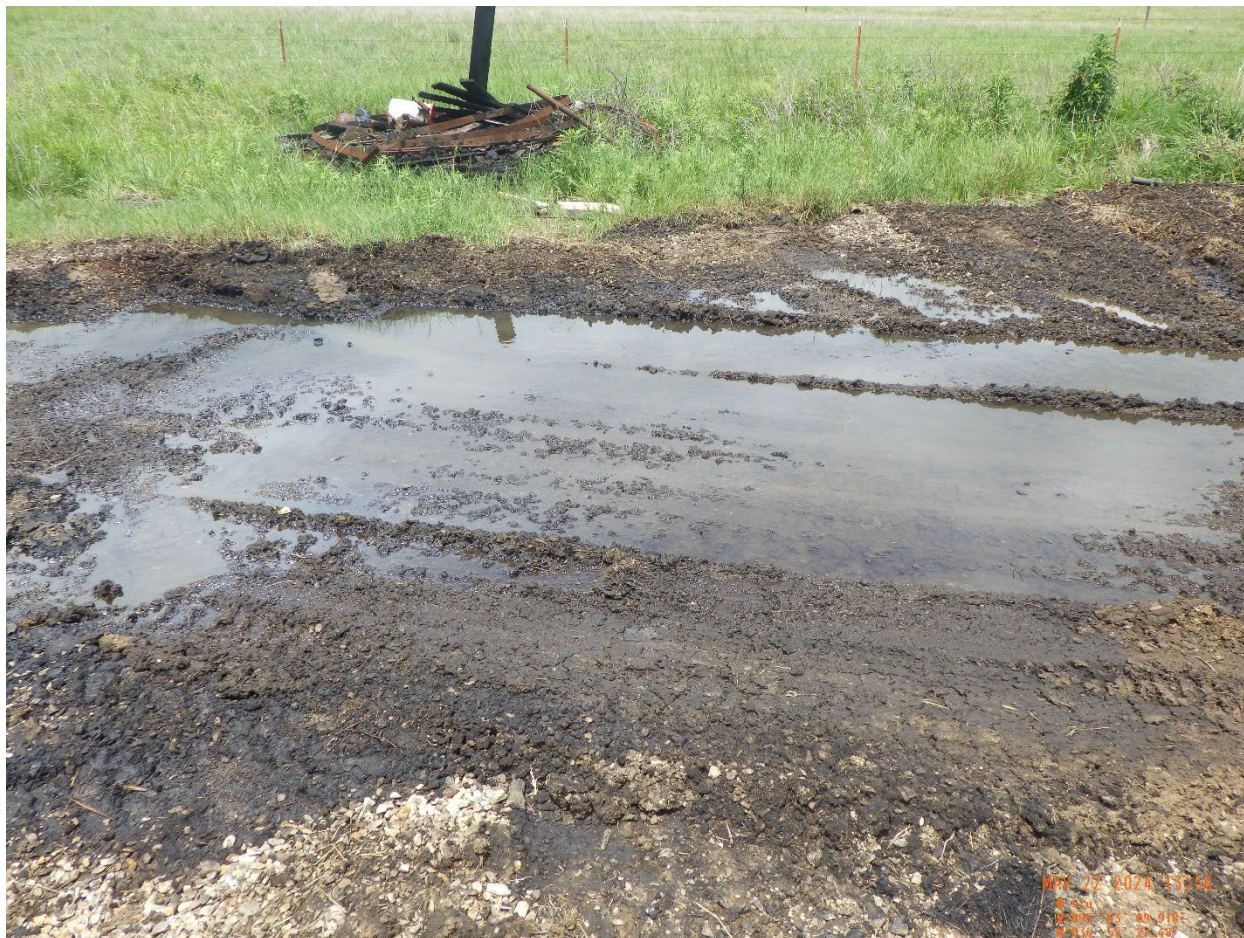
Photo No. 7

I observed oil-stained soil and gravel outside the secondary containment near the west end of the facility. See photo. No. 7.

**Description:** This was an area of oil-stained soil/gravel immediately outside the secondary containment on the west side of the facility.

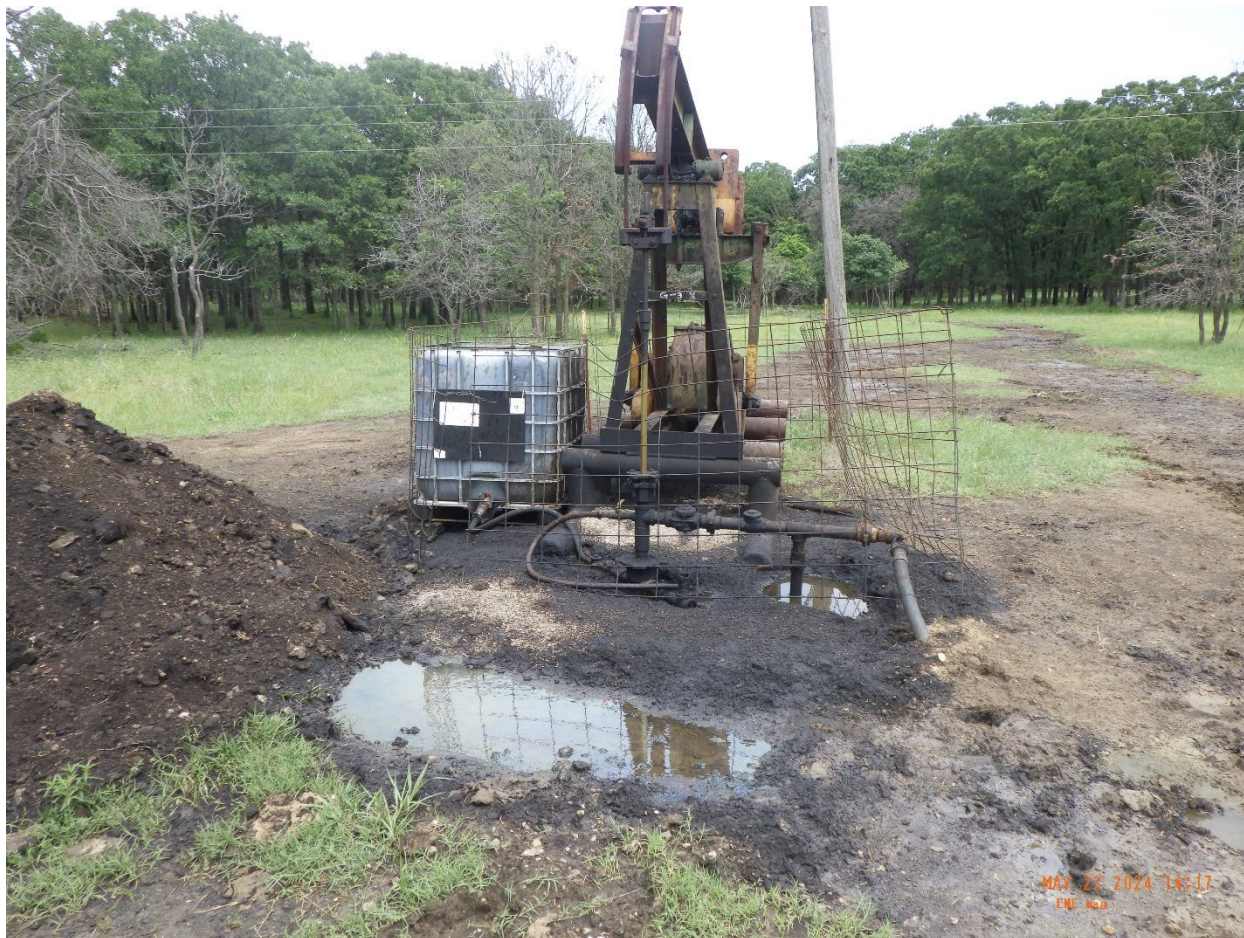
Photo No. 8

I observed one of the producing wells which was connected to the Gilmore-Wilcoxon tank battery. I observed evidence of a recent oil and saltwater spill event. Oil-stained soil and gravel can be seen around the wellhead. Brine impacted soil and vegetation can be seen to the NE of the well location along the flowpath of the spill. At this same location, there was a plastic “tote” with oil and water being stored with no secondary containment. See photo No. 8.

**Description:** This was a well connected to the Gilmore-Wilcoxon tank battery with oil-stained soil and gravel, evidence of a recent produced water spill travelling to the NE and a container holding oil without secondary containment.

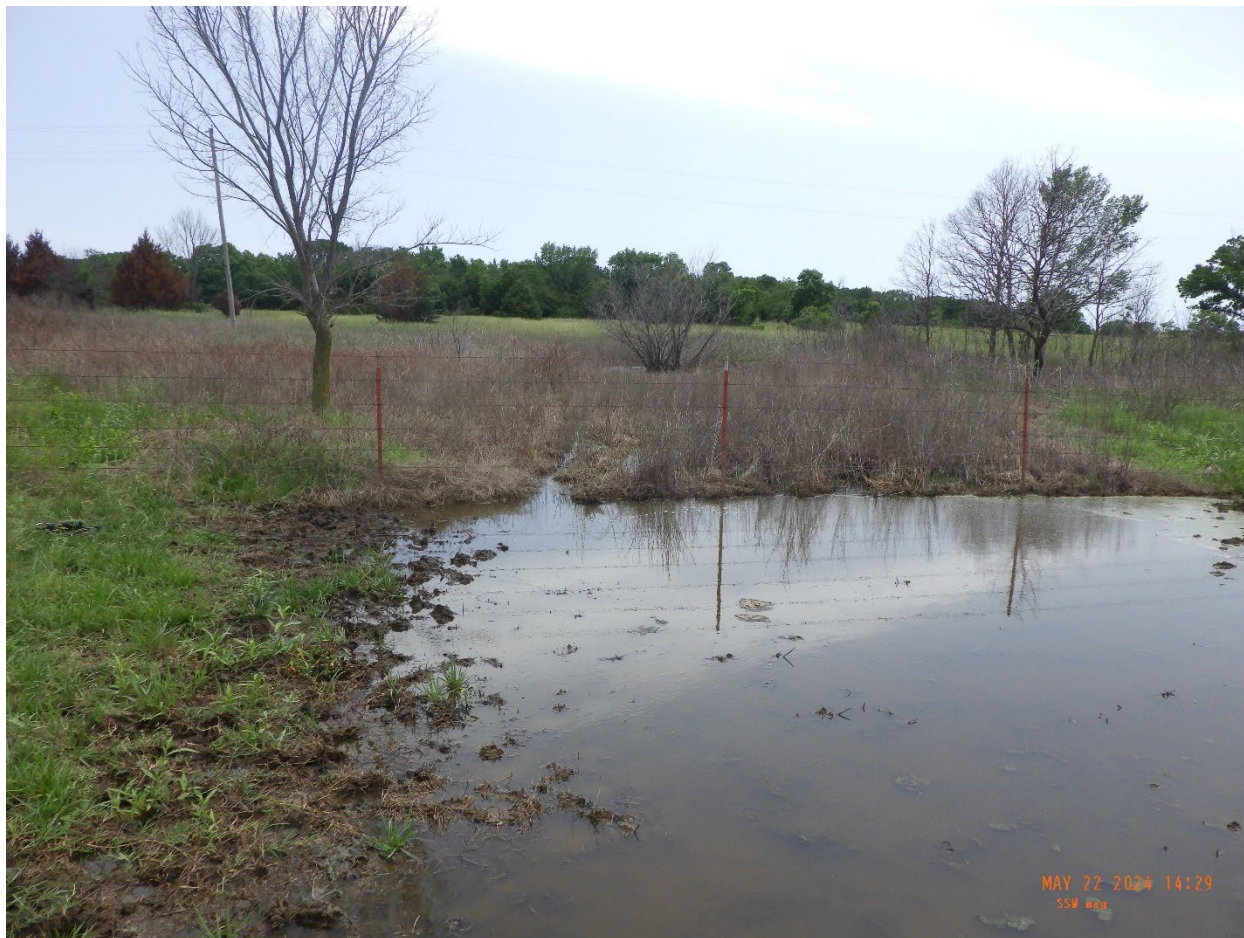
Photo No. 9

I observed impacted vegetation (dead grass and trees) and a pool of water which had been impacted by produced water. An elevated TDS field reading of approximately 3,700 mg/L was observed. The flowpath for the spill travelled from SE to NW. The spill originated from a flowline connected to the Gilmore-Wilcoxon tank battery. This impacted water was not impacting a significant waterway at the time of the inspection but there had been no action taken by the operator to prevent further migration of the impacted waters. See photo No. 9.

Additional areas of concern included the spill areas noted in the observations and photo log, including the area of elevated TDS water along the flowpath noted in photo No. 9. The primary area of concern was the lack of action to prevent further migration of spill impacts toward major waterways and no apparent spill cleanup or mitigation efforts had been implemented.

**Description:** This was an area of vegetation and a pool of water which was impacted by produced water. Grass and trees had been killed by the elevated brine concentration. Elevated TDS field readings of approximately 3,700 mg/L were observed at the location. The spill path was visible travelling from SE to NW.

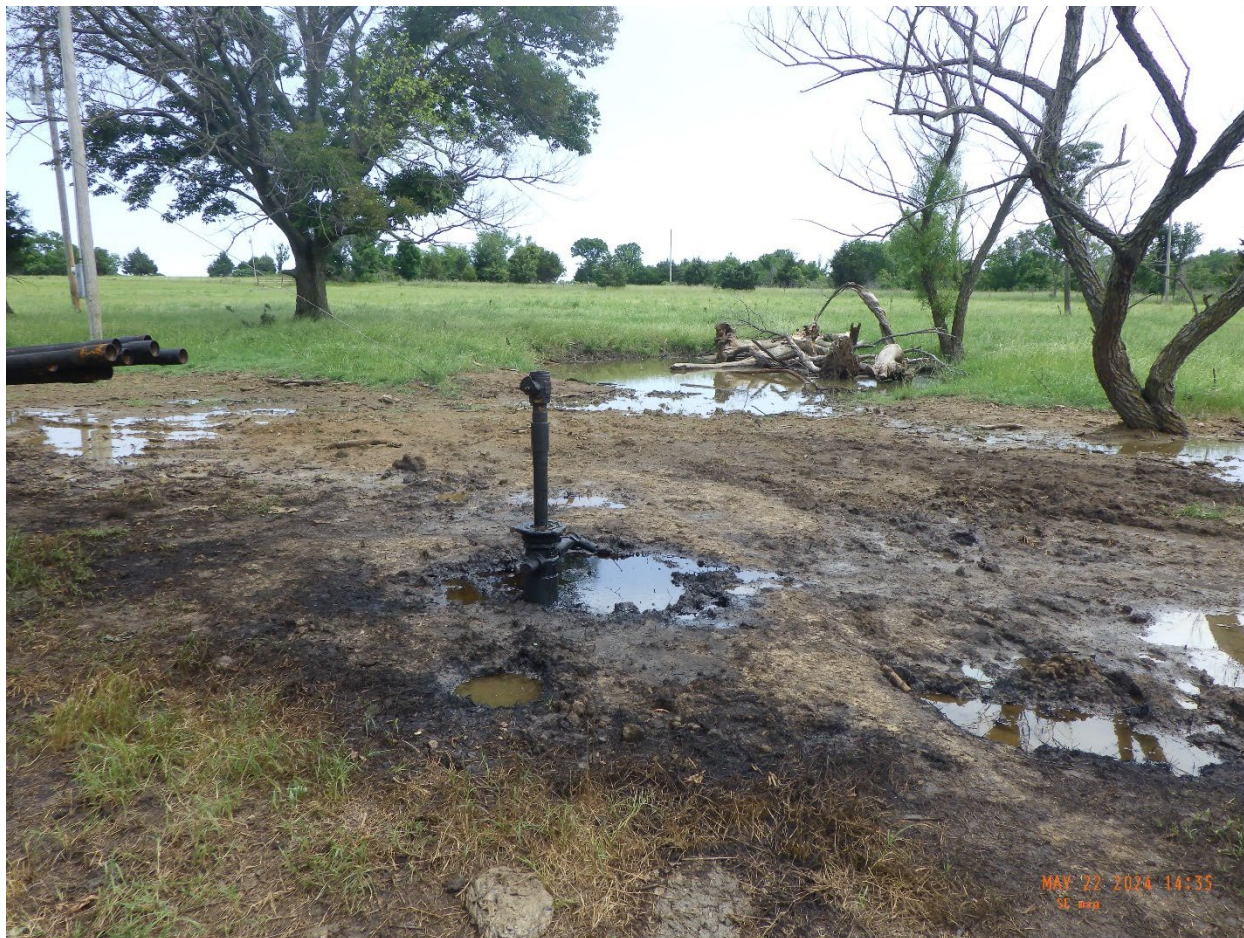
Photo No. 10

I observed a temporarily abandoned well which had loose oil on the ground. There was no signage to identify the well. At the same location, I observed evidence of recent spill impacts which could be identified by the gray and brown grass extending to the west of the well location. See photos No. 10 and 11.

**Description:** This was a temporarily abandoned well with free oil, oil-stained soil, and oil-stained vegetation.

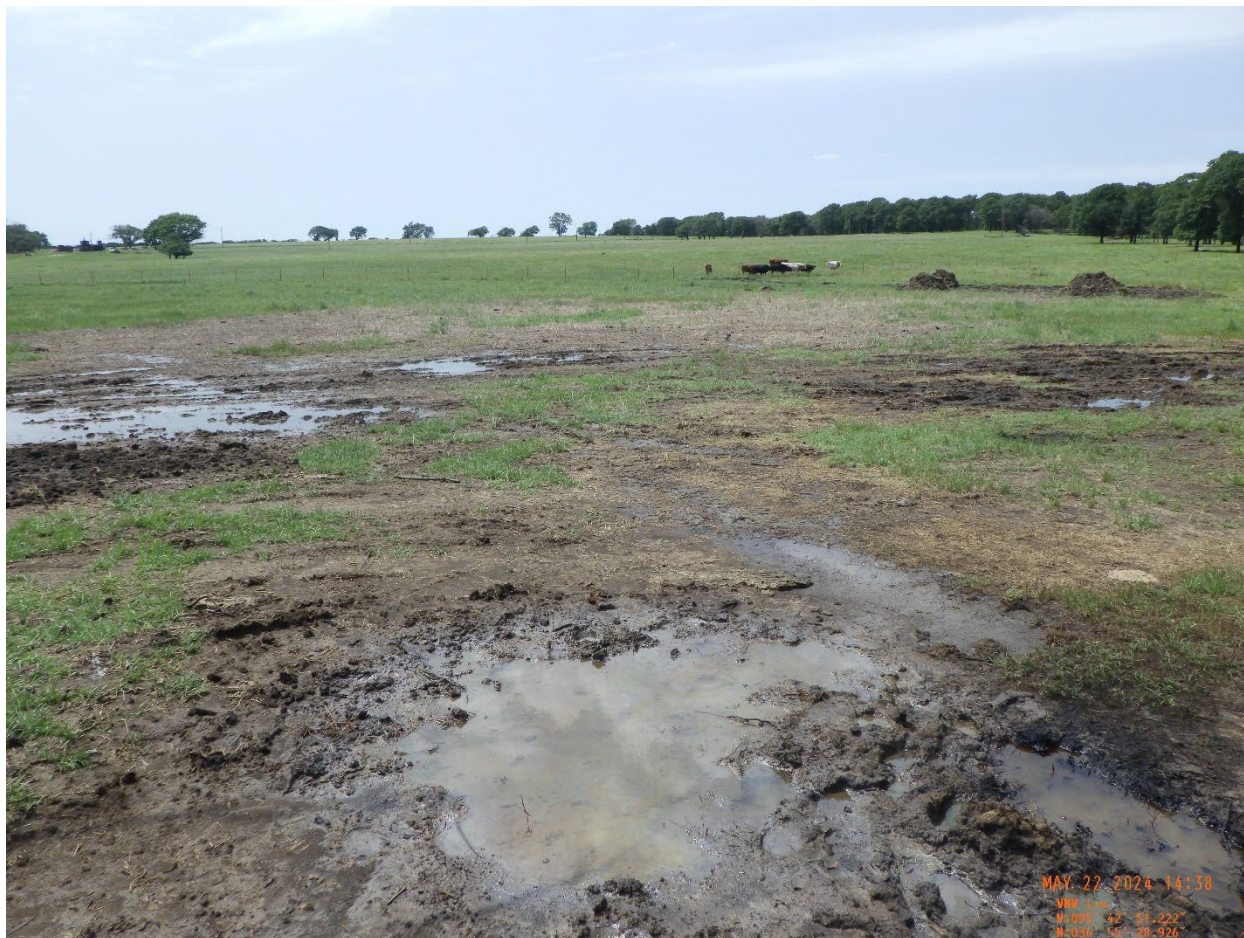
Photo No. 11

**Description:** This was the flowpath from a recent spill which travelled west from the well in photo No. 10. The flowpath is defined in the photo by the brown and gray dead grass.
