**Well Inspection**  
**Osage DNR / Environmental Protection Agency**  
**1201 Elm Street, Suite 500**  
**Dallas, Texas 75270**

| <b>Operator Info</b> | Performance Energy Resources, LLC | <b>Inventory ID</b> | OS4742000 | | |
| | Barnsdall, OK 74002 | <b>Lease Name</b> | Anticline | | |
| | Phone: 918-847-2531 | <b>Well ID</b> | 2E | | |

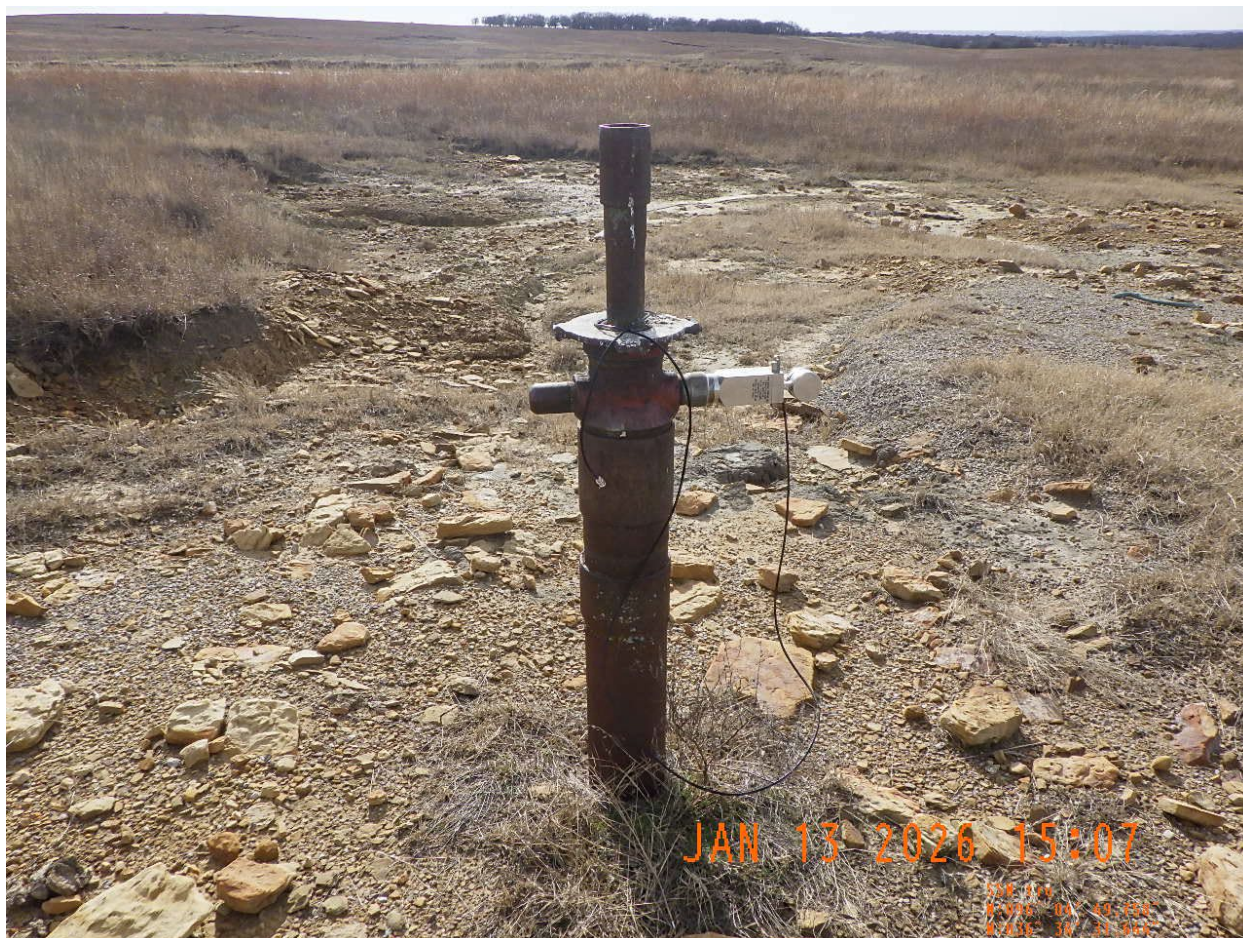
Photo No. 1

**Description:** This was well OS4742000 at the time of the inspection. At the time of the inspection the well was overdue for MIT. There was no well sign present at the location. The tubing was obstructed with grass and dirt preventing observance of the fluid level down the tubing. The annulus fluid level was observed to be 877' below the surface.
