## **RCRA Inspection Report**

TAV Holdings, Inc.  
3311 Empire Boulevard  
Atlanta, Fulton County, Georgia 30354

January 19, 2023

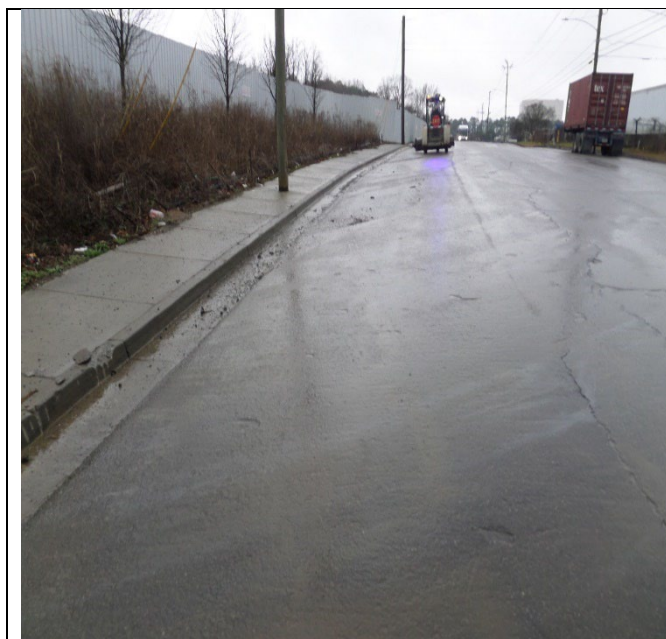
The inspectors observed ASR material on the east side of the road from the 3320 Empire Boulevard south gate entrance and observed stormwater from a rain event carried ASR material north down the hill several hundred feet to the MARTA bus stop #178 near South Industrial Park (Photograph 13). The inspectors also observed ASR material on the ground along the edge of the driveway to 3311 Empire Boulevard (Photographs 3 and 12).

3320 Empire Boulevard. The inspectors observed ASR material on the east side of the road and north down the hill Photograph 1 taken at 9:30 a.m.

**Pursuant to Paragraph 82 of the RCRA 7003 Order, Respondents must “immediately cease all activities (including operations, business practices, and material management, including commingling, mixing, and receipt and transfer of ASR waste) that may result in the release of solid and/or hazardous waste into the environment, including, but not limited to, ceasing the placement of ASR waste, intermediates from the processing of ASR waste, materials resulting from the processing of ASR waste, wastewaters and/or process waters, sludge, and/or any other wastes, directly onto the ground, including onto asphalt, concrete, or other surfaces.”**

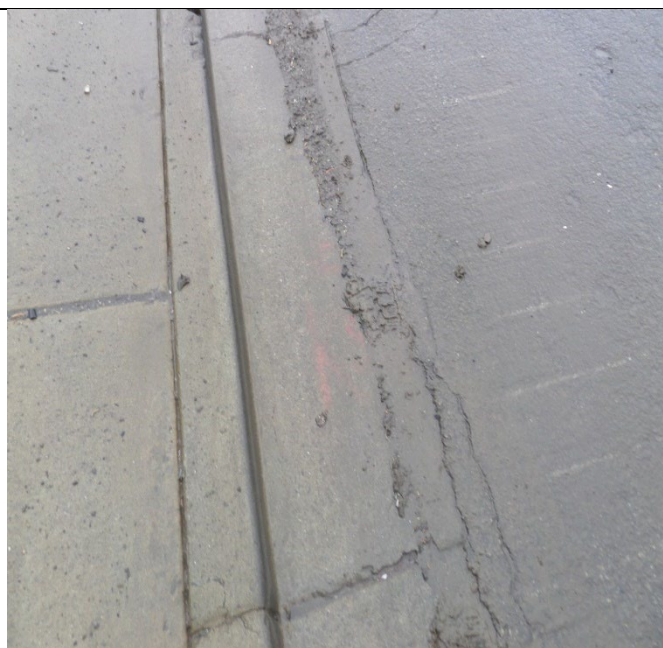
3320 Empire Boulevard. The inspectors observed ASR material on the east side of the road and north down the hill. Photograph 2 taken at 9:30 a.m.

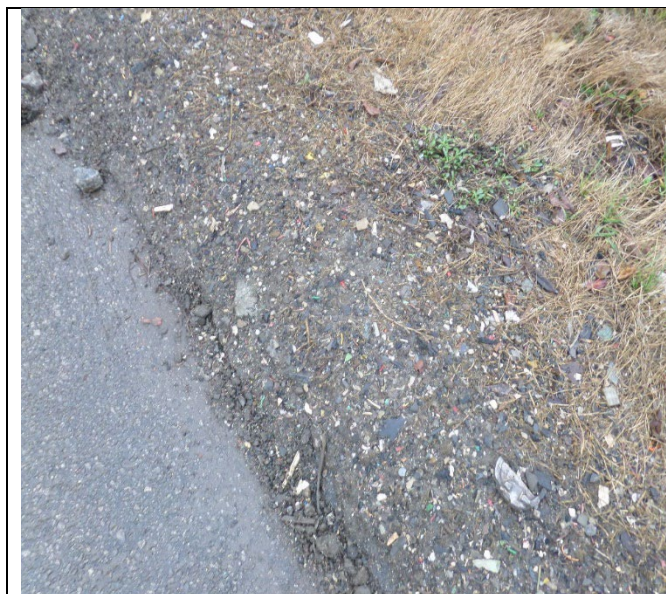
The inspectors and LSASD waited for Brent Fairchild to arrive and began to organize the sampling event across the street from the 111 Hollow Tree Lane Parking Lot. While organizing the sampling event, the inspectors observed ASR material on Empire Boulevard. The inspectors observed ASR material on the road between 3320 Empire Boulevard and the 111 Hollow Tree Lane and the 3311 Empire Boulevard parcels. The ASR material was observed on the east side of the road adjacent to the curb and sidewalk. The inspectors observed TAV was using a street sweeper to sweep the ASR material to the side of the road next to the curb. The inspectors did not observe a response by TAV to remove the ASR material off the road. The release of ASR material extended from the 3320 Empire Boulevard south gate entrance (Photographs 5 and 6) down the hill to the north (Photographs 1, 2, 4 through 11 and 13) and to the MARTA bus stop #178 near South Industrial Park (Photograph 14). The inspectors observed stormwater from a rain event carried the ASR material approximately several hundred feet along the curb on the road to a storm drain at the corner of South Industrial Park, near the MARTA bus stop. The inspectors also observed ASR material on the ground along the edge of the driveway to 3311 Empire Boulevard (Photographs 3 and 12).

3320 Empire Boulevard. The inspectors observed ASR material on the ground along the edge of the driveway to 3311 Empire Boulevard. Photograph 3 taken at 9:30 a.m.

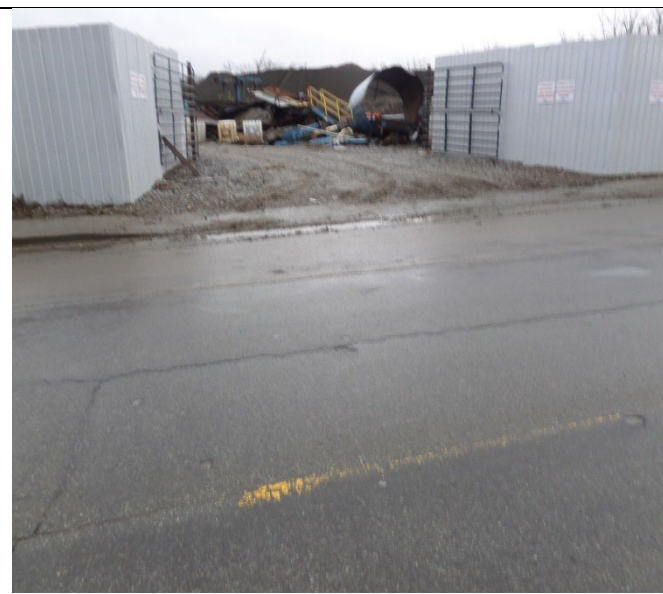
3320 Empire Boulevard. The inspectors observed ASR material on the east side of the road and north down the hill. Photograph 4 taken at 9:30 a.m.

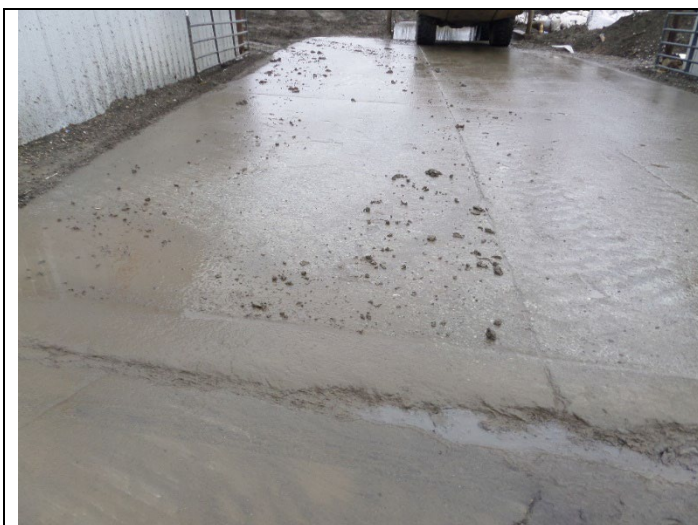
3320 Empire Boulevard. The inspectors observed the release of ASR material was from the 3320 Empire Boulevard south gate entrance. Photograph 5 taken at 9:30 a.m.

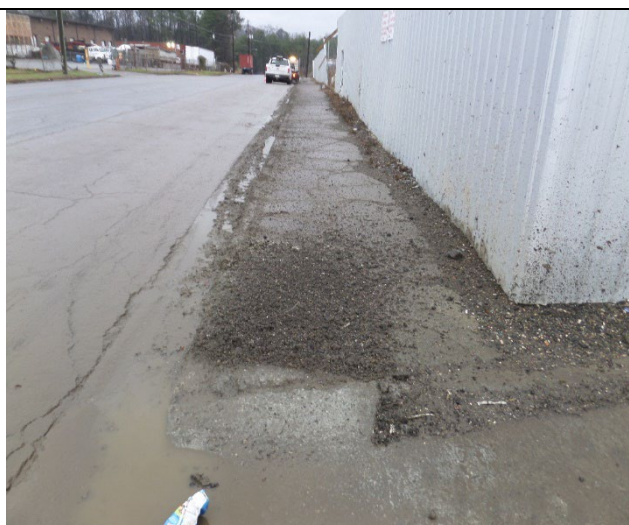
3320 Empire Boulevard. The inspectors observed the release of ASR material was from the 3320 Empire Boulevard south gate entrance. Photograph 6 taken at 9:30 a.m.

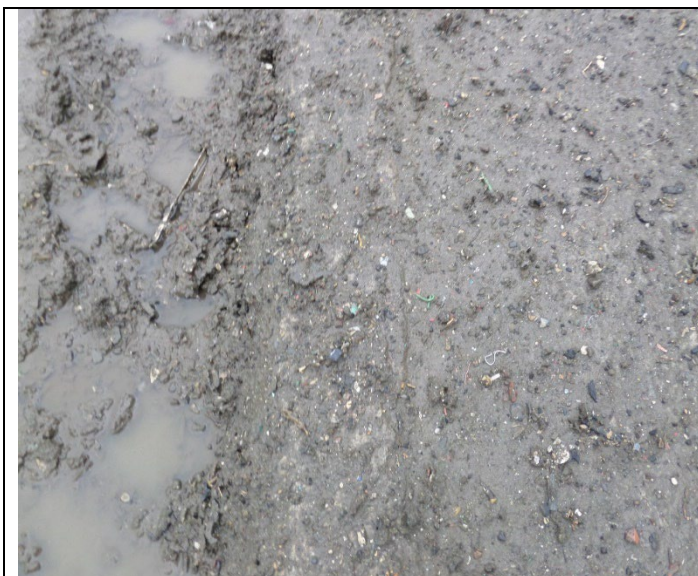
3320 Empire Boulevard. The inspectors observed ASR material on the east side of the road and north down the hill. Photograph 7 taken at 9:30 a.m.

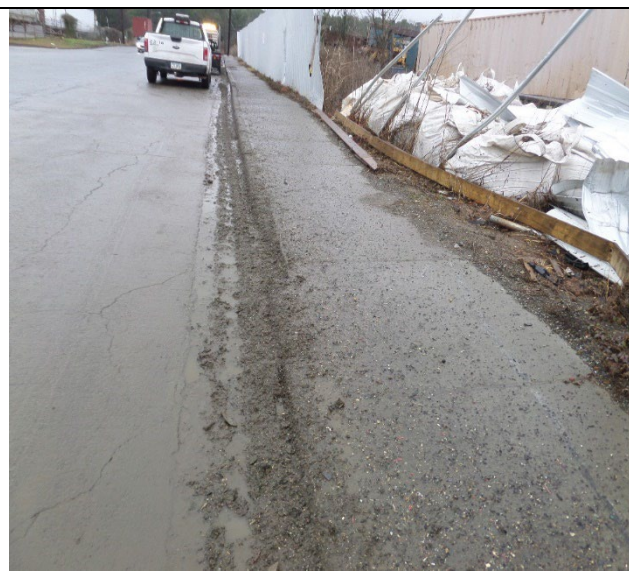
3320 Empire Boulevard. The inspectors observed ASR material on the east side of the road and north down the hill. Photograph 8 taken at 9:30 a.m.

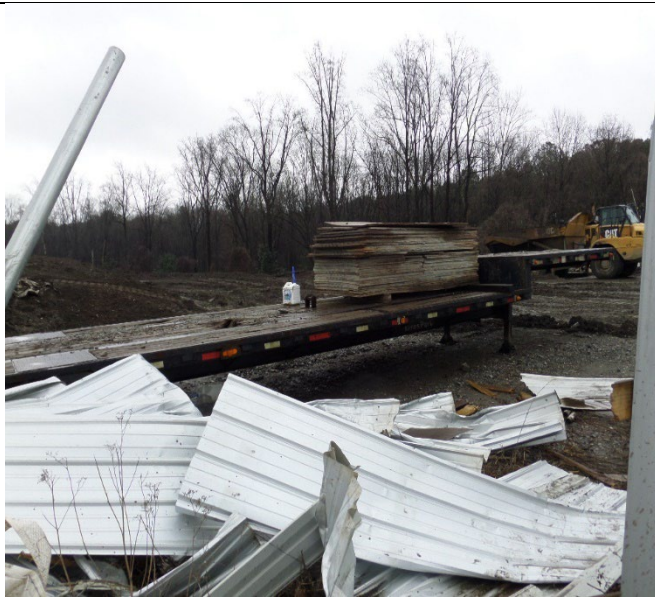
3320 Empire Boulevard. The inspectors observed ASR material on the east side of the road and north down the hill. Photograph 9 taken at 9:30 a.m.

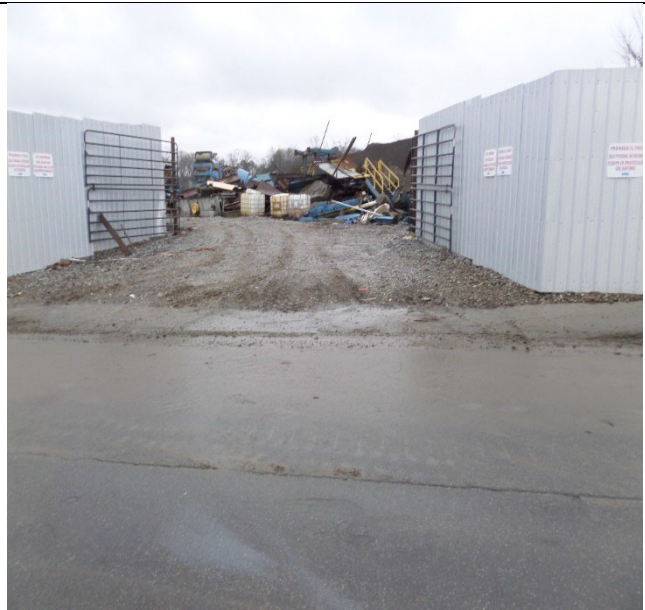
3320 Empire Boulevard. The inspectors observed ASR material on the east side of the road and north down the hill. Photograph 10 taken at 9:30 a.m.

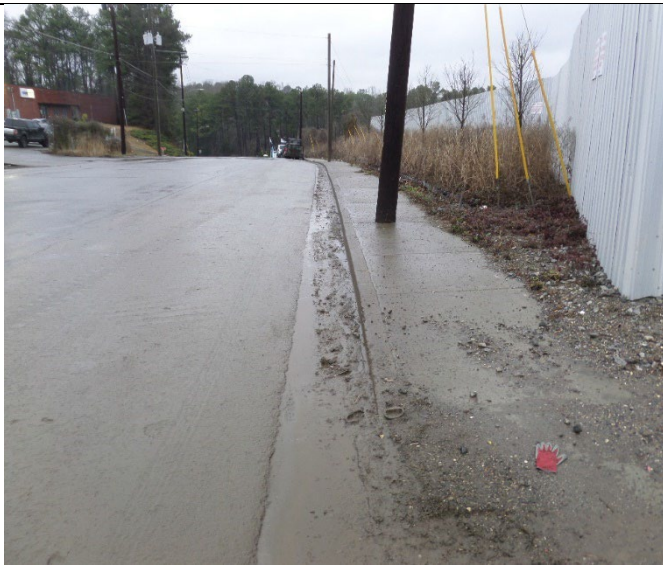
3320 Empire Boulevard. The inspectors observed ASR material on the east side of the road and north down the hill. Photograph 11 taken at 9:30 a.m.

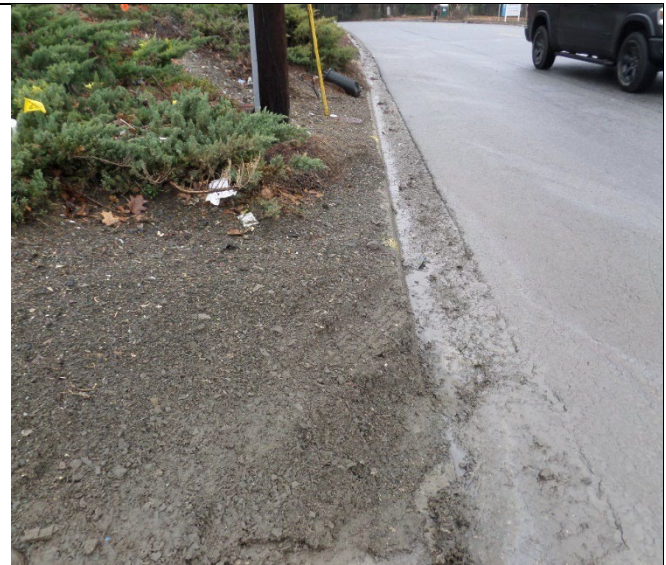
3320 Empire Boulevard. The inspectors observed ASR material on the ground along the edge of the driveway to 3311 Empire Boulevard. Photograph 12 taken at 9:38 a.m.

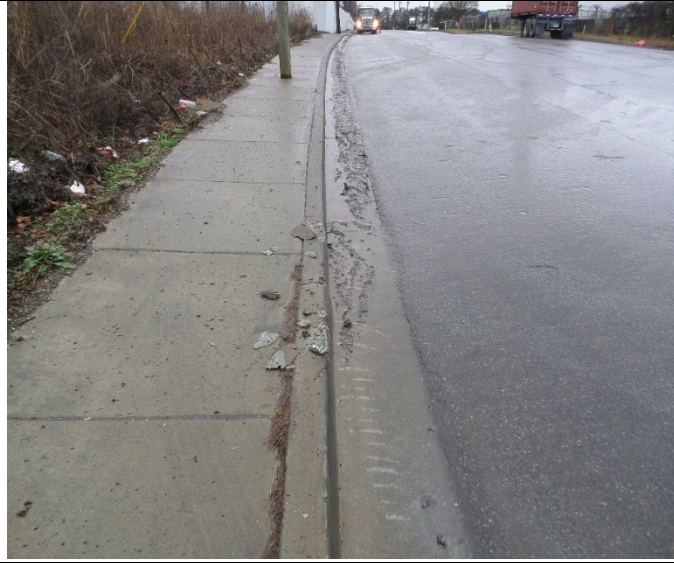
3320 Empire Boulevard. The inspectors observed ASR material on the east side of the road and north down the hill. Photograph 13 taken at 10:29 a.m.

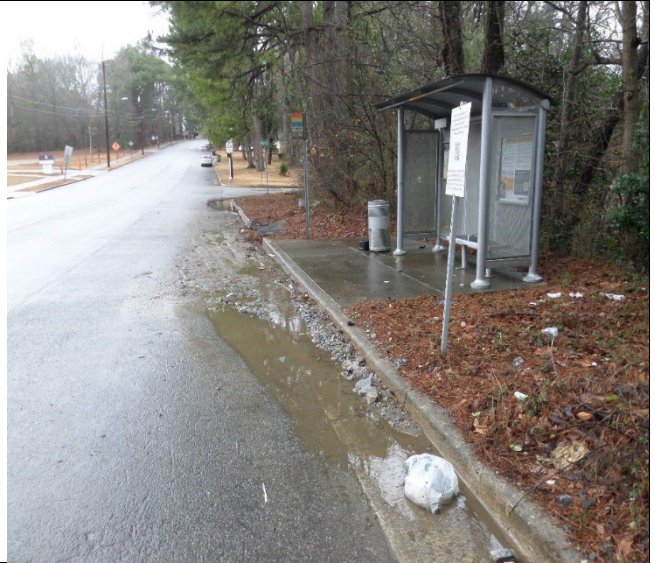
The inspectors observed ASR material on the ground next to the curb at the MARTA bus stop #178 near South Industrial Park. The bus stop is approximately one quarter mile north from the ASR material observed on the road near the 3320 Empire Boulevard south gate entrance (Photograph 14). The inspectors observed some vehicles passing on the road during the sampling event.

3320 Empire Boulevard. MARTA Bus Stop #178. The inspectors observed ASR material on the east side of the road and north down the hill to the MARTA bus stop #178 near South Industrial Park. Photograph 14 taken at 10:50 a.m.

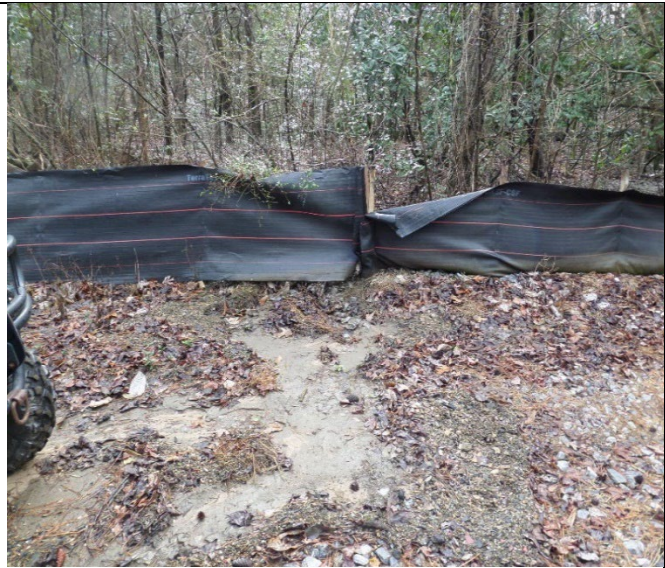
The inspectors observed a washout containing ASR material released from the hill Outfall pipe (Outfall Number 3) to ground surfaces at approximately 10 to 15 feet from the Outfall (Photographs 16, 18, 19, 20 and 54). The inspectors followed the path of the washout and observed ASR material on the ground at a distance from the Outfall of approximately 30-45 feet (Photograph 17). The inspectors continued to follow the path of the washout and observed ASR material on the ground at a distance from the Outfall of approximately 90-105 feet (Photographs 21 and 22). The inspectors reached the edge of the woods next to the silt fence and observed the ASR material reached the earthen access path at a distance from the Outfall of approximately 150-180 feet (Photographs 15, 24, 52 and 53).

Access Path Next to Wooded Area Behind Keebler North Bunker Area. The inspectors observed a washout containing ASR material flowing from Outfall #3 pipe to the earthen access path. Distance from Outfall #3 pipe approximately 150-180 feet. Photograph 15 taken at 11:09 a.m.

**Pursuant to Paragraph 82 of the RCRA 7003 Order, Respondents must “immediately cease all activities (including operations, business practices, and material management, including commingling, mixing, and receipt and transfer of ASR waste) that may result in the release of solid and/or hazardous waste into the environment, including, but not**

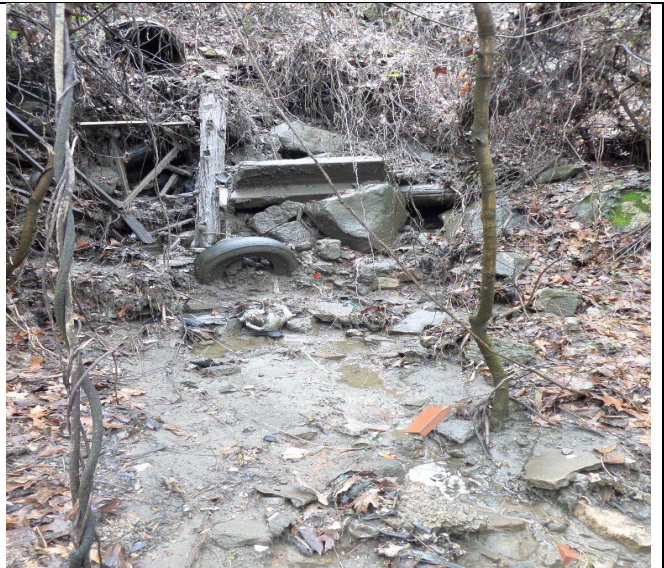
Wooded Area Behind Keebler North Bunker Area. The inspectors observed a washout containing ASR material flowing from the outfall #3 pipe to ground surfaces. See outfall pipe in top left corner of photograph. Photograph 16 taken at 11:17 a.m.

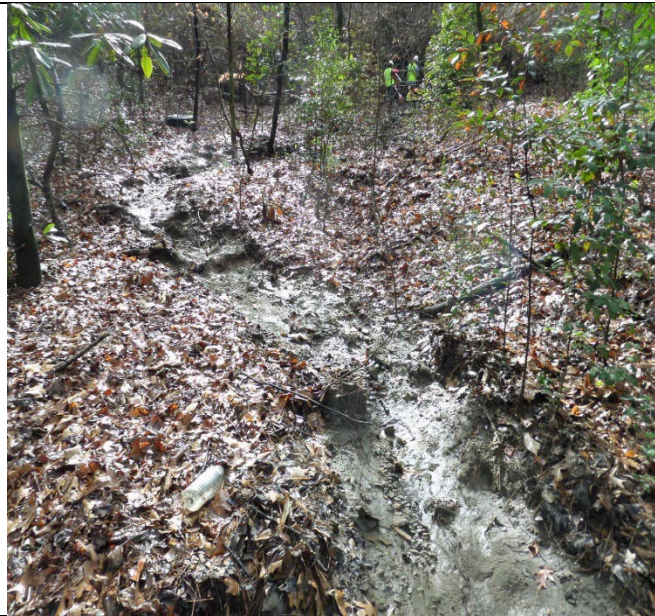
Wooded Area behind Keebler North Bunker Area. The inspectors observed a washout containing ASR material flowing from outfall #3 pipe to the earthen access path. Distance from Outfall #3 pipe is approximately 30-45 feet. Photograph 17 taken at 11:19 a.m.

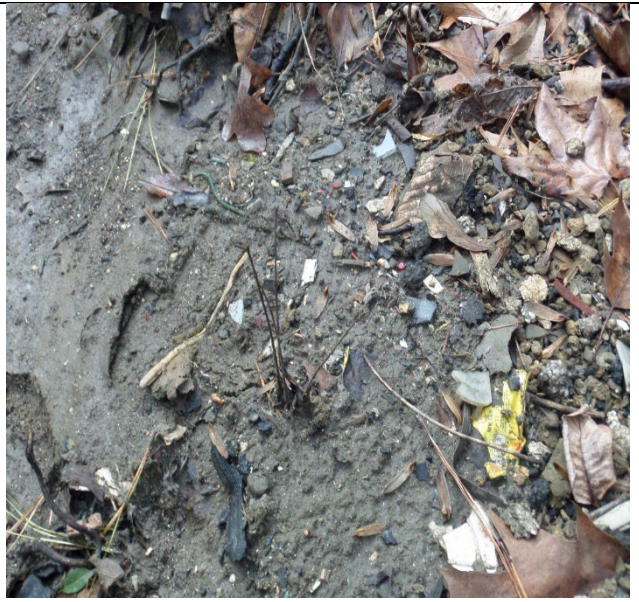
Wooded Area Behind Keebler North Bunker Area. The inspectors observed a washout containing ASR material near the Outfall #3 pipe. Close-up of washout observed in photograph 16. Photograph 18 taken at 11:21 a.m.

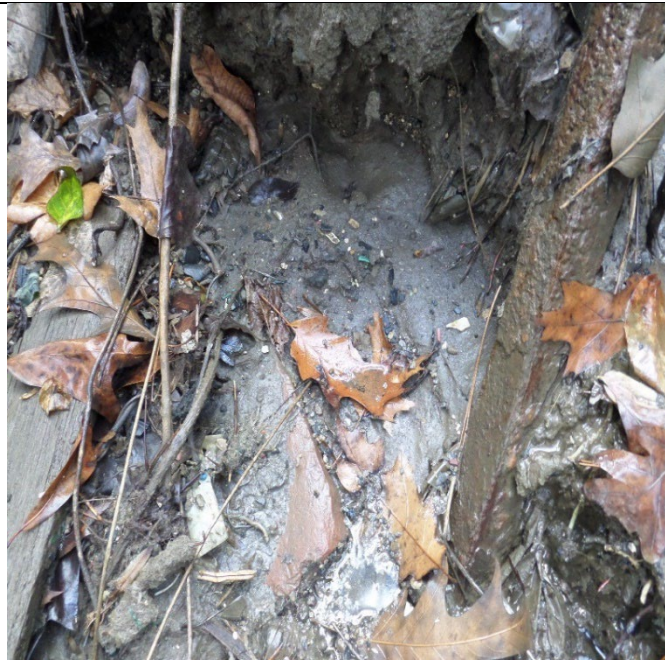
Wooded Area behind Keebler North Bunker Area. The inspectors observed a washout containing ASR material near the Outfall #3 pipe. Close-up of washout observed in photograph 16. Photograph 19 taken at 11:21 a.m.

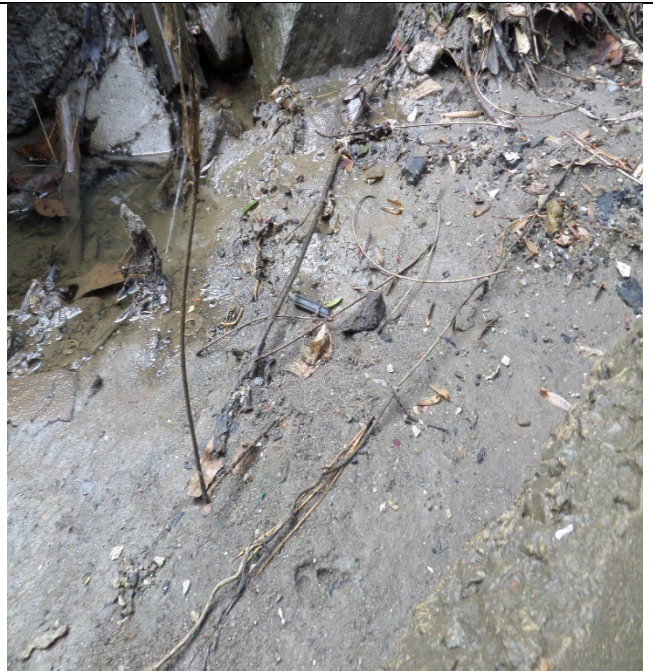
Wooded Area behind Keebler North Bunker Area. The inspectors observed a washout containing ASR material near the Outfall #3 pipe. Close-up of washout observed in photograph 16. Photograph 20 taken at 11:21 a.m.

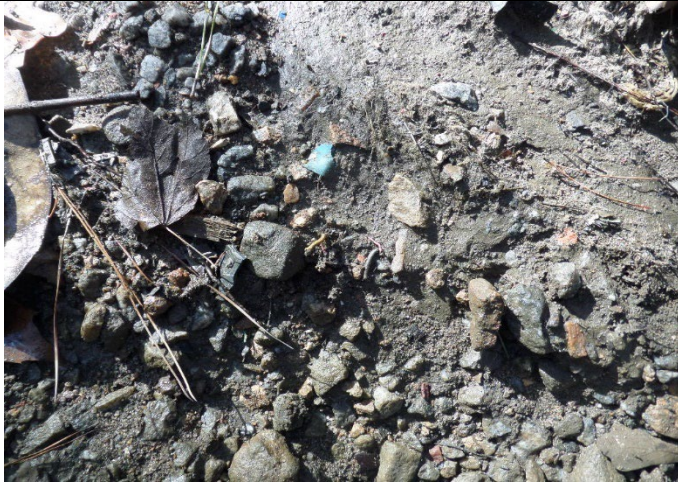
Wooded Area behind Keebler North Bunker Area. The inspectors observed a washout containing ASR material flowing from outfall #3 pipe downhill to the earthen access path. Distance from Outfall #3 pipe approximately 90-105 feet. Photograph 21 taken at 11:28 a.m.

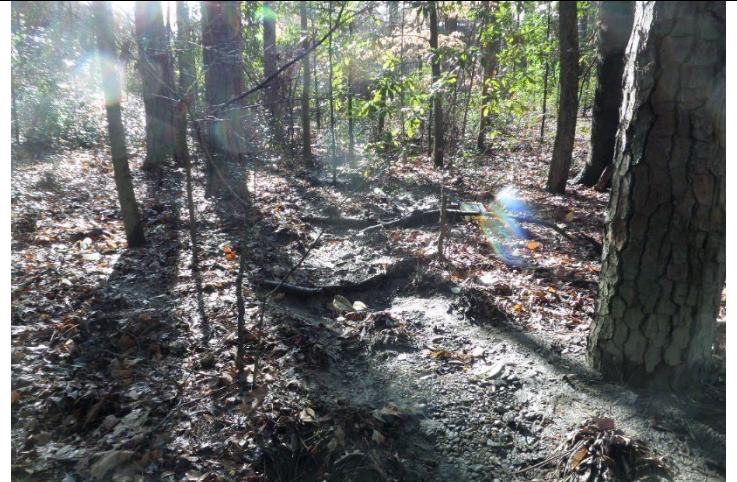
Wooded Area behind Keebler North Bunker Area. The inspectors observed a washout containing ASR material flowing from outfall #3 pipe downhill to the earthen access path. Distance from Outfall #3 pipe approximately 90-105 feet. General impression of Photograph 21. Photograph 22 taken at 11:30 a.m.

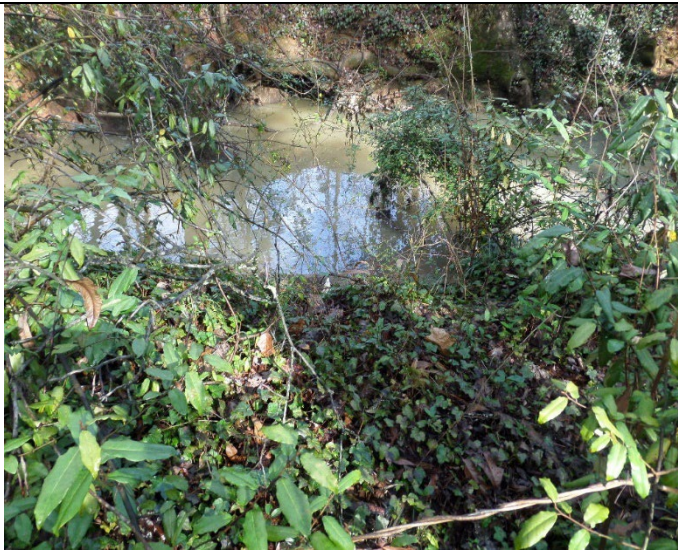
The inspectors observed a path that appeared to be washed out depressing the vegetation and the grassy area to the unnamed tributary (Photographs 23 and 25).

Unnamed Tributary Next to Access Path. The inspectors observed a path that appeared to be washed out depressing the vegetation and the grassy area to the unnamed tributary. Photograph 23 taken at 11:35 a.m.

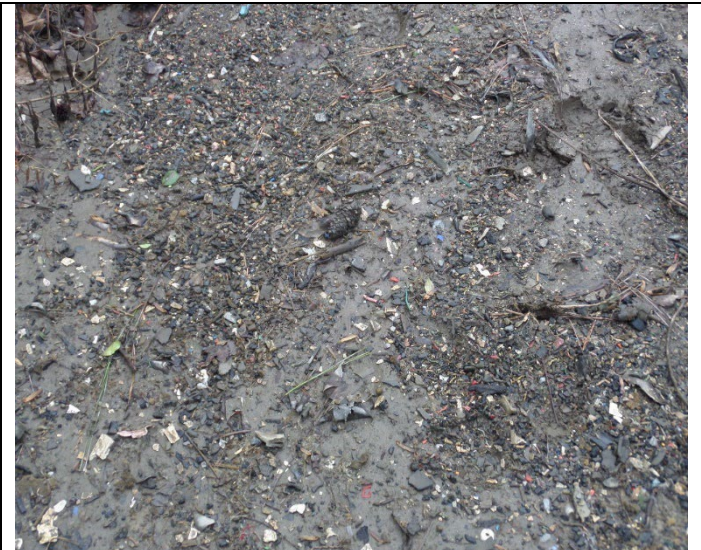
Access Path Next to Wooded Area between Keebler North and Unnamed Tributary. The inspectors observed washout of ASR material on the earthen access path. Distance from Outfall #3 pipe approximately 150-180 feet. Photograph 24 taken at 11:44 a.m.

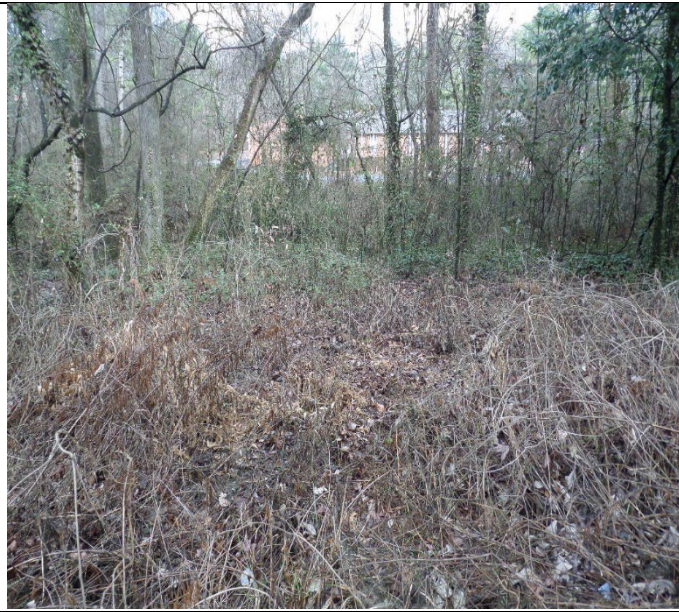
Grassy Area Next to Unnamed Tributary. The inspectors observed a path that appeared to be washed out depressing the vegetation and the grassy area to the unnamed tributary. Photograph 25 taken at 11:45 a.m.

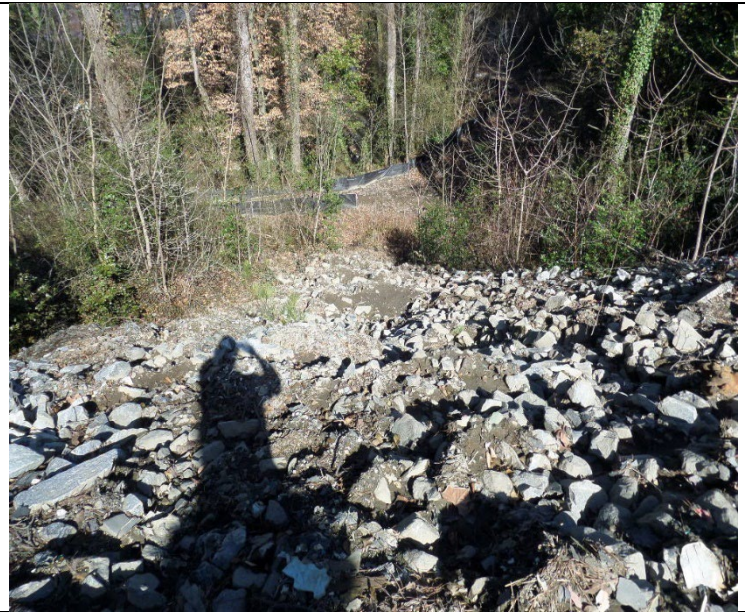
The inspectors observed a release(s) of ASR material along the length of the rip rap. The rip rap continues downhill to the earthen access path and to the unnamed tributary (Photographs 26, 27, 28 and 29).

Outfall #2 Area - Keebler West. The inspectors observed apparent ASR material released to rip rap. Rip rap continues downhill to earthen access path and unnamed tributary. Photograph 26 taken at 1:15 p.m.

**Pursuant to Paragraph 82 of the RCRA 7003 Order, Respondents must “immediately cease all activities (including operations, business practices, and material management, including commingling, mixing, and receipt and transfer of ASR waste) that may result in the release of solid and/or hazardous waste into the environment, including, but not limited to, ceasing the placement of ASR waste, intermediates from the processing of ASR waste, materials resulting from the processing of ASR waste, wastewaters and/or process waters, sludge, and/or any other wastes, directly onto the ground, including onto asphalt, concrete, or other surfaces.”**

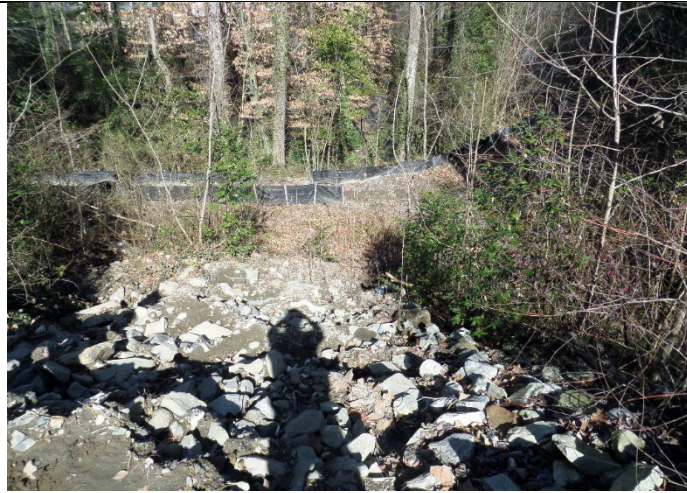
Outfall #2 Area - Keebler West. The inspectors observed apparent ASR material released to rip rap. Rip rap continues downhill to earthen access path and unnamed tributary. Photograph 27 taken at 1:24 p.m.

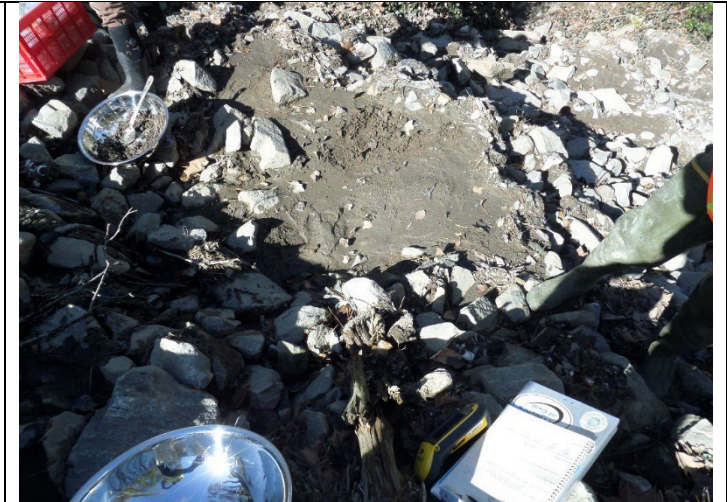
Outfall #2 Area - Keebler West. The inspectors observed apparent ASR material from release accumulated on rip rap. Rip rap continues downhill to earthen access path and unnamed tributary. Photograph 28 taken at 1:27 p.m..

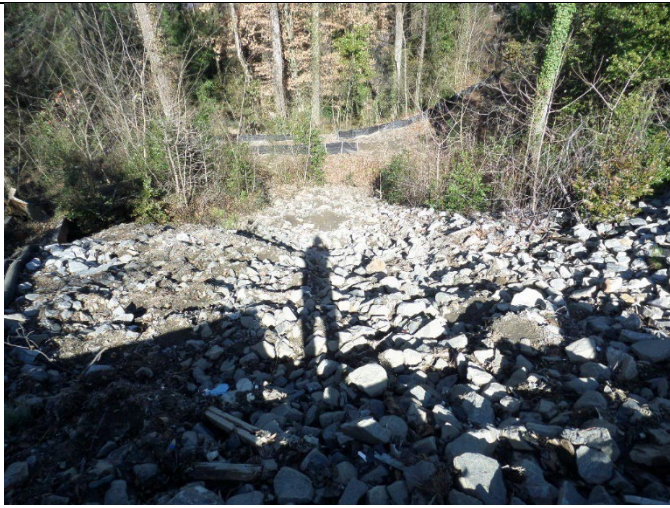
Outfall #2 Area - Keebler West. The inspectors observed apparent ASR material released to rip rap. Rip rap continues downhill to earthen access path and unnamed tributary. Photograph 29 taken at 1:29 p.m.

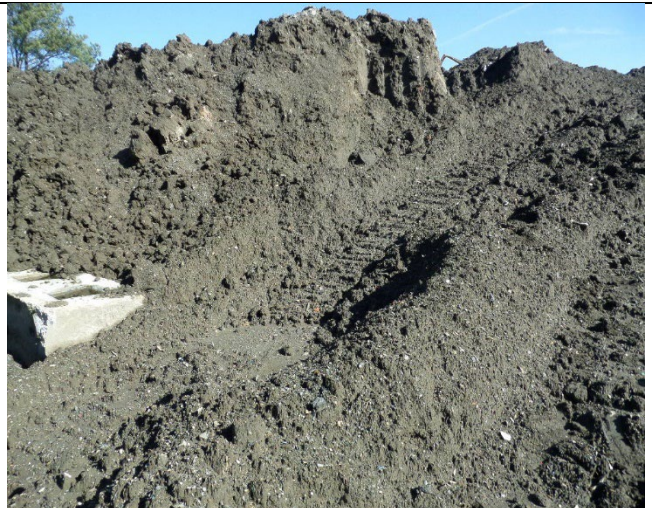
The inspectors observed areas of the Keebler West ASR Storage Area were cleared of ASR material. The inspectors observed the exposed asphalt from the original parking lot appeared worn, cracked and in disrepair (Photograph 31). The inspectors observed ASR material continued to be accumulated in the Keebler West ASR Storage Area and on the ground in piles in the Keebler North Area (Photographs 30 and 32).

Keebler West Pile Area. The inspectors observed ASR material accumulating on ground in piles. Photograph 30 taken at 1:34 p.m.

**Pursuant to Paragraph 82 of the RCRA 7003 Order, Respondents must “immediately cease all activities (including operations, business practices, and material management, including commingling, mixing, and receipt and transfer of ASR waste) that may result in the release of solid and/or hazardous waste into the environment, including, but not limited to, ceasing the placement of ASR waste, intermediates from the processing of ASR waste, materials resulting from the processing of ASR waste, wastewaters and/or process waters, sludge, and/or any other wastes, directly onto the ground, including onto asphalt, concrete, or other surfaces.”**

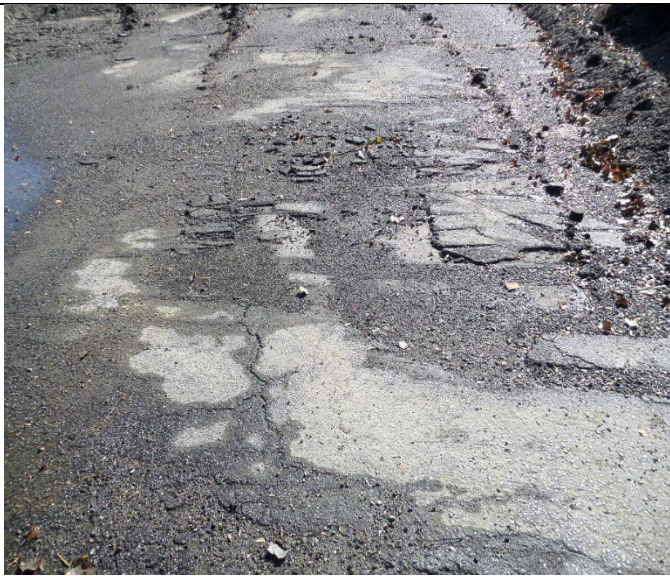
Keebler West Pile Area. The inspectors observed ASR material removed from the Keebler West storage area. The inspectors observed the original asphalt lot appeared worn, cracked and in disrepair. Photograph 31 taken at 1:38 p.m.

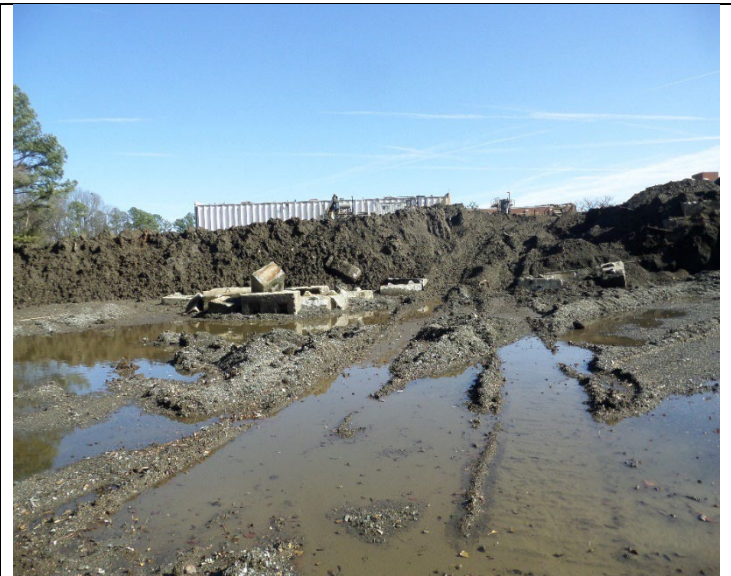
Keebler West Pile Area. The inspectors observed ASR material accumulating on the ground in piles. Photograph 32 taken at 1:47 p.m.

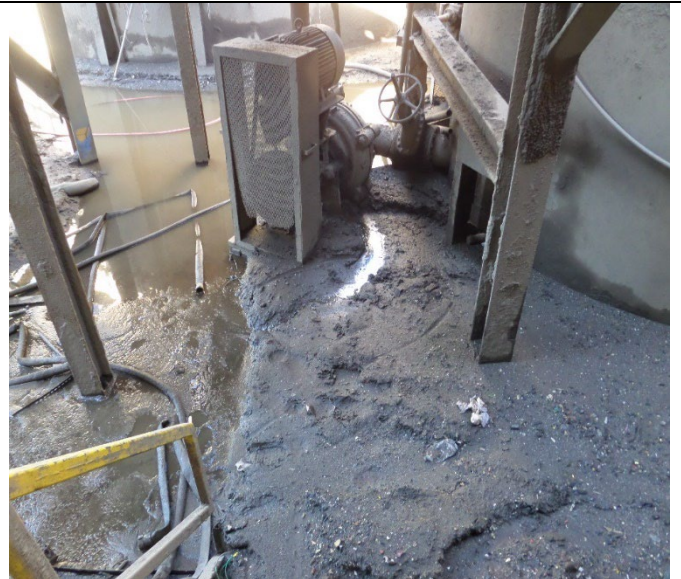
TAV manages process water, wastewater and ASR sludge on the floor in the wastewater treatment area (WWT). It is comingled on the ground where it is exposed to stormwater. The comingled waste migrates downgradient to the Jig Pad Area. The inspectors observed several inches of wastewater and ASR solids and sludge mixed throughout this area (Photographs 34, 35 and 36).

Wastewater Treatment/Area. The inspectors observed solids/sludge containing ASR material accumulating in this area. Photograph 34 taken at 2:02 p.m.

**Pursuant to Paragraph 82 of the RCRA 7003 Order, Respondents must “immediately cease all activities (including operations, business practices, and material management, including commingling, mixing, and receipt and transfer of ASR waste) that may result in the release of solid and/or hazardous waste into the environment, including, but not limited to, ceasing the placement of ASR waste, intermediates from the processing of ASR waste, materials resulting from the processing of ASR waste, wastewaters and/or process waters, sludge, and/or any other wastes, directly onto the ground, including onto asphalt, concrete, or other surfaces.”**

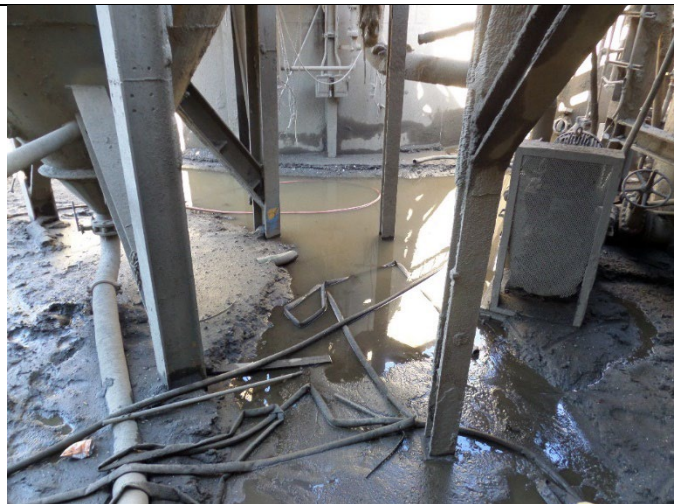
Wastewater Treatment Area. The inspectors observed solids/sludge containing ASR material accumulating in this area. Photograph 35 taken at 2:04 p.m.

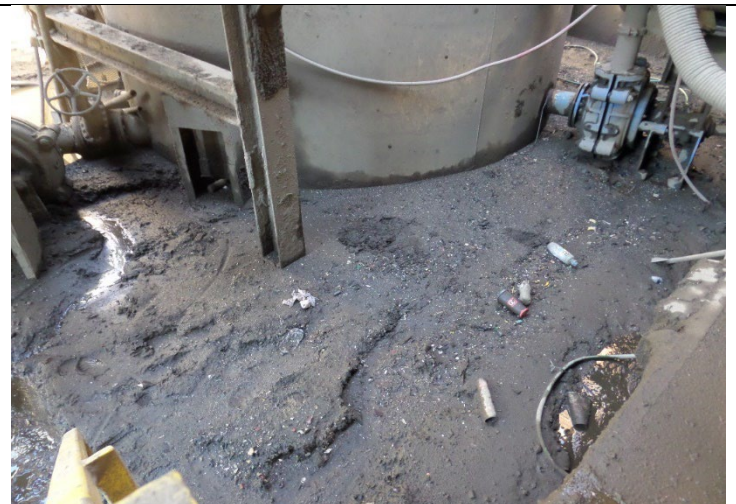
Wastewater Treatment Area. The inspectors observed solids/sludge containing ASR material accumulating in this area. Photograph 36 taken at 2:06 p.m.

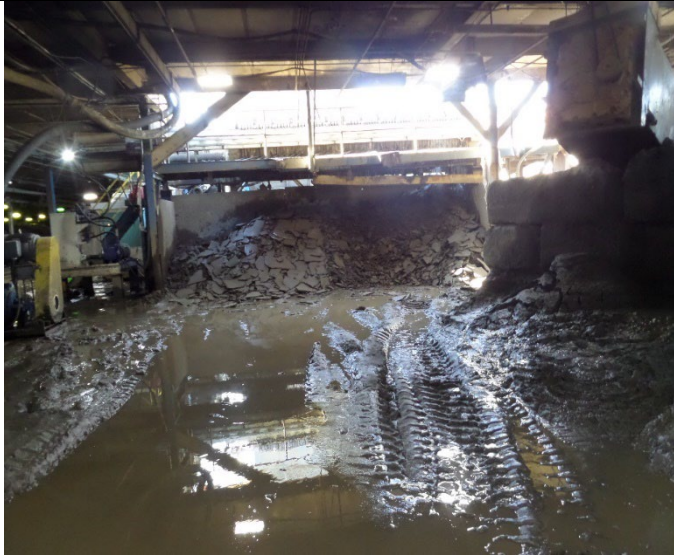
The inspectors observed filter cake generated from the filter press. The filter cake was accumulating on the floor under the filter press comingled with wastewater and sludge. The inspectors also observed the area next to the filter press contained wastewater and sludge accumulating on the concrete floor (Photographs 37, 38 and 40).

Keebler Plant Building Filter Press Area. The inspectors observed filter cake generated from the filter press accumulating with wastewater and solids on the concrete floor. Photograph 37 taken at 2:07 p.m.

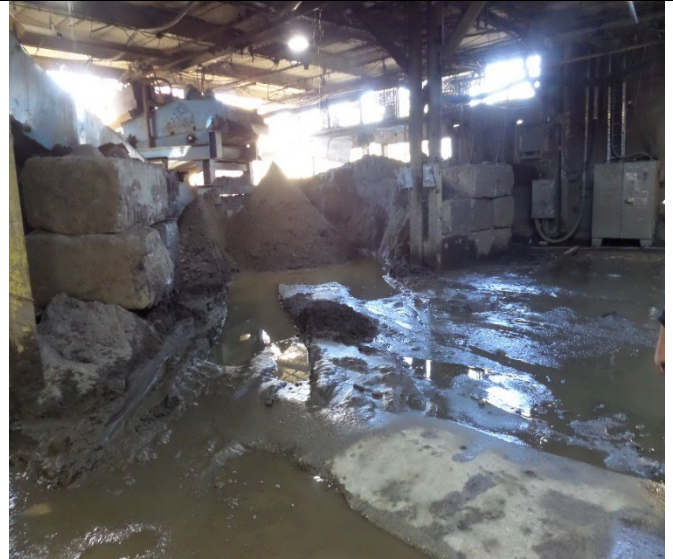
Keebler Plant Building Filter Press Area. The inspectors observed the area next to filter press contained wastewater and solids accumulating on the concrete floor. Photograph 38 taken at 2:07 p.m.

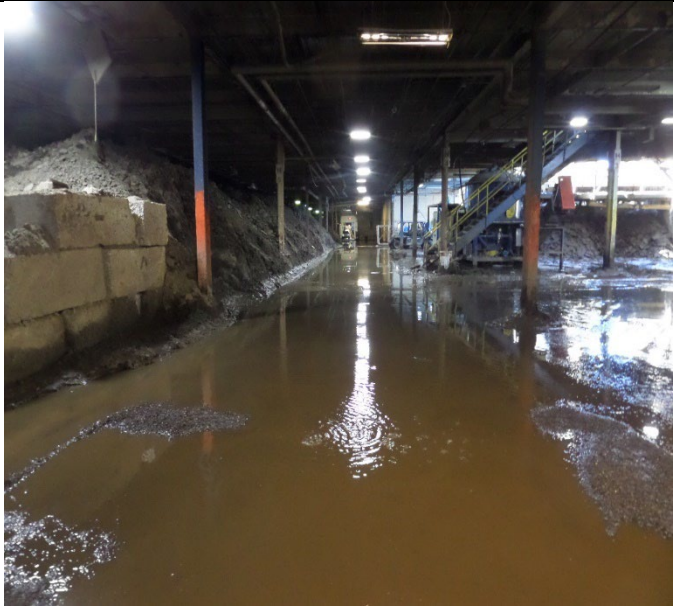
The inspectors observed several inches of wastewater and sludge accumulating on the concrete floor in the alley way next to the filter cake storage area (Photograph 39).

Keebler Plant Building Filter Cake Pile/Alley Way. The inspectors observed wastewater and solids accumulating on the concrete floor in the alley way next to filter cake storage area. Approximated several inches of water throughout the area. Photograph 39 taken at 2:08 p.m.

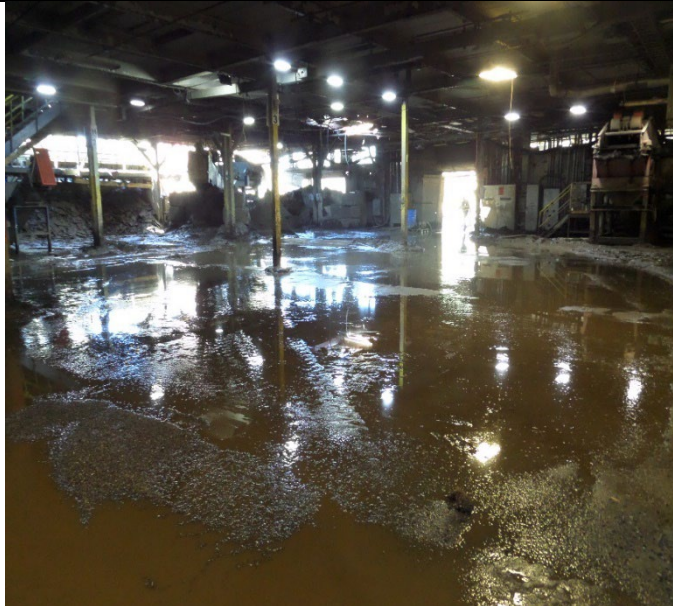
Keebler Plant Building Filter Press Area. The inspectors observed filter cake generated from the filter press accumulating with wastewater and solids on the concrete floor. Photograph 40 taken at 2:08 p.m.

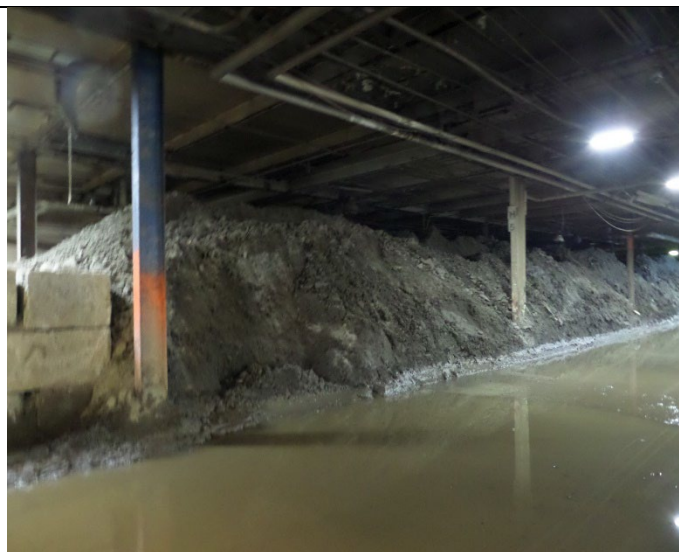
Keebler Plant Building Filter Cake Pile. The inspectors observed wastewater and solids accumulating on the concrete floor next to the Pile. Photograph 41 taken at 2:29 p.m.

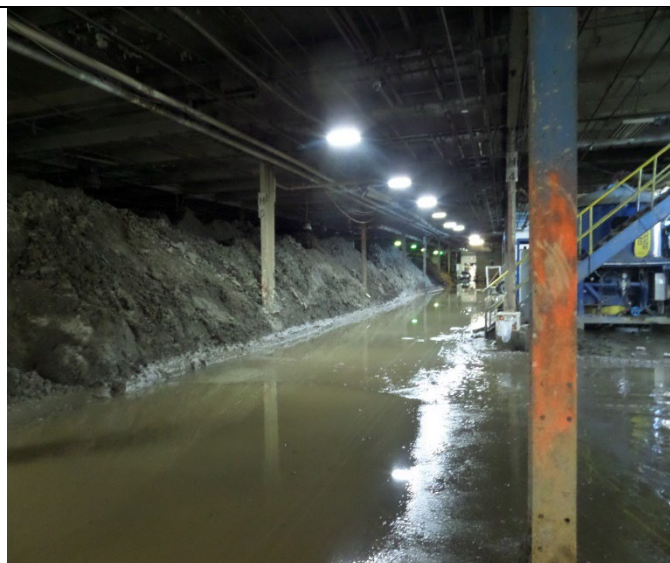
Keebler Plant Building Filter Cake Pile. The inspectors observed wastewater and solids accumulating on the concrete floor next to the Pile. Photograph 42 taken at 2:29 p.m.

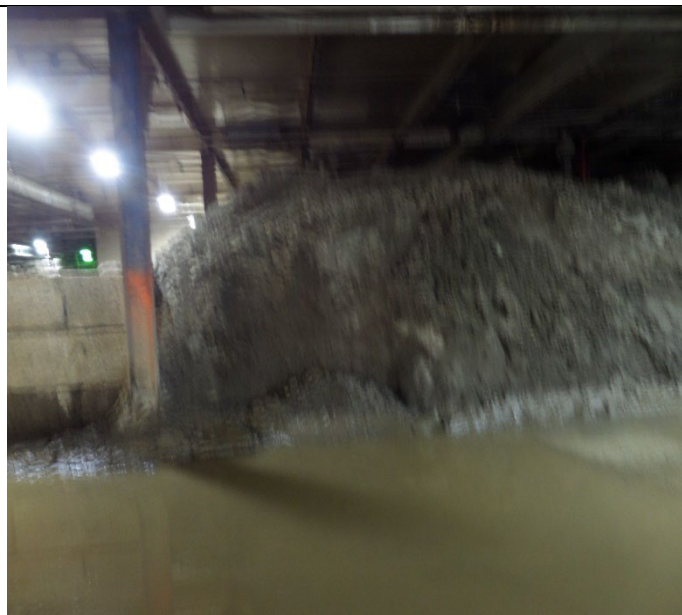
Keebler Plant Building Filter Cake Pile. The inspectors observed wastewater and solids accumulating on the concrete floor next to the Pile. Photograph 43 taken at 2:30 p.m.

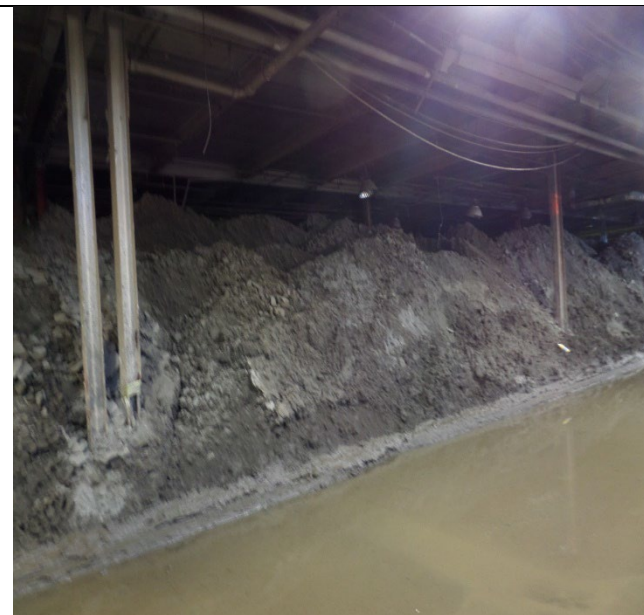
Keebler Plant Building Filter Cake Pile. The inspectors observed wastewater and solids accumulating on the concrete floor next to the Pile. Photograph 44 taken at 2:30 p.m.

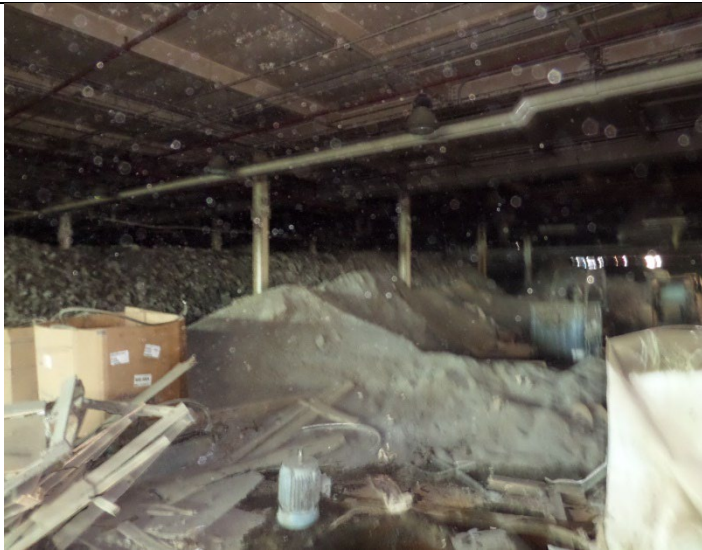
Keebler Plant Building Filter Cake - Backside Pile. The inspectors observed filter cake in this area. Photograph 45 taken at 2:35 p.m.

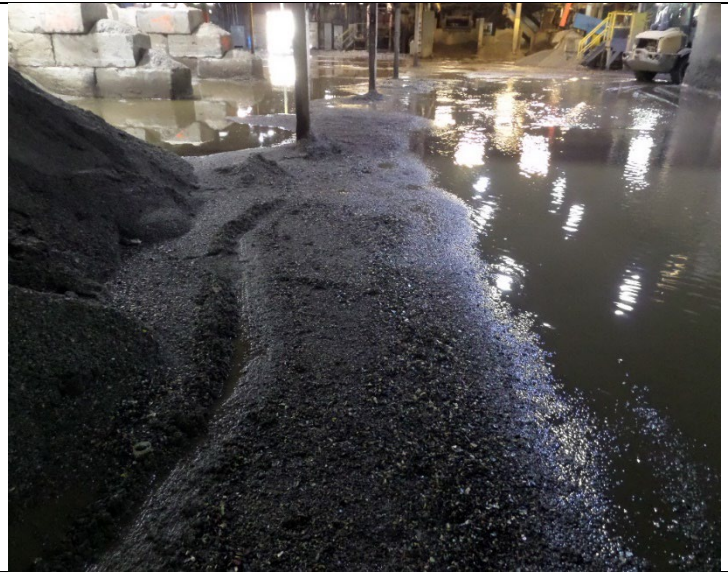
Keebler Plant Building Filter Cake Pile. The inspectors observed wastewater and solids accumulating on the concrete floor next to the Pile. Photograph 46 taken at 2:38 p.m.

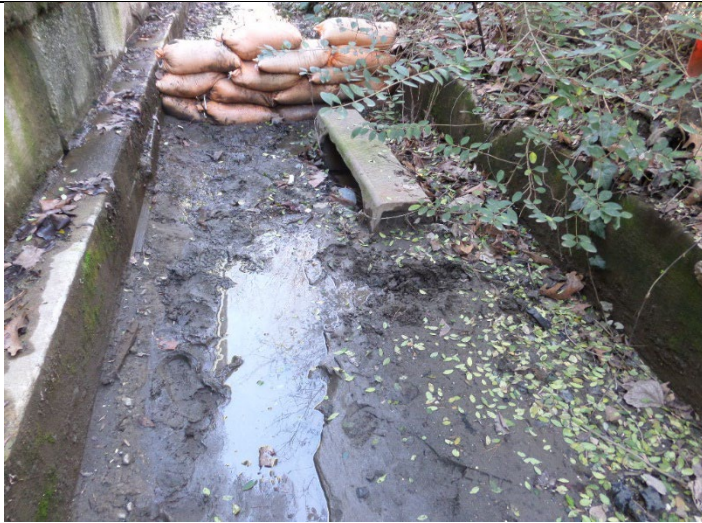
The inspectors observed ASR material accumulating on top of the Bunker block wall, in the concrete conveyance and on the ground mixed with soil next to the concrete conveyance. The inspectors observed water next to a drain that is released to the wooded area through the outfall pipe (Photographs 47 through 51).

Keebler North Concrete Conveyance for Outfall #3. The inspectors observed a drain that discharges to the outfall pipe in the wooded area in Photograph 16. Photograph 47 taken at 2:59 p.m.

**including commingling, mixing, and receipt and transfer of ASR waste) that may result in the release of solid and/or hazardous waste into the environment, including, but not limited to, ceasing the placement of ASR waste, intermediates from the processing of ASR waste, materials resulting from the processing of ASR waste, wastewaters and/or process waters, sludge, and/or any other wastes, directly onto the ground, including onto asphalt, concrete, or other surfaces.”**
