## **RCRA Inspection Report**

TAV Holdings, Inc.  
3311 Empire Boulevard  
Atlanta, Fulton County, Georgia 30354

January 19, 2023

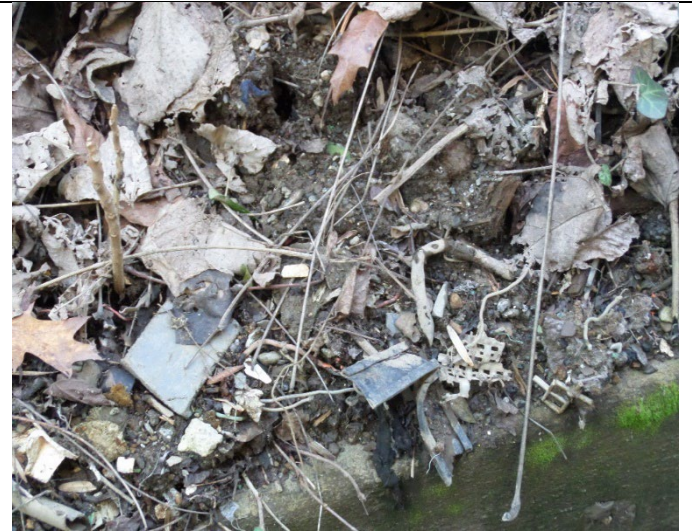
The inspectors observed ASR material accumulating on top of the Bunker block wall, in the concrete conveyance and on the ground mixed with soil next to the concrete conveyance. The inspectors observed water next to a drain that is released to the wooded area through the outfall pipe (Photographs 47 through 51).

Keebler North Concrete Conveyance for Outfall #3. The inspectors observed ASR material accumulating on soil surfaces. Photograph 48 taken at 3:00 p.m.

**including commingling, mixing, and receipt and transfer of ASR waste) that may result in the release of solid and/or hazardous waste into the environment, including, but not limited to, ceasing the placement of ASR waste, intermediates from the processing of ASR waste, materials resulting from the processing of ASR waste, wastewaters and/or process waters, sludge, and/or any other wastes, directly onto the ground, including onto asphalt, concrete, or other surfaces.”**

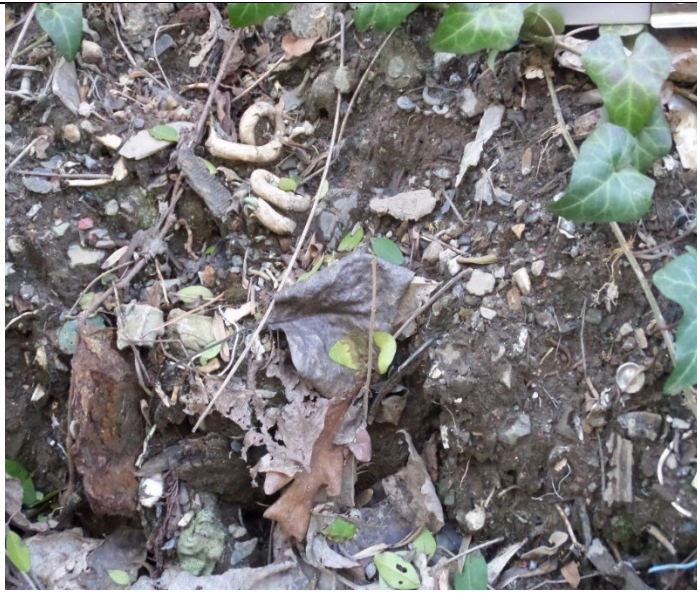
Keebler North Concrete Conveyance for Outfall #3. The inspectors observed ASR material accumulating on soil surfaces. Photograph 49 taken at 3:00 p.m.

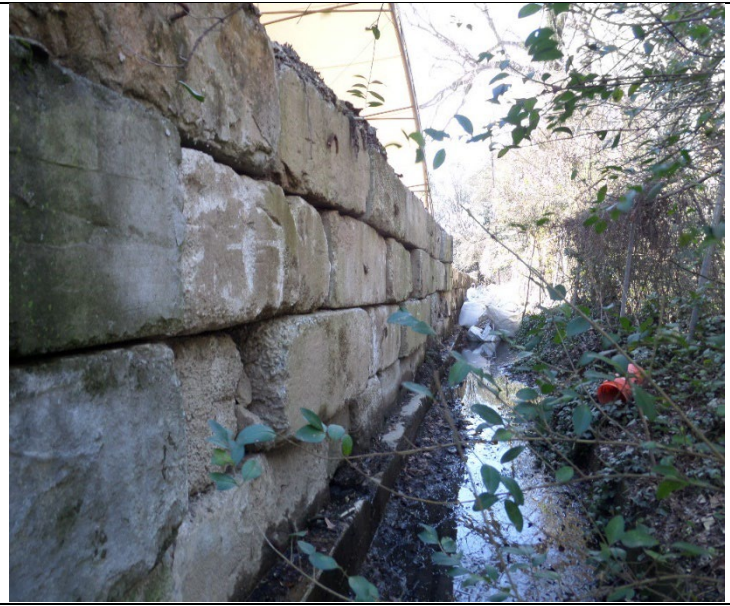
Keebler North Concrete Conveyance for Outfall #3. The inspectors observed ASR material accumulating on top of the Bunker block wall. Photograph 50 taken at 3:06 p.m.

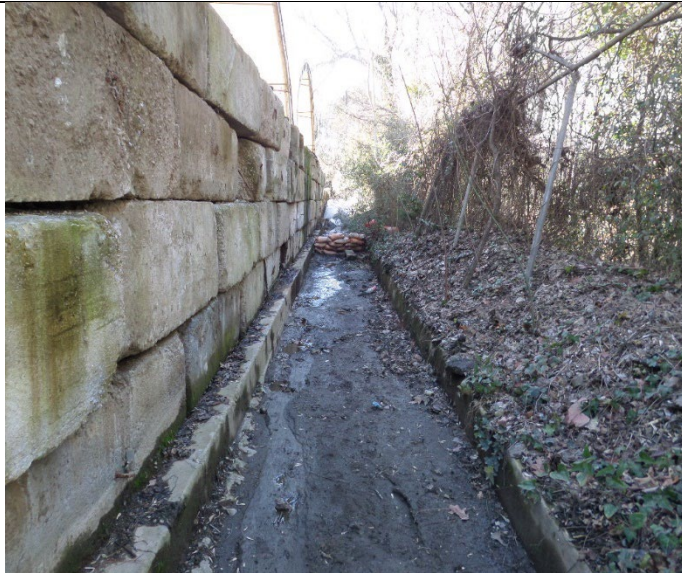
Keebler North Concrete Conveyance for Outfall #3. The inspectors observed ASR material and solids accumulating in the concrete conveyance and on soil surfaces. Photograph 51 taken at 3:07 p.m.

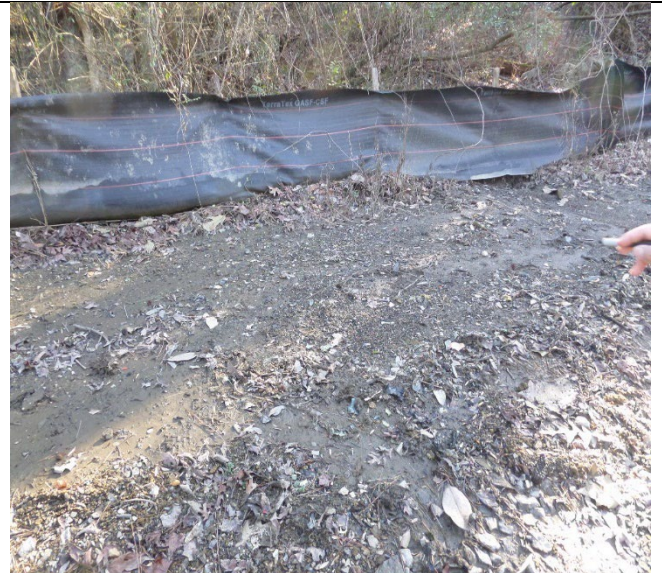
The inspectors observed a washout containing ASR material released from the hill Outfall pipe (Outfall Number 3) to ground surfaces at approximately 10 to 15 feet from the Outfall (Photographs 16, 18, 19, 20 and 54). The inspectors followed the path of the washout and observed ASR material on the ground at a distance from the Outfall of approximately 30-45 feet (Photograph 17). The inspectors continued to follow the path of the washout and observed ASR material on the ground at a distance from the Outfall of approximately 90-105 feet (Photographs 21 and 22). The inspectors reached the edge of the woods next to the silt fence and observed the ASR material reached the earthen access path at a distance from the Outfall of approximately 150-180 feet (Photographs 15, 24, 52 and 53).

Access Path Next to Wooded Area Behind Keebler North Bunker Area. The inspectors observed a washout containing ASR material flowing from Outfall #3 pipe to the earthen access path. Distance from Outfall #3 pipe approximately 150-180 feet. Photograph 52 taken at 3:12 p.m.

**Pursuant to Paragraph 82 of the RCRA 7003 Order, Respondents must “immediately cease all activities (including operations, business practices, and material management, including commingling, mixing, and receipt and transfer of ASR waste) that may result in the release of solid and/or hazardous waste into the environment, including, but not**

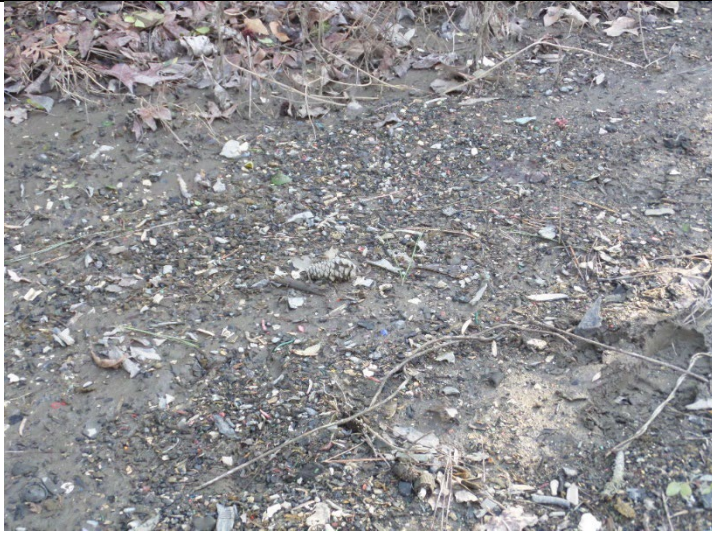
Access Path Next to Wooded Area Behind Keebler North Bunker Area. The inspectors observed a washout containing ASR material flowing from Outfall #3 pipe to the earthen access path. Distance from Outfall #3 pipe approximately 150-180 feet. Photograph 53 taken at 3:13 p.m.

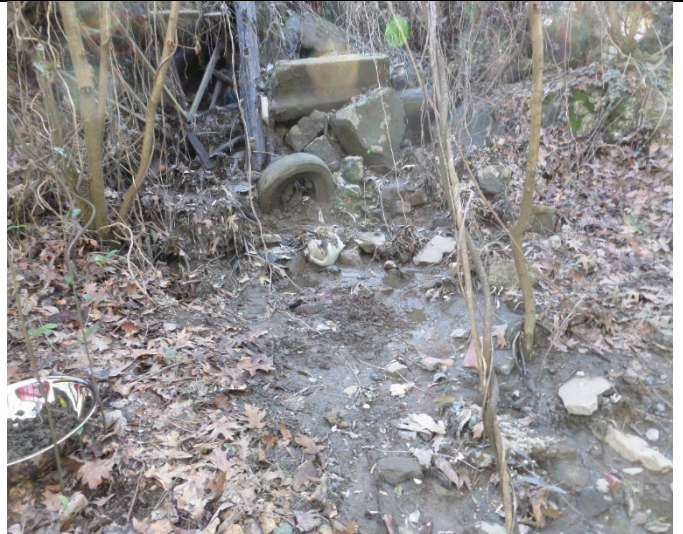
Wooded Area Behind Keebler North Bunker Area (see photograph 16). The inspectors observed a washout containing ASR material flowing from the outfall #3 pipe to ground surfaces. The inspectors took a split sample in this area. Photograph 54 taken at 3:21 p.m.

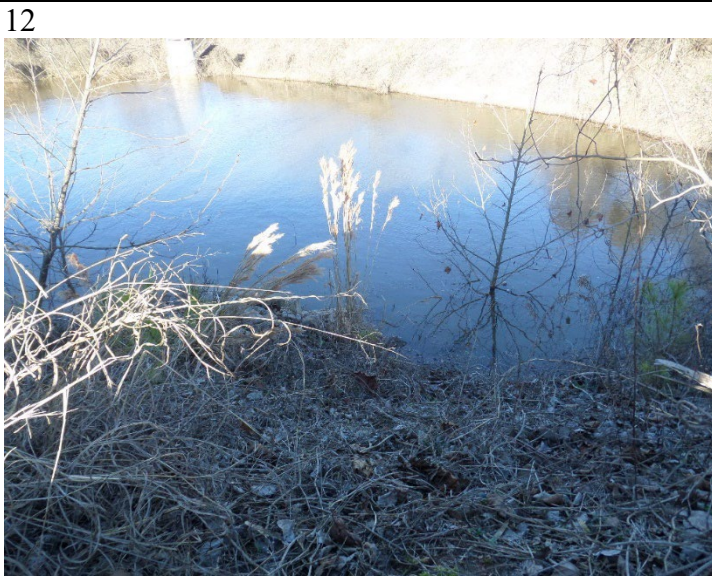
The sample is referred to as TAV12. The sample is described as storm water, muddy with some floating vegetative matter. The sample was analyzed for total metals and PCBs. The total antimony concentration was found at 15 ug/L and lead at 30 ug/L. Table 9 below summarizes each analyte for TAV12 which is above the RSLs for the MCLs for antimony and lead.

The inspectors observed the surface water in the pond appeared muddy with some floating vegetative matter (Photograph 55).

3320 Empire Boulevard Stormwater Pond. A water sample was collected from the pond. Photograph 55 taken at 4:28 p.m.

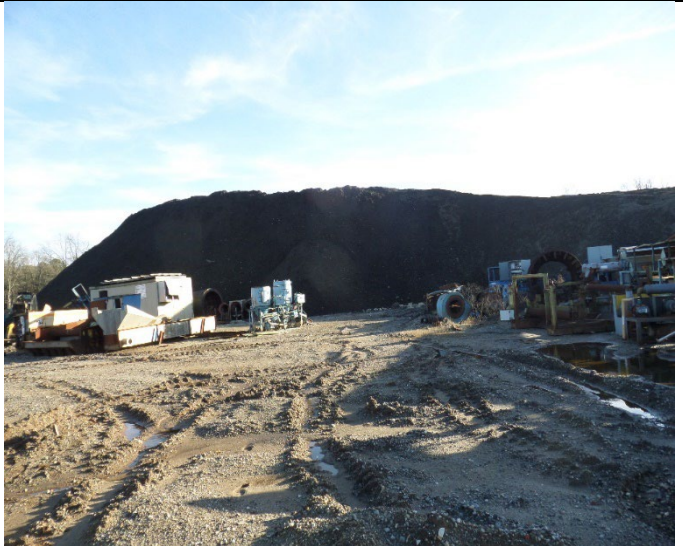
3320 Empire Boulevard ASR Pile. The inspectors observed a large ASR pile. Photograph 56 taken at 4:30 p.m.

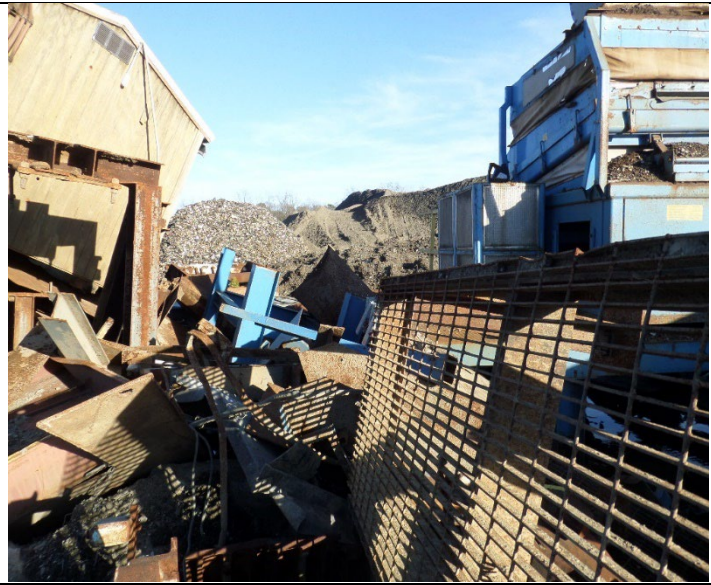
3320 Empire Boulevard ASR Pile. The inspectors observed a white colored pile next to ASR Pile. Photograph 57 taken at 4:33 p.m.
