**Region 6 Compliance Assurance and Enforcement Division  
INSPECTION REPORT**

| Inspection Date(s): | 05/21/2018 | | |
| Company Name: | Tyson Poultry, Inc. | | |
| Facility Name: | Tyson Poultry, Inc. – Nashville Complex | | |

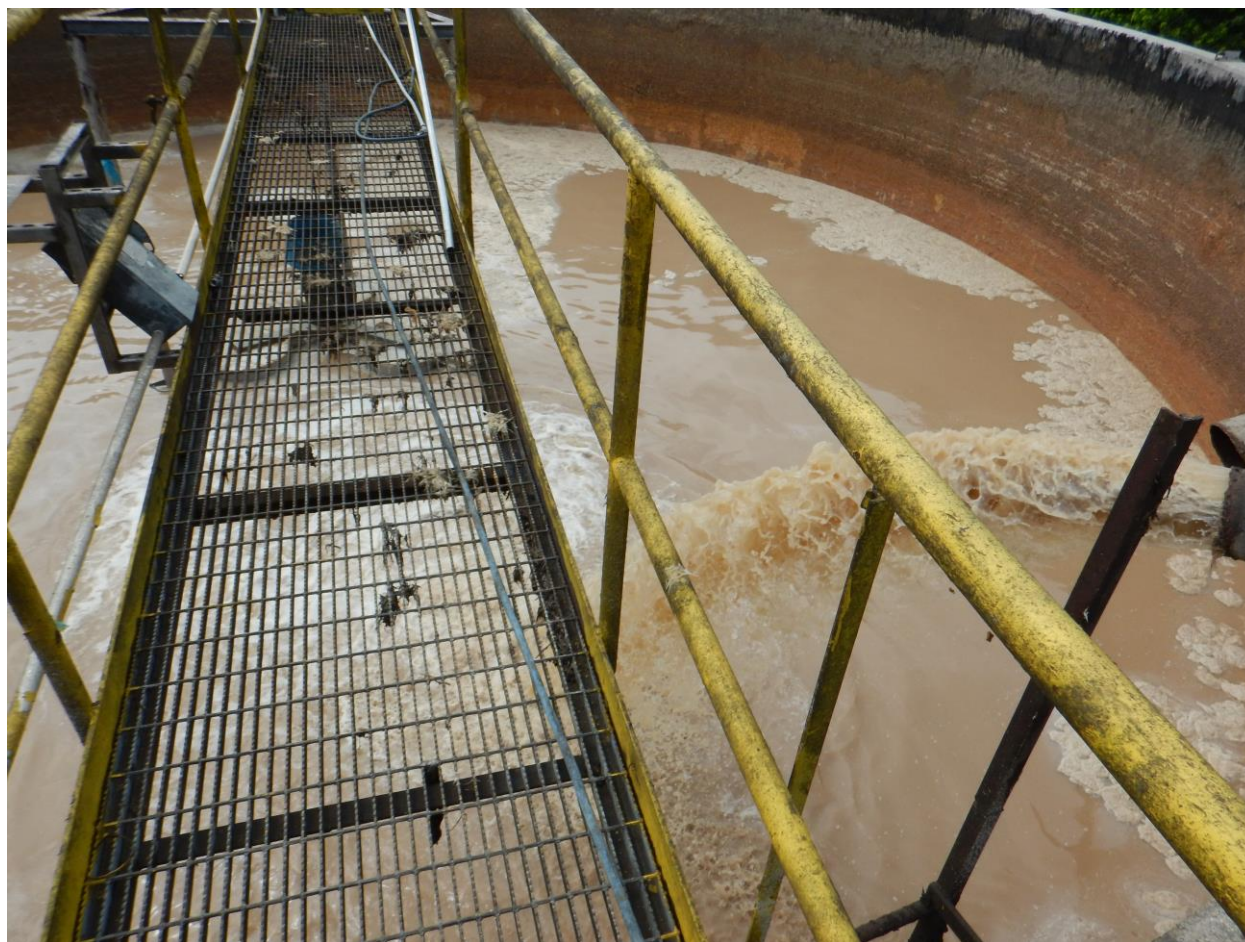
Photo No. 1

in that it was operable but empty. DAF 2 did not trigger into operation until the effluent level reached 14 feet in the 325,000-gallon EQ tank (Aerated Equalization). The EQ tank was manually turned on by the operator so that the inspector could observe (Appendix 1, Photo 1). At the time of the inspection, the effluent appeared to be at 11 feet. The 1.5-million-gallon Aeration Basin (Appendix 1, Photo 2) contained three surface aerators and two venturi aerators and appeared to be in good working order. One of the Aeration Basin's pumps did not appear to be actively leaking but some traces of sludge were observed around the concrete pad (Appendix 1, Photo 3). Despite the visible signs of sludge, the runoff would most likely still end up in the Aeration Basin and not create an improper offsite discharge. From the Aeration Basin, wastewater was carried to the 3.3-million gallon Oxidation Ditch where the mixed liquor had a nice tan color. A reading was taken and recorded as 5500 ppm for mixed liquor suspended solids (MLSS) and 3.5 ppm DO (Appendix 1, Photo 4). The effluent was treated with aluminum chloride which was used to bind copper, zinc, sulfates, and other settling agents. Effluent was then sent to the 1-million-gallon Clarifier which was located within the Oxidation Ditch racetrack (Appendix 1, Photo 4). The operator took a sludge judge reading at the time of the inspection. The operator indicated that a sludge judge reading was taken twice a day. The inspectors observed six inches of sludge and approximately four inches of cloudy old sludge which indicated that the Clarifier did not need to be dredged. At the disinfection area, UV lights were used. Some white flakes were observed at the disinfection area (Appendix 1, Photo 5). One bank of bulbs was out of order at the time of the inspection. The flow meter was an ISCO 1310 UltraSonic that had been calibrated on October 20<sup>th</sup>, 2017. The aerobic digester was located at the center of the Oxidation ditch and Clarifier racetrack and appeared to be in good working order.

Description: Influent from screening is received into the Aerated Equalization (EQ) basin. Debris was observed on the walking platform.

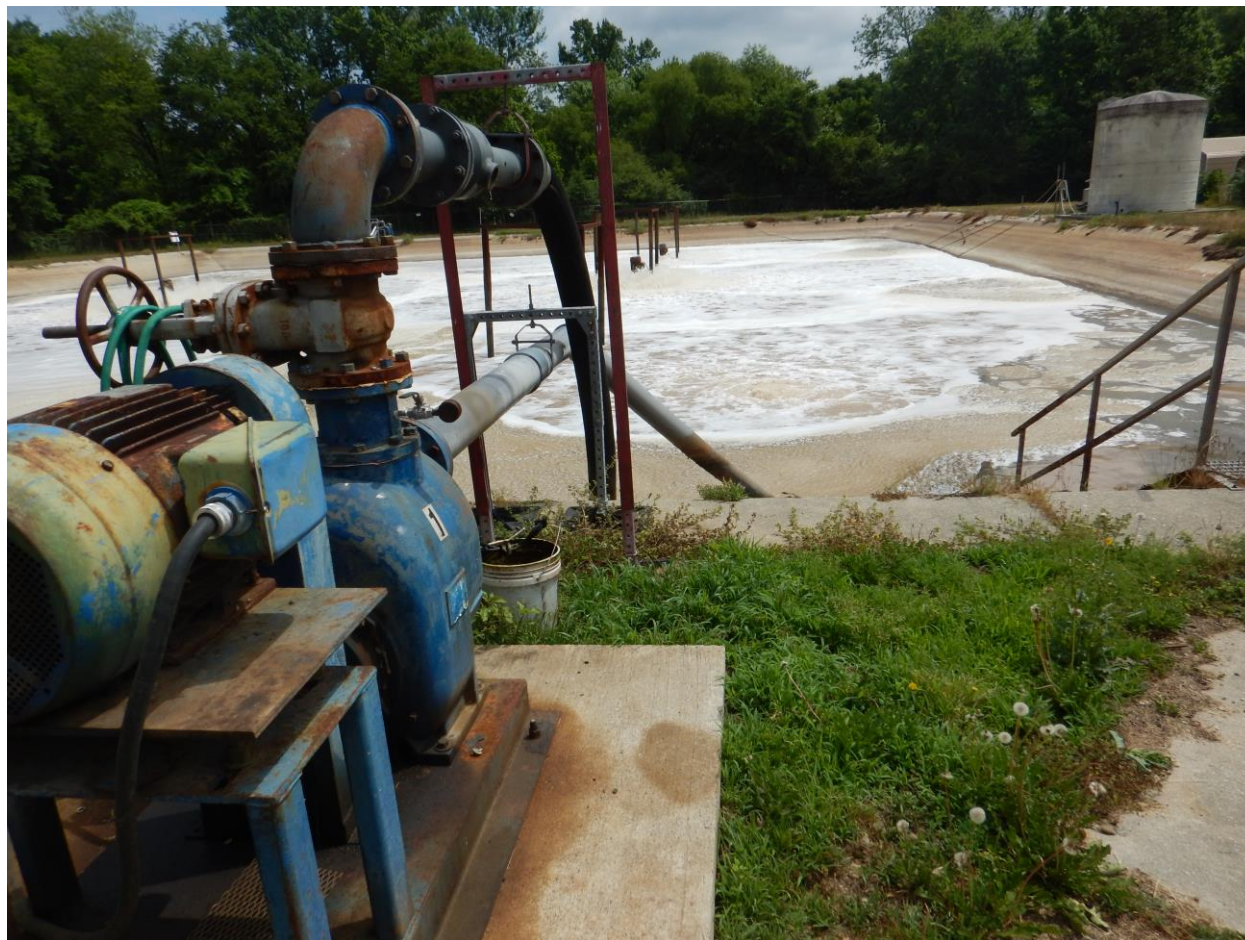
Photo No. 2

Description: The aeration basin appeared to be in good working order. Pumps and piping appeared to be clear of major leaks.

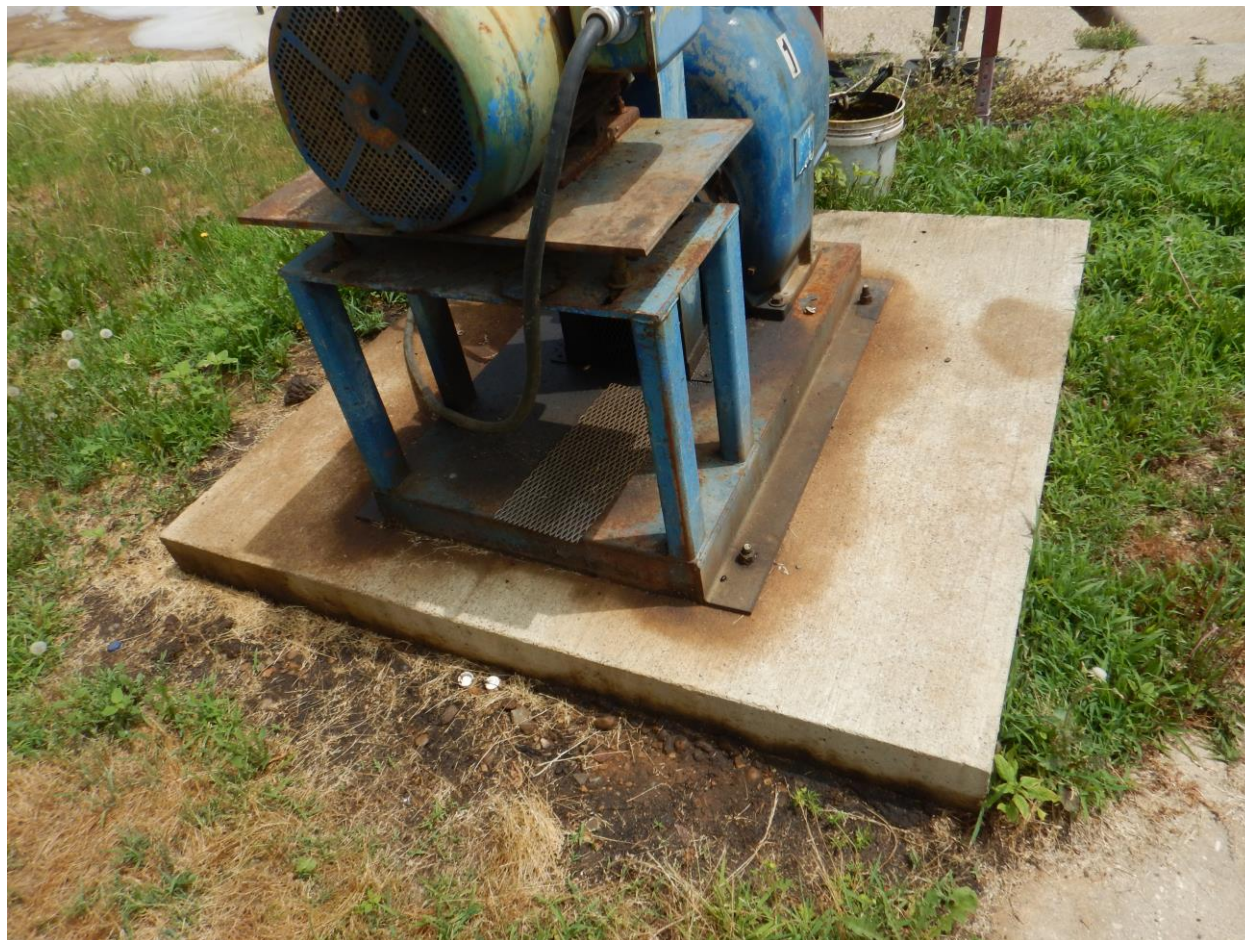
Photo No. 3

Description: One of the pumps for the aeration basin did not appear to be actively leaking but traces of sludge were observed around its concrete pad which would indicate that some leaking had occurred before and had not been cleaned up. Despite the visible signs of sludge exposed to storm water, it would appear that the runoff would still head towards the aeration basin.

- 1) An Aeration Basin pump seemed to have spilled some sludge either due to a leak or just a changing of hoses. The sludge should be removed and disposed of properly (Appendix 1, Photo 3).

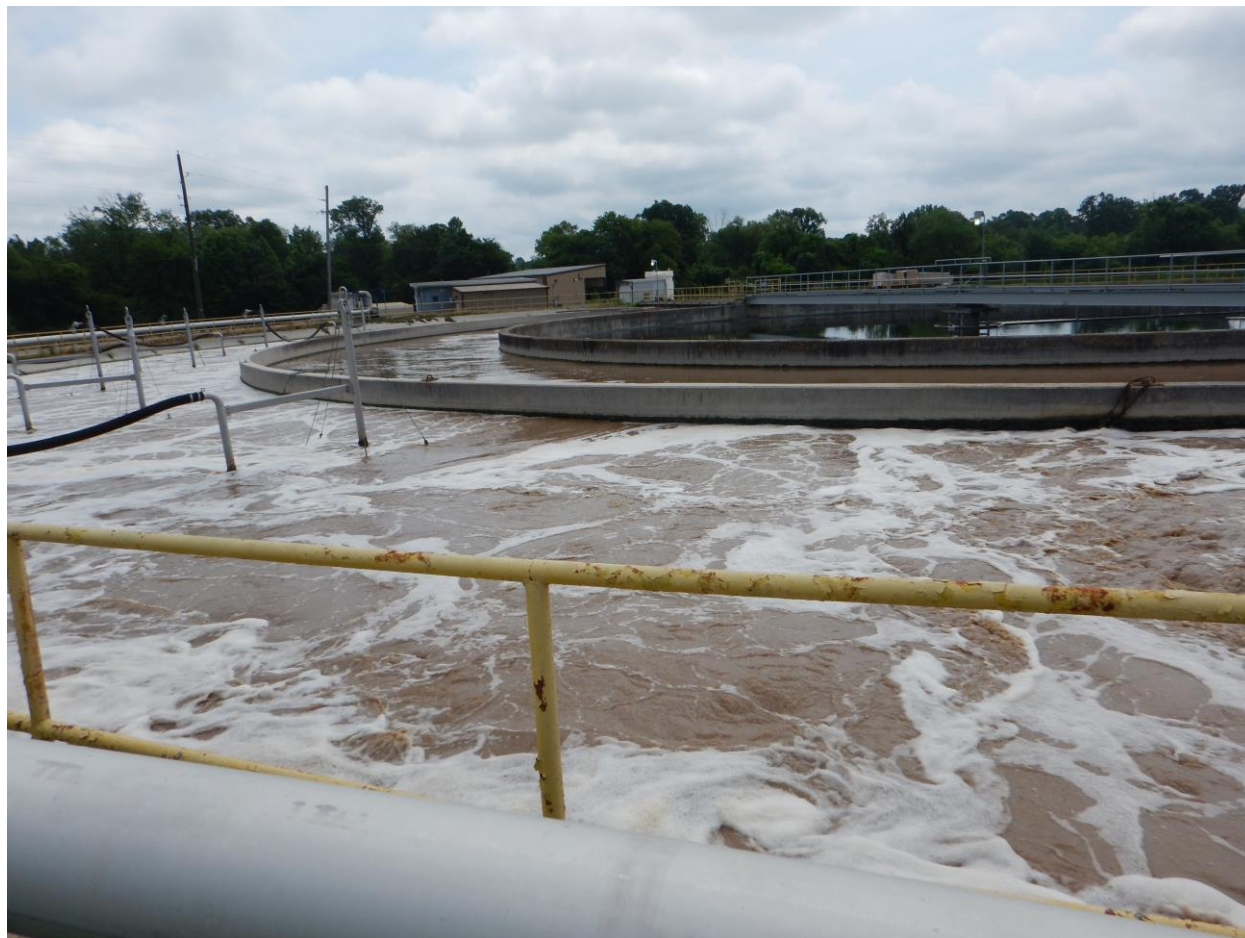
Photo No. 4

Description: The photo was taken of the oxidation ditch which appeared to be a good, healthy, tan color.

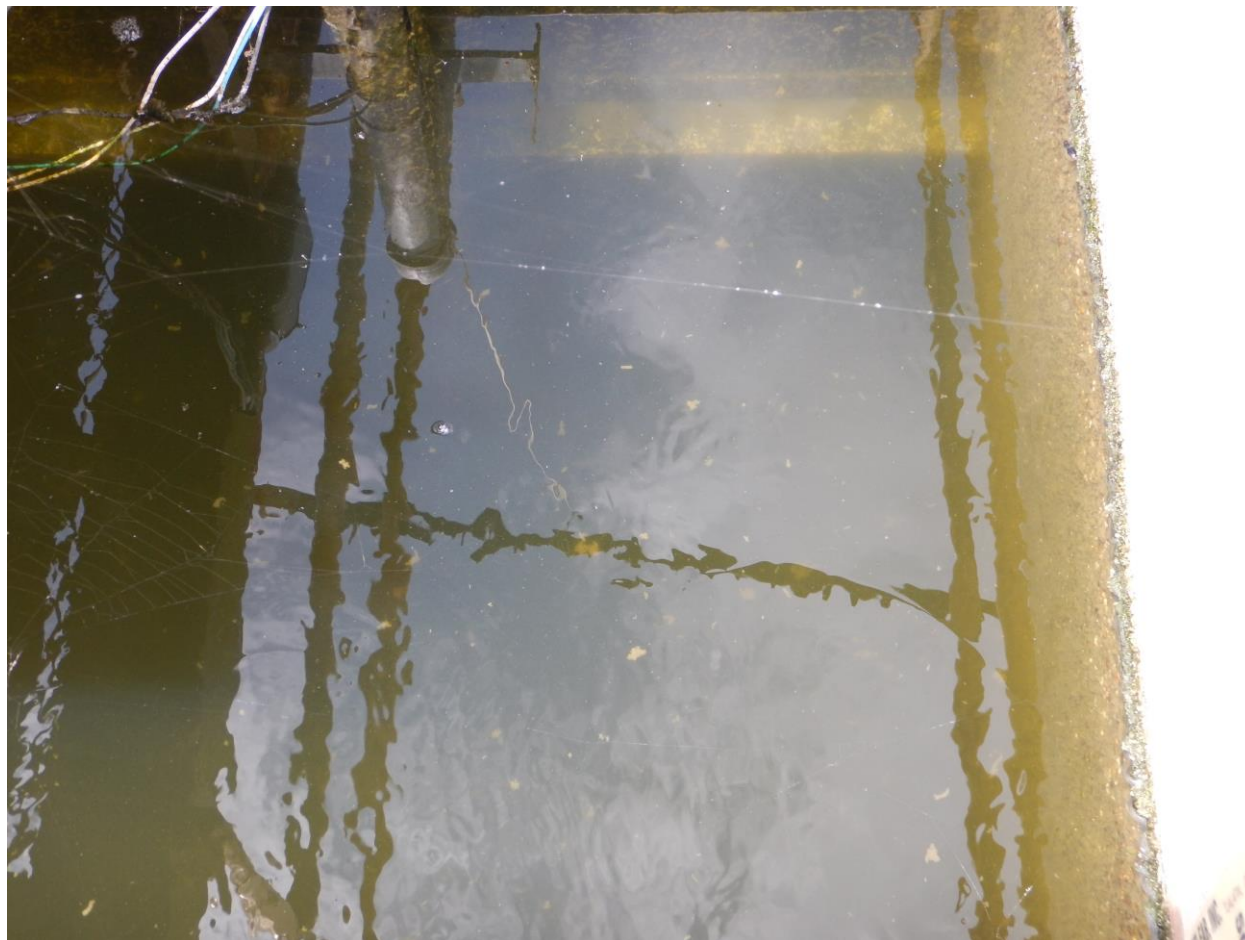
Photo No. 5

Description: The photo was taken of the disinfection area where some white flakes were visible.

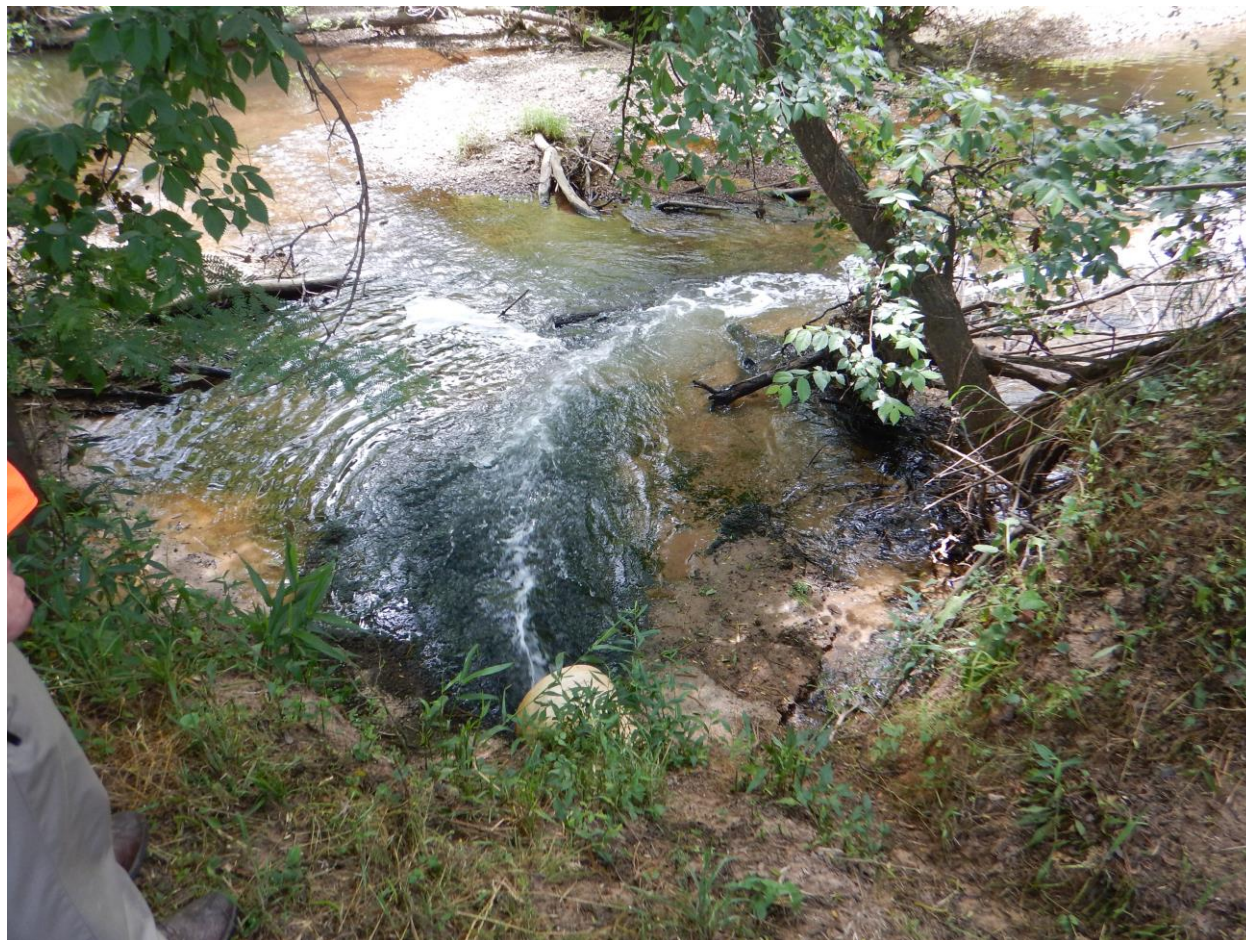
Photo No. 6

The plant's 24-hour composite sampler was located following the final treatment unit (UV disinfection). At the discharge point, some algae was observed at the base of the white pipe which was an indicator of ammonia that may have accumulated over time (Appendix 1, Photo 6). A minimal amount of foam was observed.

Description: The photo was taken of the final outfall point. Some green algae can be seen at the base of the white pipe. This was an indicator of ammonia that may have accumulated over time. A minimal amount of foam was observed. The receiving stream appeared clear and free of turbidity.
