**Region 6 Compliance Assurance and Enforcement Division  
INSPECTION REPORT**

| Inspection Date(s): | 07/18/2017 | | |
| Company Name: | Farrell Cooper Mining Company | | |
| Facility Name: | Liberty Mine #7 | | |

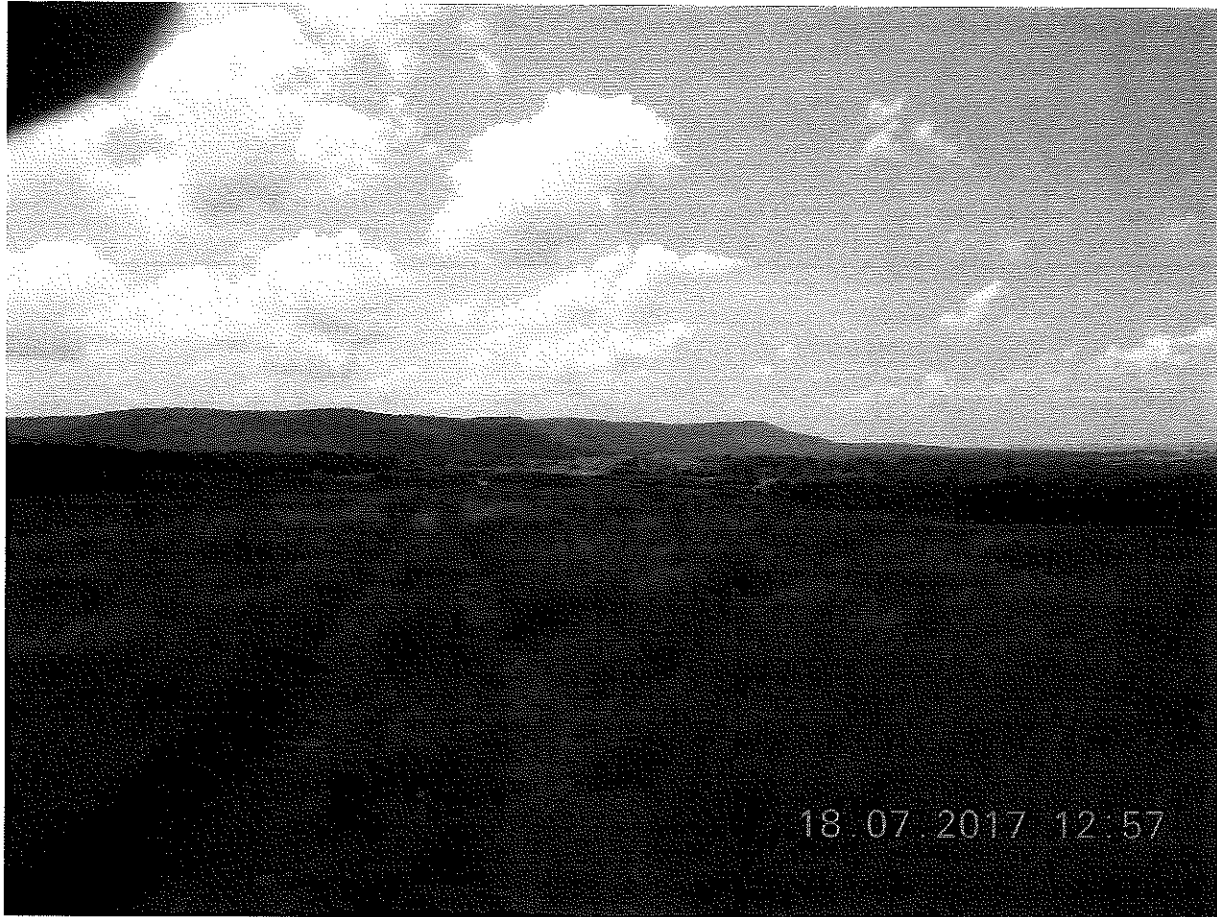
Photo File Name: DSCN0018.JPG

Description: Liberty mine area that has undergone site reclamation after removal of coal
