**Region 6 - Enforcement & Compliance Assurance Division**  
**INSPECTION REPORT**

| Regulatory Program(s) | NPDES Stormwater/CWA 402 | |
| Facility Name: | Morgan Farms Phase 1 & 2 | |
| Identification/Permit Number: | TXR1566SV | |

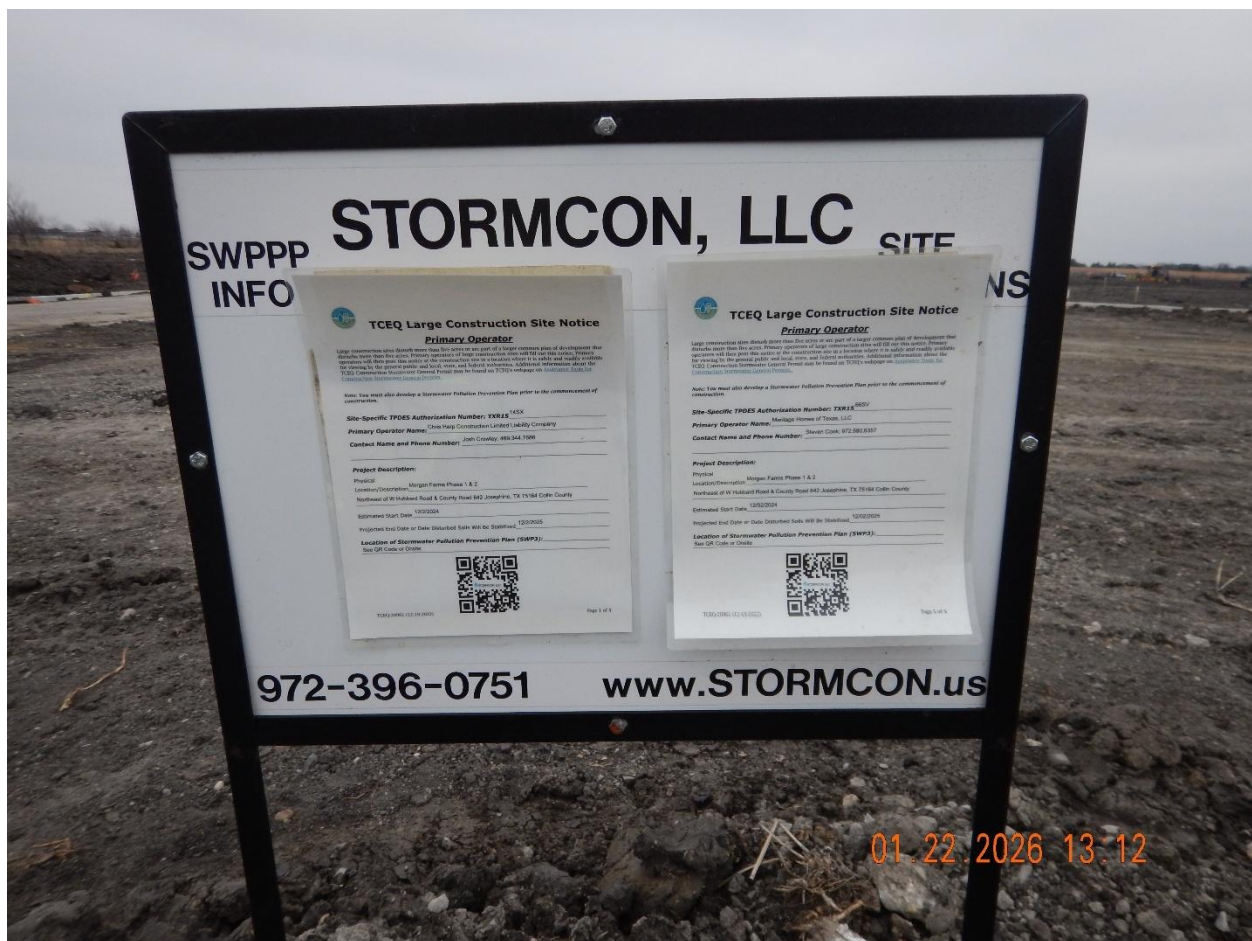
Photo no. 1

- The CSN listed both Meritage Homes (TCEQ Permit Number TXR1566SV) and Chris Harp Construction (TCEQ Permit Number TXR1514SX) as operators of the site (**Appendix 1, Photo 1**). The site SWPPP indicates that Meritage Homes is responsible for the installation and maintenance of BMPs.

Description: The Construction Site Notice (CSN) posted near the northern entrance off of Co Rd 642. Meritage Homes (TXR1566SV) and Chris Harp Construction (TXR1514SX) are both listed as primary operators.

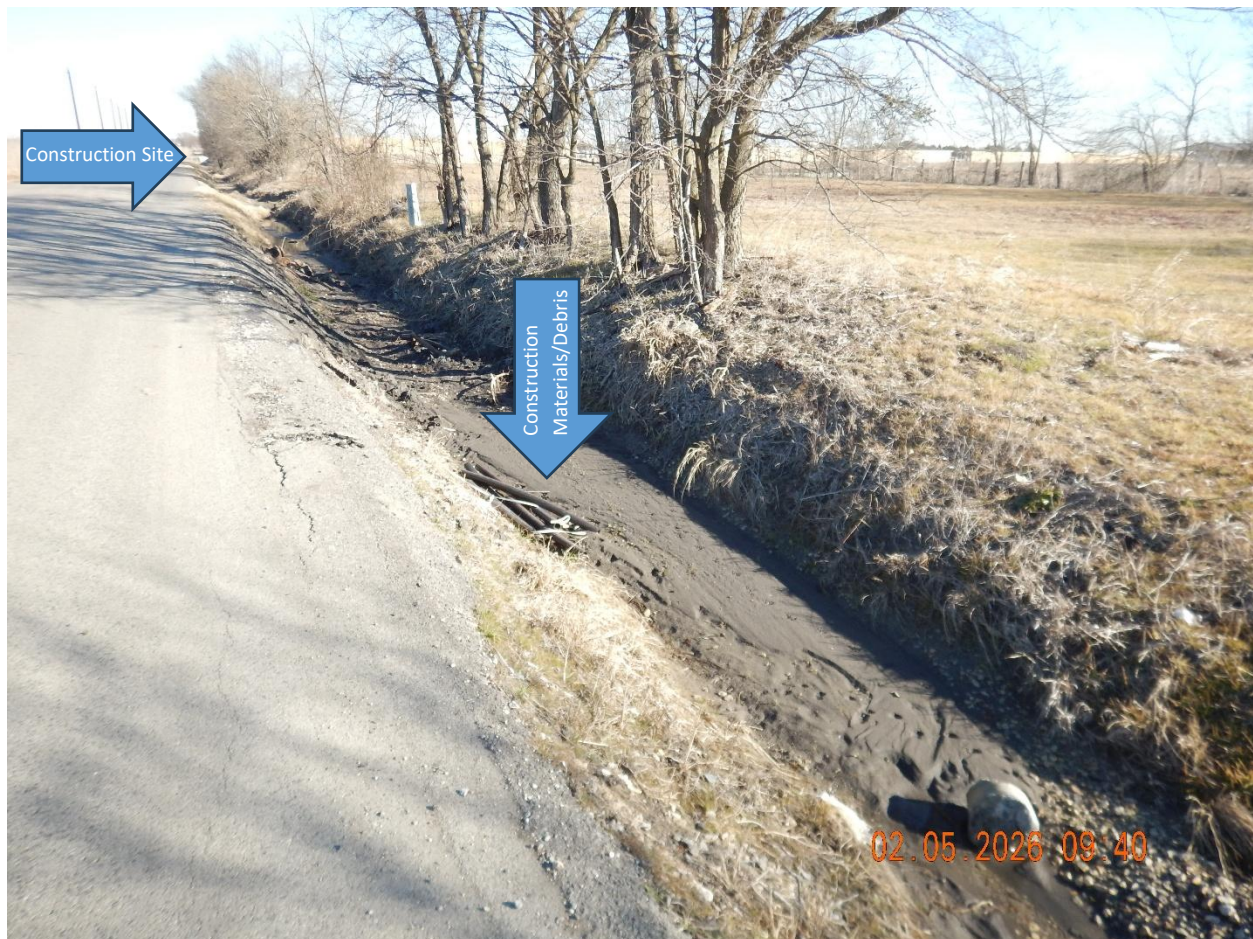
Photo no. 2

1. Sediment and construction materials/debris were observed in the ditch along Co Rd 642 (**Appendix 1, Photo 2**).
2. The rock check dams along Co Rd 642 were covered with soil on January 22, 2026 (**Appendix 1, Photo 3**). On February 5, 2026, the accumulated sediment was no longer present.

Description: Sediment and construction materials/debris (black pipe) in the ditch along Co Rd 642.

- Sediment from the site is present in the ditch along Co Rd 642. Effective BMPs must be installed to prevent future sediment discharges.
  - *Once the area dries out we will excavate the sediment and place riprap down per the erosion control plan. This is scheduled for Monday 2/23. With all the rainfall that has occurred along with the relatively recent snow we have been unable to install riprap due to extreme moisture. Riprap is on site and ready to be installed ASAP. Checkdams have also been installed as a temporary measure.*

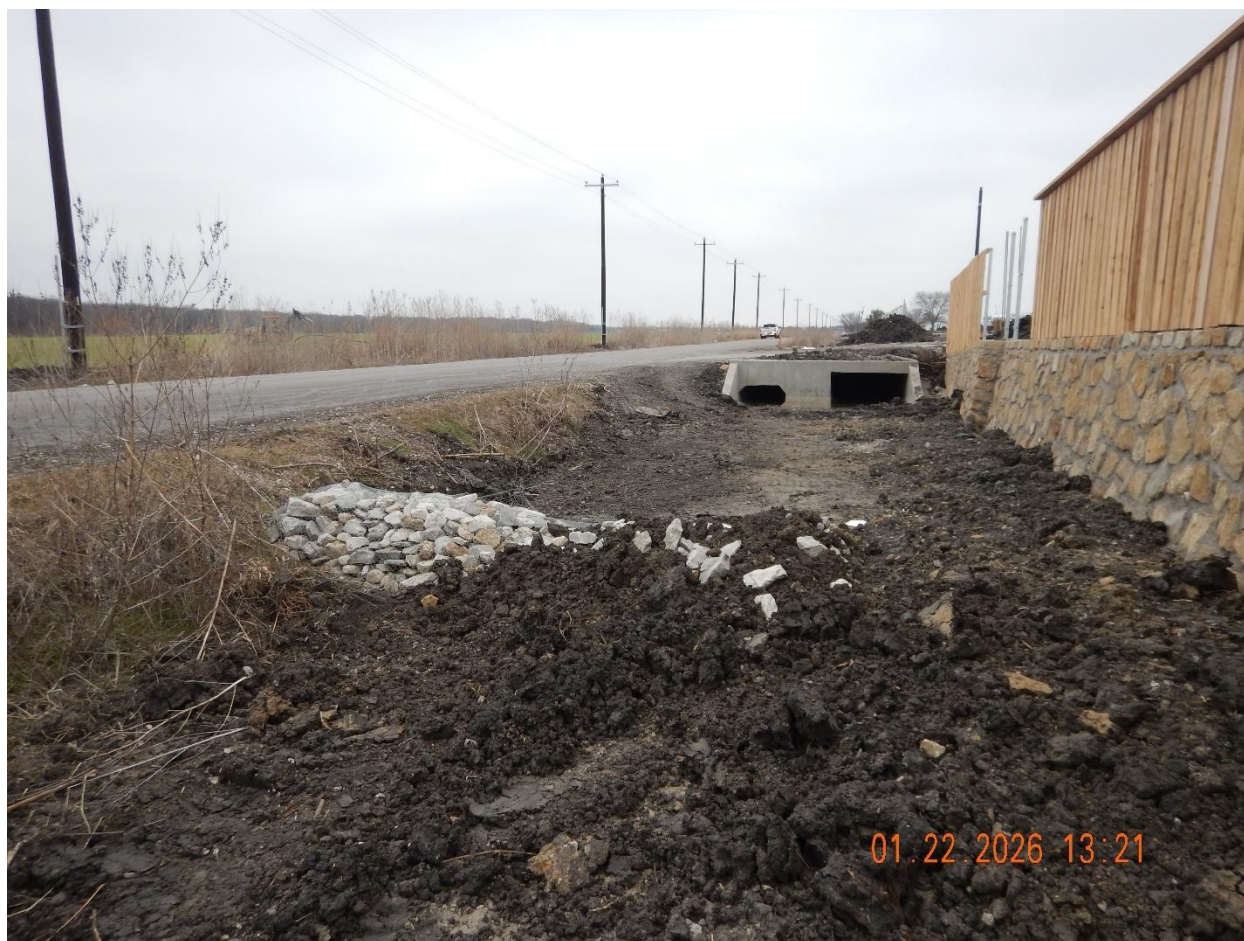
Photo no. 3

Description: A rock check dam along Co Rd 642 covered in sediment on January 22, 2026. The rock check dam was cleaned by the February 5, 2026, inspection. Also note the large stockpile with no BMPs near the construction entrance in the background.

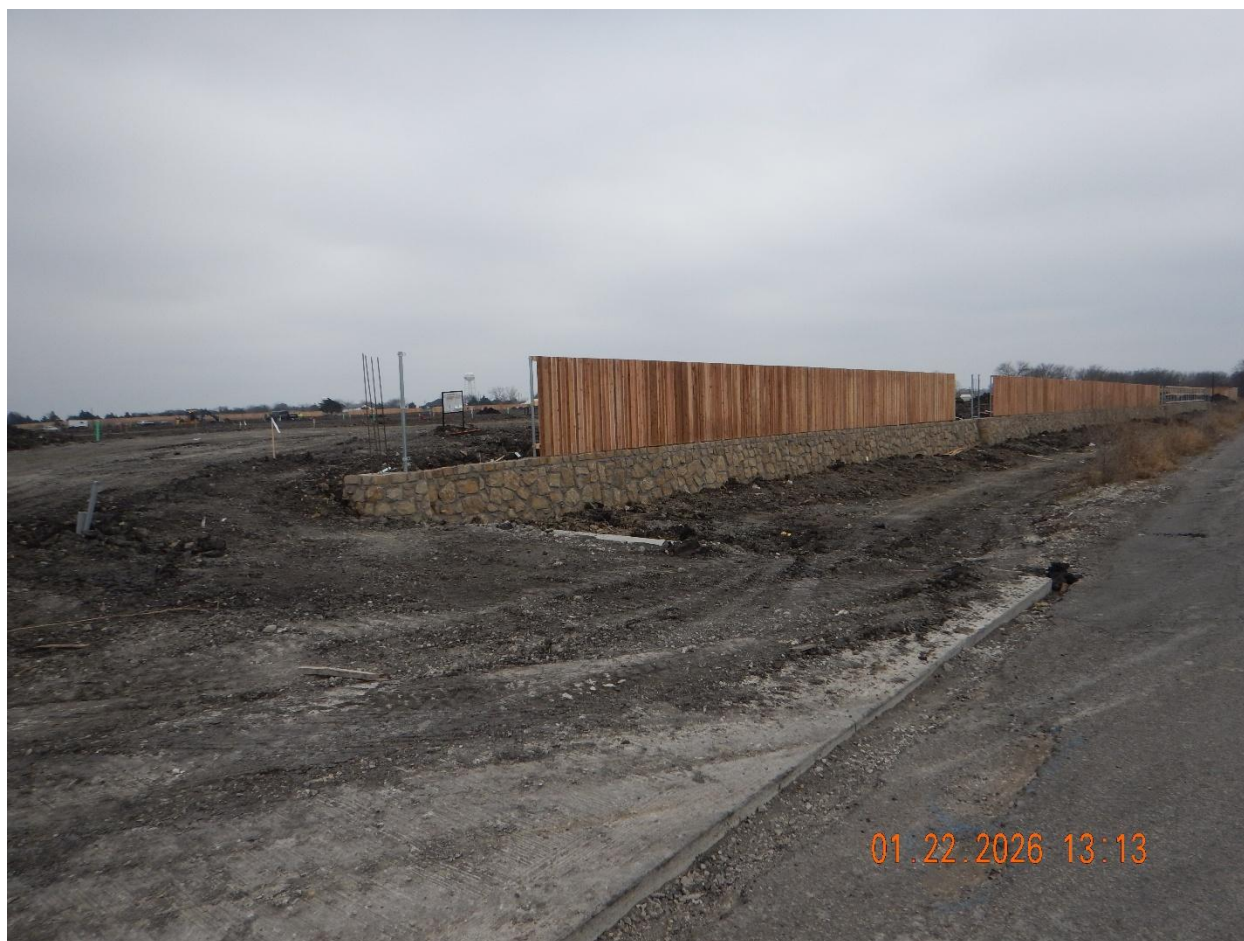
Photo no. 4

3. The lots throughout Phase 1 had no BMPs installed, resulting in a significant amount of exposed soil throughout the site (**Appendix 1, Photos 4-11**). Sediment was observed on the streets and off-site in the ditch (**Appendix 1, Photos 2, 4-5, 7, and 10-11**).

Description: Photo taken from the northern construction entrance off of Co Rd 642. The lots and western perimeter of the site have no BMPs installed, resulting in a significant amount of exposed sediment. Sediment was observed on the paved areas and in the ditch along Co Rd 642.

- There is a significant amount of exposed sediment throughout the site. Please minimize exposed sediment by installing effective BMPs at the perimeters of the site and on the interior lots where active construction is not occurring.
  - Back of curb curlex has been installed throughout the site, perimeter silt fence has been refreshed throughout. Streets have been scraped and storm drains cleaned.

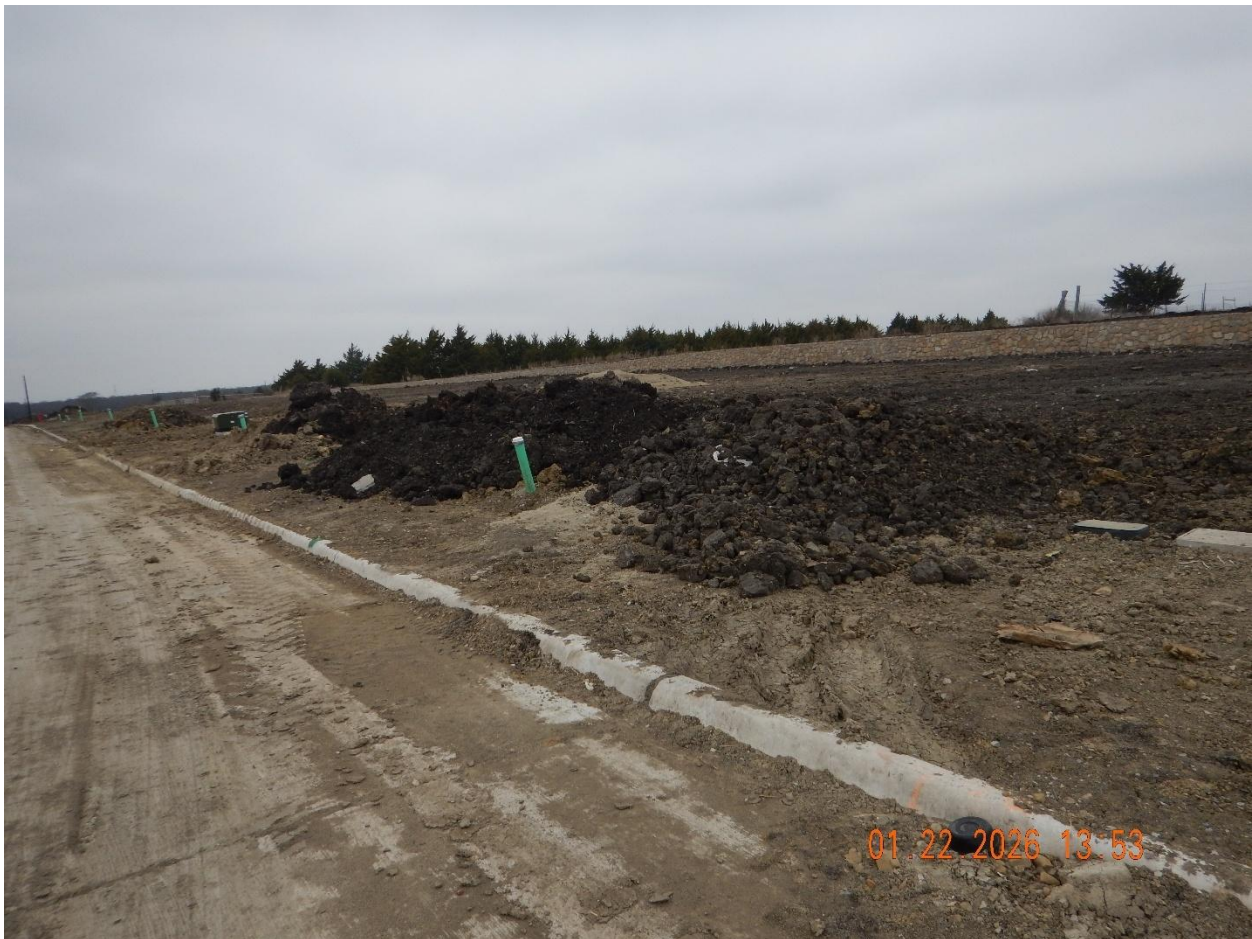
Photo no. 5

4. Large stockpiles were observed near the curbs throughout the site (**Appendix 1, Photos 3 and 5-6**). No BMPs were observed around or near the stockpiles to indicate that they are contained when not in use, at the end of each workday, or during rain events.

Description: Exposed sediment and stockpiles along the northern lots of Phase 1, resulting in sediment in the street.

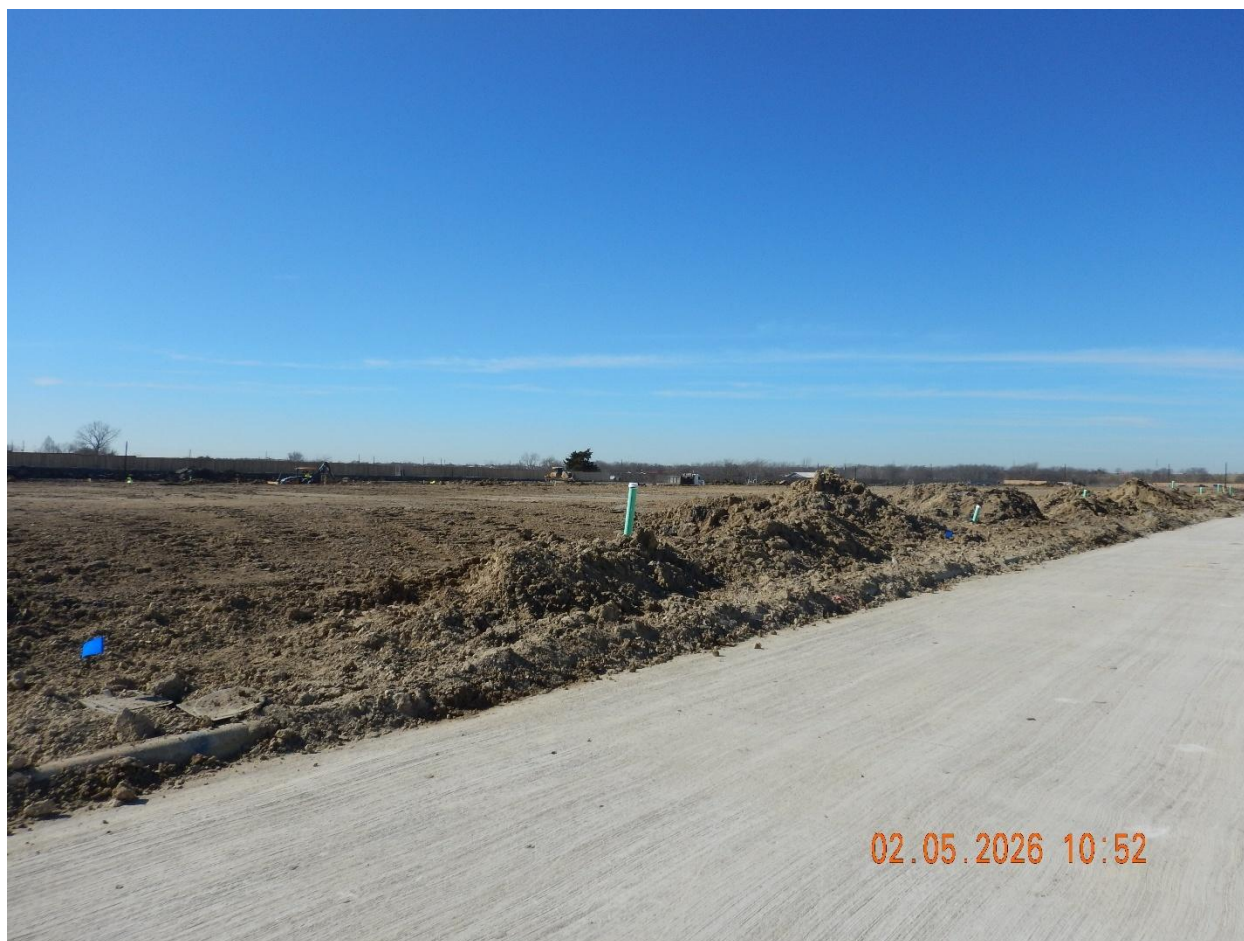
Photo no. 6

Description: Exposed sediment and stockpiles with no BMPs along the interior lots of Phase 1.

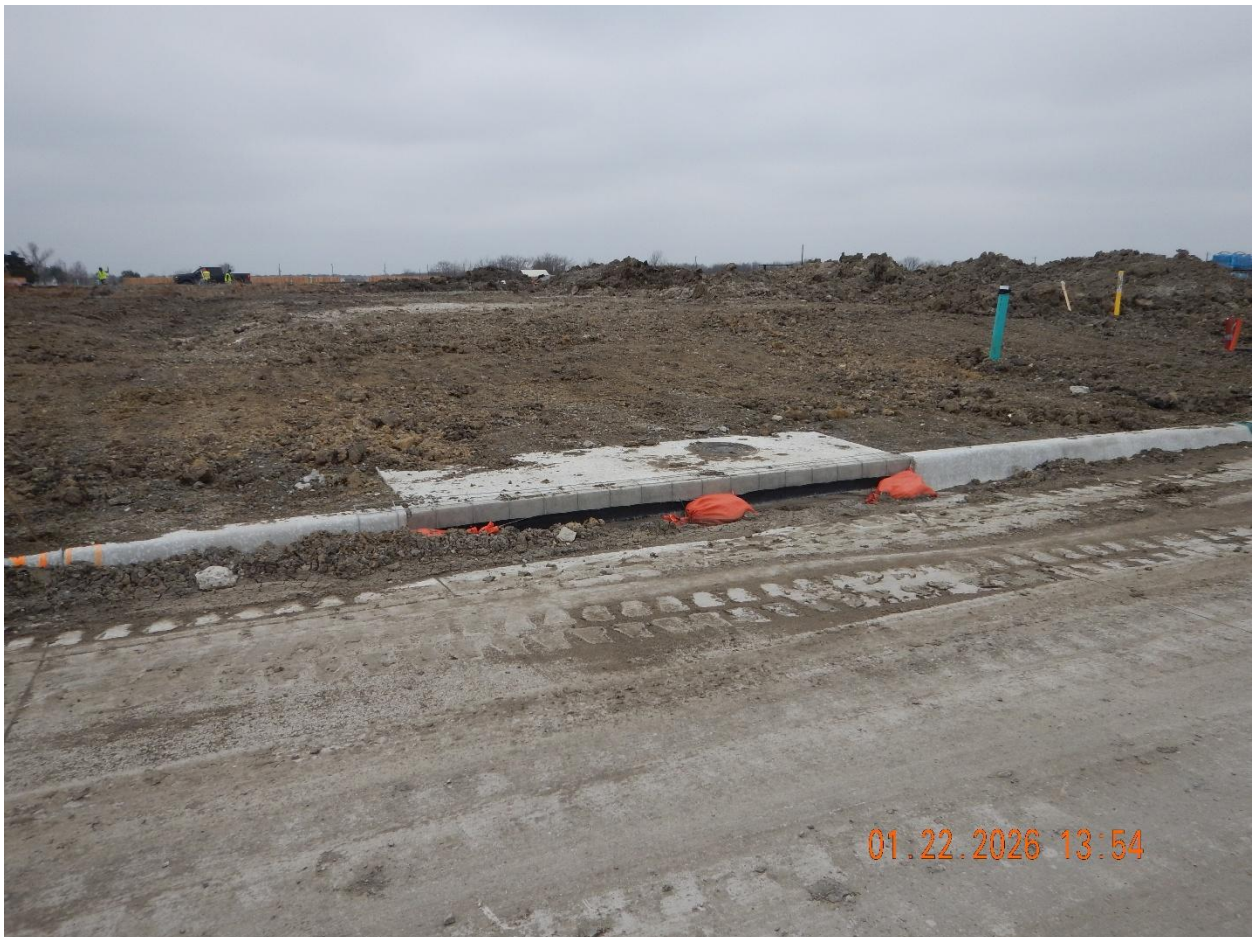
Photo no. 7

5. Inlet protection was observed on the curb inlets throughout Phase 1. However, sediment buildup was observed on multiple inlets throughout the site (**Appendix 1, Photo 7**).

Description: Inlet protection requiring maintenance due to sediment buildup. Also pictured is exposed sediment along the lots and sediment on the street in Phase 1.

- Ensure inlet protection is being properly maintained (minimal sediment buildup and properly installed).
  - *Inlet protection has been refreshed throughout the site and is being cleaned after major rain events. There is currently some sediment build up on our protections as we have been completing dirtwork and the site is still quite moist from the recent extreme rain event. Will be sure to continue maintaining these controls moving forward.*

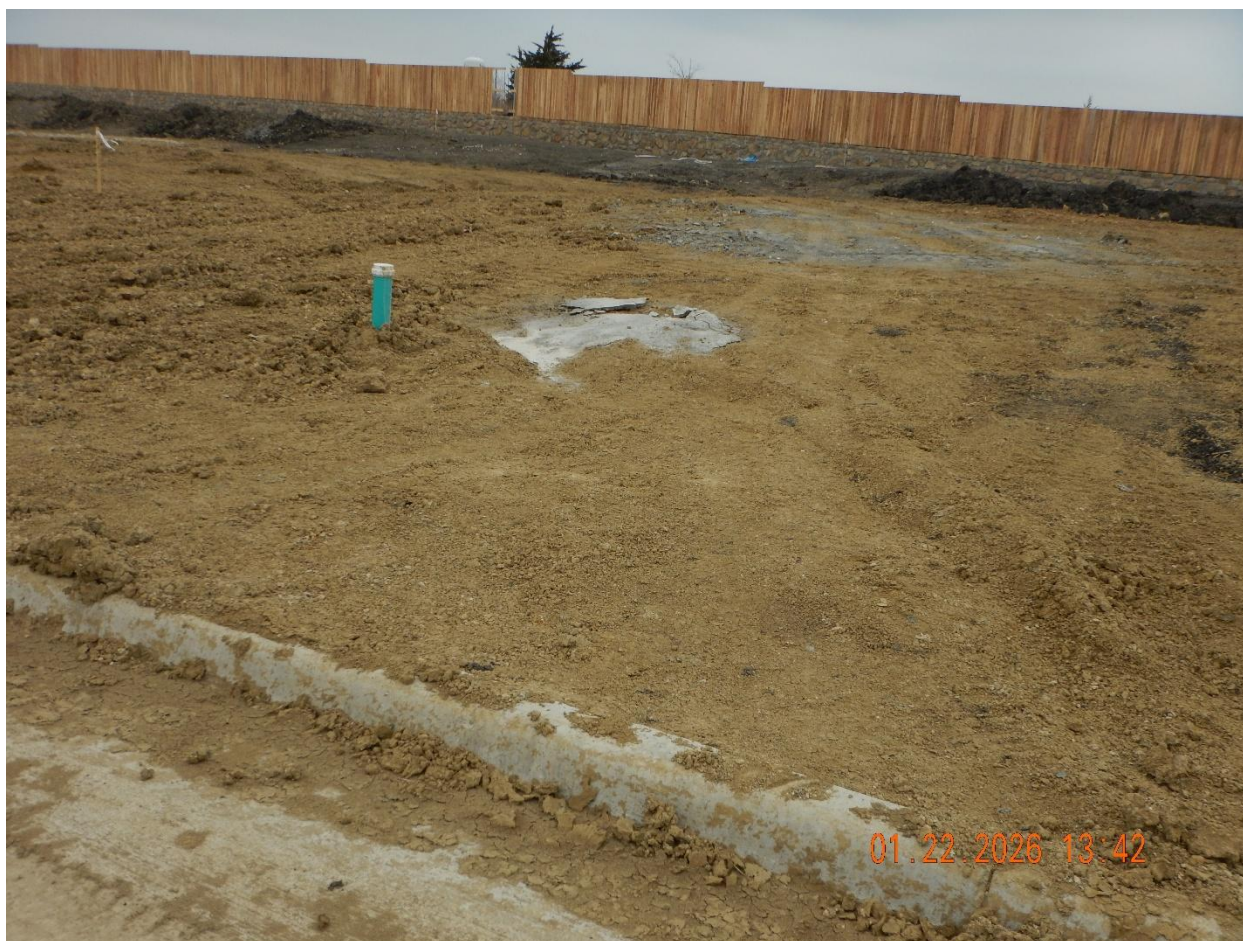
Photo no. 8

6. Mortar/concrete washout was discarded directly on the soil in multiple areas throughout Phase 1 (**Appendix 1, Photo 8-9**).
7. Blowable trash was observed in multiple areas on January 22, 2026. The trash was no longer present during the February 5, 2026, inspection.

Description: Mortar/concrete washout discarded directly on a lot near the southern perimeter of Phase 1. Also pictured is exposed sediment along the lots and sediment in the street.

- There were multiple areas (both Phase 1 & Phase 2) observed where mortar/concrete was discarded directly on the lots/sediment. Please clean up and ensure an appropriate area to dispose of concrete/mortar in the future.
  - *This is completely inappropriate and will not continue. All mortar/concrete has been removed. There is currently no concrete washout station as paving is complete – phase 2 will implement a proper concrete washout station and I will provide pictures as requested once construction begins.*

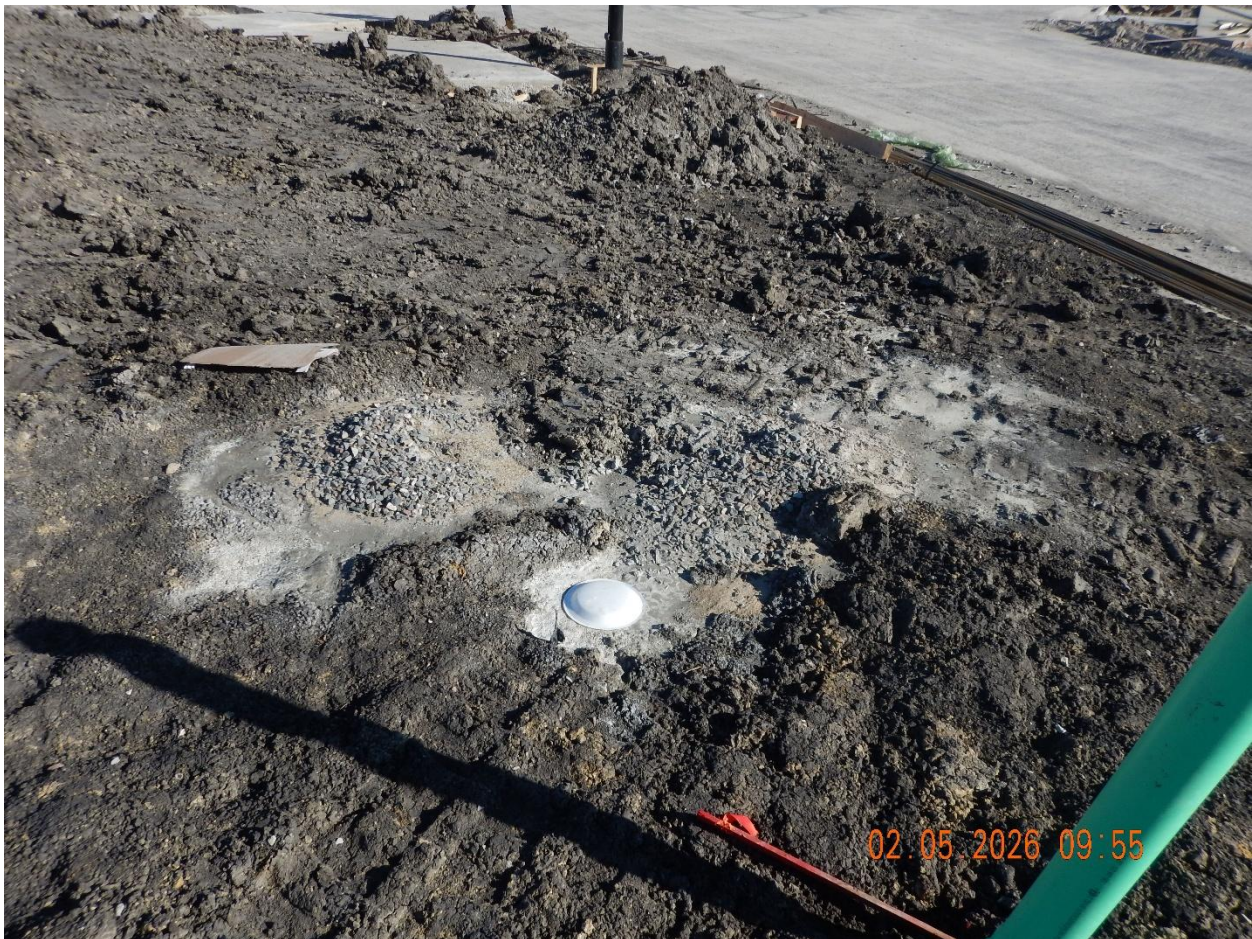
Photo no. 9

Description: Slurry mix washout discarded directly on a lot near the construction entrance (northern entrance off Co Rd 642). Also pictured is exposed sediment along lots that slope towards the street.

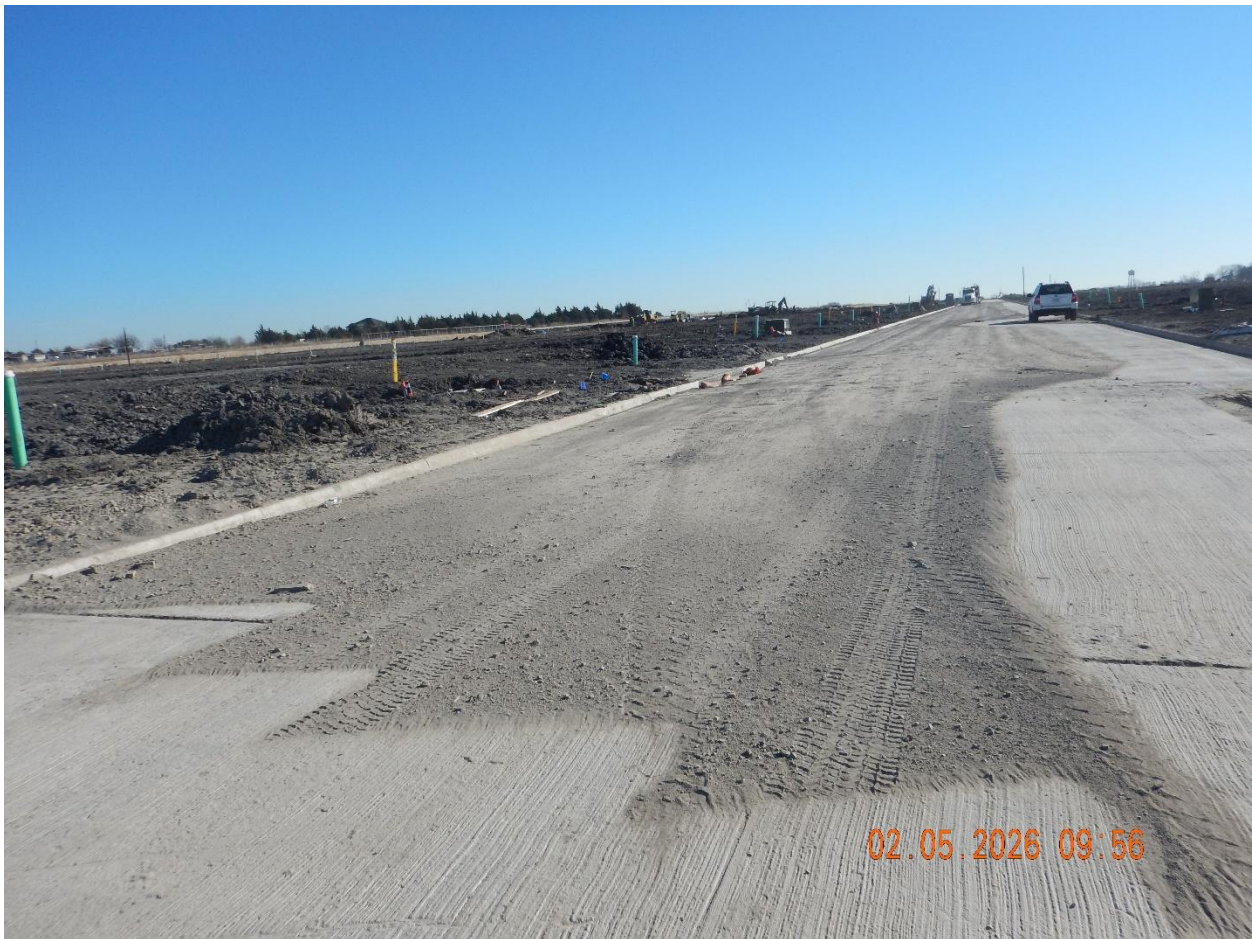
Photo no. 10

Description: Exposed sediment along the lots and soil on the street near the western perimeter of Phase 1.

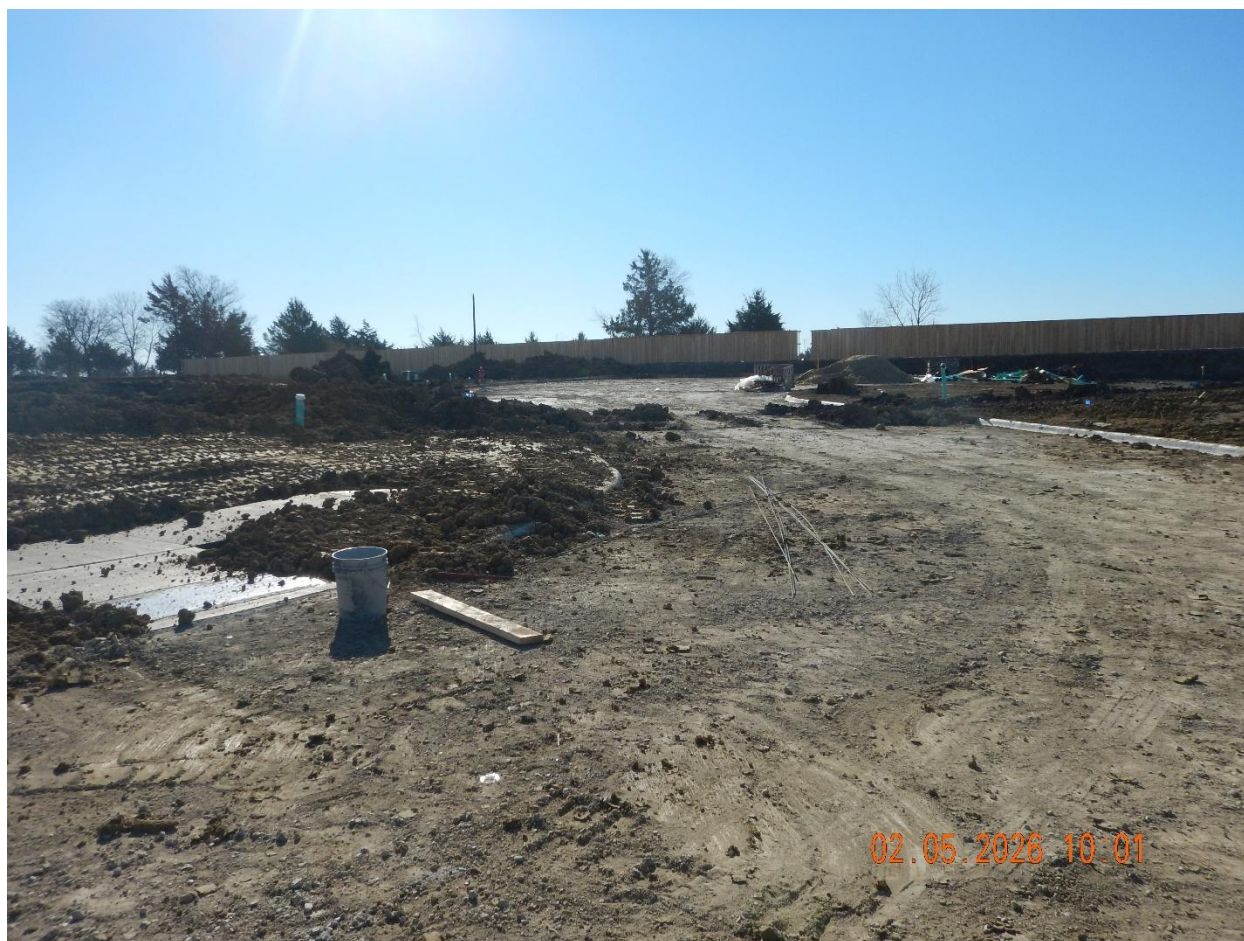
Photo no. 11

Description: Exposed sediment along the lots and sediment track-out on the street near the southern perimeter of Phase 1.

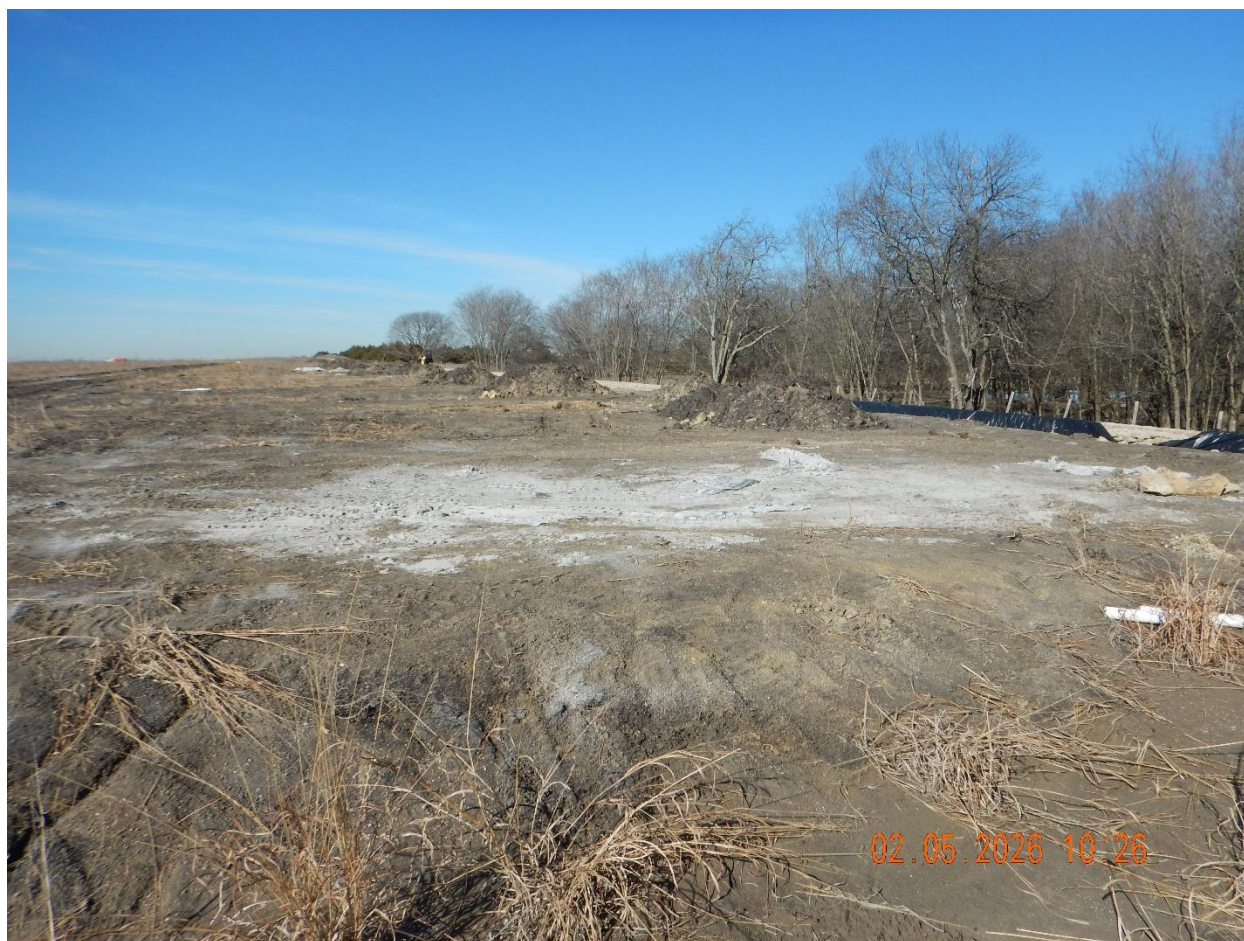
Photo no. 12

8. Mortar/concrete washout was discarded directly on the soil (**Appendix 1, Photo 12**) near the northeast corner of Phase 2.
9. An area at a steep slope with no BMPs was observed along the northern perimeter of Phase 2 (**Appendix 1, Photos 13-14**).
10. During the inspection Daniel Hibbs (Inspector of Stormcon, LLC) advised that Phase 2 is not being inspected because the area is considered temporarily stabilized. This information was confirmed upon reviewing the SWPPP. However, large areas of exposed sediment, including along the perimeters, were observed during the inspection (**Appendix 1, Photos 12-16**). In its current state, Phase 2 must be inspected routinely as required by the CGP to ensure that sediment and other pollutants are properly contained.

Description: Mortar/concrete washout discarded in the sediment near the northeastern perimeter of Phase 2. Also pictured is the large quantity of exposed sediment in this area and damaged silt fence in the background.

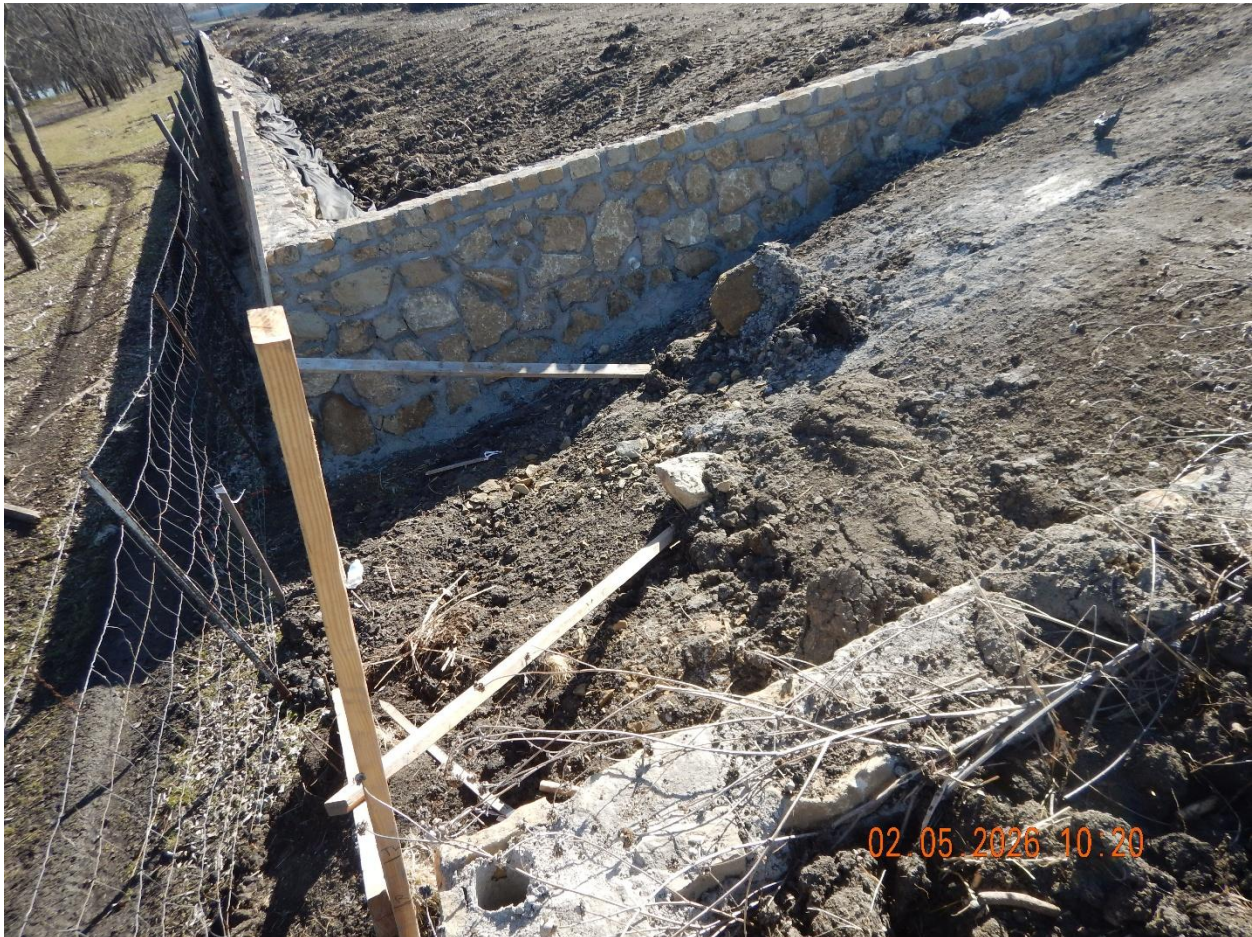
Photo no. 13

Description: A steeply sloped area along the northern retaining wall in Phase 2 requiring BMPs to minimize potential sediment discharge during a rain event.

- Along the retaining wall in Phase 2 there was an area sloping downwards towards the neighboring property (see picture below). Please take steps to prevent any sediment from discharging off-site during a potential rain event (install BMPs or otherwise minimize exposed sediment in this area).
  - *This area has been addressed with silt fence and curlex. We will continue to monitor.*

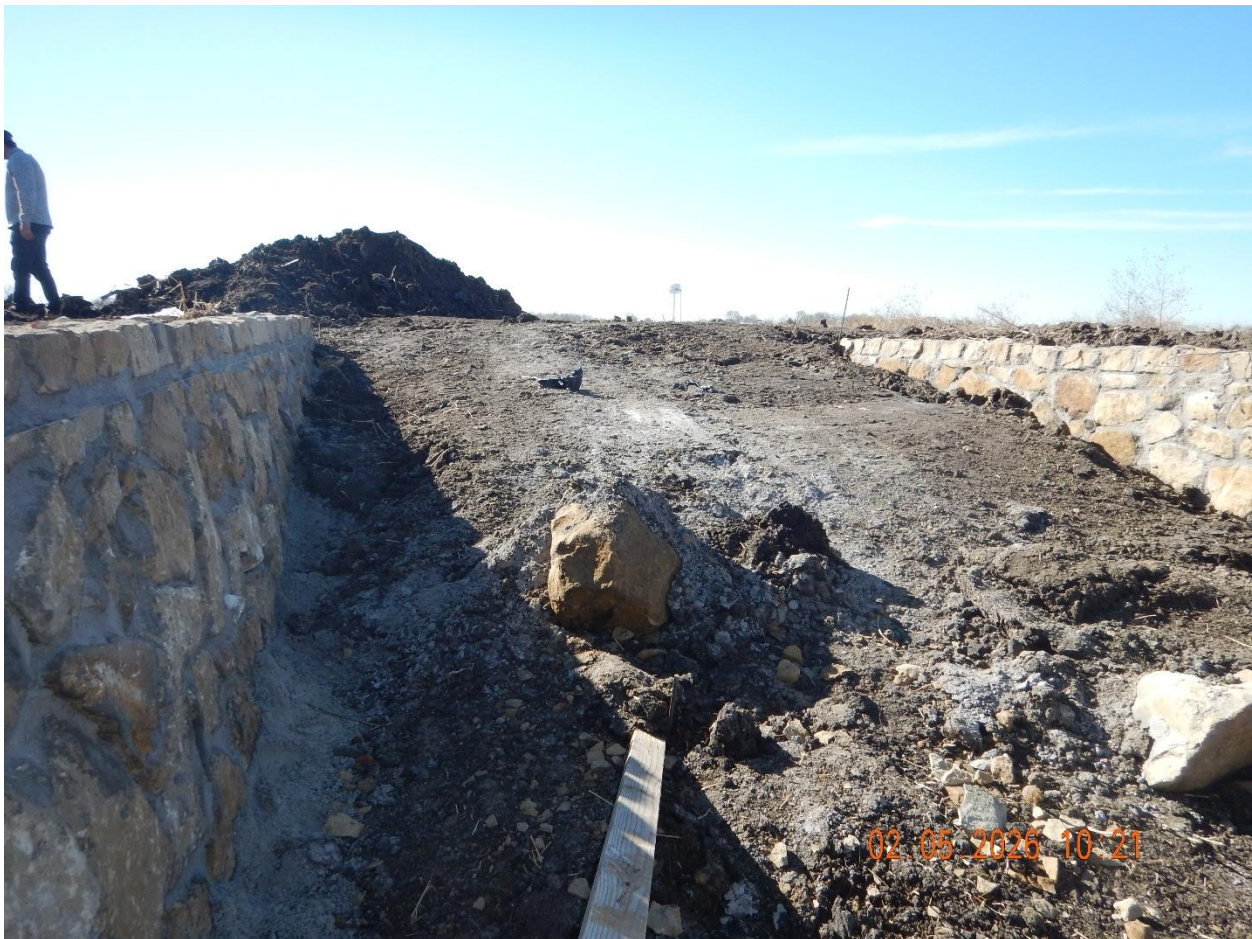
Photo no. 14

Description: Another view of the steeply sloped area along the northern retaining wall in Phase 2 requiring BMPs to minimize potential sediment discharge during a rain event. Also pictured are a large stockpile and exposed sediment at the top of the slope.

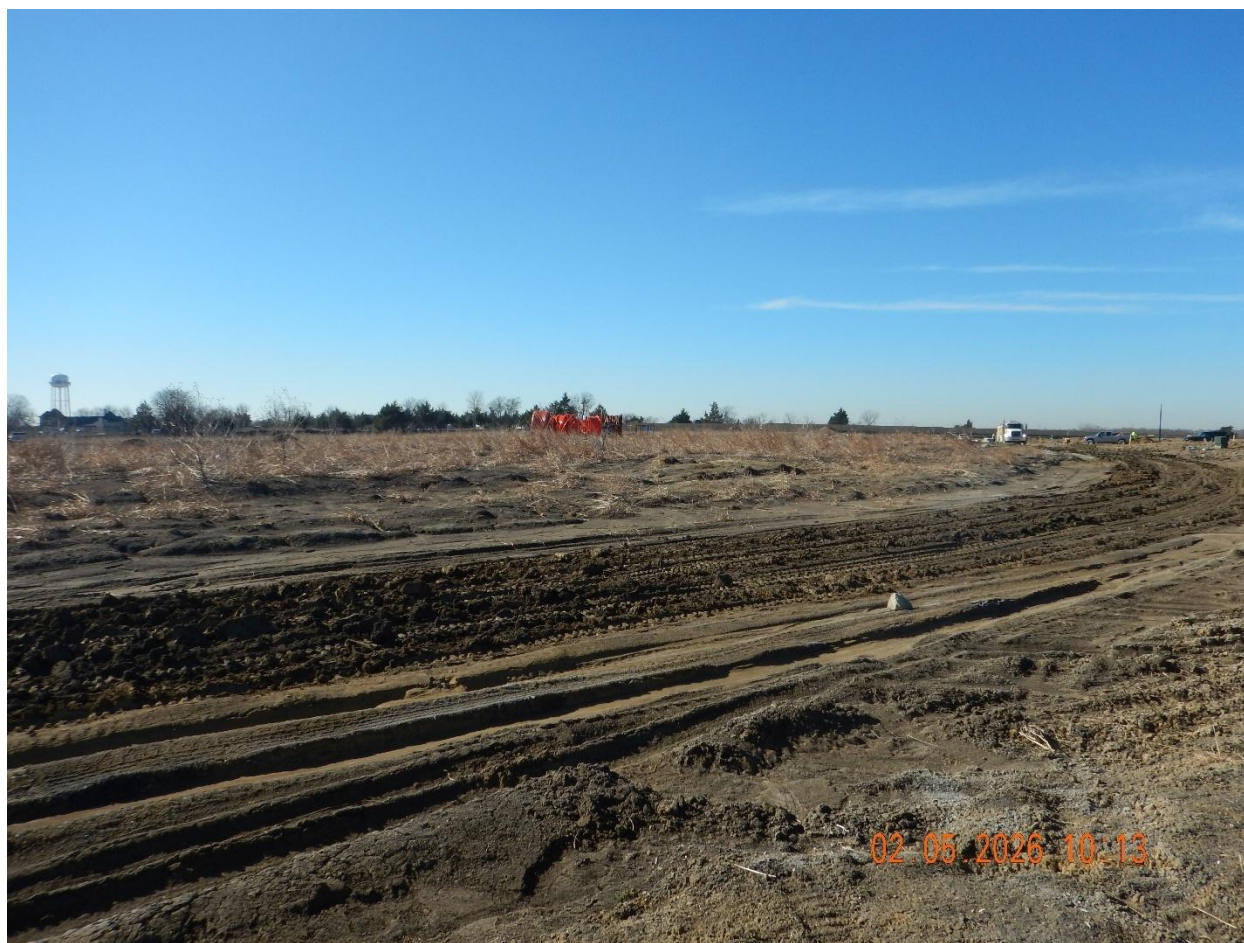
Photo no. 15

Description: Photo taken standing at the northern perimeter of Phase 2, facing south. Phase 2 consisted of large quantities of exposed sediment intermingled with vegetation. The area closest to the northern boundary line consisted of primarily exposed soil and therefore does not appear to meet the definition of stabilized. Phase 2 in its observed state requires routine inspections.

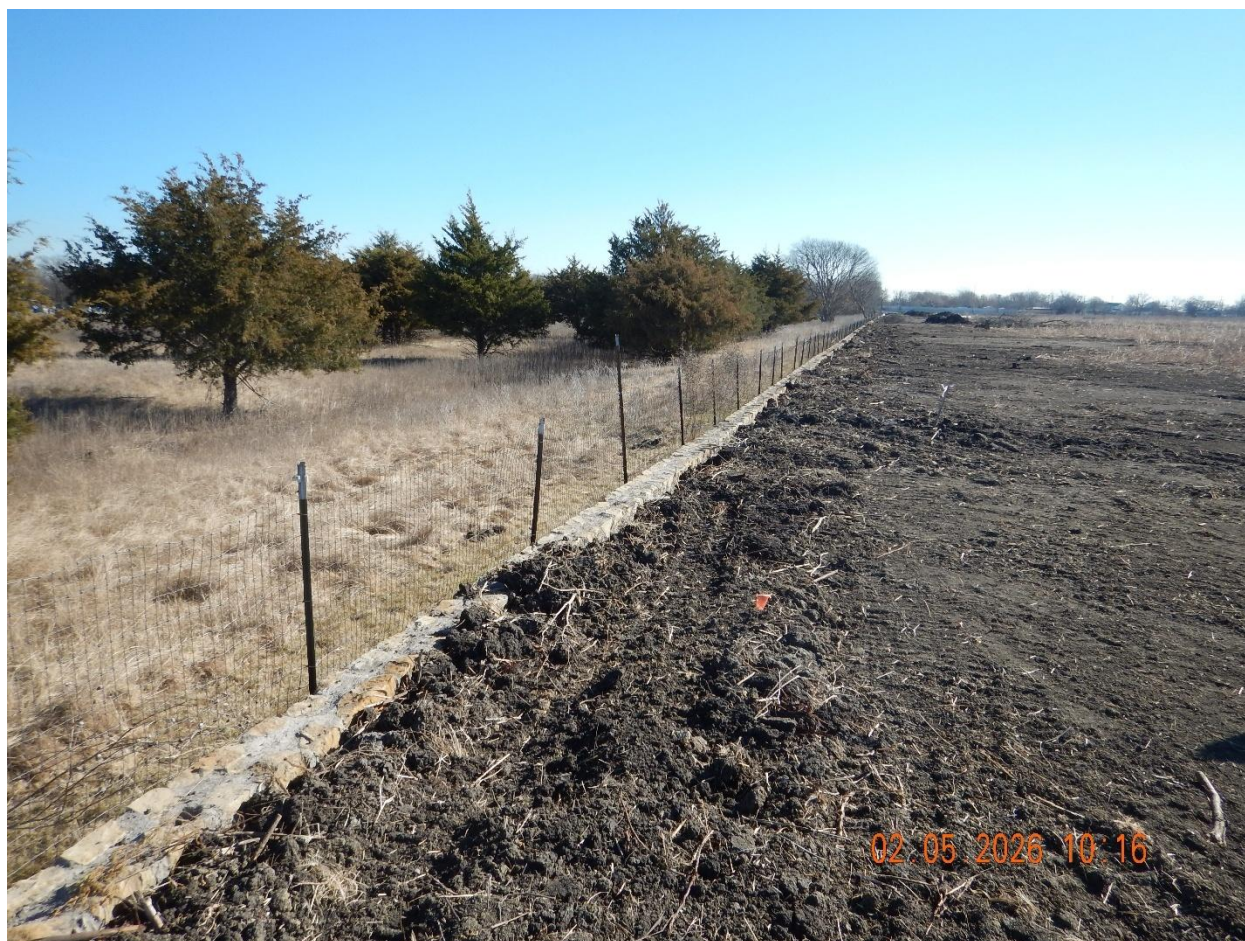
Photo no. 16

Description: Photo taken at the northern boundary line of Phase 2, facing east. Large areas of exposed sediment run along the property line.

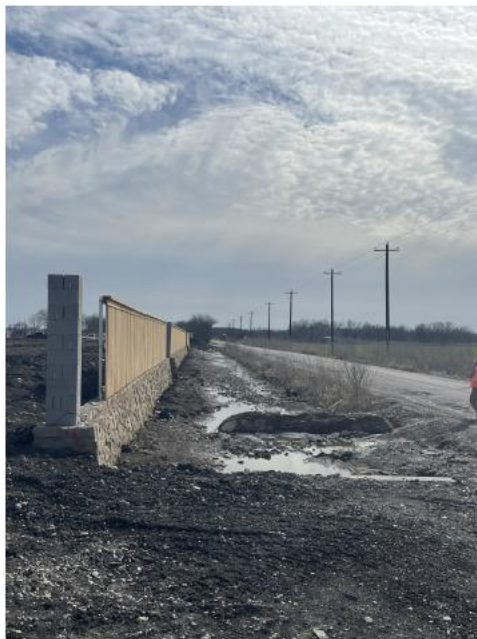
UNITED STATES ENVIRONMENTAL PROTECTION AGENCY  
Appendix 2: Corrected Items Photograph Log  
Photo no. 1

Description: Photo of the construction entrance off Co Rd 642.

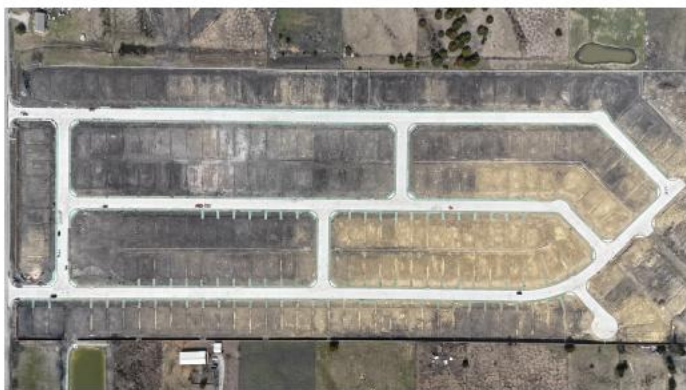
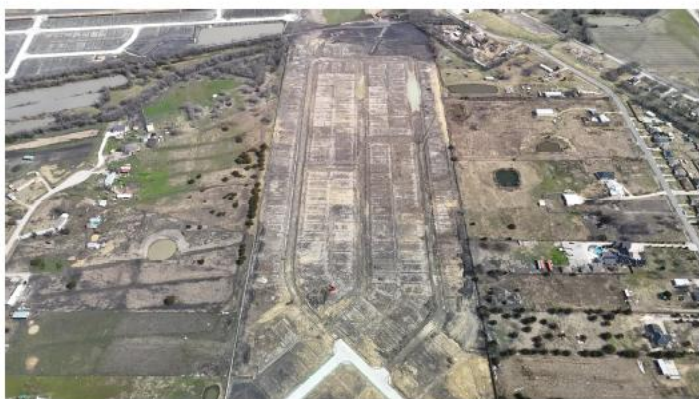
Photo no. 2

Description: Aerial drone image of the site, illustrating that curlex was installed along the lots. Also noted in the photo description is that perimeter controls have been refreshed, streets swept, and storm drains cleaned.

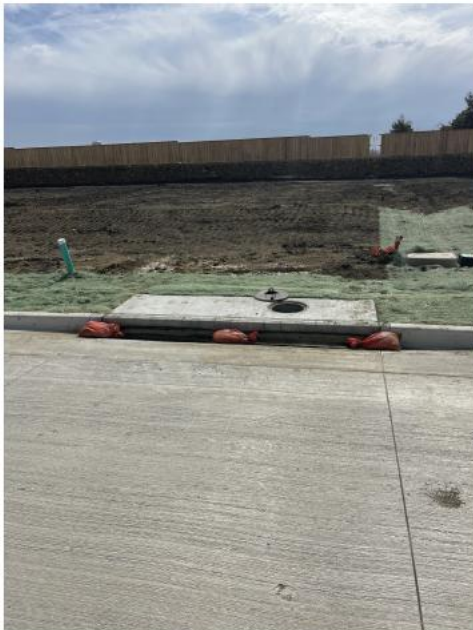
Photo no. 3

Description: Photo of lots with BMPs installed and inlet protection in effective operating condition.

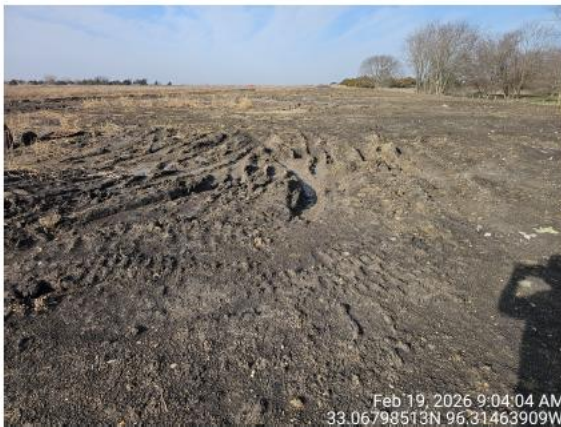
Above is the location where concrete/mortar was dumped.

Description: Photo of the mortar/concrete mix cleaned up in Phase 2.

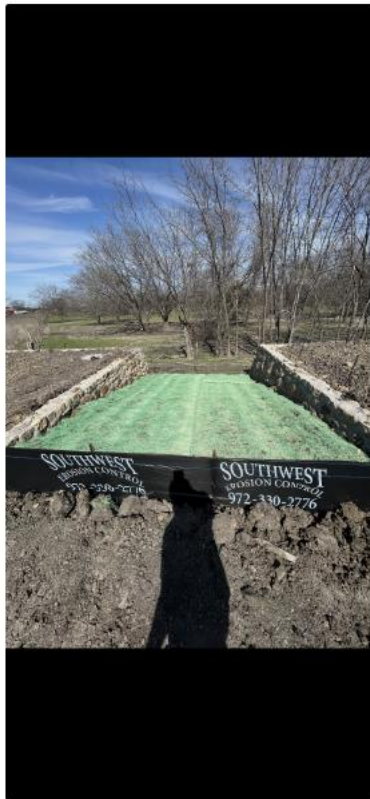
Photo no. 5

Description: Photo of BMPs installed along the steep slope in Phase 2.
