## Region 6 - Enforcement & Compliance Assurance Division

### INSPECTION REPORT

| Company Name: | CTC Contractors, LLC | |
| Facility Name: | Shops at Shadowbend | |

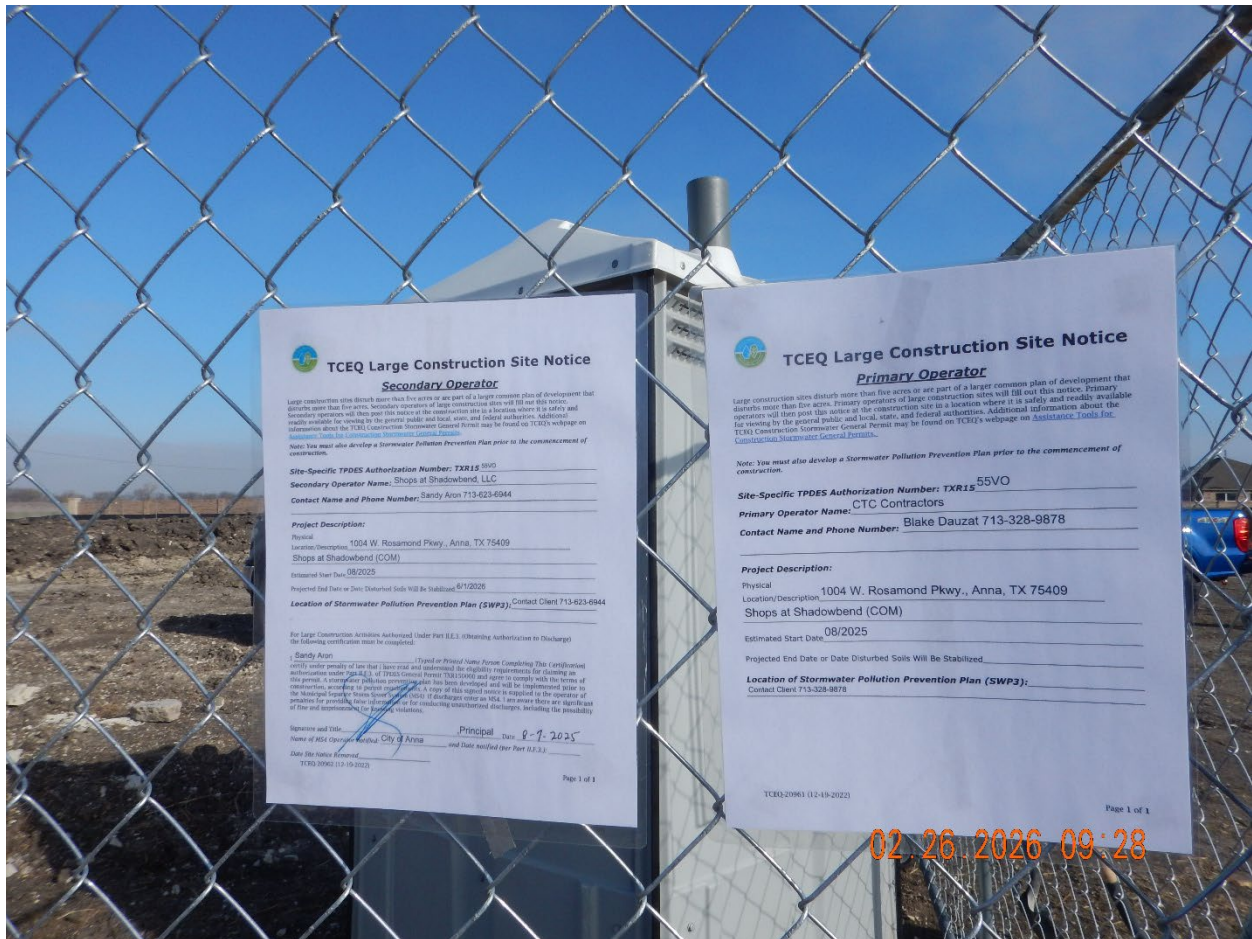
Photo no. 1

- The Construction Site Notices (CSNs) were posted on the fence at the construction entrance off West Rosamond Parkway (**Appendix 1, Photo 1**).
- The construction entrance off West Rosamond Parkway was stabilized with rock/gravel (**Appendix 1, Photo 2**).

Description: The Construction Site Notices (CSNs) posted on the fence at the construction entrance off West Rosamond Parkway.

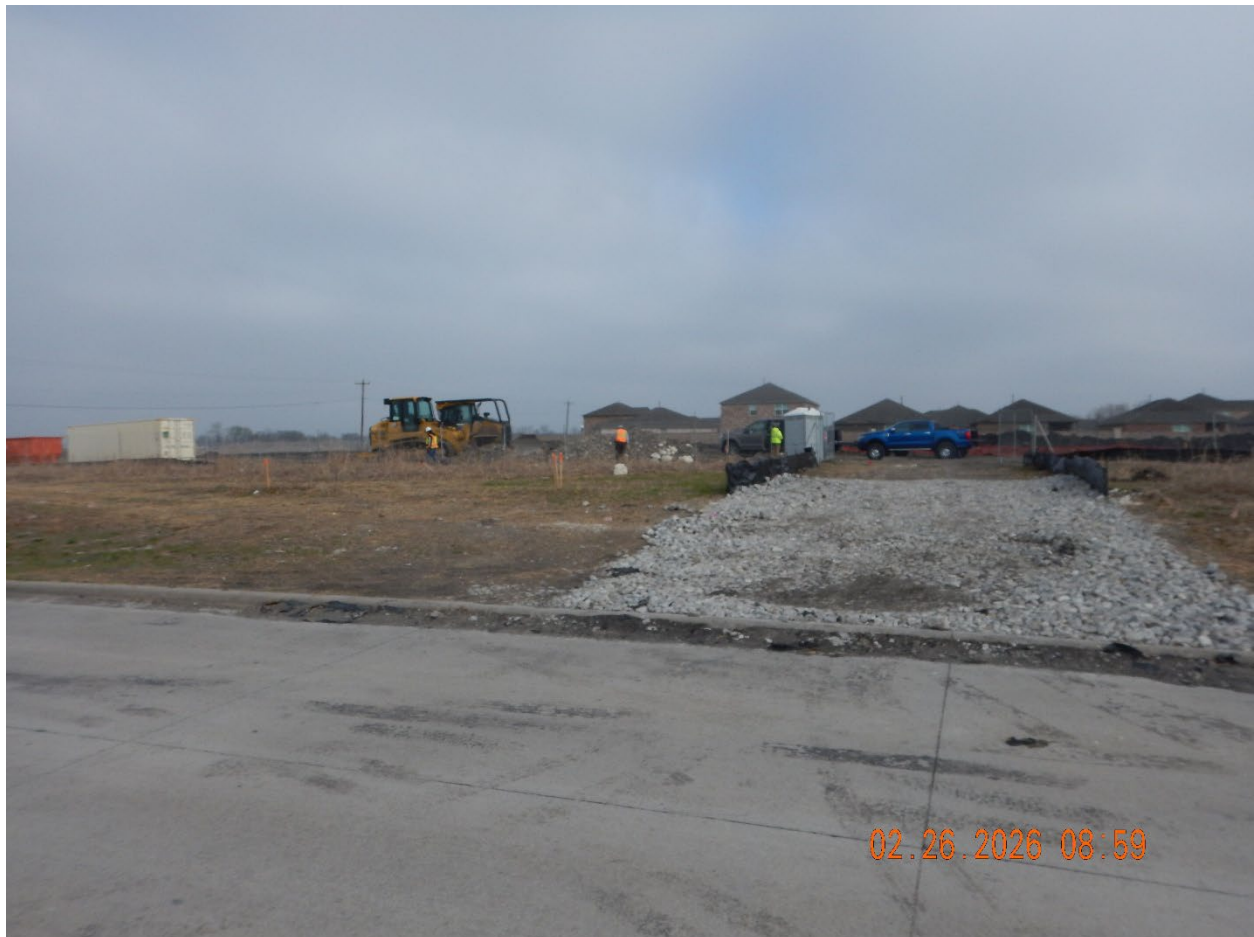
Photo no. 2

1. The perimeter silt fence was improperly installed (not trenched) in multiple areas (**Appendix 1, Photo 6**). During the inspection we observed a work crew removing the southern perimeter silt fence to be re-installed (**Appendix 1, Photo 2**). At approximately 9:30 AM, a Greenrise Technologies truck arrived on-site (**Appendix 1, Photo 8**) and photos were provided after the inspection concluded illustrating that new silt fence was installed and the rock/gravel entrance was refreshed/expanded (**See Appendix 2**).
2. Two (2) BlueDef and two (2) 1-gallon heavy duty synthetic diesel motor oil containers were stored on the ground near the double walled fuel cube (**Appendix 1, Photo 5**). The BlueDef and diesel motor oil containers were moved into a large storage cube container after discussing with Mr. Mills during the inspection/closing conference (**Appendix 1, Photo 7**).

Description: The construction entrance off West Rosamond Parkway stabilized with rock/gravel. Also pictured are two crew members in reflective clothing removing the existing perimeter silt fence. There were areas of silt fence not properly maintained and therefore, required re-installation. We observed a Greenrise Technologies work truck entering the site at approximately 9:30 AM (as shown in Appendix 1, Photo 8) to install new BMPs.

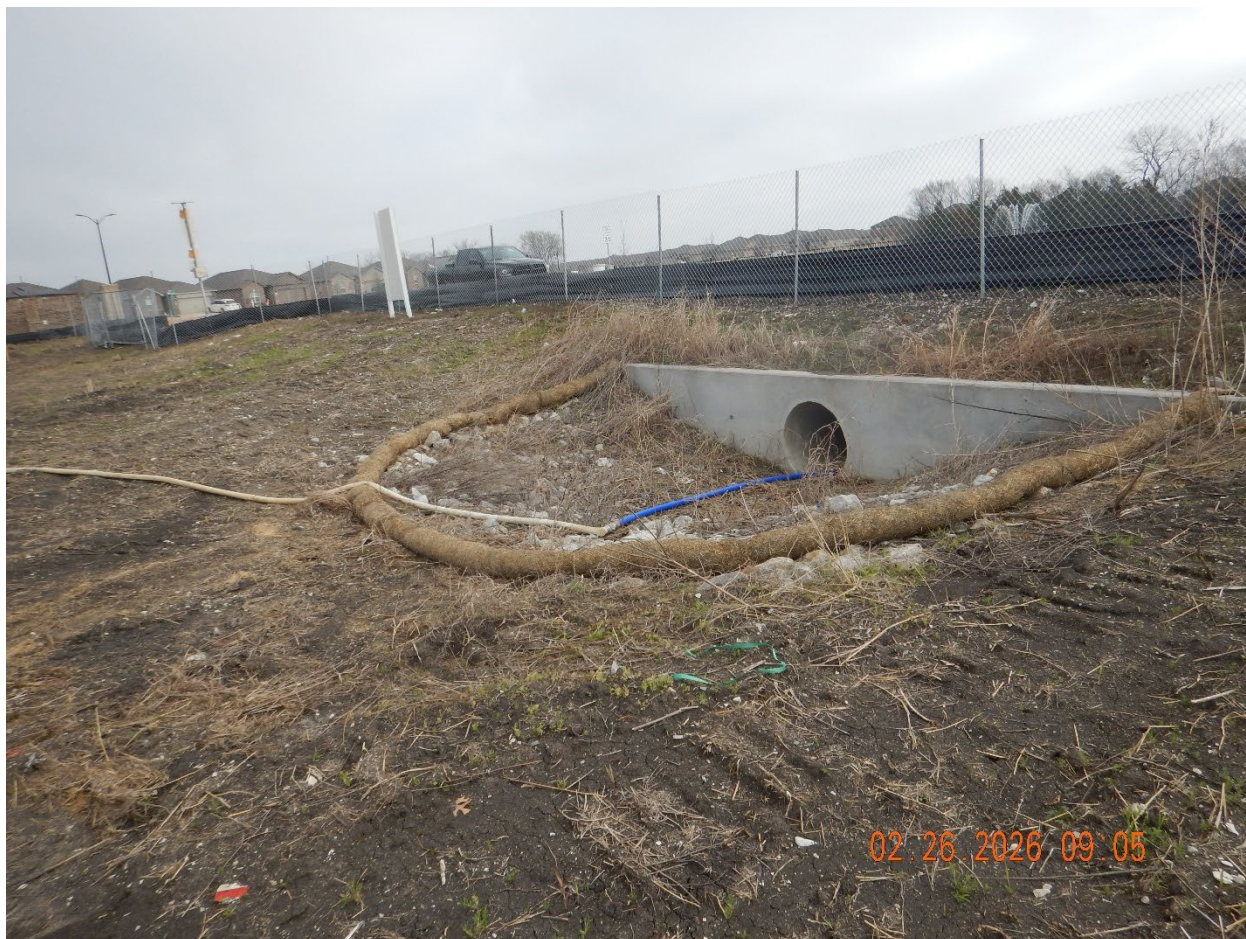
Photo no. 3

- A headwall was observed along the eastern perimeter of the site (**Appendix 1, Photo 3**). The headwall connected to an existing permanent retention pond across West Crossing Boulevard.

- An unconnected hose without a filter bag was observed resting in the headwall along the eastern perimeter of the site (**Appendix 1, Photos 3-4**). During the closing conference, Mr. Mills stated that the hose was sometimes connected to a nearby fire hydrant and was not used to pump stormwater off-site.

Description: A headwall along the eastern perimeter of the site that drains into an existing permanent retention pond across West Crossing Boulevard. An unconnected hose without a filter bag was observed resting in the headwall. Also note the silt fence installed along the east perimeter of the site.

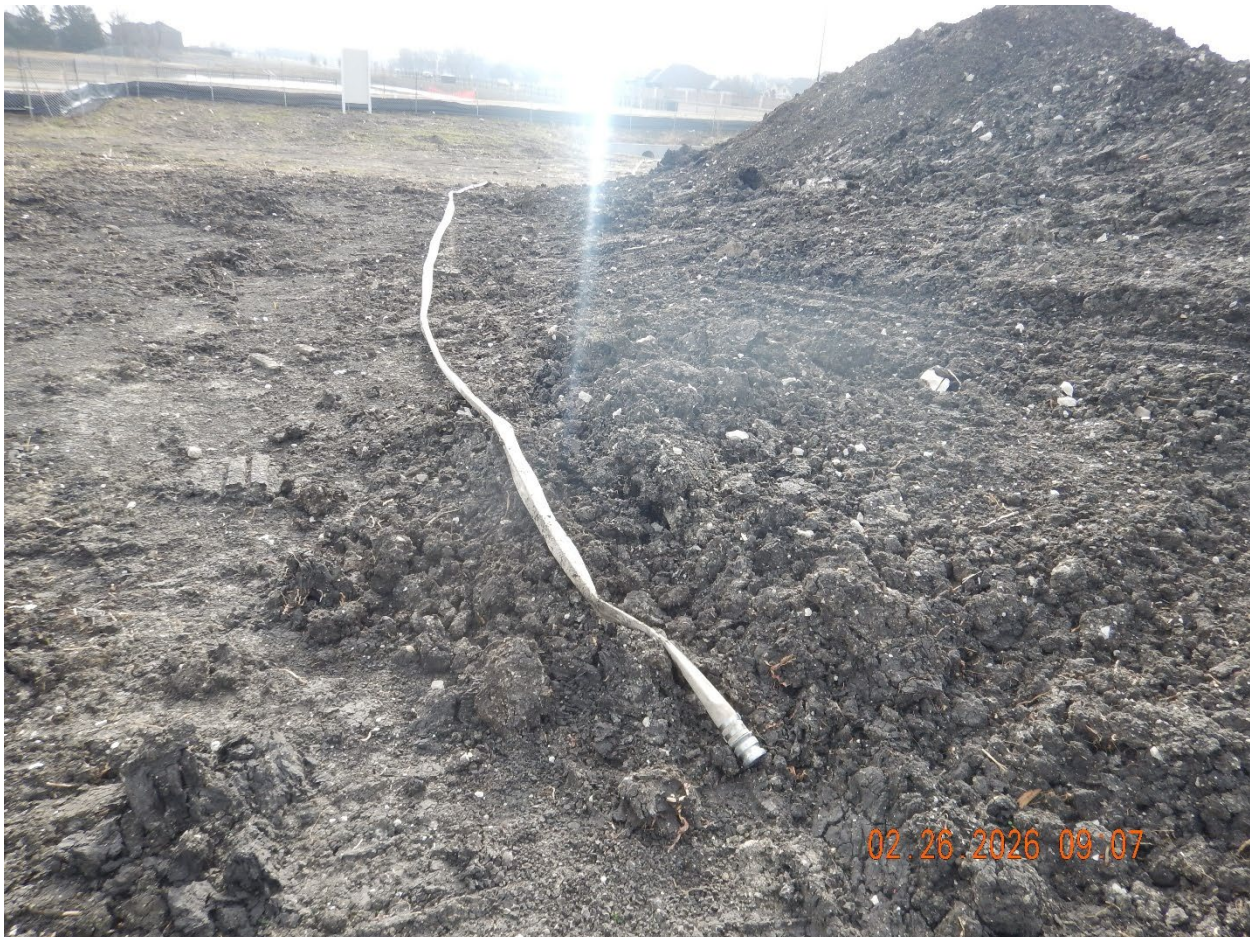
Photo no. 4

Description: The unconnected hose observed resting in the headwall in Photo 3. Also note the silt fence installed along the east perimeter of the site.

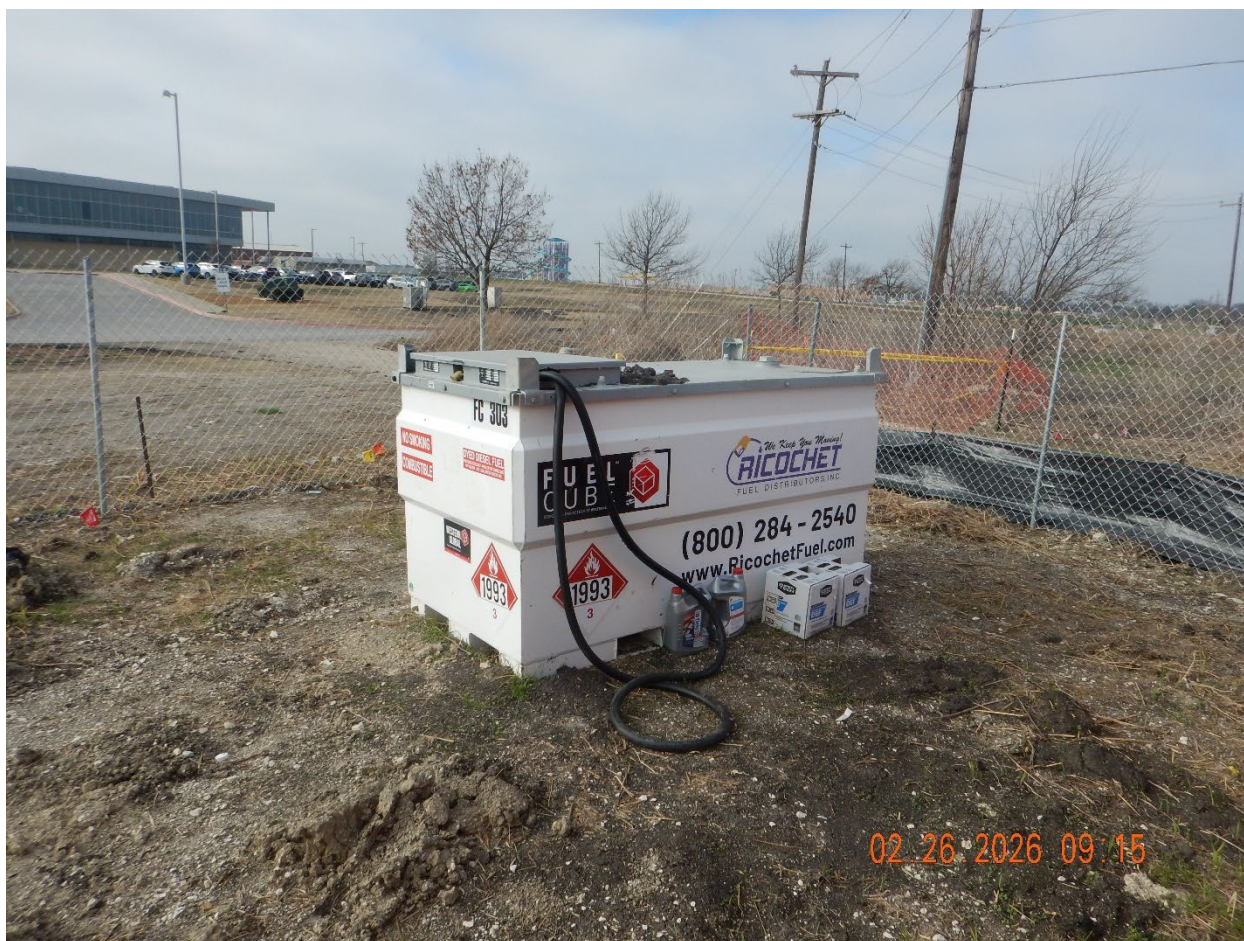
Photo no. 5

- A double walled fuel cube was observed at the southwest corner of the site with no evidence of leakage (**Appendix 1, Photo 5**).
- We observed a roll-off dumpster in the southwestern corner of the construction site (**Appendix 1, Photo 7**). No blowable trash was observed on-site.

Description: A double walled fuel cube observed at the southwest corner of the site with no evidence of leakage. Two (2) BlueDef and two (2) 1-gallon heavy duty synthetic diesel motor oil containers were stored on the ground near the double walled fuel cube. Also note the silt fence along the western perimeter of the site.

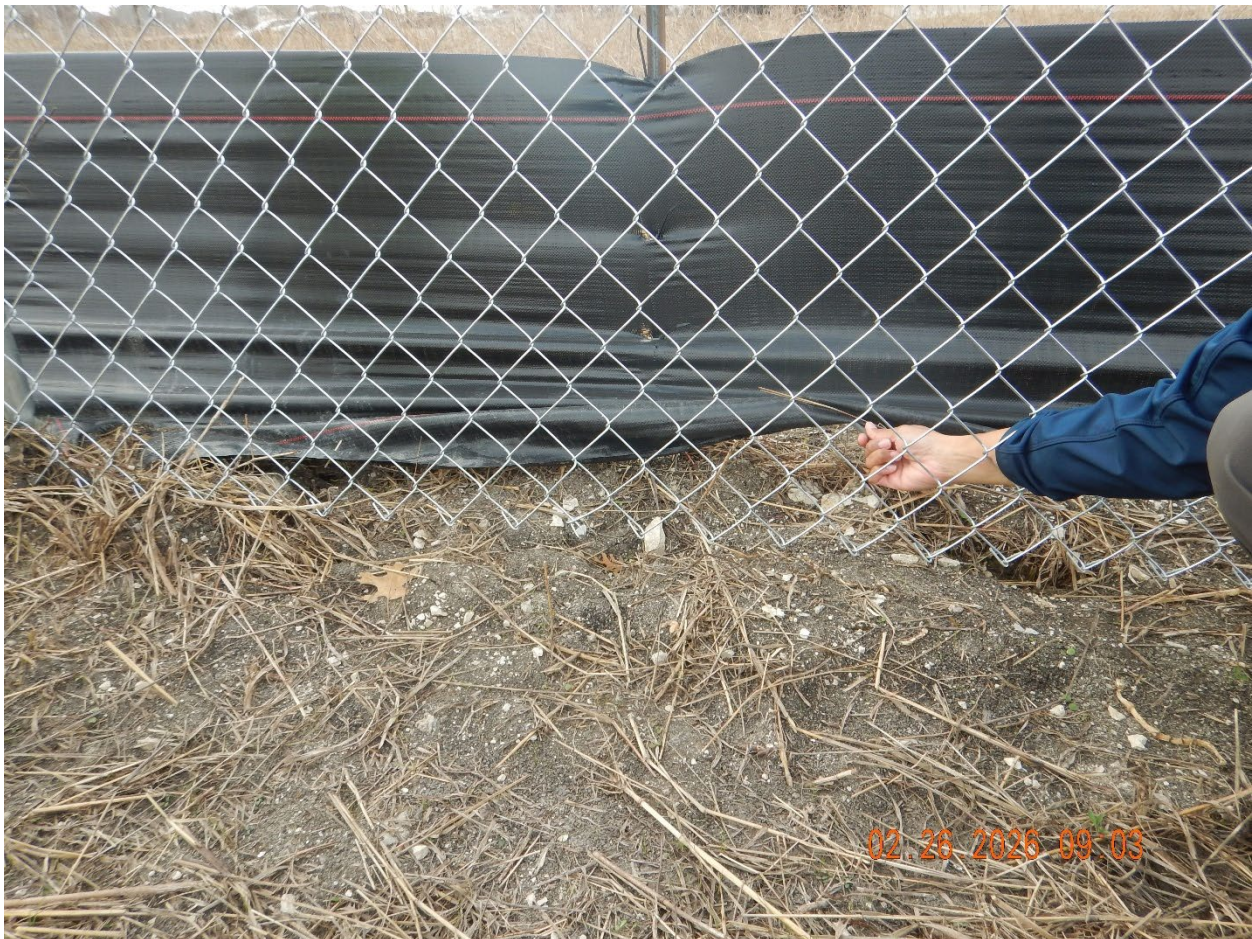
Photo no. 6

Description: Improperly installed silt fence along the south perimeter of the site.

**Note: AOCs 1-2 were addressed by CTC Contractors either as observed by the inspectors (AOC 2) or as illustrated through photo evidence provided by Mr. Geraty on or around March 2, 2026, as shown in Appendix 2 of this report.**

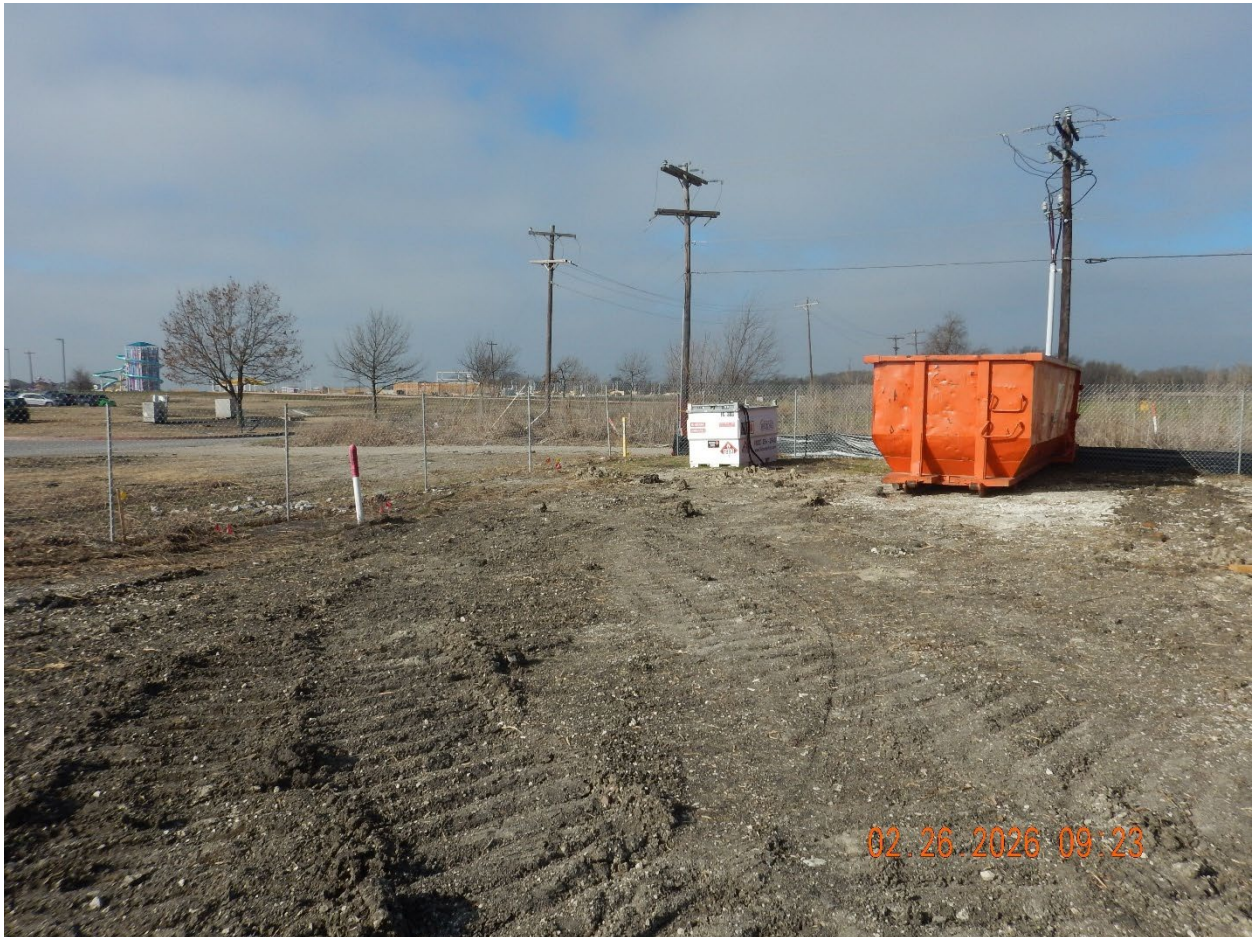
Photo no. 7

Description: A roll-off dumpster in the southwestern corner of the construction site. No blowable trash was observed on-site. Also shown is the BlueDef and motor oil having been removed from near the fuel cube and relocated to an enclosed storage cube (not pictured but located to the right of the roll-off dumpster) after discussing with Mr. Mills during the closing conference. Additionally, pictured is silt fence installed along the west perimeter of the site and the recently removed section of silt fence along the south perimeter of the site.

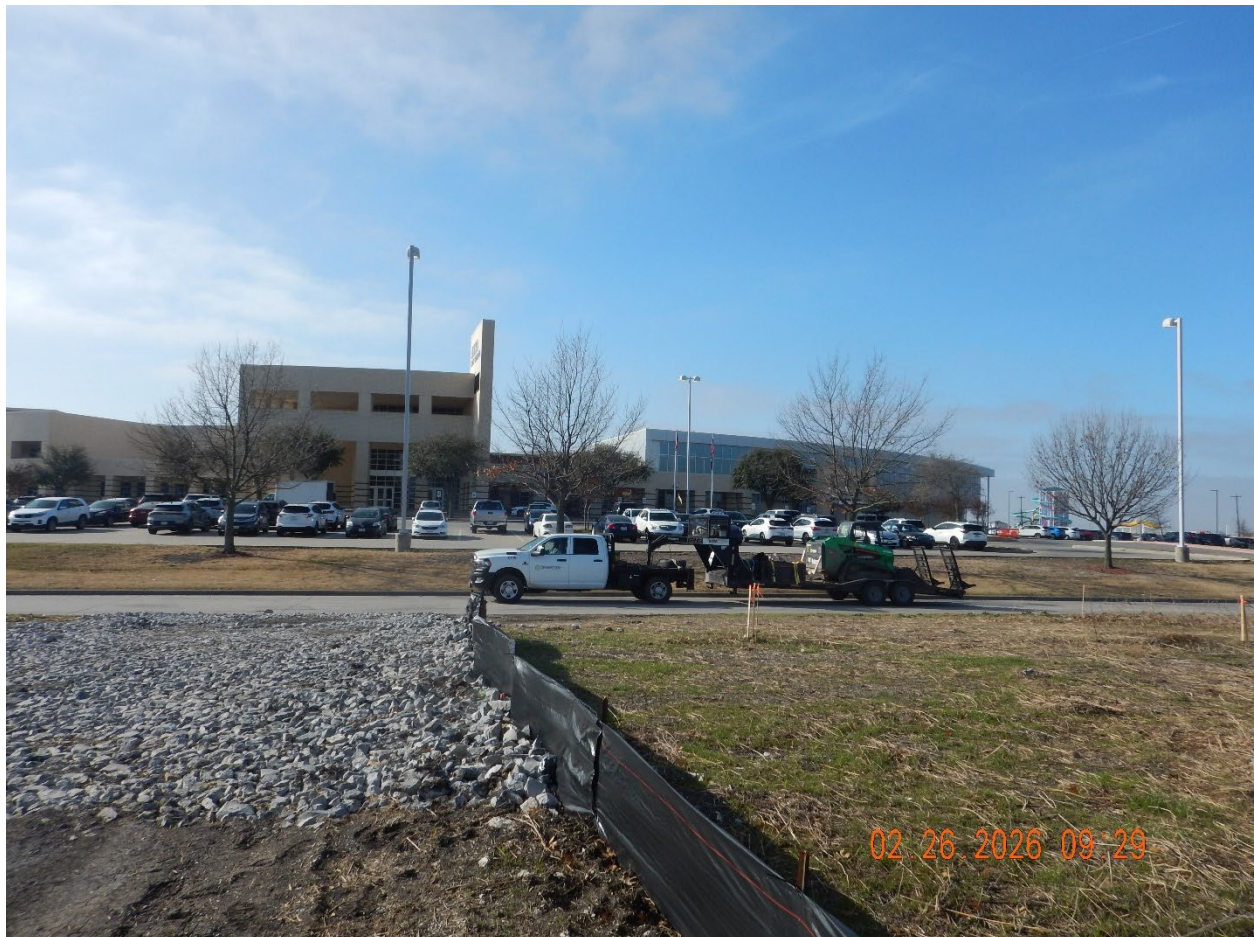
Photo no. 8

Description: A Greenrise Technologies work truck arriving on-site towards the end of the inspection to re-install the perimeter silt fence and refresh the construction entrance rock/gravel. Photos of the completed work was emailed by Mr. Geraty on March 2, 2026, with photos in Appendix 2 of this report.
