**Well Inspection**  
**Osage DNR / Environmental Protection Agency**  
**1201 Elm Street, Suite 500**  
**Dallas, Texas 75270**

| | | <b>Lease Name</b> | Ballew | | |
| | | <b>Well ID</b> | 05-1 | | |

# Photograph Log

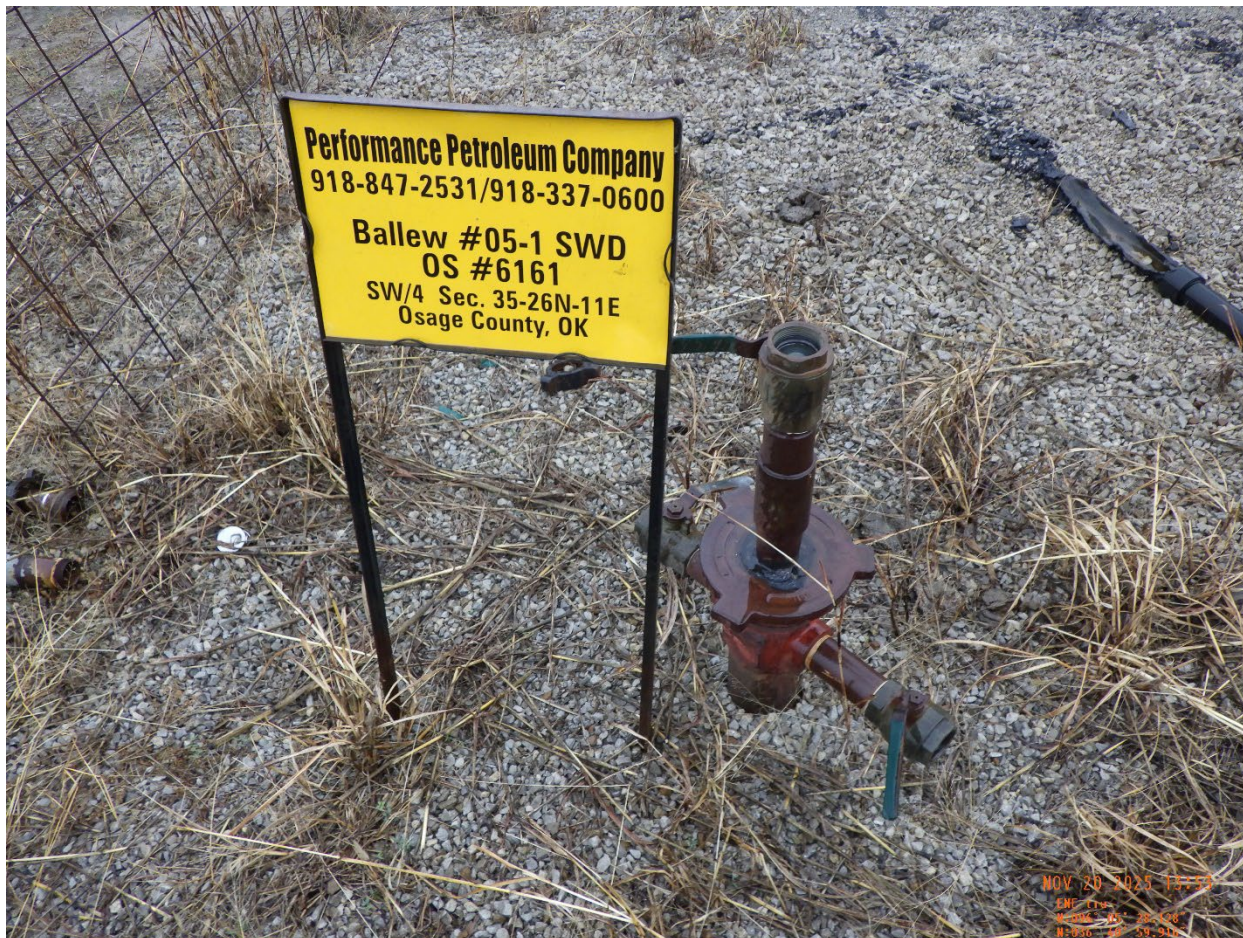
Photo No. 1

**Description:** This was well OS6161000. At the time of the inspection, the well was reduced to a 2" ball valve atop the tubing. The flowline was disconnected. The flowline was also disconnected at the tank battery. Jim Virden stated the well was previously converted to gas production.
