REPORT OF COMPLIANCE EVALUATION INSPECTION  
(INDUSTRIAL STORMWATER)

**Advantage Metals Recycling LLC. - Manchester Facility**

Authorization Number: **MO-0115801**

June 21, 2023

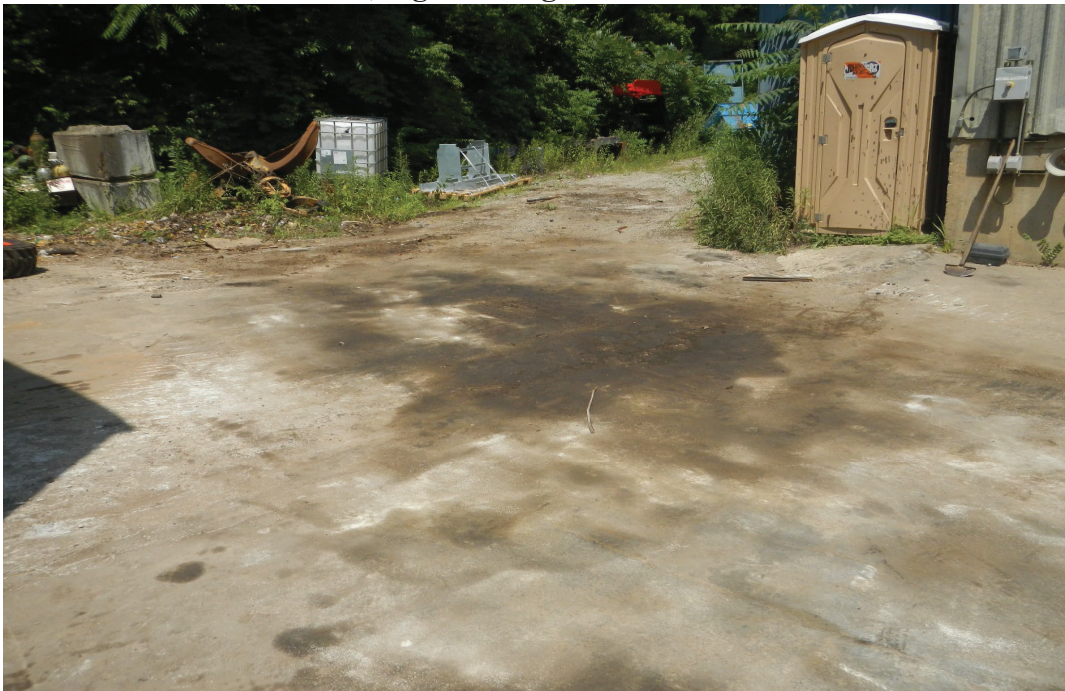
10. I issued NOPF #1 for the significant ground discoloration near the fuel tanks storage shed as can be seen in photo number 17 below. Facility personnel indicated that they would clear discoloration as soon as possible.

**Photo 17, Significant ground discoloration**

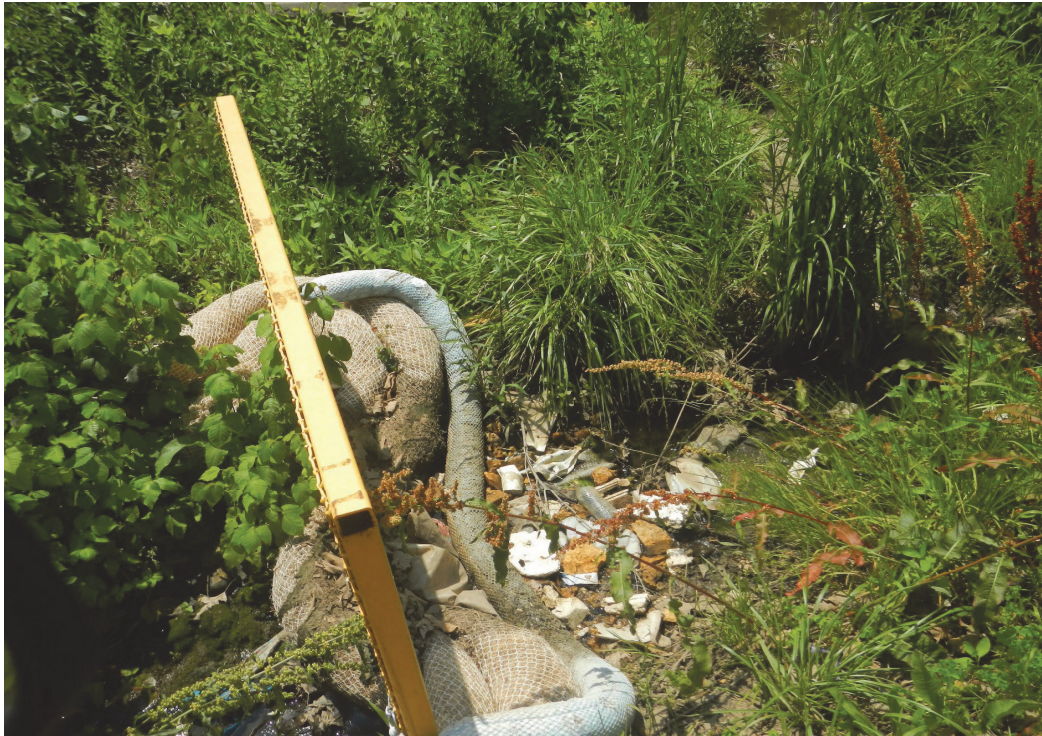
11. I also issued NOPF #2 for the accumulation of floatables at the outlet of Outfall 001 as shown in photo number 26 and Outfall 003. Although discharge water was clear of floatables at both outfalls, I pointed out to Facility personnel that this is part of good housekeeping practices. Facility personnel indicated that they would pick-up and clean the floatables as soon as possible.

**Photo 26, Floatables accumulating at Outfall 001**
