**Well Inspection**  
**Osage DNR / Environmental Protection Agency**  
**1201 Elm Street, Suite 500**  
**Dallas, Texas 75270**

| | | <b>Lease Name</b> | NMU | | |
| | | <b>Well ID</b> | 38-4 | | |
| <b>Inspection Reason</b> | MIT | <b>Responsible Company at Time of Inspection</b> | Lime Rock Resources III | | |

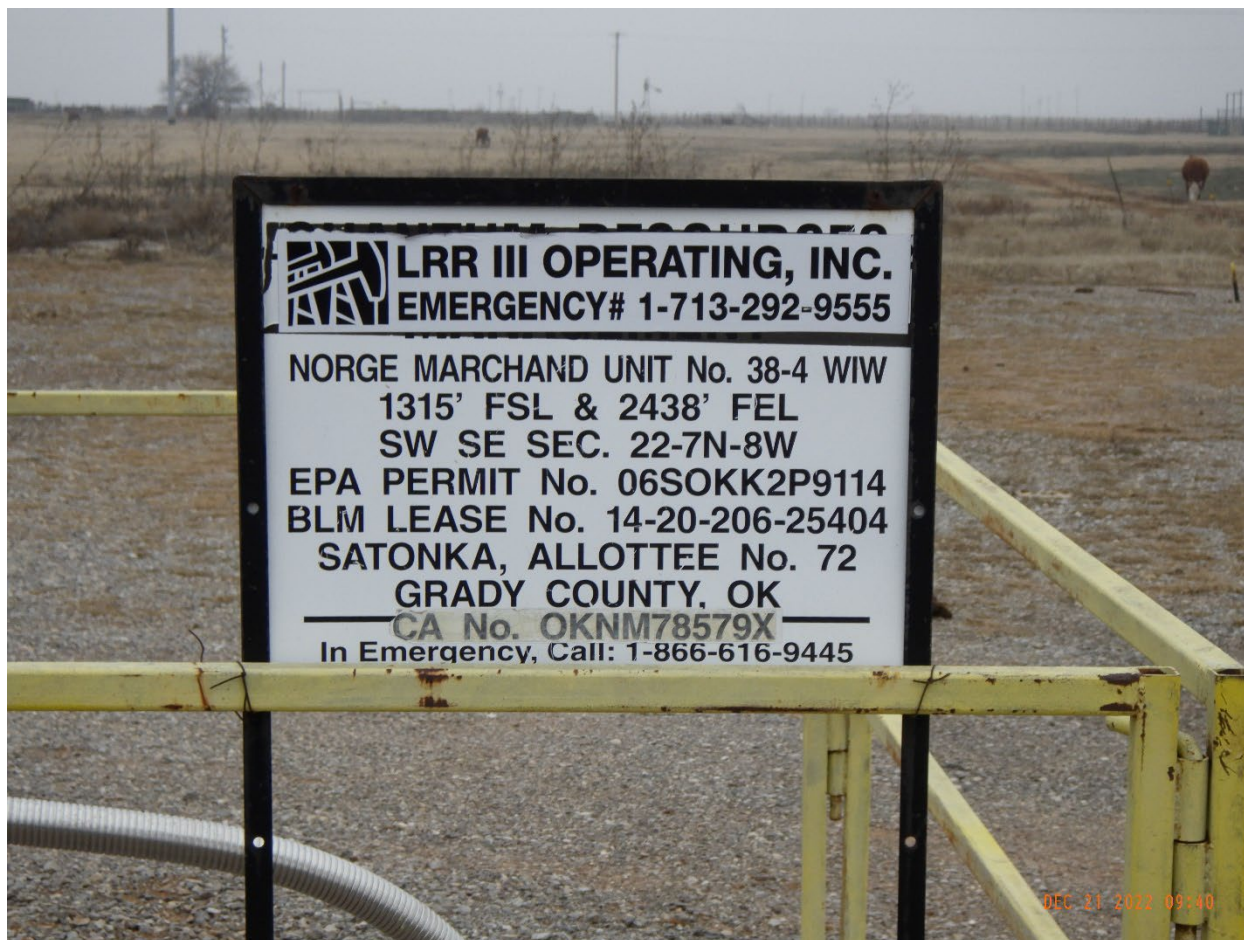
Photo No. 1

**Description:** Well sign for well, OK9114000.

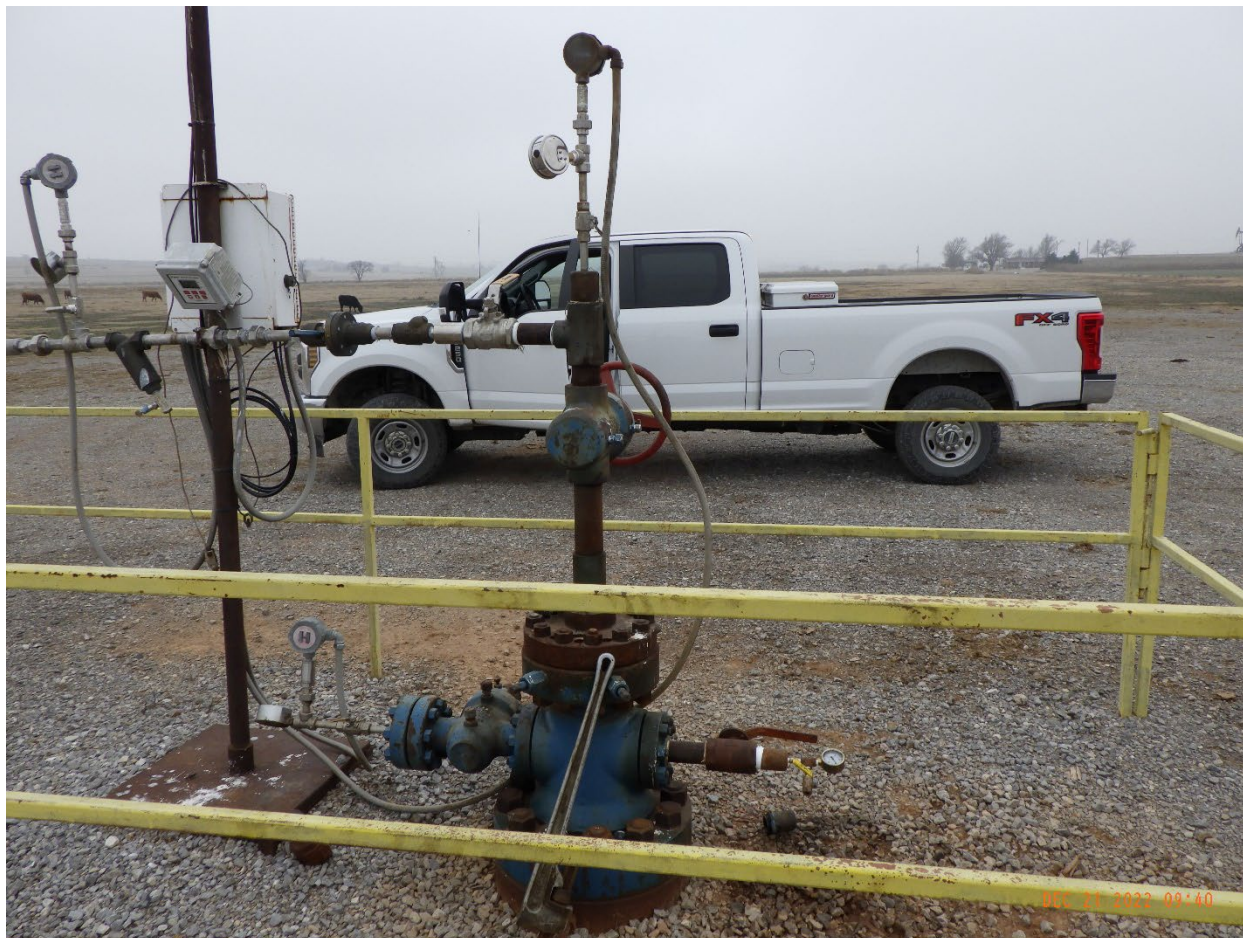
Photo No. 2

| <b>Inspection Comments</b> | <p>Inspector witnessed Standard Annulus Pressure Test (SAPT) on well OK9114000. Pressure, hold OK. I observed no areas of concern at the time of the inspection. EPA enforcement staff will review inspection data to determine compliance with EPA UIC regulations.</p> <p>Initial: 300psi<br/> Mid: 290psi<br/> Final: 290psi<br/> Pressure Hold OK</p> <p>Total flowback: 26,000ml</p> | | | | |

**Description:** Overview of well, OK9114000.
