## Region 6 Compliance Assurance and Enforcement Division

### INSPECTION REPORT

| Company Name: | <b>Perdure Petroleum, LLC</b> | | |
| Facility Name: | <b><i>North Burbank Unit 56-12</i></b> | | |

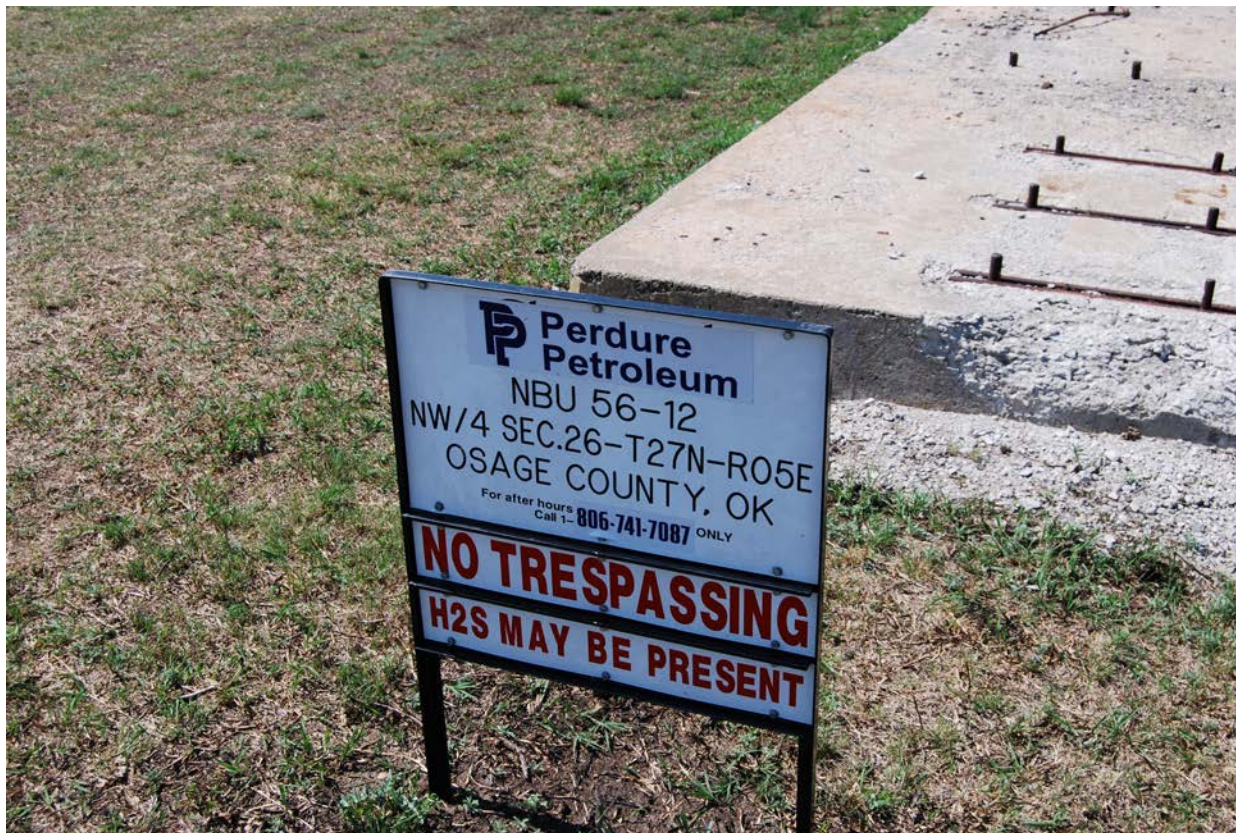
Photo No. 1

Description: This photo shows the sign at the Perdure Petroleum, LLC, North Burbank Unit 56-12. A discharge of produced fluids (brine) originated in a line a few yards from the injection well at this site.

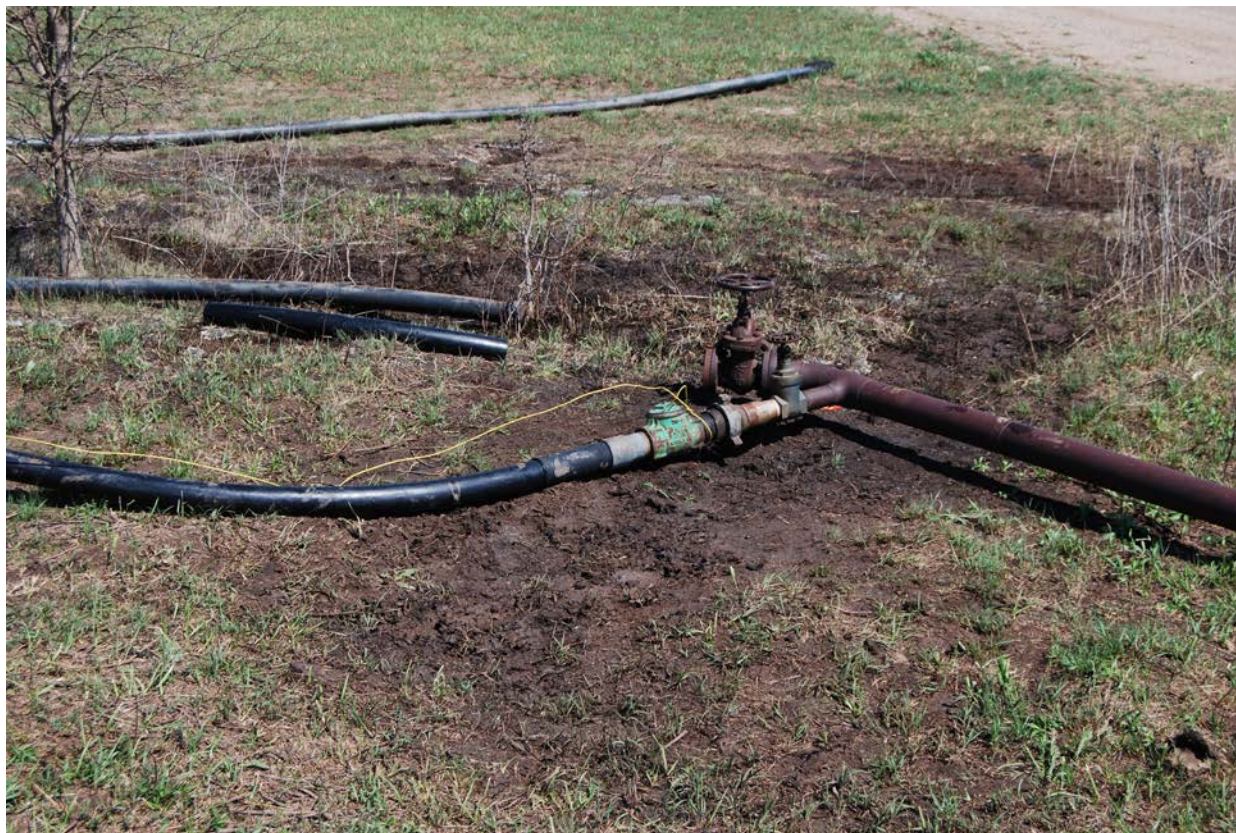
Photo No. 2

Description: The line shown parted and temporarily repaired after spilling produced water, or brine, and some oil to the nearby tributary of Mud Creek.

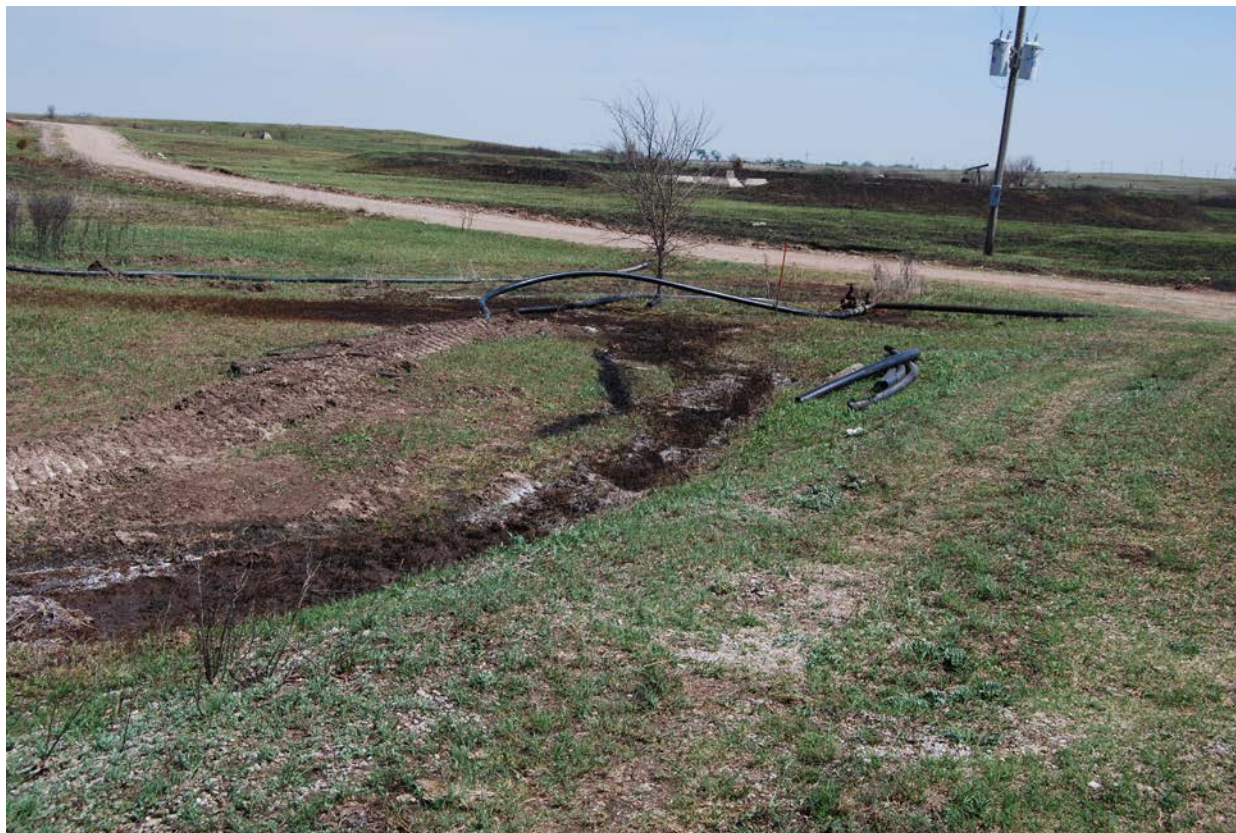
Photo No. 3

Description: The discharge of brine flowed from the leaking flow line south towards the tributary of Mud Creek, as shown in this photo.

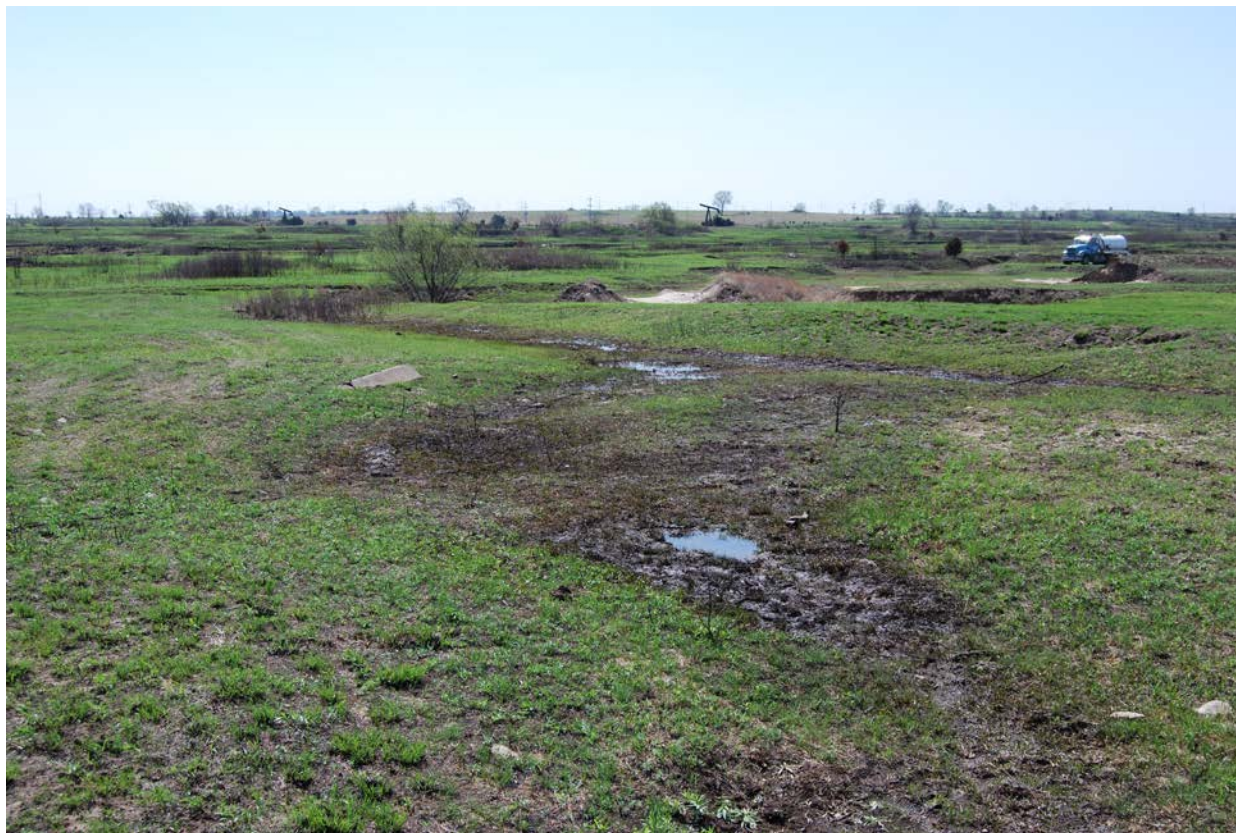
Photo No. 4

Description: This discharge flow path flowed towards the tributary of Mud Creek located near the tank truck seen in this photo.

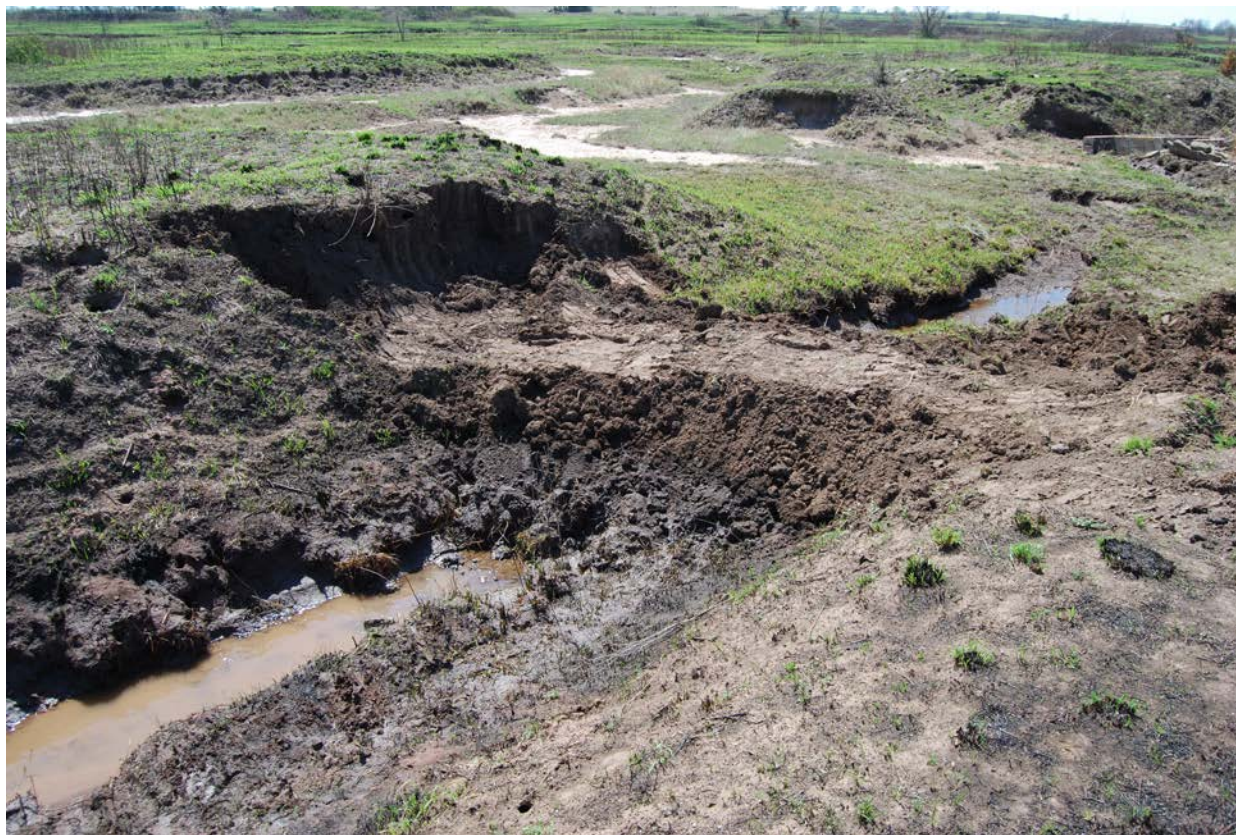
Photo No. 5

Description: The first temporary dam along the flow path at the point of entry to the tributary of Mud Creek is shown here. I observed oil sheen at this location.

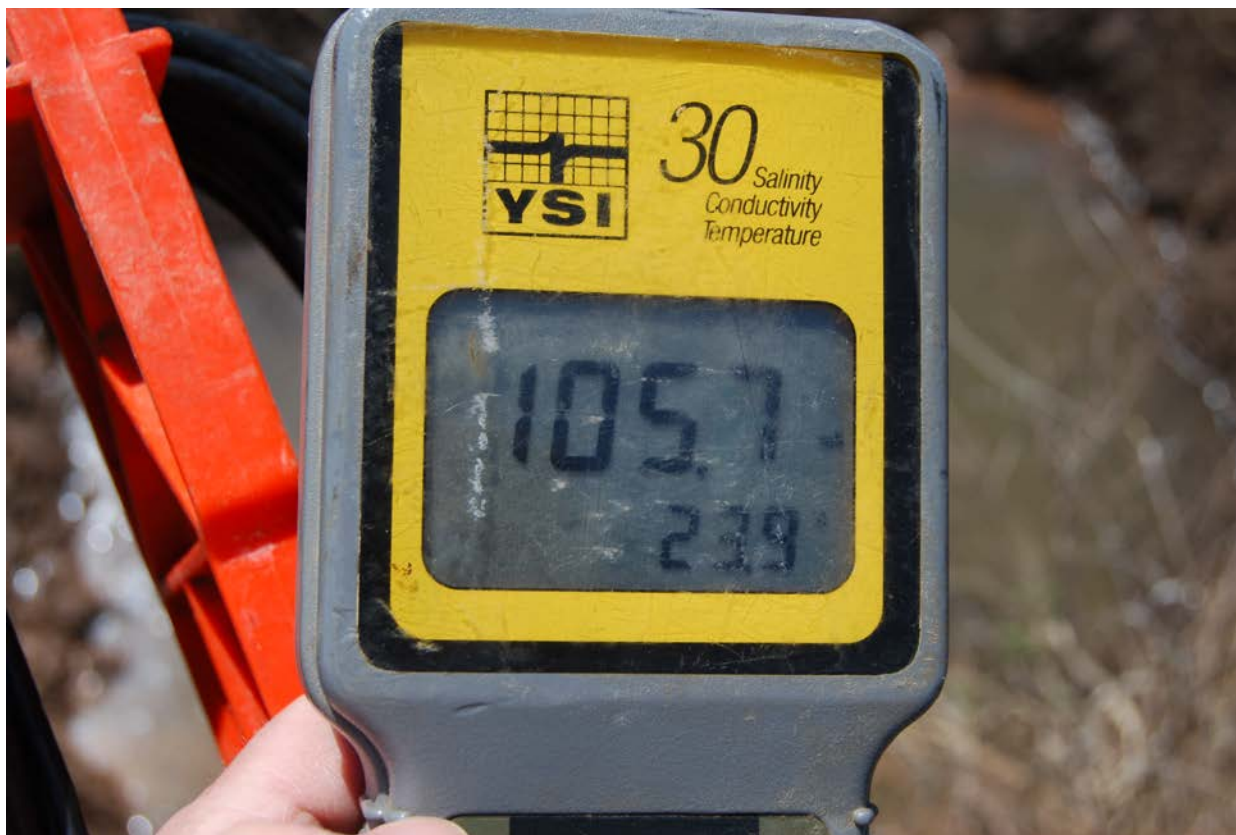
Description: A Specific Conductance field reading was taken with a calibrated YSI 30 Conductivity Meter at the point of entry, from fluids at the first temporary dam was 105.7 milliSiemens/centimeters (mS/cm), which was converted to 68,705 milligrams/Liter (mg/L) Total Dissolved Solids (TDS) as shown in Appendix 2.

| Inspection Report<br>Photo No. | Specific Conductance<br>Reading (mS/cm) | Specific Conductance<br>(uS/cm) | Converted Total<br>Dissolved Solids (mg/L)* |
|---|---|---|---|
| Photo No. 6 | 105.7 mS/cm | 105,700 uS/cm | 68,705 mg/L |

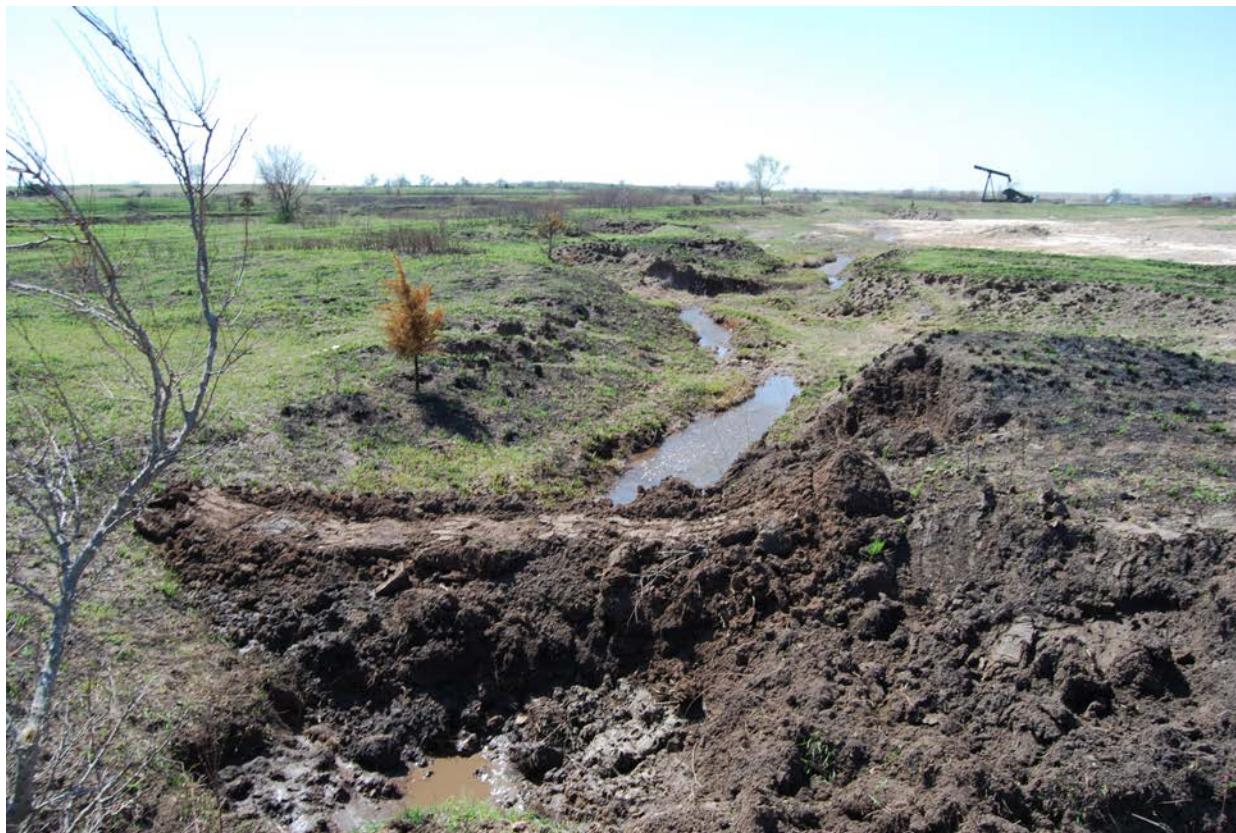
Photo No. 7

Description: The brine flowed south to the second temporary dam in the tributary of Mud Creek shown here.

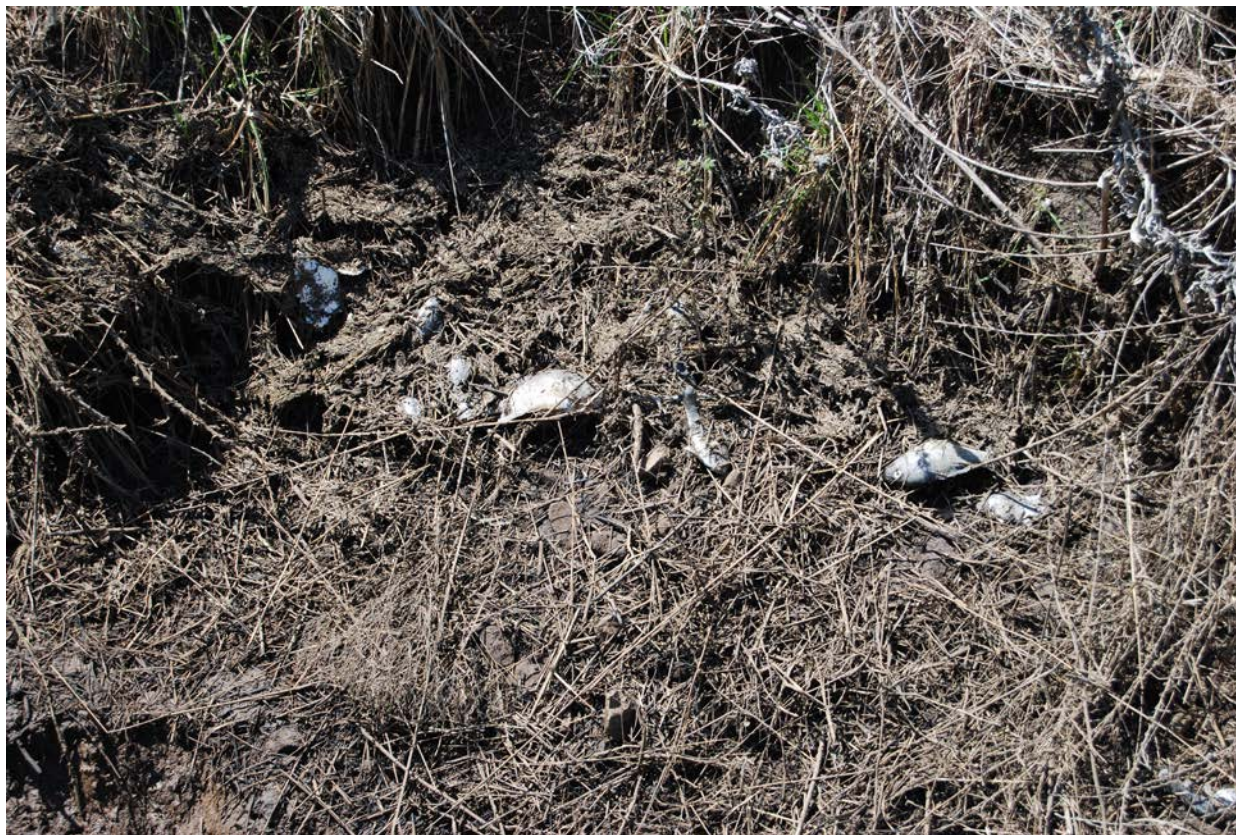
Photo No. 8

Description: I observed dead fish along the tributary of Mud Creek the second temporary dam location.

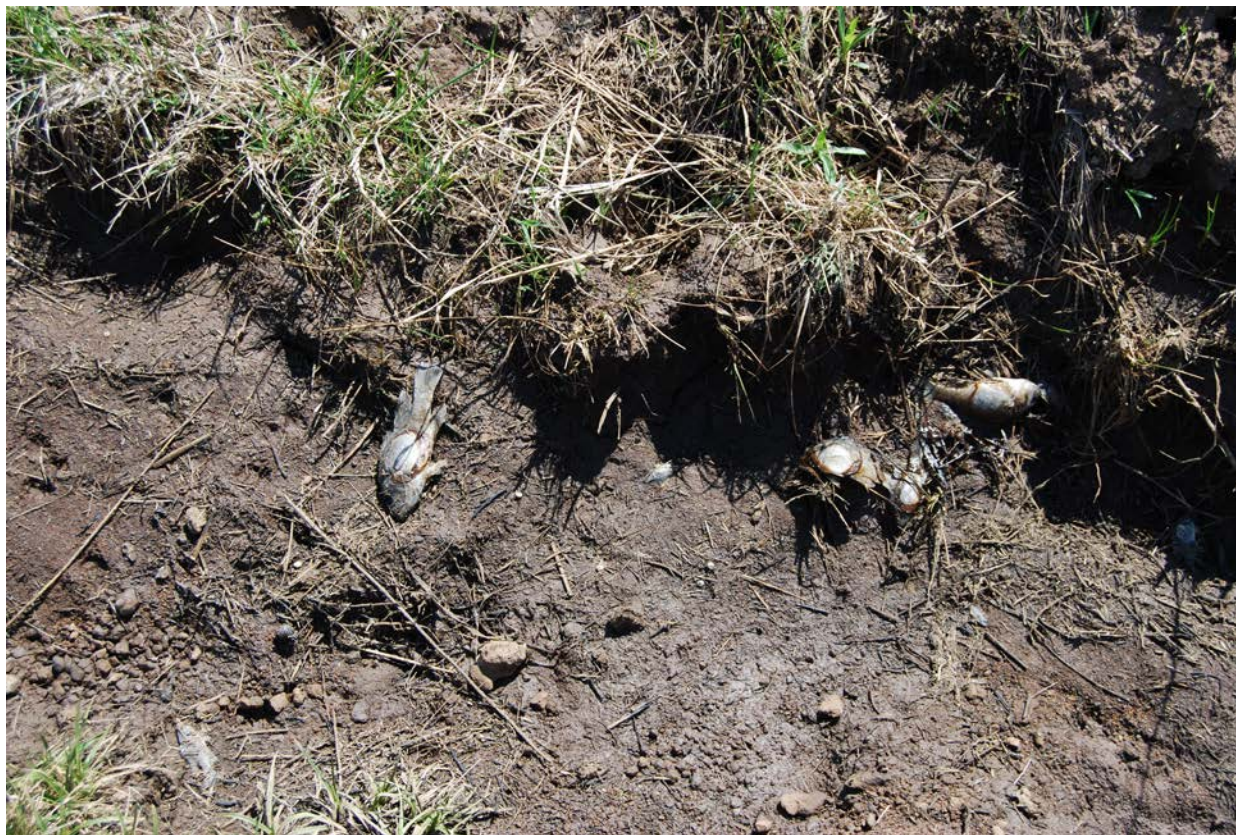
Photo No. 9

Description: I observed more dead fish in and around the second temporary dam 2 location.

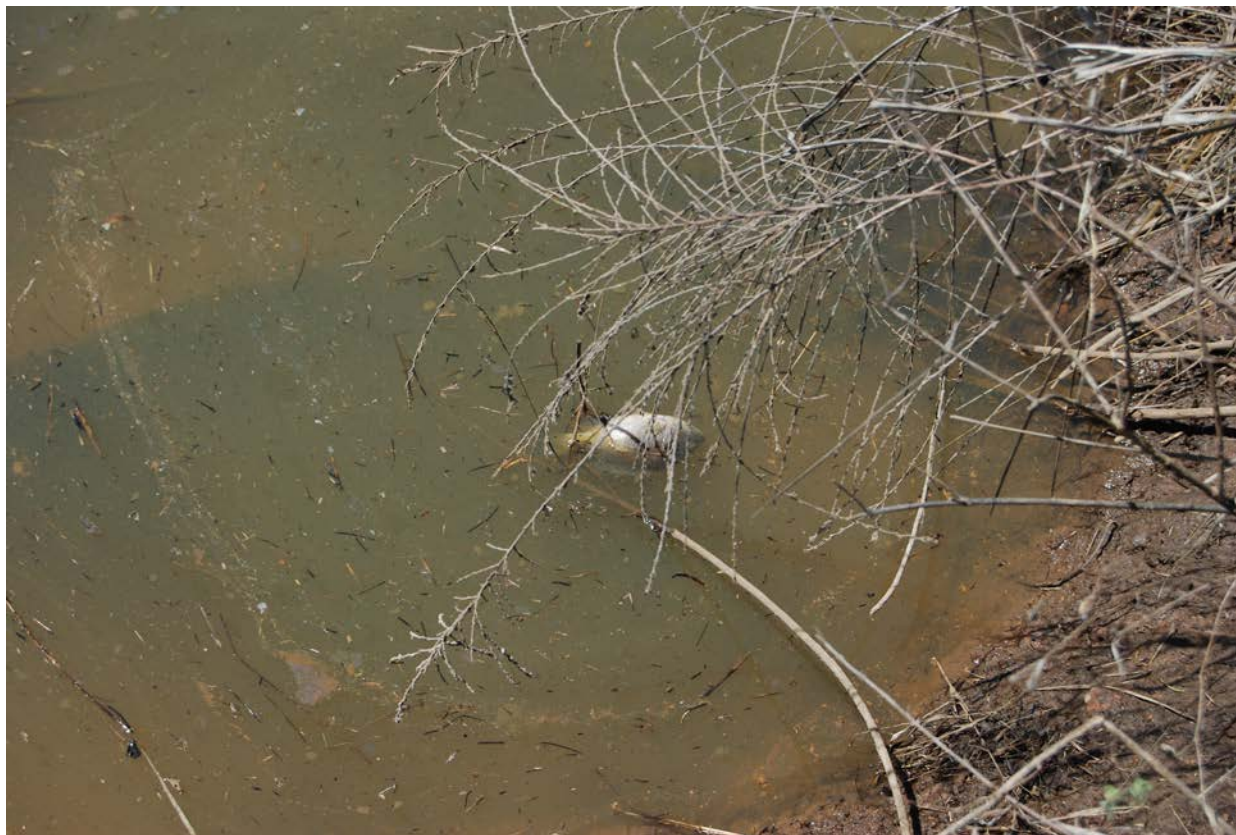
Photo No. 10

Description: I observed another dead fish at the second dam site in the tributary of Mud Creek.

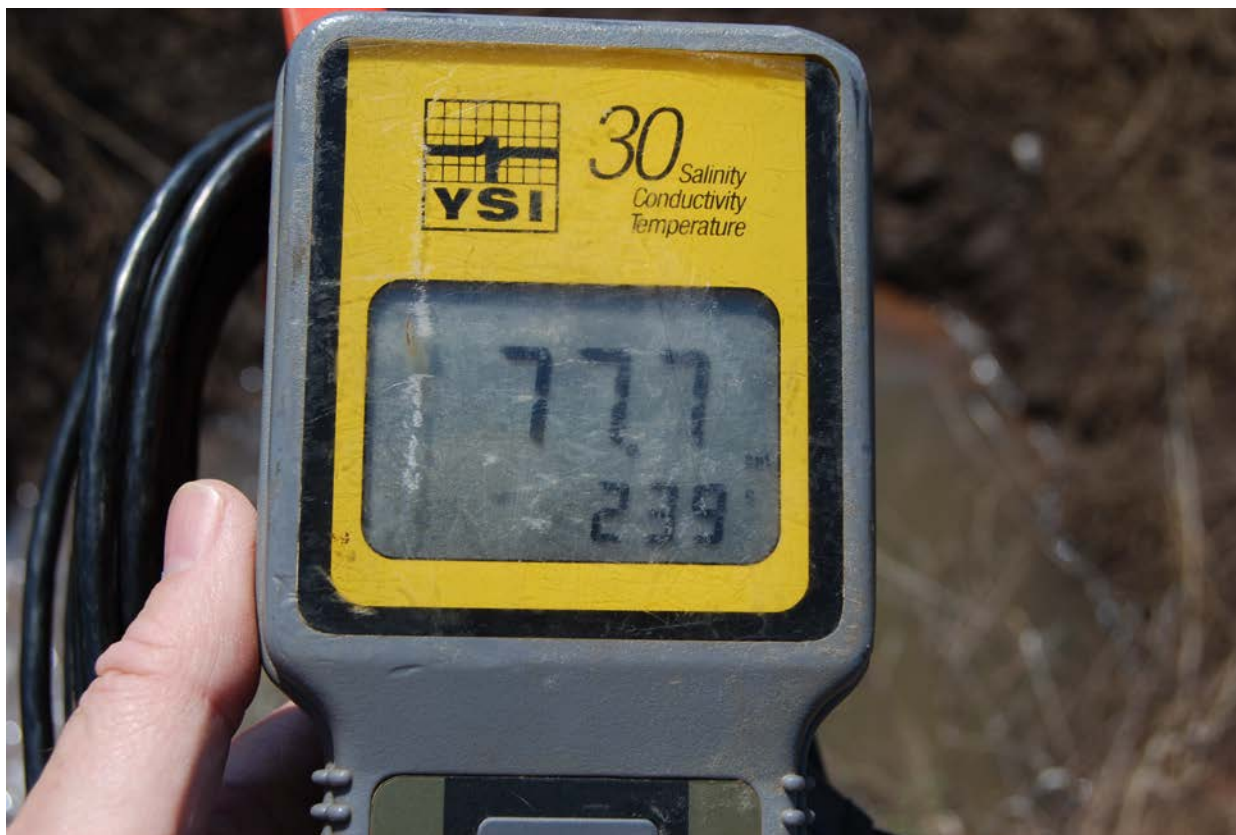
Description: A Specific Conductance field reading was taken at the second temporary dam, from fluids at the second temporary dam was 77.7 mS/cm, which was converted to 50,505 mg/L TDS as shown in Appendix 2.

| Inspection Report<br>Photo No. | Specific Conductance<br>Reading (mS/cm) | Specific Conductance<br>(uS/cm) | Converted Total<br>Dissolved Solids (mg/L)* |
|---|---|---|---|
| Photo No. 11 | 77.7 mS/cm | 77,700 uS/cm | 50,505 mg/L |

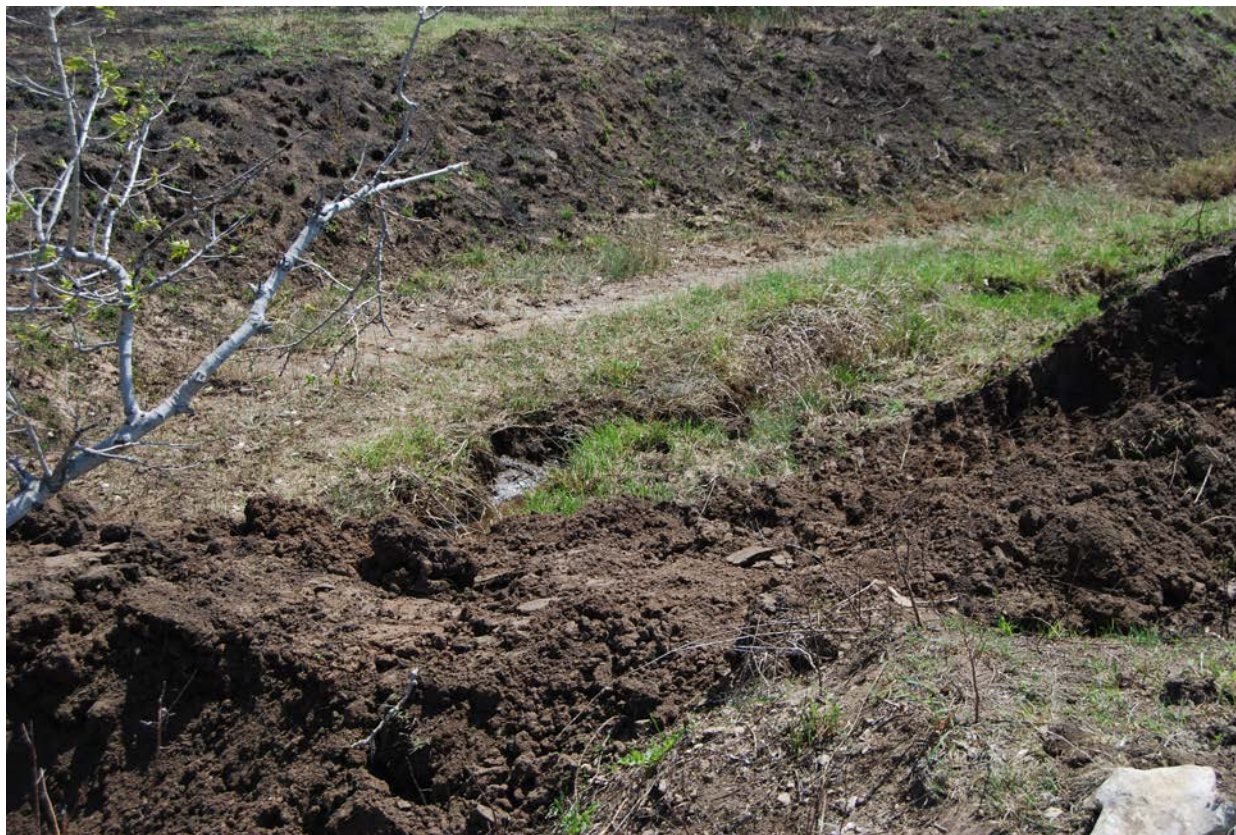
Photo No. 12

Description: The third temporary dam shown here is located downstream from the second temporary dam, where an additional branch to the tributary of Mud Creek was flowing into the tributary from the northeast.

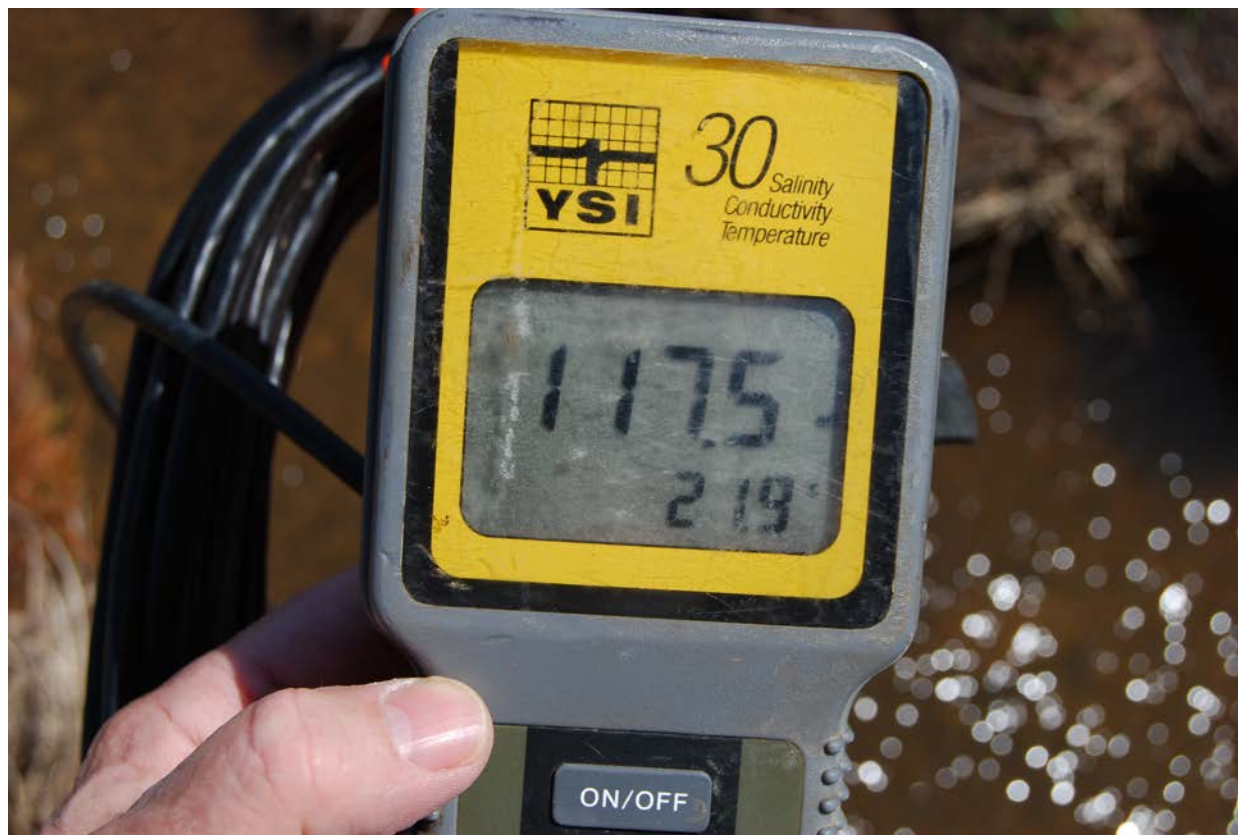
Description: A Specific Conductance field reading was taken at the third temporary dam, from fluids at the third temporary dam was 117.5 mS/cm, which was converted to 76,375 mg/L TDS as shown in Appendix 2.

| Inspection Report<br>Photo No. | Specific Conductance<br>Reading (mS/cm) | Specific Conductance<br>(uS/cm) | Converted Total<br>Dissolved Solids (mg/L)* |
|---|---|---|---|
| Photo No. 13 | 117.5 mS/cm | 117,500 uS/cm | 76,375 mg/L |

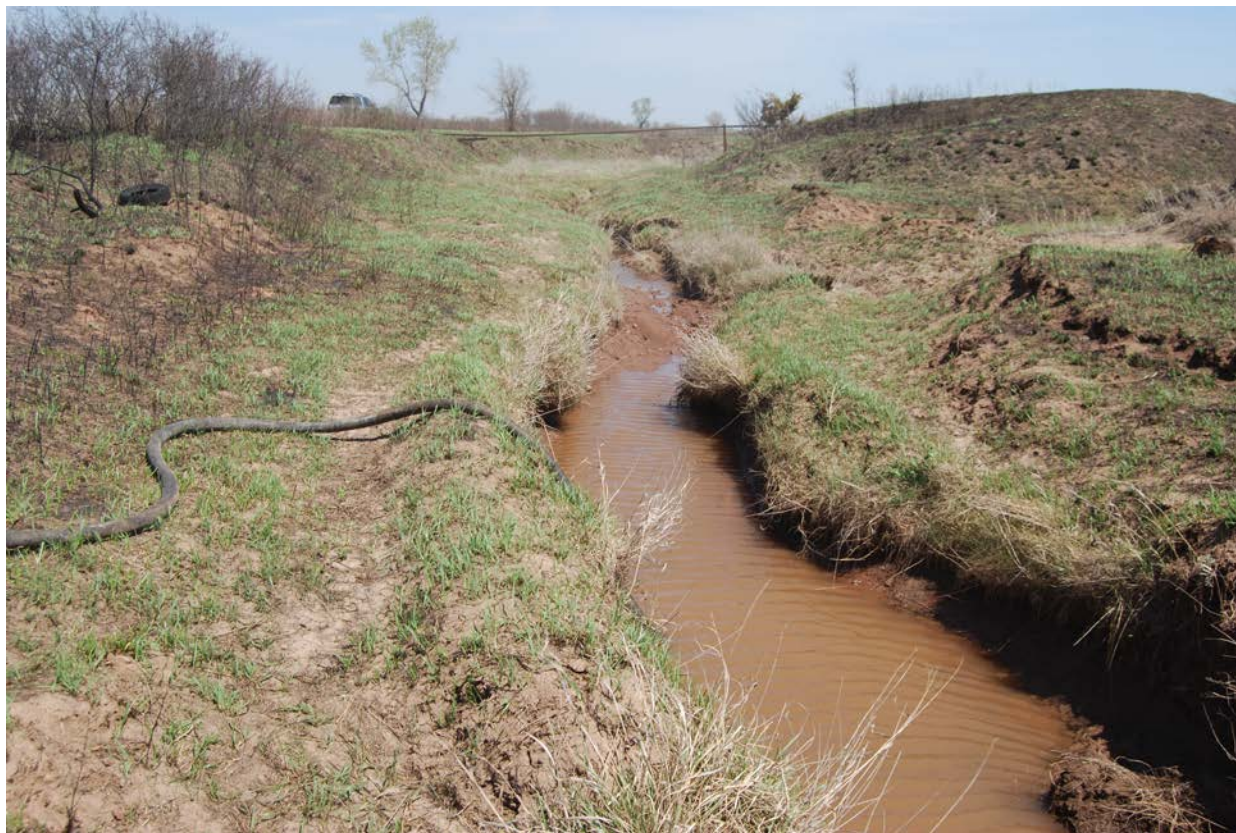
Photo No. 14

Description: The tributary of Mud Creek south of the third temporary dam is shown here. I observed that trucks were pumping out the tributary during the inspection at this location.

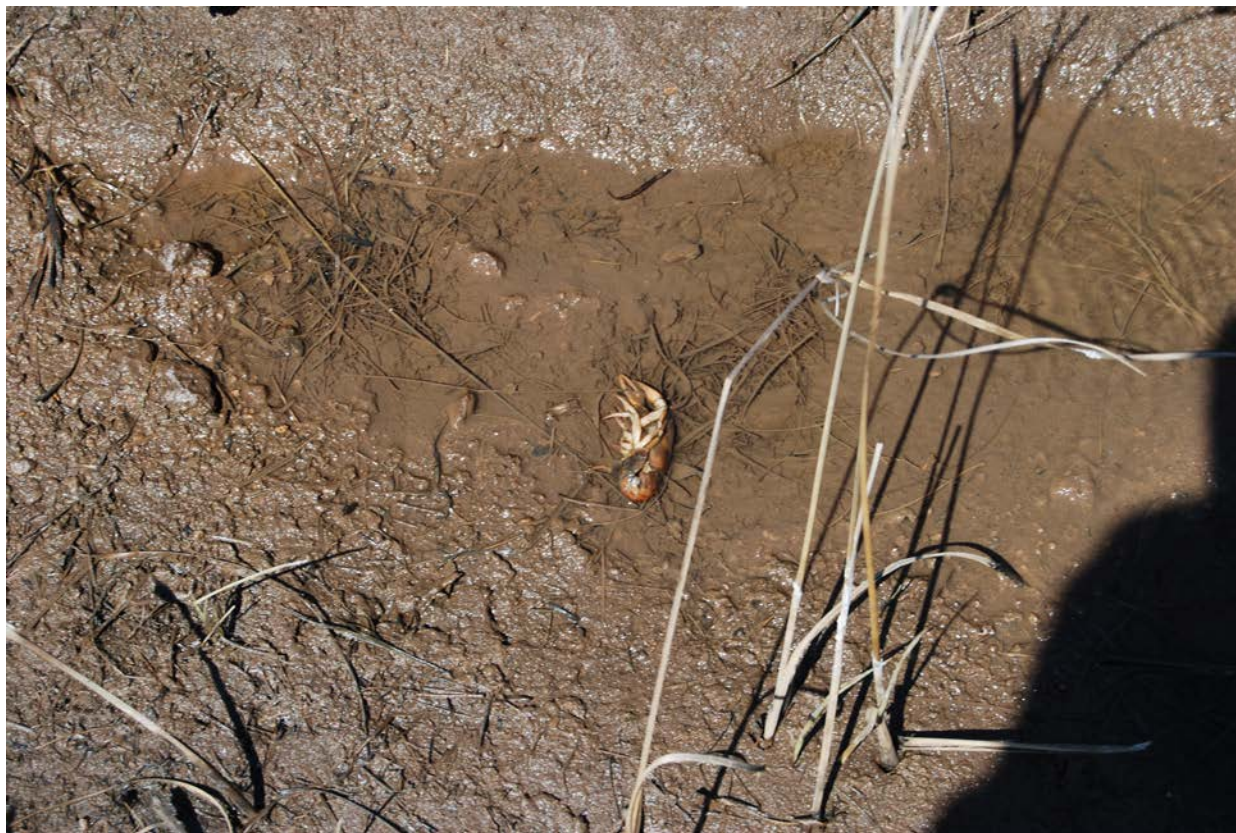
Photo No. 15

Description: I observed one dead crayfish near the location shown in Photo 14 in the tributary of Mud Creek.

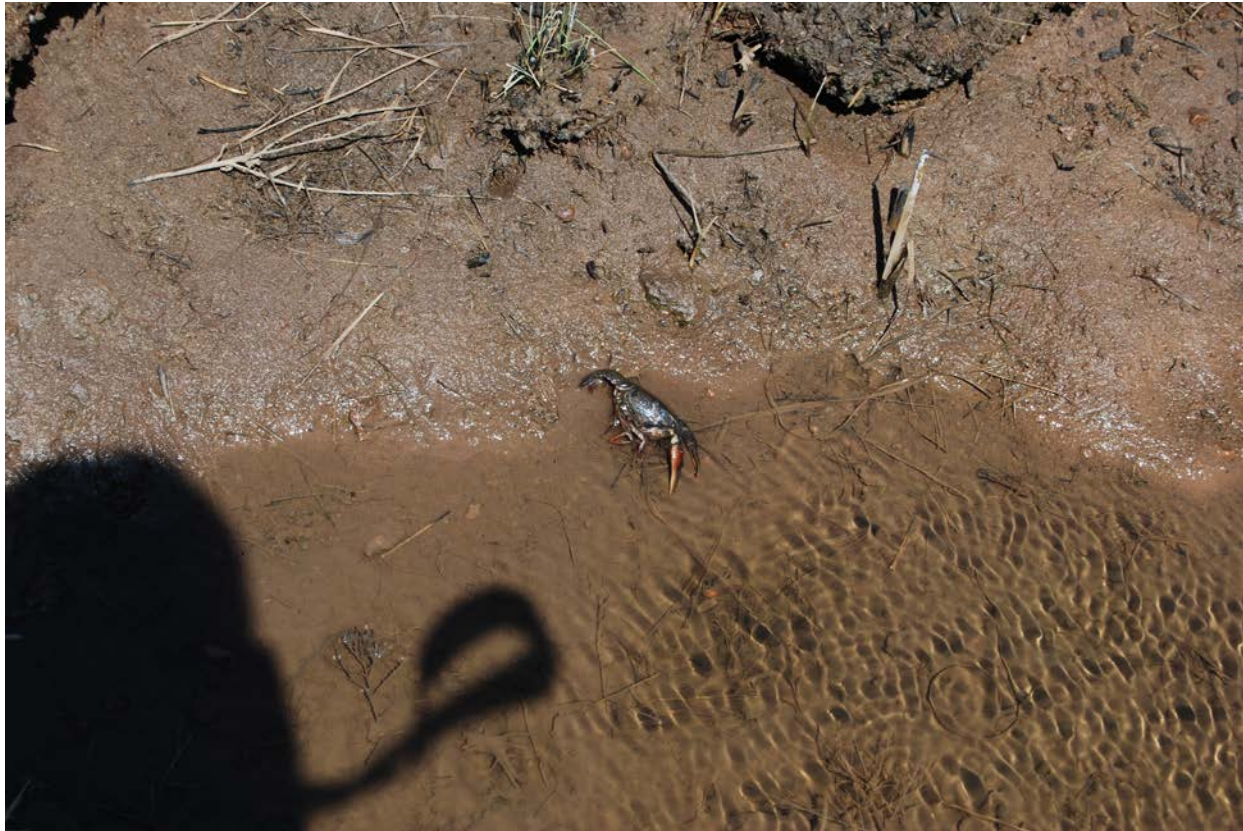
Photo No. 16

Description: I observed an additional dead crayfish near the third temporary dam site in the tributary of Mud Creek.

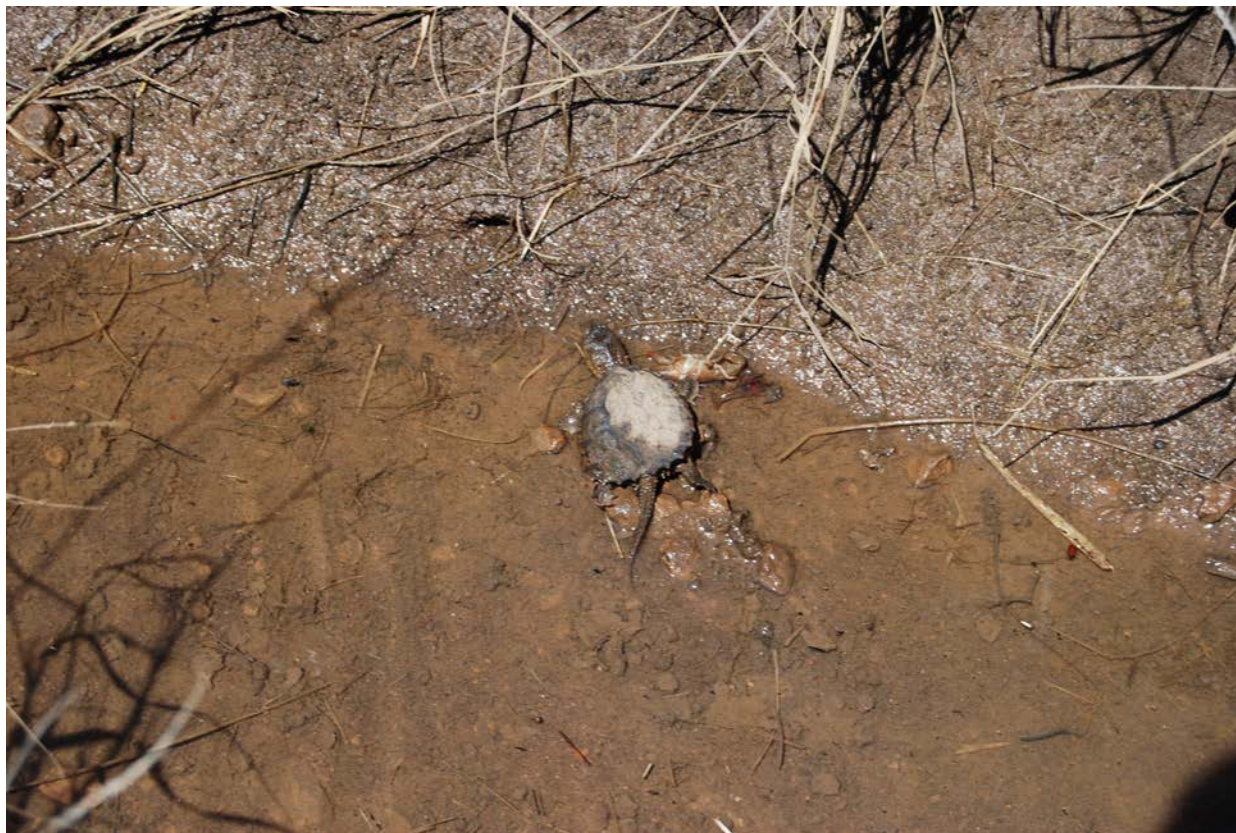
Photo No. 17

Description: I observed a dead turtle in the tributary of Mud Creek near the third temporary dam during the inspection.

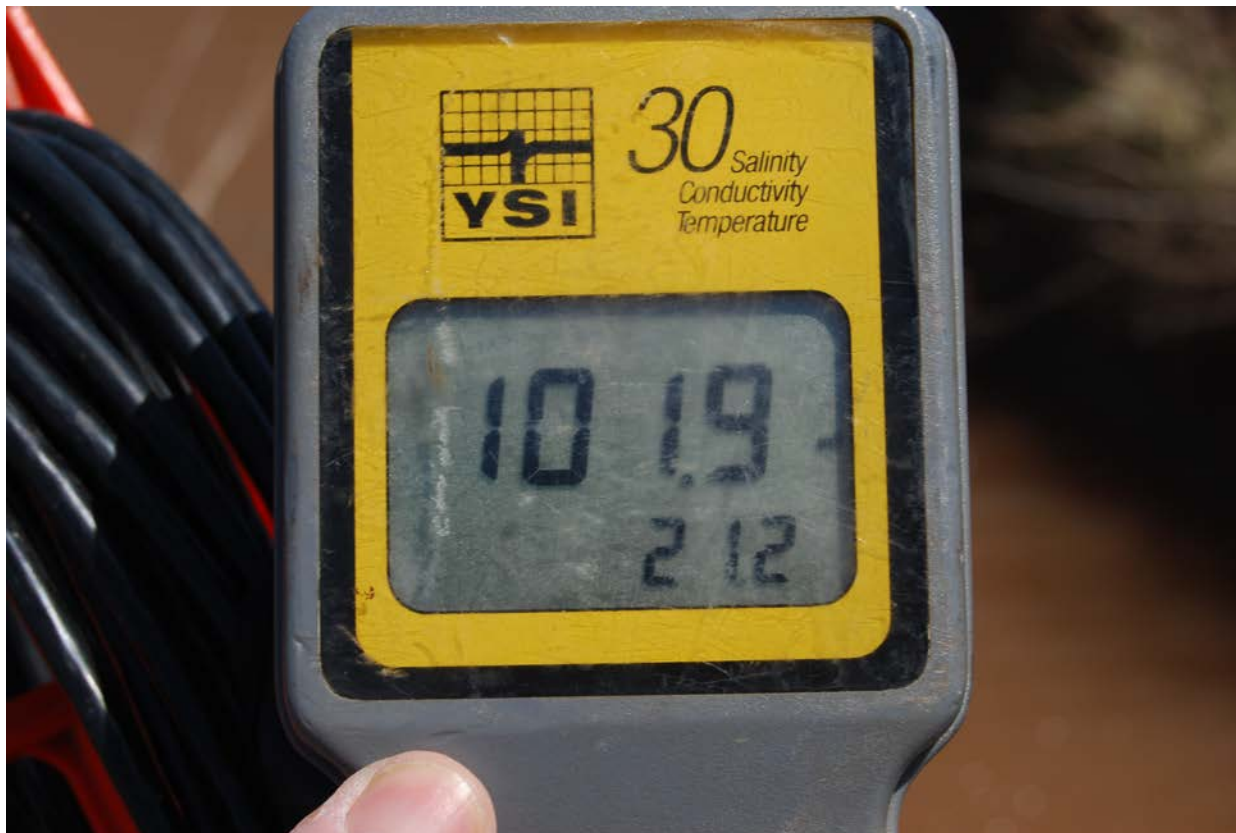
Description: An additional Specific Conductance field reading was taken at the third temporary dam and was 101.9 mS/cm, which was converted to 66,235 mg/L TDS as shown in Appendix 2.

| Inspection Report<br>Photo No. | Specific Conductance<br>Reading (mS/cm) | Specific Conductance<br>(uS/cm) | Converted Total<br>Dissolved Solids (mg/L)* |
|---|---|---|---|
| Photo No. 18 | 101.9 mS/cm | 101,900 uS/cm | 66,235 mg/L |

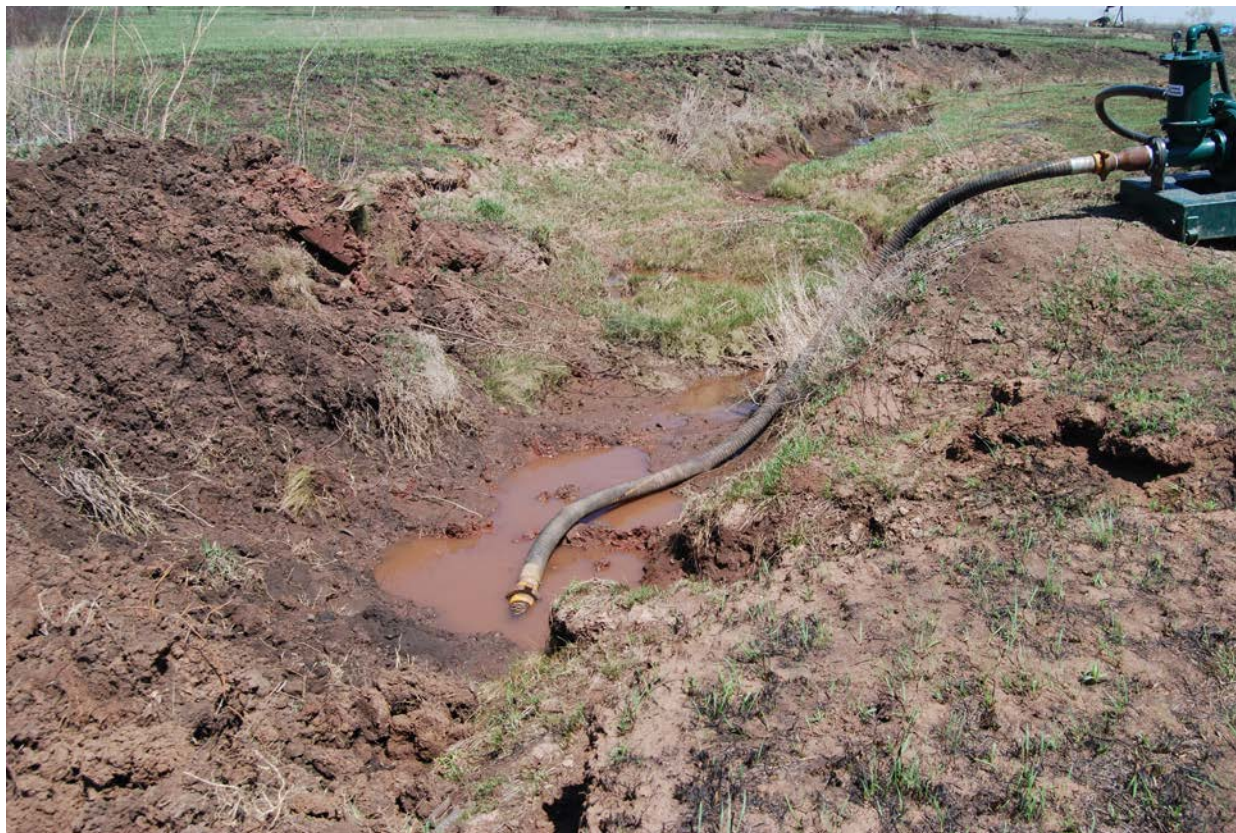
Photo No. 19

Description: I observed a fourth temporary dam, which is shown here in this photo. A pump was being used to pump tributary fluids to a frac tank south of this area.

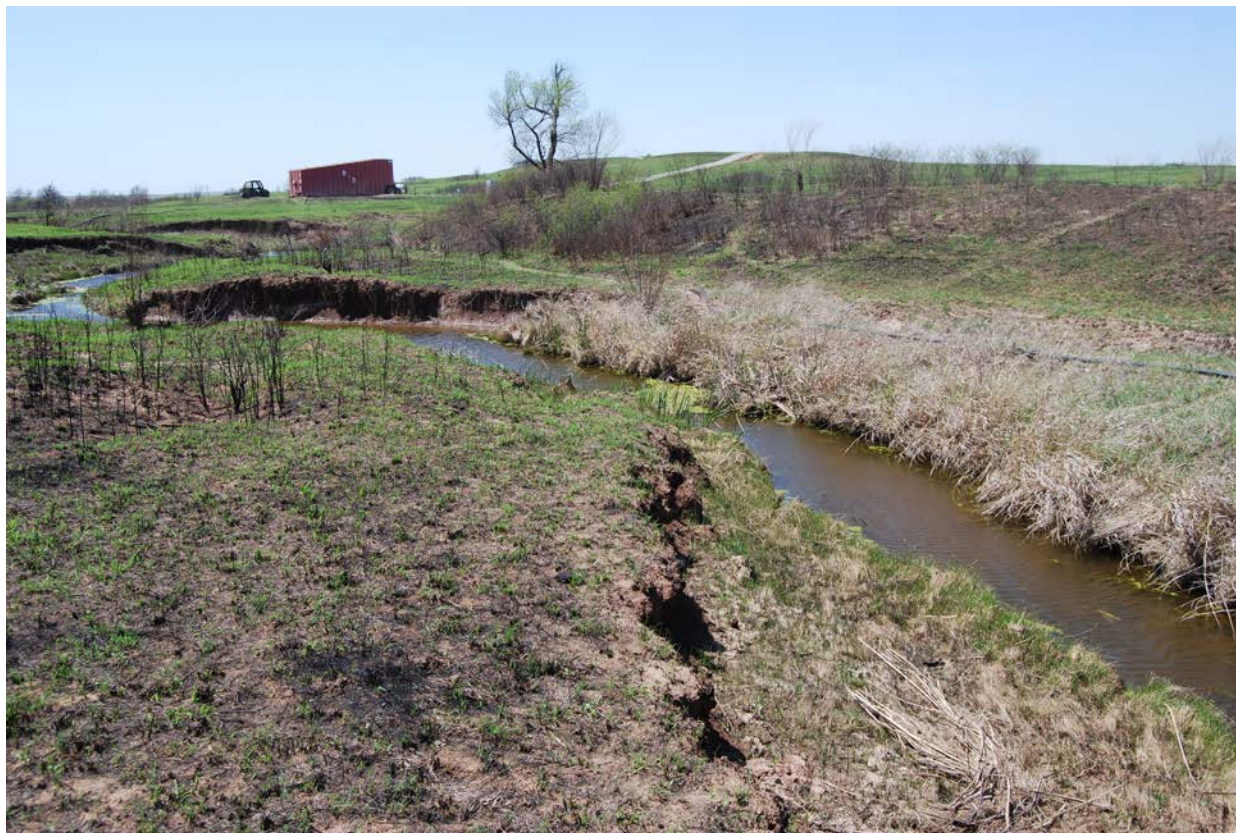
Photo No. 20

Description: This photo shows a view of the tributary of Mud Creek south of the fourth temporary dam. I observed that most of the fluids upstream of this point along the tributary had been removed due to pumping out activities.

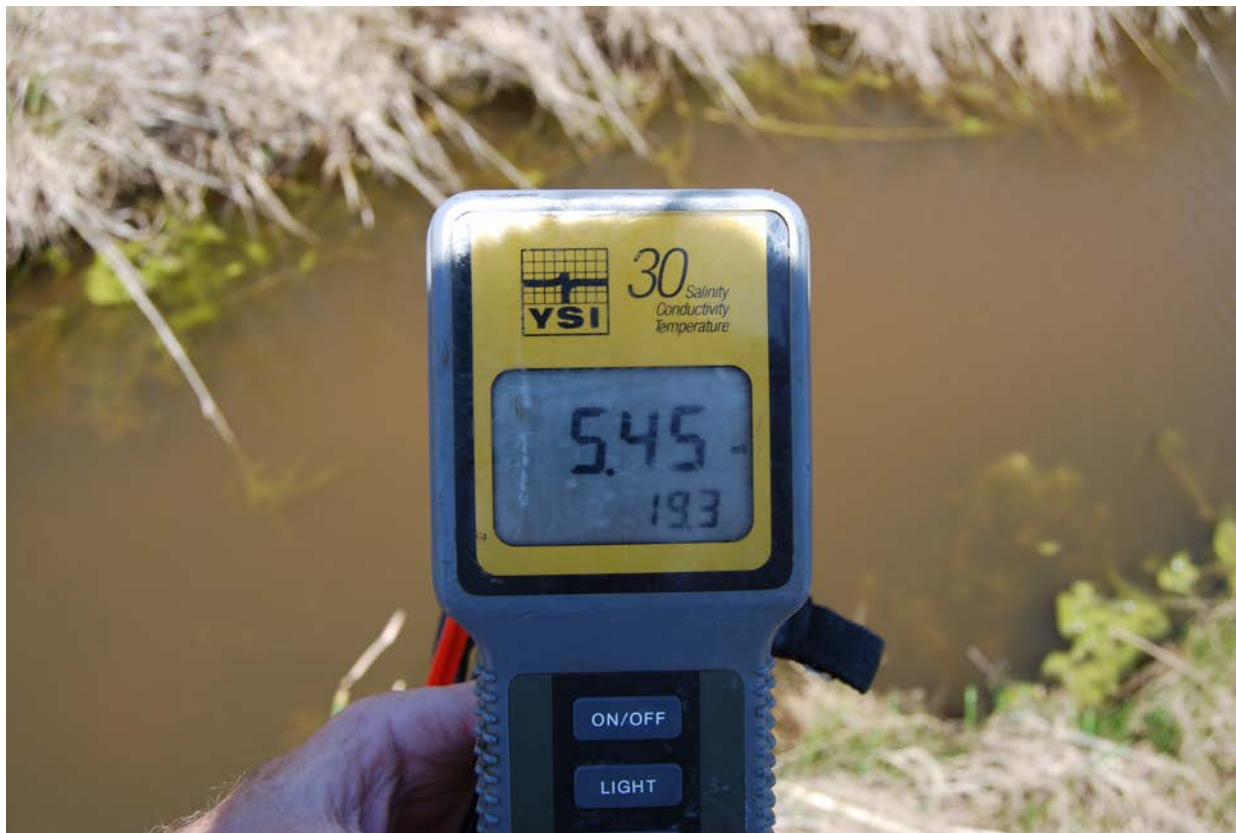
Description: An additional Specific Conductance field reading was taken at Photo No. 20 and was 5.45 mS/cm, which was converted to 3,542.5 mg/L TDS as shown in Appendix 2.

| Inspection Report<br>Photo No. | Specific Conductance<br>Reading (mS/cm) | Specific Conductance<br>(uS/cm) | Converted Total<br>Dissolved Solids (mg/L)* |
|---|---|---|---|
| Photo No. 21 | 5.45 mS/cm | 5,450 uS/cm | 3,542.5 mg/L |
