## Region 6 Compliance Assurance and Enforcement Division

### INSPECTION REPORT

| Company Name: | <b>Perdure Petroleum, LLC</b> | | |
| Facility Name: | <b><i>North Burbank Unit 56-12</i></b> | | |

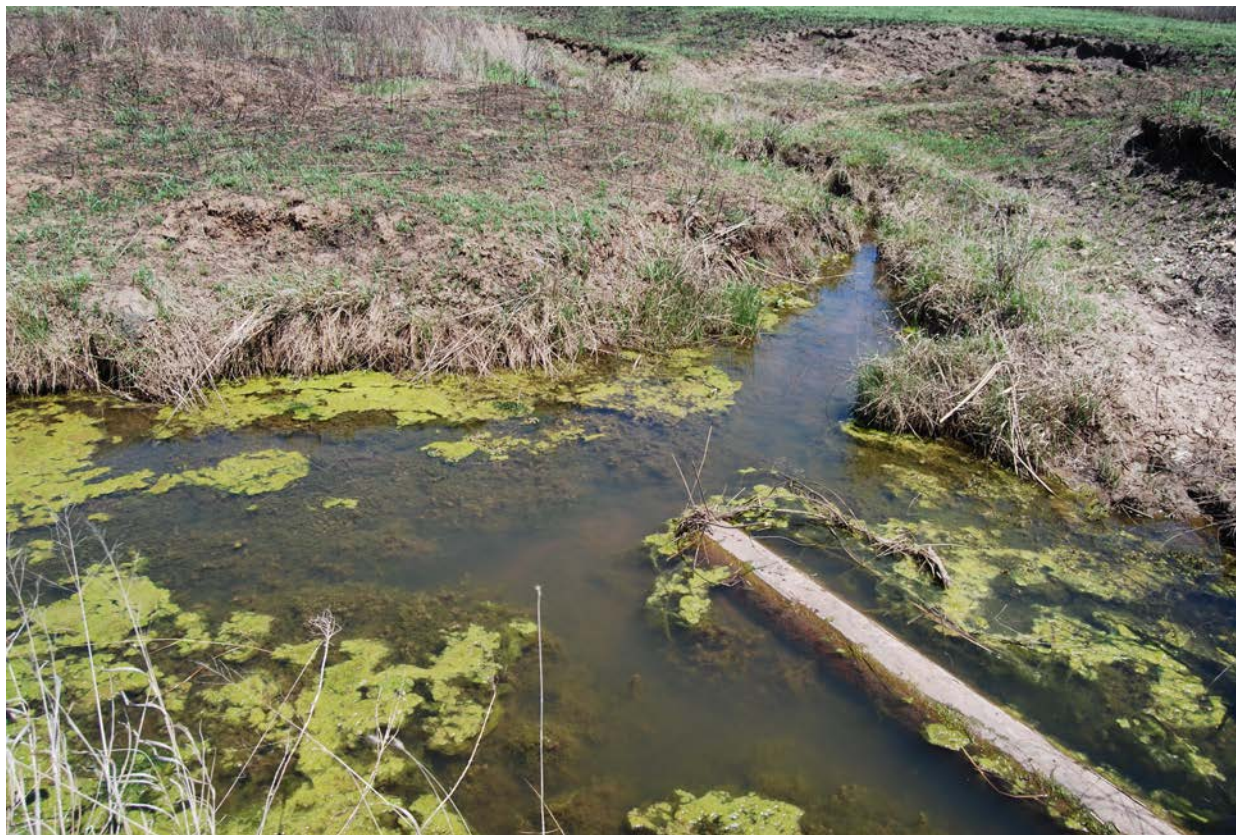
Photo No. 22

Description: The tributary of Mud Creek was joined by another branch of Mud Creek coming from the northeast shown here. The confluence of the two tributaries was downstream of all the temporary dams within the tributary of Mud Creek.

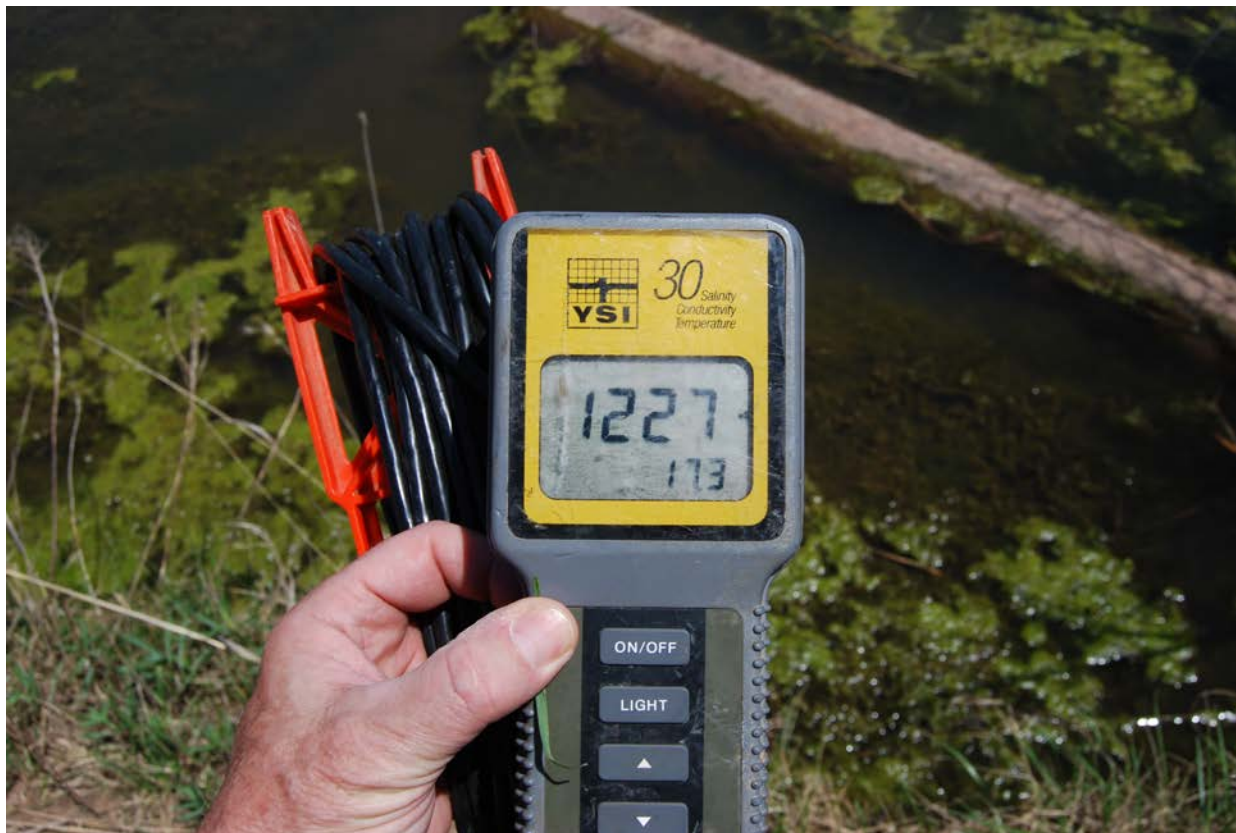
Photo No. 23

Description: A Specific Conductance field reading was taken at Photo No. 22 and was 1,227 microSiemens/centimeters (uS/cm), which was converted to 797.5 mg/L TDS as shown in Appendix 2.

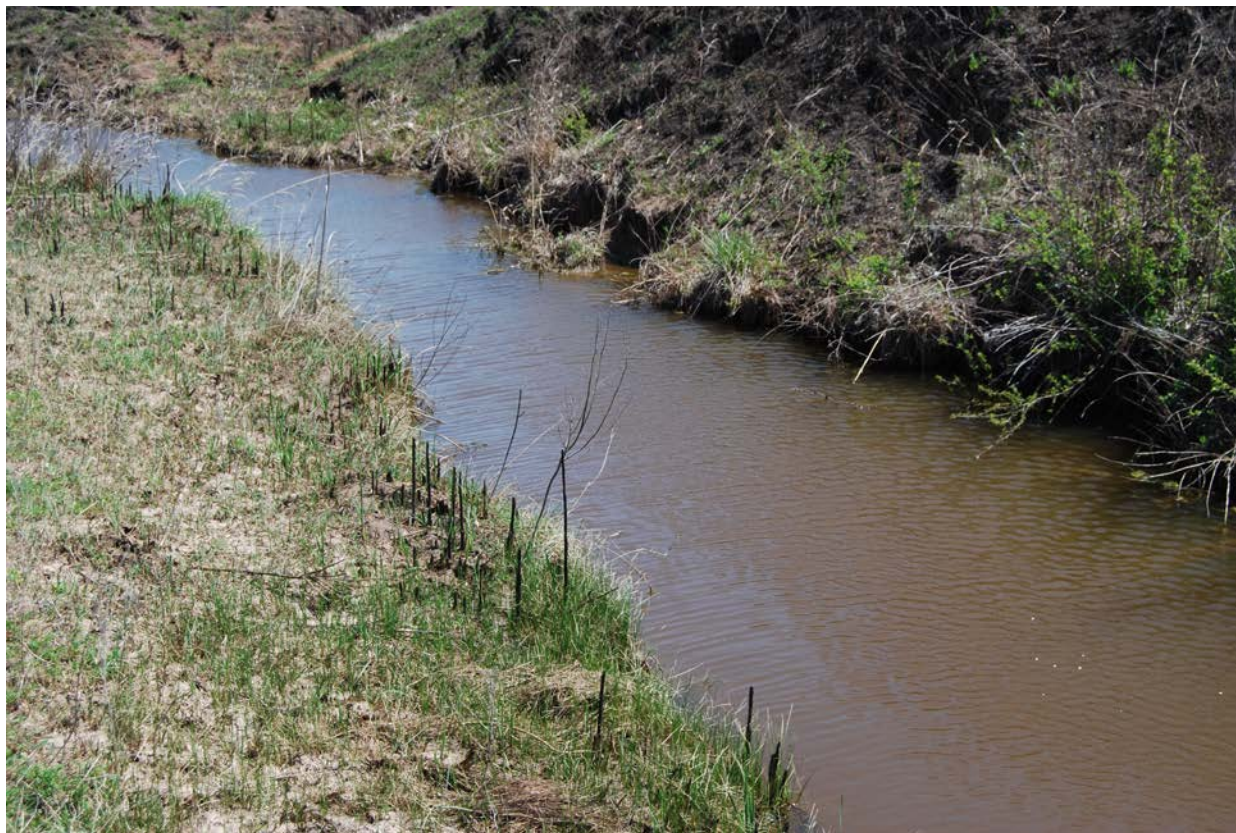
Photo No. 24

Description: This photo shows an unaffected upstream area in a tributary of Mud Creek, which is upstream from the contaminated area near the third temporary dam. This tributary was the first branch that joined the contaminated tributary of Mud Creek near the third dam site.

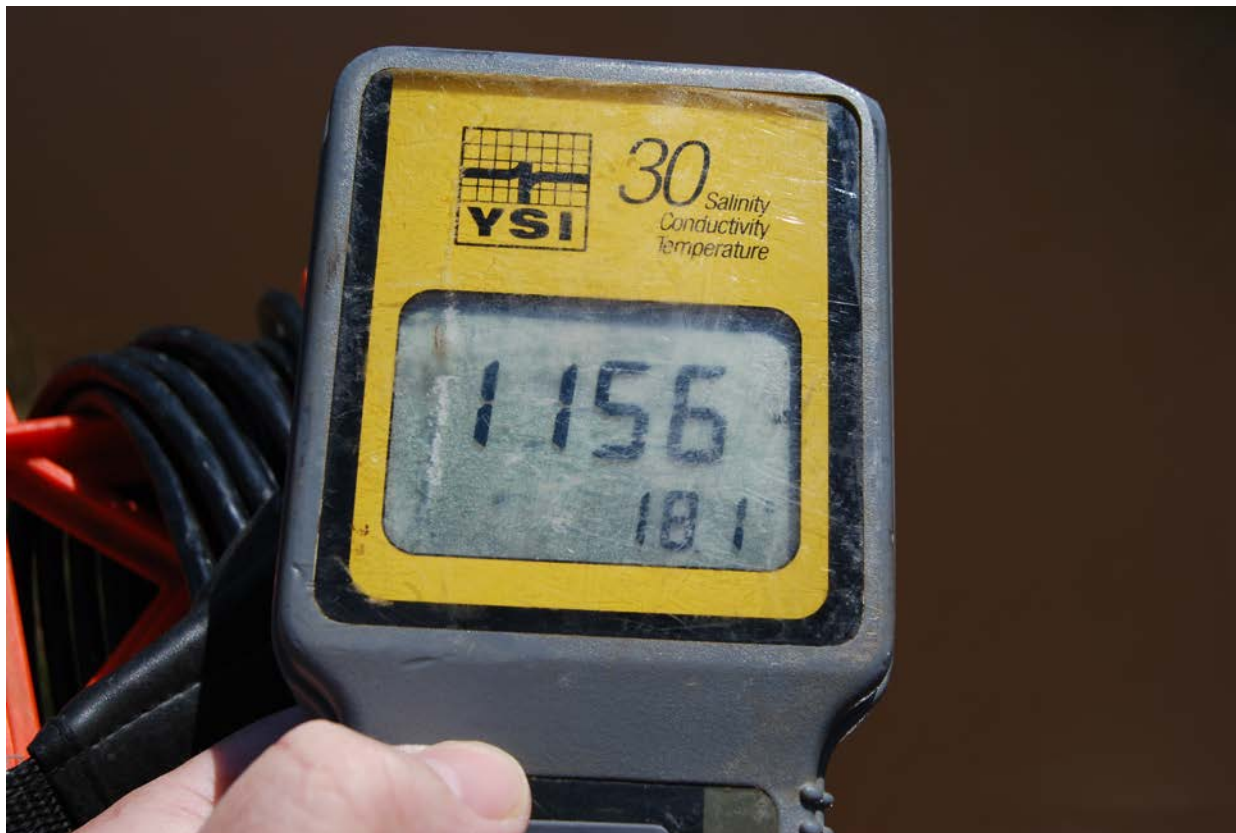
Photo No. 25

Description: A Specific Conductance field reading was taken at Photo No. 24, an unaffected portion of the tributary of Mud Creek and was 1,156 uS/cm, which was converted to 751.4 mg/L TDS as shown in Appendix 2.
