**UNITED STATES ENVIRONMENTAL PROTECTION AGENCY  
REGION III**

**Report Title:** Clean Water Act, Section 404 Inspection Report for the Sun  
Outdoors Chesapeake Bay Site  
**Inspection Date(s):** 04/05/2023  
**Start Time:** 8:55 **End Time:** 11:30

**Regulatory Program(s):** Inspections authorized pursuant to Clean Water Act, Sections 308  
and 404 (33 U.S.C. §§ 1318 and 1344)  
**Site Name:** Sun Outdoors Chesapeake Bay

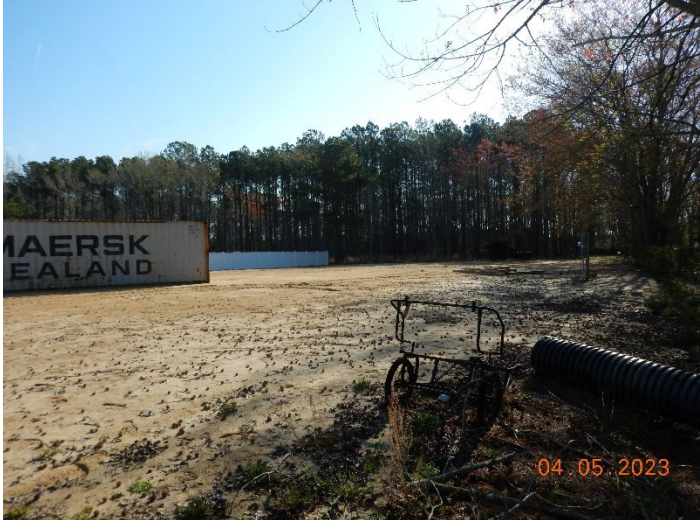
Following the Opening Conference, the inspectors traveled to the southeast of the Welcome Center where Mr. Iocona had stated that approximately 40 truckloads of fill were recently placed. The inspectors observed a rectangular area where brown sandy fill had been discharged (Attachment 2, DSCN4601-DSCN4604). Henceforth, this area will be referred to as Area of Concern (“AOC”) 1.

| | <p>Sun Outdoors Chesapeake Bay<br/>Date: April 5, 2023<br/>Photo ID: DSCN4601<br/>Photo taken by: Katelyn Almeter</p> <p>Notes: Area of Concern (“AOC”) 1 located to the southeast of the Welcome Center where sandy fill had recently been placed.</p> |

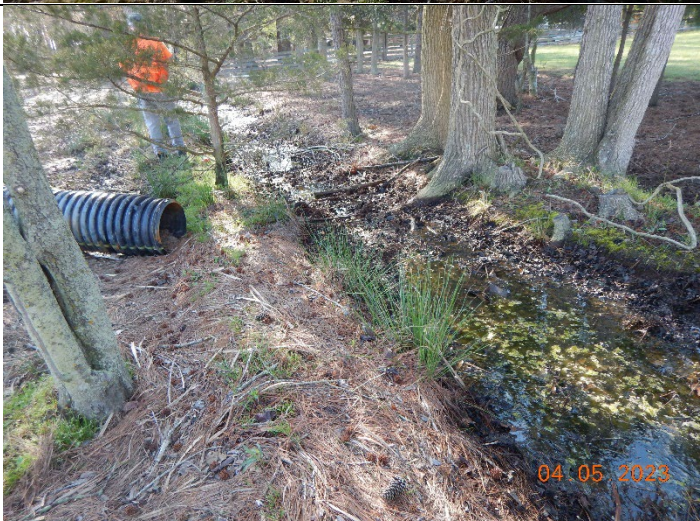
| | <p>Sun Outdoors Chesapeake Bay<br/>Date: April 5, 2023<br/>Photo ID: DSCN4602<br/>Photo taken by: Katelyn Almeter</p> <p>Notes: Eastward view of a linear ditch that was observed to the south of AOC-1.</p> |

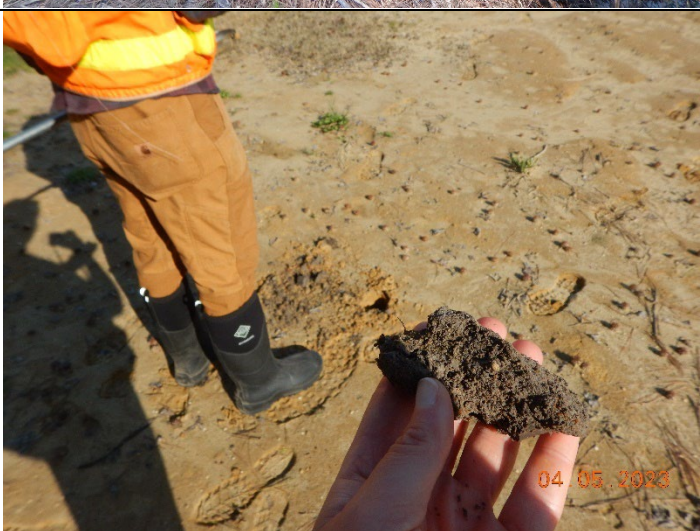
| | <p>Sun Outdoors Chesapeake Bay<br/>Date: April 5, 2023<br/>Photo ID: DSCN4603<br/>Photo taken by: Katelyn Almeter</p> <p>Notes: Sandy fill placed over AOC-1.</p> |

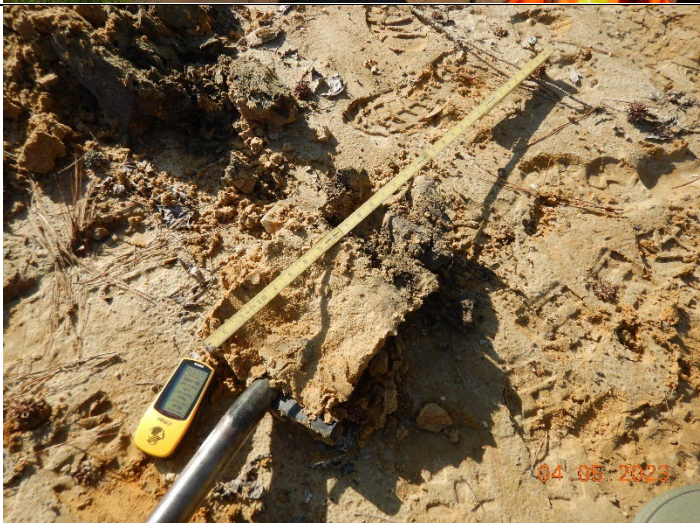
Soil boring Bor-1 was documented at the southwestern corner of AOC-1 at 37.929544, -75.653214 (See Site Figure [Attachment 1] and photos DSCN4605-DSCN4607): [0-8 inches] mixed matrix 80% 7.5YR 5/6 sandy fill and 20% 7.5YR 4/6 sandy fill; [8-11 inches] root mat and native soil surface encountered, 10YR 3/1 sand with 2% 2.5YR 3/6 oxidized rhizospheres; [11-19+ inches] 10YR 3/1 sand with 5% 2.5YR 3/6 redoximorphic features. The observed native soil profile met the technical definition of a hydric soil (Indicator S5). Vegetation was not observed within AOC-1 as all three parameters (i.e., vegetation, soil, and hydrology) were significantly disturbed by the discharge of fill.

| A close-up photograph of a soil profile. A yellow measuring tape is stretched across the top of the soil. A yellow handheld GPS device is placed on the left side of the profile. The soil is light brown and appears to be a mix of sand and silt. A date stamp '04.05.2023' is in the bottom right. | <p>Sun Outdoors Chesapeake Bay<br/>Date: April 5, 2023<br/>Photo ID: DSCN4605<br/>Photo taken by: Katelyn Almeter</p> <p>Notes: Soil profile extracted from Bor-1 at AOC-1.</p> |

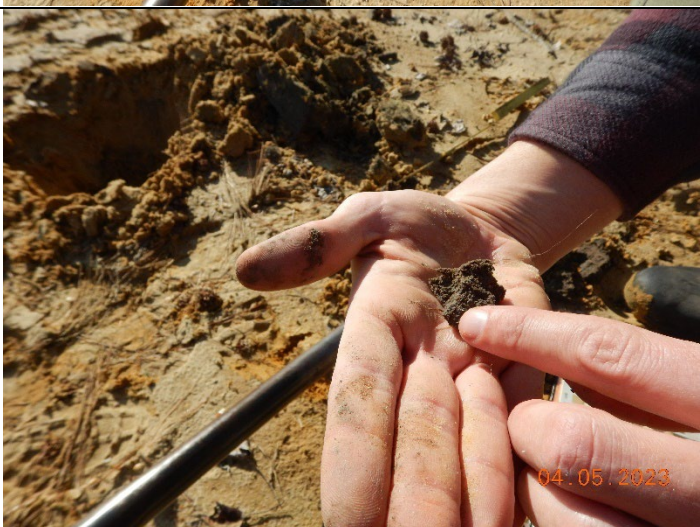
| A close-up photograph of a person's hands holding a small amount of dark, moist soil. The soil is being held between the fingers. The background shows the same soil profile as the previous photo. A date stamp '04.05.2023' is in the bottom right. | <p>Sun Outdoors Chesapeake Bay<br/>Date: April 5, 2023<br/>Photo ID: DSCN4606<br/>Photo taken by: Katelyn Almeter</p> <p>Notes: Native soil extracted from Bor-1 exhibiting redoximorphic features.</p> |

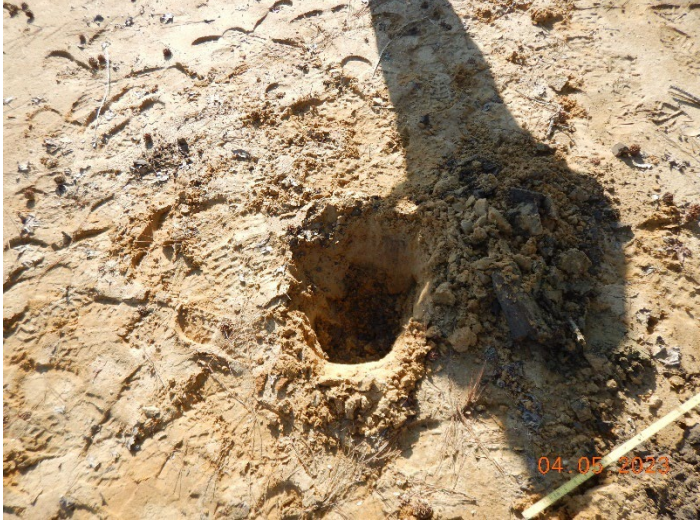
| A close-up photograph of a sandy, light-brown fill material. A yellow measuring tape is visible in the lower right corner, showing a measurement of approximately 1 foot. The date stamp '04.05.2023' is visible in the bottom right corner of the photo. | <p>Sun Outdoors Chesapeake Bay<br/>Date: April 5, 2023<br/>Photo ID: DSCN4607<br/>Photo taken by: Katelyn Almeter</p> <p>Notes: Sandy fill placed at AOC-1.</p> |

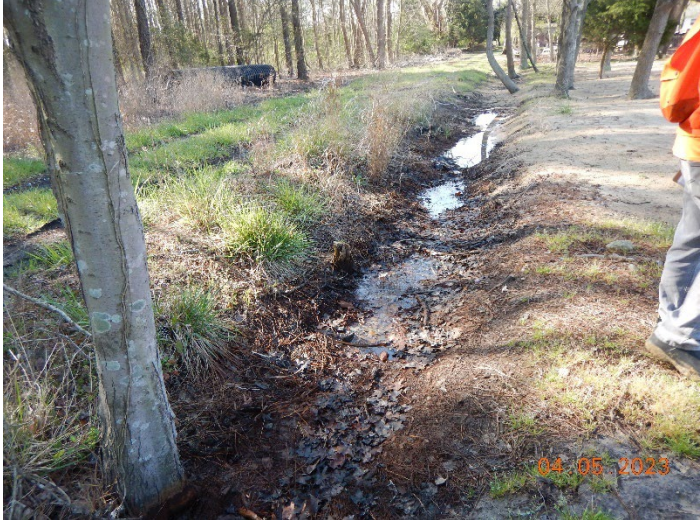
The inspectors walked east and encountered a linear ditch bordering the property, oriented from north to south. The ditch possessed an ordinary high-water mark, flow, and the bed was indicative of regular flow. At the time of inspection, the ditch was full of water with discernable flow toward the Pocomoke Sound. Sandy fill was observed within this ditch (DSCN4608 and DSCN4609). Soil boring Bor-2 was documented immediately to the west of the ditch at the northeastern corner of AOC-1 at 37.929619, -75.652603 (DSCN4610- DSCN4612): [0-10 inches] mixed matrix 80% 7.5YR 5/2 sandy fill and 20% 7.5YR 5/8 sandy fill; [10-11 inches] root mat and native soil surface encountered, 10YR 2/1 organic peat; [11-14+ inches] 10YR 3/1 sandy loam with 5% 2.5YR 3/6 oxidized rhizospheres. The observed native soil profile met the technical definition of a hydric soil (Indicator S5). Vegetation was not observed within AOC-1 as all three parameters (i.e., vegetation, soil, and hydrology) were significantly disturbed by the discharge of fill. AOC-1 was further documented, and fill was observed butting up against multiple tree trunks (DSCN4613- DSCN4615).

| A photograph showing a linear ditch or channel filled with water, running through a wooded area. The ditch is bordered by grass and trees. The date stamp '04.05.2023' is visible in the bottom right corner of the photo. | <p>Sun Outdoors Chesapeake Bay<br/>Date: April 5, 2023<br/>Photo ID: DSCN4608<br/>Photo taken by: Katelyn Almeter</p> <p>Notes: Southward view of a linear ditch observed along the eastern boundary of the Site.</p> |

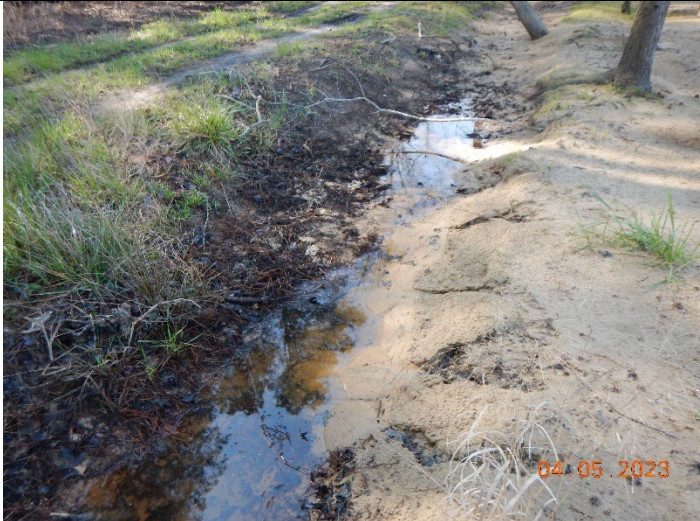
| A photograph showing a linear ditch or channel filled with water, running through a wooded area. The ditch is bordered by grass and trees. The date stamp '04.05.2023' is visible in the bottom right corner of the photo. | <p>Sun Outdoors Chesapeake Bay<br/>Date: April 5, 2023<br/>Photo ID: DSCN4609<br/>Photo taken by: Katelyn Almeter</p> <p>Notes: Southward view of a linear ditch observed along the eastern boundary of the Site. Note the sandy fill discharged into the ditch.</p> |

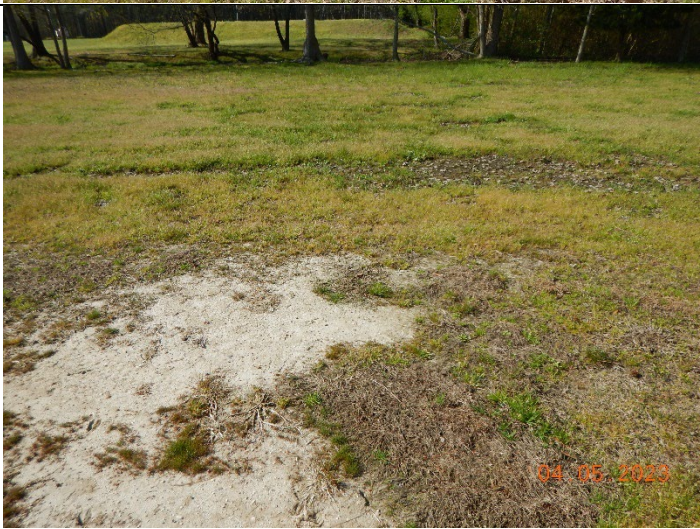
| | <p>Sun Outdoors Chesapeake Bay<br/>Date: April 5, 2023<br/>Photo ID: DSCN4623<br/>Photo taken by: Katelyn Almeter</p> <p>Notes: View of AOC-2. Note sandy fill present at the surface.</p> |

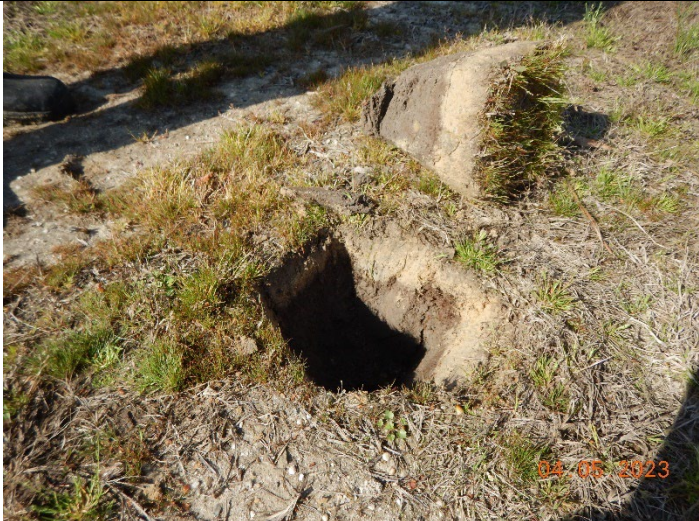
Soil boring Bor-3 was extracted from AOC-2 at 37.929972, -75.655328 (DSCN4627-DSCN4630): [0-3.5 inches] mixed matrix 80% 7.5YR 6/3 sandy fill and 20% 10YR 4/1 sandy loam; [3.5-13 inches] native soil surface encountered, 10YR 4/1 sandy loam with 15% 2.5YR 3/6 oxidized rhizospheres. The observed native soil profile met the technical definition of a hydric soil (Indicator S5). Bor-3 was collected from mowed field which was dominated by turfgrass: Bermudagrass (*Cynodon dactylon*) and annual bluegrass (*Poa annua*). Vegetation in this area was altered by regular maintenance and the soil was impacted by the discharge of fill. While AOC-2 was further documented, including a ditch to the south (DSCN4631-DSCN4637), Ms. Scott stated that in December 2022 a storm inundated the eastern portion of the Site and Mr. Iocona followed up that material was placed in that area in January 2023 because maintenance trucks had difficulty with access.

| | <p>Sun Outdoors Chesapeake Bay<br/>Date: April 5, 2023<br/>Photo ID: DSCN4627<br/>Photo taken by: Katelyn Almeter</p> <p>Notes: Bor-3 extracted from AOC-2.</p> |

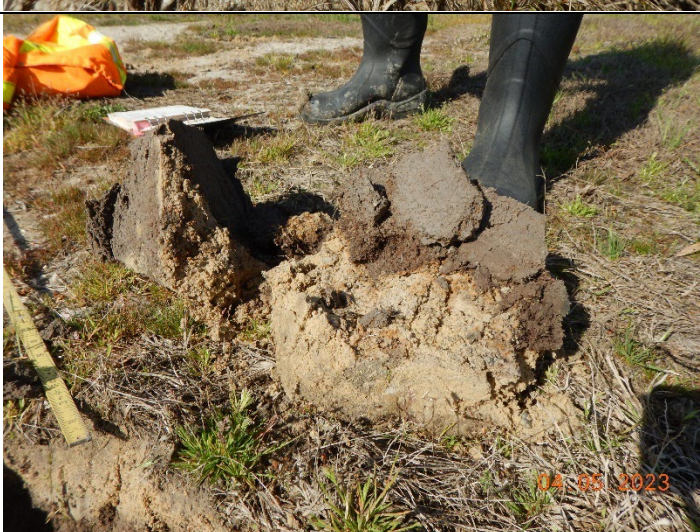
| | <p>Sun Outdoors Chesapeake Bay<br/>Date: April 5, 2023<br/>Photo ID: DSCN4630<br/>Photo taken by: Katelyn Almeter</p> <p>Notes: Bor-3 extracted from AOC-2.</p> |

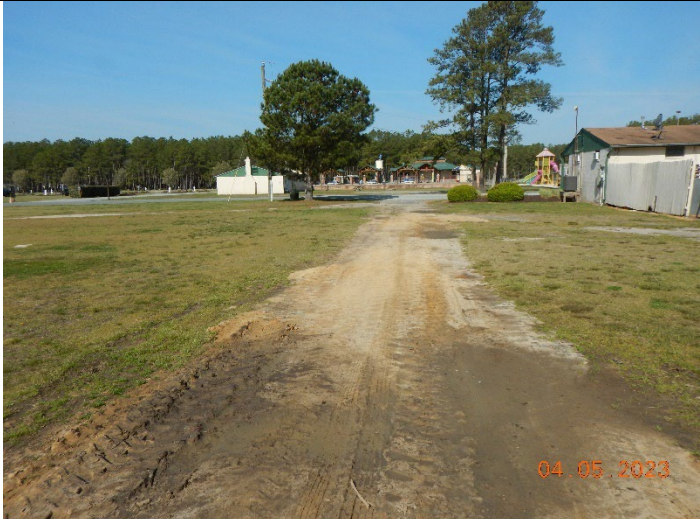
The inspection team then traveled to this area on the central-eastern portion of the Site where a road constructed of fill material was documented (DSCN4639-DSCN4640). Piles of logs, firewood, mulch and general woody refuse were also observed. Additionally, the area was used to store miscellaneous items associated with the operation, landscaping equipment and materials (DSCN4641- DSCN4648). Henceforth, this area will be referred to as AOC-3. Some miscellaneous items were scattered to the east of the Site throughout the forest. Mr. Iocona stated that this was due the recent flooding event in December 2022.

| | <p>Sun Outdoors Chesapeake Bay<br/>Date: April 5, 2023<br/>Photo ID: DSCN4639<br/>Photo taken by: Katelyn Almeter</p> <p>Notes: Westward view of road constructed within AOC-3.</p> |

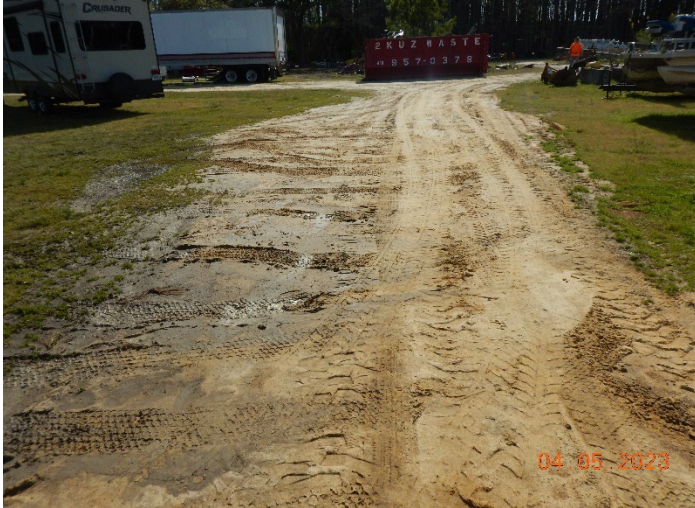
| | <p>Sun Outdoors Chesapeake Bay<br/>Date: April 5, 2023<br/>Photo ID: DSCN4640<br/>Photo taken by: Katelyn Almeter</p> <p>Notes: Eastward view of road constructed within AOC-3.</p> |

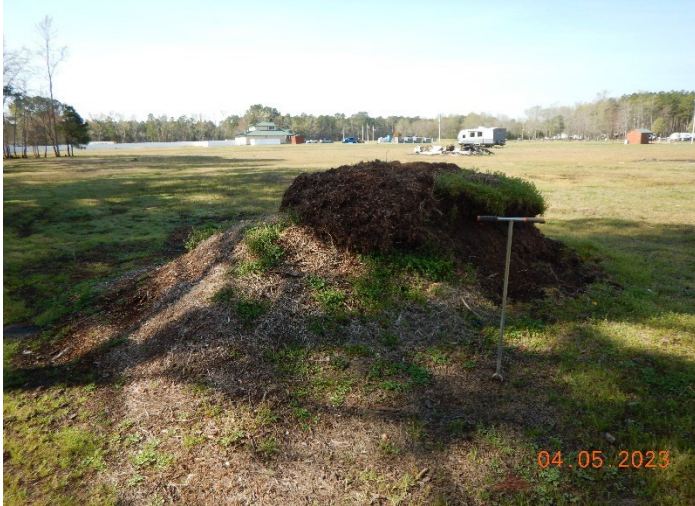
| | <p>Sun Outdoors Chesapeake Bay<br/>Date: April 5, 2023<br/>Photo ID: DSCN4643<br/>Photo taken by: Katelyn Almeter</p> <p>Notes: Pile of fill located within AOC-3.</p> |

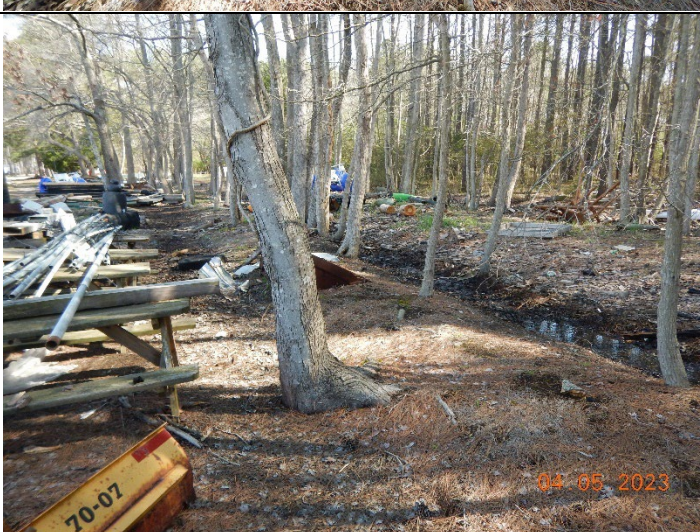
| A photograph showing a wooded area with a large pile of refuse, including branches, leaves, and other debris, scattered on the ground. The ground is covered with dry leaves and pine needles. A date stamp "04.05.2023" is visible in the bottom right corner of the photo. | <p>Sun Outdoors Chesapeake Bay<br/>Date: April 5, 2023<br/>Photo ID: DSCN4648<br/>Photo taken by: Katelyn Almeter</p> <p>Notes: Eastward view of refuse which was scattered by inundation during a December 2022 storm.</p> |

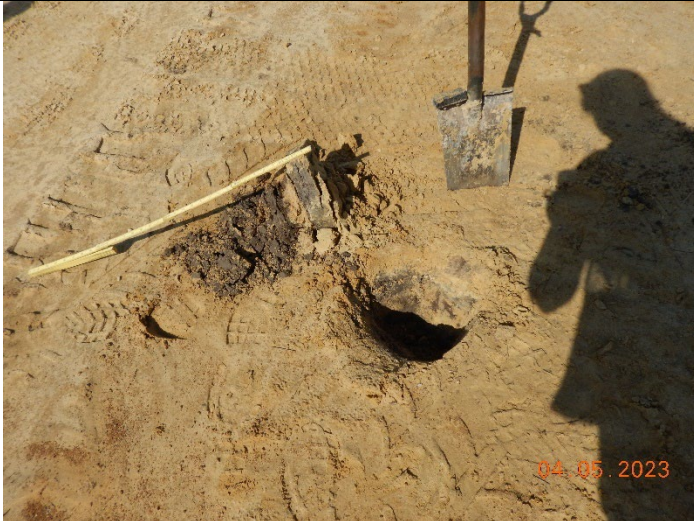
| A close-up photograph of sandy soil. A shovel is stuck in the sand, and a yellow measuring stick is placed horizontally across the sand. The shadow of the person taking the photo is visible on the right. A date stamp "04.05.2023" is visible in the bottom right corner. | <p>Sun Outdoors Chesapeake Bay<br/>Date: April 5, 2023<br/>Photo ID: DSCN4651<br/>Photo taken by: Katelyn Almeter</p> <p>Notes: Bor-4 collected from road constructed of sandy fill.</p> |

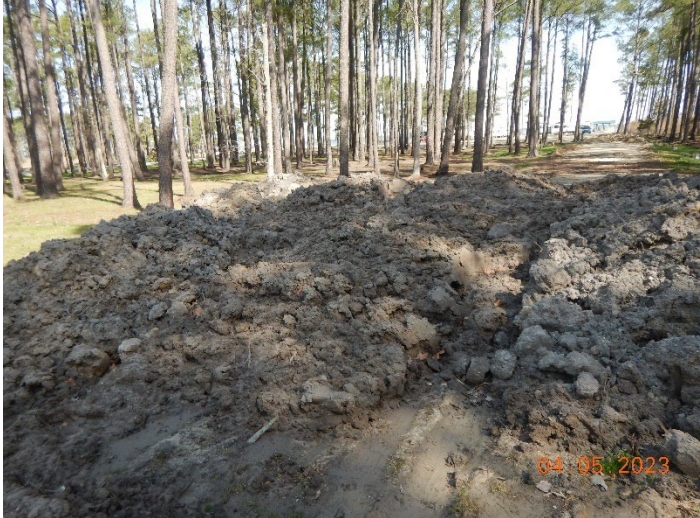
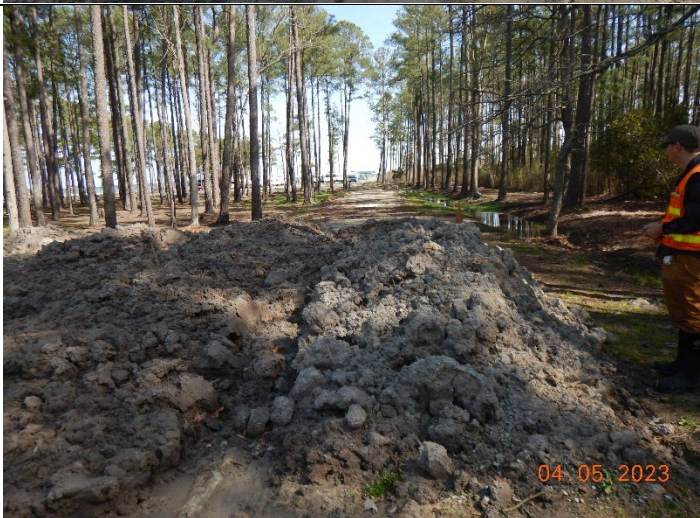
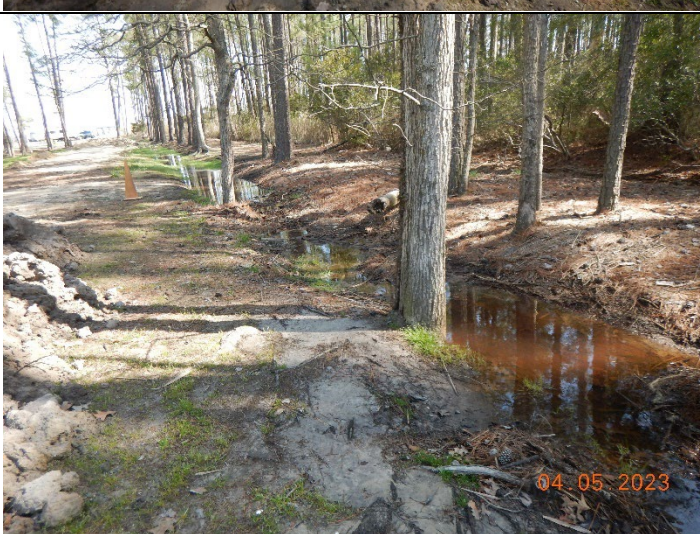
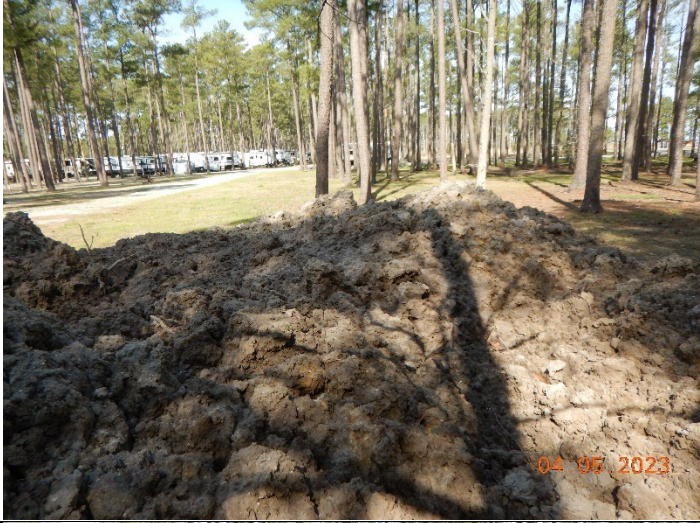
The road continued northward, and large fill piles were observed on the road (DSCN4652-DSCN4655). Ms. Scott stated that the piles were comprised of spoils excavated from the where the new septic system was recently installed (See above at Section III, Paragraph 4 [pg. 5] and photos DSCN4618-DSCN4619). The inspection team continued northward on the road, and it appeared that some of the sand used to construct the road had spilled into a ditch, which ran parallel east of the road (DSCN4656- DSCN4661). This was a downstream section of the ditch abutting AOC-1.

| | <p>Sun Outdoors Chesapeake Bay<br/>Date: April 5, 2023<br/>Photo ID: DSCN4652<br/>Photo taken by: Katelyn Almeter</p> <p>Notes: Fill piles observed on the road at AOC-4. Ms. Scott stated that the piles were spoils excavated from the area where the new septic system was recently installed (see DSCN4618 and DSCN4619 above).</p> |

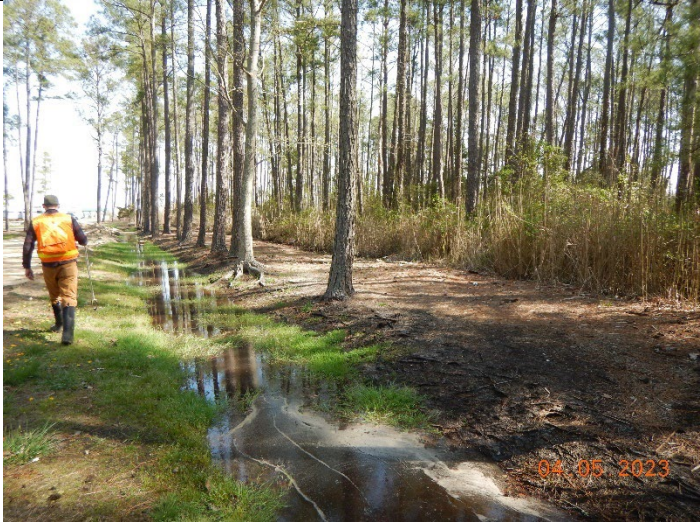
| | <p>Sun Outdoors Chesapeake Bay<br/>Date: April 5, 2023<br/>Photo ID: DSCN4656<br/>Photo taken by: Katelyn Almeter</p> <p>Notes: Northward view of above-grade road constructed of sand. Note the linear ditch running parallel along the eastern boundary. AOC-4</p> |

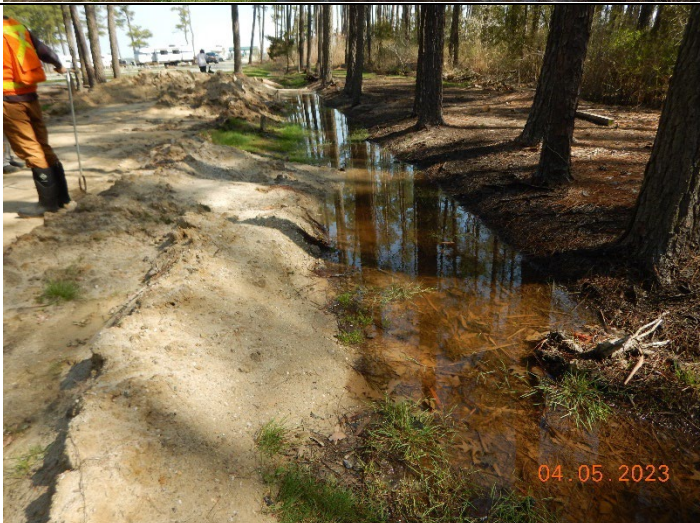
| | <p>Sun Outdoors Chesapeake Bay<br/>Date: April 5, 2023<br/>Photo ID: DSCN4657<br/>Photo taken by: Katelyn Almeter</p> <p>Notes: Northward view of above-grade road constructed of sand. Note the linear ditch running parallel along the eastern boundary. AOC-4</p> |

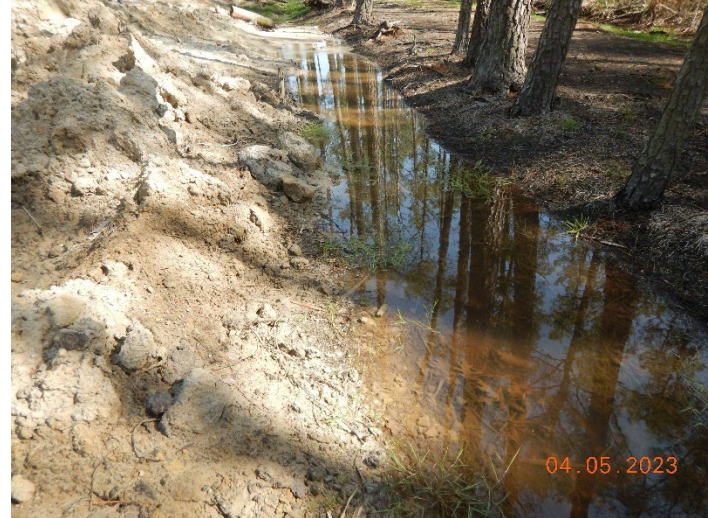
| | <p>Sun Outdoors Chesapeake Bay<br/>Date: April 5, 2023<br/>Photo ID: DSCN4661<br/>Photo taken by: Katelyn Almeter</p> <p>Notes: View of ditch to the east of the road where sand was discharged.<br/>AOC-4</p> |

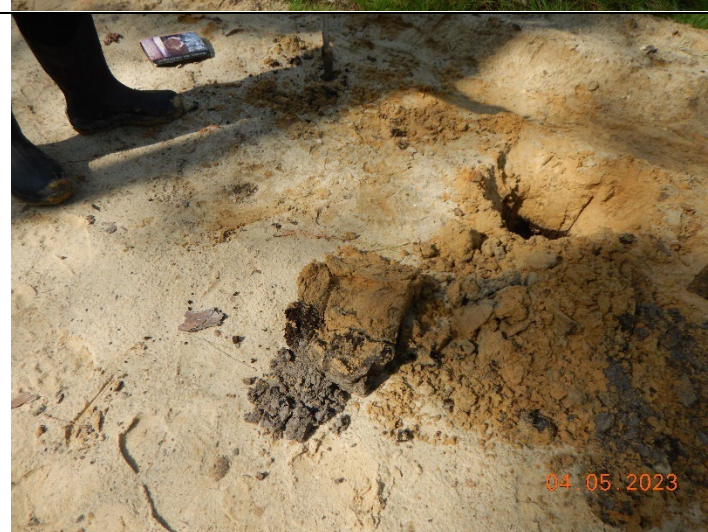
| | <p>Sun Outdoors Chesapeake Bay<br/>Date: April 5, 2023<br/>Photo ID: DSCN4663<br/>Photo taken by: Katelyn Almeter</p> <p>Notes: Bor-5 collected from AOC-4. Note upper 9" which was comprised of sandy fill.</p> |

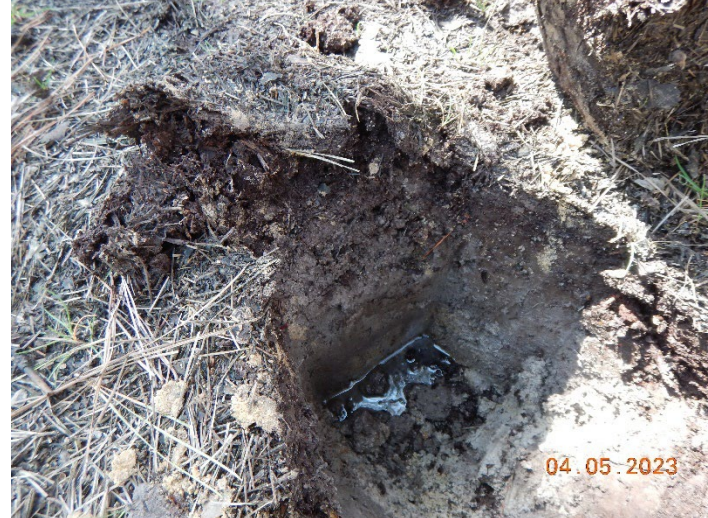
| | <p>Sun Outdoors Chesapeake Bay<br/>Date: April 5, 2023<br/>Photo ID: DSCN4665<br/>Photo taken by: Katelyn Almeter</p> <p>Notes: View of Bor-6. Note the water table seeping into the boring.</p> |

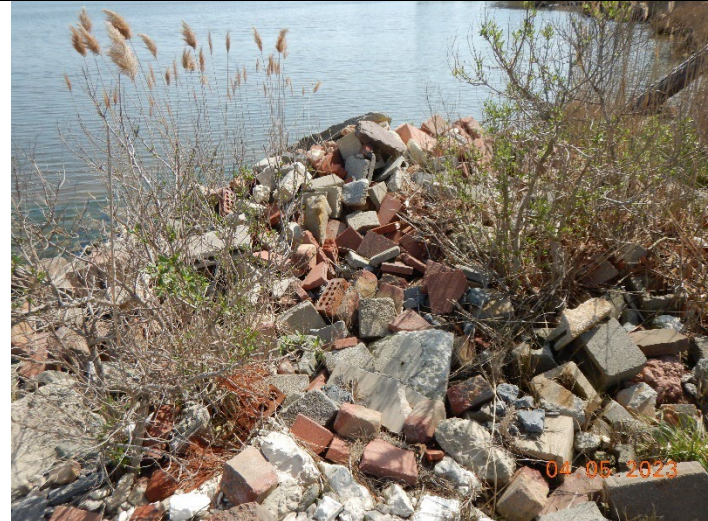
| | <p>Sun Outdoors Chesapeake Bay<br/>Date: April 5, 2023<br/>Photo ID: DSCN4675<br/>Photo taken by: Katelyn Almeter</p> <p>Notes: Bricks, concrete, and cinder blocks located waterward of the concrete bulkhead.</p> |

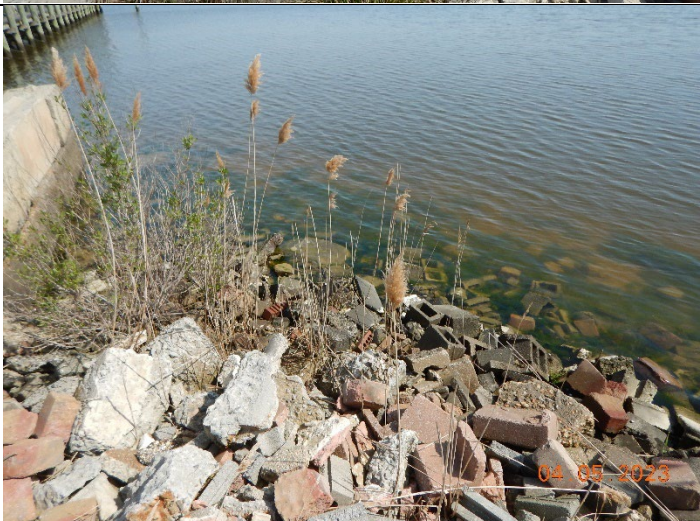
| A photograph showing a concrete bulkhead on the left. To the right of the bulkhead is a large pile of debris in the water, including red bricks, grey concrete slabs, and light-colored cinder blocks. The water is calm and blue. A date stamp '04.05.2023' is visible in the bottom right corner of the photo. | <p>Sun Outdoors Chesapeake Bay<br/>Date: April 5, 2023<br/>Photo ID: DSCN4677<br/>Photo taken by: Katelyn Almeter</p> <p>Notes: Bricks, concrete, and cinder blocks located waterward of the concrete bulkhead.</p> |

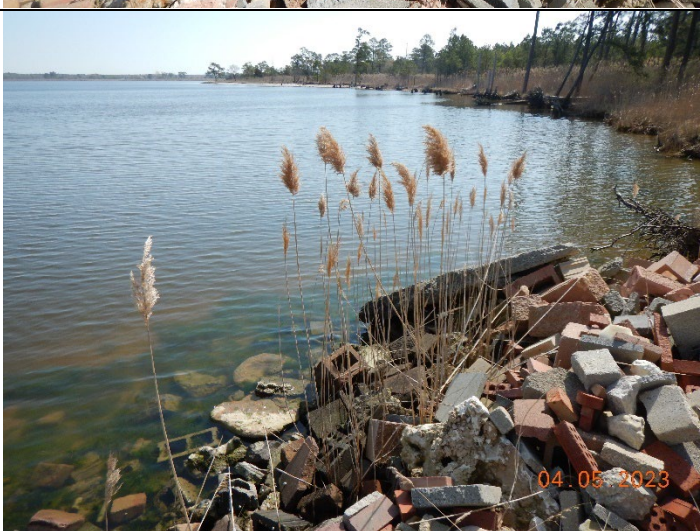
| A photograph showing a concrete bulkhead on the left. To the right of the bulkhead is a large pile of debris in the water, including red bricks, grey concrete slabs, and light-colored cinder blocks. The water is calm and blue. A date stamp '04.05.2023' is visible in the bottom right corner of the photo. | <p>Sun Outdoors Chesapeake Bay<br/>Date: April 5, 2023<br/>Photo ID: DSCN4678<br/>Photo taken by: Katelyn Almeter</p> <p>Notes: Bricks, concrete, and cinder blocks located waterward of the concrete bulkhead.</p> |

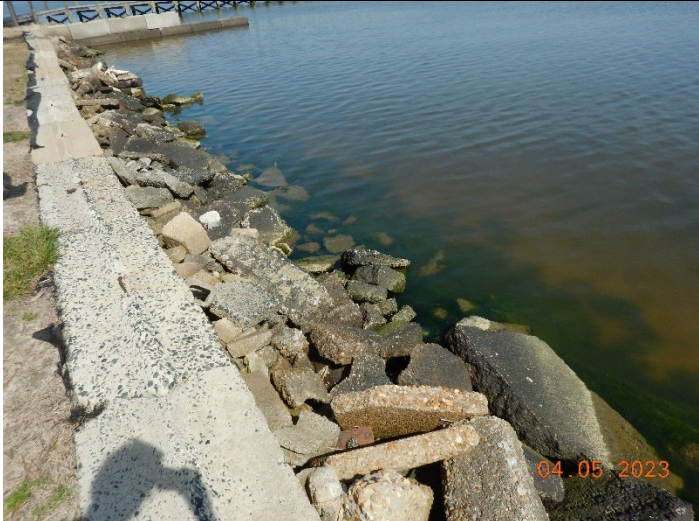
| A photograph showing a concrete bulkhead in the foreground, with a pile of bricks, concrete blocks, and cinder blocks scattered in the water just beyond it. The water is calm and reflects the sky. A date stamp "04.05.2023" is visible in the bottom right corner of the photo. | <p>Sun Outdoors Chesapeake Bay<br/>Date: April 5, 2023<br/>Photo ID: DSCN4681<br/>Photo taken by: Katelyn Almeter</p> <p>Notes: Bricks, concrete, and cinder blocks located waterward of the concrete bulkhead.</p> |

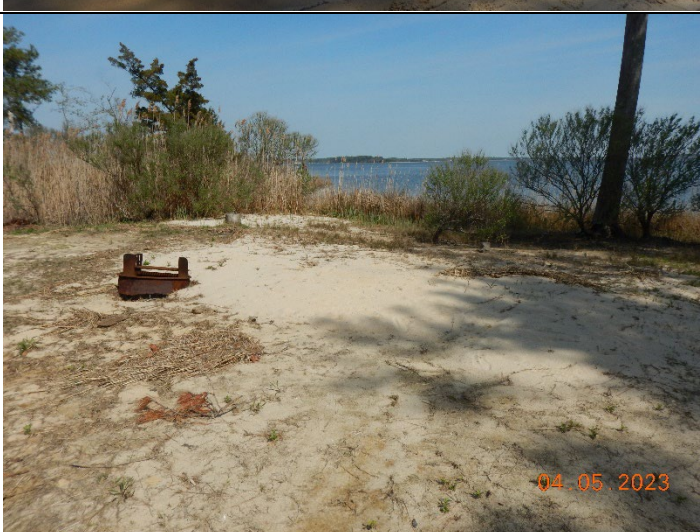
| | <p>Sun Outdoors Chesapeake Bay<br/>Date: April 5, 2023<br/>Photo ID: DSCN4690<br/>Photo taken by: Katelyn Almeter</p> <p>Notes: Northwestern portion of the Site. Note sparsely vegetated sand.</p> |

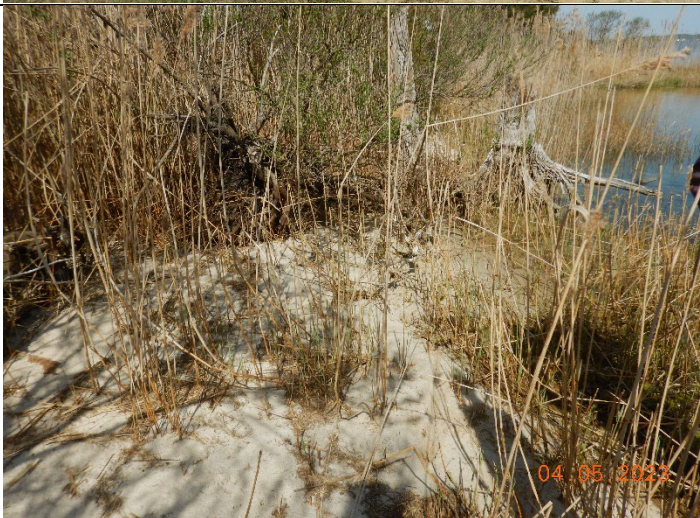
| A photograph showing a mound of sand with reeds in the foreground and a body of water in the background. The date stamp '04.05.2023' is visible in the bottom right corner. | <p>Sun Outdoors Chesapeake Bay<br/>Date: April 5, 2023<br/>Photo ID: DSCN4692<br/>Photo taken by: Katelyn Almeter</p> <p>Notes: Area where a mound of sand was observed on northwestern portion of the Site.</p> |
