INSPECTION REPORT

| Type of Inspection | Compliance Evaluation Inspection (CEI) | | |
| Company Name | Safety Waste Incineration | | |
| Type of Operation | Waste treatment and disposal of medical waste | | |

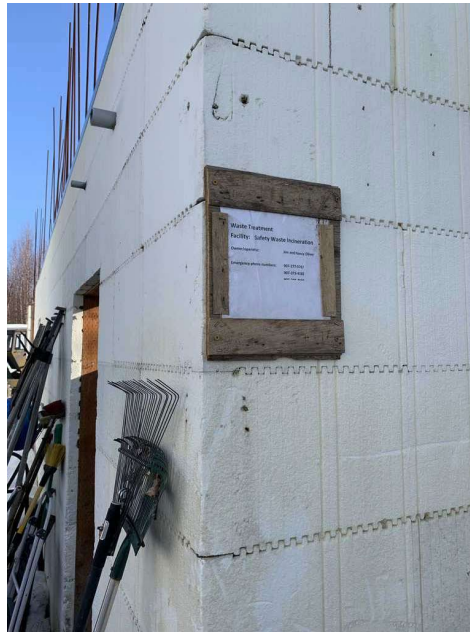
| [Title] | | | IMG_0964.jpg |

| View of facility signage posted outside of the Autoclave Treatment building. | | | |

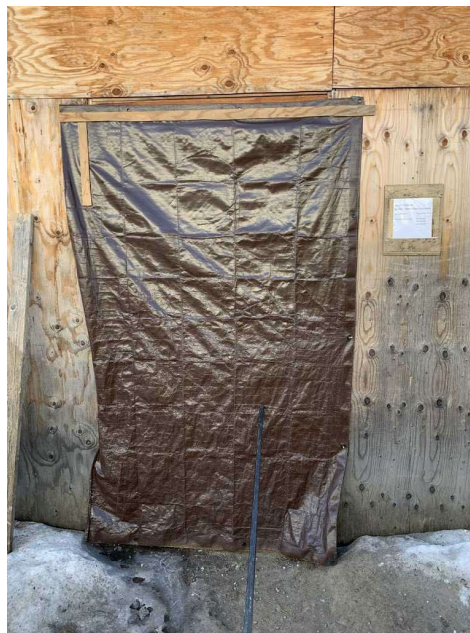
| [Title] | | | IMG_0965.jpg |

| View of a brown tarp being used to cover the entrance to the Autoclave Treatment building. | | | |

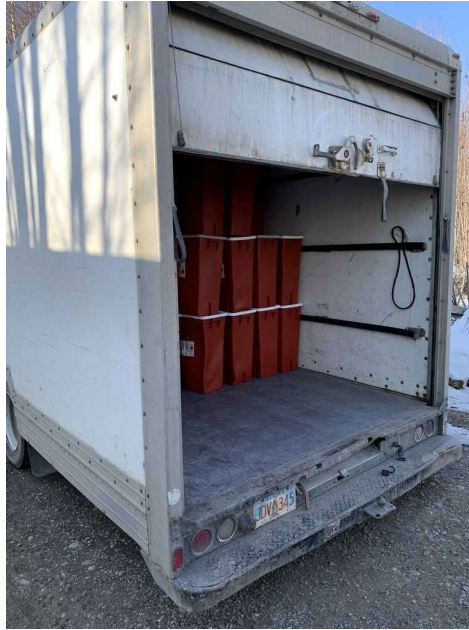
| [Title] | | | IMG_0967.jpg |

| Another view of red containers holding medical waste that has been processed in the autoclave. | | | |

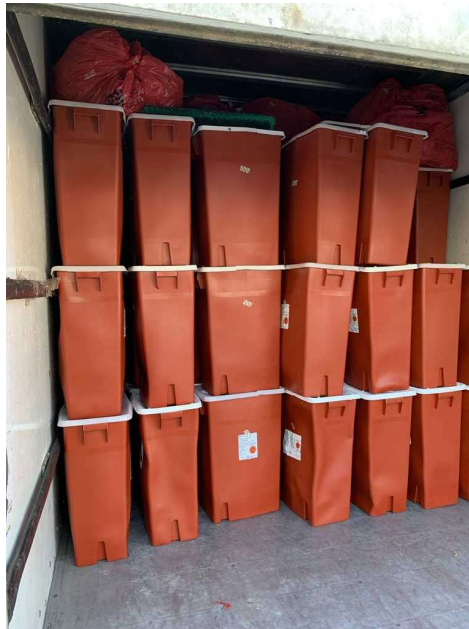
| [Title] | | | IMG_0969.jpg |

| View of red containers holding medical waste that has been processed in the autoclave. | | | |

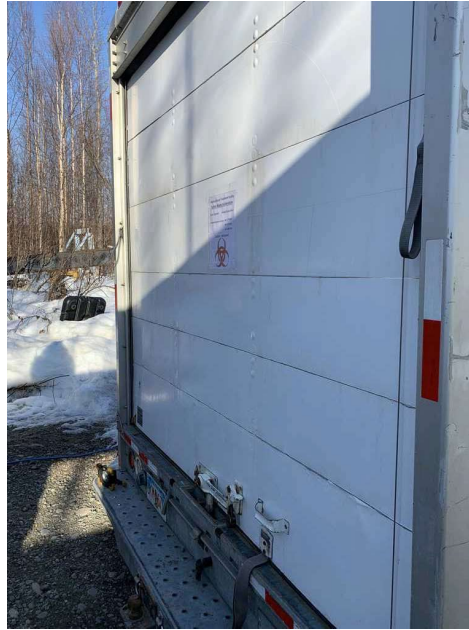
| [Title] | | | IMG_0970.jpg |

| View of the locked roll-up door on a box truck used to transport medical waste to the facility. | | | |

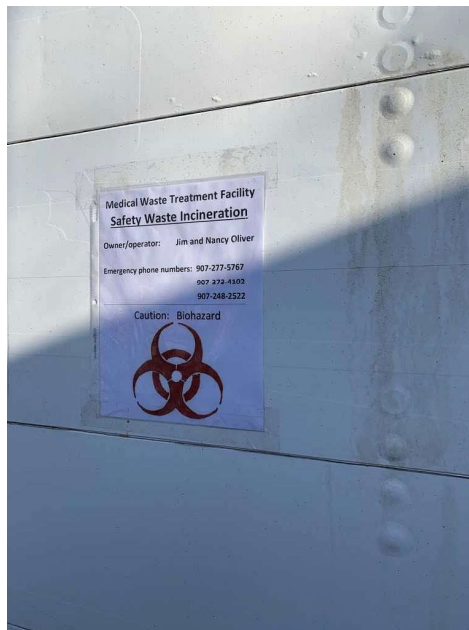
| [Title] | | | IMG_0971.jpg |

| Close-up view of facility signage posted on the locked roll-up door of a medical waste transport box truck located just outside of Autoclave Treatment building. | | | |

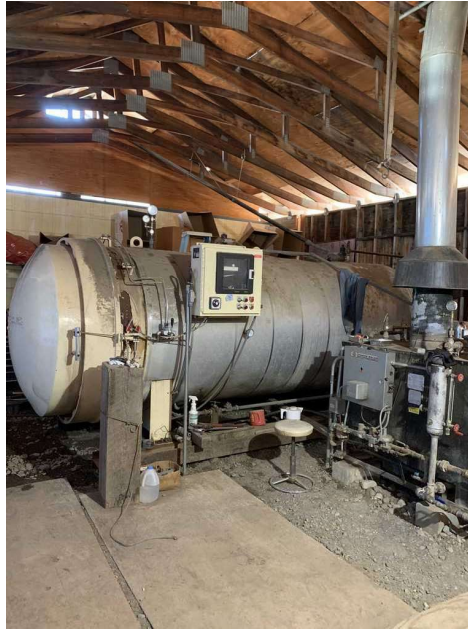
| [Title] | | | IMG_0972.jpg |

| View of the autoclave. | | | |

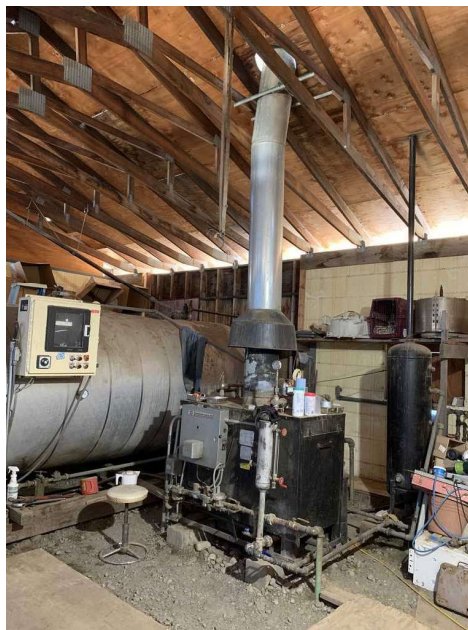
| [Title] | | | IMG_0973.jpg |

| Another view of the autoclave. | | | |

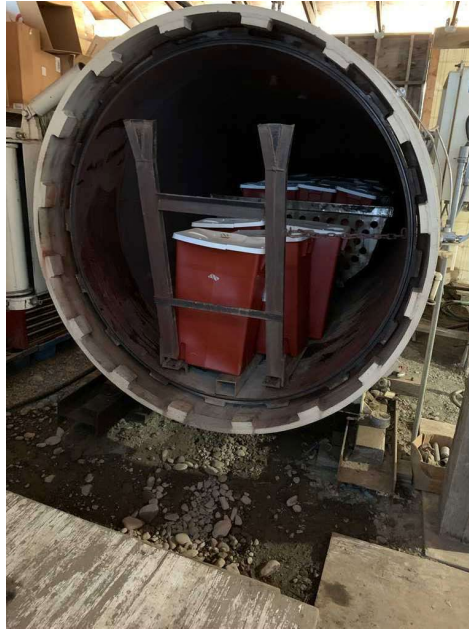
| [Title] | | | IMG_0974.jpg |

| View of treated medical waste seen inside of the autoclave. | | | |

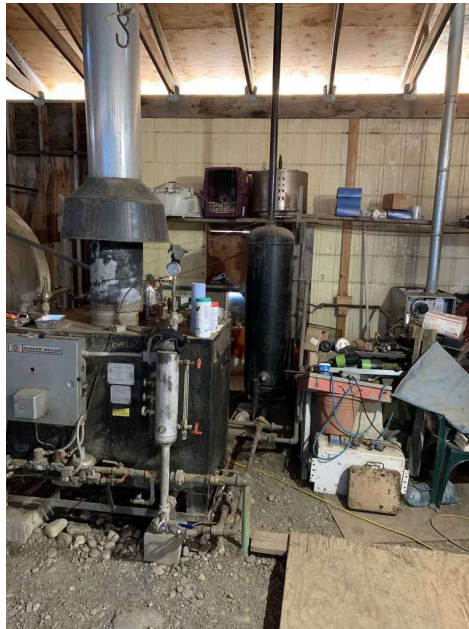
| [Title] | | | IMG_0975.jpg |

| View of the heating element for the autoclave. | | | |

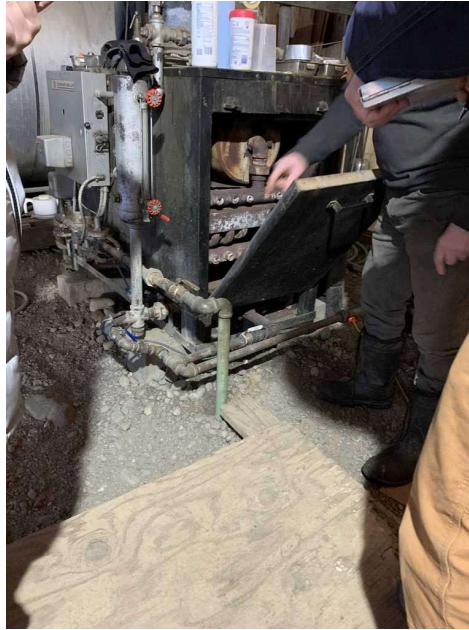
| [Title] | | | IMG_0976.jpg |

| Another view of the heating element for the autoclave. | | | |

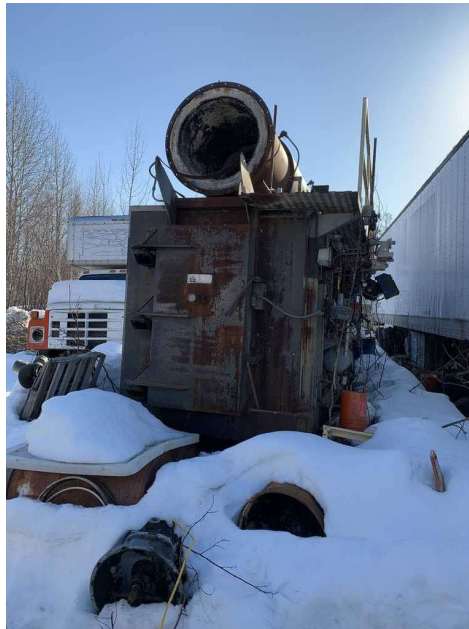
| [Title] | | | IMG_0977.jpg |

| <p>At the time of the inspection, I saw that the facility's incinerator was covered in a tarp. I had Mr. Oliver uncover the incinerator during the inspection. Once the incinerator was uncovered, we could see there was significant deterioration and that it could no longer be used for its intended purpose. The condition of the facility's incinerator was documented in photos taken during the inspection.</p> | | | |

| View of an old inoperable rectangular incinerator in the equipment yard. | | | |

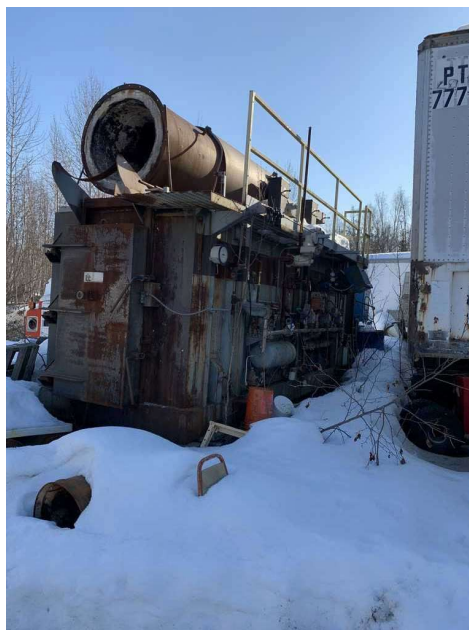
| [Title] | | | IMG_0978.jpg |

| Another view of the inoperable incinerator in the equipment yard. | | | |

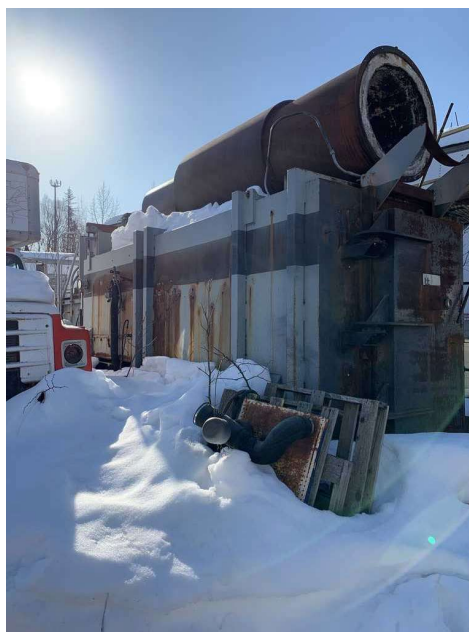
| [Title] | | | IMG_0979.jpg |

| Another view of the same inoperable incinerator in the equipment yard. | | | |

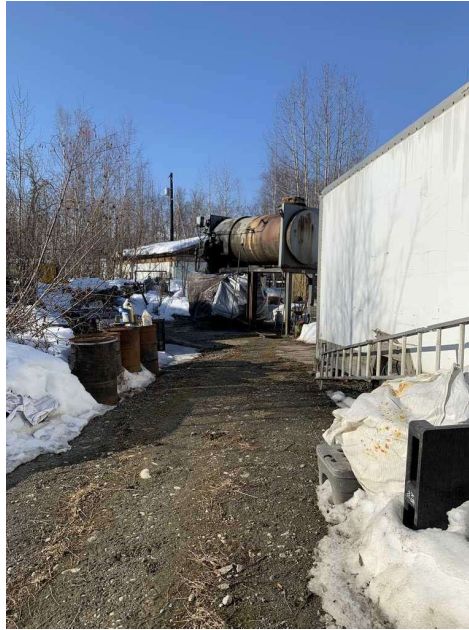
| [Title] | | | IMG_0980.jpg |

| View of the deteriorated incinerator, seen here in the center of the photo covered in a tarp. | | | |

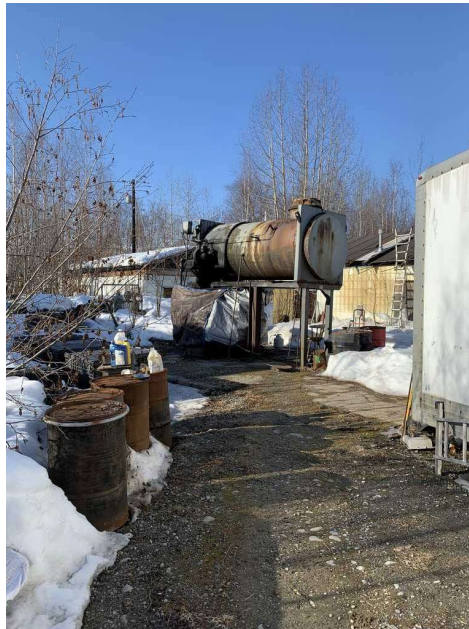
| [Title] | | | IMG_0981.jpg |

| Another view, showing the deteriorated incinerator, seen here covered in a tarp. | | | |

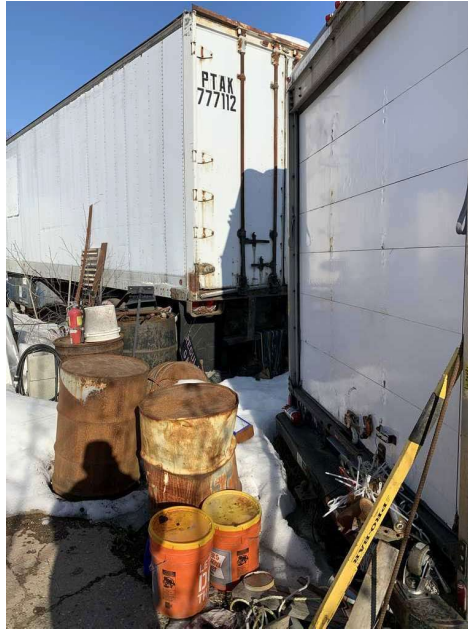
| [Title] | | | IMG_0982.jpg |

| View of a box truck and trailer rig adjacent to the facility's incinerator. | | | |

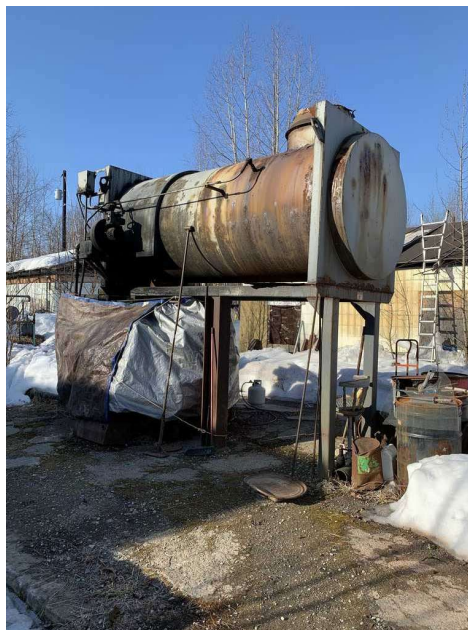
| [Title] | | | IMG_0983.jpg |

| Another view, showing the deterioration of the incinerator, seen here covered in a tarp. | | | |

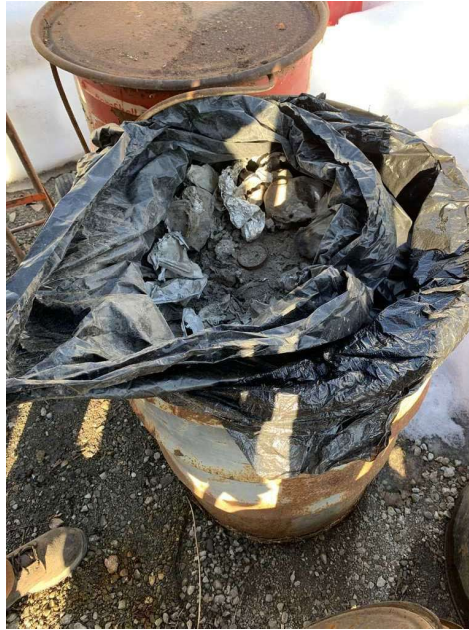
| [Title] | | | IMG_0984.jpg |

| Close-up view of a container holding incinerator ash. | | | |

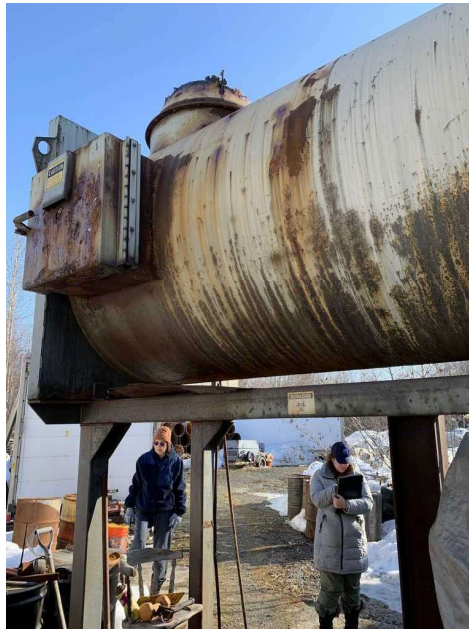
| [Title] | | | IMG_0985.jpg |

| Another close-up view, showing the deterioration of the incinerator. | | | |

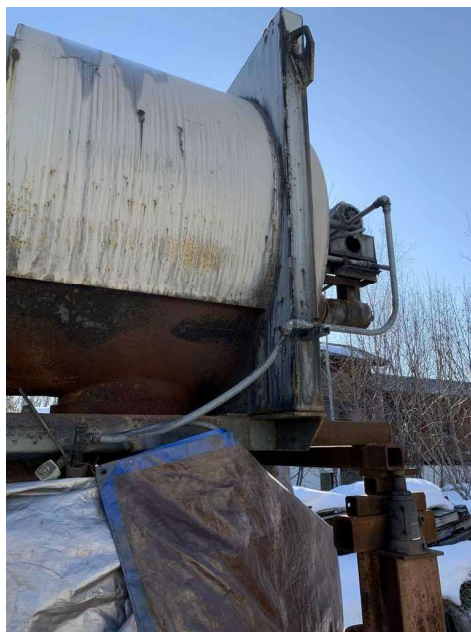
| [Title] | | | IMG_0986.jpg |

| View of the backside of the incinerator, seen here covered with a tarp. | | | |

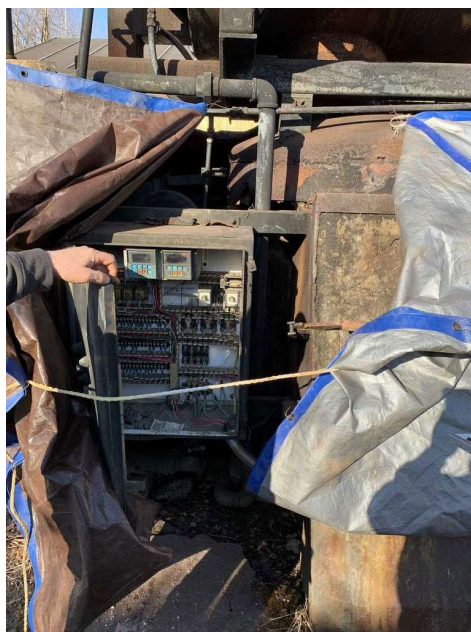
| [Title] | | | IMG_0987.jpg |

| Another close-up view, showing the deterioration of the incinerator. | | | |

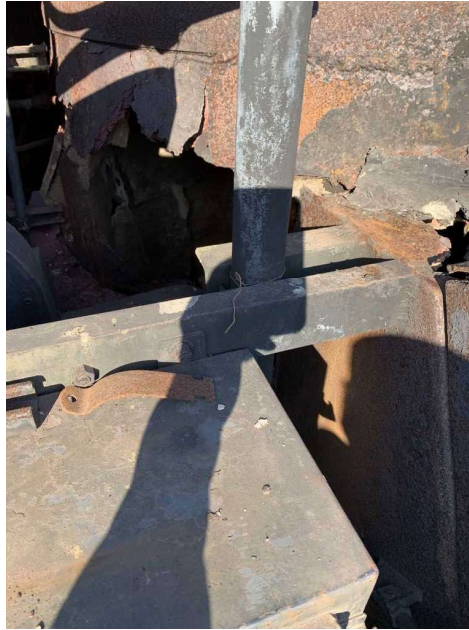
| [Title] | | | IMG_0988.jpg |

| Another close-up view, showing the deterioration of the incinerator. | | | |

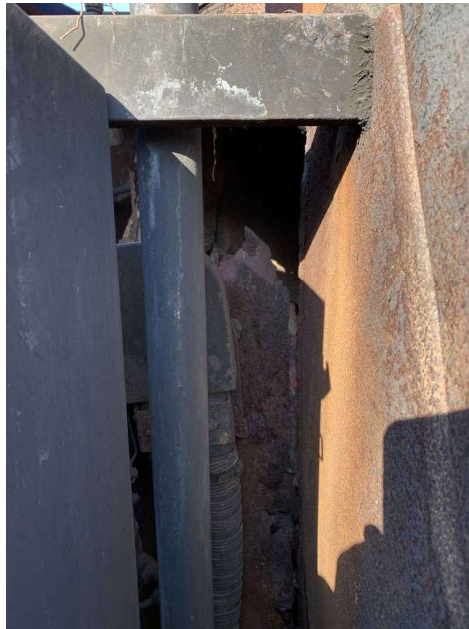
| [Title] | | | IMG_0989.jpg |

| Close-up view of the incinerator, showing the extreme deterioration of the unit. | | | |

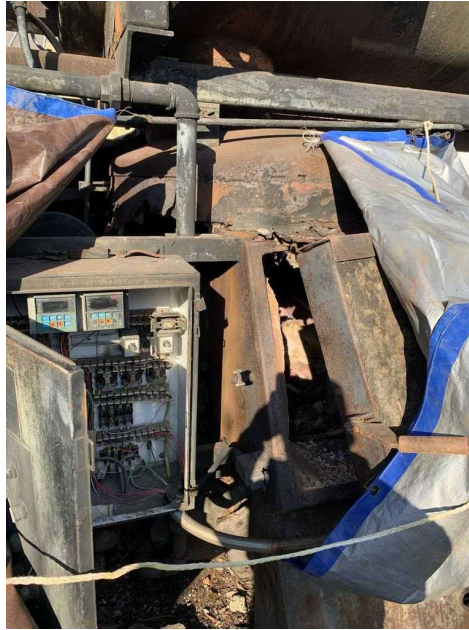
| [Title] | | | IMG_0990.jpg |

| Another close-up view, showing the deterioration of the incinerator. | | | |

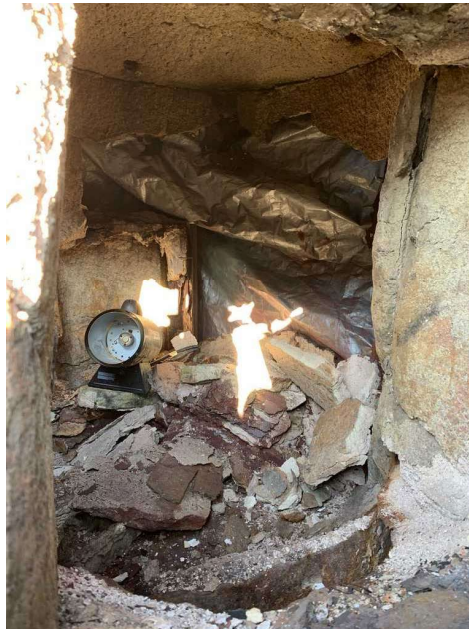
| [Title] | | | IMG_0991.jpg |

| Another close-up view, showing the deterioration of the incinerator. | | | |

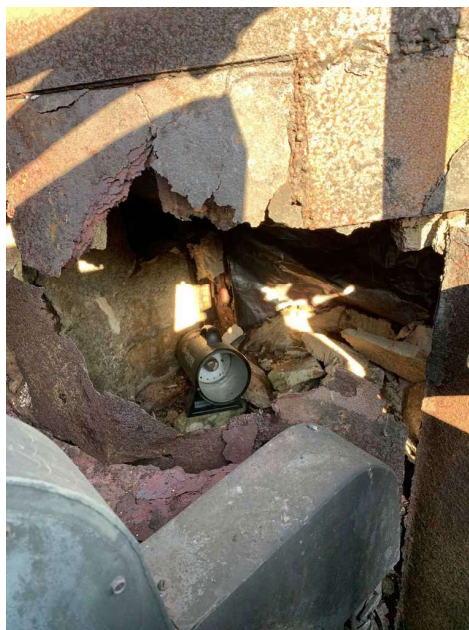
| [Title] | | | IMG_0992.jpg |

| Another close-up view, showing the deterioration of the incinerator. | | | |

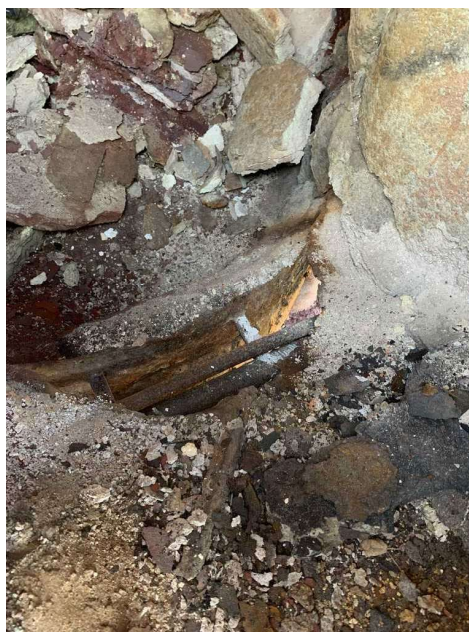
| [Title] | | | IMG_0993.jpg |

| Another close-up view, showing the deterioration of the incinerator. | | | |

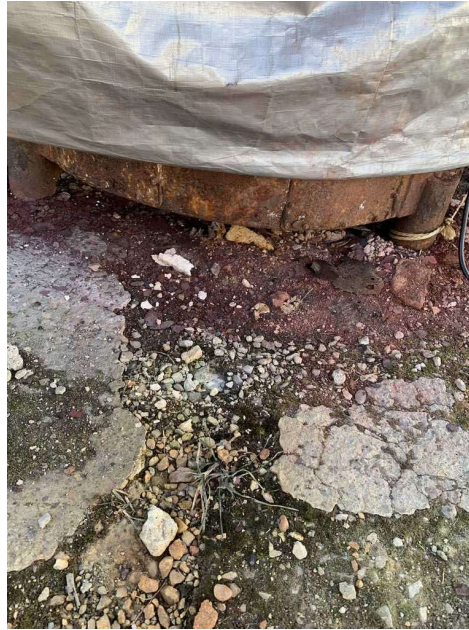
| [Title] | | | IMG_0994.jpg |

| Another close-up view, showing the deterioration of the incinerator. | | | |

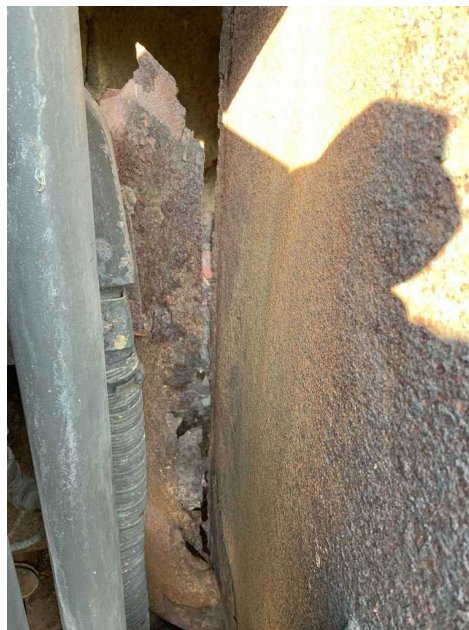
| [Title] | | | IMG_0995.jpg |

| Another close-up view, showing the deterioration of the incinerator. | | | |

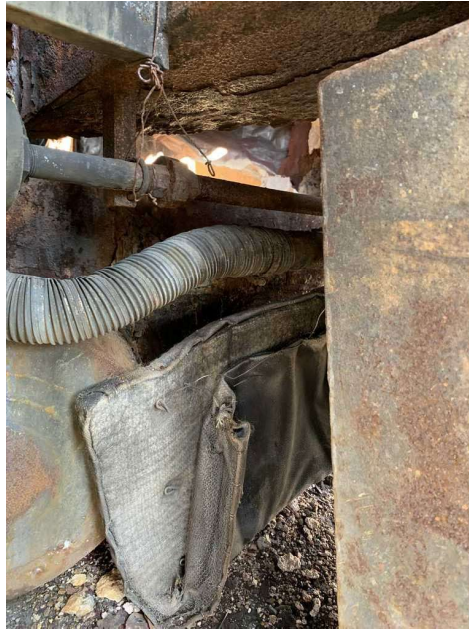
| [Title] | | | IMG_0996.jpg |

| Another close-up view, showing the deterioration of the incinerator. | | | |

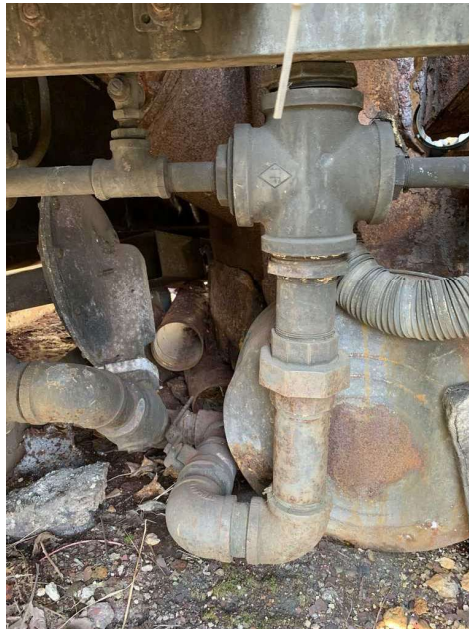
| [Title] | | | IMG_0997.jpg |

| Another close-up view, showing the deterioration of the incinerator. | | | |

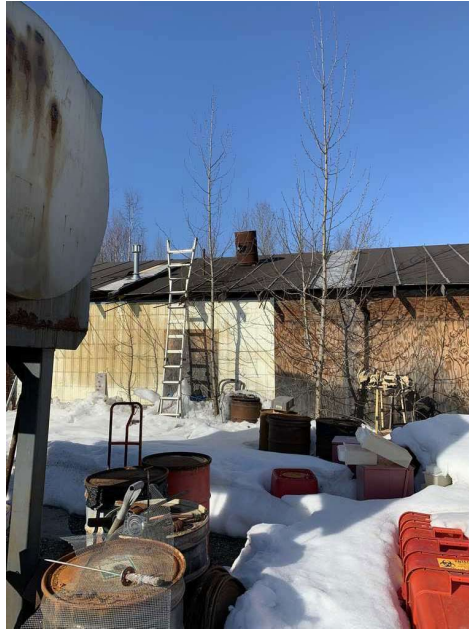
| [Title] | | | IMG_0998.jpg |

| View of a drum, seen here covering the stack on the roof of the Autoclave Treatment building. | | | |

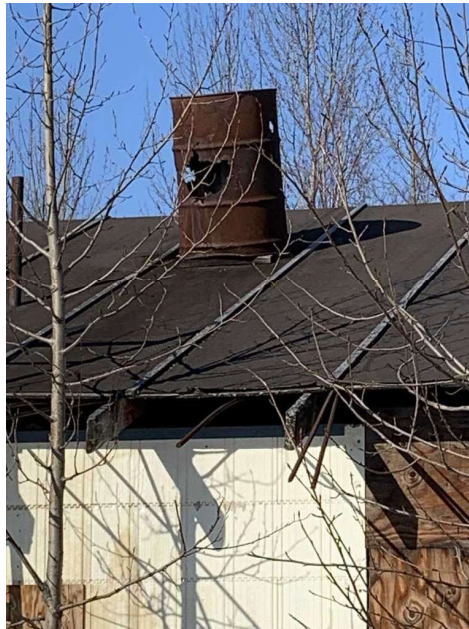
| [Title] | | | IMG_0999.jpg |

| Close-up view of a drum, seen here covering the stack on the roof of the Autoclave Treatment building. | | | |

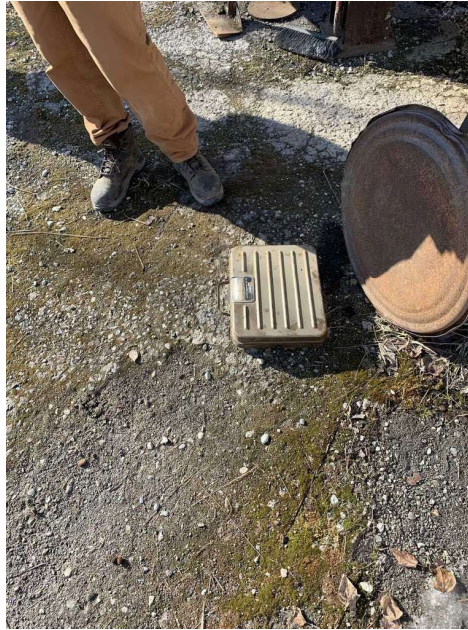
| [Title] | | | IMG_1001.jpg |

| View of a scale used by the facility to weigh the waste going into the incinerator. | | | |

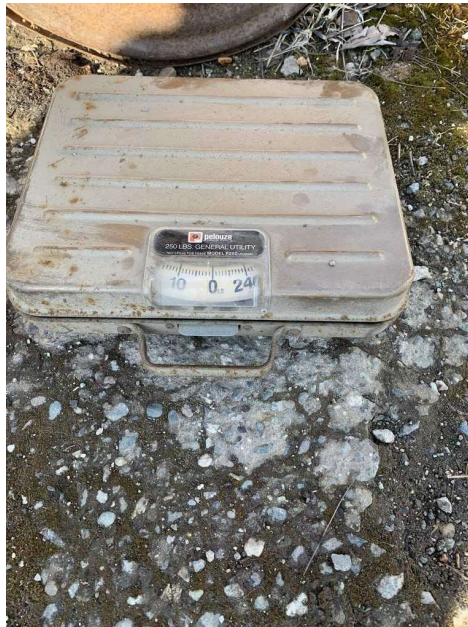
| [Title] | | | IMG_1002.jpg |

| Close-up view of a scale used by the facility to weigh the waste going into the incinerator. | | | |
