**UNITED STATES ENVIRONMENTAL PROTECTION AGENCY**  
**REGION 5**  
**77 WEST JACKSON BOULEVARD**  
**CHICAGO, ILLINOIS 60604**

**SUBJECT:** CLEAN WATER ACT INSPECTION REPORT  
*Village of Doylestown Wastewater Treatment Plant, Wayne County, Ohio*

**NPDES Permit Number:** *OH0021342*

**Date(s) of Inspection:** April 15 to 16, 2025

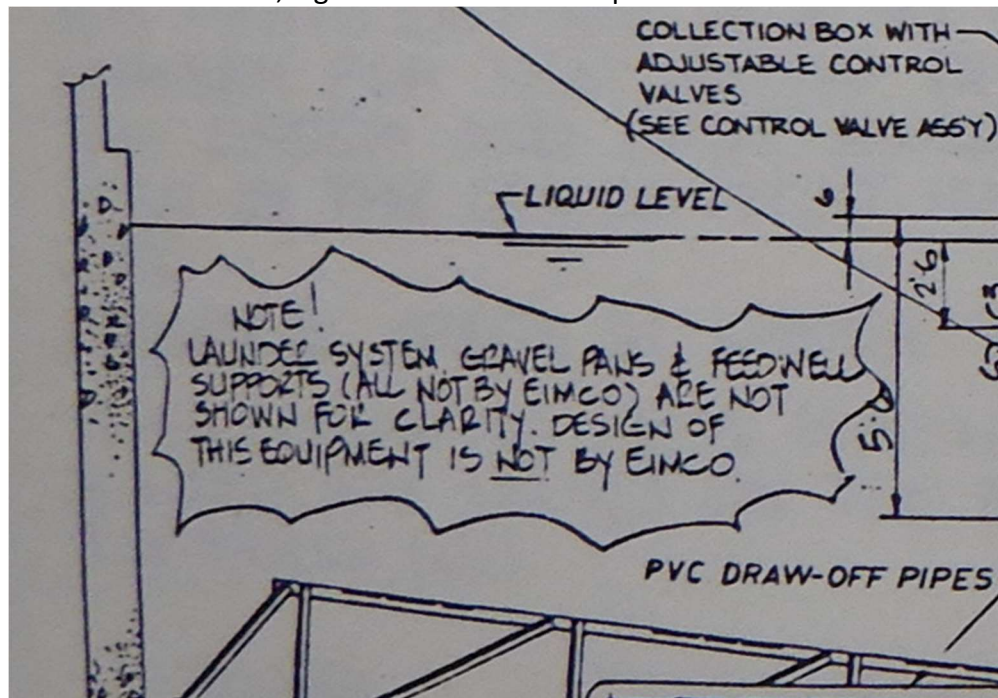
From DSCN2614.JPG, Figure 5.11-1 from the Operations Manual.

The manual included diagrams of the secondary clarifier with a note stating *“Launder system, gravel pans & Feedwell supports (all not by EIMCO) are not shown for clarity. Design of this equipment is not by EIMCO.”* A screen grab of the note is provided on the next page.

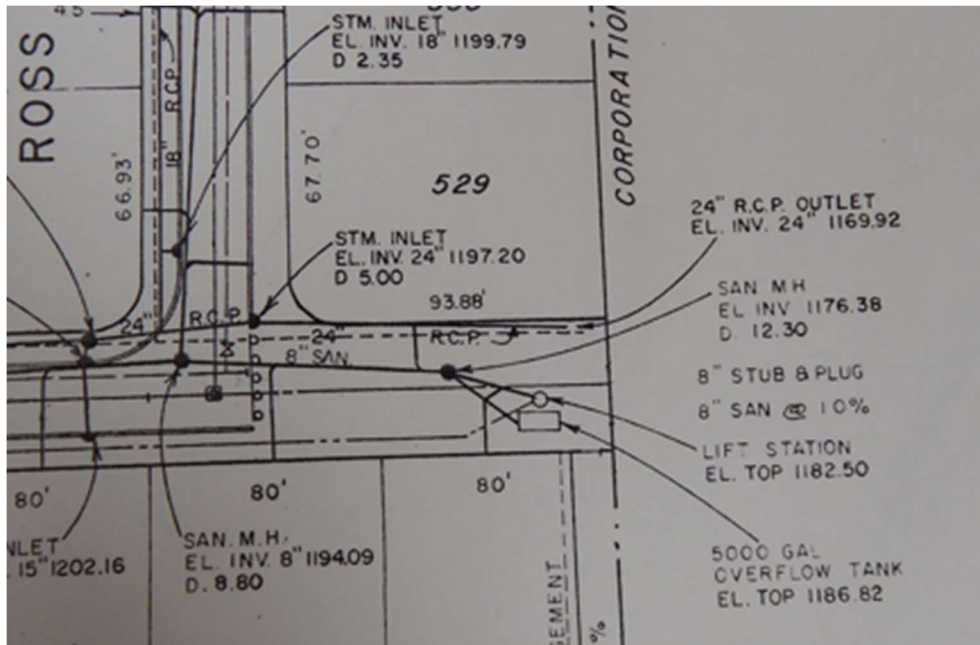
At 1:20 PM on 4/15/2025 EPA observed the lift station and overflow tank near Ross Avenue and Summit Street. At the time of the inspection the overflow tank could not be opened. The lift station was equipped with a high-level alarm and a light. The configuration of the lift station and the overflow tank could not be determined at the time of the inspection.

Clip of image DSCN2590.JPG Drawing of the lift station and overflow tank at Ross Avenue and Summit Street.

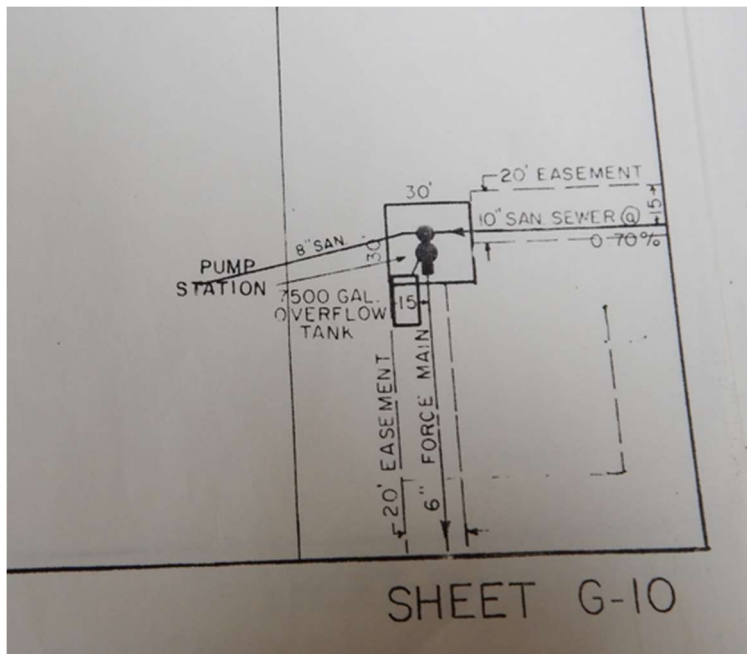
At 1:34 PM on 4/15/2025 EPA observed the lift station and overflow tank near Greenwood Drive and Collier Drive. The lift station was equipped with a high-level alarm and a light. The configuration of the lift station and the overflow tank could not be determined at the time of the inspection.

Clip of photo DSCN2591.JPG – Drawing of the lift station and overflow tank at Greenwood Drive and Collier Drive.

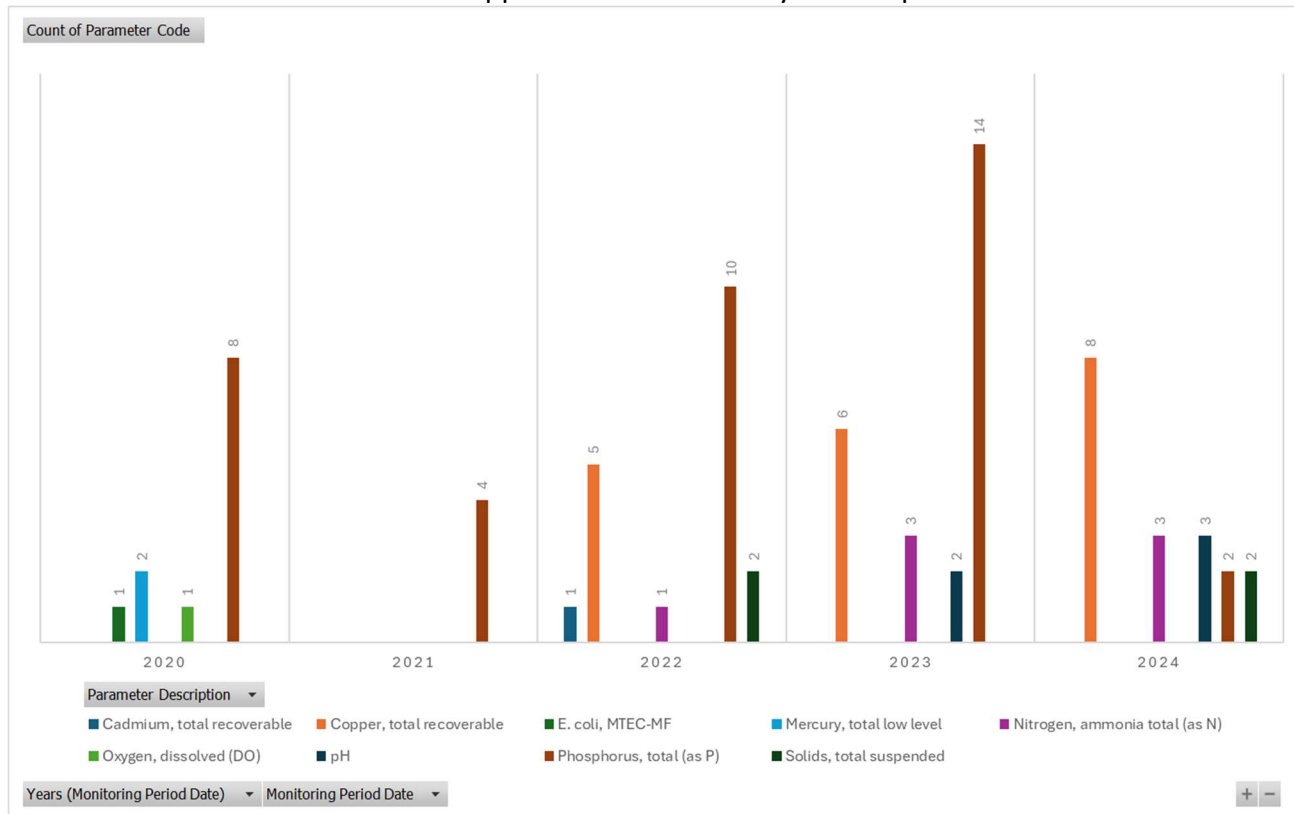
Between January 1, 2020 and December 31, 2024 there were 78 instances of effluent exceedances. In the most recent 12 months the facility experienced exceedances for pH, total suspended solids, copper, phosphorous, and ammonia. A full table of exceedances is included in Appendix D. A summary chart is provided below.

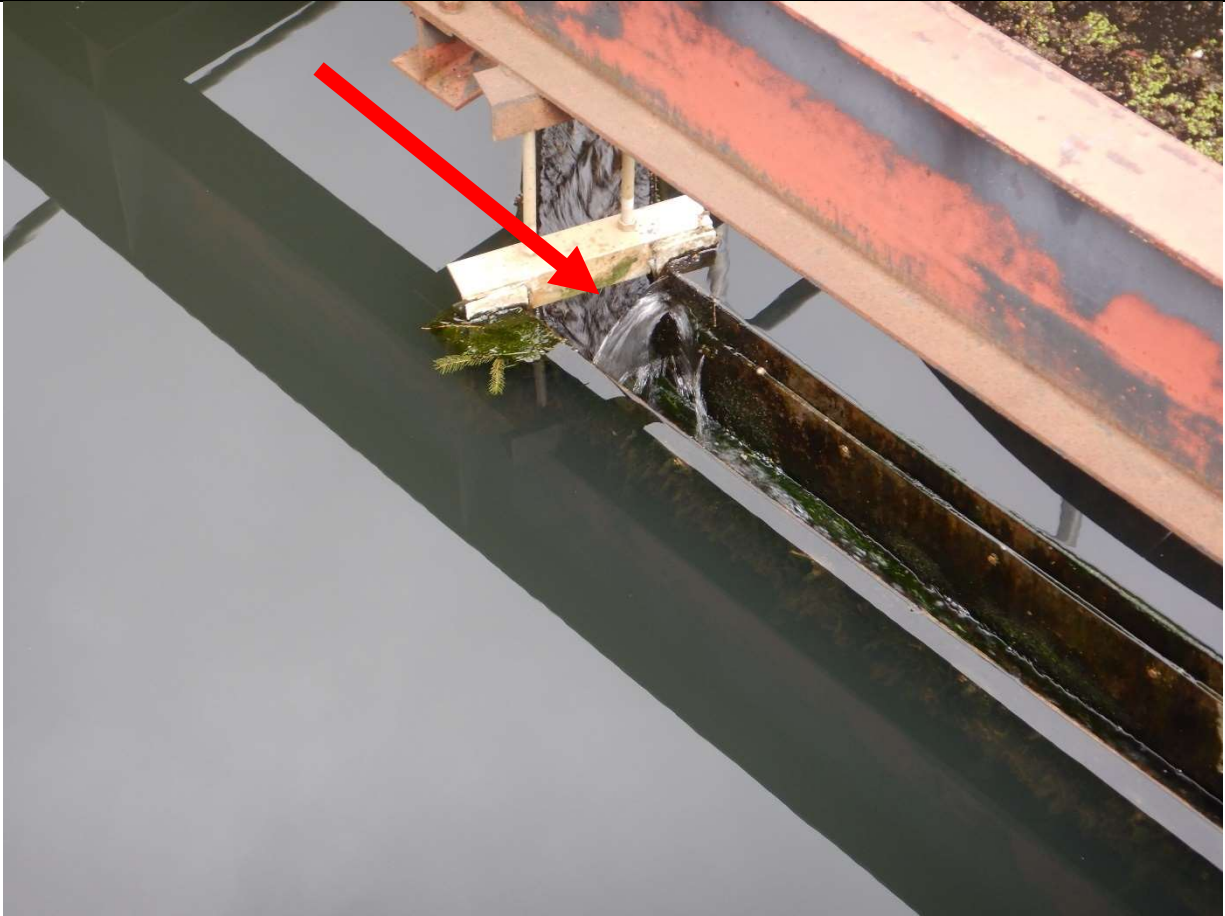
34: DSCN2559.JPG

- There were gaps or leaks at the supports for the weir plates at the overflow from the secondary clarifier. Additionally, the weir edges were straight and not level which resulted in an uneven flow over the weir, with some locations being dry and showing no water flow over the weir (Photos 33 through 46).

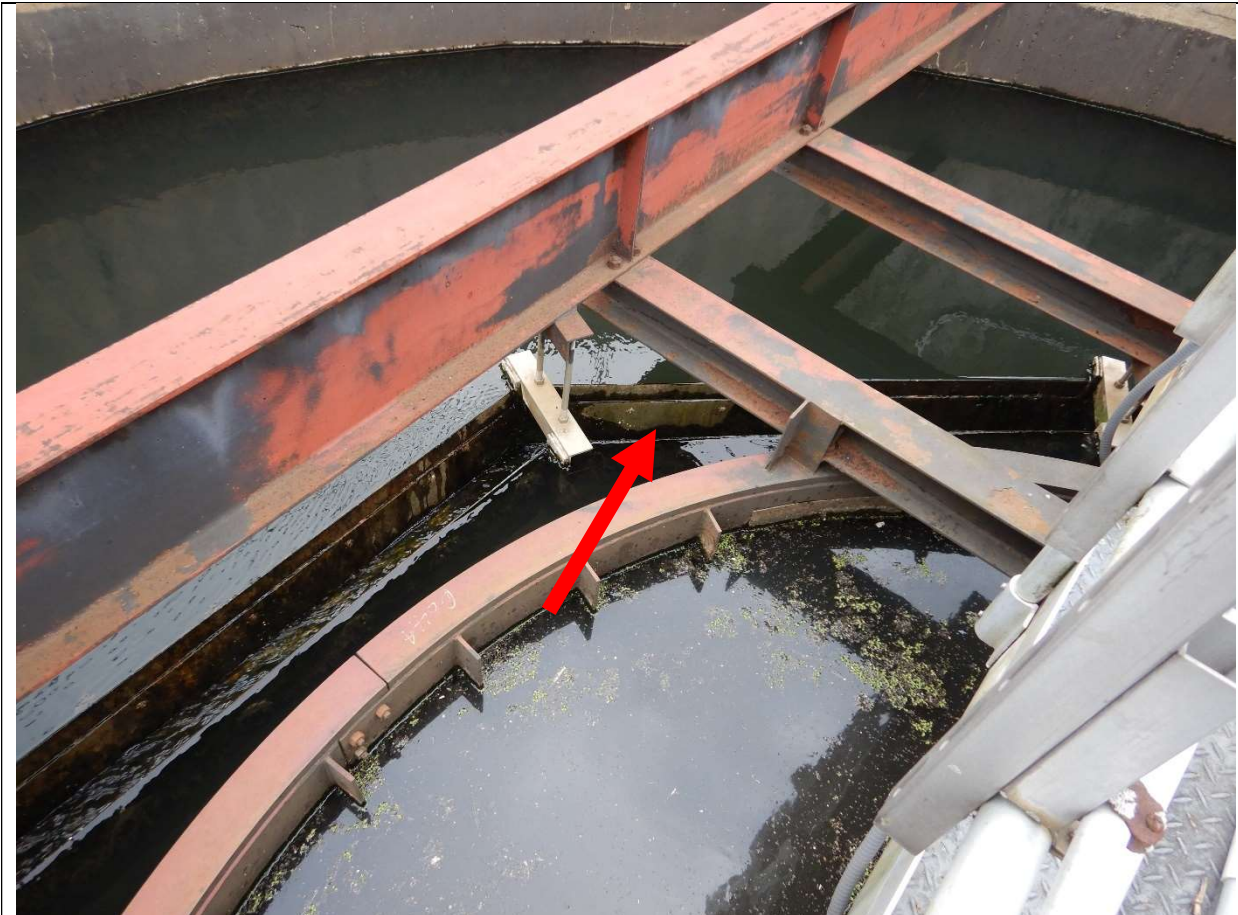
**36: DSCN2561.JPG**

At 9:18 AM there were leaves and debris located on the surface of the clarifier, adjacent to the overflow weir on the eastern (lower) clarifier (photo 44). Both the eastern and western clarifiers had scum and floating material on the surface of the water inside the center wells, upstream of the baffles and overflow weirs (photos 36, 39, 45 and 46).

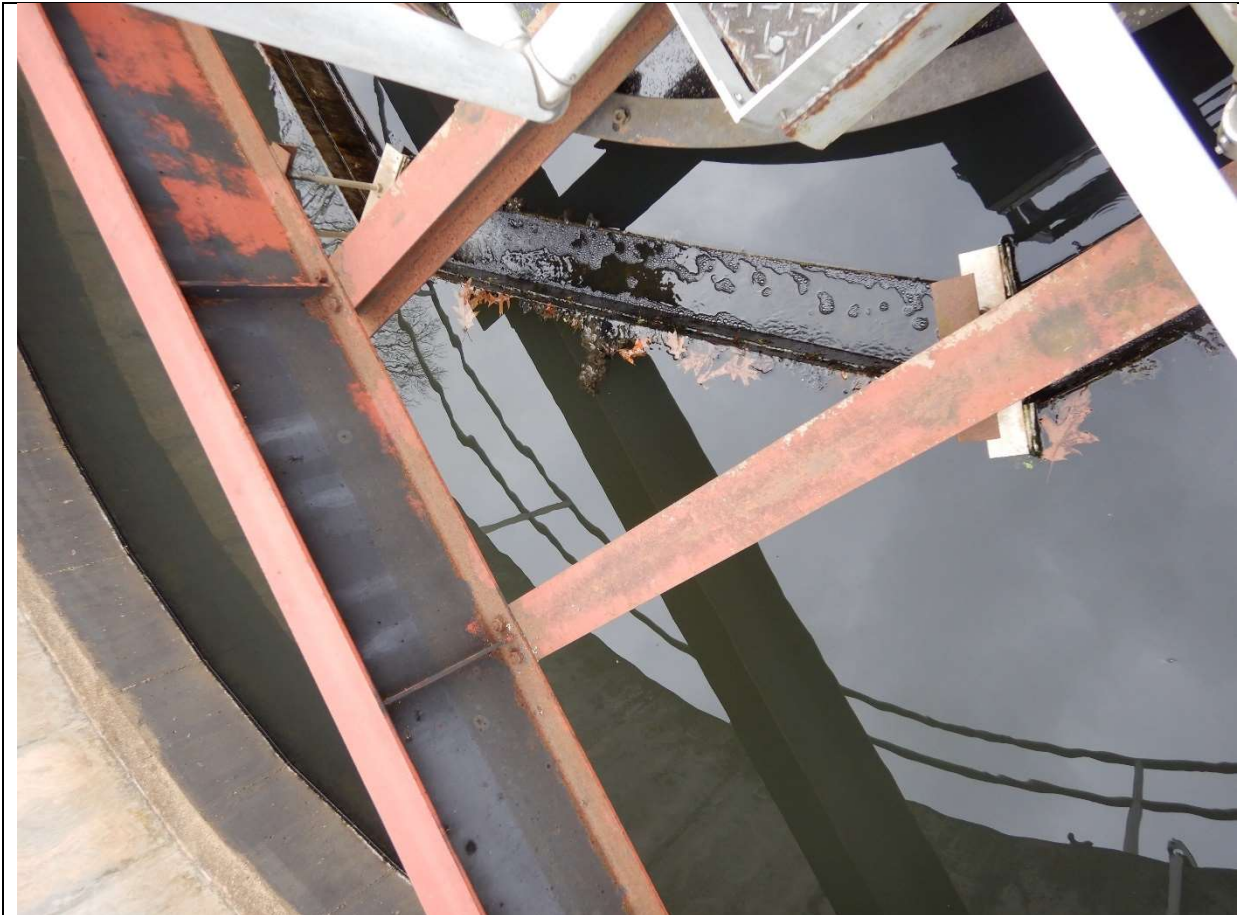
44: DSCN2569.JPG

- Floating debris, scum and leaves were present on the surface of the secondary clarifier. The clarifier was not equipped with an automatic scum removal equipment downstream of the center well baffle.

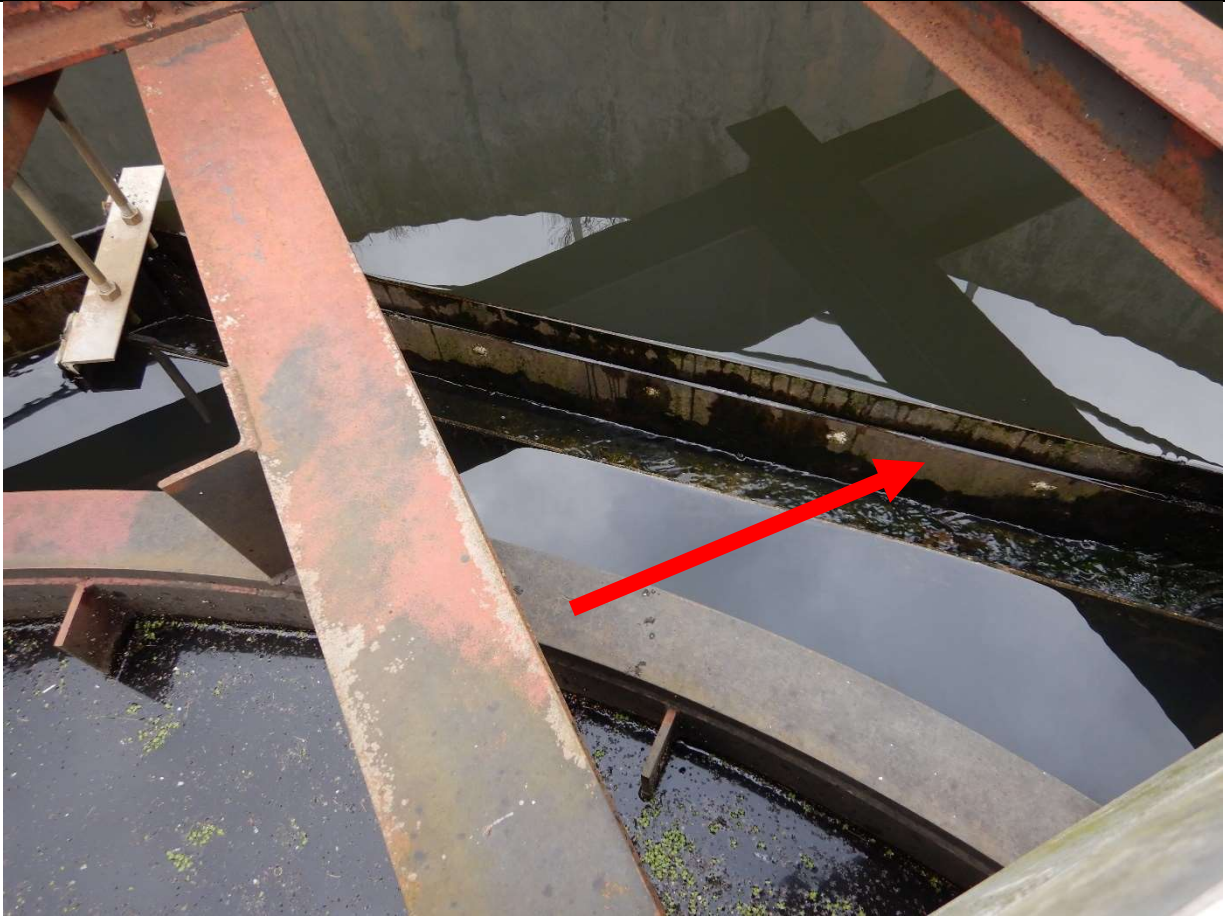
45: DSCN2570.JPG

On 4/16/2025 the inspection resumed at the secondary clarifiers. There are two secondary clarifiers, the western clarifier is also called the upper clarifier, and the eastern clarifier is called the lower clarifier. The overflow weir into the outlet trough, or launderer is a double-sided octagon shaped trough surrounding the center well. The weir plate was smooth, without a saw-toothed pattern. At 9:06 there was flow through gaps in the launderer wall near the support structure (photo 34). There were breakthroughs at several other locations shown in photos 38, and 43 (eastern clarifier). At 9:17 AM EPA observed uneven flow of water over portions of the overflow weir into the secondary clarifier outlet trough, or launderer. This condition is visible in photos 35, 36, 39, 43, 45, and 46 where the inside side of the launderer wall is dry.
