NARRATIVE REPORT - TOXIC CHEMICAL RELEASE (VINYL CHLORIDE) - (continued)

BFGOODRICH CHEMICAL  
- SUSPENSION RESIN POLYMERIZER -  
HENRY, ILLINOIS

REPETITIVE ACCIDENT NO. 10-A TOXIC CHEMICAL RELEASE (VINYL CHLORIDE)  
INCIDENT OF EXPERIENCE VALUE

REPETITIVE ACCIDENT NO. 10-A -- VINYL CHLORIDE GAS RELEASE  
(REFRIGERATION VAPOR LOCK INCIDENT)

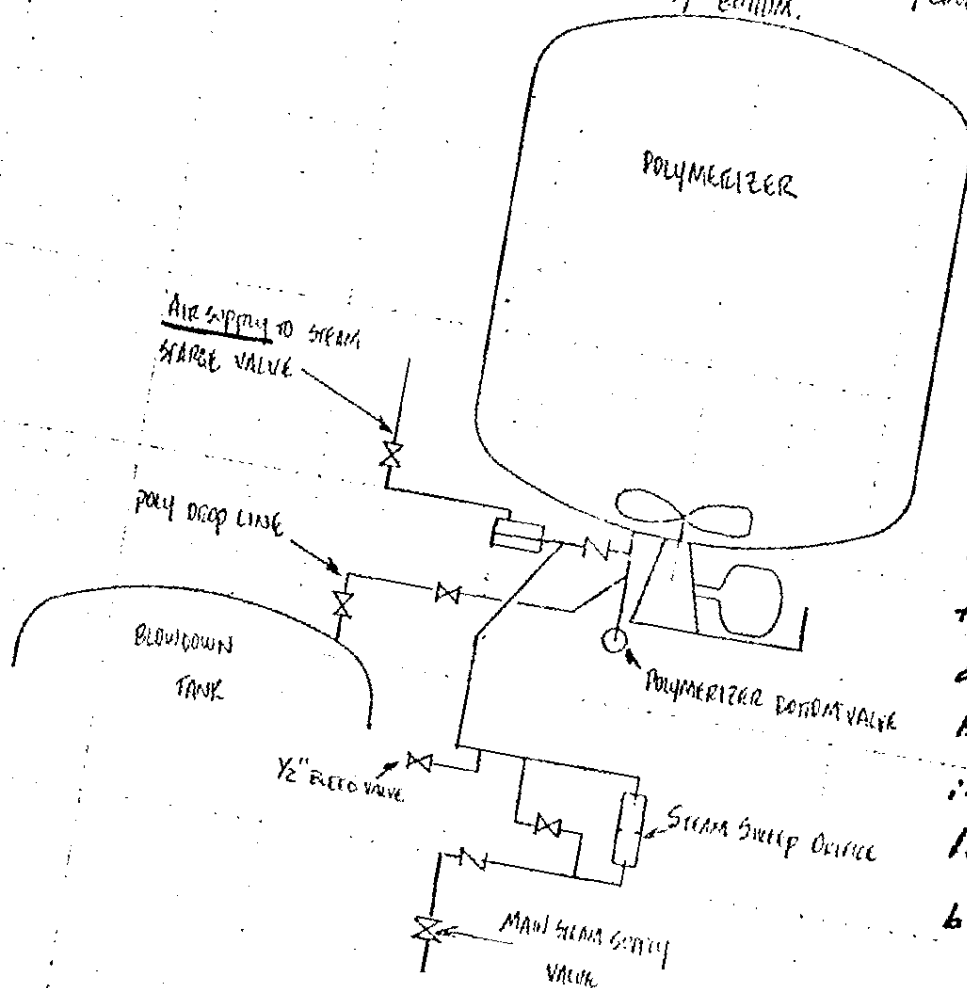
ARRANGEMENT OF STEAM & SLURRY LINES  
ON POLY. BOTTOM.

1. Poly #20 had been entered for chipping late on the 3-11 shift, October 23, 1980. At this time the steam supply line was secured in a double block and bleed arrangement. Also, up to this point, the poly entry check sheet had been followed. *If the steam valves are air operated, is the air disconnected for entry?*

3. Because of miscommunications between the two operators, the polymerizer bottom valves were not set back up properly for the polymerizer to be placed in service: 1) the main steam supply valve was left closed, 2) the 1/2" bleed valve was inadvertently left open.

I'm interested  
in learning the  
position of all  
these valves  
during entry.  
How do they  
isolate the ste  
line and t  
blowdown line.  
g.w.ale

6. Modify the poly entry check sheet to insure that the air line to the S2 Fetterolf air valve is closed prior to entry. If this valve had been closed, no emission would have resulted in spite of the miscommunication. R. C. Linneman, K. E. Musselman

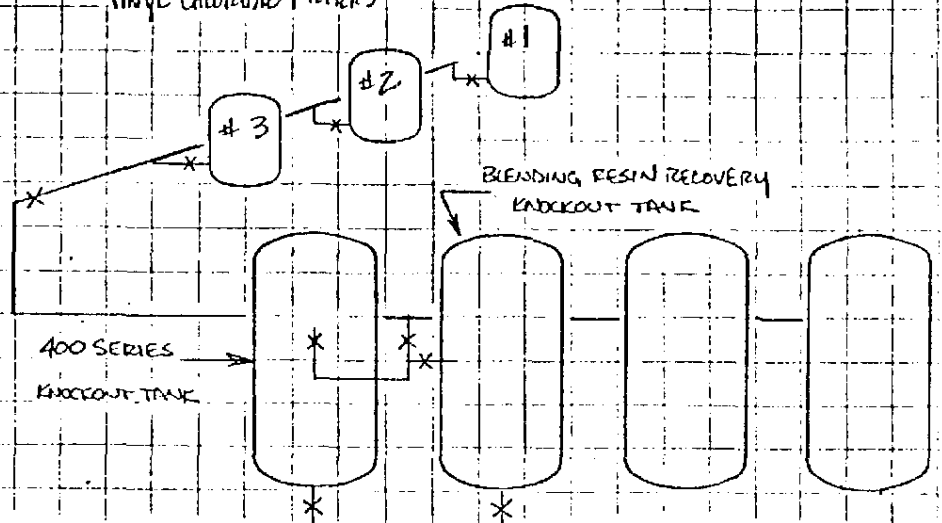
VINYL CHLORIDE FILTERS

1. Vinyl chloride monomer was charged through No. 2 filter to a suspension polymerizer while the filter was on recovery to the blending resin recovery knock-out tank.

2. The blending resin recovery knock-out tank was being drained by the lo-sope/ blending resin operator who thought the drain line was connected to the lo-sope foam trap.

6. No. 1 filter was open to the atmosphere.
7. The blending resin recovery knock-out tank had drained to the blending resin slurry blend tank, but due to quality reasons the line was removed and allowed to drain to the floor after confirming that the water drained from the knock-out tank met EPA requirements.

1. Disciplinary counseling will be conducted with the personnel involved, using Interaction Management Guidelines. J. V. Nordmeyer
2. Repipe the blending resin recovery knock-out tank and the 400 series knock-out tank to the lo-sope scrubber. This action would have contained the filter misoperation and no gas release would have occurred. A. W. Bade
3. Revise the pearl charging procedure to incorporate the tagging of the inlet, outlet and recovery valves when the filter is on recovery. R. C. Linneman
4. Incorporate the proper knock-out draining procedure into the blending resin procedure. S. L. McDonald
5. Review the gas alarm and its seriousness at the next safety meeting.

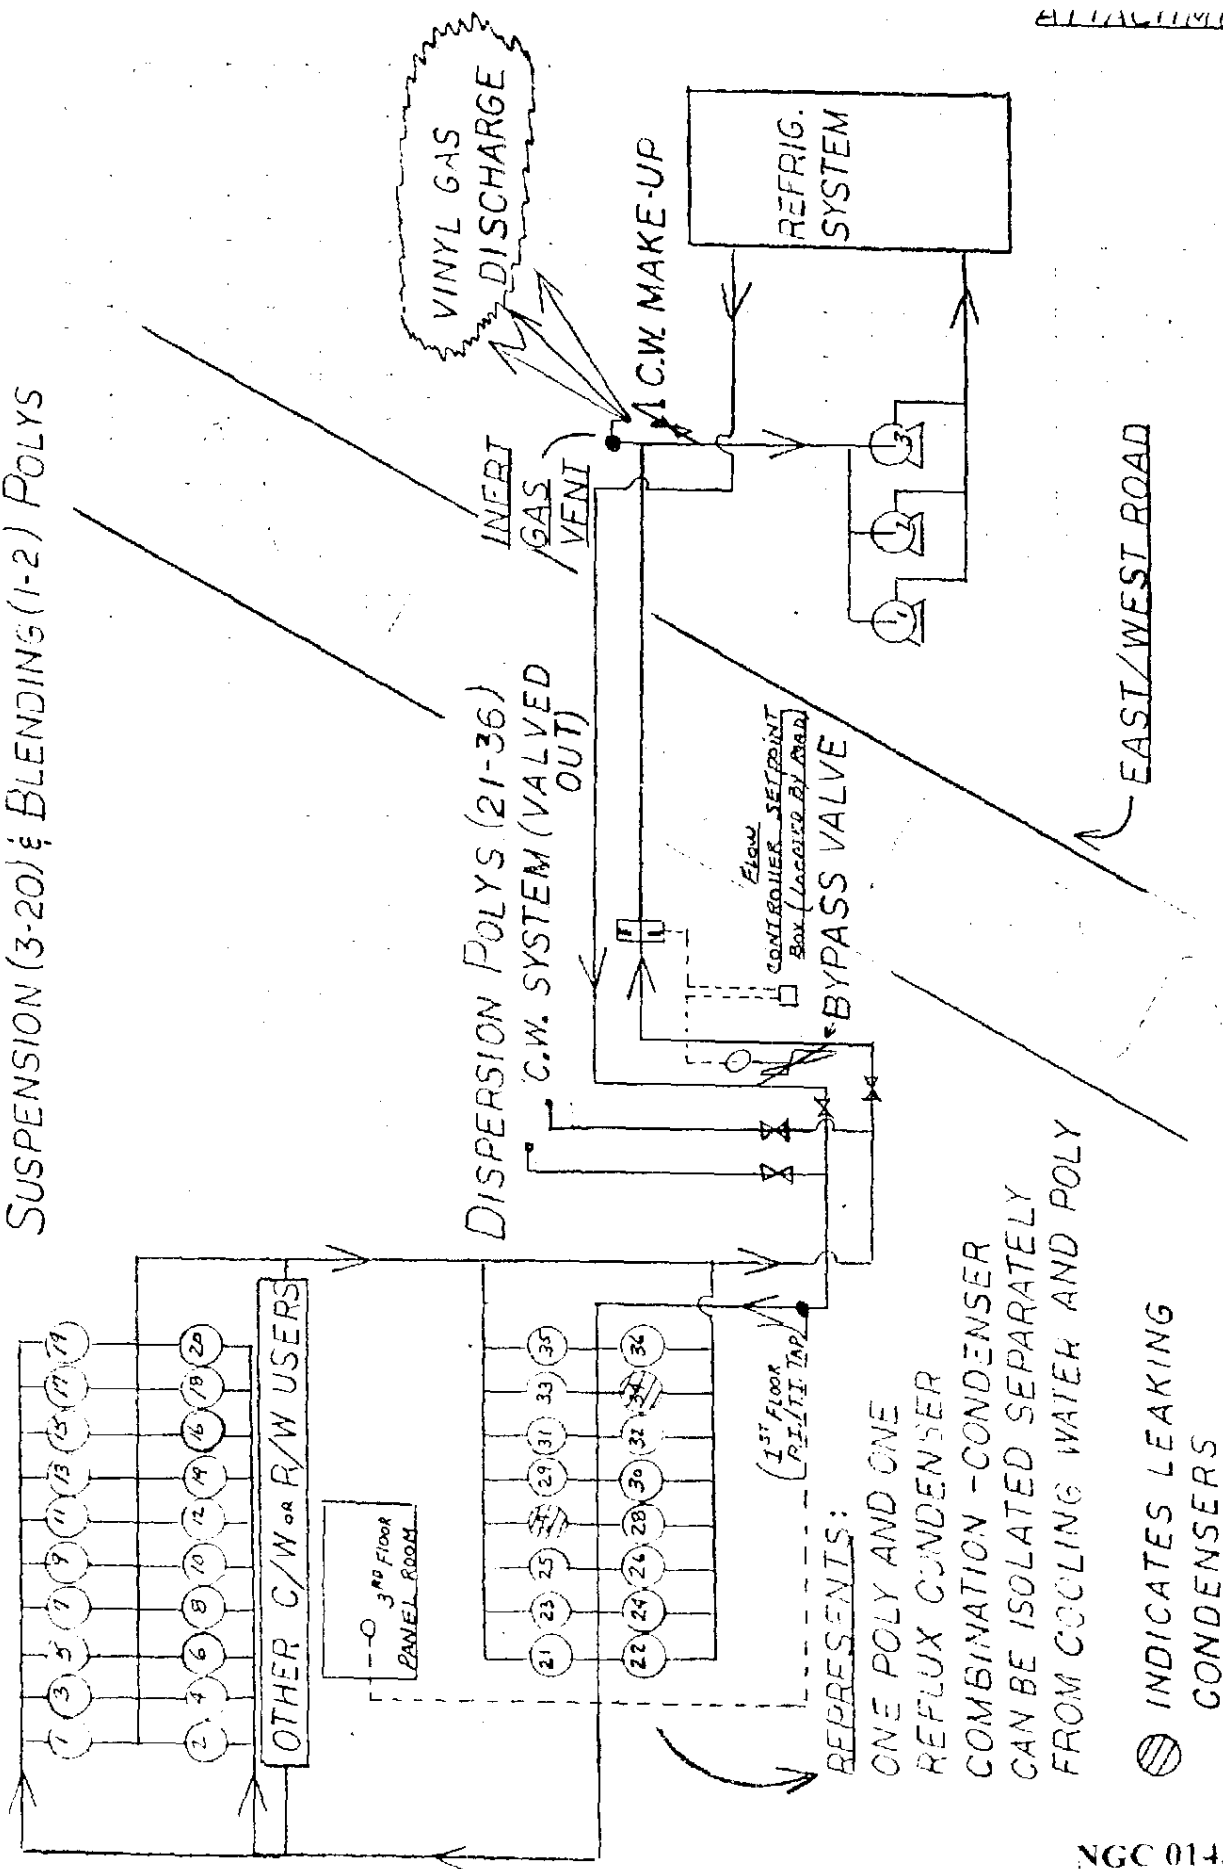
# REFRIGERATION VAPOR LOCK INCIDENT (8/15/82)

7. Vinyl chloride discharge occurred in a remote area that involved no vinyl chloride exposure to personnel (see diagram).

The incident occurred when vinyl chloride leaked from P27 and P34 reflux condensers into the refrigerated water header system. The vinyl chloride pressure was sufficient to push the refrigerated water back into the cooling water make-up supply line which is always open to maintain a hydraulic full refrigerated water system. Once the water level became low enough to affect the R/W\* pumping efficiency, the flow to the Poly Building was severely reduced. Simultaneously, the gas vapor began to bleed from the inert gas vent valve.

⊗ INDICATES LEAKING  
CONDENSERS

1. Check the integrity of the nitric oxide addition system for subtle leaks and other problems. Completed 8/17/82. (R.D.Moore)
2. Implement a vacuum check system on the dispersion reflux condensers. Completed 8/20/82. (S.L.McDonald)

8. Check all 16 polymerizer reflux condensers for refrigerated water leakage. Completed 8/20/82. (D.E.Giffin)
9. Investigate method for measuring inert gas vent valve venting frequency. (W.W.Walk)
