**Region 6 - Enforcement & Compliance Assurance Division**  
**INSPECTION REPORT**

| Inspection Date(s): | 11/08/2019 | |
| Company Name: | <b>Red Oak Operating, LLC</b> | |
| Facility Name: | <b>Shiloh Lease</b> | |

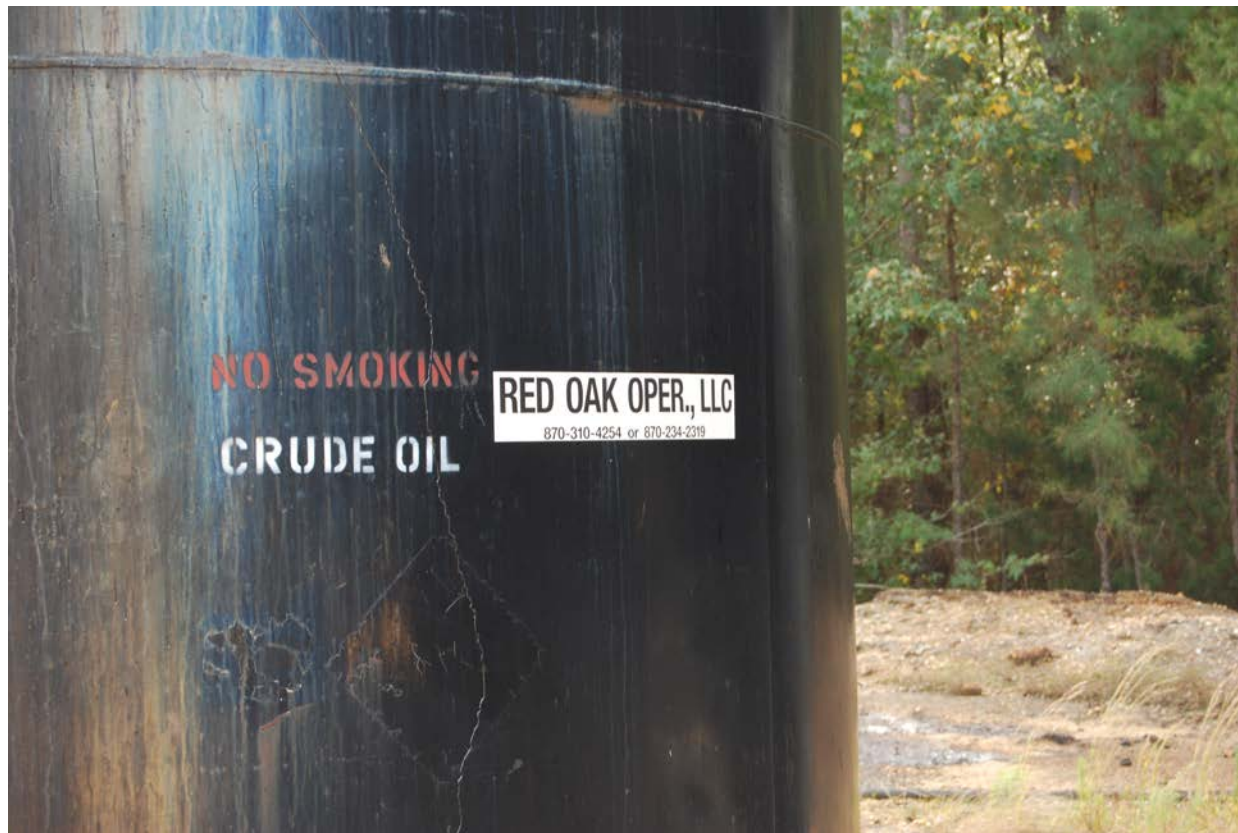
Photo No. 1

Description: This was the first sign that identified the owner and operator at the lease during the inspection.

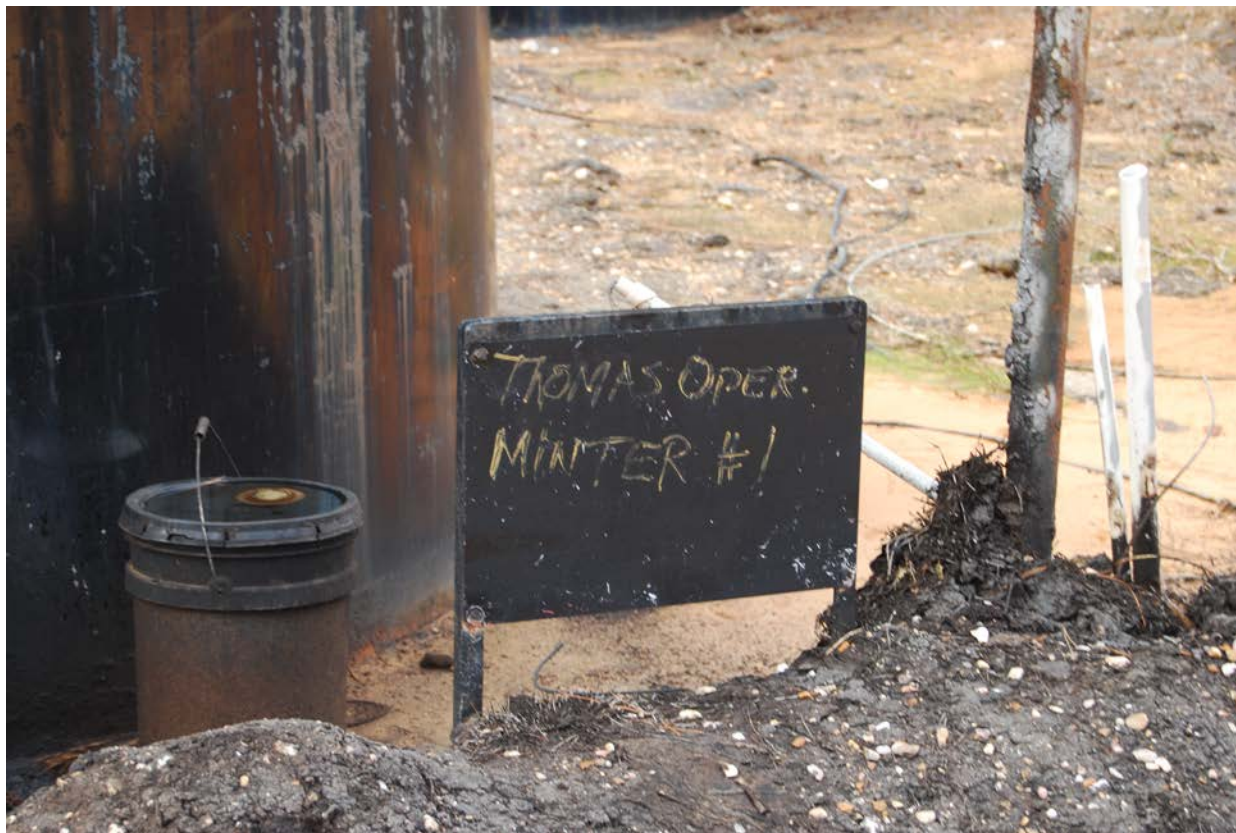
Photo No. 2

Description: This sign located at the tank battery identified itself as the Minter #1.

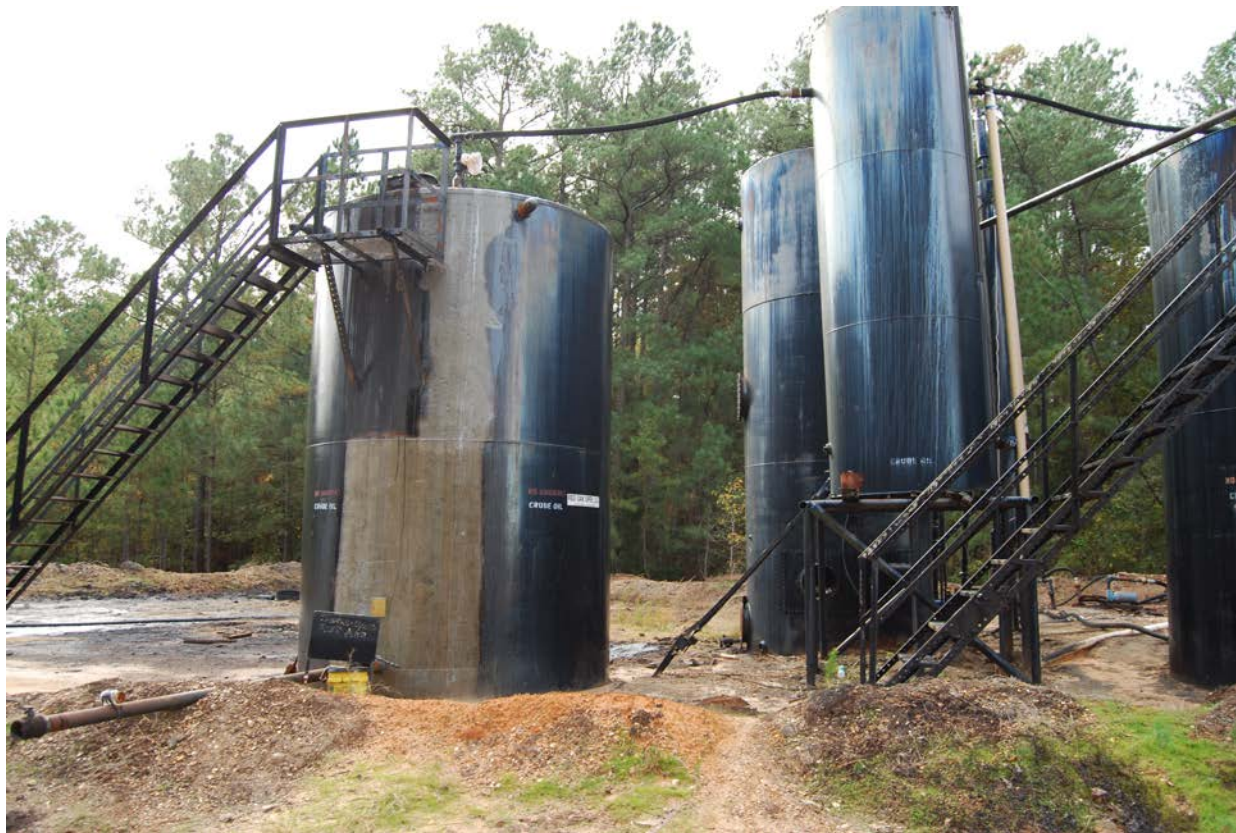
Photo No. 3

Description: This image shows the overview of the tank battery and secondary containment pit, which had recently been drained. The pit was the source of the discharge or brine from the facility to Clear Creek.

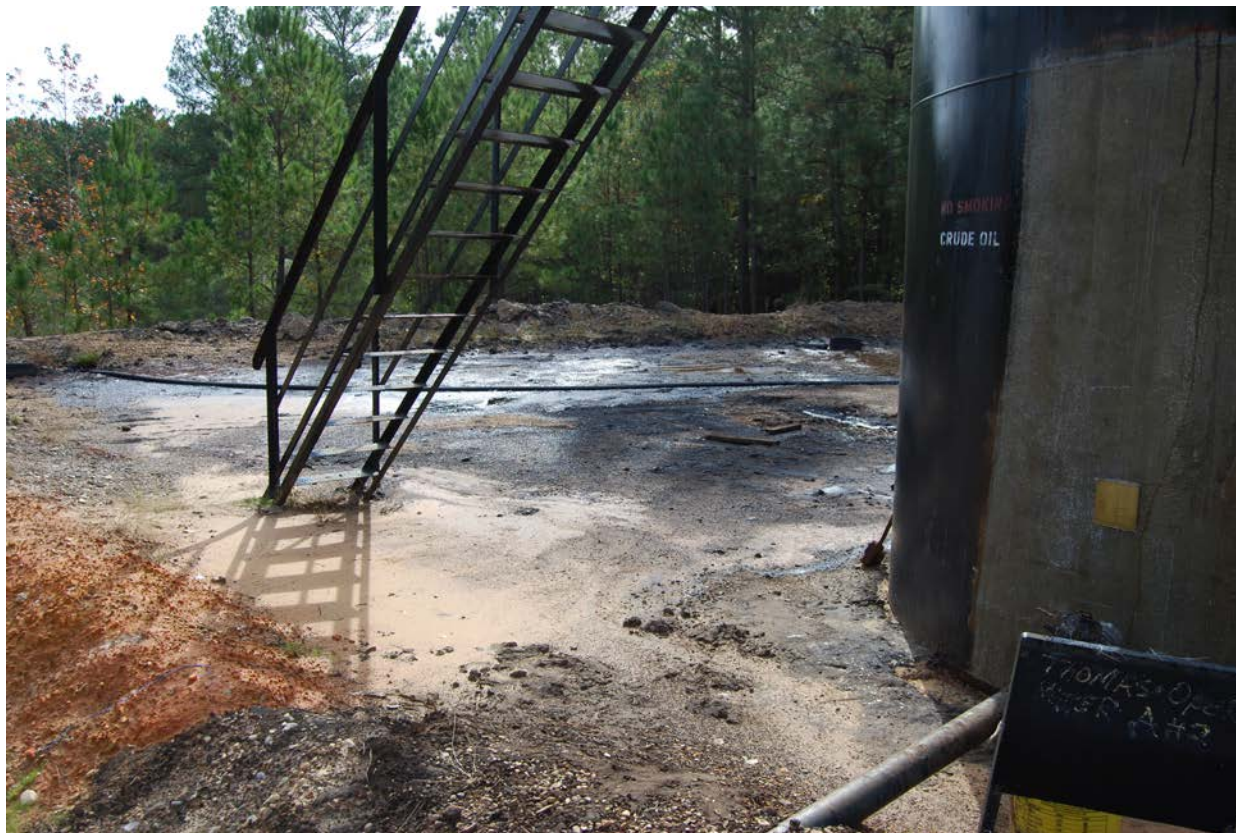
Photo No. 4

Description: I observed that the tank battery pit was dry after had been drained recently from the facility to Clear Creek.

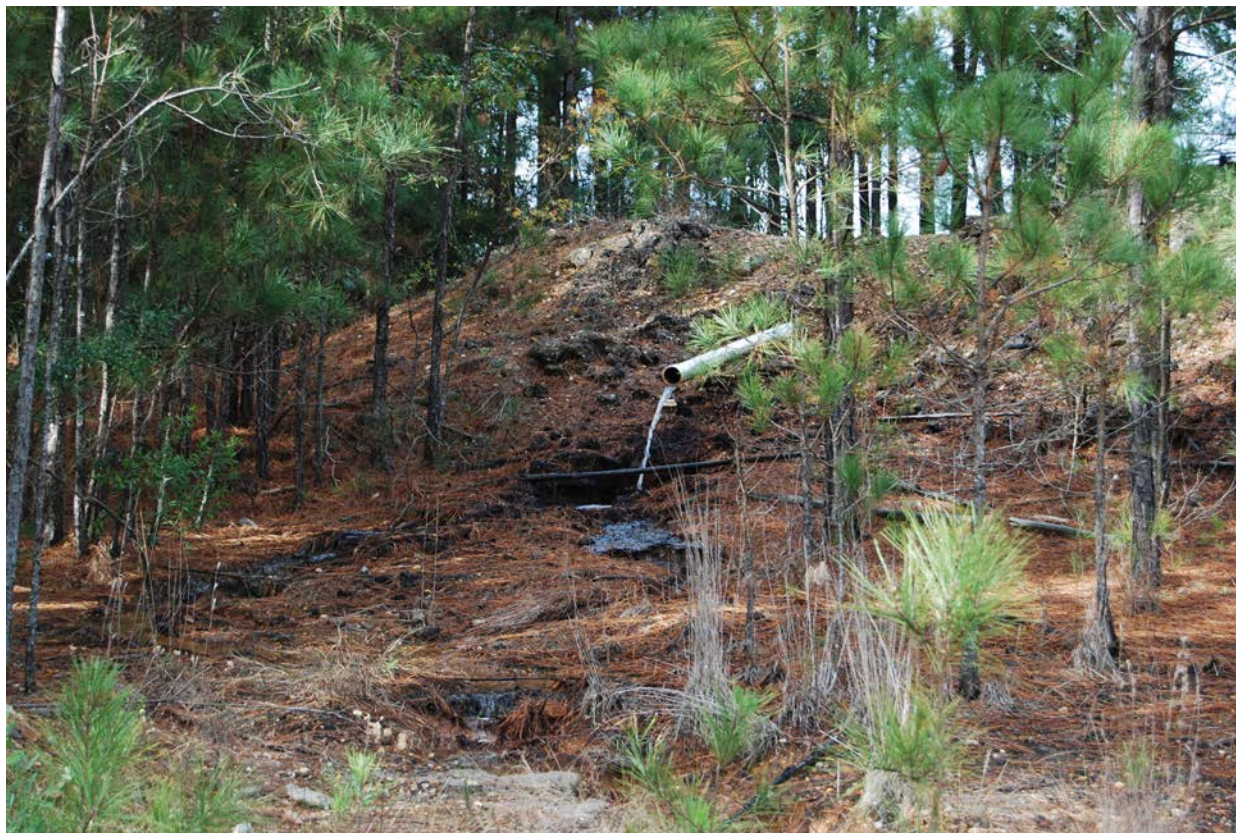
Photo No. 5

Description: I observed the drain pipe was draining brine from the tank battery pit to Clear Creek, during the inspection. I observed an oil sheen along the flow path as well.

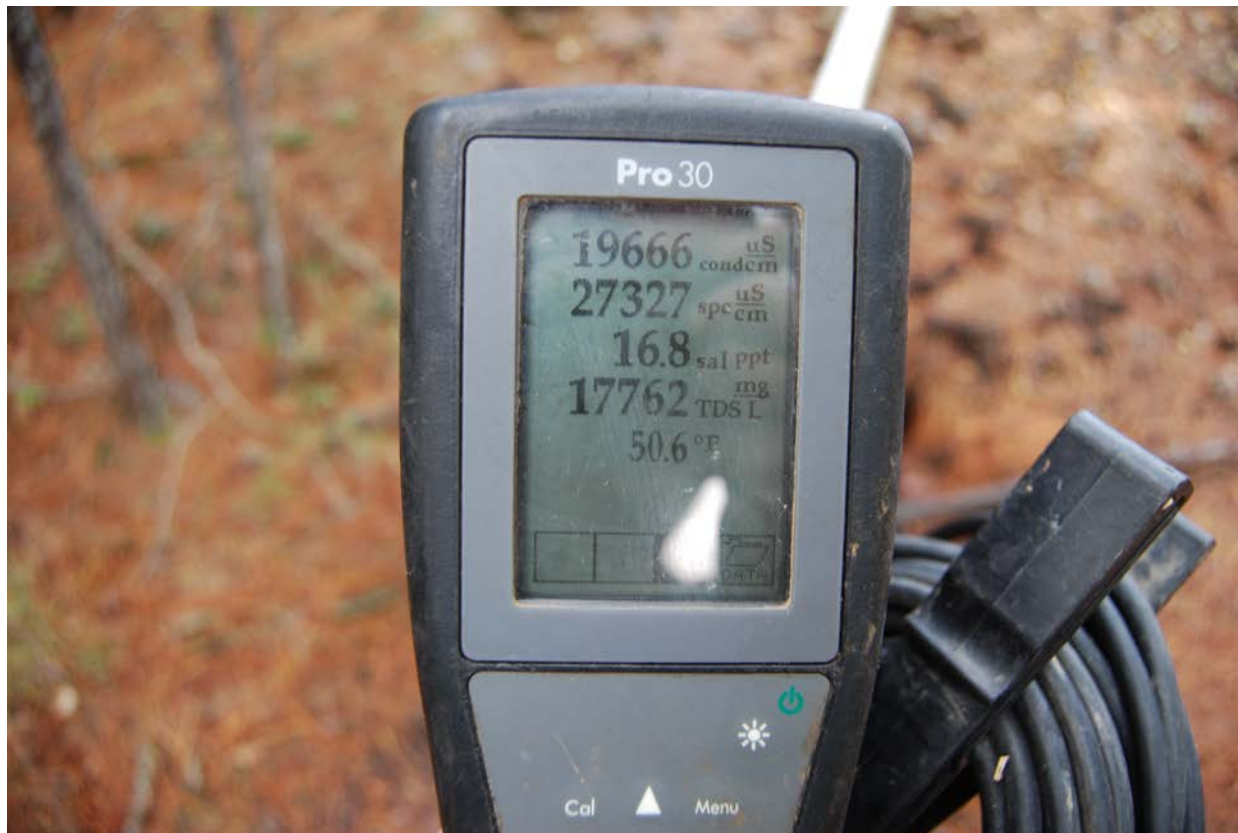
Photo No. 6

Description: With a calibrated YSI Pro 30 conductivity meter, I measured Total Dissolved Solids (TDS) at the drain pipe and the discharged fluid, including brine, measured 17,762 milligrams per liter (mg/L).

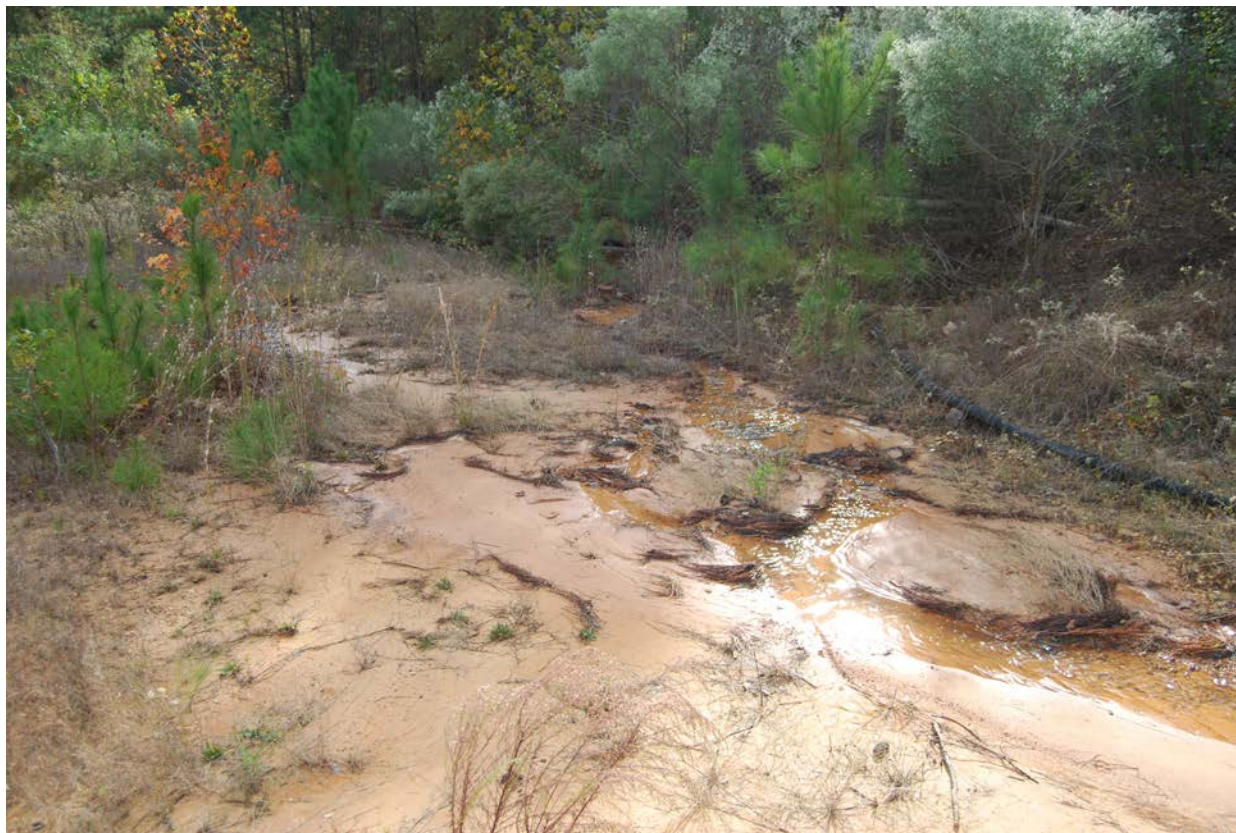
Photo No. 7

Description: I observed brine that flowed from the pit and the flow path went east toward Clear Creek.

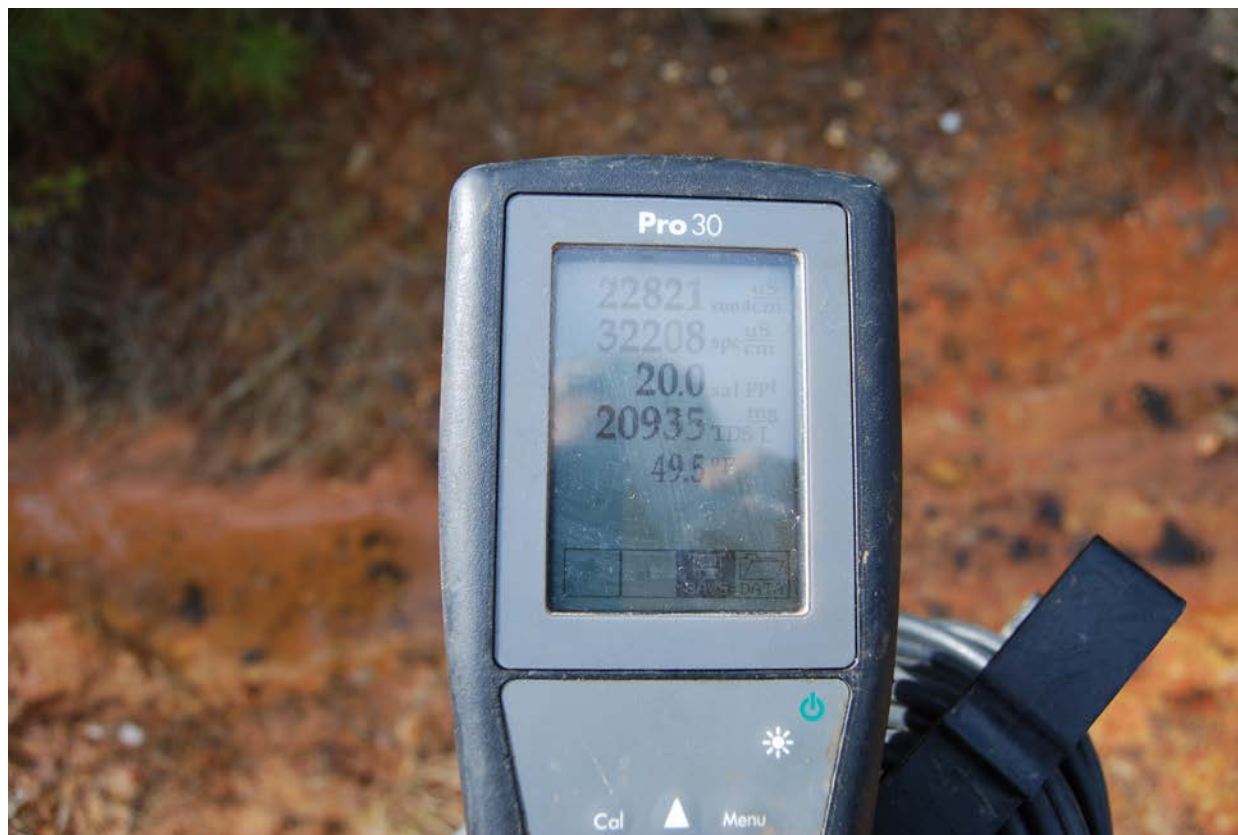
Photo No. 8

Description: The TDS at the location shown in Photo 7 measured 20,935 mg/L.

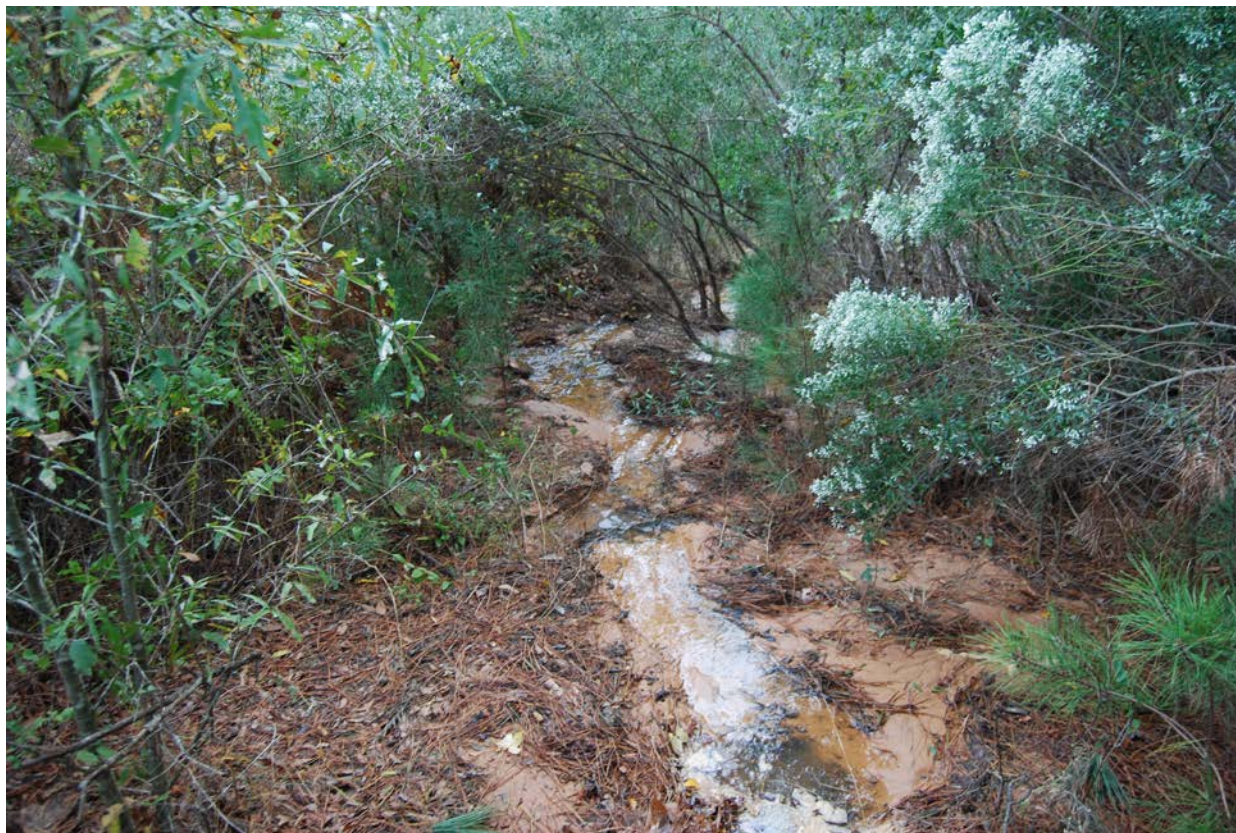
Photo No. 9

Description: The brine flowed into the woods here, on the way to the Clear Creek.

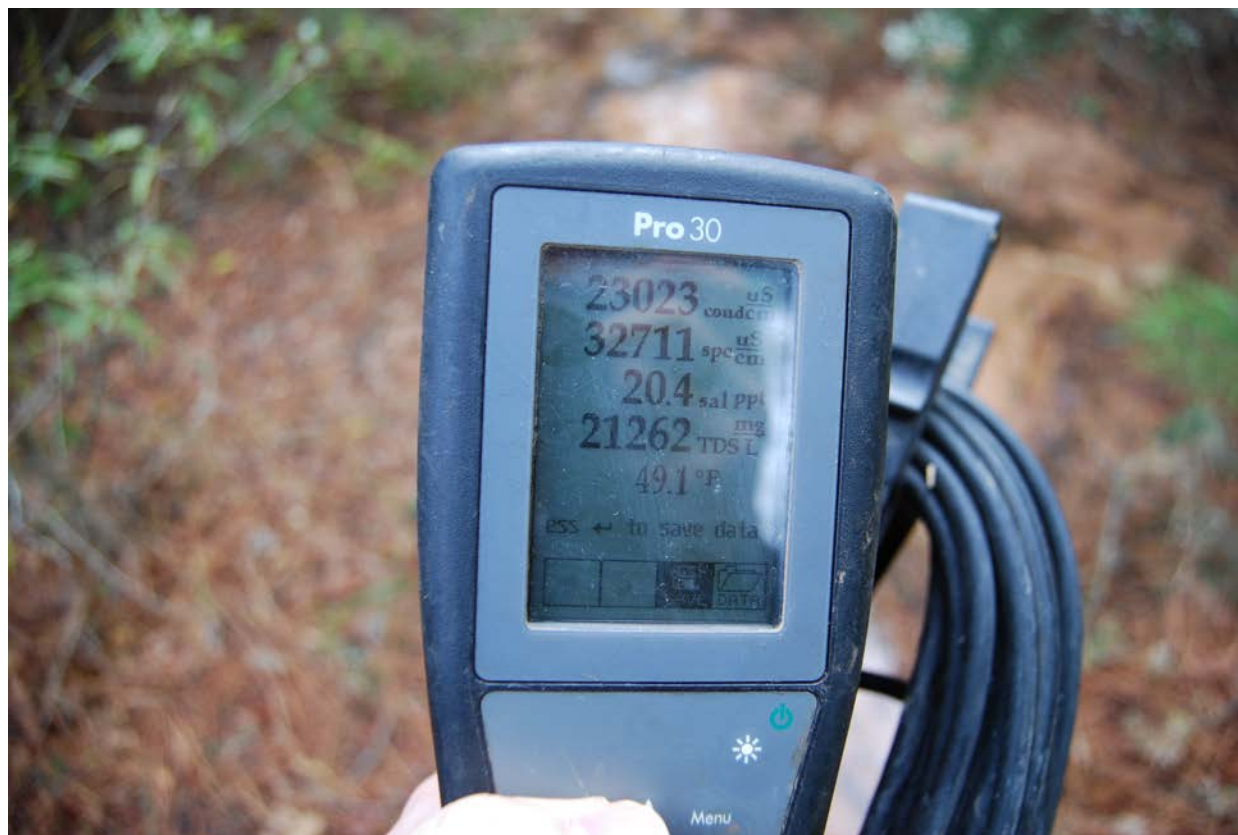
Photo No. 10

Description: The TDS at the location shown in Photo 9 measured 21,262 mg/L.

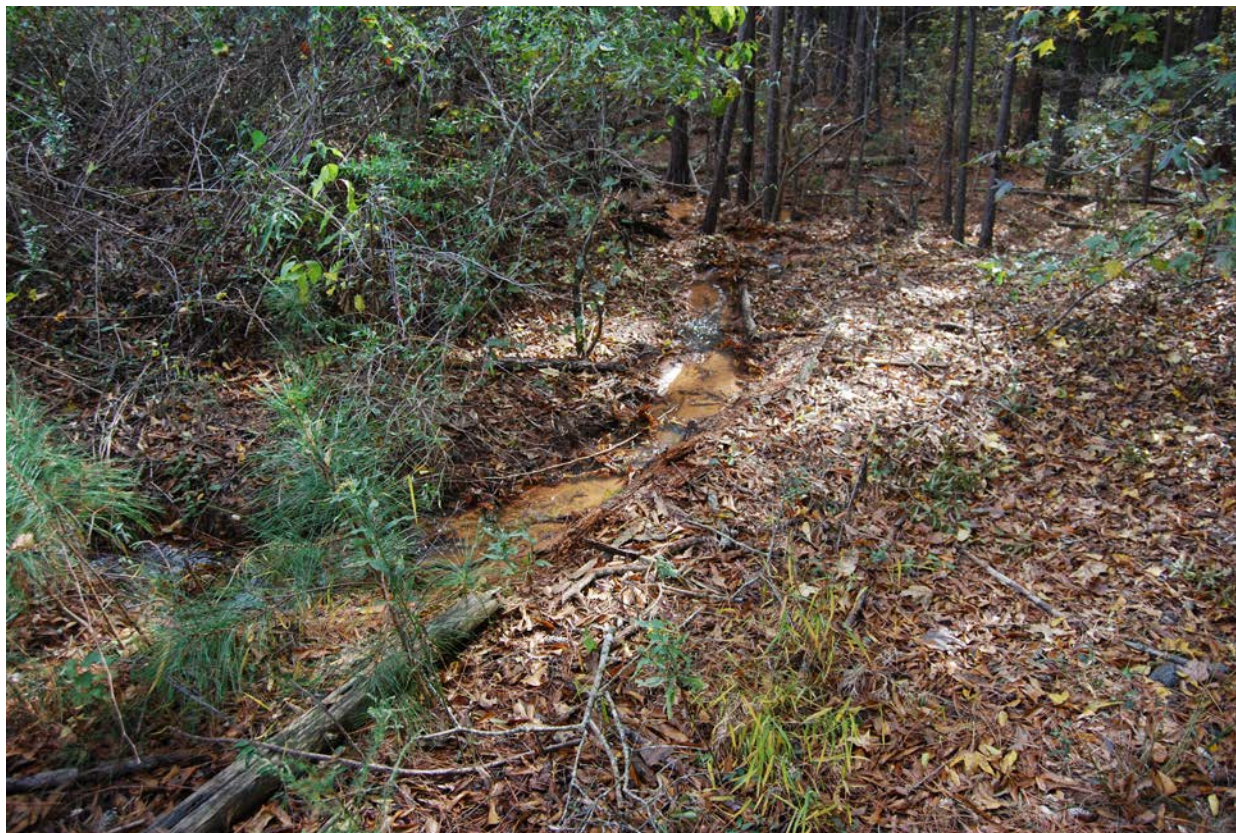
Photo No. 11

Description: This was a view of the brine discharge flowing towards the point of entry to Clear Creek.

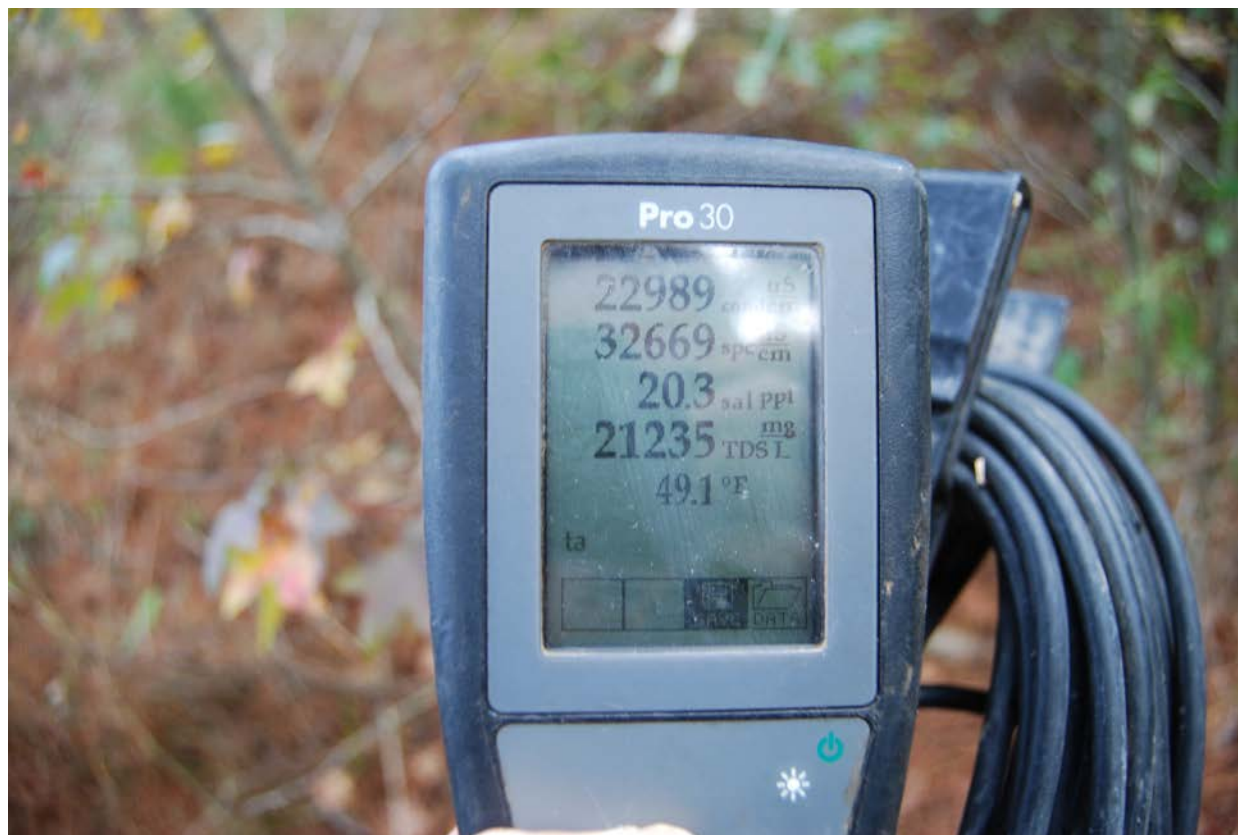
Photo No. 12

Description: The TDS of the discharge location shown in Photo 11 measured 21,235 mg/L.

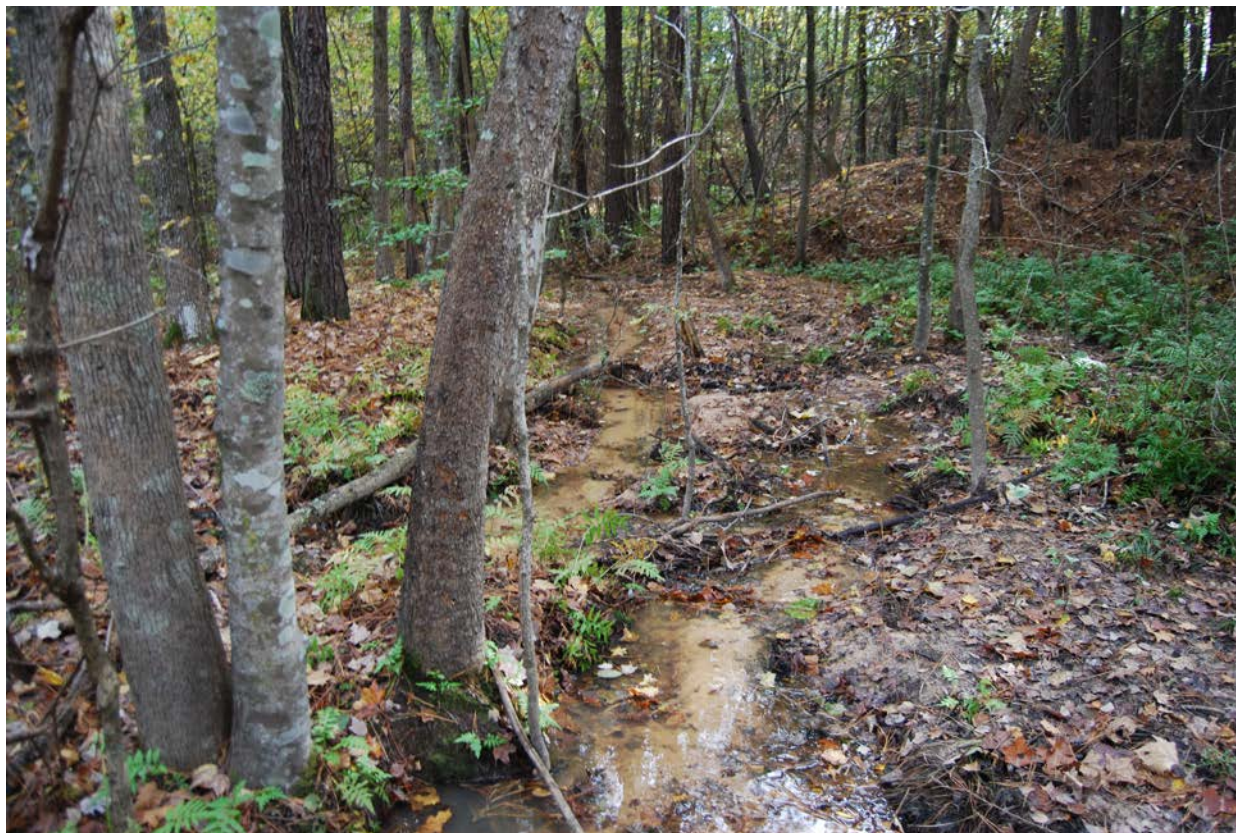
Photo No. 13

Description: I observed that the brine discharge from the Shiloh lease facility entered Clear Creek here.

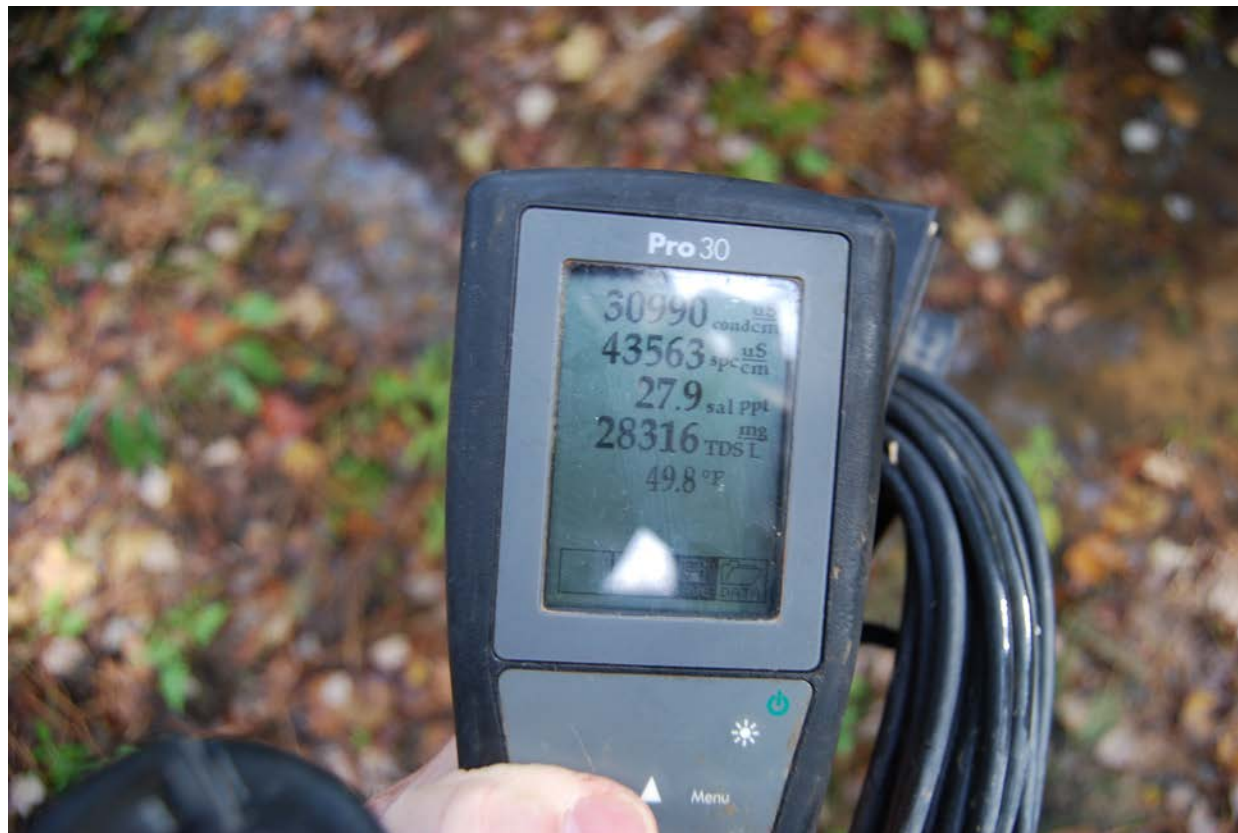
Photo No. 14

Description: The TDS of Clear Creek at the point of entry measured 28,316 mg/L.

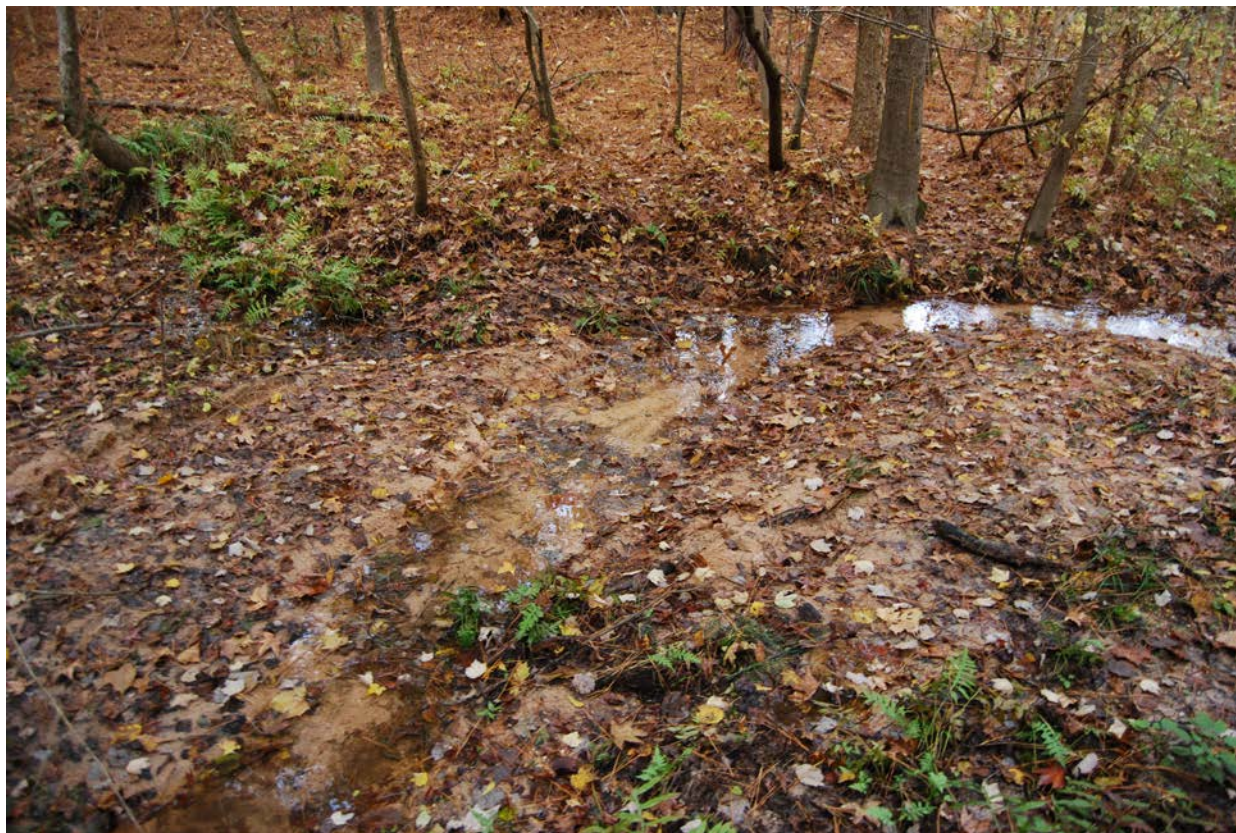
Photo No. 15

Description: I observed Clear Creek upstream from the point of entry of the discharged brine, here. The creek was flowing at the time of the inspection.

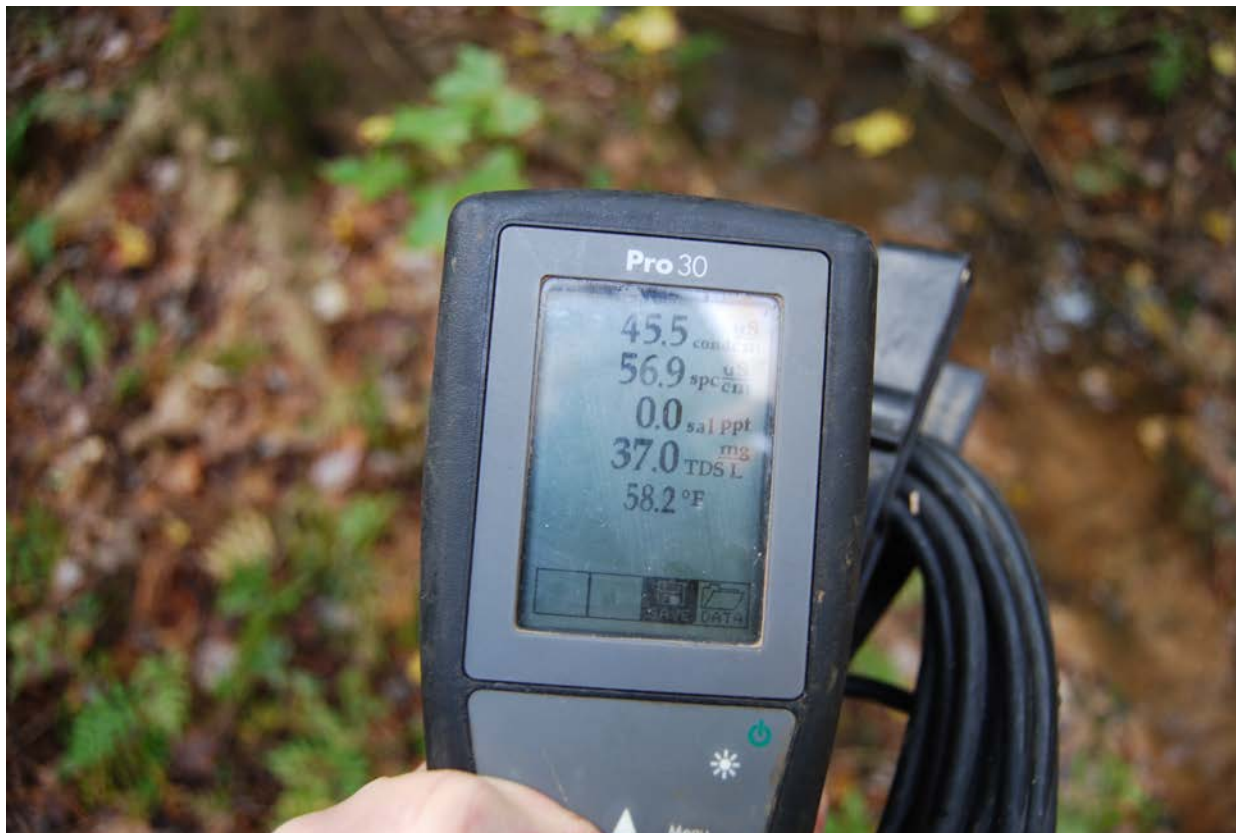
Photo No. 16

Description: The TDS of Clear Creek, upstream of the discharge entry point measured 37 mg/L.
