Howell Industries, Inc./Howell Cattle Feedlot  
Inspection Date 09/20/2022

**Region 6 - Enforcement & Compliance Assurance Division**  
**INSPECTION REPORT**

| Facility Name: | <b>Howell Cattle Feedlot (27.351956, -98.226426)</b> | |

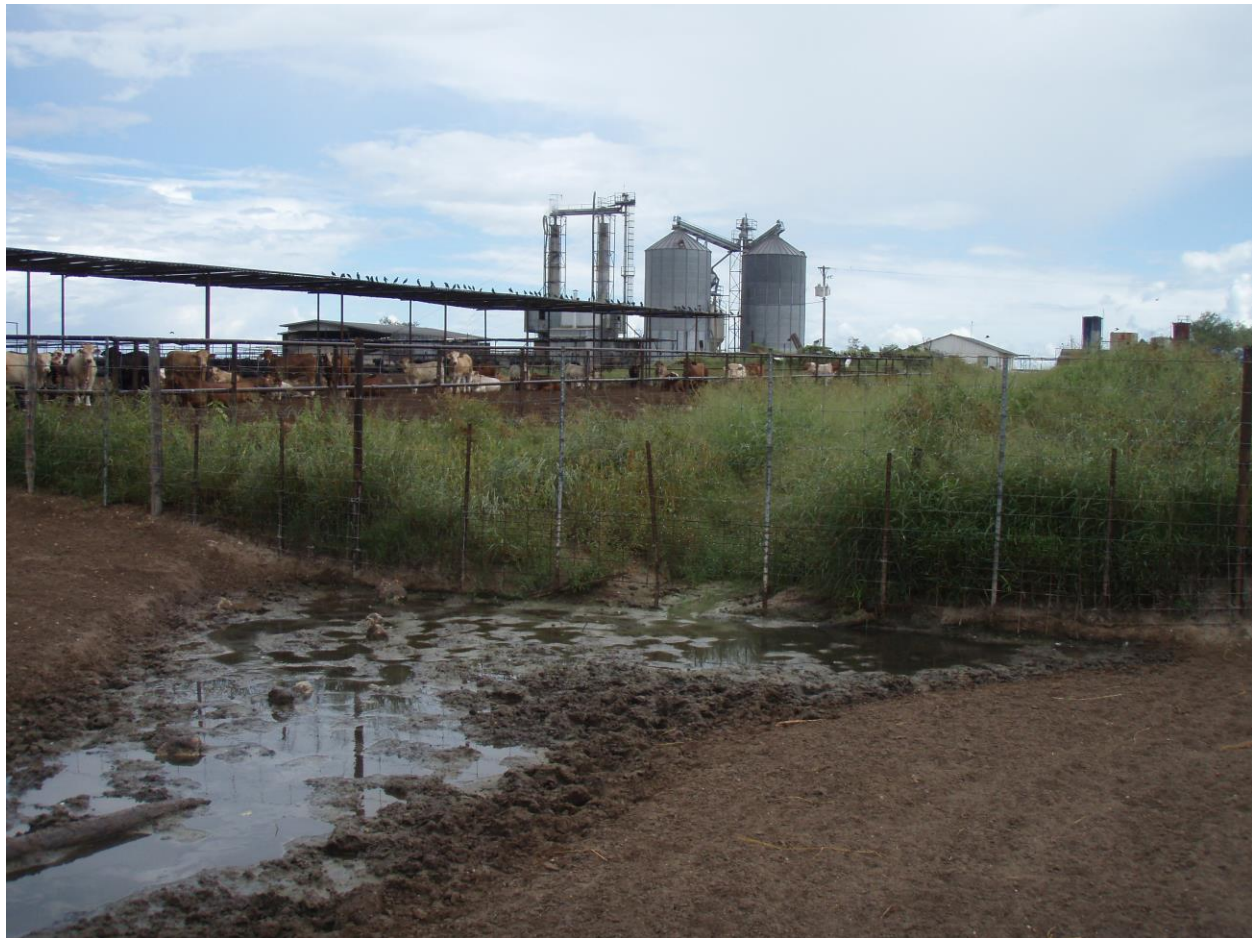
Photo No. 1

The drainage culvert going under County Road 417, leading into the RCS, did not appear to be freely flowing and could possibly cause a back-up of production area wastewater onto the county's property. The culvert and the slopes leading to and from the culvert need to be cleared to prevent ponding and back-ups during rain events. See photos 1-4.

Description: Looking east at the discharge from the pens and feed mill. The discharge is flowing toward the RCS.

AOC 5: The drainage culvert going under County Road 417, leading into the RCS, did not appear to be freely flowing and could possibly cause a back-up of production area wastewater onto the county's property. The culvert and the slopes leading to and from the culvert need to be cleared to prevent ponding and back-ups during normal operating periods and rain events as required by the Permit Part III.A.6.(c).(3).

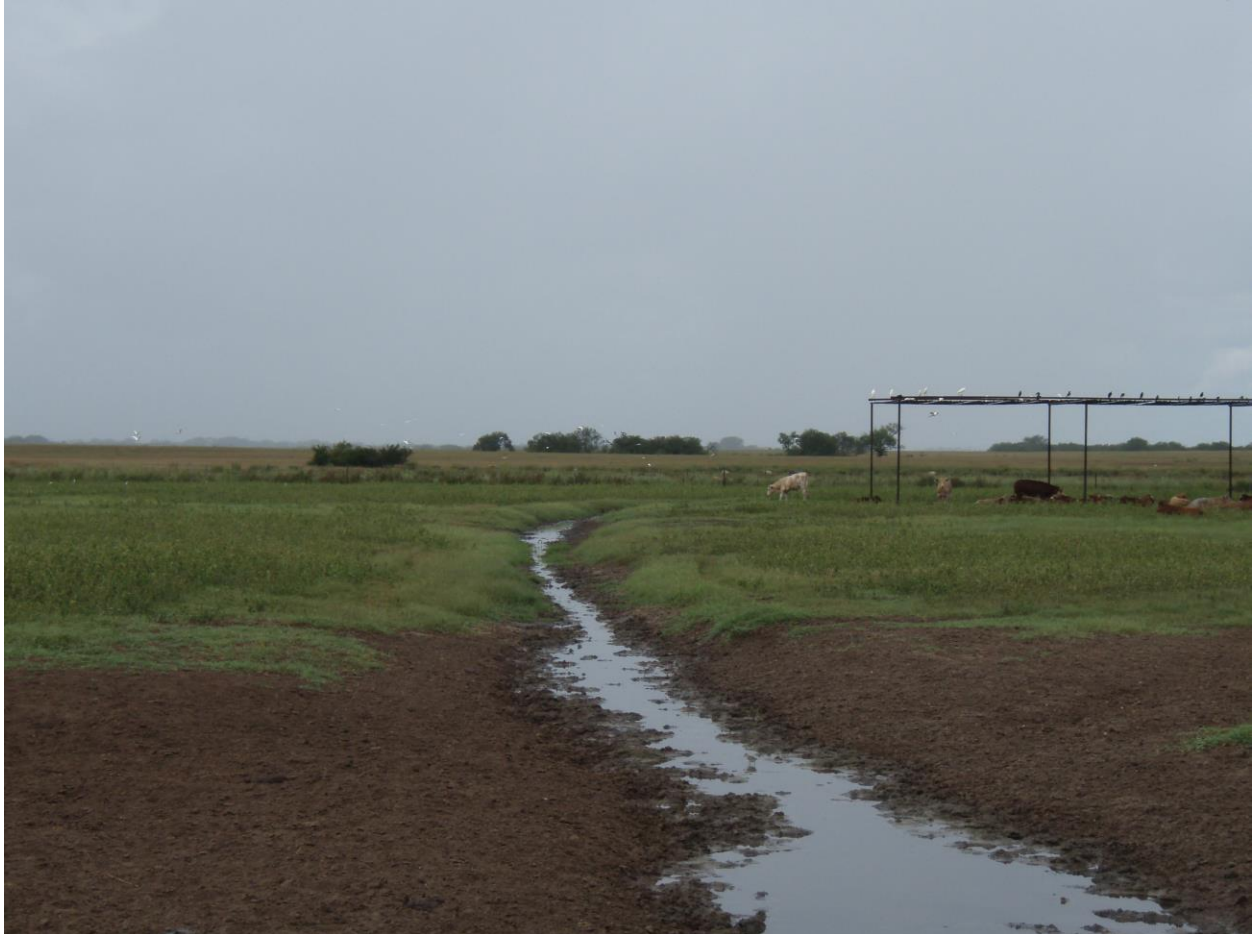
Photo No. 2

Description: Looking west at the production area discharge channel leading from the production area (pens and feed mill) to the RCS.

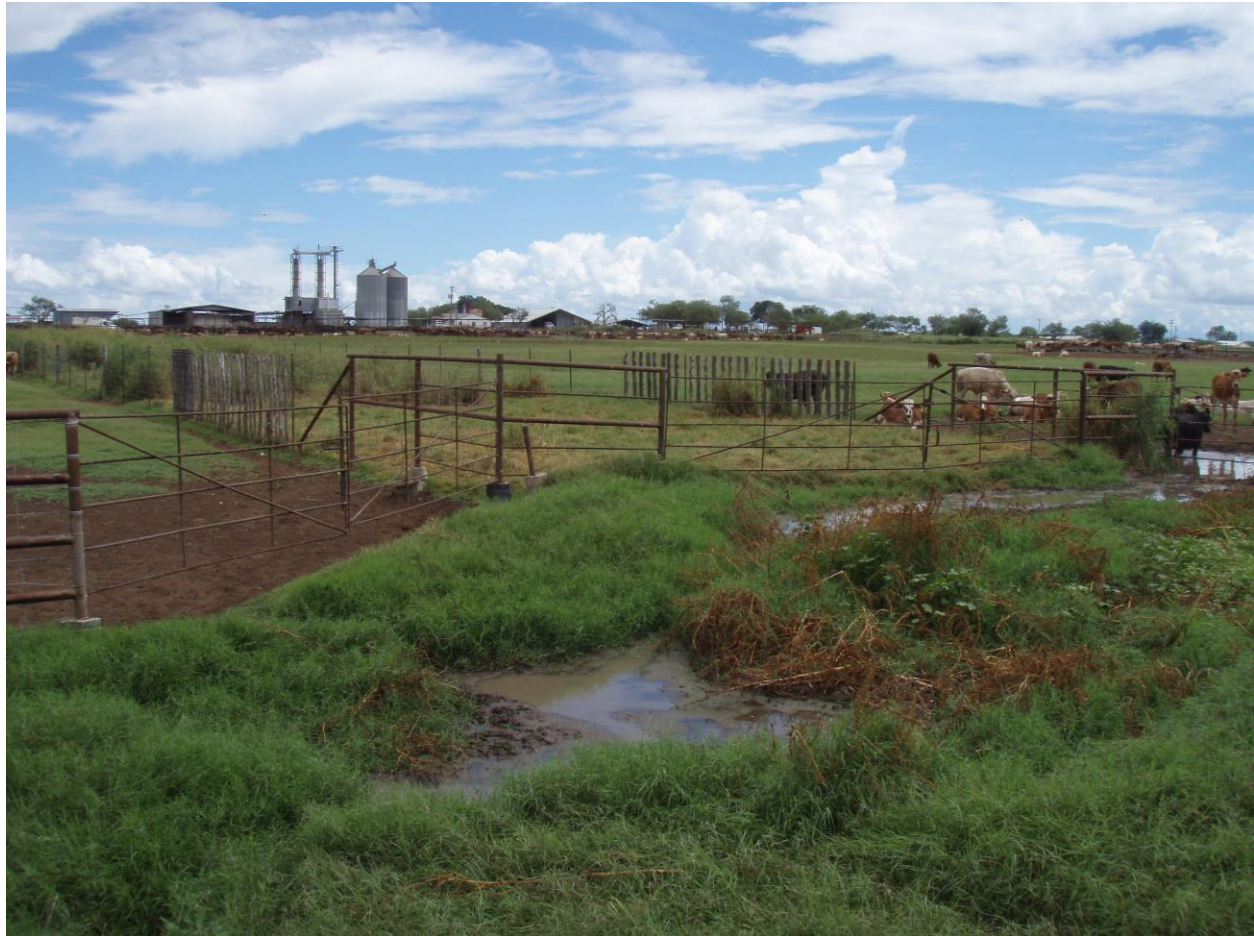
Photo No. 3

Description: The drainage channel shown in photos 1 and 2 has ponded near the culvert that goes under County Road 417. The view is toward the east-southeast.

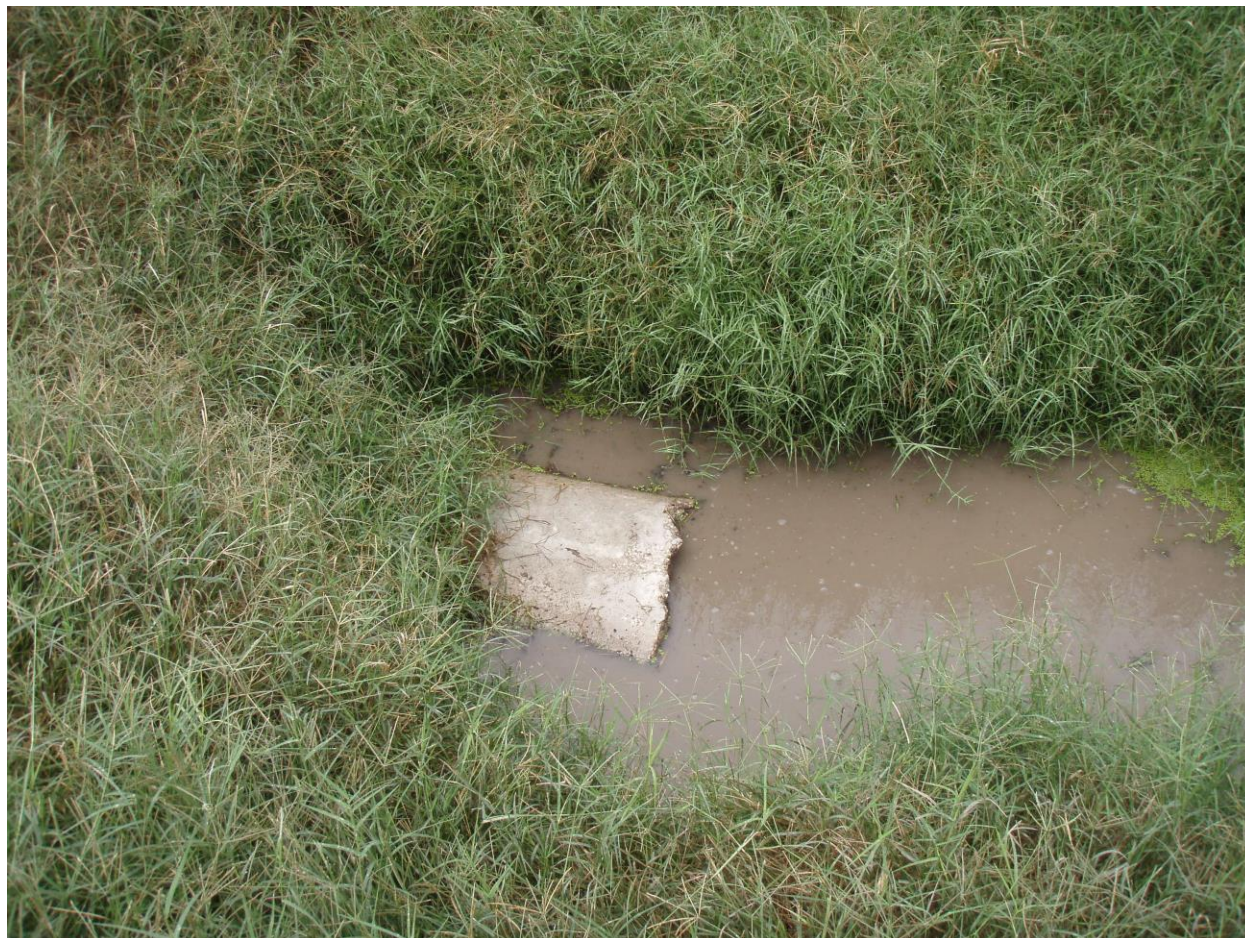
Photo No. 4

Description: The ponded discharge at the culvert going under County Road 417. The flow appears to be somewhat obstructed and not free flowing. The photo was taken from the upstream side of the culvert on the east side of the road.

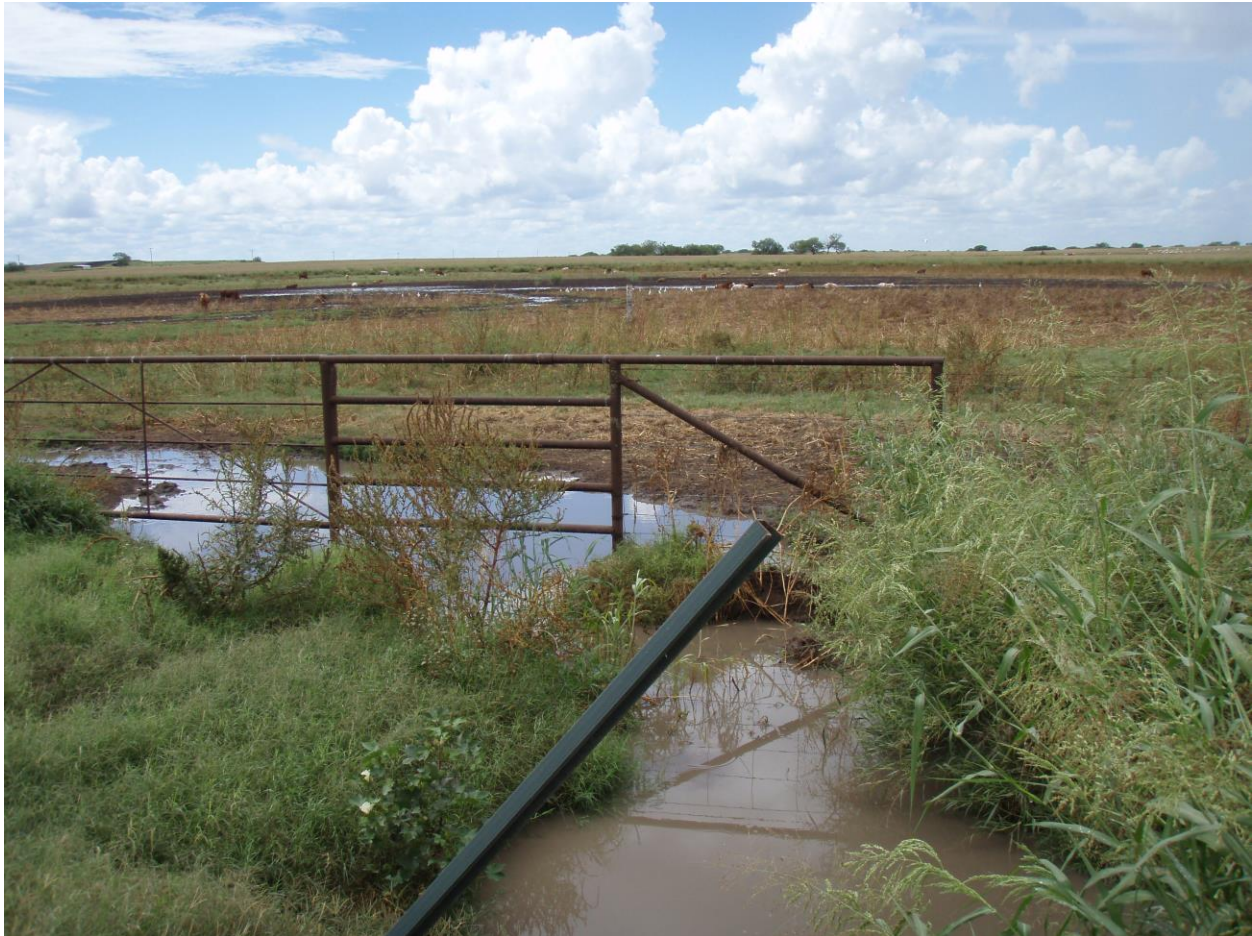
Photo No. 5

The RCS has the original lagoon certifications from 10/22/2001 by Ben Weinheimer, P.E., showing a liner permeability of  $6.6 \times 10^{-9}$ . The RCS was recertified on 5/10/2018. The RCS has three issues which do not meet the TCEQ requirements for operation and maintenance. 1) The RCS is not fenced-off from the rest of LMU 1 which has allowed cattle to graze and walk around the RCS. The unit must be fenced to prevent animal intrusion onto the RCS liner. 2) The pole marker has faded-out and is not readable. The pole marker must be clearly marked in 1-ft increments so that weekly lagoon measurements can be made, and the 25-yr/24-hr rain event mark must also be designated to ensure that adequate capacity is available. These marks must be accurately posted on the pole marker. 3) There are four small trees growing in the RCS which must be removed. See Appendix 1 photolog (photos 5-6) showing the 286 acre-ft RCS.

Description: Looking west at the playa RCS. The RCS is not fenced and cattle are in the unit. The pole marker located in the center of the photograph shows <1' of water in the RCS. The photo was taken from County Road 417.

AOC 1: 1) The RCS (the playa lake) is not fenced-off from the rest of LMU 1 which has allowed cattle to graze and walk around the RCS. The unit must be fenced to prevent animal intrusion onto the RCS liner as required by the TCEQ CAFO General Permit (Permit) Part III.10.(f)(2) which states that "Liners must be protected from animals by fences or other protective devices". 2) The pole marker has faded-out and is not readable. The pole marker must be clearly marked in 1-ft increments so that weekly lagoon measurements can be made, and the 25-yr/24-hr rain event mark must also be designated to ensure that adequate capacity is available. These marks must be accurately posted on the pole marker as required by the Permit Part III.10.(c) . 3) There are four small trees growing in the RCS. The TCEQ Permit states that "No tree shall be allowed to grow such that the root zone would intrude or compromise the structure of the liner or embankment" and as such must be removed as required by the Permit Part III.10.(f)(3).

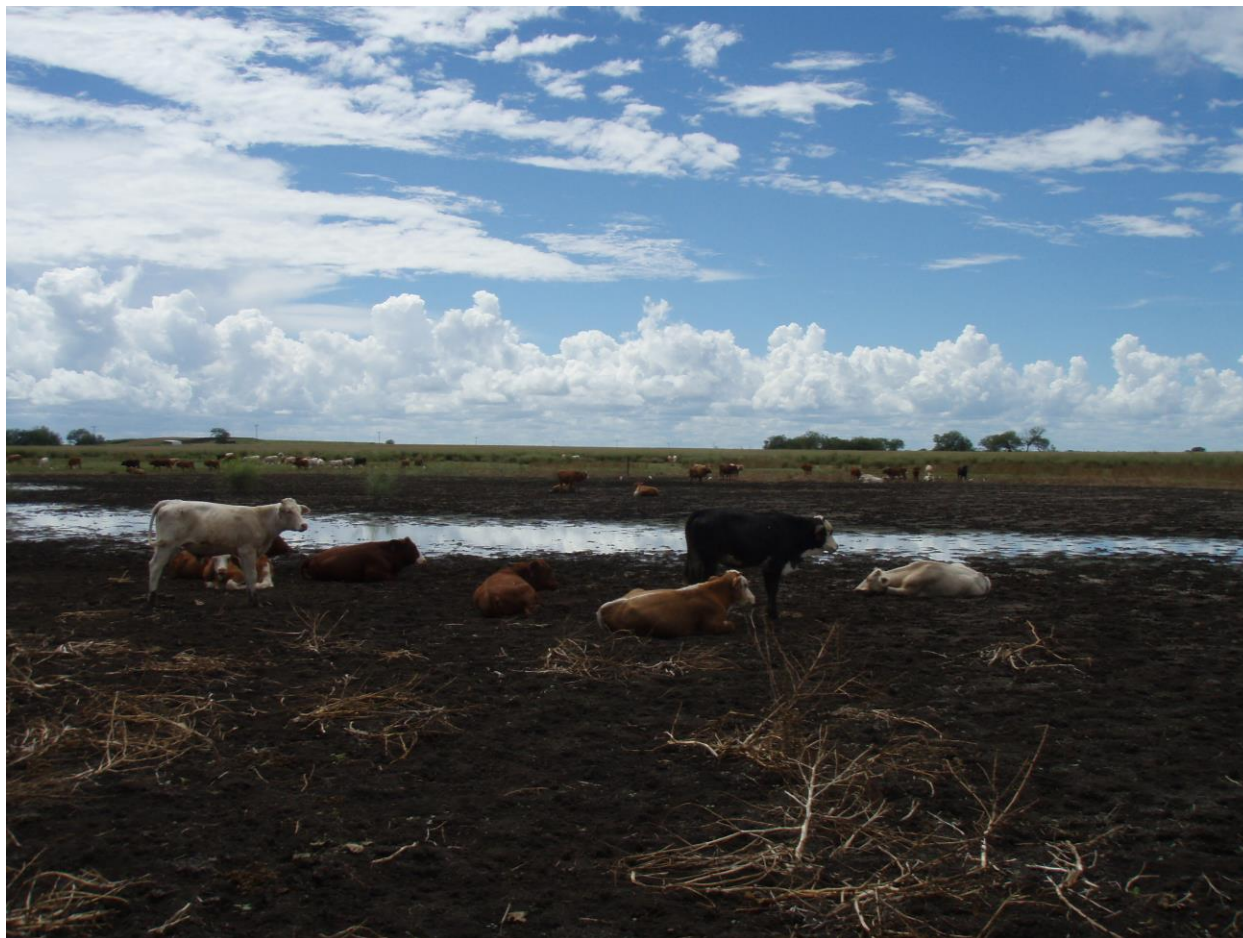
Photo No. 6

Description: A close-up view of the playa RCS showing the cattle in the unit and small trees growing within the RCS. The RCS is not fenced-off from the rest of LMU 1. The view is toward the west.

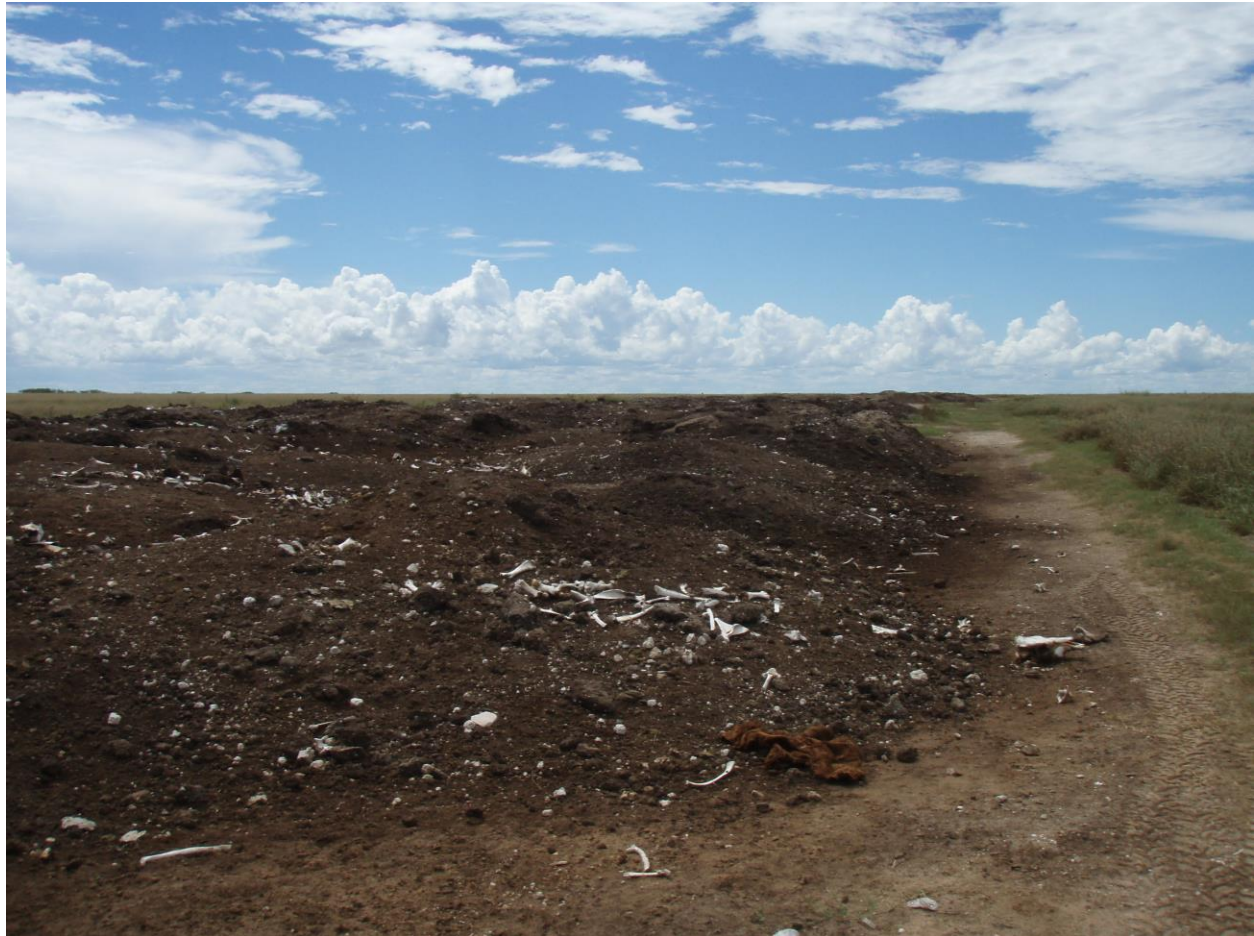
Photo No. 7

The old mortality compost area is located within LMU 1, upslope of the RCS. The piles were large and appeared to be quite old. However, the piles have many hundreds of bones sticking out of them and scattered on the surface of the piles. This is not proper for the disposal of the mortalities, and the bones should be screened, landfilled or re-composted, and the finished compost should be land applied at an agronomic rate or given/sold to a third party (see photo 7). This includes the finished composted mortality materials in the new borrow pit near LMU 6 (see photo 10).

Description: The old mortality composting area located in LMU 1, upslope of the RCS, has hundreds of exposed cattle bones on the surface of the manure compost piles. Mortality composting must be managed consistent with the TCEQ regulations and appropriate NRCS procedures. The view is toward the west.

AOC 4: The old mortality compost area is located within LMU 1, upslope of the RCS. The piles were large and appeared to be quite old with many hundreds of bones sticking out of them and scattered on the surface of the piles. This is not proper for the disposal of the mortalities, and the bones should be screened, landfilled or re-composted, and the finished compost should be land applied at an agronomic

rate or given/sold to a third party. The mortality management area must be properly managed as required by the Permit Part III.A.11.(c) (which further references 4 TAC Sections 31.3, 58.31(b), and RG-419). Also the requirements of 30 TAC Chapter 332.(4) were not met due to the apparent scavenging that occurred and nuisance conditions generated.

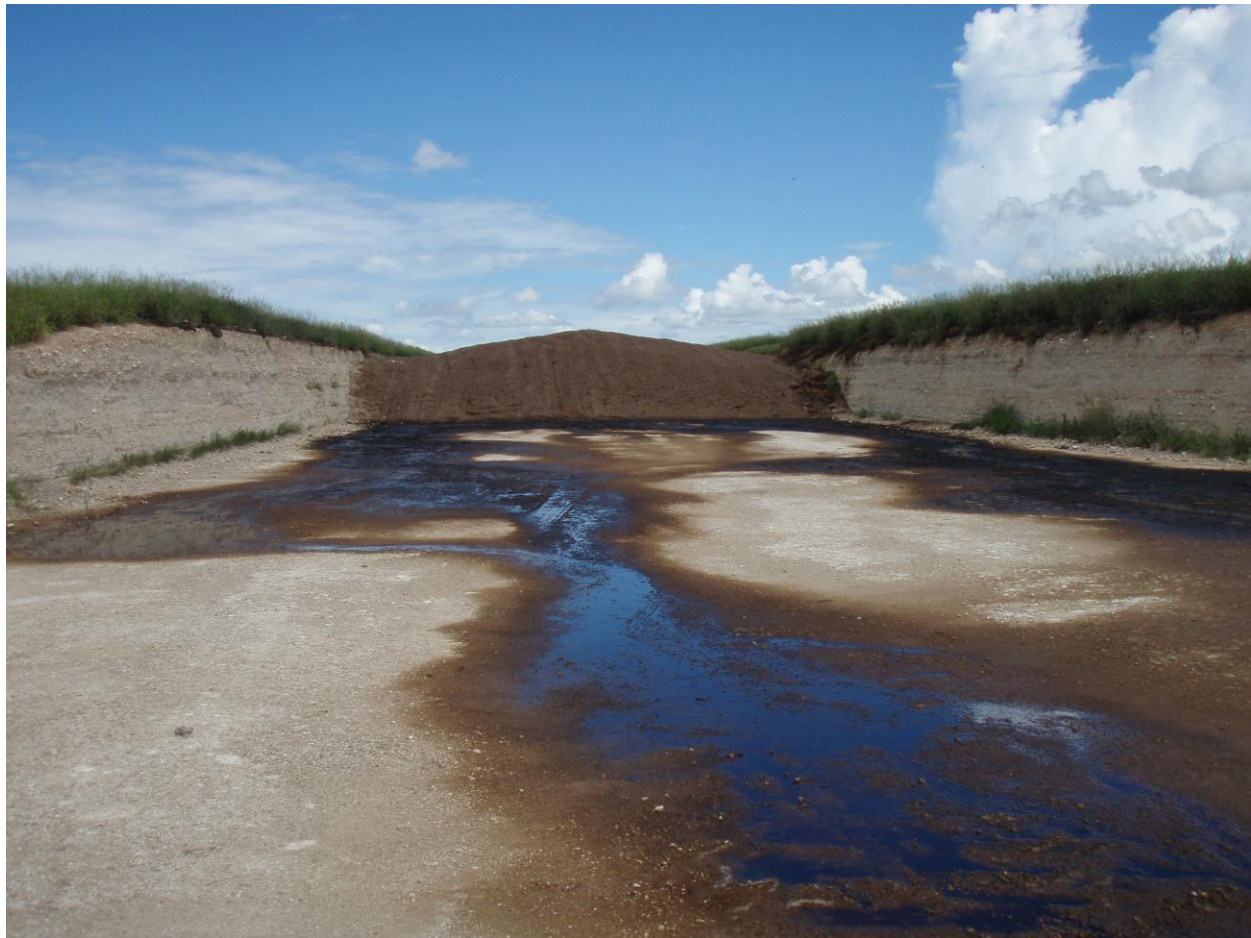
Photo No. 8

Commodities stored near the cattle pens and grain mill were either under cover, in tanks, and otherwise within the watershed of the RCS. These include corn, cotton seed hulls, whole cotton seed, cotton seed meal, fats, finisher liquids, pasture mix with molasses and hay. The feedlot also raises sorghum for sorghum silage. This silage was stored uncovered within two silage bunkers located next to LMU 6 (the sorghum land application site) and outside of the drainage area of an RCS. The two silage bunkers have a discharge of silage liquor which discharged from the east and west sides of the bunkers into LMU 6. See photos 8-9 and 11-12.

Description: One of the two silage bunkers located within LMU 6, but outside of the watershed of an RCS, is discharging silage liquor from the west side of the silage pile. This discharge flows into LMU 6. The view is toward the east.

AOC 3: There are discharges of silage leachate going into LMU 6 which is the sorghum land application site. The silage stored within two bunkers within LMU 6 is completely uncovered and exposed to the elements including rainfall. The silage bunkers have a discharge of silage liquor from the east and west sides of the bunkers into LMU 6. The bunkers are outside of the drainage area of an RCS. Per the Permit Part III.4.(a) Potential pollutant sources include "...silage stockpiles...". Furthermore, "An evaluation of potential pollutant sources shall identify the sources, "and indicate all measures that will be used to prevent contamination from the pollutant sources." Also, per Part III.5.(a).(2). "Manure, sludge, and wastewater generated by a CAFO shall be retained and used in an appropriate and beneficial manner as provided in this general permit." Additionally, the facility NMP requires that production area runoff be discharged into an RCS.

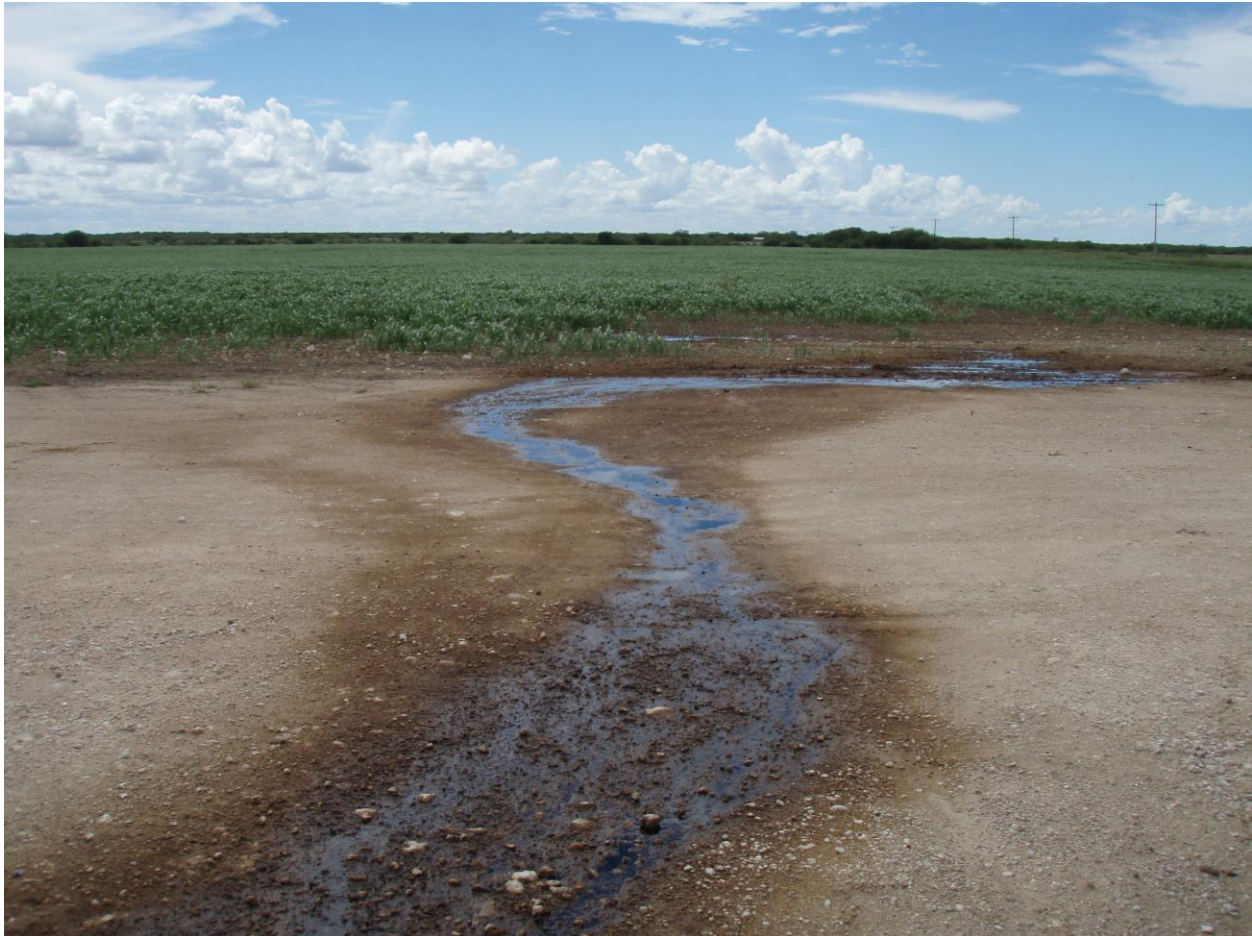
Photo No. 9

Description: The silage liquor shown in photo 8 is discharging into the 200-acre LMU 6, but outside of the watershed of an RCS. LMU 6 is used for growing sorghum. The view is toward the west.

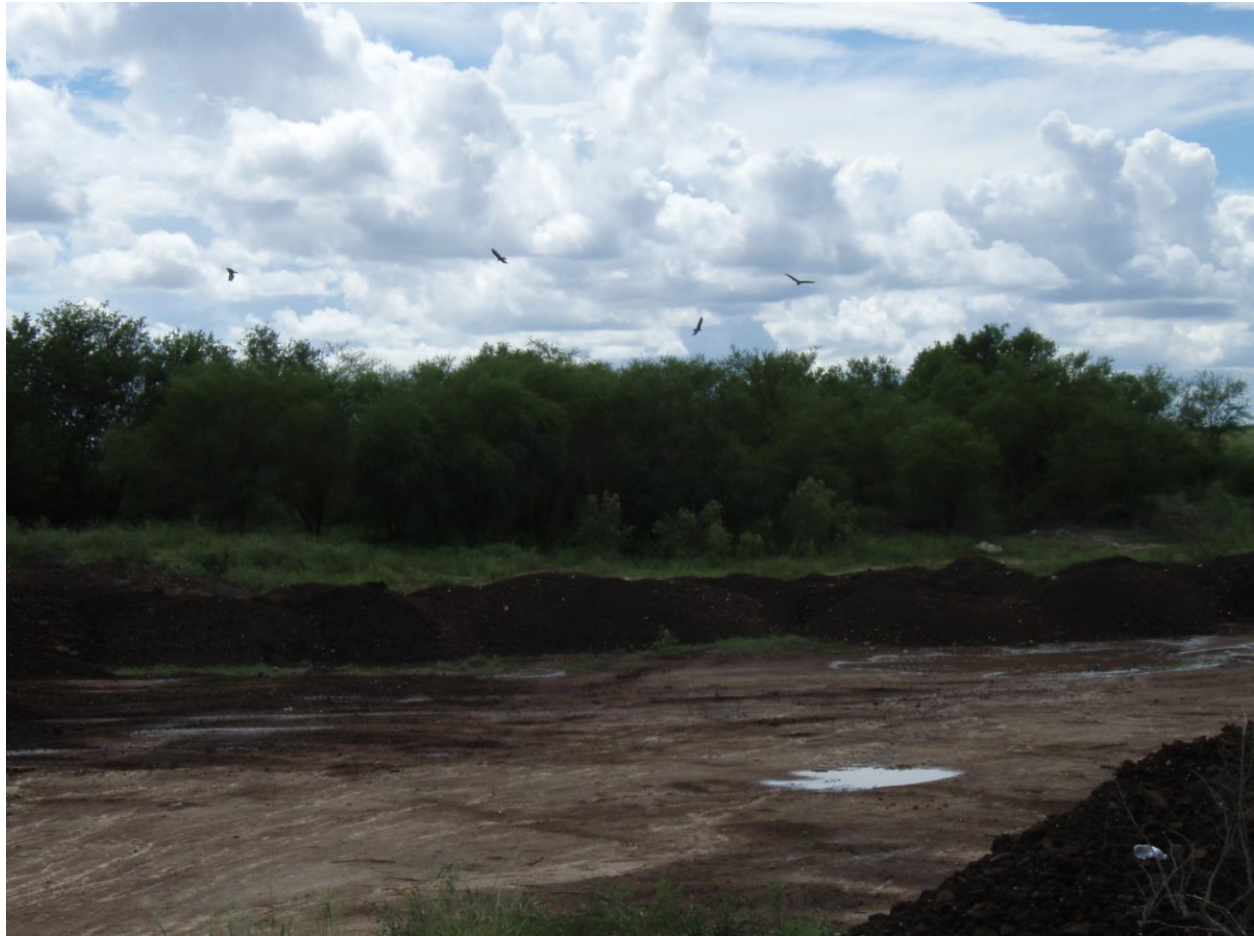
Photo No. 10

Description: The new mortality compost pile located within a borrow pit near LMU 6. The composting appears to be well managed with only a small portion of one dead calf exposed (hence the vultures). All mortalities must be properly covered and the finished product properly land applied for beneficial use. The view is toward the south.

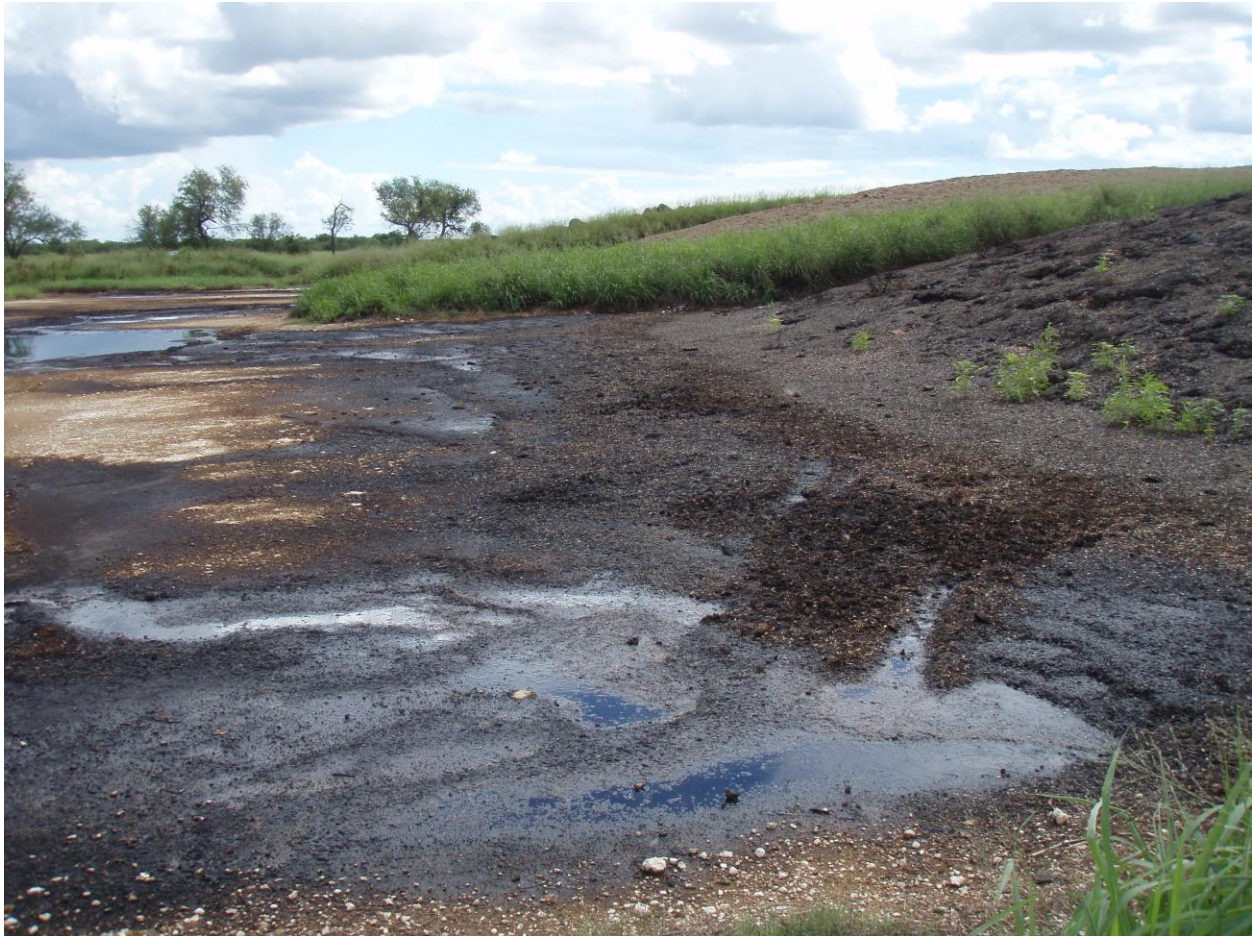
Photo No. 11

Description: One of the two silage bunkers located within LMU 6, but outside of the watershed of an RCS, is discharging silage liquor from the east side of the silage pile. This discharge flows into LMU 6. The view is toward the south. See photos 8 and 9 for the view of the discharge from the west side of the silage bunkers.

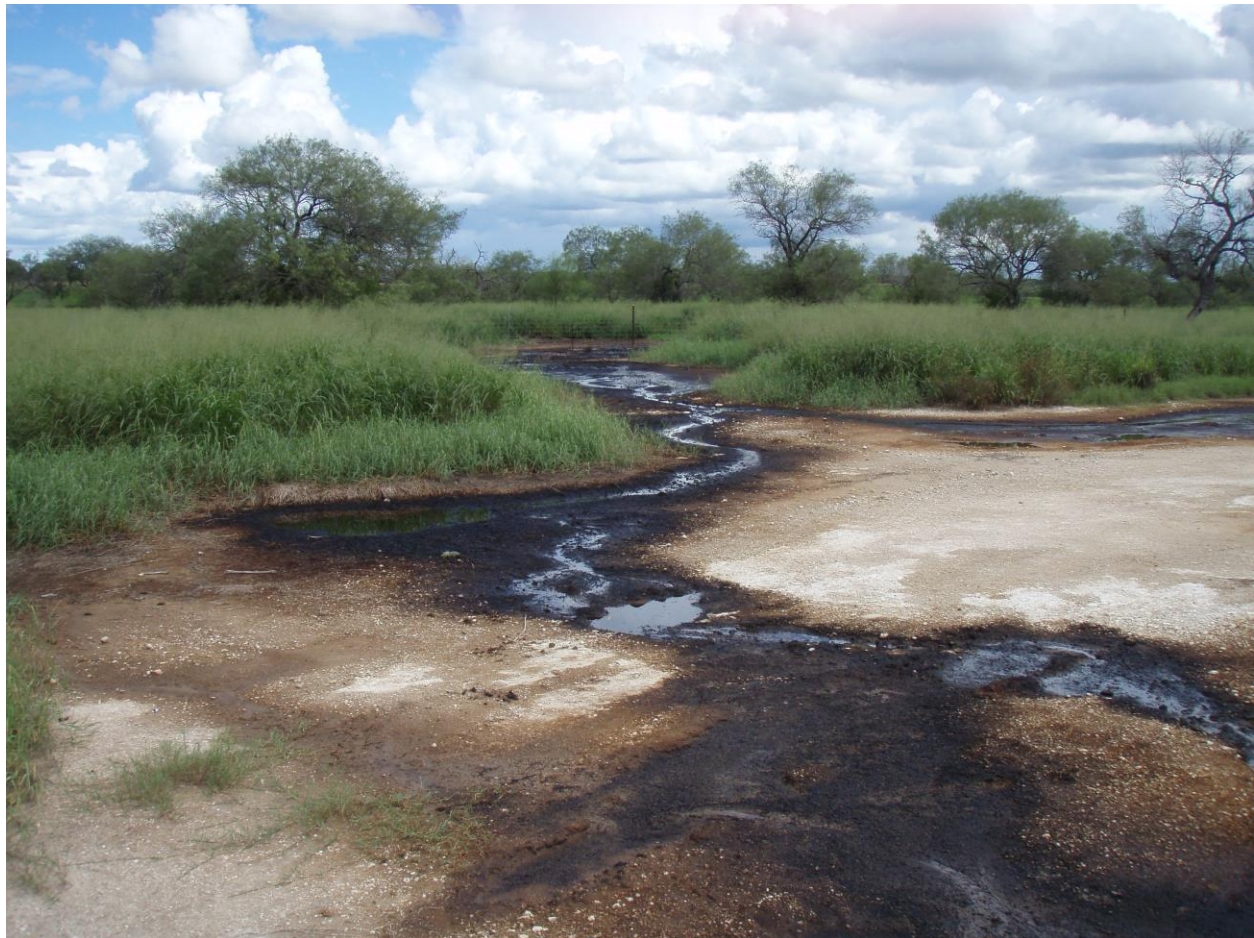
Photo No. 12

Description: The silage liquor discharge from the east side of the silage pile flows into a wooded area located near LMU 6 and outside the drainage area of an RCS. The view is toward the east. See photos 8 and 9 for the view of the discharge from the west side of the silage bunkers.

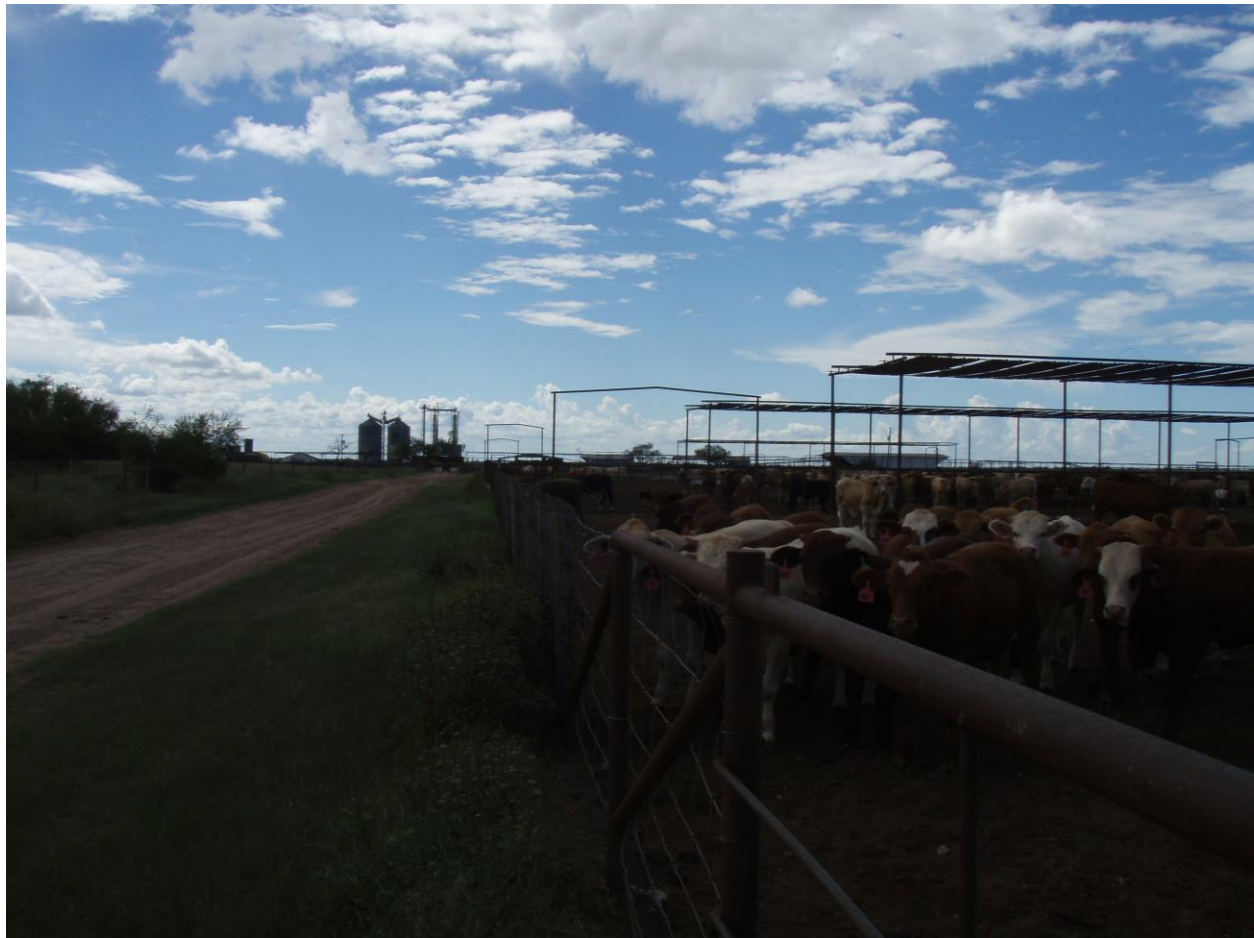
Photo No. 13

All but the most eastern cattle pens (called G3 pens) were sloped to drain storm water runoff toward the RCS. G3 pens, however, sloped in the opposite direction of the RCS. The facility contour map showed the location of a ridge that ran north-south along a crest situated at 109 feet elevation. The crest slopes downward from that point toward the east and west. The location of this crest was clearly visible during the site inspection with the majority of the cattle pens on the western slope which drains toward the RCS. The G3 pens and possibly other G pens fell outside of that slope (see photo 13). The use of these pens must either be discontinued, or provisions made to capture storm water runoff from a 25-yr/24-hr rain event into an RCS.

Description: The G3 cattle pens (and possibly other G pens as well) located on the far east side of the production area slope away from the watershed of an RCS. All pens must be located within the drainage area of an RCS. The view is toward the west.

AOC 2: The G3 pens and possibly other G pens located at the far east side of the cattle pen area fell outside of the watershed of the RCS. Per the Permit Part III.6.(d) "The operator of the CAFO shall design, construct, operate, and maintain RCSs to contain all volumes required by this section including the runoff and direct precipitation from the design rainfall event for the location of the facility."
