REPORT OF COMPLIANCE EVALUATION INSPECTION  
(INDUSTRIAL STORMWATER)

**Linwood Mining and Minerals Corporation**

NPDES General Permit No. 3: **IA0617-0435**

OCTOBER 26 and 27, 2023

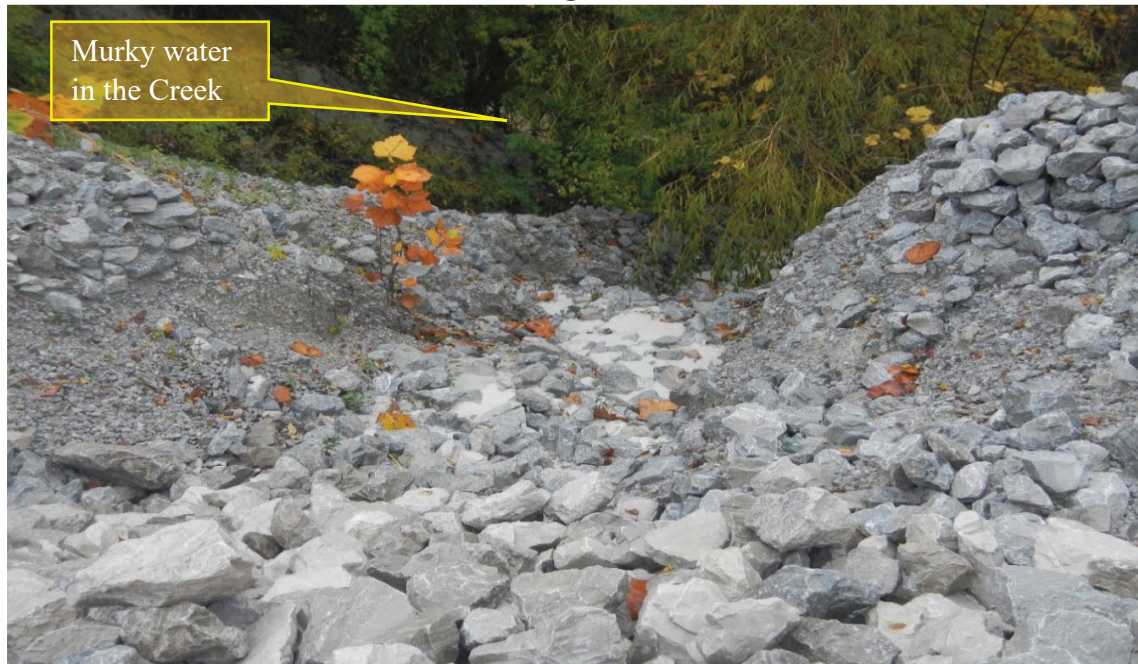
unidentified point between Outfalls GP3-02 and GP3-03 into Donaldson Creek, causing water in the creek to be significantly murky as shown in photos 14 and 10 below. Contaminated water was flowing through the inadequate structural control best management practices (BMPs). I pointed out to Mr. Osland that this location should be identified as an outfall, should be added to the map, and the SWPPP should be updated as well. Additional structural and administrative BMP controls would also be needed at the newly identified outfall.

**Photo 14, Sediment flowing down into Donaldson Creek**

- b. He also attached a photo of the silt removed and area flattened out from the location where sediment was leaving the site from an unidentified point between Outfalls GP3-02 and GP3-03 into Donaldson Creek at the time of the inspection. He added “*we are tooling up to regrade (excavator) the area that crossed the creek so that water be forced to head south to our quarrying plant. I will monitor this area during the next storms to make sure that storm water is not entering the creek at this site. If we are successful in getting the grade proper, then I will add this spot to our plant and designate an outfall number*”.

2. In order to ensure that BMPs are adequate, facility personnel should conduct thorough inspections of all stormwater controls.
3. The point of discharge where sediment was leaving the site from an unidentified point should be considered as an outfall and should be included on the site map, and the SWPPP should be updated to reflect this location as a GP3 outfall.

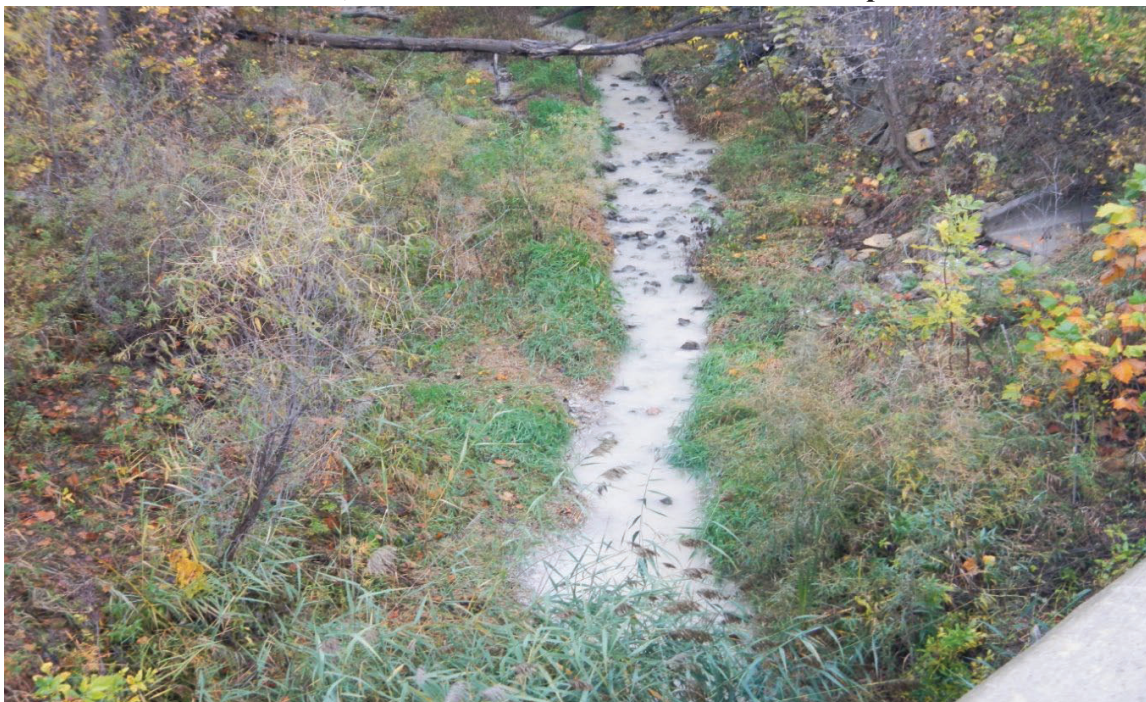
**Photo 10, Donaldson Creek at the time of the inspection**
