**Region 6 - Enforcement & Compliance Assurance Division**  
**INSPECTION REPORT**

| Inspection Date(s): | 9/19/2025 | |
| Media Program: | Water | |
| Regulatory Program(s) | CWA | |

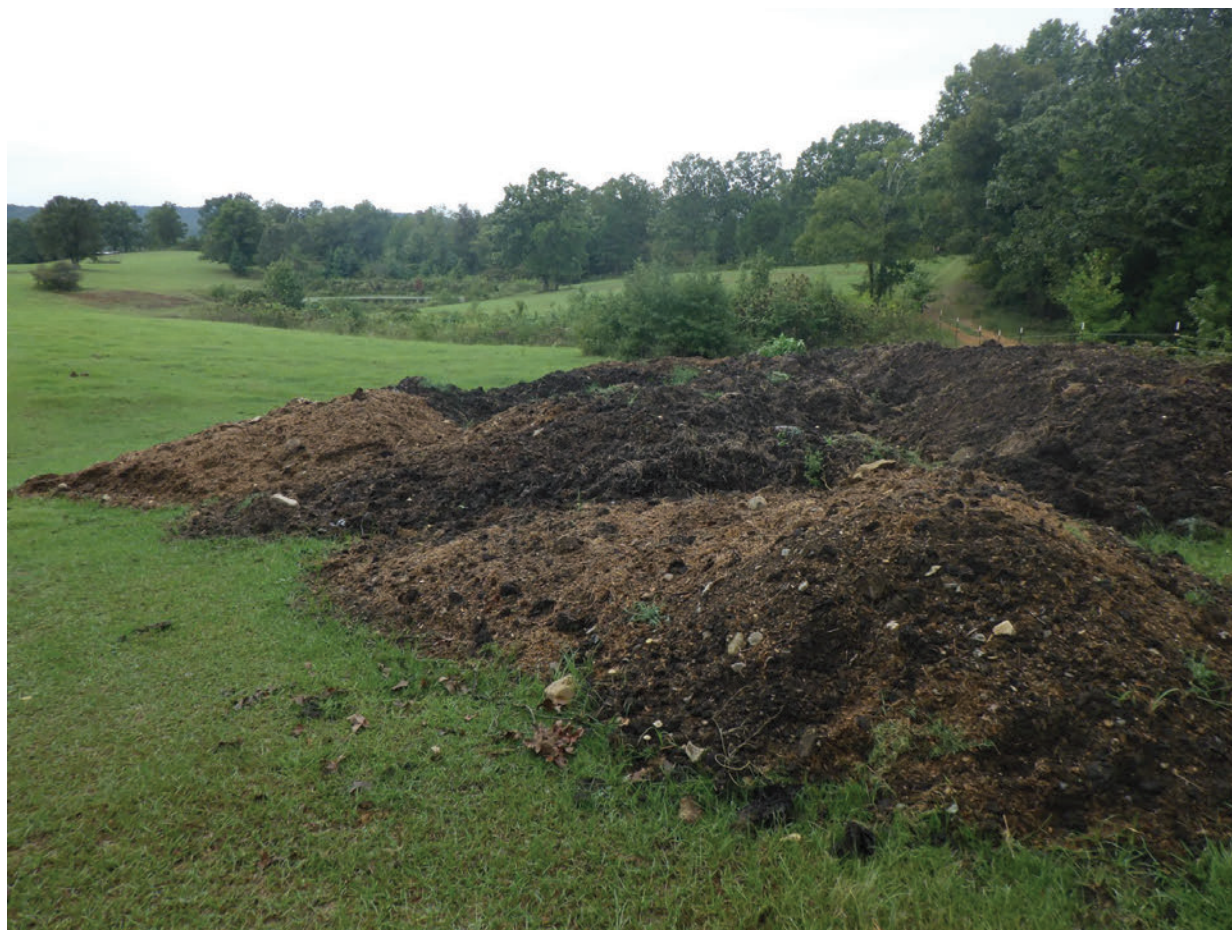
Photo No. 1

- Large, uncovered manure piles were observed on the northern edge of the property line without cover. The topographical landscape appeared to have runoff head to a small pond on the property. (Photo 1, Appendix 1).
- A small pond at the center of the property appeared to receive runoff from the uphill runoff (Photo 2, Appendix 1).
- The heavily vegetated path from the uphill uncovered manure piles to the pond (Photo 3, Appendix 1)
- A manure pile was observed outside of containment near the horse barn (Photo 4, Appendix 1).
- The burial site was observed to be clean and well covered with dirt.
- Feed for the animals was kept under cover in the horse barn.

- Manure piles were observed outside containment where they would be susceptible to rain runoff (Appendix 1, Photo 1 and 4) Nutrients and bacteria from these manure piles can lead to algae blooms in downstream waterbodies such as [REDACTED] [40 CFR §122.42(e)(1)(vi)].
- EPA received a citizen complaint regarding the exposed manure piles.

| Description: | Large, uncovered manure piles were located on the northern edge of the property. The gradient of the landscape has runoff heading towards a pond shown in the background. | | |

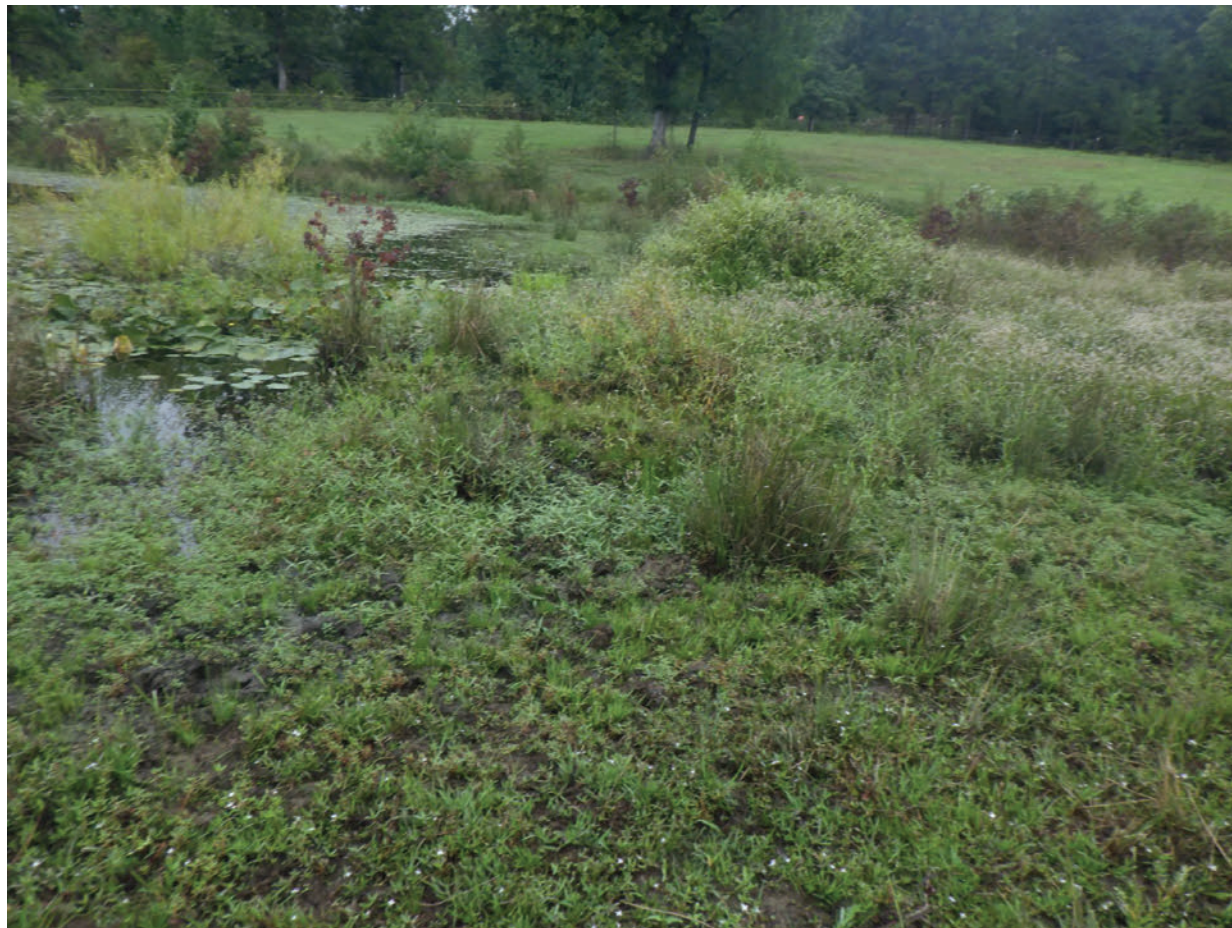
Photo No. 2

| Description: | A small pond was observed downhill from the manure piles. | | |

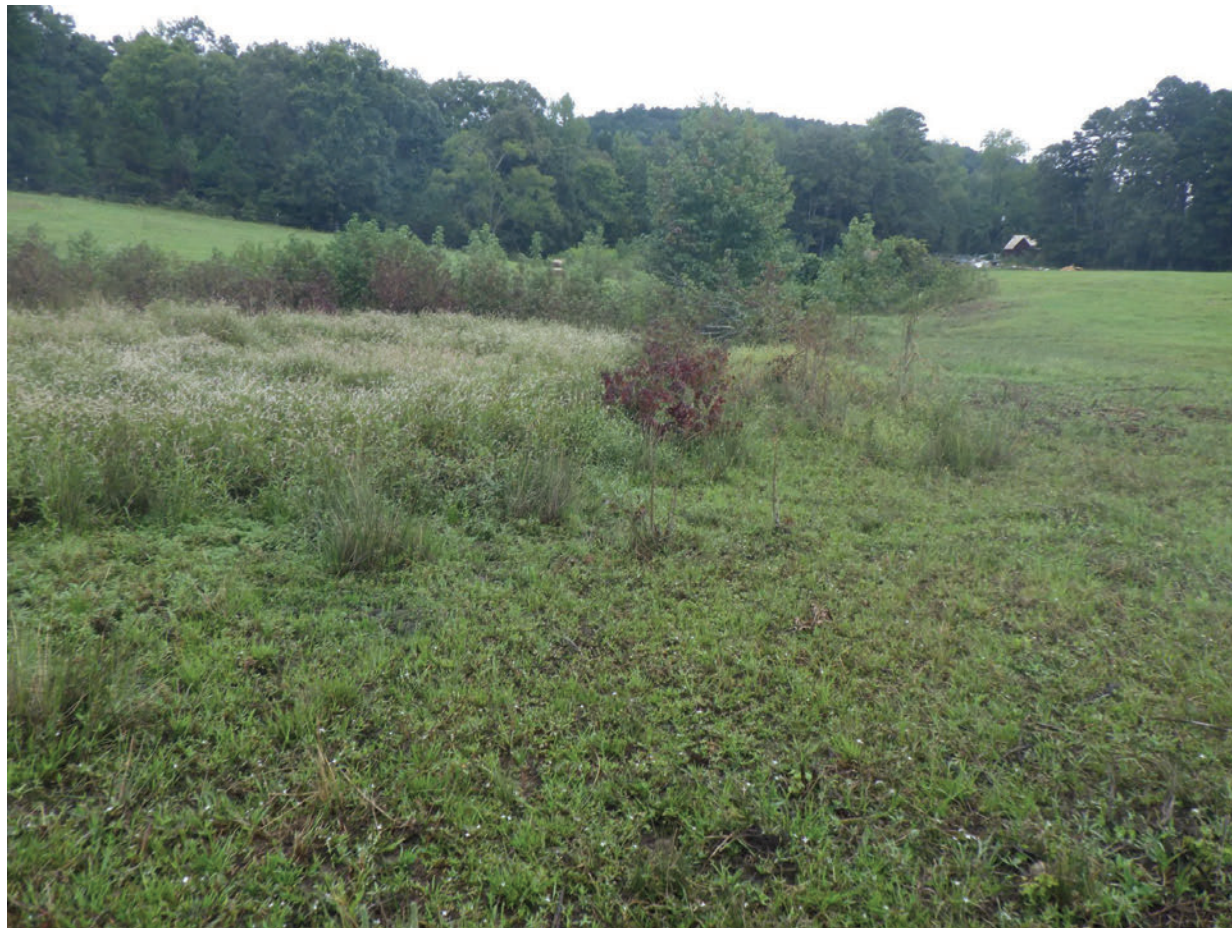
Photo No. 3

| Description: | Runoff from the manure piles appears to be run downhill along the heavily vegetated area. | | |

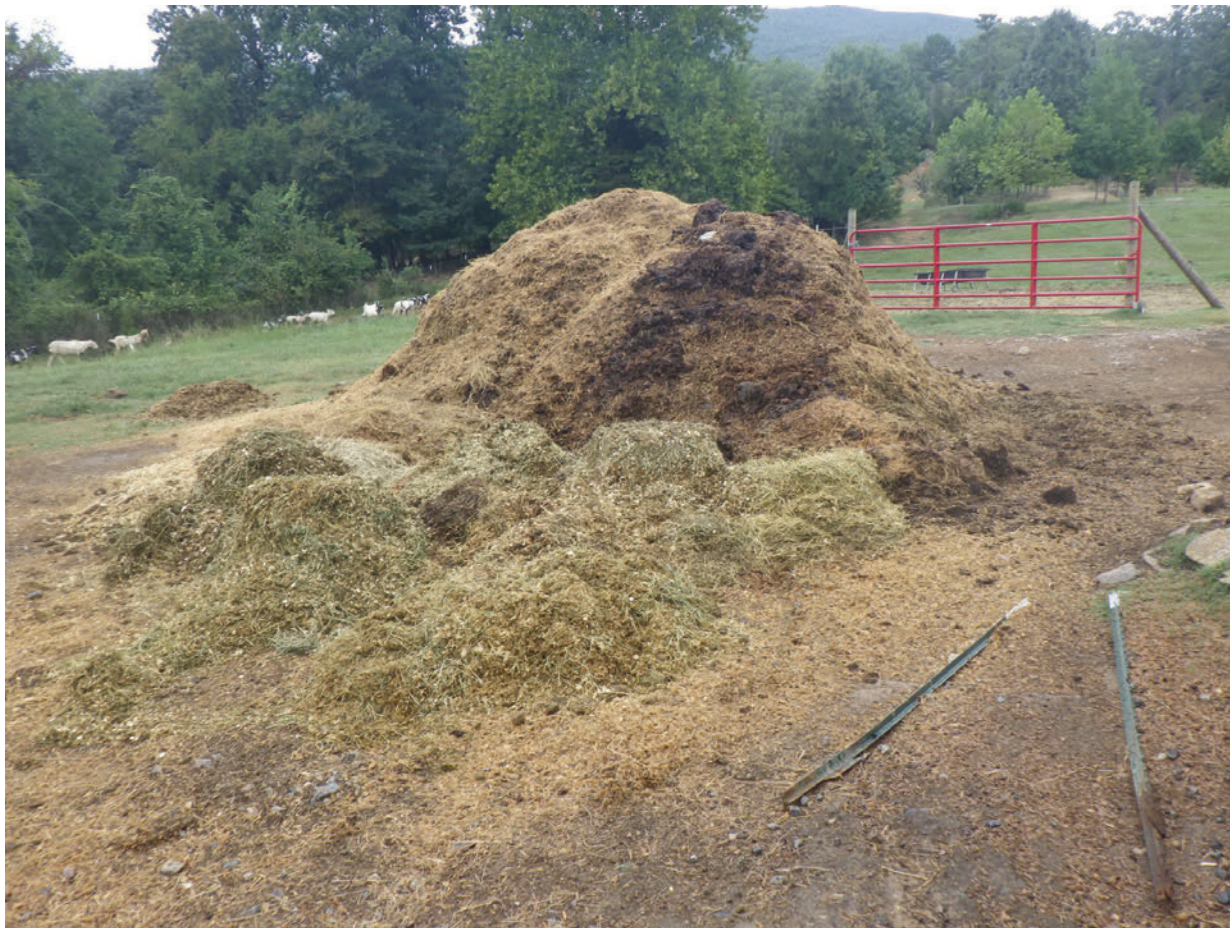
Photo No. 4

| Description: | A manure pile was staged outside the horse barn for a week. The pile was not covered. | | |
