**Region 6 - Enforcement & Compliance Assurance Division**  
**INSPECTION REPORT**

| Inspection Date(s): | 8/10/2023 | |
| Company Name: | Town of Highland Park | |
| Facility Name: | Wastewater Utility Department | |

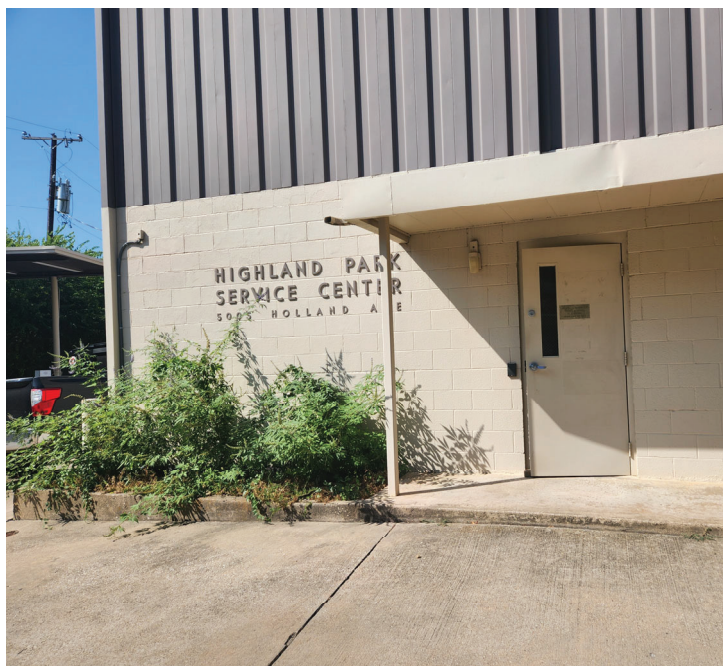
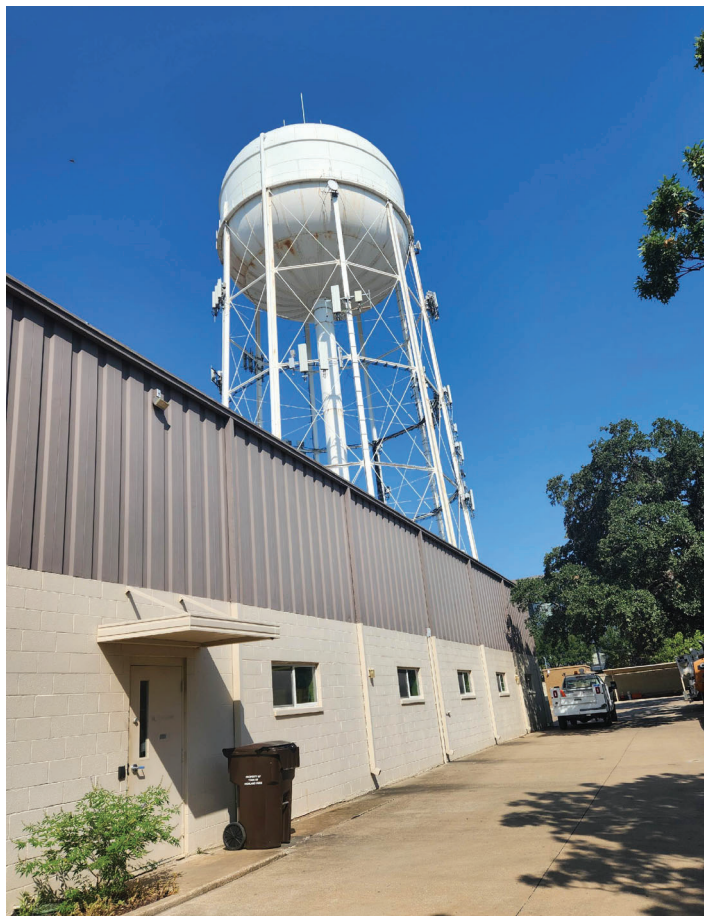
Photos No. 1

Description: Utility Building

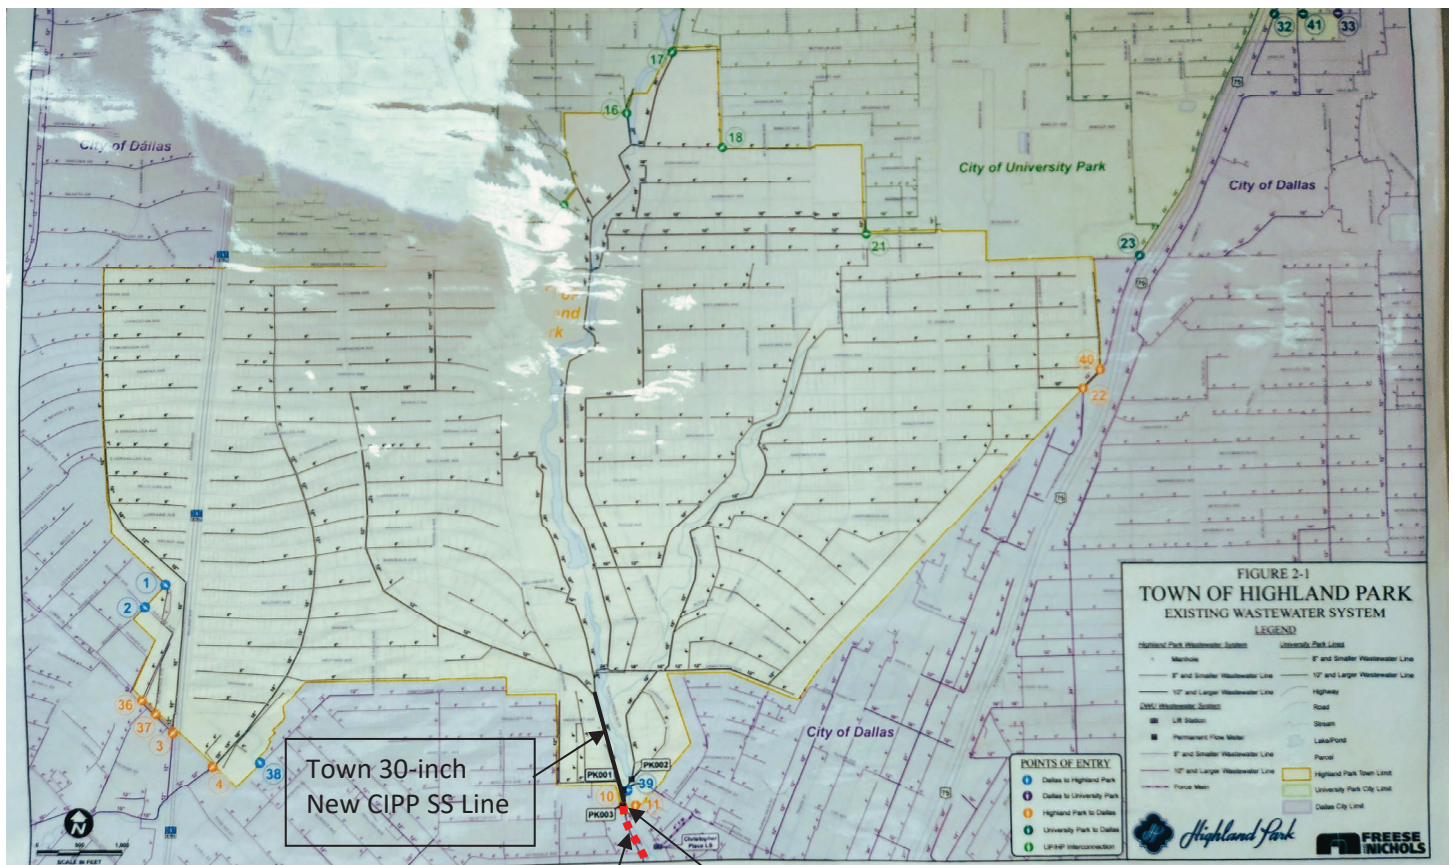
Photos No. 2

Description: Utility Building

Highland Park to DWU  
Point of Entry

DWU 30-inch  
Transmission Line

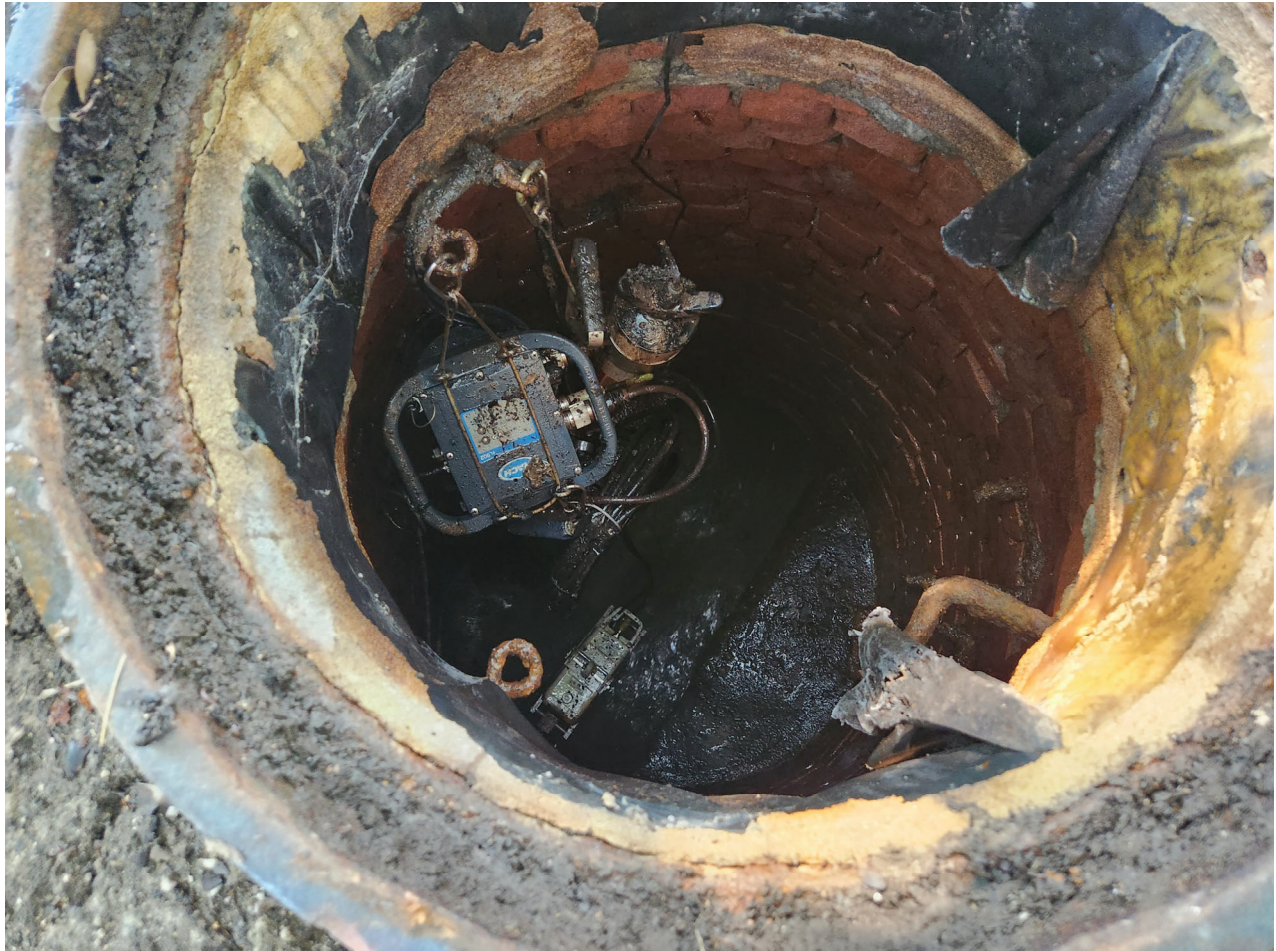
Photos No. 3

1. Recurring wet weather SSOs are caused by the DWU 30-inch collector backflow due to insufficient hydraulic capacity.

Description: Highland Park 30-inch SS Connection Point and metering MH to DWU 30-inch Collector.
