PROJECT REPORT

INDUSTRIAL HYGIENE SURVEY

BOUND BROOK PLANT

DATE: August 5, 1971

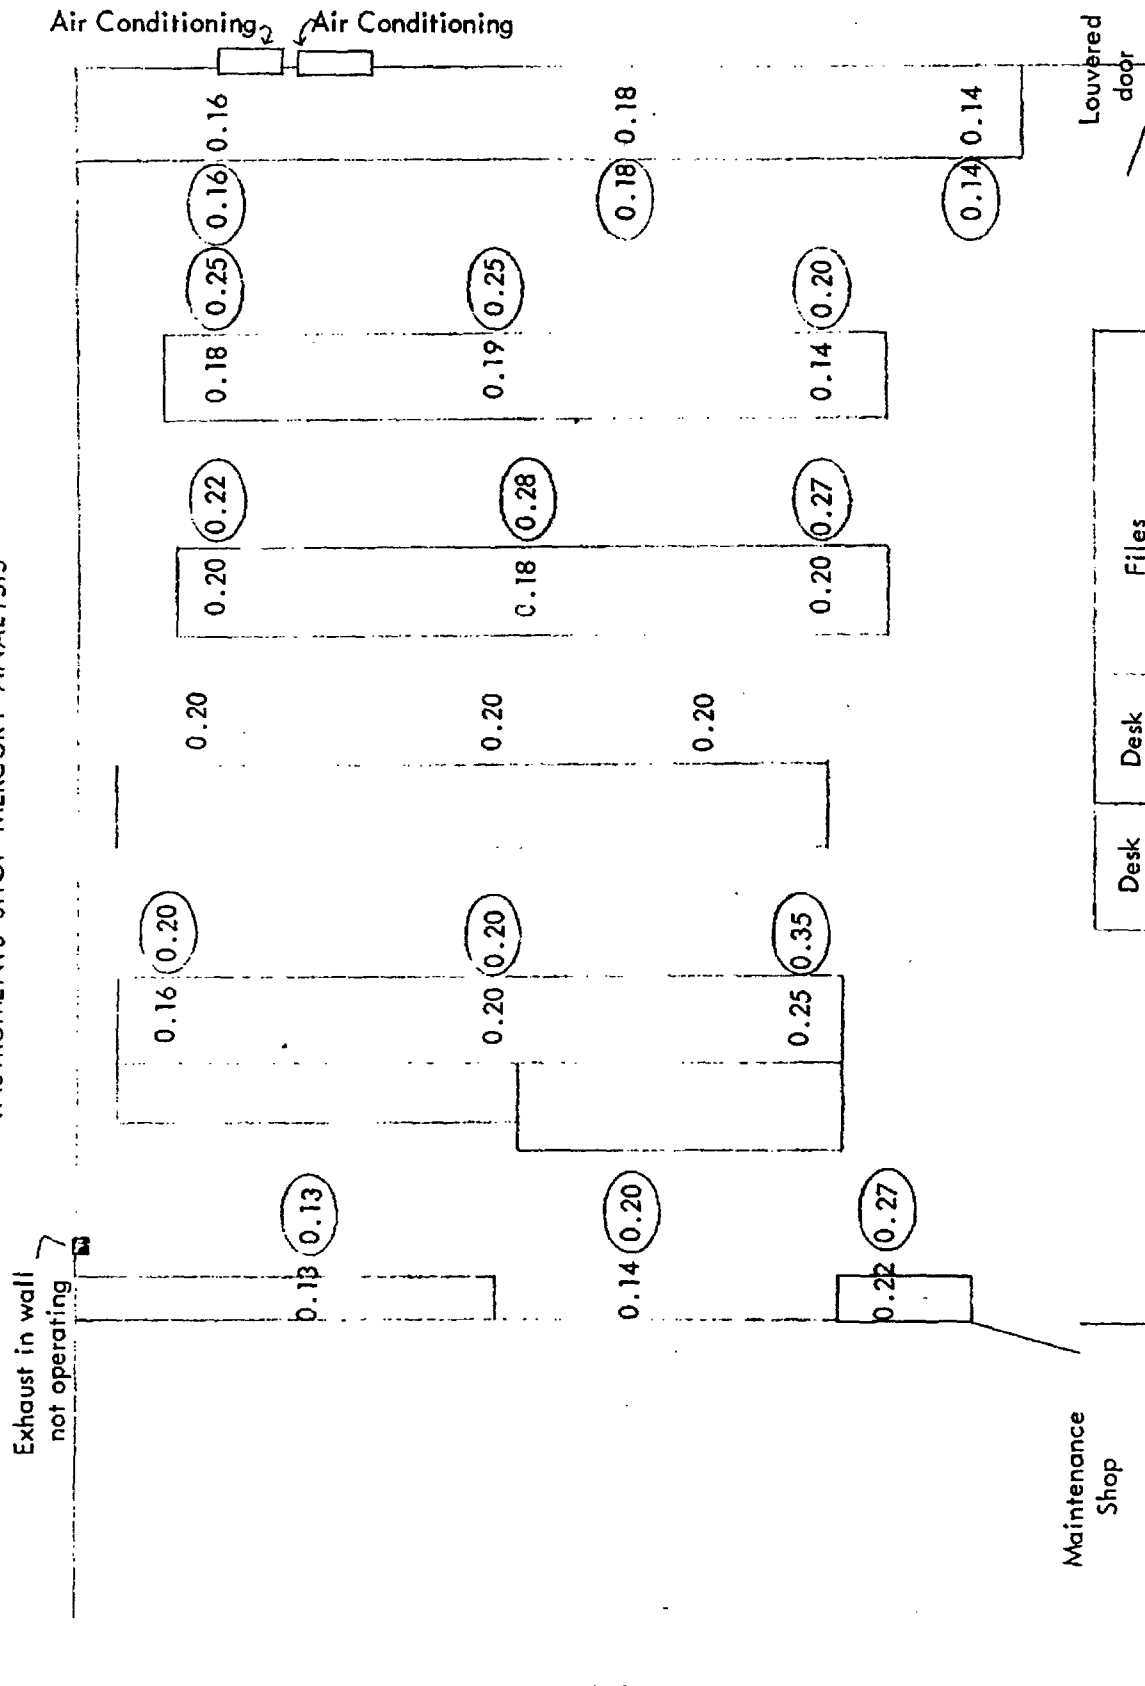
FIGURE 1

Mercury - Last year, during a similar visit to the Plant, mercury vapor was found in the air of the instruments shop. At that time the concentrations were from 0.2 to 0.4 mg/M<sup>3</sup> as compared to the threshold limit value (TLV) of 0.1 mg/M<sup>3</sup>. There were changes made after that visit which improved the general ventilation in the room. Two fans were placed in an opening above the door to the Maintenance Shop. An exhaust was placed in the east wall and a louvered panel was placed in the door in the southwest corner of the room. In addition, the room was also given a general cleaning. This lowered the readings below the TLV. I did not expect concentrations of mercury to be above the TLV this time. However, as will be noted in Figure 1, it was again found that the mercury vapor concentration was nearly double the TLV. This room should be put on a routine schedule for periodic testing to see that the mercury vapor concentration is being maintained below the TLV. It would also be advisable to clean the floor area thoroughly to remove mercury deposits which are apparently ground into or under the floor tile. In addition, further effort should be made to provide and maintain adequate ventilation in this room.

INSTRUMENTS SHOP MERCURY ANALYSIS

3. Renew efforts to clean up the floor area and cabinets in the instruments shop to reduce the possibility of high concentrations of mercury vapor. The shop should continue to be sampled at regular intervals to determine the mercury vapor concentration in air.
