# NPDES Compliance Inspection Report

## Hill AeroSystems

**NPDES Permit Tracking Number  
# WAR126743**

**Inspection Date: 05/12/2023**

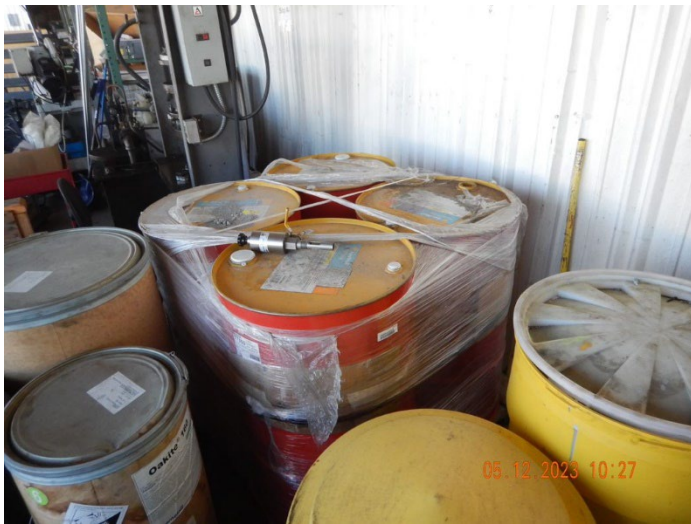
Photo: #01 (DSCN0583.JPG)

Against the building's exterior wall, next to a spill kit, we saw a pallet with four 55-gallon drums of hydraulic fluid staged for pickup (**Photo 1**). Next to the spill kit we saw a partly full 275-gallon tote of used oil (background, **Photo 6**). Next to the hydraulic fluid, on an adjacent pallet, we saw containers of various chemicals including sodium hydroxide and muriatic acid (**Photo 2**), and a drum with an open bung hole labeled as "Waste paint" (**Photo 10**). I pointed out the incompatibility and general unsafe storage of keeping a base next to an acid to Mr. Thornton. We also discussed the volume of liquids stored in the waste storage area specifically, and an apparent lack of curbing, dikes, or spill containment pallets.

11. During the inspection, at the outside waste storage area, we observed numerous containers of waste oils, paints, fuels, solvents, and other chemicals stored without containment (**Photos 1-3, 5-7, 9 and 10**)

Description: In the covered, outside waste storage area, four 55-gallon drums of oil-based hydraulic fluid waiting disposal.

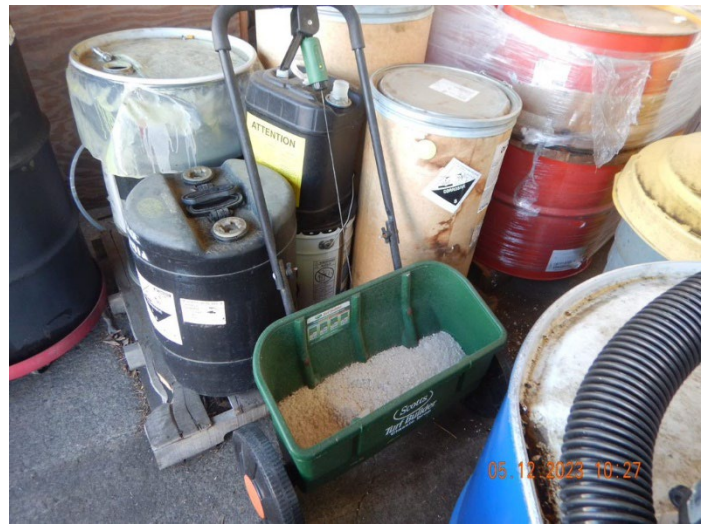
Photo: #02 (DSCN0584.JPG)

13. During the inspection we observed containers of sodium hydroxide and muriatic acid sitting next to each other (**Photos 2 and 10**). These two chemicals are mutually incompatible, and a spill of either could result in a dangerous reaction threatening human health and the environment.

Description: In the covered, outside waste storage area, multiple containers of wastes waiting disposal. The rightmost, upright fiber drum was labeled "Sodium Hydroxide," and the leftmost black drum was labeled "Muriatic Acid."

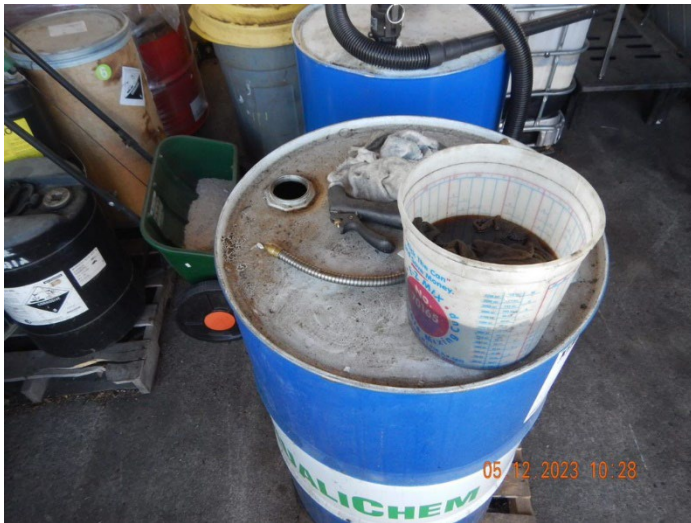
Photo: #03 (DSCN0585.JPG)

Next, we saw a 55-gallon drum of QualiChem with an open bung and a small bucket holding an oily liquid and rags (**Photo 3**). In the area, we also saw two clamshell-type over containers. One held two drums of product solvent, both isopropyl alcohol and methyl ethyl ketone. The second, with a faded Hazardous Waste label on the lid (**Photo 4**) held an open drum holding smaller containers of discarded coatings and other products, including aerosol cans. Mr. Thornton told us he thought the second drum was empty.

Description: In the outside, covered waste storage area, one open 55-gallon drum labeled "QualiChem" with an open container on top holding an oily liquid and rags.

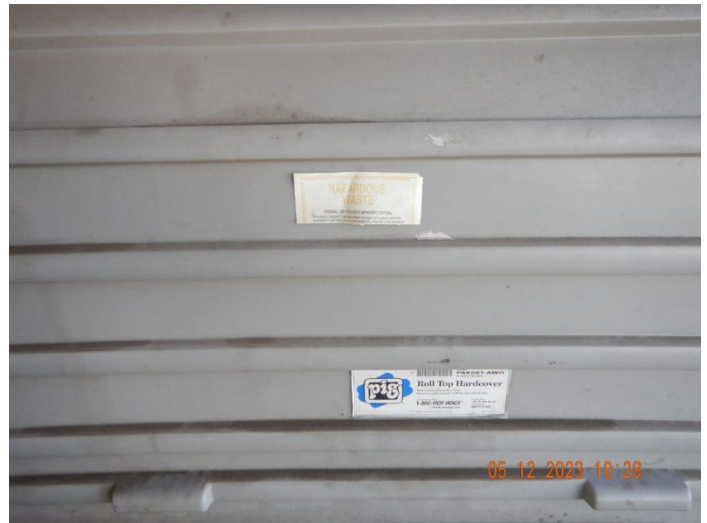
Photo: #04 (DSCN0586.JPG)

Description: In the outside, covered waste storage area, one clamshell-type container labeled "Hazardous Waste."

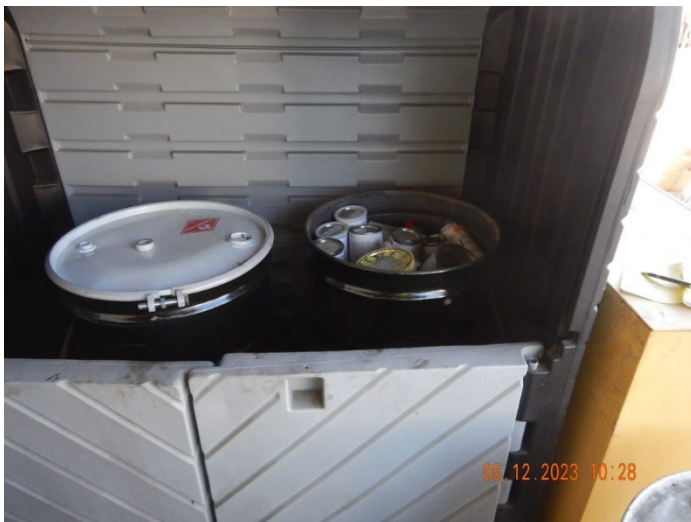
Photo: #05 (DSCN0587.JPG)

Description: In the outside, covered waste storage area, inside the clamshell-type container, one drum holding smaller containers of assorted coatings, with a second, empty, drum formerly holding solvent.

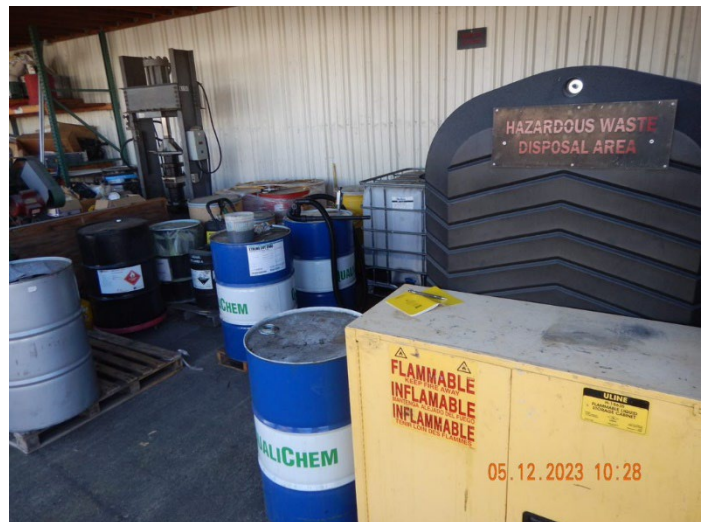
Photo: #06 (DSC0588.JPG)

Description: Overview photo of the outside, covered waste storage area. The intermediate bulk container (tote) in background held machining oil.

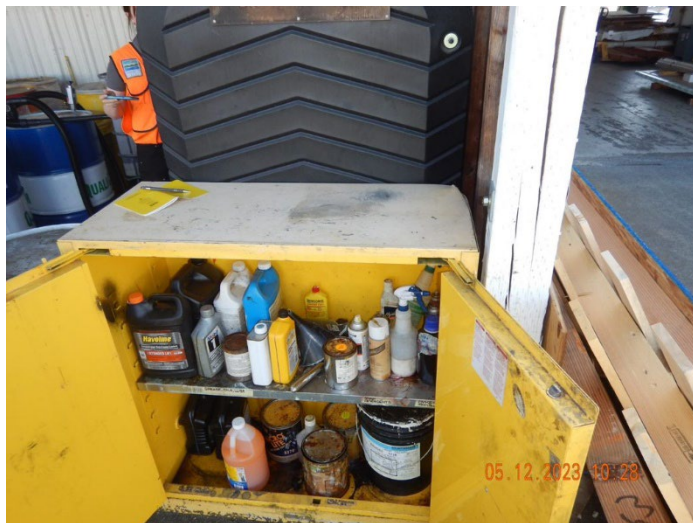
Photo: #07 (DSCN0589.JPG)

By the clamshells we saw a flammables storage cabinet holding a variety of chemical products Mr. Thornton characterized as largely expired (**Photo 7**). Inside the cabinet we saw a variety of oils, including lighter fluid and motor oil, paints, and detergents. Looking north from this spot we saw six dumpsters in a row that Mr. Thornton said accumulated various sizes and types of scrap metal generated at the Facility (**Photo 8**). Mr. Thornton pointed out the constructed roof lines overhanging the northmost dumpsters. He said staff routinely add scrap to those dumpsters during their shifts and tended to leave the attached lids open. Later, we saw absorbent sock-style filters placed on the ground around the bases of the dumpsters. The photo also shows the entire raised dock-like outdoor storage area lacked a berm or other surface feature serving as a means of containment.

Description: In the outside, covered waste storage area, a flammables cabinet holding a variety of expired chemicals, including oils, and coatings.

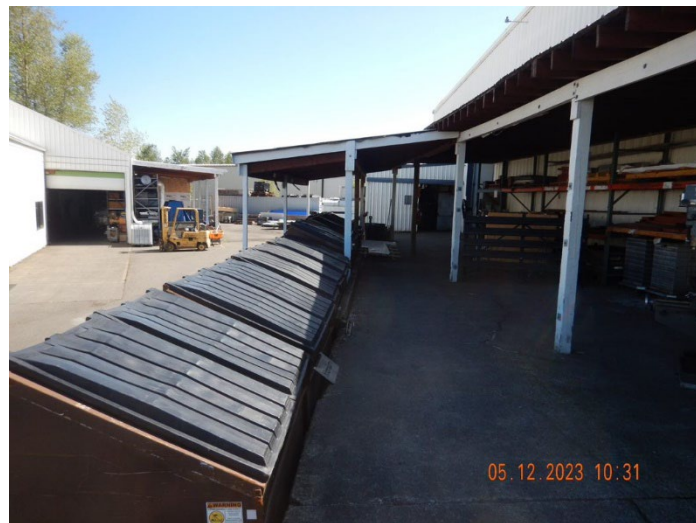
Photo: #08 (DSCN0590.JPG)

Description: Facing east, by the covered waste storage area, a row of covered dumpsters holding various scrap metals. The additional roofing provides cover to dumpsters occasionally left open as they are filled routinely (partly visible in background).

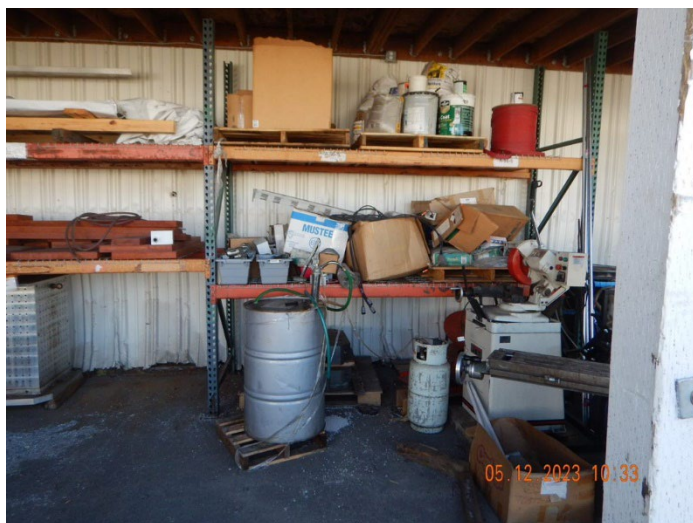
Photo: #09 (DSCN0591.JPG)

North of the outdoor waste storage area we saw additional material storage and an approximately 30-gallon gray drum on a wood pallet with a pump on top (**Photo 9**). We also noted the apparent absorbent material on the ground in the drum's vicinity. Southwest of the area storing the Facility's hazardous waste we saw two dumpsters next to the exterior wall of the Facility. The lid on the rearmost dumpster sat open. In the foreground we saw reddish fine particulate matter on the ground. It appeared similar to a spent blasting material like garnet (**Photo 11**).

Description: Next to the waste storage area, additional material storage. Our site contact told us the gray drum holds diesel.

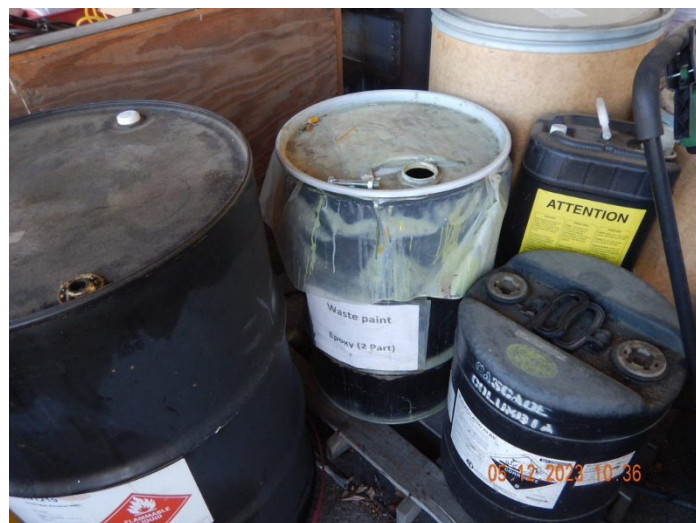
Photo: #10 (DSC0592.JPG)

Description: In the covered waste storage area, similar to Photo 2, with clearer view of "Waste paint" drum left open; also, clearer view of muriatic acid label.

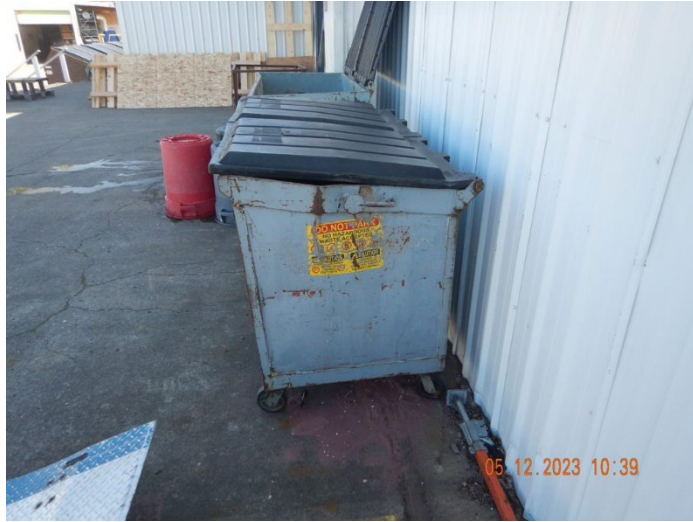
Photo: #11 (DSCN0593.JPG)

7. We observed one open dumpster during the inspection (**Photo 11**).

8. During the inspection we observed an apparent spill of a reddish fine substance similar to spent blast material or sand next to an open dumpster (**Photo 11**).

Description: Facing northeast, to the southwest of the waste storage area, a large open dumpster holding solid waste. Also visible on the paved surface in the foreground, a reddish fine substance like spent blast material or sand.

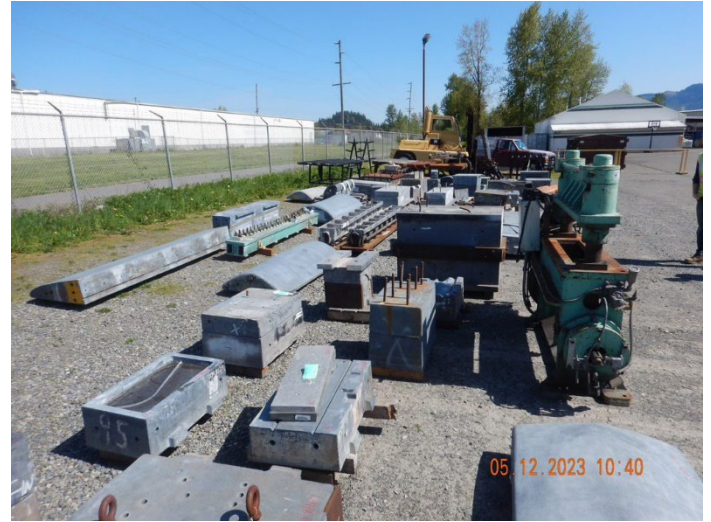
Photo: #12 (DSCN0594.JPG)

Further to the southwest, we saw many large aircraft part tooling pieces lying on the ground (**Photo 12**). Mr. Thornton explained the equipment was out of date and the Facility was attempting to send it back to their principal client. We also saw an older drill staged here. Mr. Thornton confirmed the Facility no longer used it and sought to move it off-site. To the north, attached to a downspout of the second building, Mr. Thornton showed us the Facility's recently installed stormwater treatment system (**Photo 13**). He said the Facility installed the biochar system after observing higher metal content in their autumn 2022 quarterly stormwater sampling.

Description: Facing north, at the western edge of the Facility, machining supplies and equipment lying exposed.

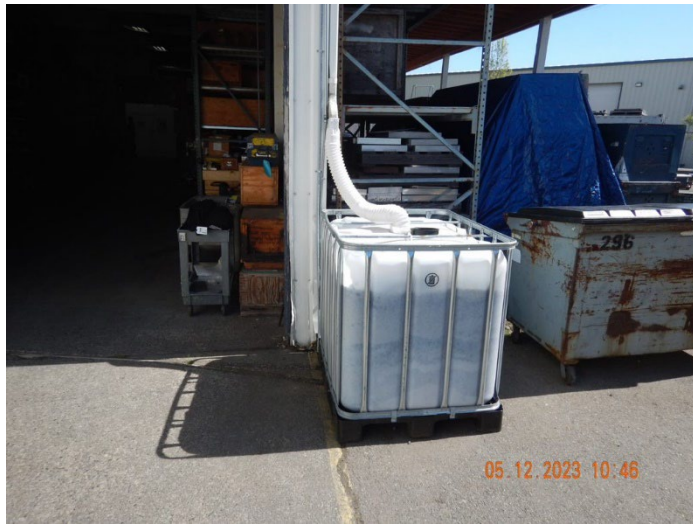
Photo: #13 (DSCN0595.JPG)

5. The Facility’s SWPPP does not list the Biochar treatment BMP we observed during the inspection (**Photo 13**). The SWPPP records a last update date of May 2023.

Description: Facing north, by Facility's secondary building, photo of recently installed roof runoff treatment system.

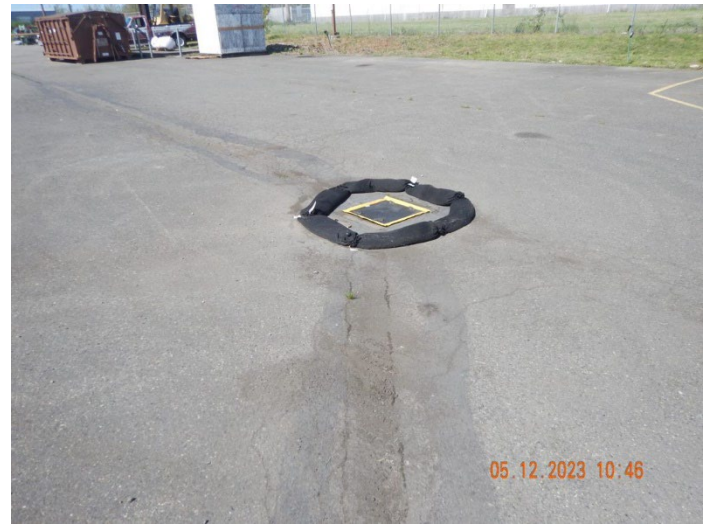
Photo: #14 (DSC0596.JPG)

Description: Facing southwest, catch basin with cover and liner, and sock-type barrier to filter stormwater. It appeared to serve as main area catch basin

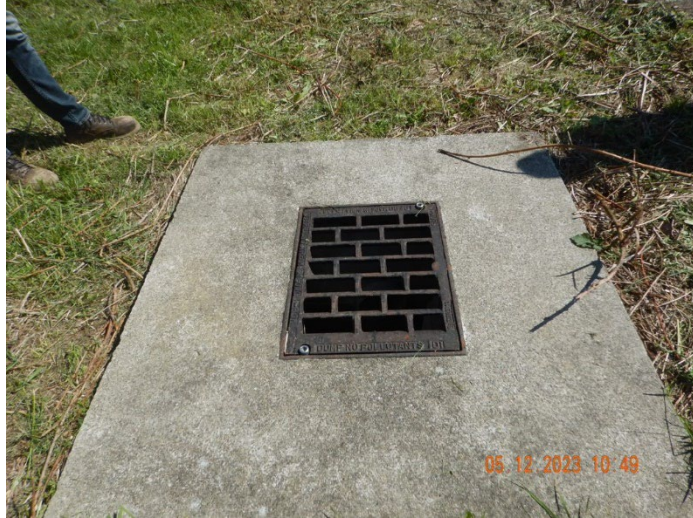
Photo: #15 (DSC0597.JPG)

Between the two buildings, in the center of the parking lot, we saw a catch basin with an inlet cover and screen installed. Mr. Thornton told us this catch basin received stormwater from the industrial areas of the Facility, and the Facility referred to it as Catch Basin 1 (**Photo 14**). Mr. Thornton told us stormwater flows northwest to a second catch basin, which he said serves as their outfall and monitoring location (**Photo 15**).

Description: Cited to the northwest of catch basin in Photo 14, this raised catch basin receives water from it and serves as the main outfall and sampling point for discharge monitoring.

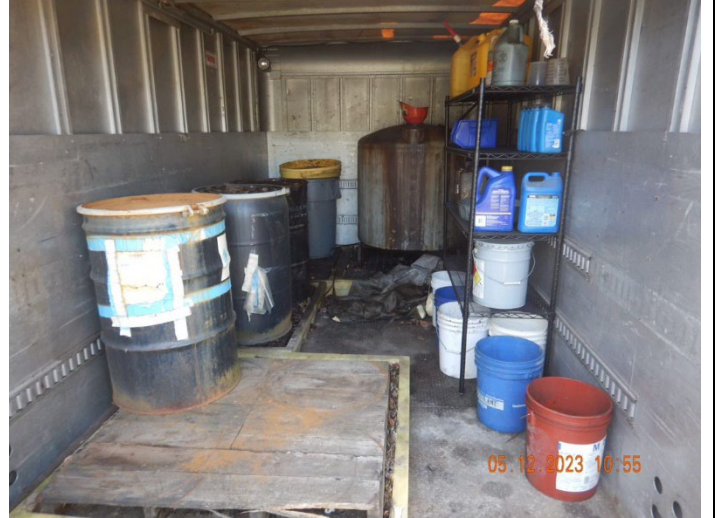
Photo: #16 (DSC0598.JPG)

We moved south, between the two buildings and saw what appeared to be the box trailer portion of a box-type truck on the ground. We looked inside and saw three 55-gallon drums, an approximately 200-gallon tank, seven 5-gallon pails, and many smaller containers holding a variety of oils (**Photo 16**). We noted one of the larger containers sat on a spill pallet with plywood covering the grating of the pallet and possibly rendering it an insufficient containment device. We also observed a spill kit in the rear of the trailer, and a large pile of used absorbent pads on the floor next to the trailer. Outside the trailer we saw more large tooling pieces stored outside without cover (**Photo 17**). Mr. Thornton indicated the Facility also sought to dispose of this equipment.

12. In the oil storage area we saw multiple containers of oil, the largest of which appeared to be a 200-gallon tank stored in an area apparently lacking 220 gallons of containment capacity (**Photo 16**).

Description: Between the two buildings, the container component of a box truck, or delivery truck, laying on the paved surface serving as an oil storage area. Note the large amount of spent absorbent pads next to the tank.

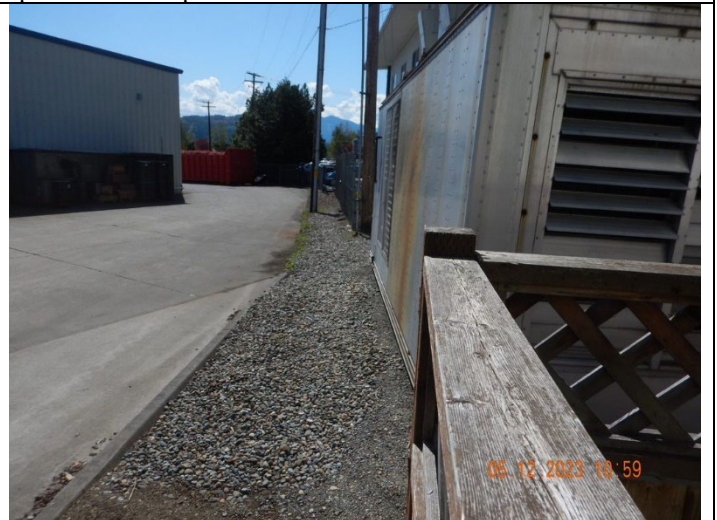
Photo: #18 (DSC0600.JPG)

We walked around the north of the main building and observed a large generator (**Photo 18**). Mr. Thornton told us the Facility rarely used the generator due to the expense of operation. We did not see fuels or other chemicals and products stored in the area. We then walked north around the perimeter of the second building. We saw a third catch basin to the north of the second catch basin (the monitoring point) (**Photo 19**). The area appeared recently cleared of vegetation. At the time Mr Thornton said he was not sure about the purpose of the catch basin because he thought the other two the extent of the conveyance system in the area.<sup>1</sup> Around this catch basin, to the north, we saw some standing water. The water appeared to flow north, across the surface, and discharge onto the neighboring property (**Photo 20**).

Description: Facing southwest, along Facility boundary, large generator rarely used.

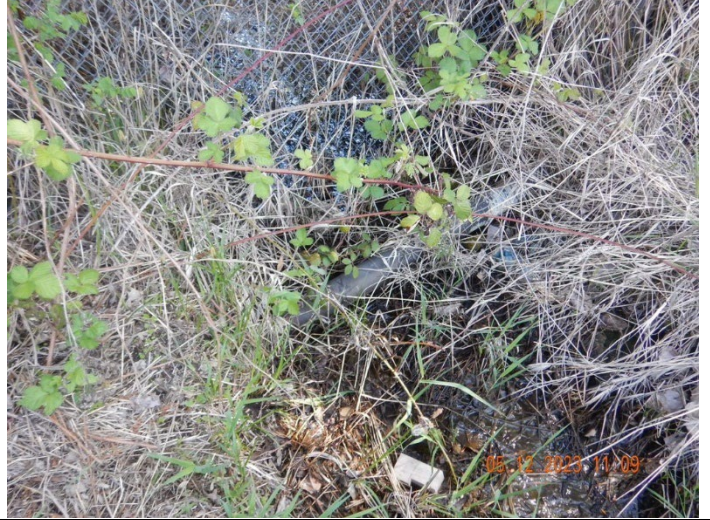
Photo: #20 (DSC0602.JPG)

3. During the inspection we observed stormwater apparently leaving the Facility at the far north of the property (**Photo 20**). The site map does not list this potential discharge point.

Description: Overgrown area at north boundary, just northwest of second building. There appeared to be water draining to the north, off-site.
