**SUBJECT:** CLEAN AIR ACT INSPECTION REPORT  
Epsilyte LLC, Peru, Illinois

**Facility Name:** Epsilyte LLC

**Date of Inspection:** 27 July 2023

**Purpose of Inspection:** CAA 112(r) inspection

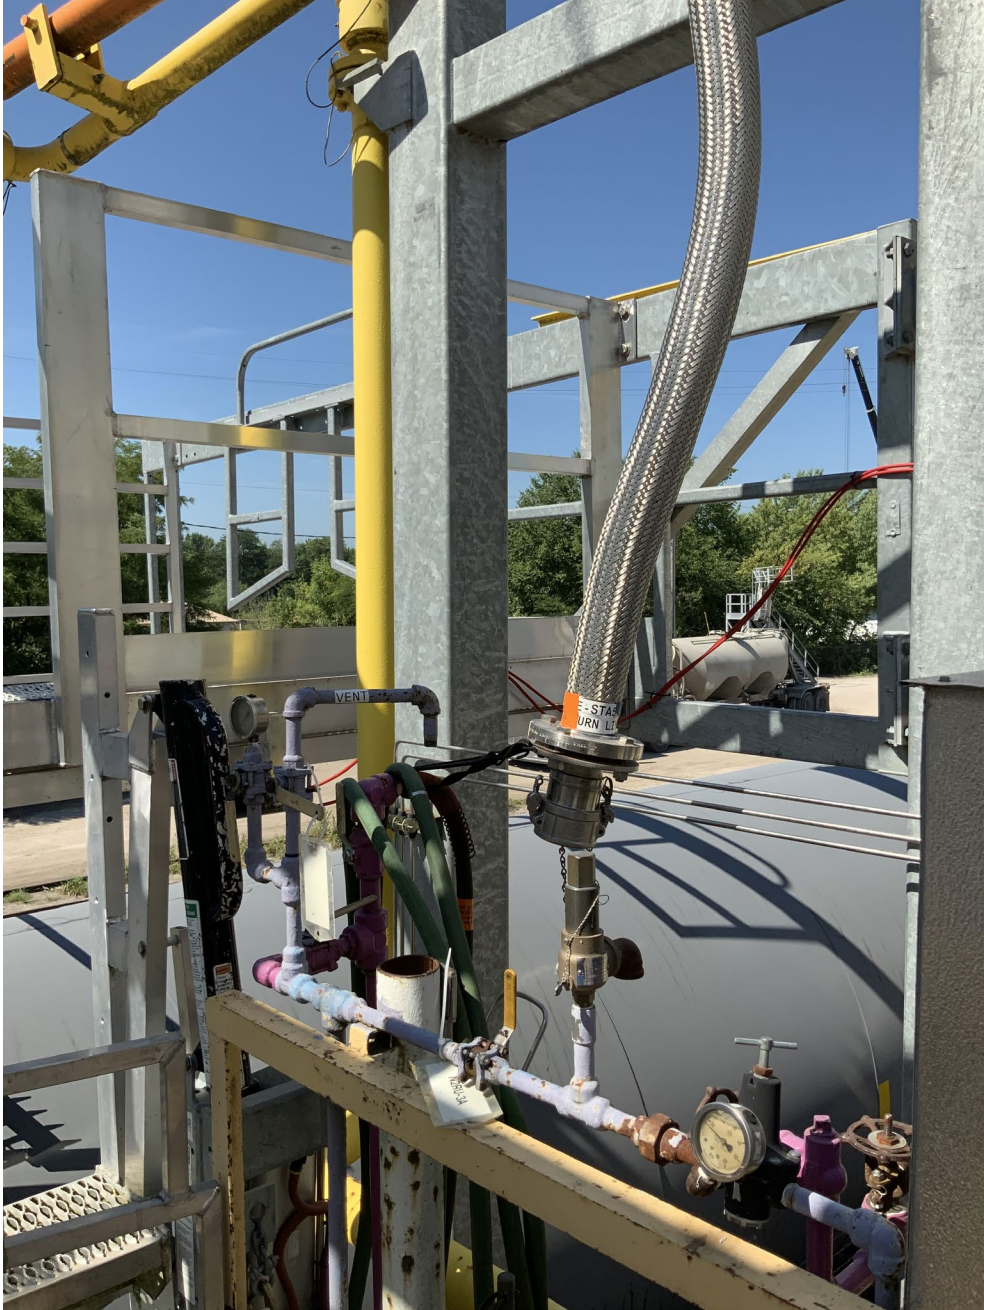
| <b>Image Number</b> | <b>Date</b> | <b>Description of Image</b> |
|---|---|---|
| 1 | 07/27/2023 | Pentane Unloading Station |

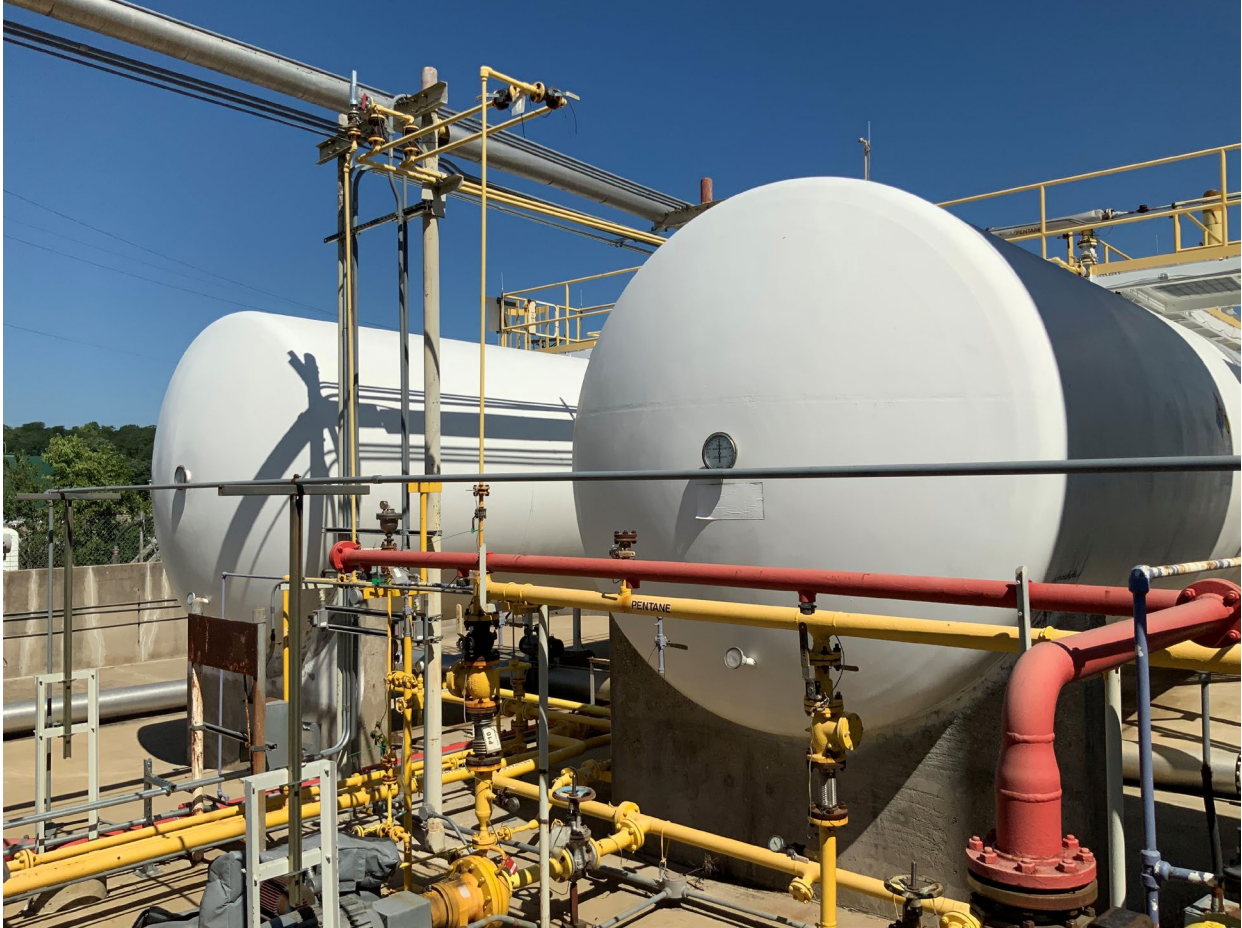
| Image Number | Date | Description of Image |
|---|---|---|
| 2 | 07/27/2023 | Pentane Tanks and Production Pumps |

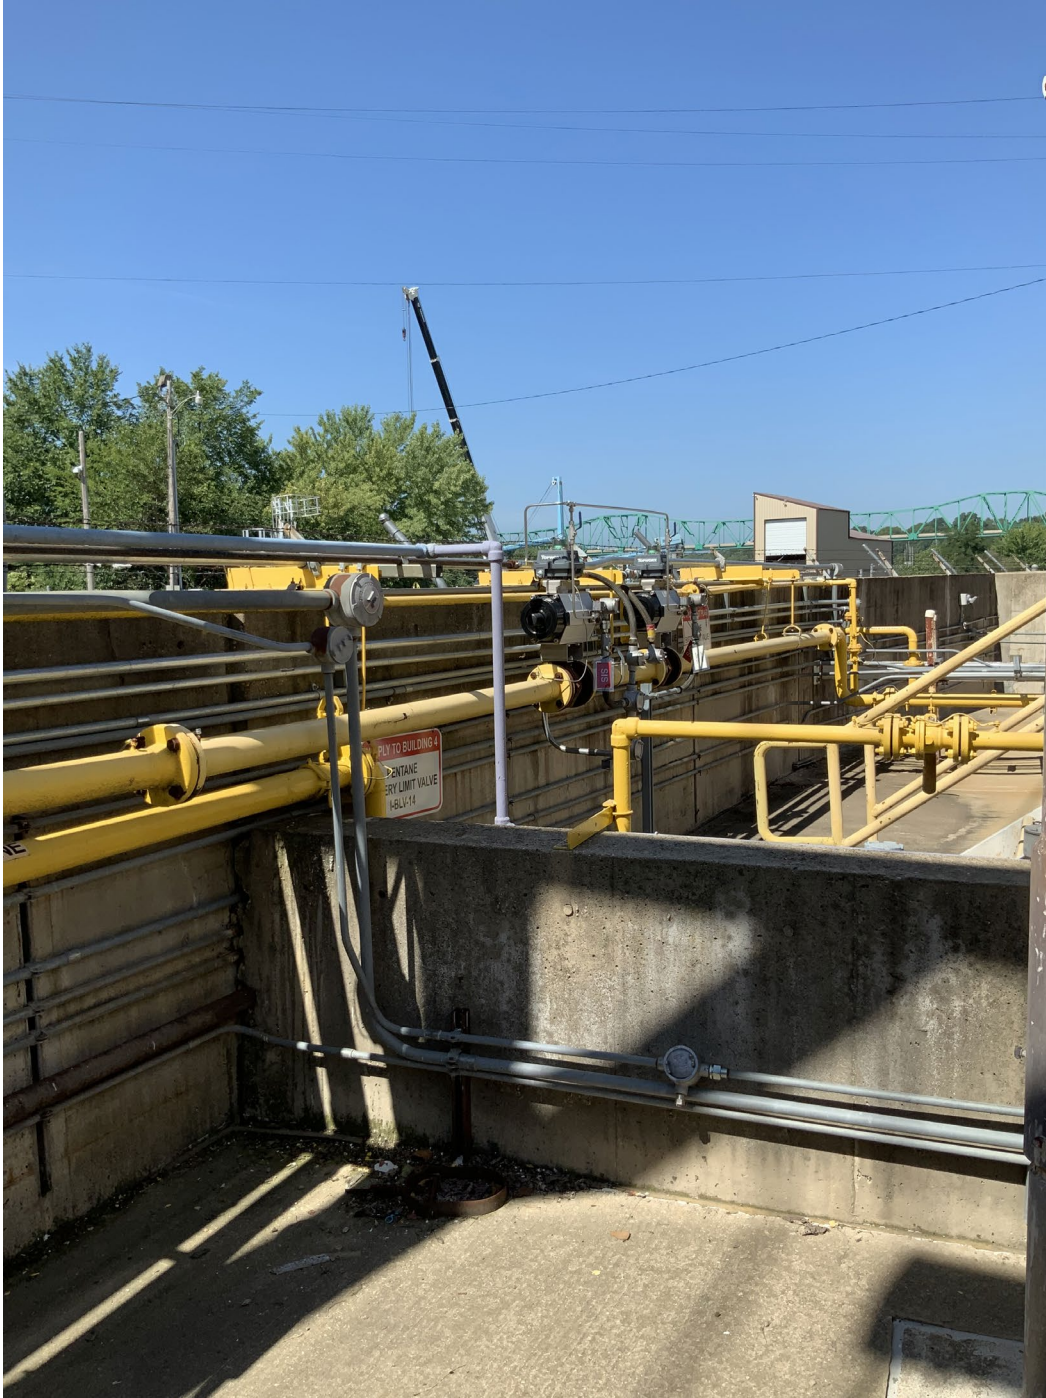
| Image Number | Date | Description of Image |
|---|---|---|
| 3 | 07/27/2023 | Pentane Safety System and Flow Meter |

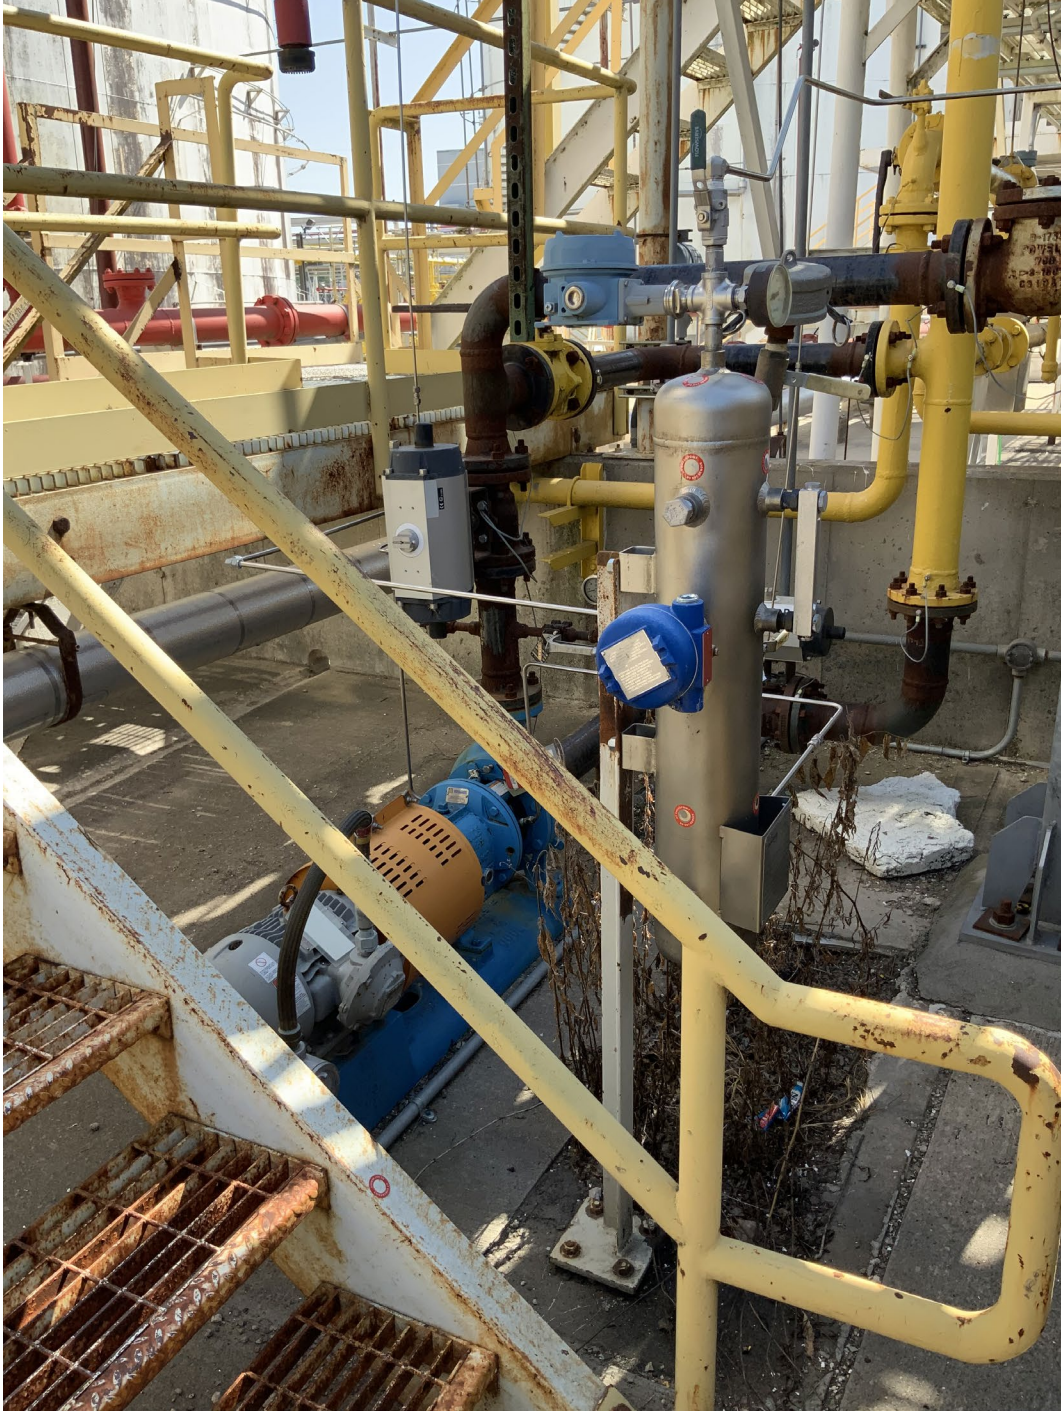
| Image Number | Date | Description of Image |
|---|---|---|
| 4 | 07/27/2023 | Pentane Tanks and Production Pumps |

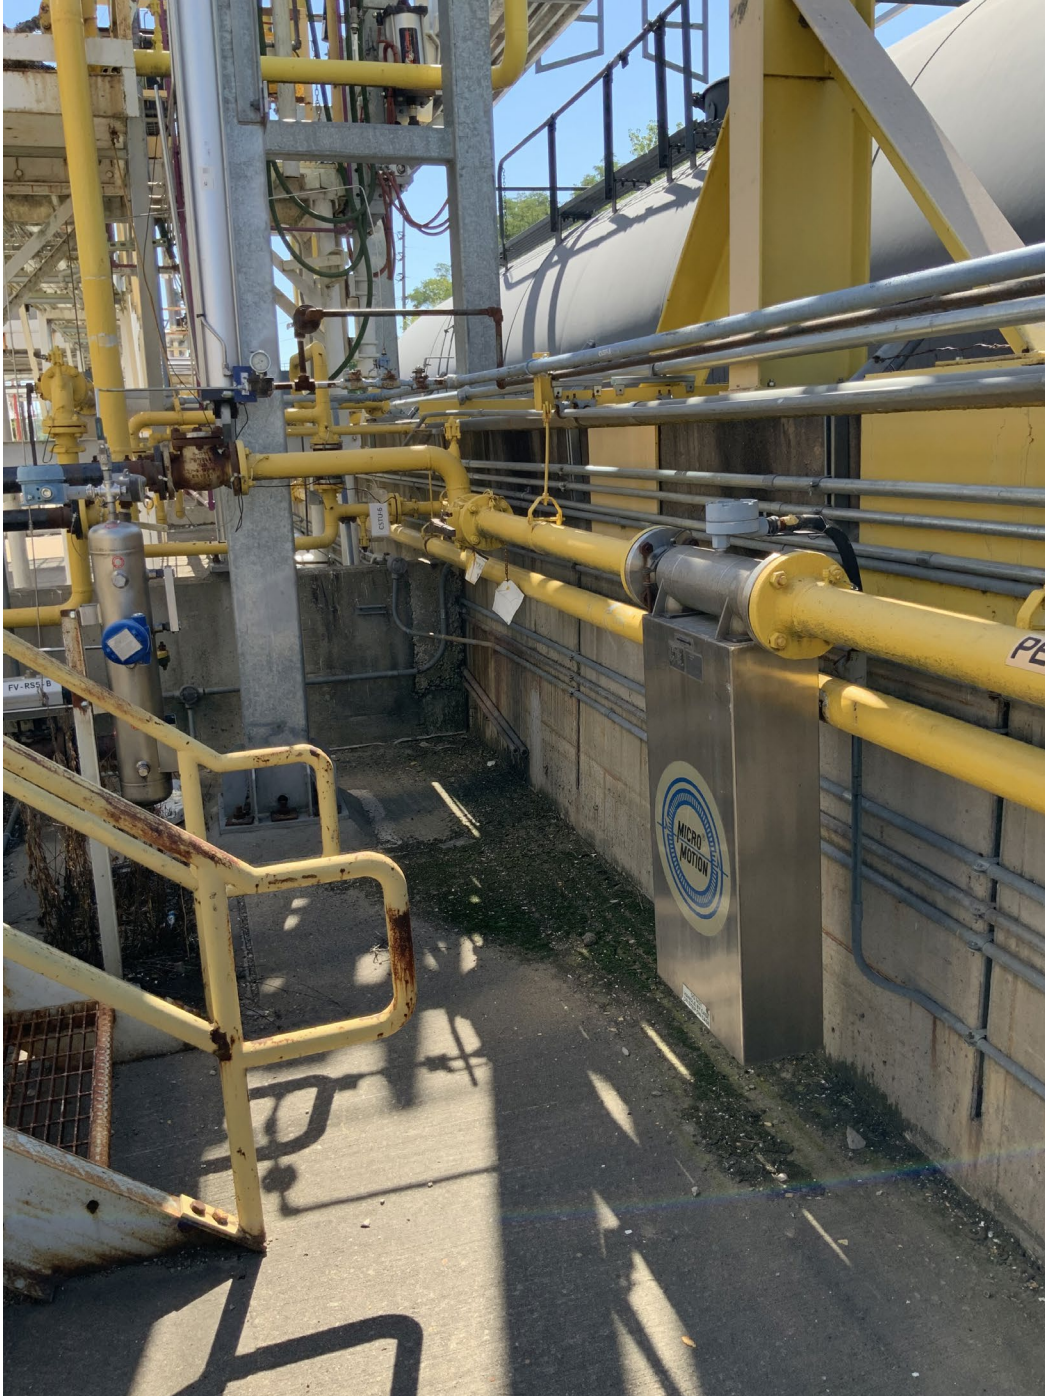
| Image Number | Date | Description of Image |
|---|---|---|
| 5 | 07/27/2023 | Pentane/Isopentane Flow Meter |

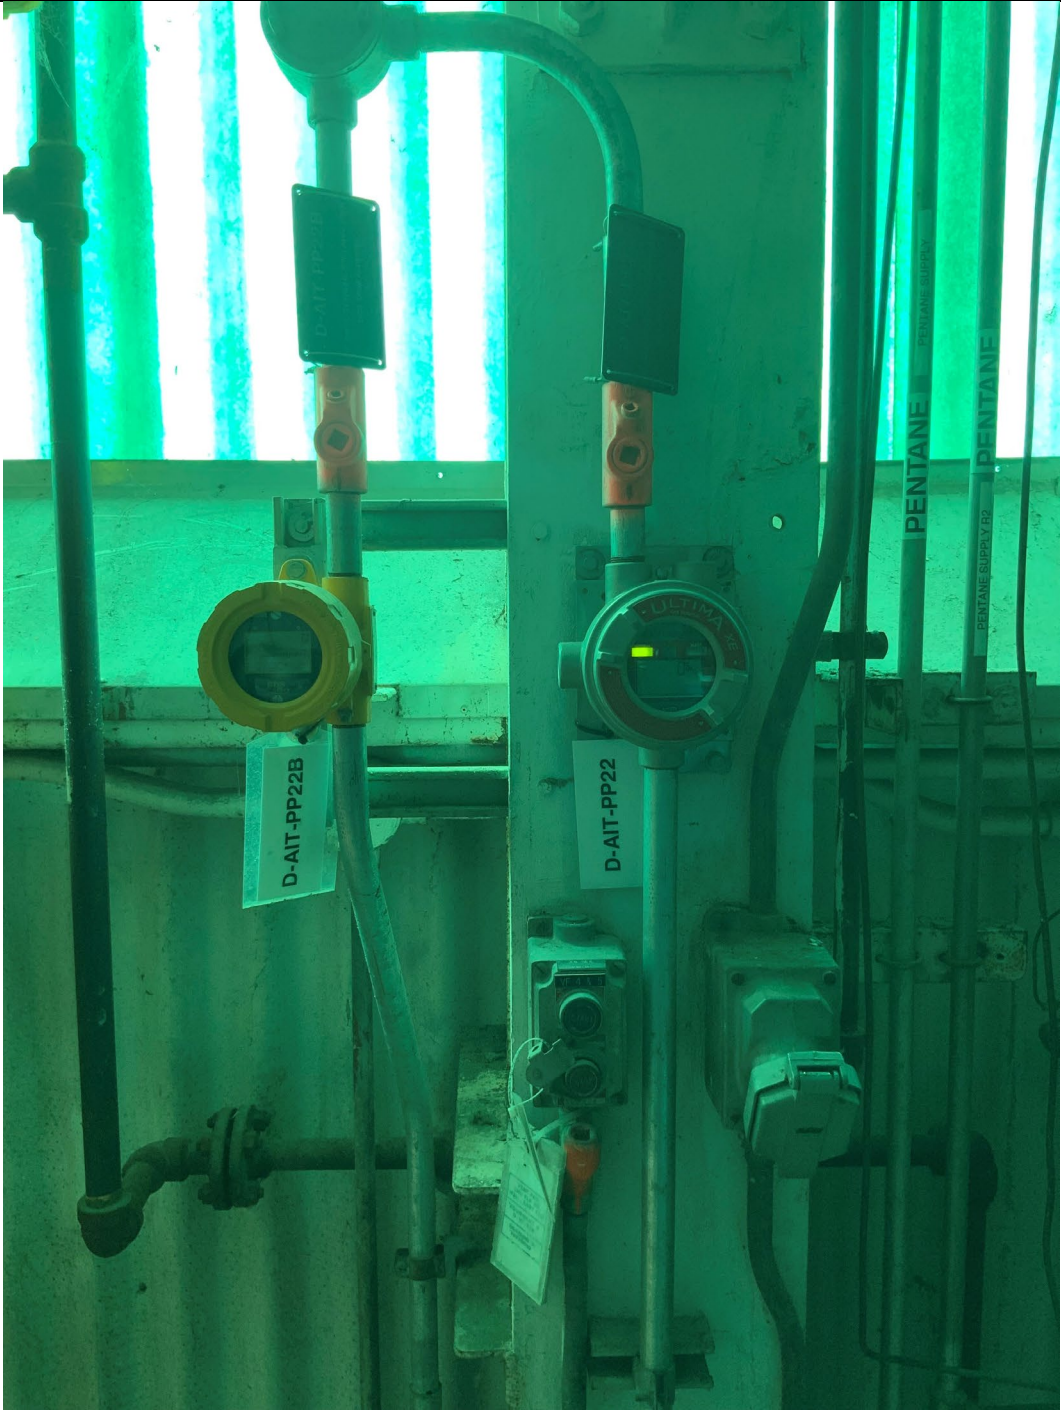
| Image Number | Date | Description of Image |
|---|---|---|
| 6 | 07/27/2023 | Pentane sensor (right) and Styrene sensor (left) |

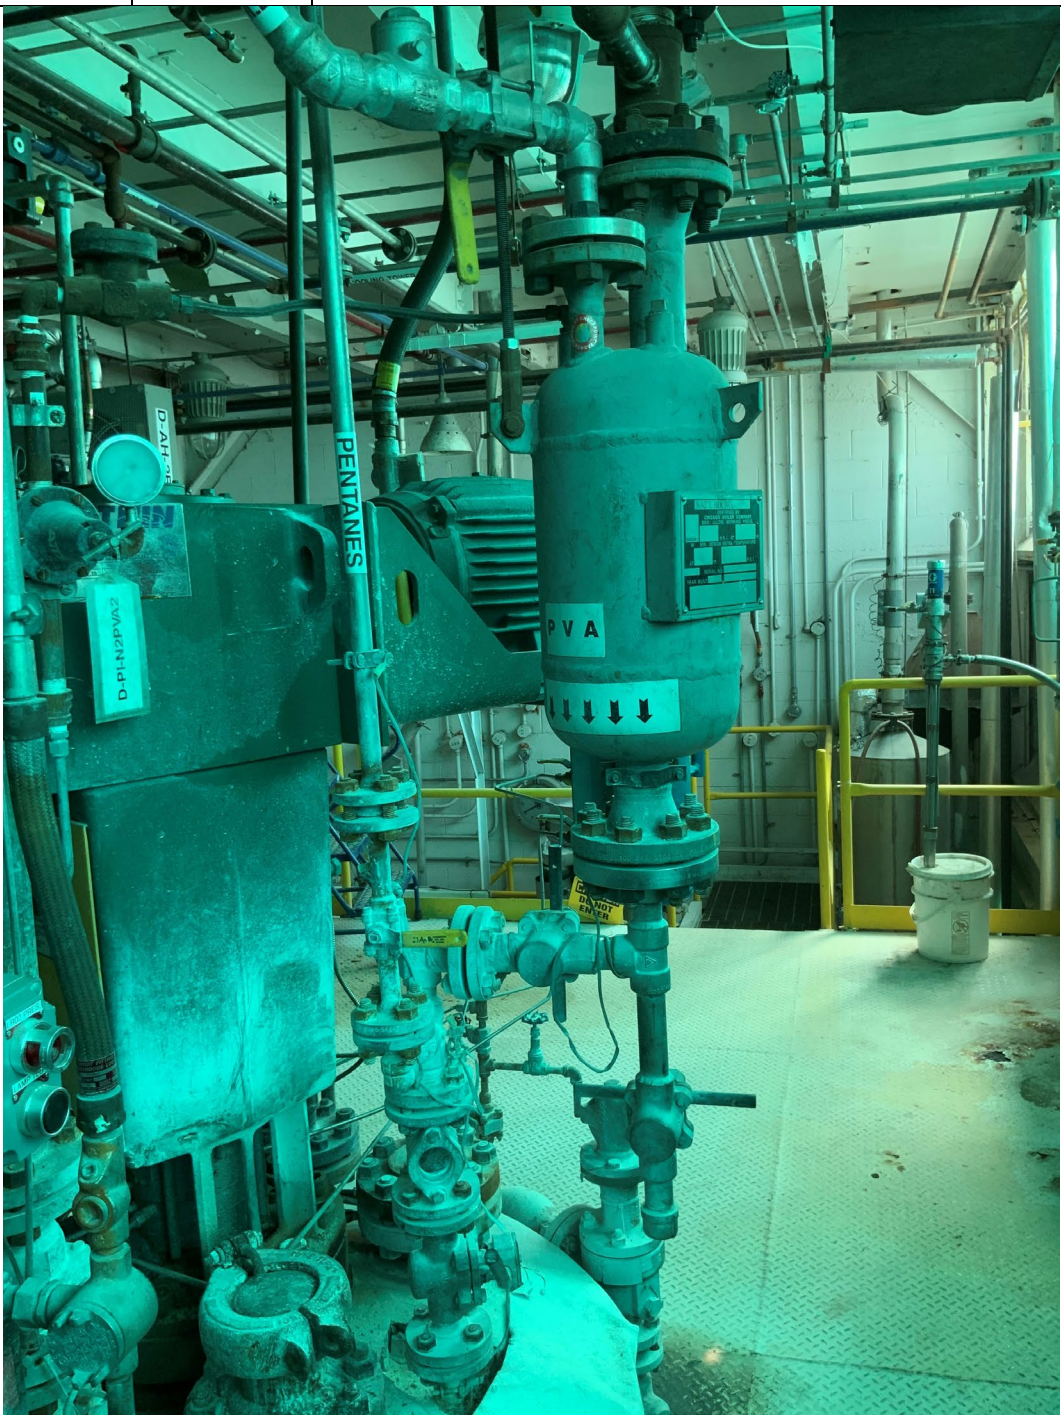
| Image Number | Date | Description of Image |
|---|---|---|
| 7 | 07/27/2023 | One of three Pilot Plant Reactors. |

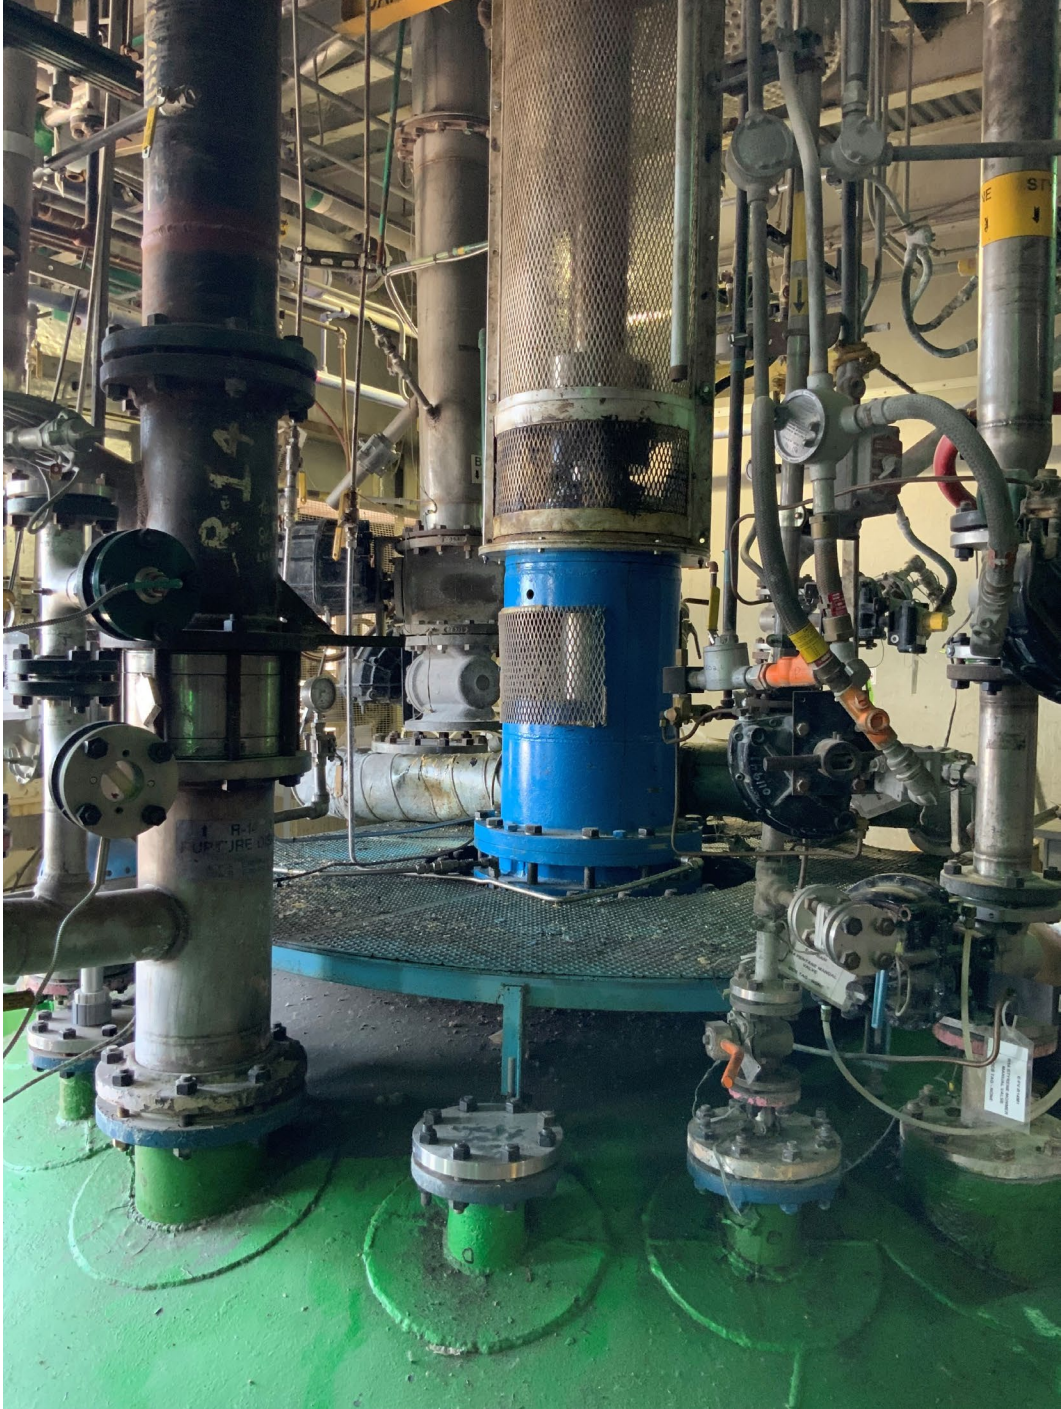
| Image Number | Date | Description of Image |
|---|---|---|
| 8 | 07/27/2023 | Building 4, 5th Floor, Top of Reactor 14.<br> |

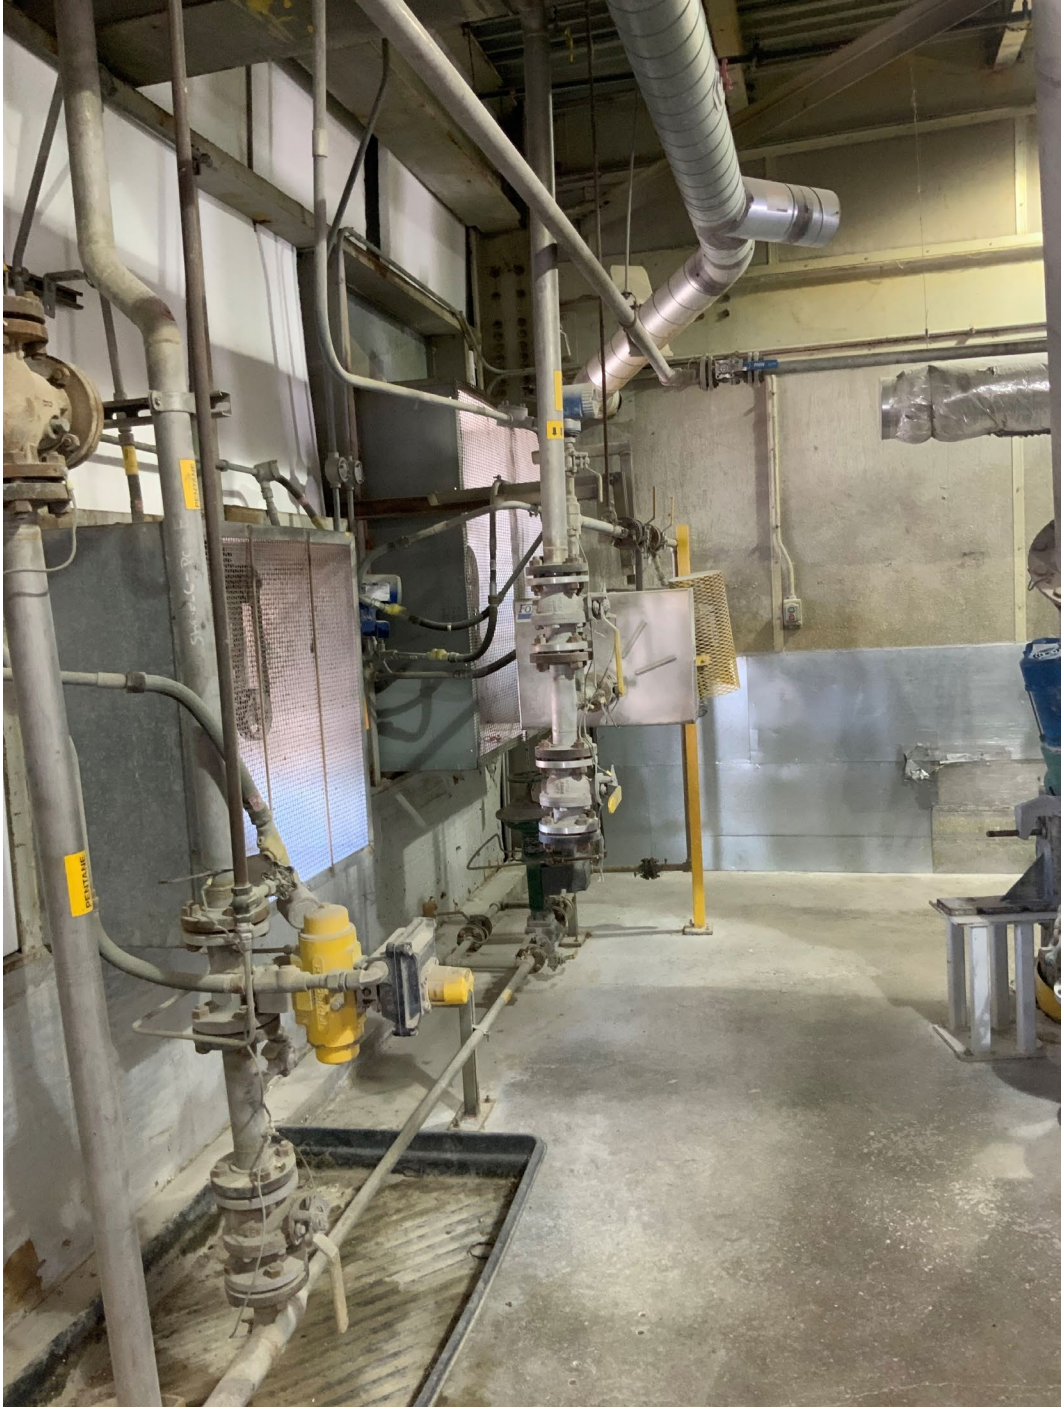
| Image Number | Date | Description of Image |
|---|---|---|
| 9 | 07/27/2023 | Entrance of Pentane Pipe into Building 4. |
