## Region 6 Compliance Assurance and Enforcement Division

### INSPECTION REPORT

| Company Name: | <b>ANGUS Chemical Company</b> | | |
| Facility Name: | <b>Sterlington Plant</b> | | |

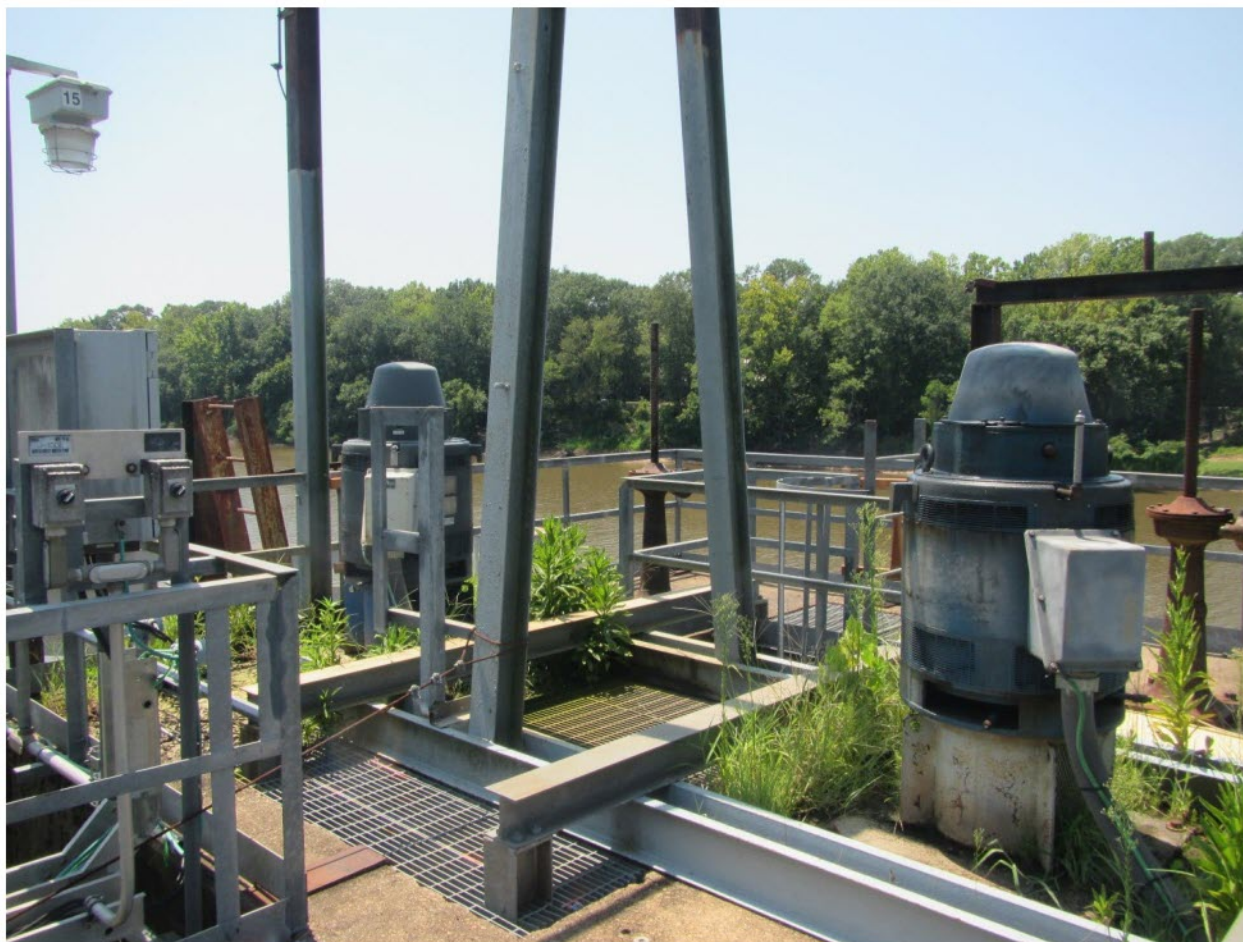
Photograph File Name: IMG\_4886.JPG  
Date of Photograph: 08/03/2023  
Latitude and Longitude: -92.086974°, 32.693761°  
Orientation: W  
Map Datum: WGS-84  
Time of Photo: 12:58 PM  
Photographer: Jack Arias  
Description: This image shows vegetation growth around the cooling intake structure's pumps.

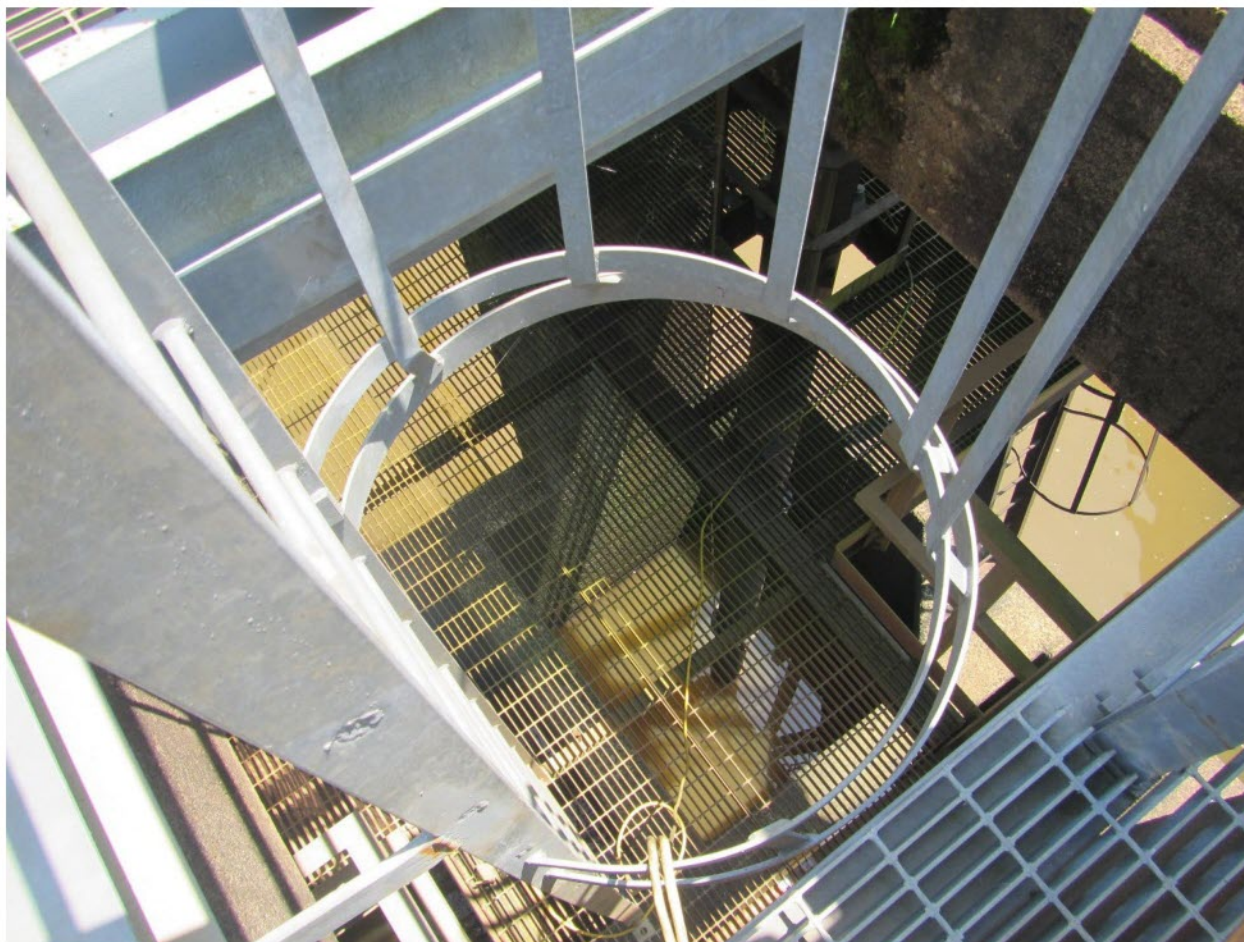
Photograph File Name: IMG\_4889.JPG  
Date of Photograph: 08/03/2023  
Latitude and Longitud: -92.086974°, 32.693761°  
Orientation: W  
Map Datum: WGS-84  
Time of Photo: 1:03 PM  
Photographer: Jack Arias  
Description: This image shows standing water at the bottom base structure of one of the cooling intake structure's pumps. This pump is inactive.

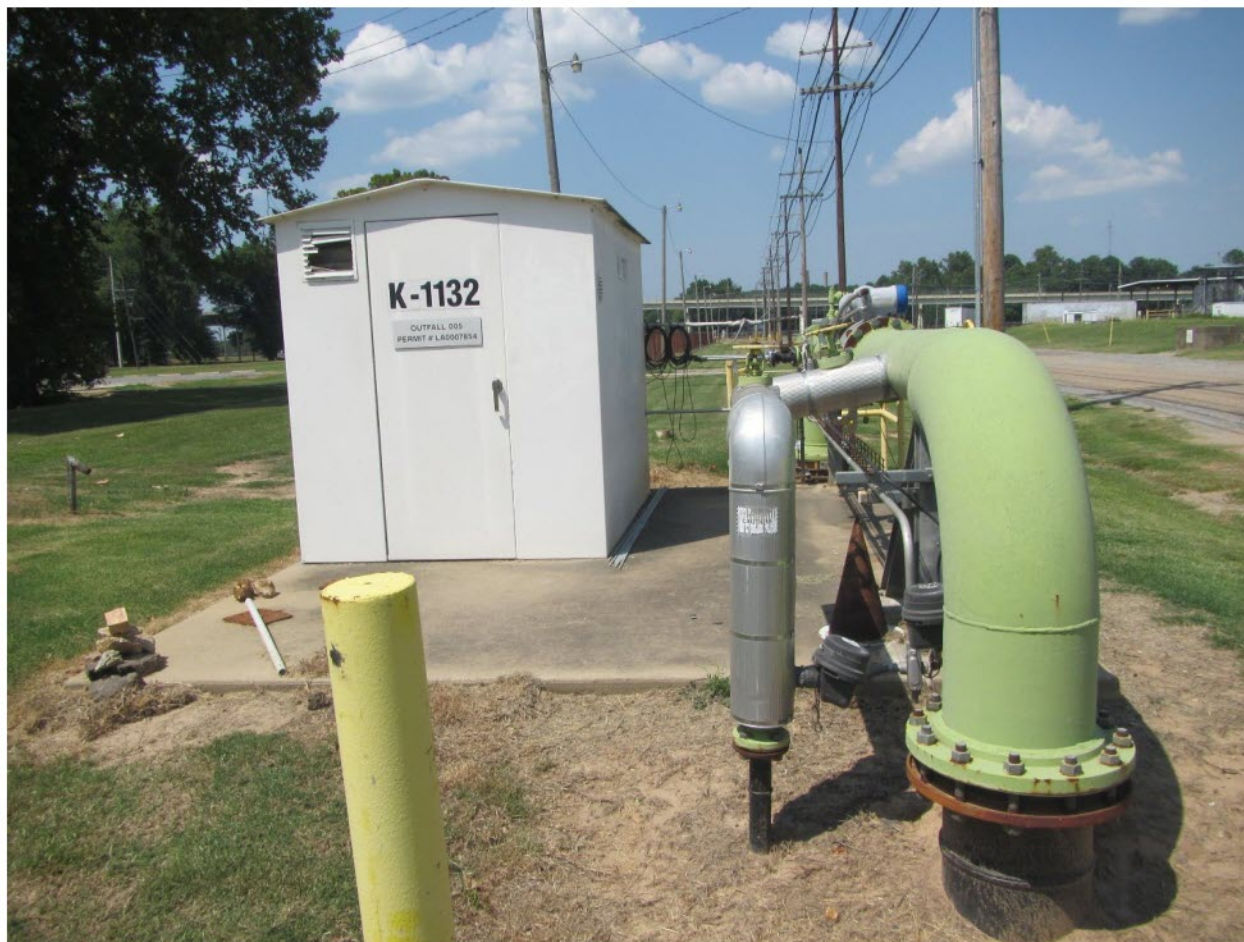
Photograph File Name: IMG\_4920.JPG  
Date of Photograph: 08/03/2023  
Latitude and Longitude: -92.084646°, 32.693074°  
Orientation: SE  
Map Datum: WGS-84  
Time of Photo: 2:13 PM  
Photographer: Jack Arias  
Description: This image shows outfall 005 system.

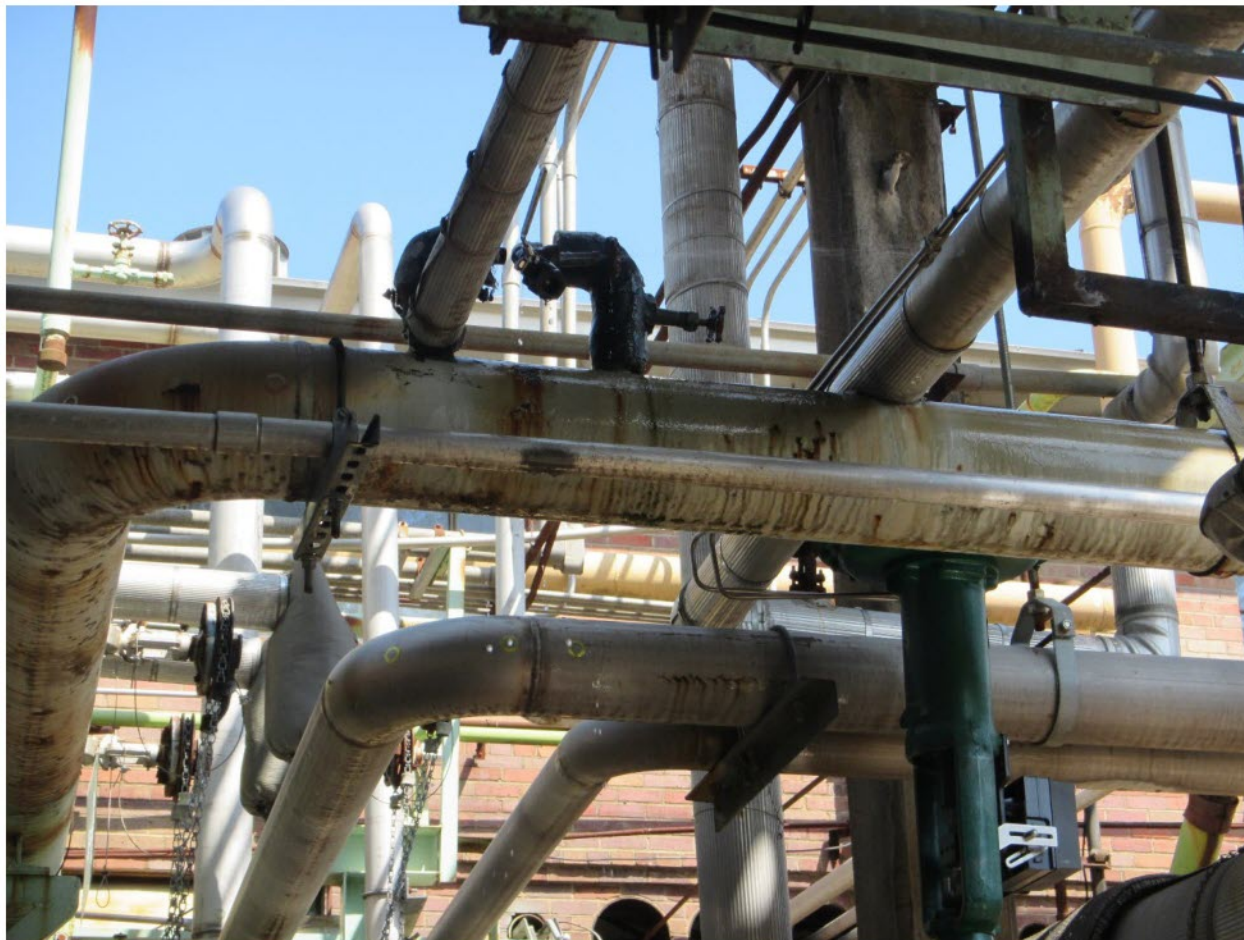
The facility shall take reasonable steps to minimize or prevent any discharge and disposal of wastewater. Also, facility shall maintain all facilities and systems to achieve compliance with the conditions of the permit. During the inspection, I observed two continuous leaks of wastewater connected with the wastewater pipe and boilers 6 and 7 blowdown pipe. These lack of preventive maintenance of the leaks may impact the integrity of the process and lead to upset conditions. Also, these leaks of wastewater may impact the discharge into the stormwater system connected to outfall 004 and may produce adverse environmental impacts (AEI) (See Photo Nos. 10 - 12 in Appendix 1).

Photograph File Name: IMG\_4929.JPG  
Date of Photograph: 08/03/2023  
Latitude and Longitud: -92.084085°, 32.690186°  
Orientation: S  
Map Datum: WGS-84  
Time of Photo: 3:00 PM  
Photographer: Jack Arias  
Description: This image shows a leak on a wastewater pipe near boilers 6 And 7.

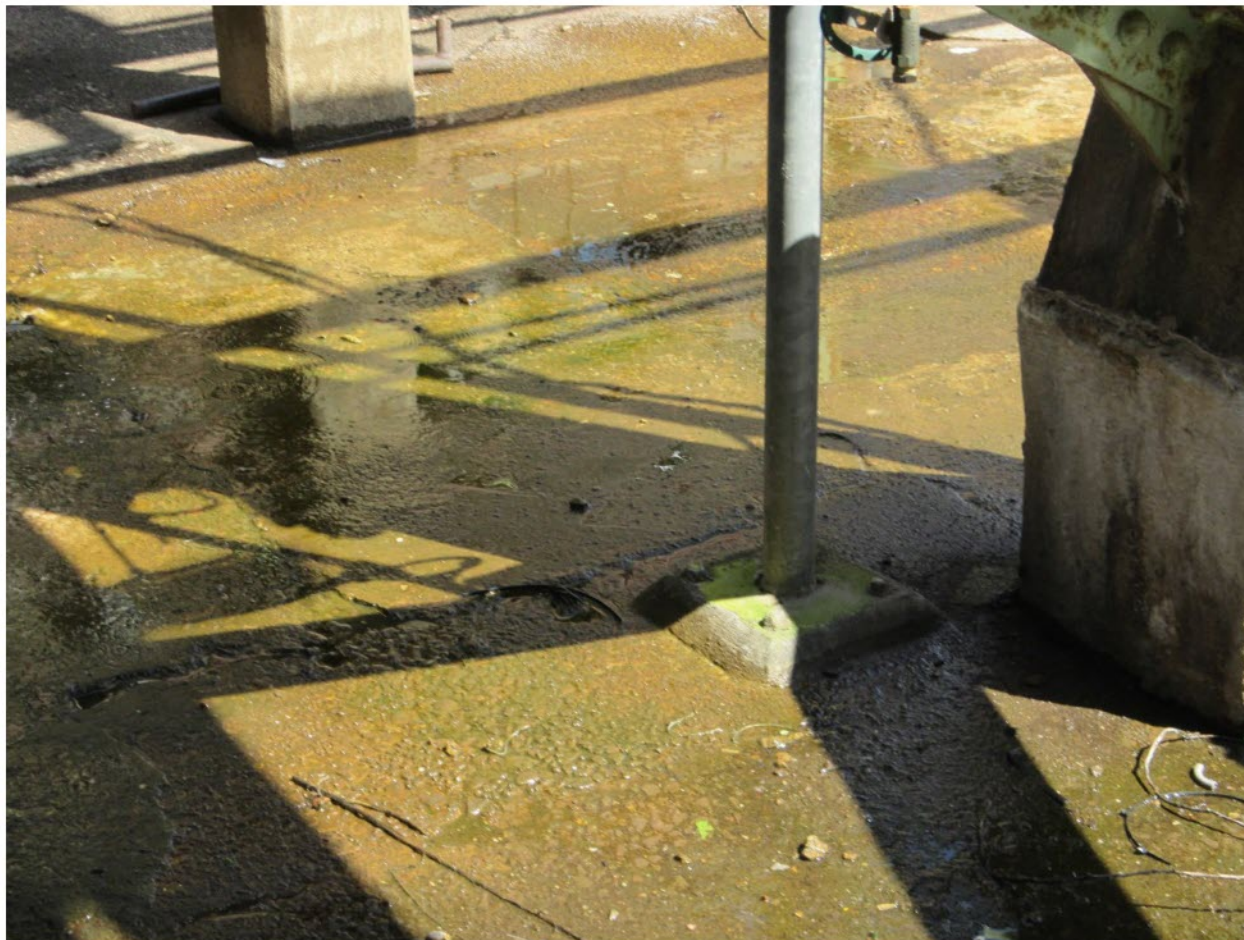
Photograph File Name: IMG\_4930.JPG  
Date of Photograph: 08/03/2023  
Latitude and Longitud: -92.084085°, 32.690186°  
Orientation: S  
Map Datum: WGS-84  
Time of Photo: 3:00 PM  
Photographer: Jack Arias  
Description: This image shows wastewater accumulation under the pipe leak near boilers 6 And 7.

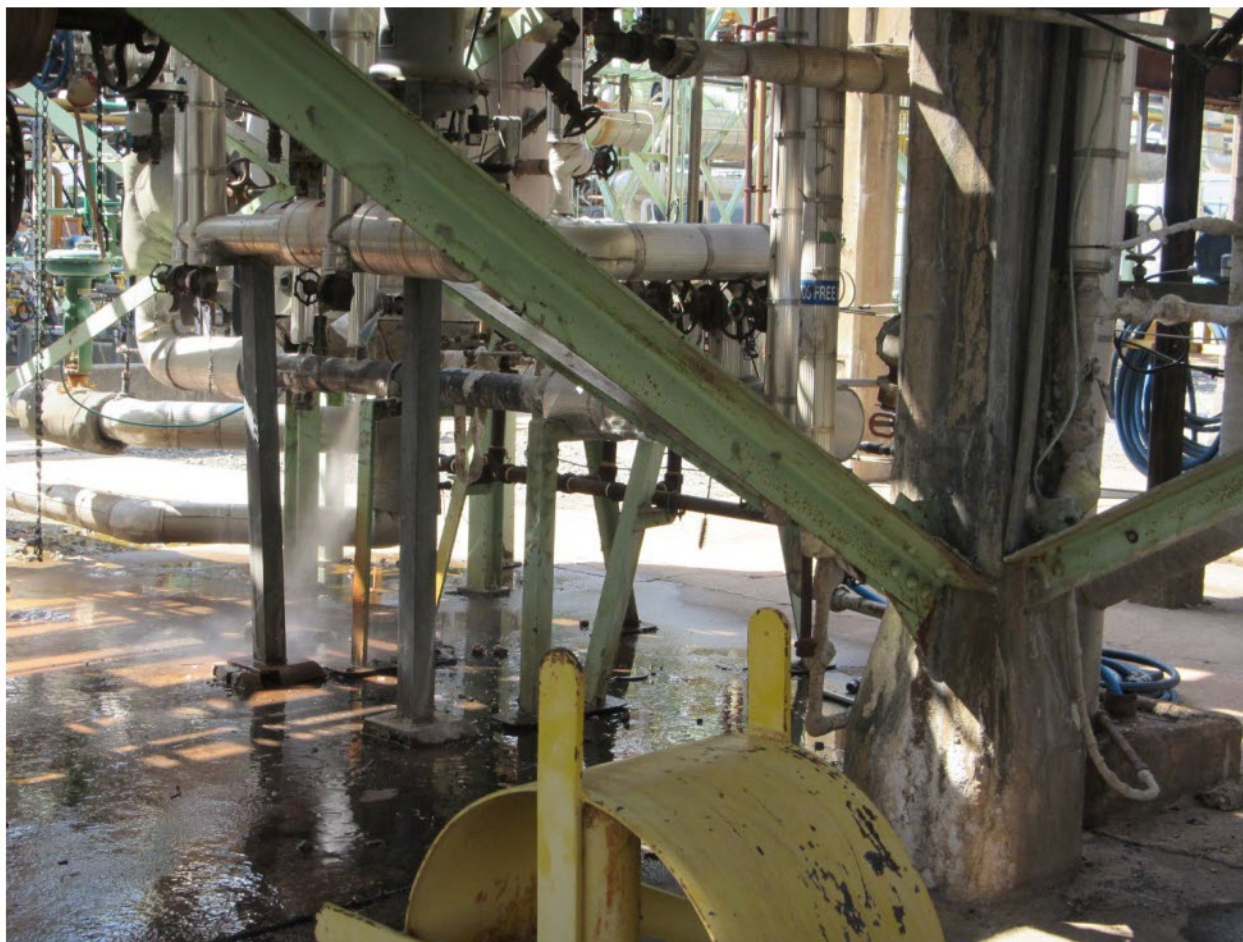
Photograph File Name: IMG\_4932.JPG  
Date of Photograph: 08/03/2023  
Latitude and Longitud: -92.084085°, 32.690186°  
Orientation: S  
Map Datum: WGS-84  
Time of Photo: 3:05 PM  
Photographer: Jack Arias  
Description: This image shows a leak from boilers 6 and 7 blowdown pipe.

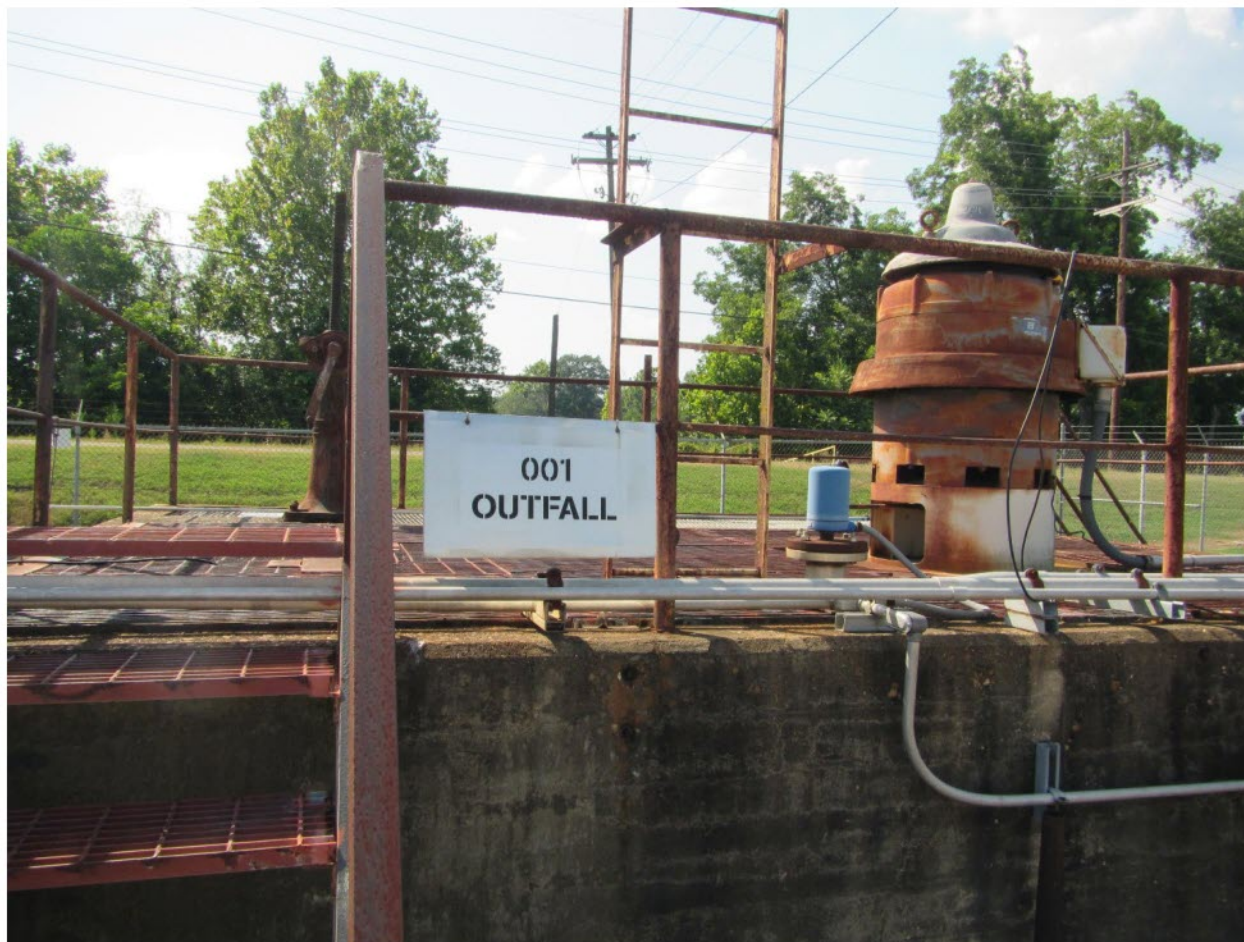
Photograph File Name: IMG\_4934.JPG  
Date of Photograph: 08/03/2023  
Latitude and Longitud: -92.087204°, 32.689748°  
Orientation: W  
Map Datum: WGS-84  
Time of Photo: 3:22 PM  
Photographer: Jack Arias  
Description: This image shows outfall 001 system.

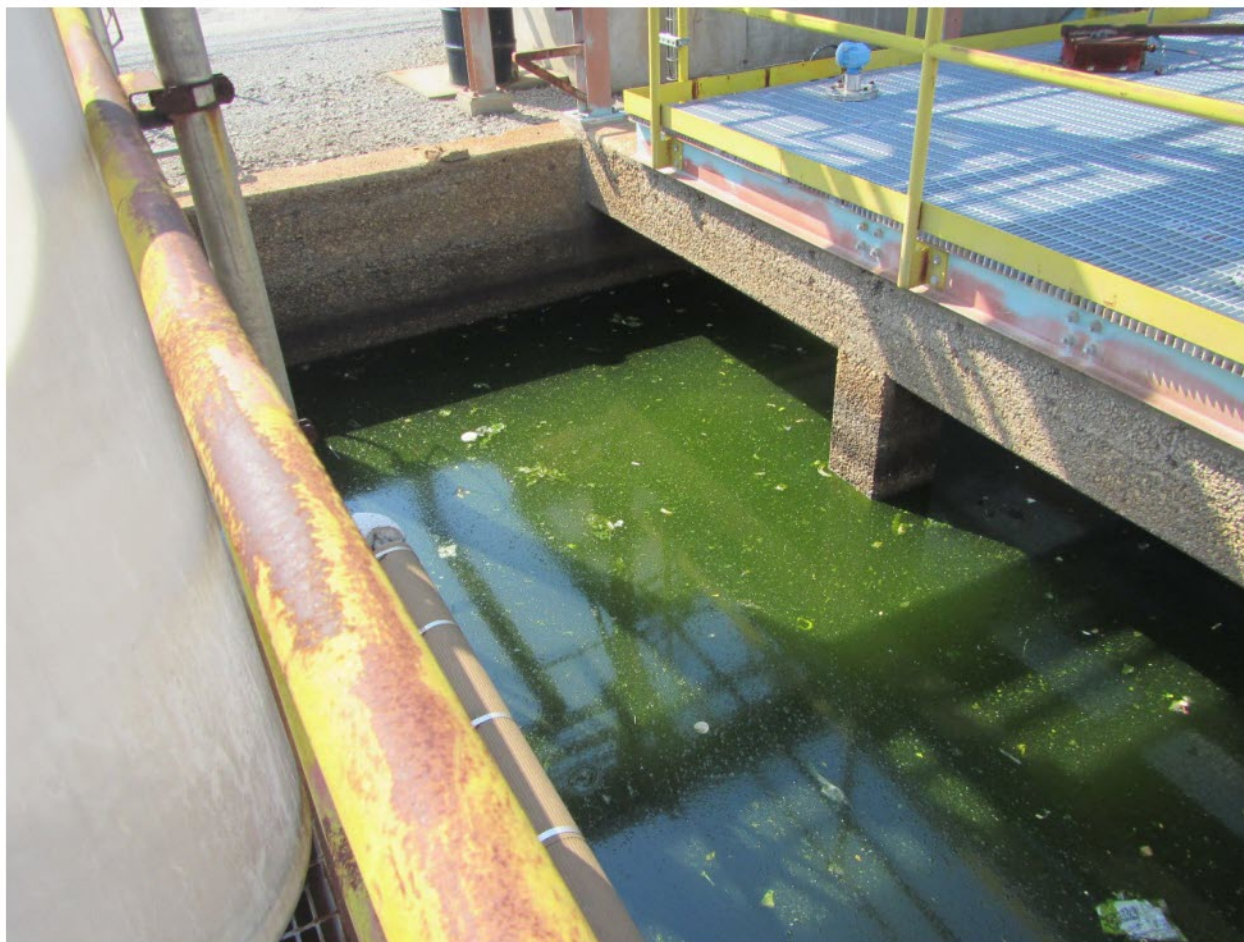
Photograph File Name: IMG\_4942.JPG  
Date of Photograph: 08/03/2023  
Latitude and Longitud: -92.079616°, 32.691198°  
Orientation: NE  
Map Datum: WGS-84  
Time of Photo: 3:43 PM  
Photographer: Jack Arias  
Description: This image shows formation of algae, sediments, and debris in the wastewater contained in the settling based area.

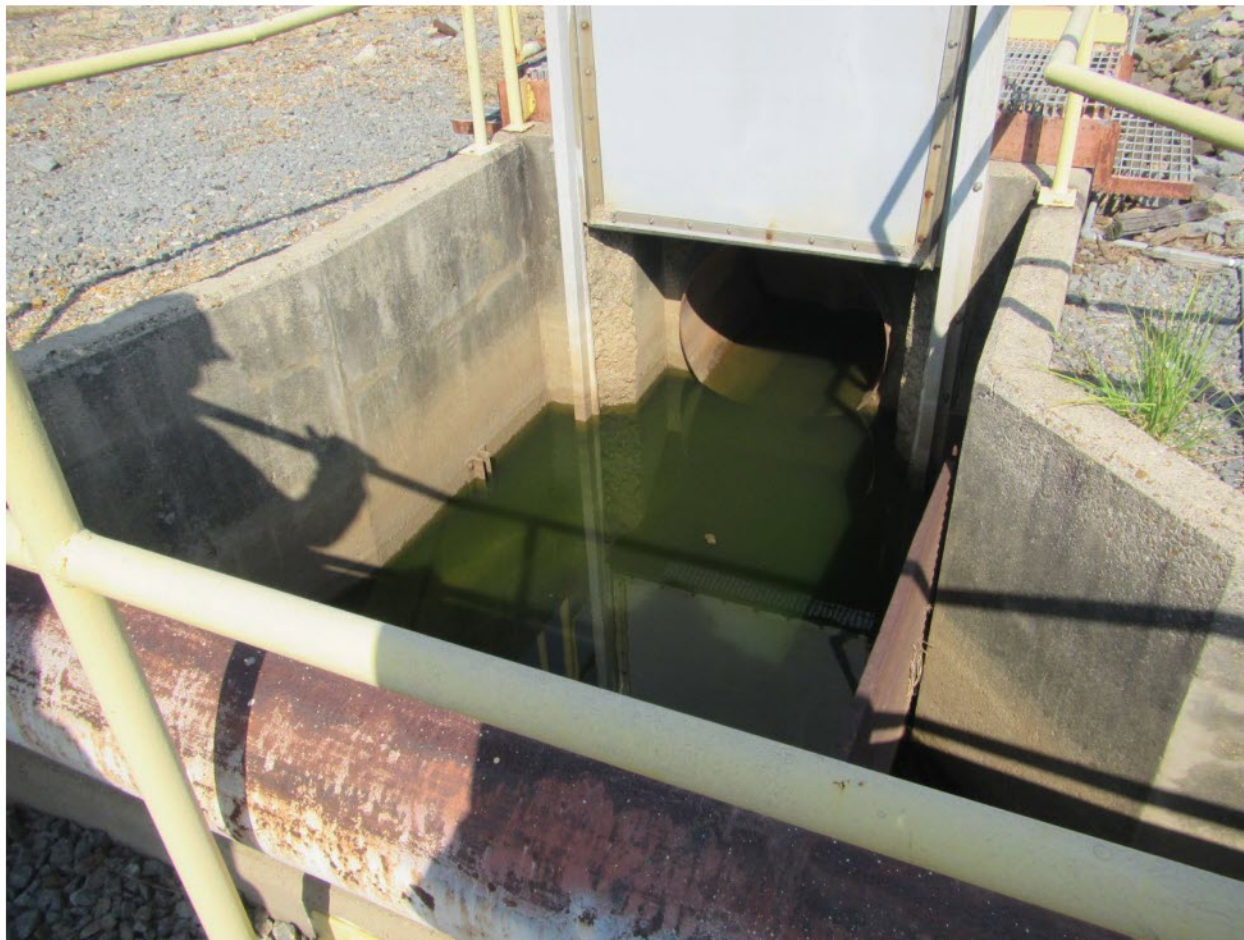
I observed that the gate of outfall 004 was open and contained fluids (See Photo Nos. 16 – 17 in Appendix 1). Facility needs to maintain the gate close to avoid any combination of wastewater from the Sterlington Ditch with non-process runoff; miscellaneous non-process and utility wastewater; and hydrostatic test wastewater from internal outfall 401.

Photograph File Name: IMG\_4944.JPG  
Date of Photograph: 08/03/2023  
Latitude and Longitud: -92.079670°, 32.691089°  
Orientation: NE  
Map Datum: WGS-84  
Time of Photo: 3:46 PM  
Photographer: Jack Arias  
Description: This image shows outfall 004 system. The gate is open and contained fluids.

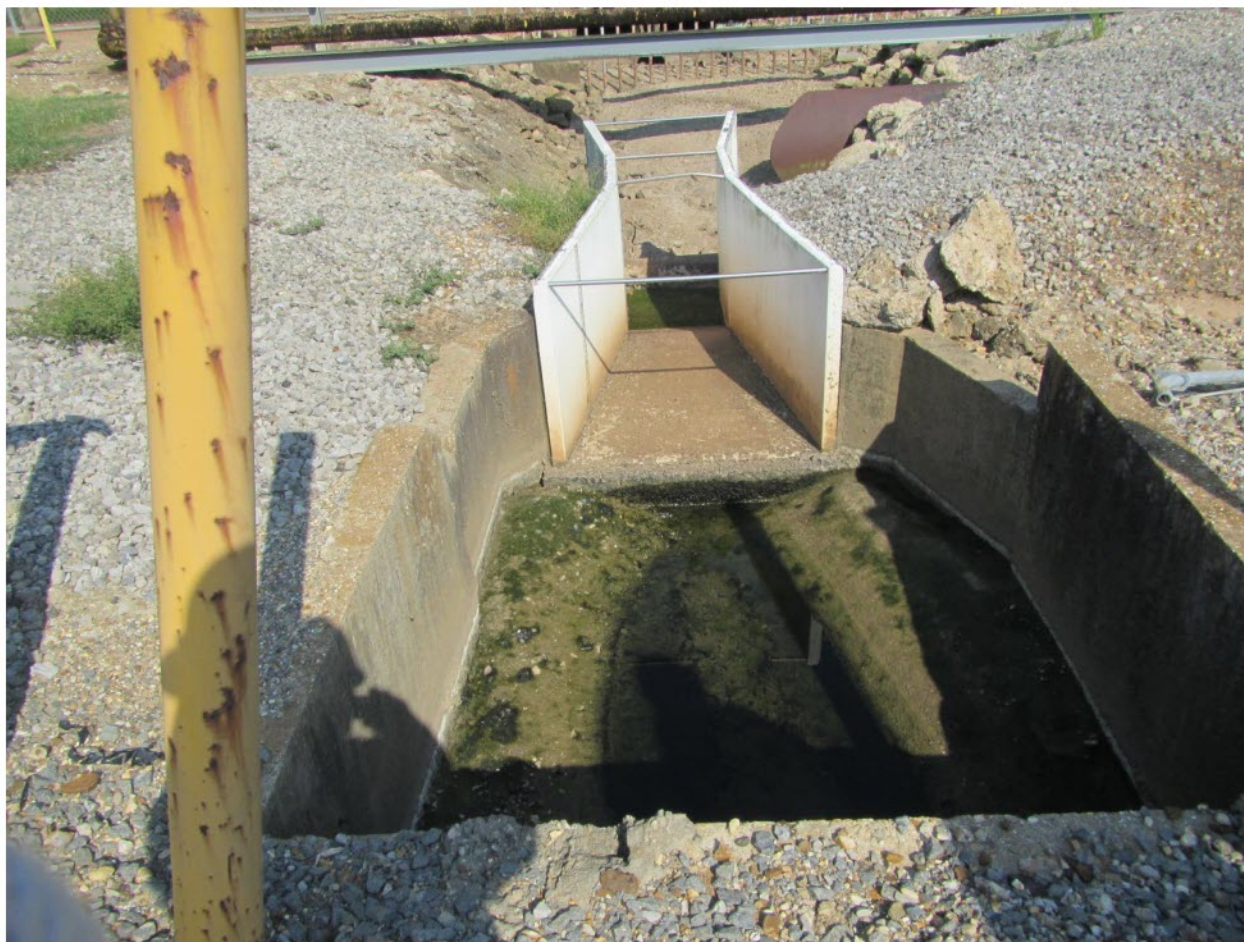
Photograph File Name: IMG\_4946.JPG  
Date of Photograph: 08/03/2023  
Latitude and Longitude: -92.078902°, 32.691019°  
Orientation: NE  
Map Datum: WGS-84  
Time of Photo: 3:54 PM  
Photographer: Jack Arias  
Description: This image shows the discharge channel for outfall 004.

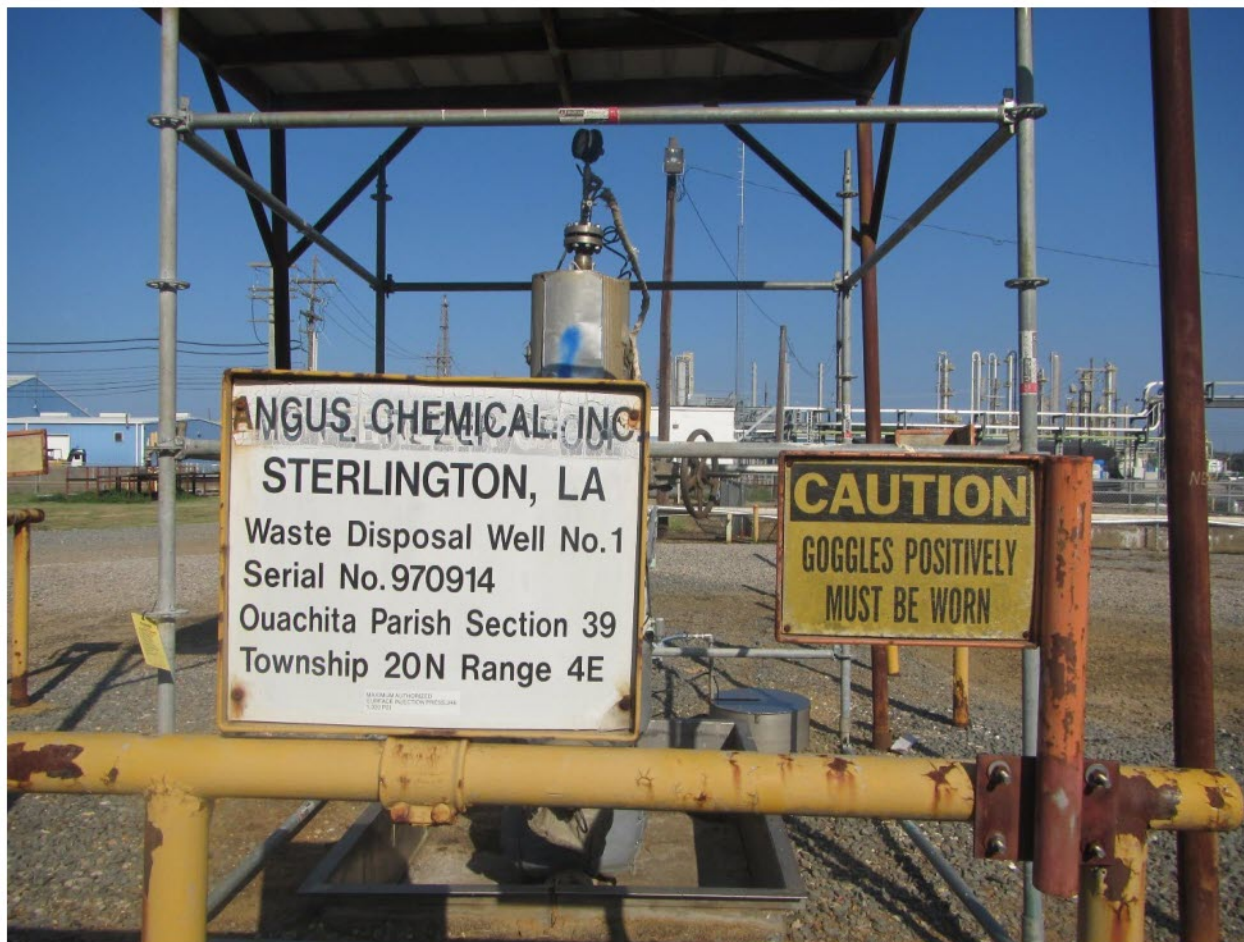
During the inspection, I observed two injections wells near the settling area and cooling tower #6. To understand the injection process and the composition of wastewater injected into the UIC system, facility need to describe the LDRN annual report and integrity test requirements (See Photo No. 21 in Appendix 1).

Photograph File Name: IMG\_4963.JPG  
Date of Photograph: 08/03/2023  
Latitude and Longitude: -92.079238°, 32.691162°  
Orientation: E  
Map Datum: WGS-84  
Time of Photo: 8:08 AM  
Photographer: Jack Arias  
Description: This image shows an injection well No.1 near the settling area and cooling tower #6.

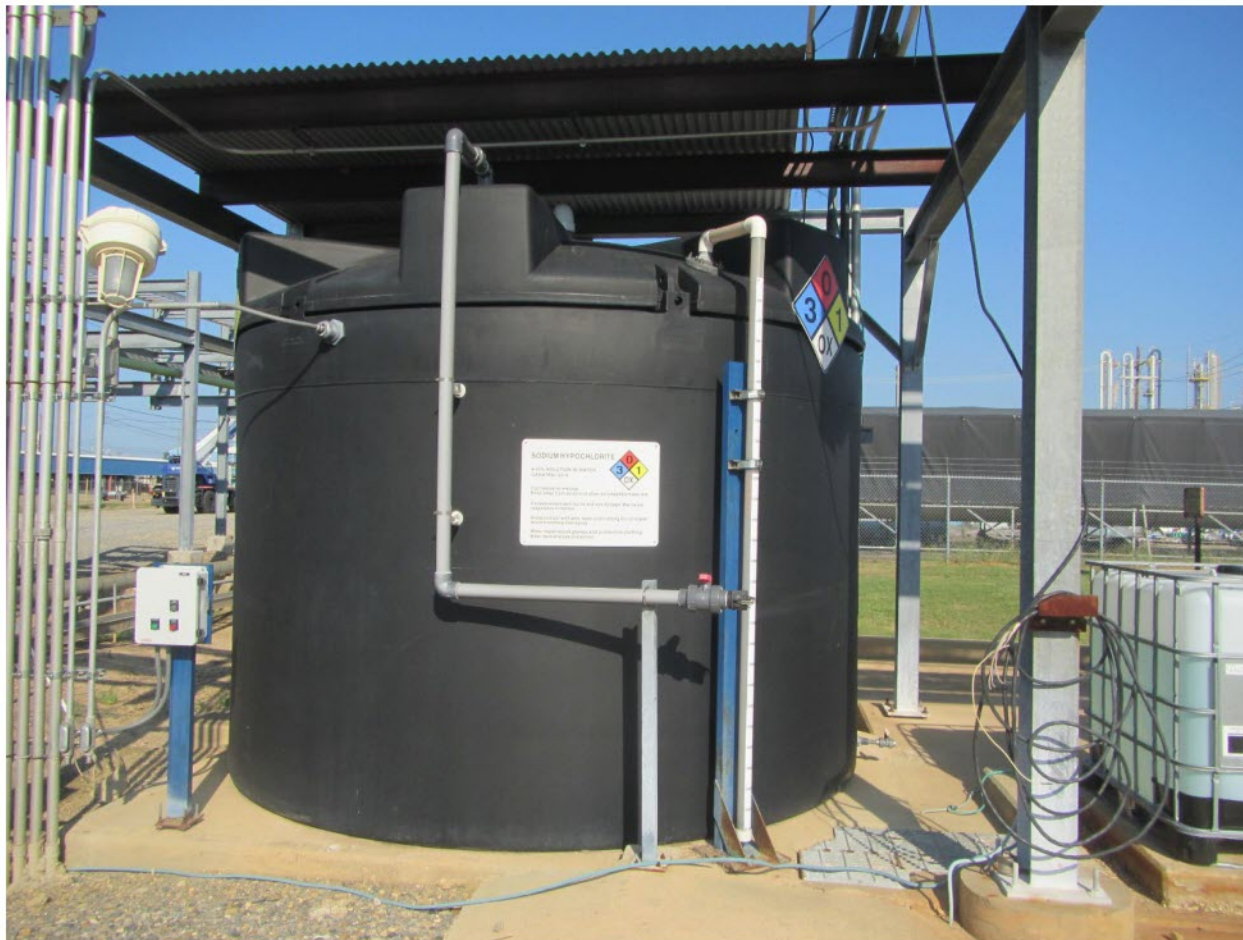
During the inspection, I observed that the Sodium Hypochlorite Tank is near to the sump basin area and stormwater area. Facility needs to reinforce the secondary containment wall around tank to prevent impact on stormwater runoff and sump area (See Photo No. 22 in Appendix 1).

Photograph File Name: IMG\_4966.JPG  
Date of Photograph: 08/03/2023  
Latitude and Longitude: -92.079227°, 32.692010°  
Orientation: NE  
Map Datum: WGS-84  
Time of Photo: 8:13 AM  
Photographer: Jack Arias  
Description: This image shows the Sodium Hypochlorite Tank near to the sump basin area and stormwater area.

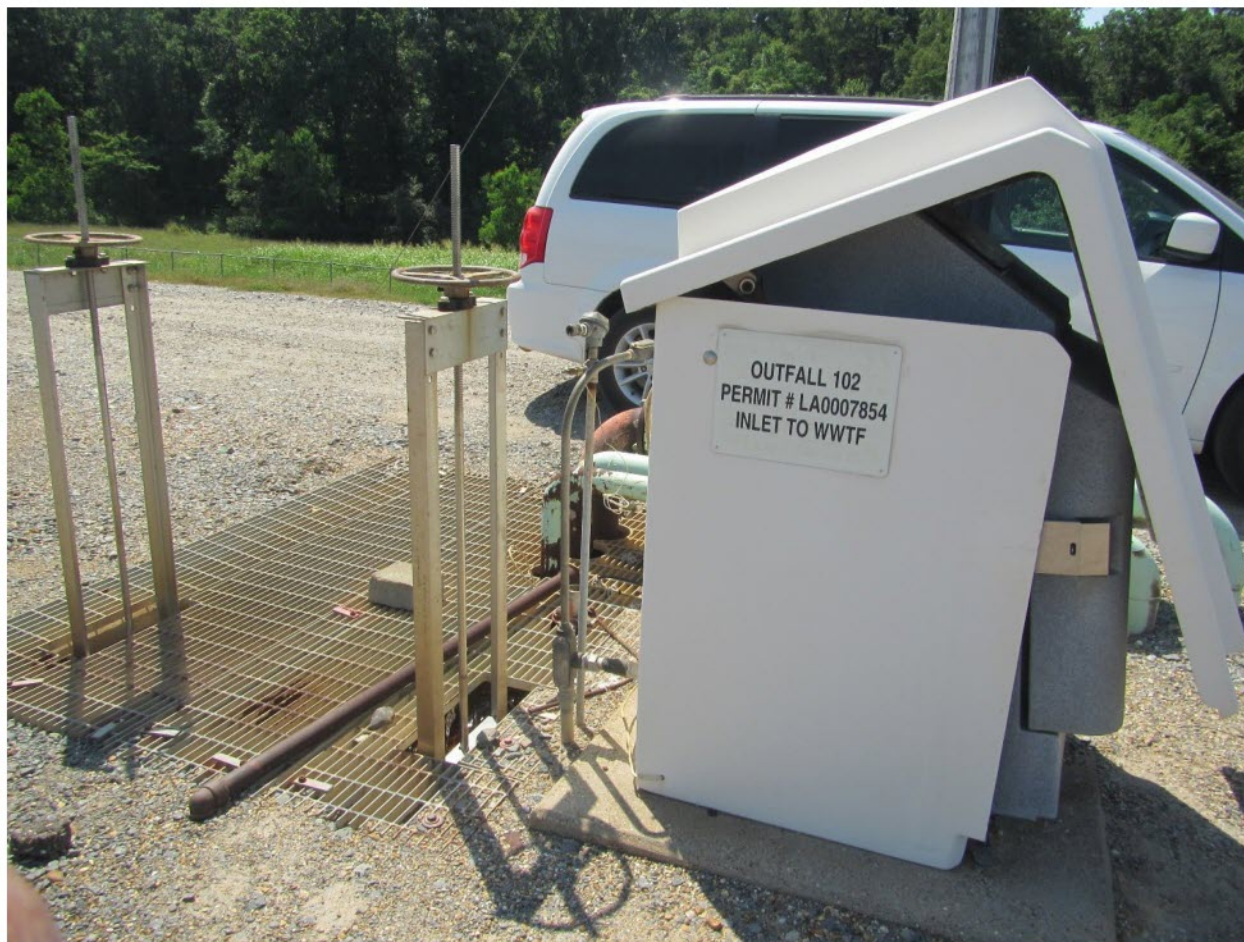
Photograph File Name: IMG\_4991.JPG  
Date of Photograph: 08/04/2022  
Latitude and Longitud: -92.113929°, 32.660463°  
Orientation: S  
Map Datum: WGS-84  
Time of Photo: 10:21 AM  
Photographer: Jack Arias  
Description: This image shows outfall 102 system.

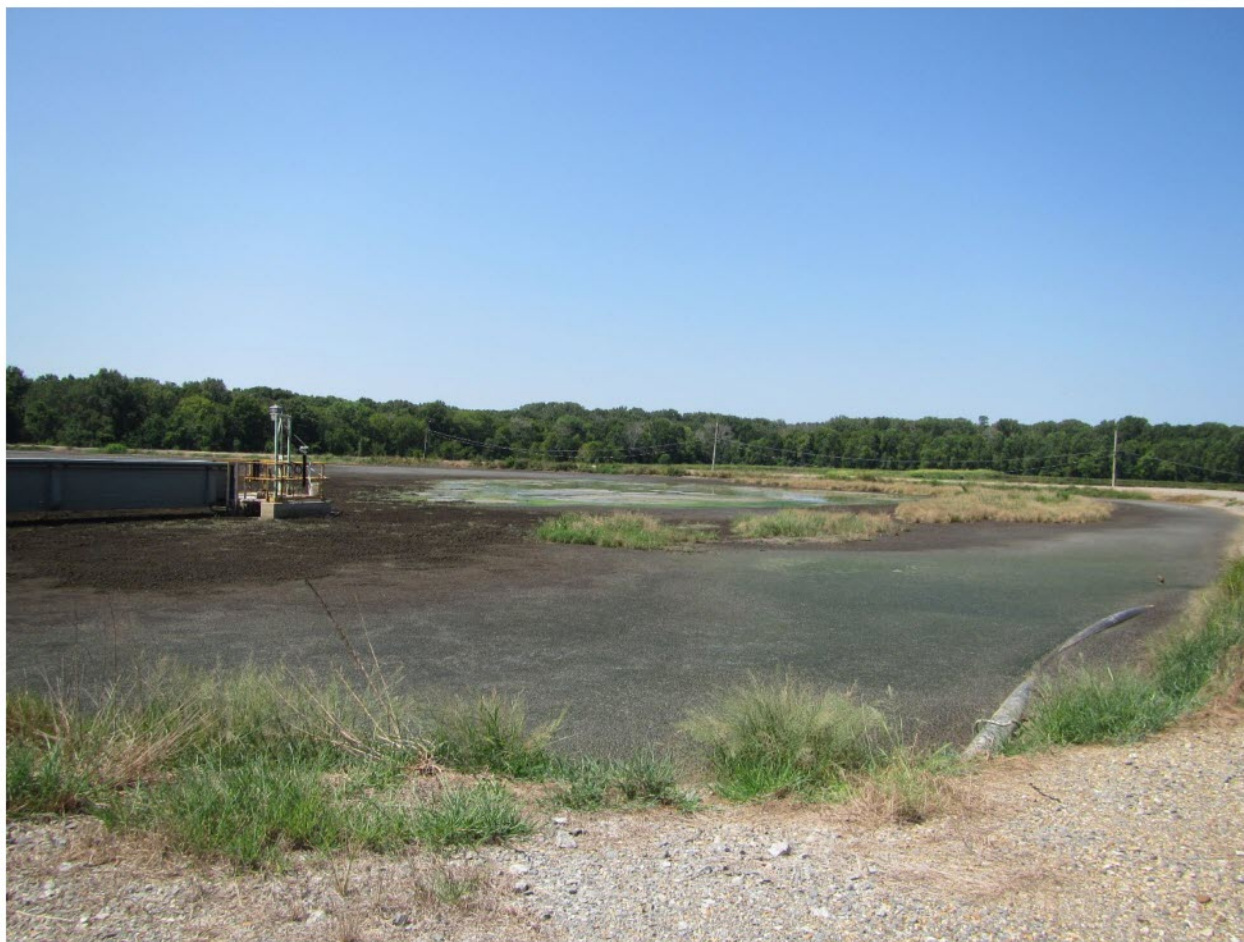
I observed that the sludge waste basin is full of sediments. This area collects undesirable sediments. Facility needs to maintain and clean the basin to guaranty holding capacity of sediment accumulation from treatment process (See Photo No. 30 in Appendix 1).

Photograph File Name: IMG\_5012.JPG  
Date of Photograph: 08/04/2023  
Latitude and Longitude: -92.116740°, 32.661012°  
Orientation: SW  
Map Datum: WGS-84  
Time of Photo: 10:34 AM  
Photographer: Jack Arias  
Description: This image shows the sludge waste basin full of sediments.

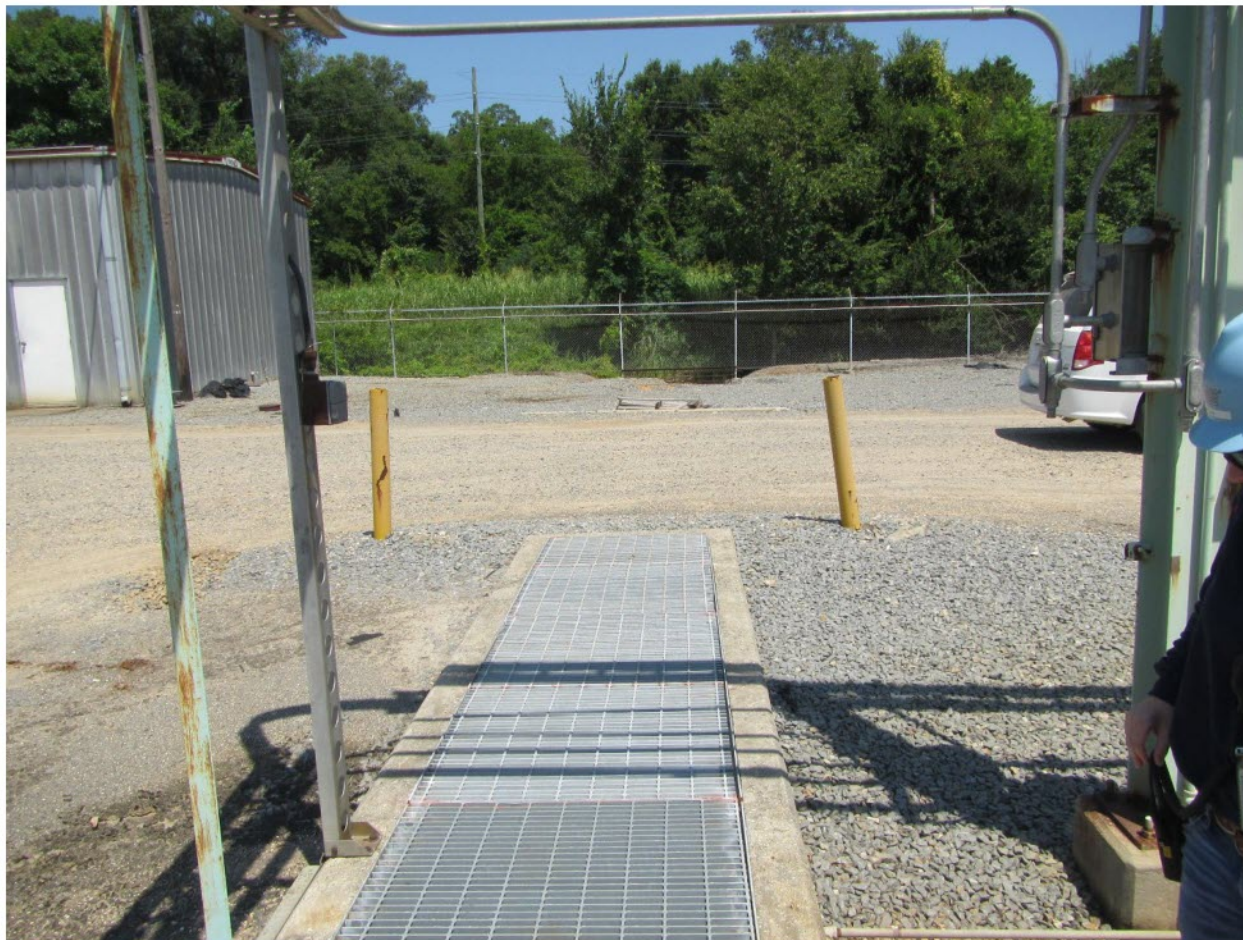
Photograph File Name: IMG\_5040.JPG  
Date of Photograph: 08/04/2023  
Latitude and Longitud: 32.704365, -93.95982  
Orientation: SW  
Map Datum: WGS-84  
Time of Photo: 11:07 AM  
Photographer: Jack Arias  
Description: This image shows discharge area for outfall 002.
