Re: NPDES Permit No. MS0057711, Reconnaissance Inspection Report

CV-MS0057711-8-3-2021

**Reconnaissance Inspection Report****SECTION A: National Data System Coding**

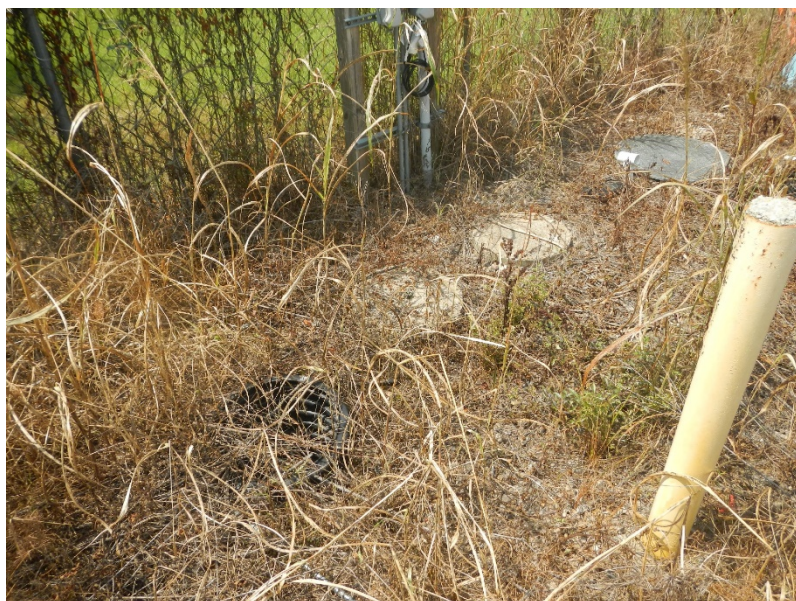
McInnis Electric Company has a small septic tank to receive wastewater from the company's three bathrooms. The septic tank, a concrete box located on the premise (Photo 1), discharges directly into a nearby ditch and does not make use of a leach field. The facility does not have land accessible nearby to site a leach field.

Photo 1: Top of concrete septic tank which receives facility wastewater.
