**Region 6 - Enforcement & Compliance Assurance Division**  
**INSPECTION REPORT**

| Inspection Date(s): | 06/15/2023 | |
| Facility Name: | <b>Cochiti Pueblo Sewage Lagoon</b> | |
| NPDES Permit Number: | NM0029831 (terminated 12/20/2002) | |

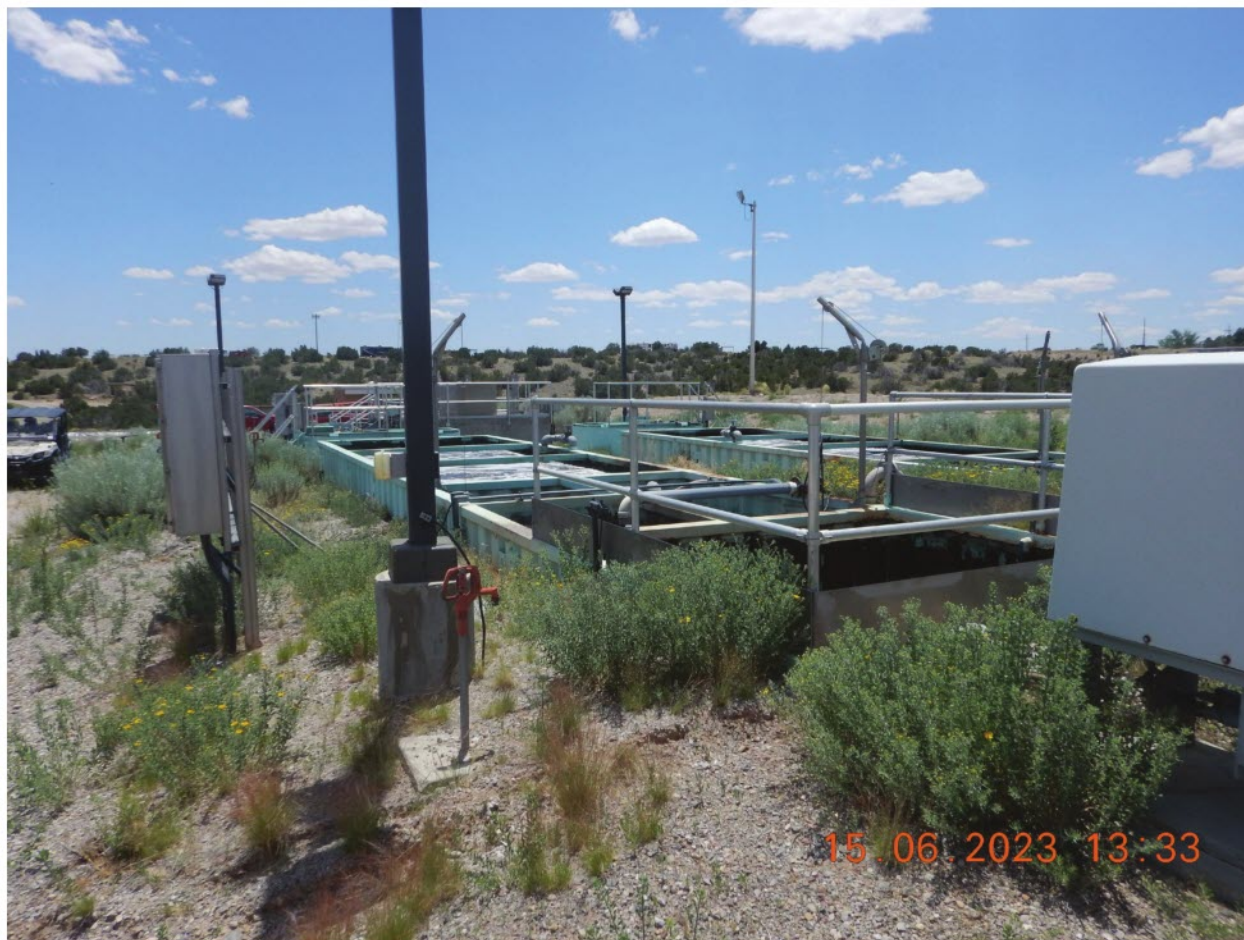
Photo No. 1

- Extensive vegetative overgrowth throughout the facility area was visible, which could potentially attract rodents and/or vermin; thus, causing undermining of the facility structures.

View looking approximately southwest towards the aeration basin treatment process equipment. The treatment structure in the foreground was offline. Note: The extensive vegetative overgrowth visible throughout the facility, which could potentially attract rodents and/or vermin; thus, causing undermining of the facility structures. (DSCN 2598). Photographed by D. Esparza.

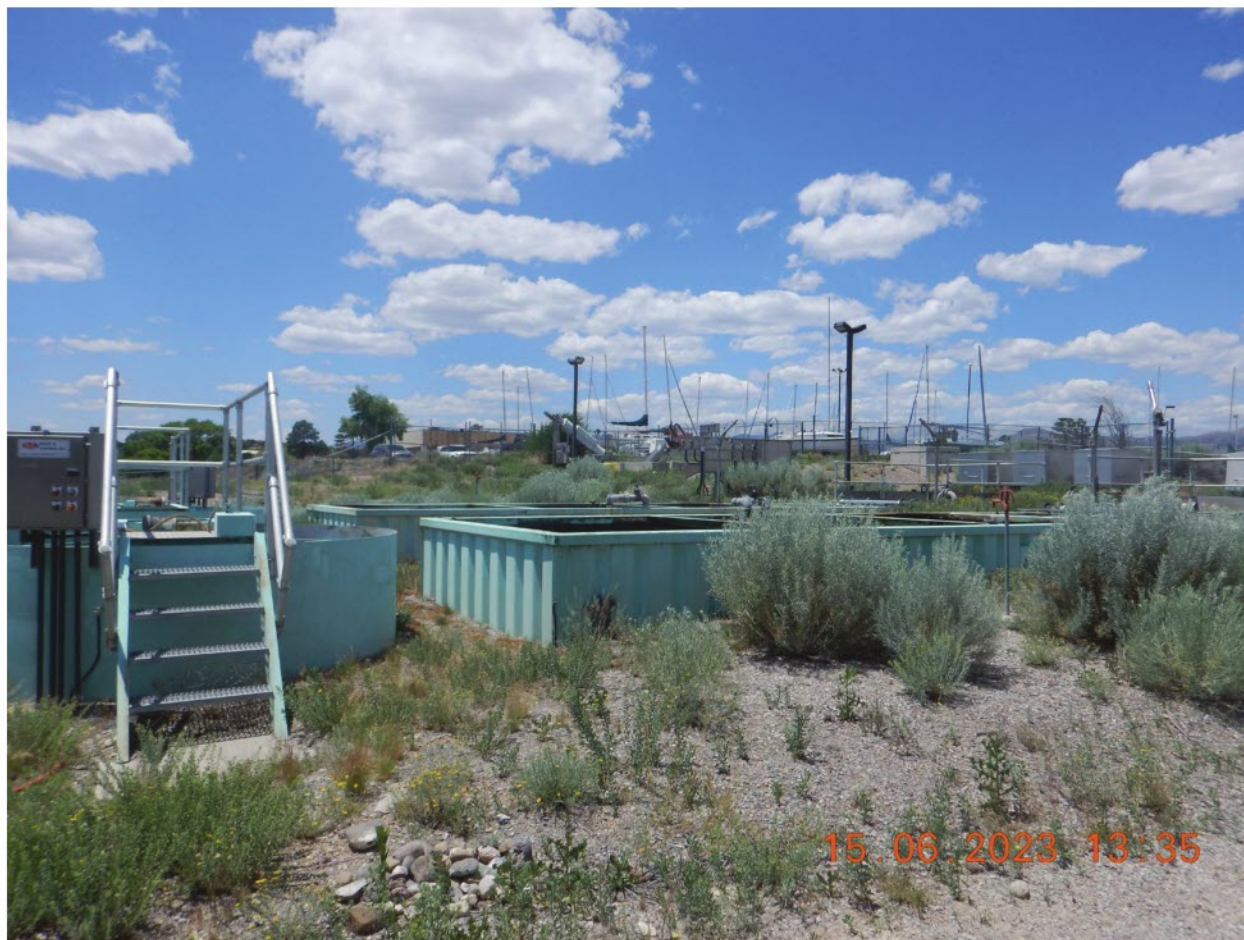
Photo No. 2

- The headworks/bar screen equipment appeared to be disconnected and non-operational. Given the fact the headworks/bar screen appear to be non-operational all inorganic material and coarse solids enter the treatment process.

View looking approximately northwest from the aeration basins on the left and an offline clarifier on the right. In the approximate upper center of the photograph is the offline headworks/bar screen. (DSCN 2600). Photographed by D. Esparza.

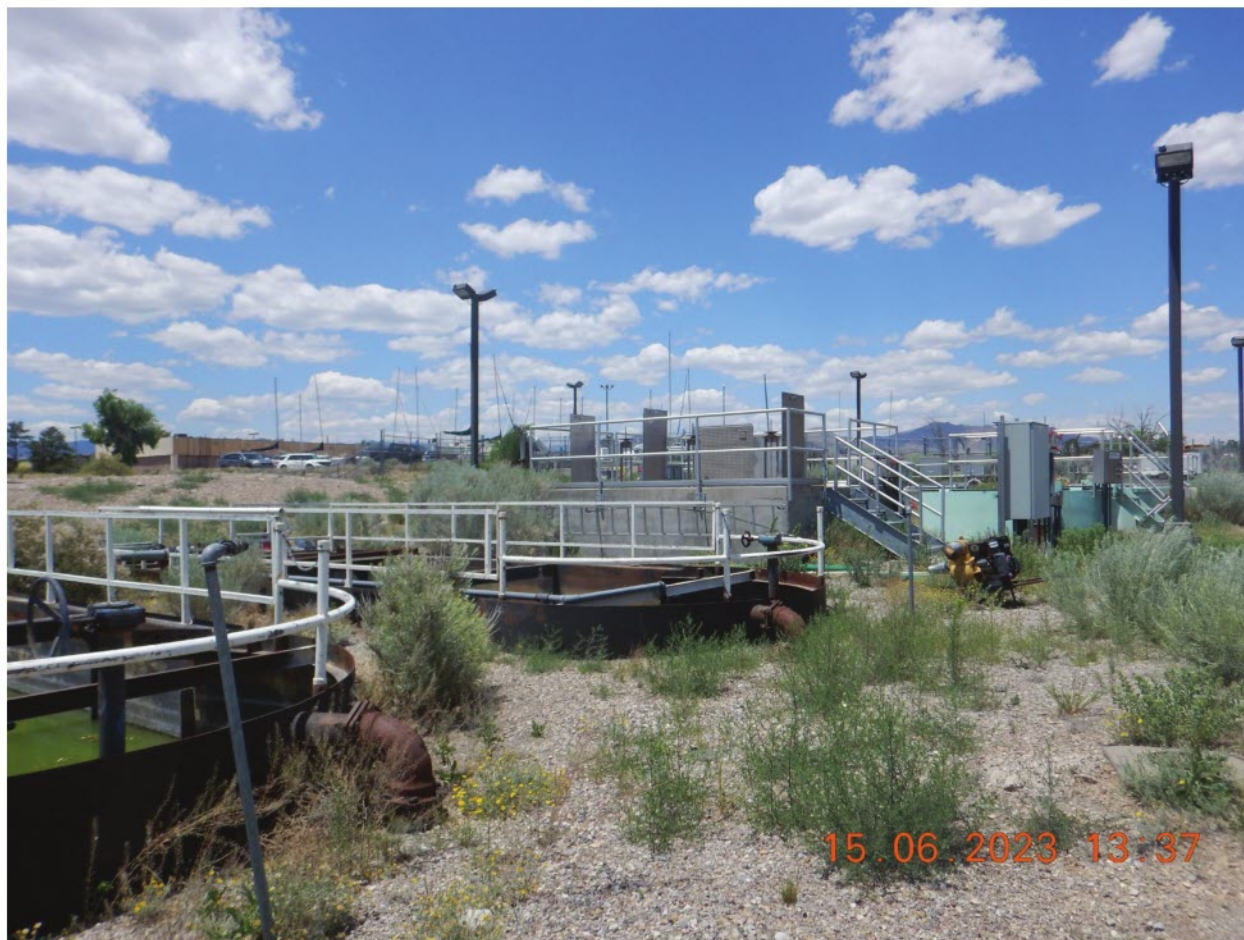
Photo No. 3

- The treatment cells exhibited limited remaining freeboard, and corrosion.
- Multiple pieces of treatment process equipment was disconnected and non-operational.

Another view looking approximately northwest of the facility. Note: the yellow sump pump at the center right of the photograph. Additionally, note the visible rust on the two (2) clarifiers. The center clarifier was almost empty and the clarifier of the left exhibited standing or stagnate aromatic water, inclusive visible algae growth. (DSCN 2601). Photographed by D. Esparza.

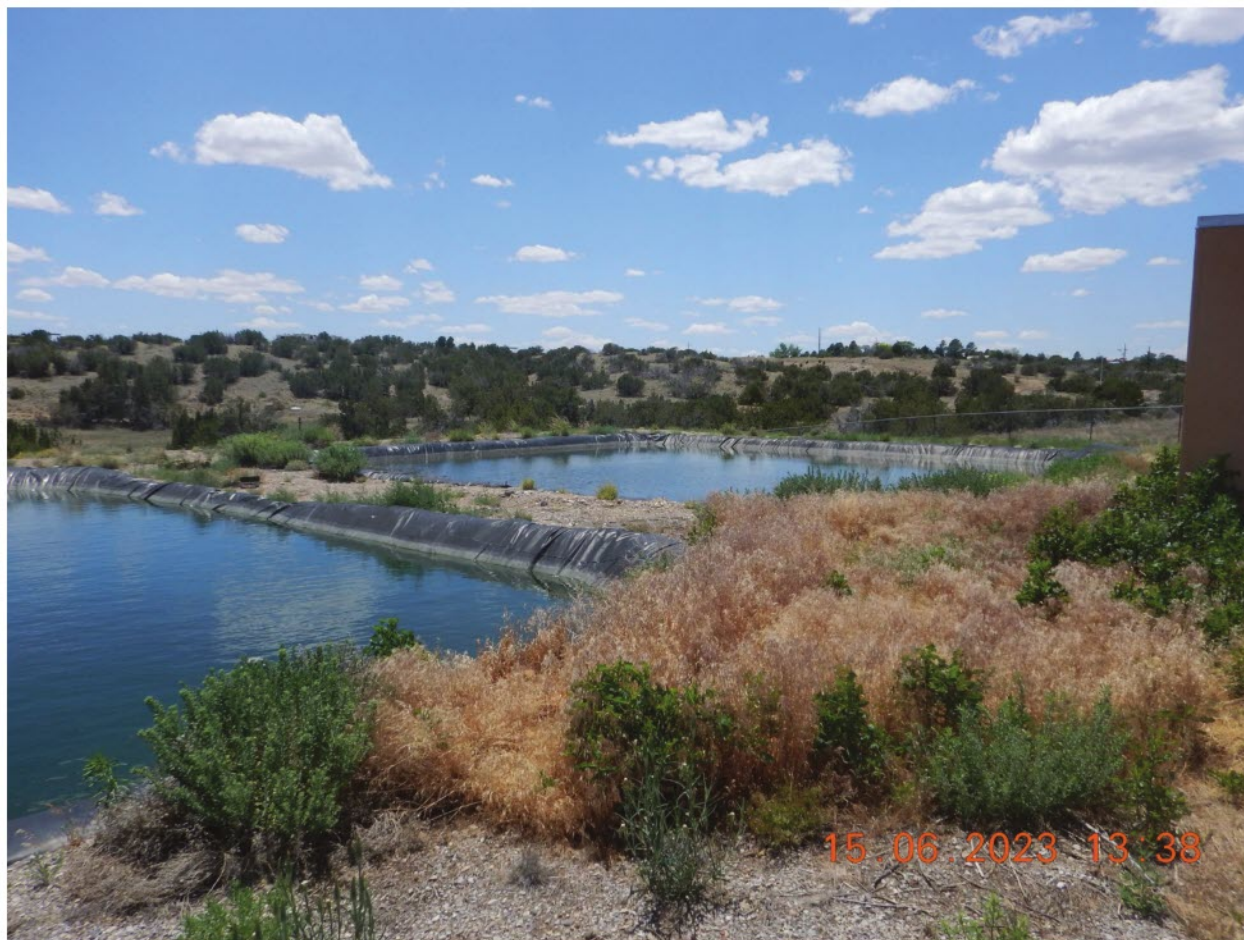
Photo No. 4

- Visual observation indicated two (2) lined lagoon cells which equate to approximately 0.06-acres (westside lagoon) and 0.10-acres (eastside lagoon), respectively in surface area. It should be noted remnants of an abandoned third lagoon located along the eastern perimeter were visible, though it was unlined.

View of both sewage evaporative lagoons. Located along the approximate southside of the facility. Note: The extensive vegetative overgrowth visible along the perimeter of the lagoons, which could potentially attract rodents and/or vermin; thus, causing undermining of the facility structures. (DSCN 2602). Photographed by D. Esparza.

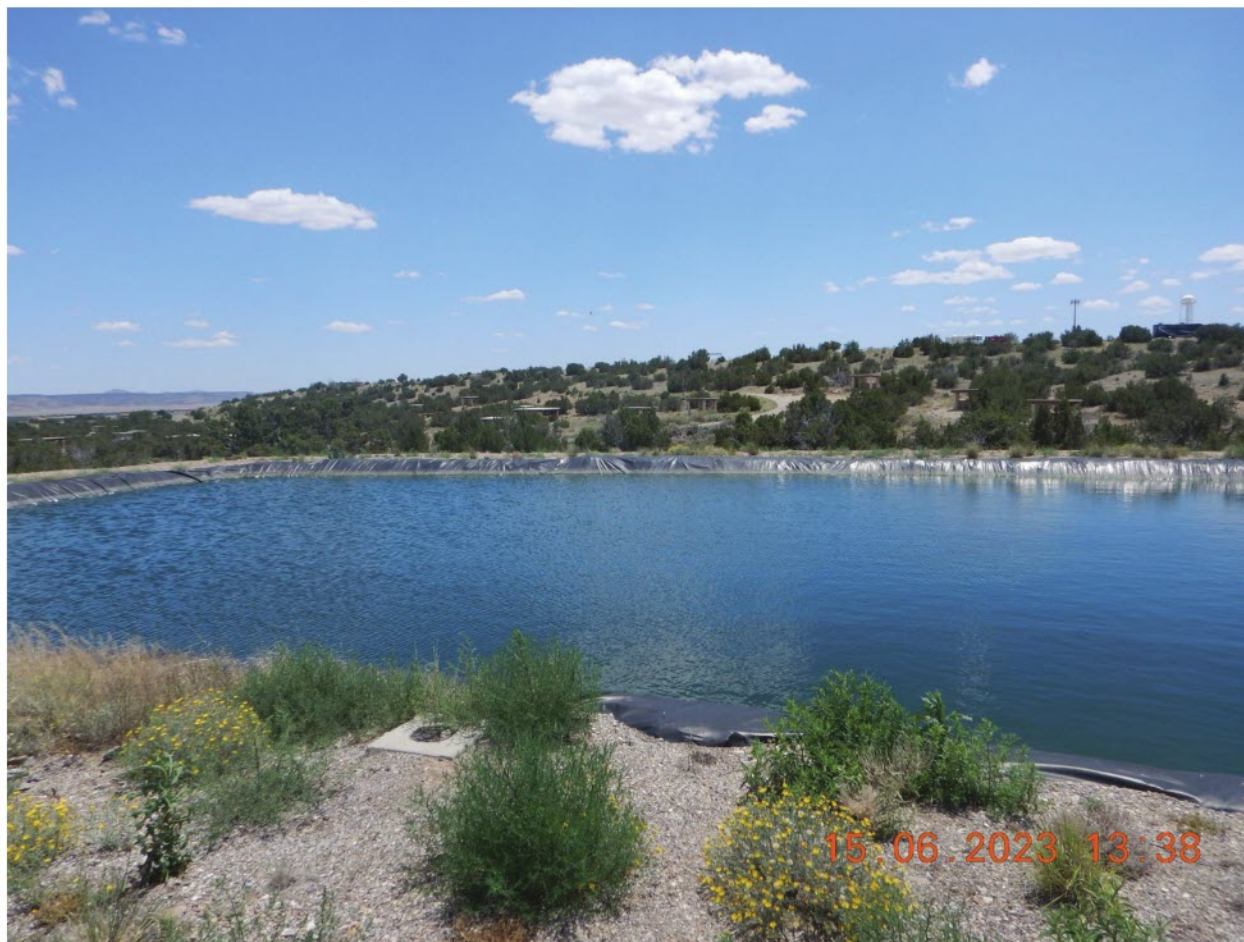
Photo No. 5

View of eastside lagoon. Note: there were visible signs of liner degradation along the containment banks in various areas. (DSCN 2603). Photographed by D. Esparza.

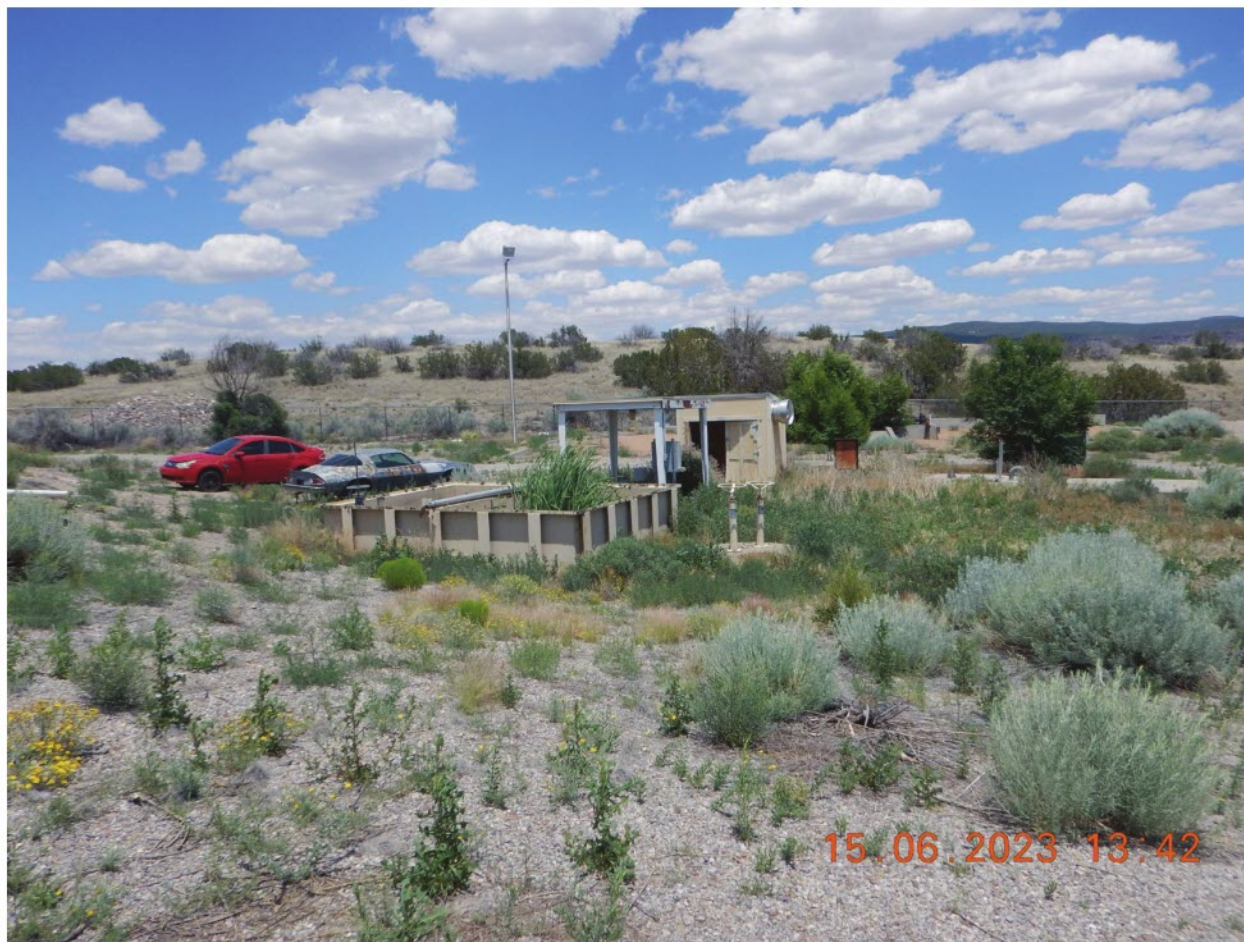
Photo No. 6

View of additional decommissioned process treatment equipment situated along the eastside of the facility. (DSCN 2604). Photographed by D. Esparza.
