DOCUMENT DESCRIPTION: Reports and Letters RE Air Quality Reports -  
Bendix Windsor Plant - Ontario Ministry of Labor

## AIR QUALITY ASSESSMENT REPORT

Date: May 31, 1979

Plant: Bendix Automotive of Canada Ltd.

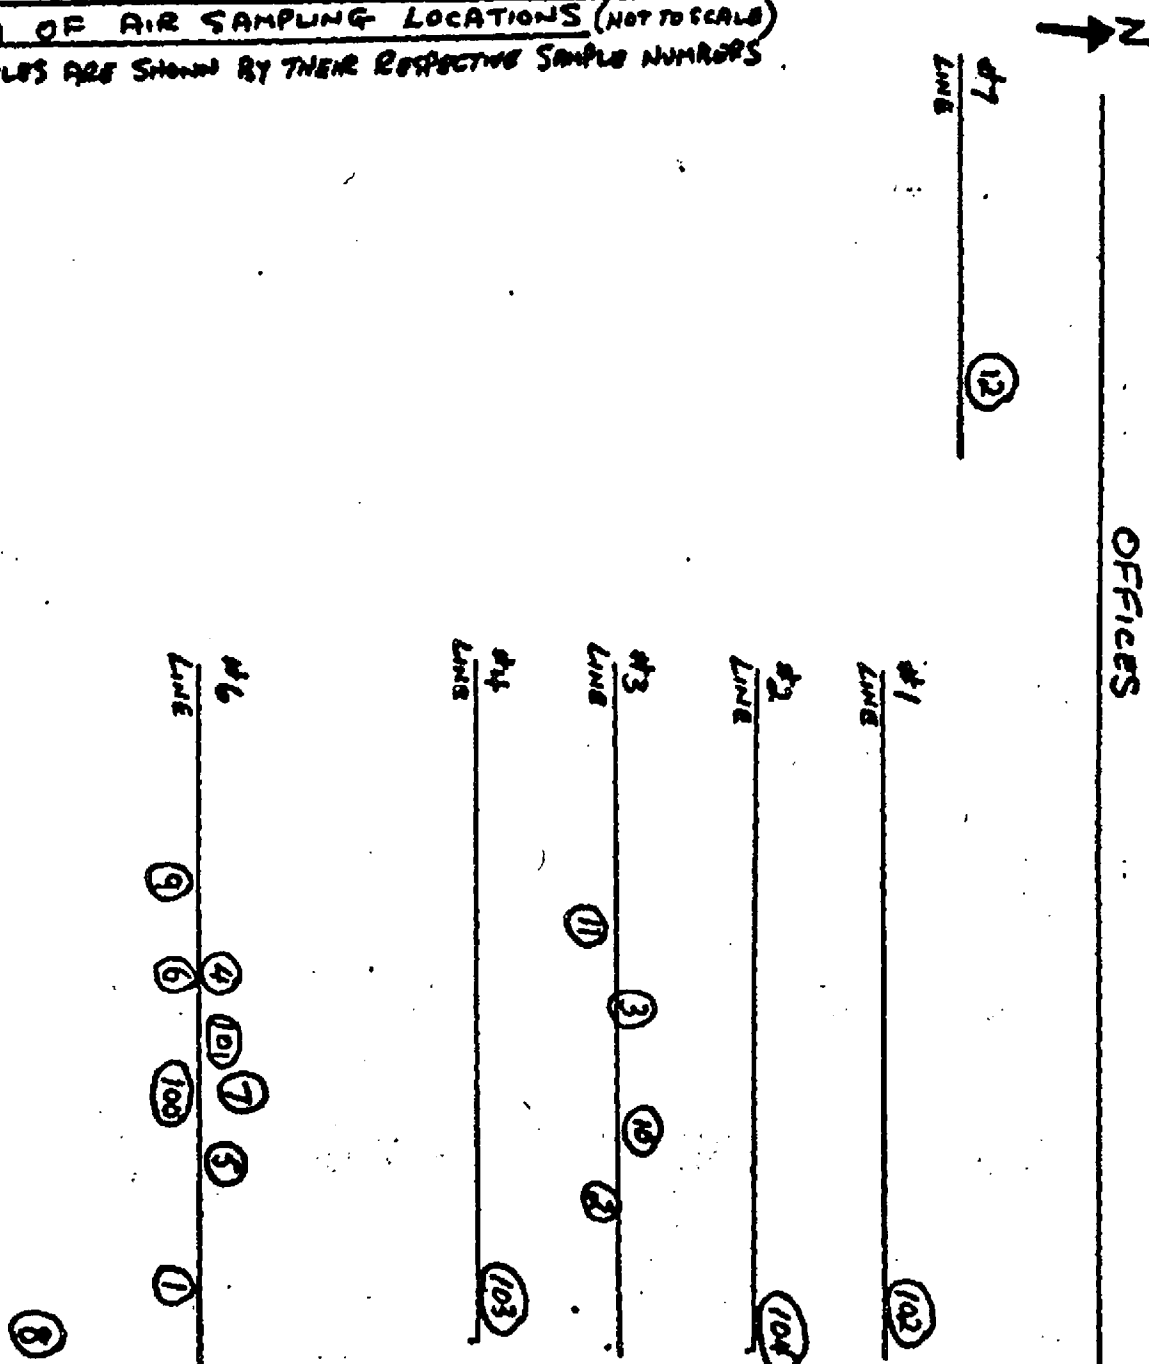
DIAGRAM OF AIR SAMPLING LOCATIONS (NOT TO SCALE)

AIR SAMPLES ARE SHOWN BY THEIR RESPECTIVE SAMPLE NUMBERS.
