INSPECTION REPORT

Inspection Date:	March 1, 2022	Inspection Announced: Yes
Time:	Entry: 8:20 AM	Exit: 4:45 PM
Media:	Wastewater and Stormwater	
Statute (s)/Program(s):	Clean Water Act, NPDES, Industrial Stormwater, Direct Discharger Clean Water Act, NPDES, Pretreatment, Indirect Discharger	
Type of inspection:	CEI - Compliance Evaluation Inspection	
Access:	Granted	
<hr/>		
Permittee Name:	Libbey Glass – Toledo Plant 27	
Facility or Site Name:	Libbey Glass – Toledo Plant 27	
Facility/Site Physical Address:	940 Ash Street	
(City, State, Zip Code)	Toledo, Ohio 43611	
County/Parish:	Lucas County	
<hr/>		
Permit and Application Number:	OH0003115; 2IN00075*GD	
SIC or NAICS:	3229

**Libbey Glass
EPA Inspection March 1, 2022
All photos taken by Ted Flatebo, Environmental Engineer, U.S. EPA
Camera: Richo WG-4**

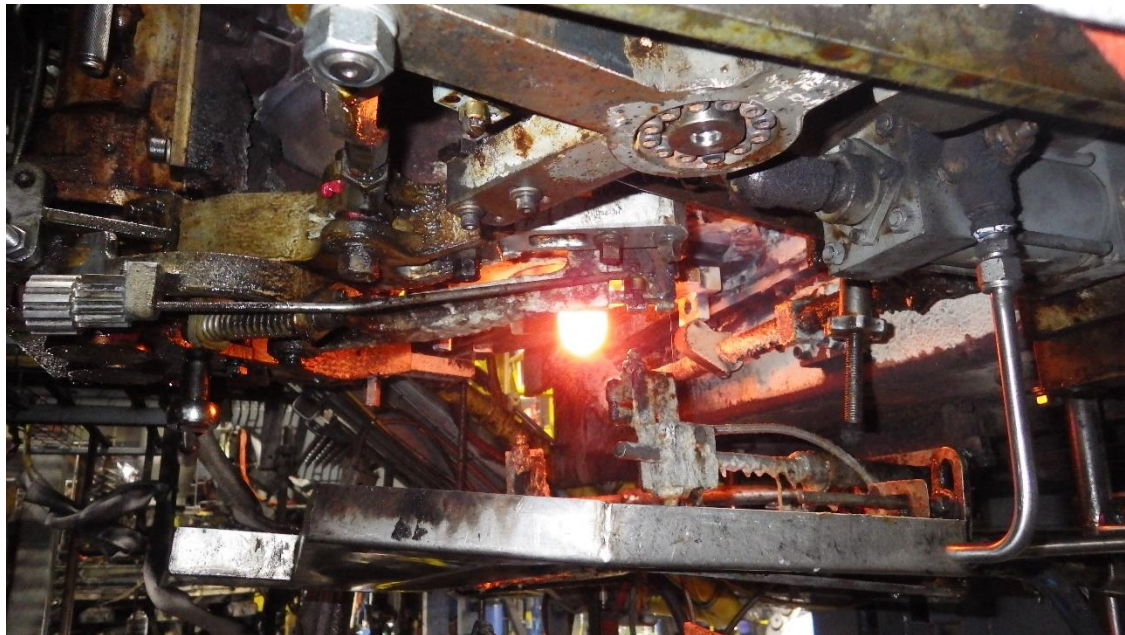
1: RIMG0003

Description: Sheers cutting molten glass while being sprayed with water, oil, and chlorine mixture.

Location: Hot production area – Machine G-6.

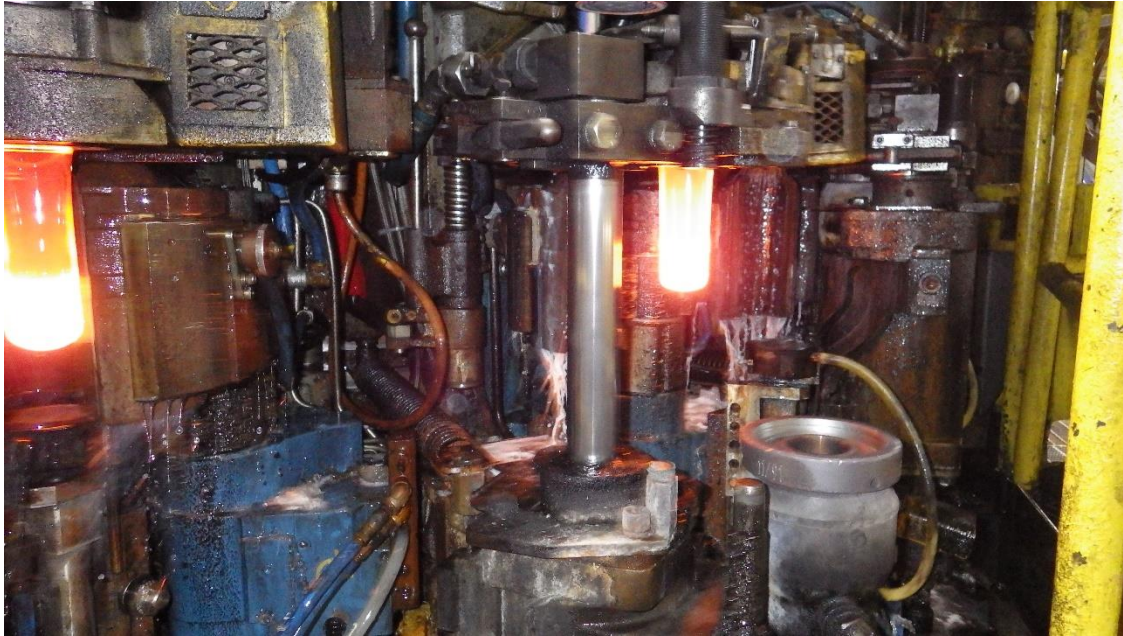
2: RIMG0004

Description: Combination of water and mold cooling additive sprayed on molds as they form molten glass.

Location: Hot production area – Machine G-6.

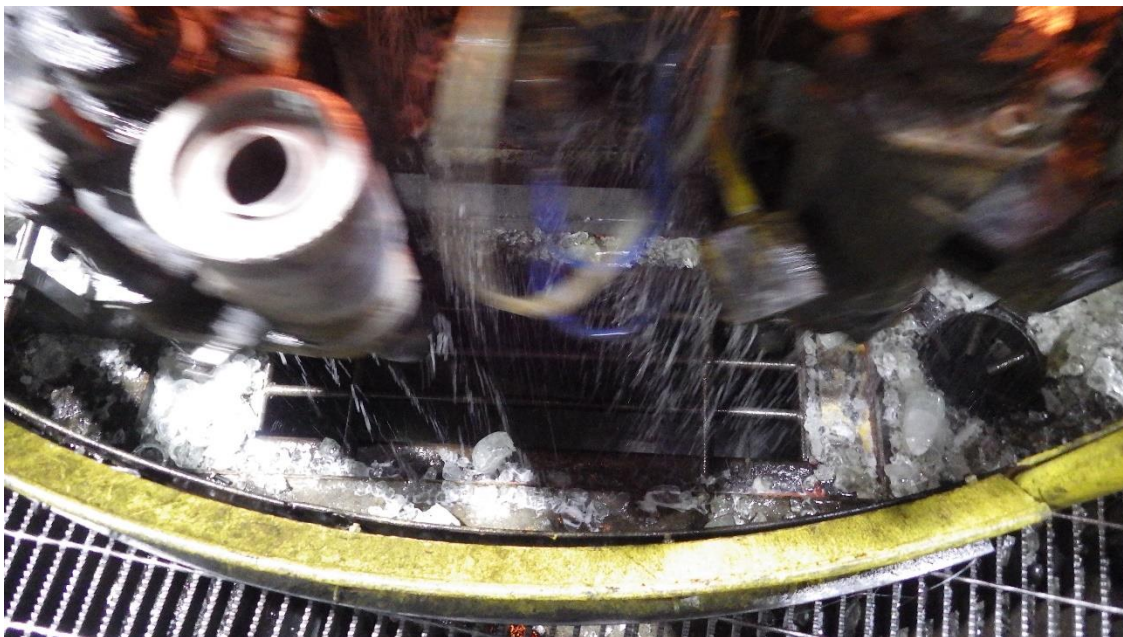
3: RIMG0005

Description: Water falling from forming machine through grate into basement area.

Location: Hot production area – Machine G-6.

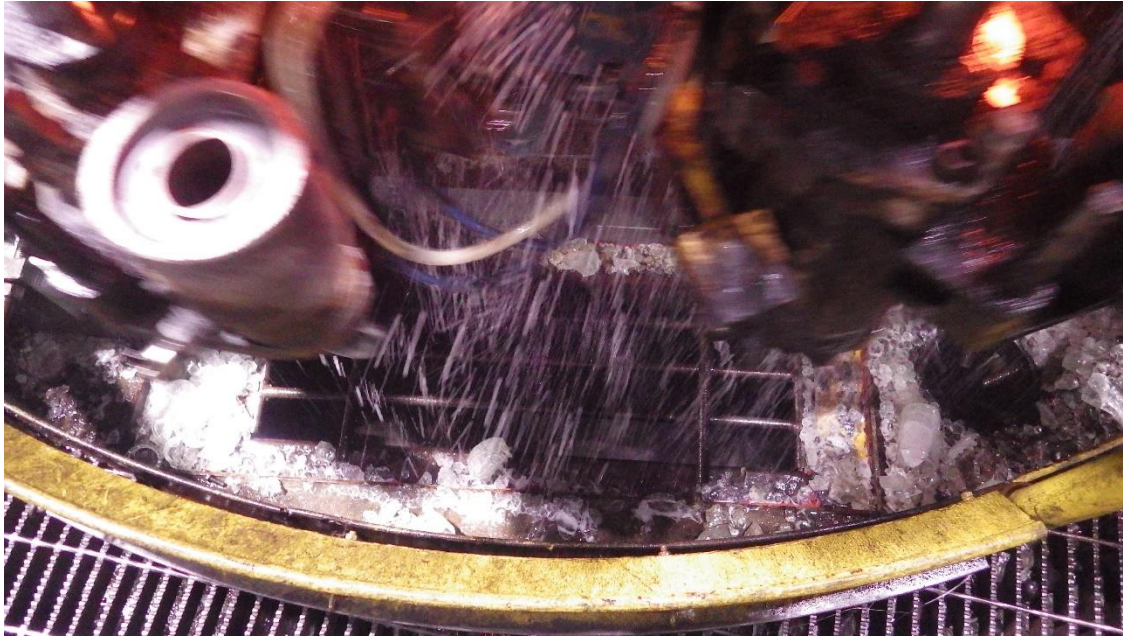
4: RIMG0006

Description: Duplicate photo of water falling from forming machine through grate into basement area.

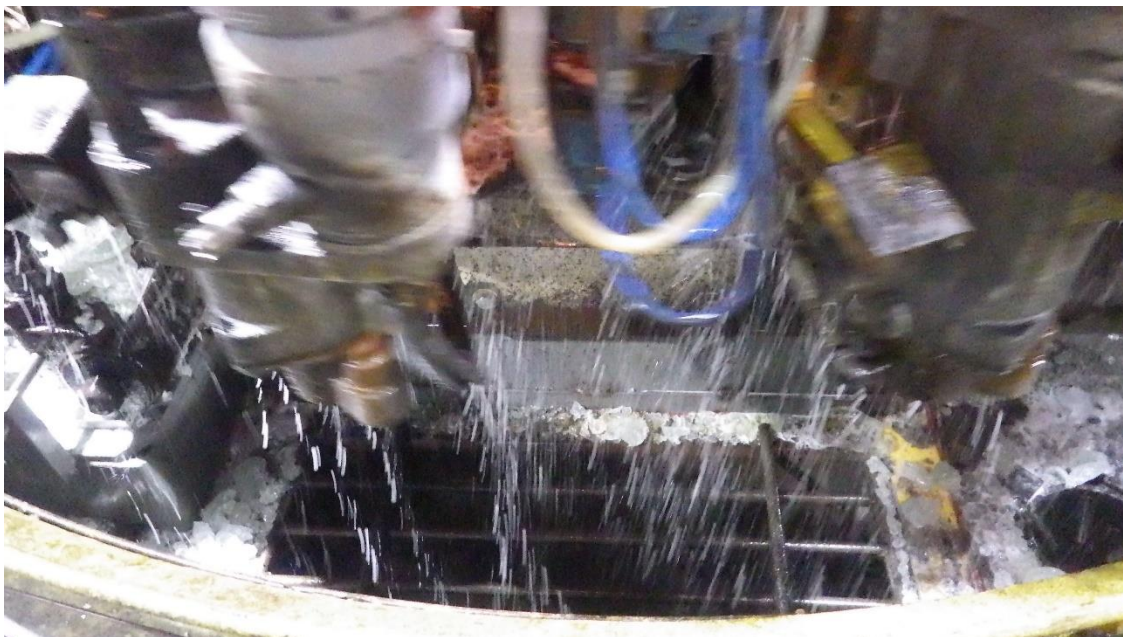
5: RIMG0007

Description: Duplicate photo of water falling from forming machine through grate into basement area.

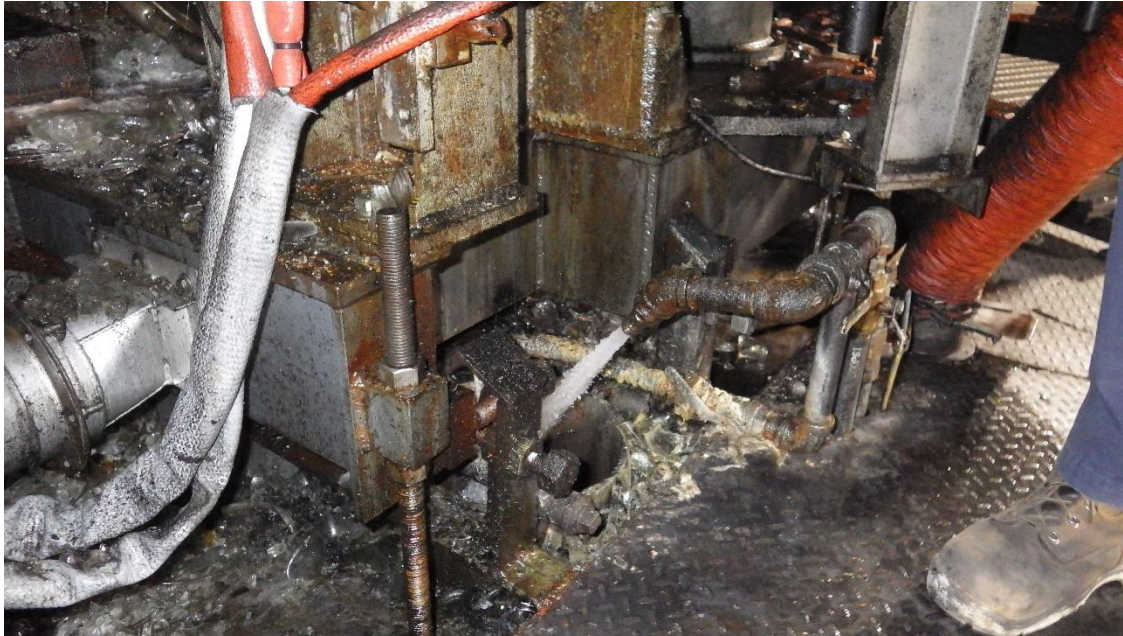
6: RIMG0008

Description: Recycled water used to flush machine to prevent clogging.

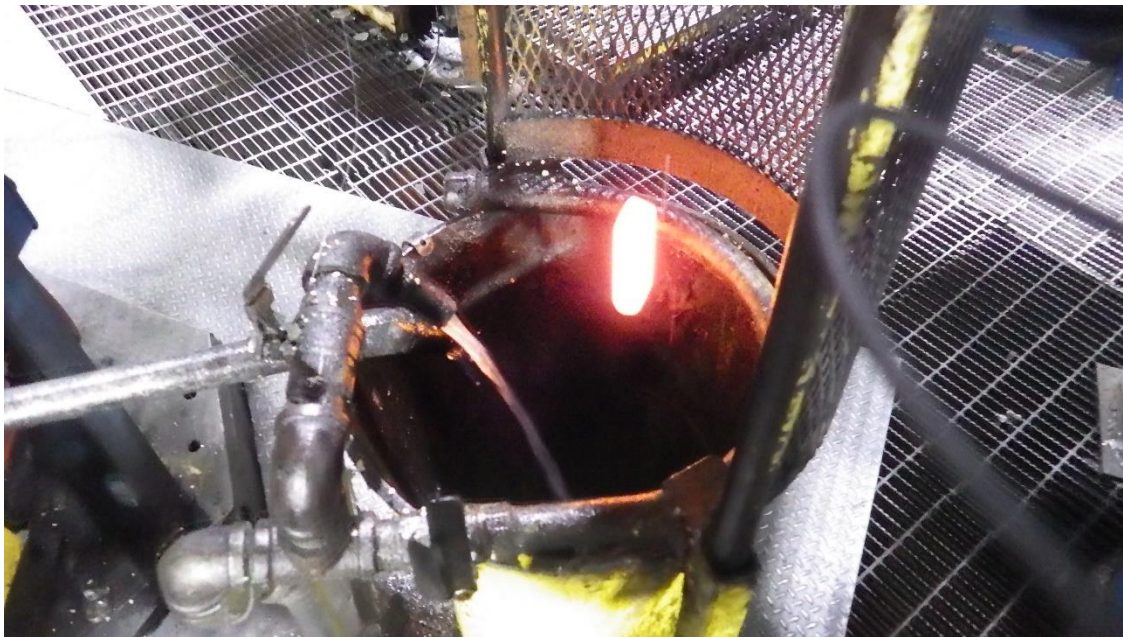
7: RIMG0009

Description: Machine offline but molten glass is still produced and sent to the basement with a flush of recycled water.

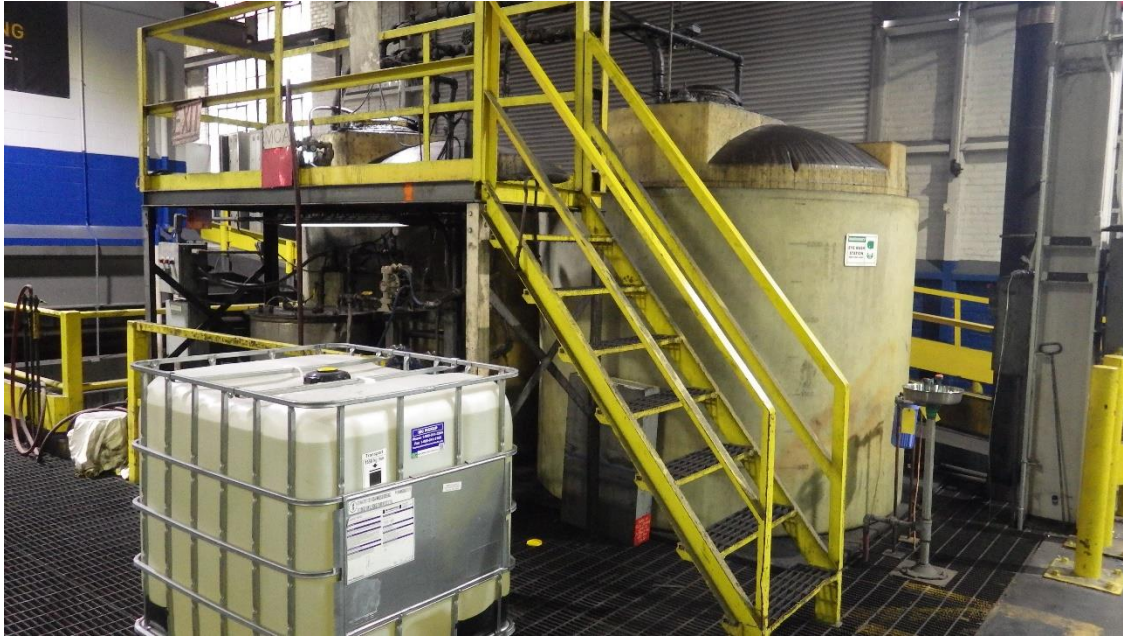
8: RIMG0010

Description: Two, 2,000-gallon tanks in background used to store mold cooling additive. Tote in foreground storing additional chemicals used in production.

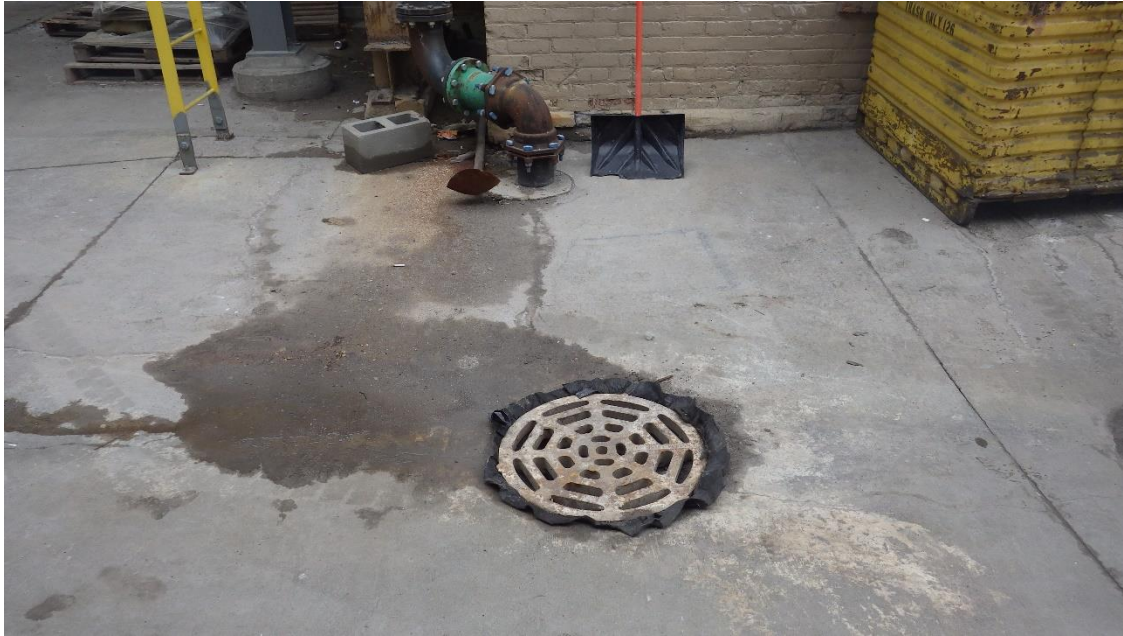
14: RIMG0016

Description: Example of a storm drain lined with a filter fabric. Note water flowing towards the storm drain is snow/ice melt water.

Location: Storm drain surface inlet to Outfall 014 located northwest of facility rail spur

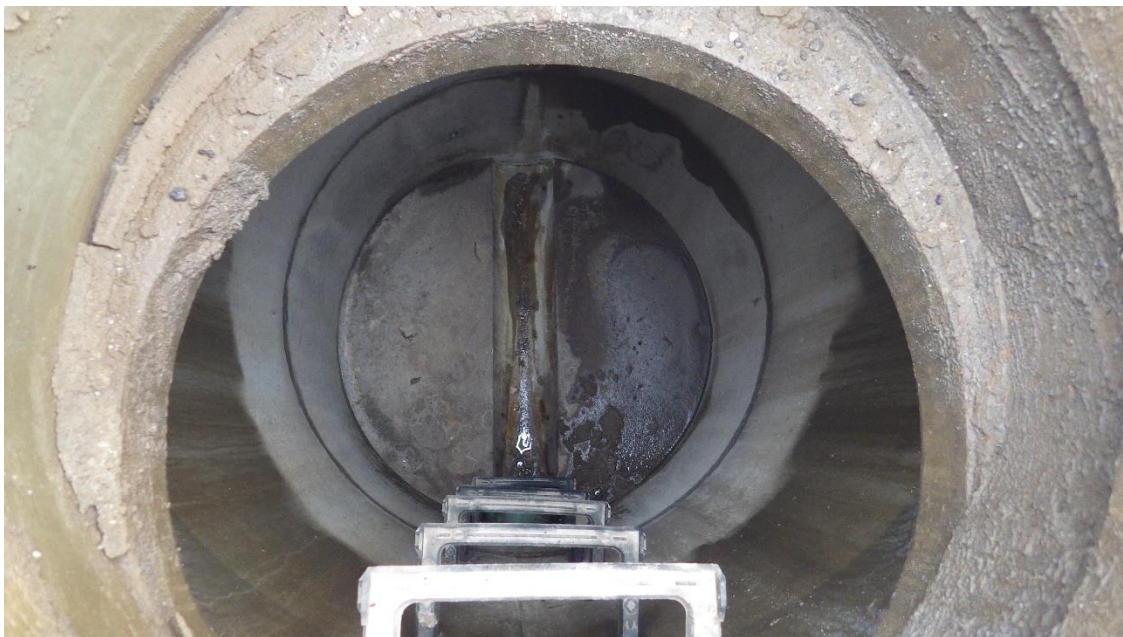
15: RIMG0017

Description: Outfall 014 sample location. No flow observed.

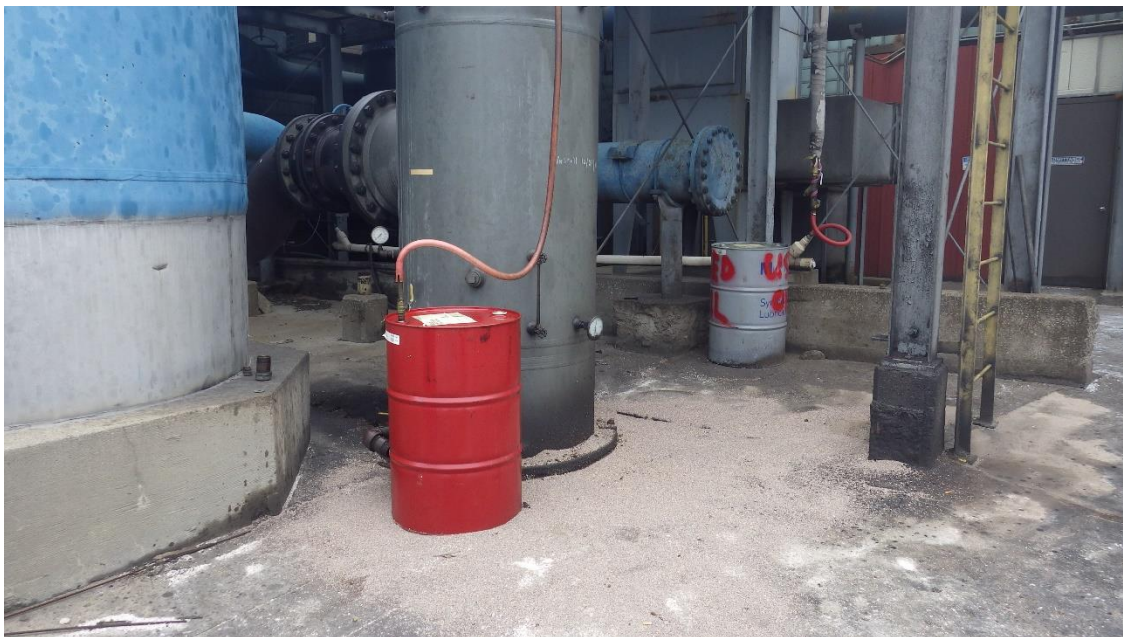
19: RIMG0021

Description: 55-gallon drum storing residual oil from the vaccum system. Note lack of secondary containment.

Location: Adjacent to power plant.

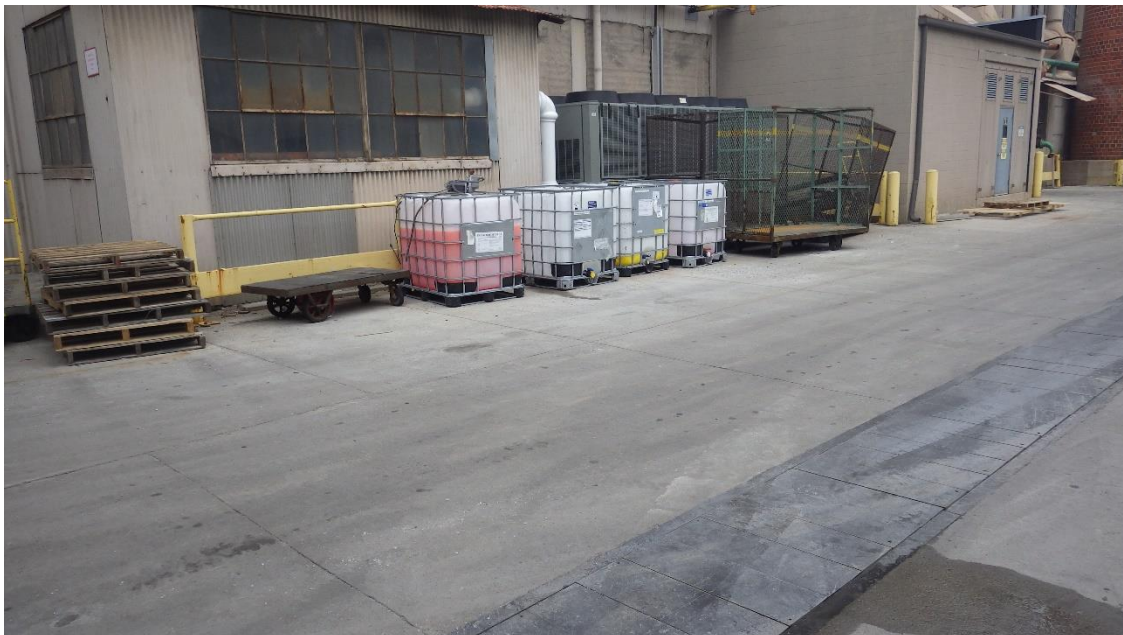
21: RIMG0023

Description: Chemical storage totes in the immediate vicinity of Outfall 012 trench drain. Note lack of secondary containment.

Location: Between the administration building and the forming building.

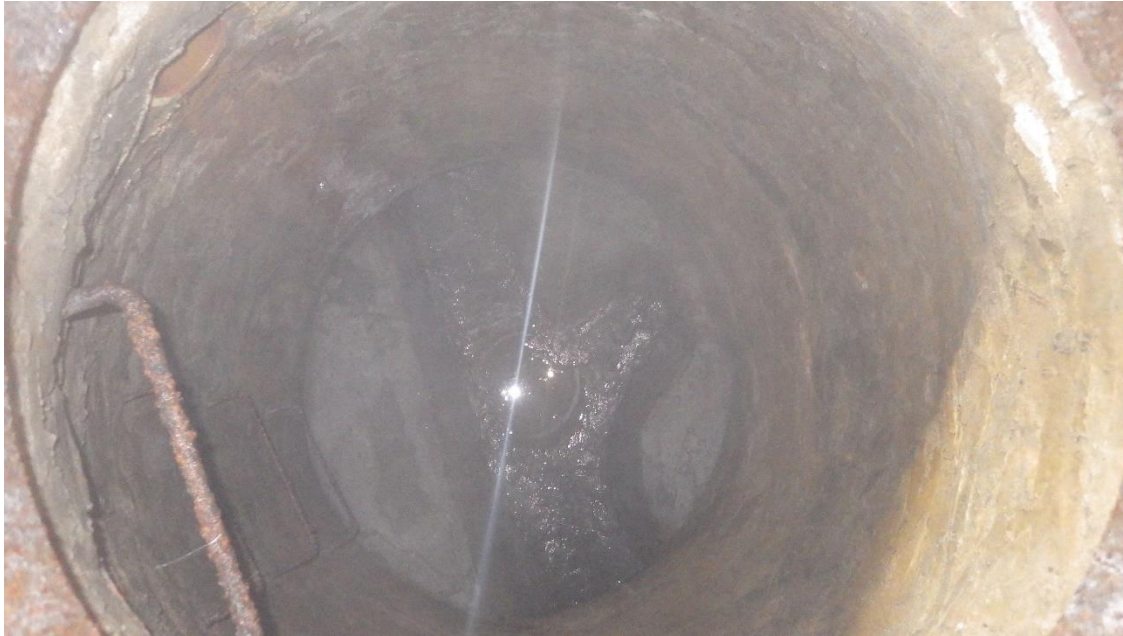
22: RIMG0024

Description: Outfall 012 sample location. There is a small amount of standing water in the trench within the manhole but no flow. This is also known as Manhole 33.

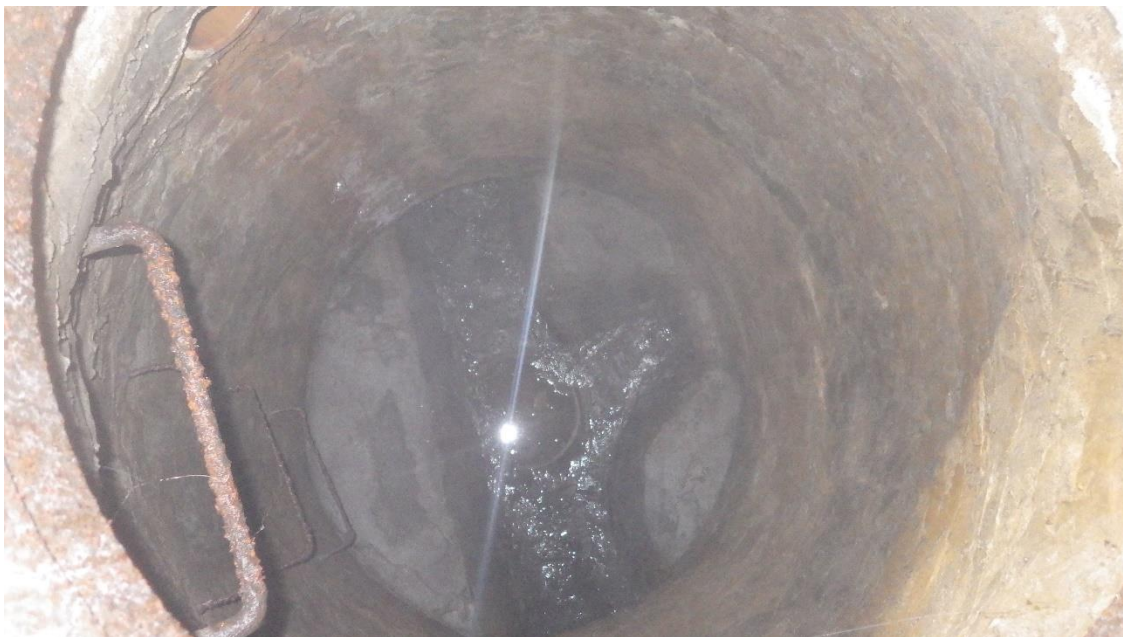
23: RIMG0025

Description: Duplicate photo of Outfall 012 sample location. There is a small amount of standing water in the trench within the manhole but no flow. This is also known as Manhole 33.

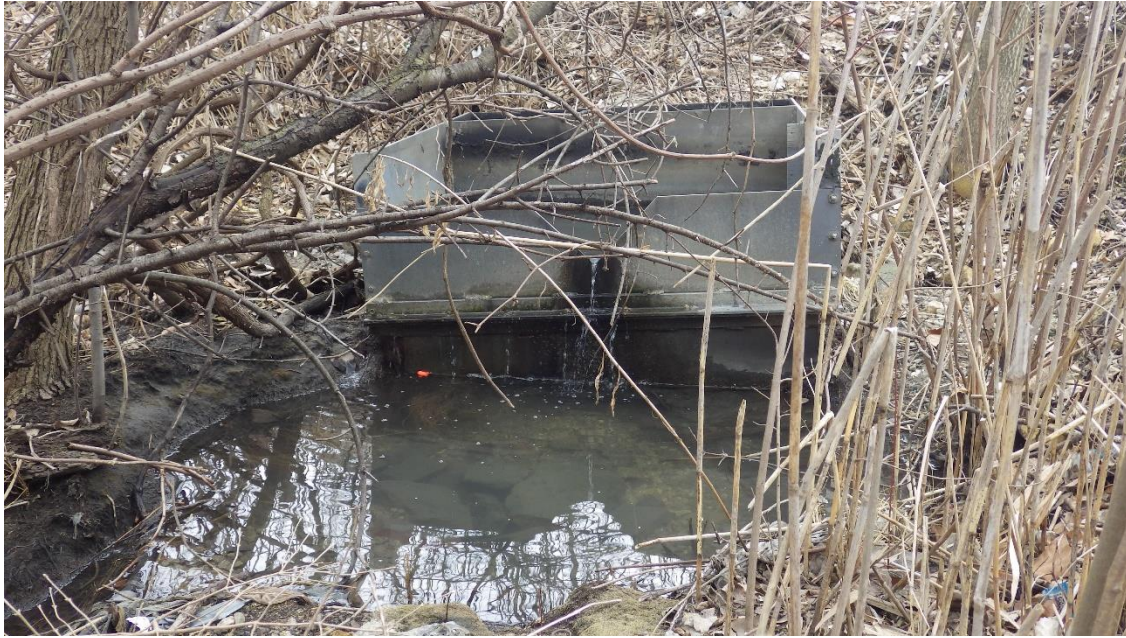
24: RIMG0026

Description: Outfall 003 with flow present. No visible oil, sheen, foam, or odor. Note presence of a weir.

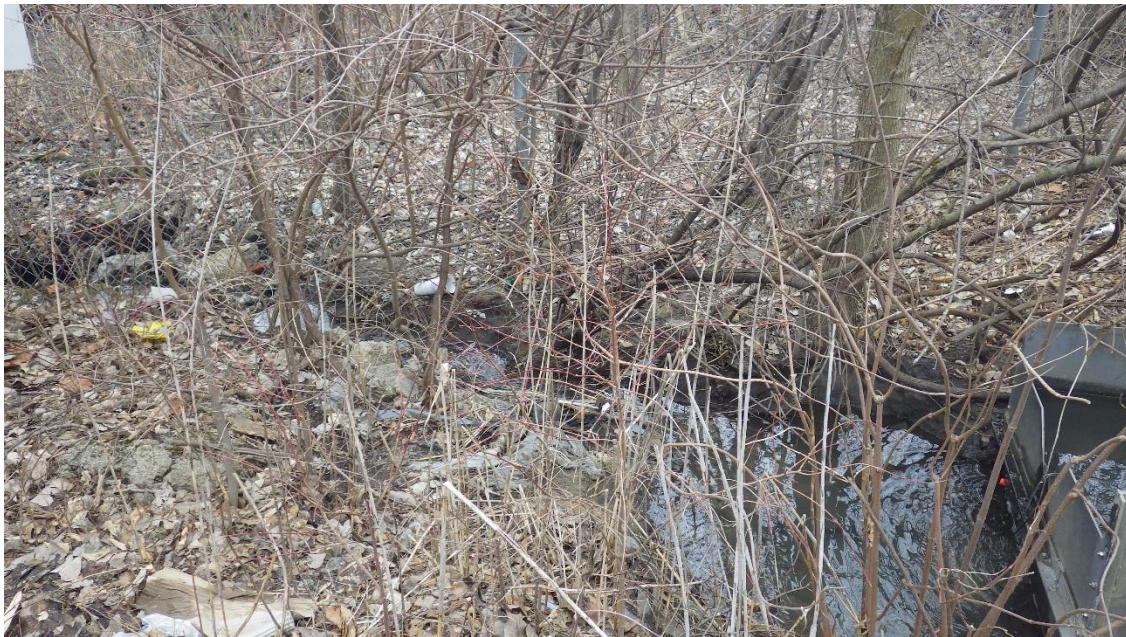
25: RIMG0027

Description: Flow from Outfall 003. Note presence of trash.

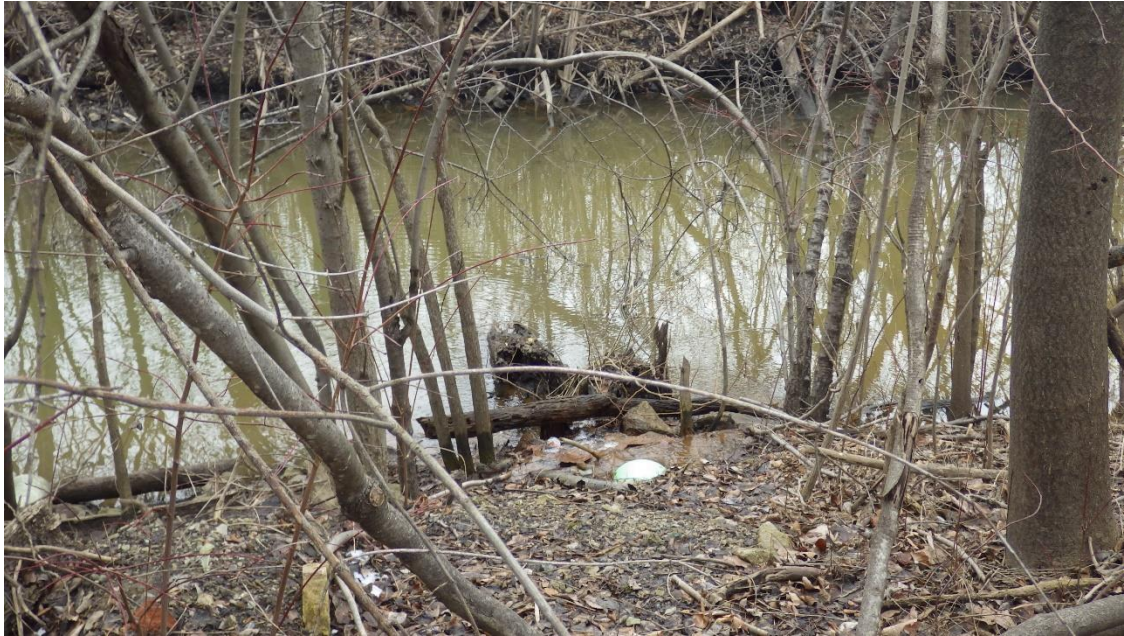
26: RIMG0028

Description: Outfall 011 with flow present. No visible oil, sheen, foam, or odor.

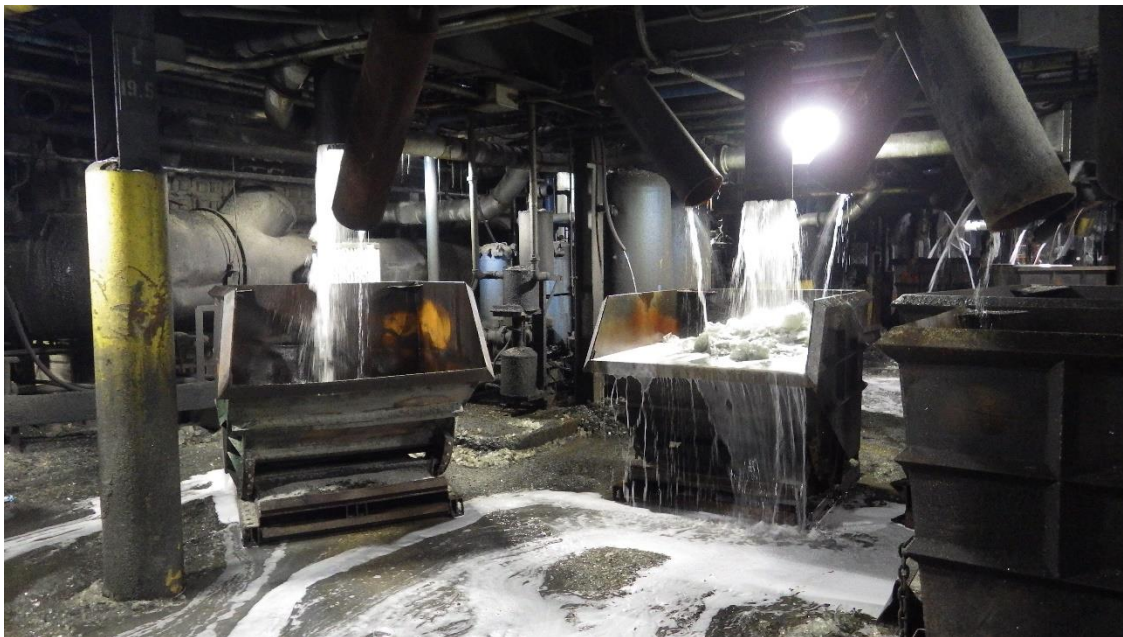
33: RIMG0035

Description: Water draining from glass forming machines down to basement. Glass is caught in bins and water flows on the ground to a trench drain.

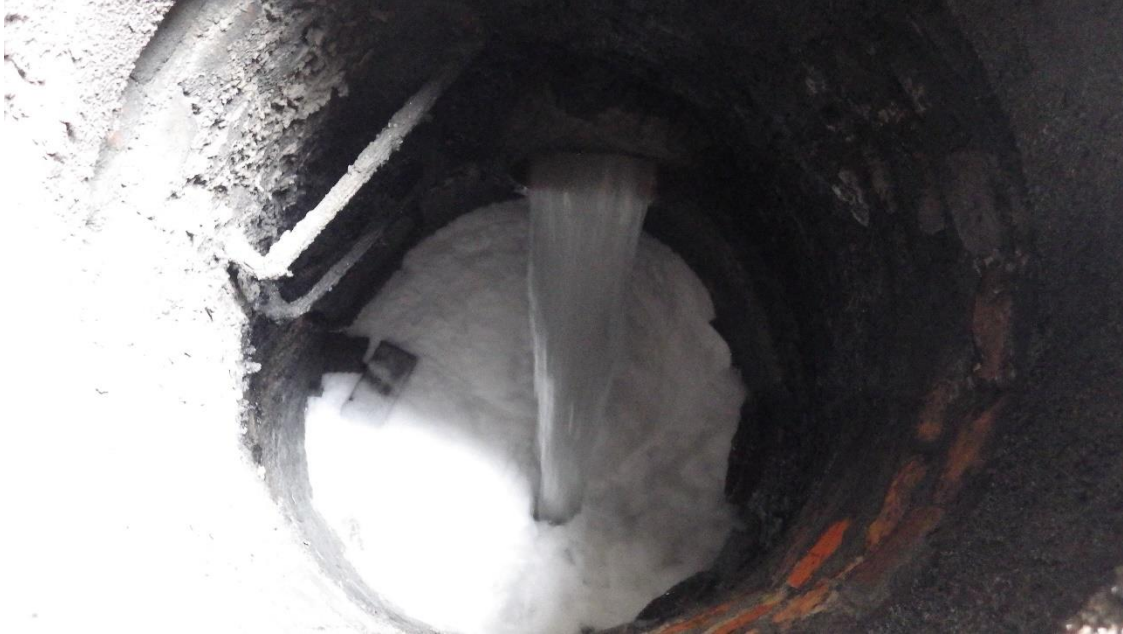
38: RIMG0040

Description: Discharge of recycled water into the City of Toledo sanitary sewer system. Note presence of foam.

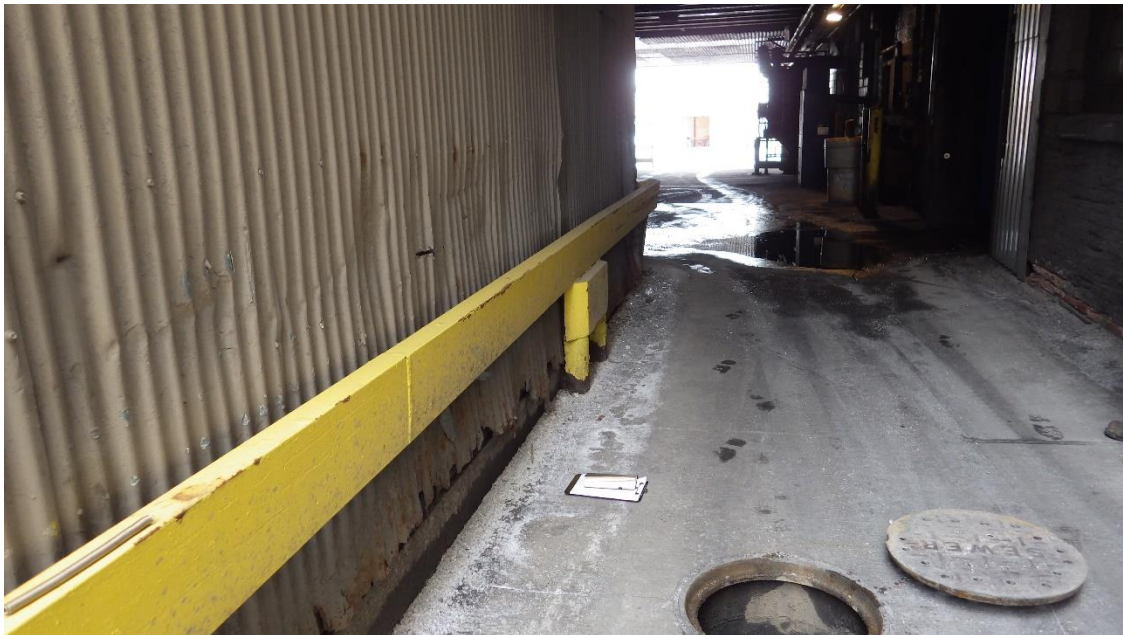
39: RIMG0041

Description: Overview of manhole in Photo 38 where recycled water is discharged into the City of Toledo sanitary sewer system.
