**Region 6 - Enforcement & Compliance Assurance Division**  
**INSPECTION REPORT**

| <b>Inspection Date(s):</b> | 12/10/2024 and 12/11/2024 | |
| <b>System Name:</b> | Tinker Air Force Base | |
| <b>PWS ID:</b> | OK2005508 | |

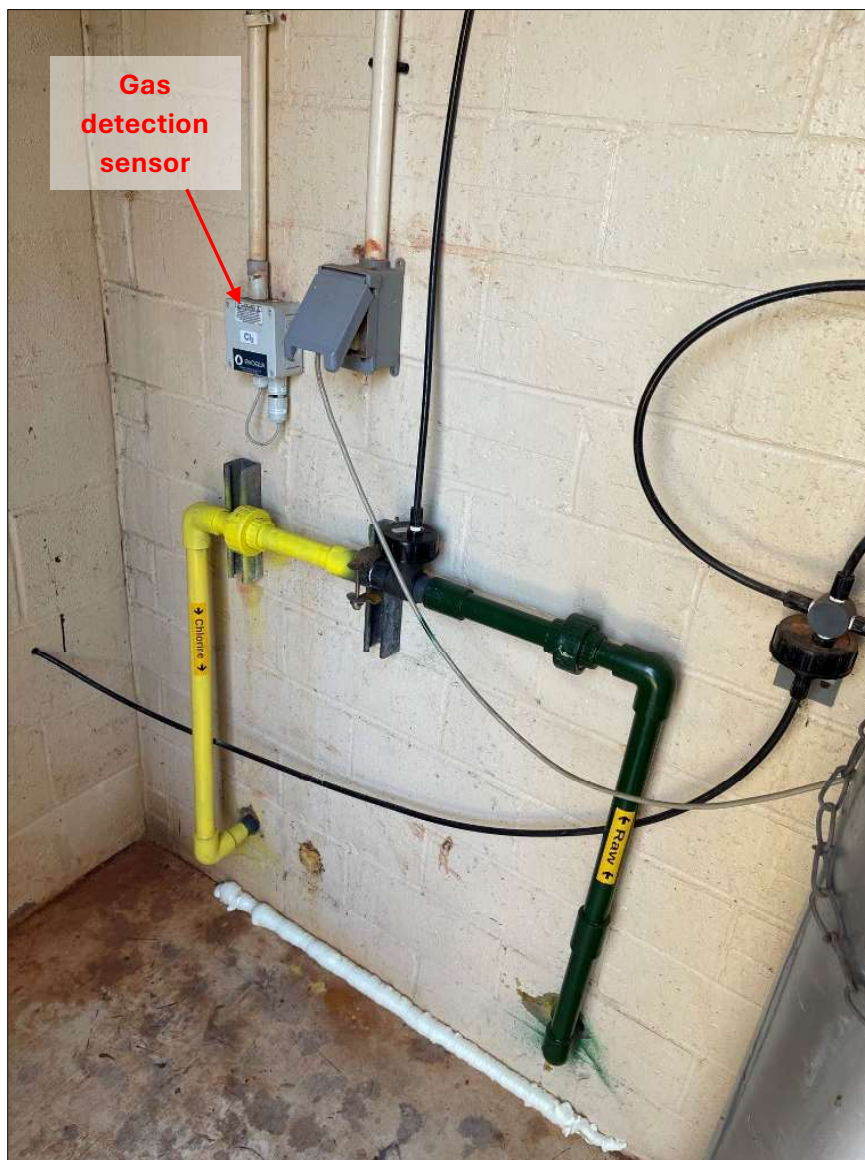
**Photograph 1. Well 25 Building 3802 IMG\_3169.jpeg**

Description: View inside the chlorine feed room. The room's chlorine gas detection sensor was approximately 4 feet above the floor.

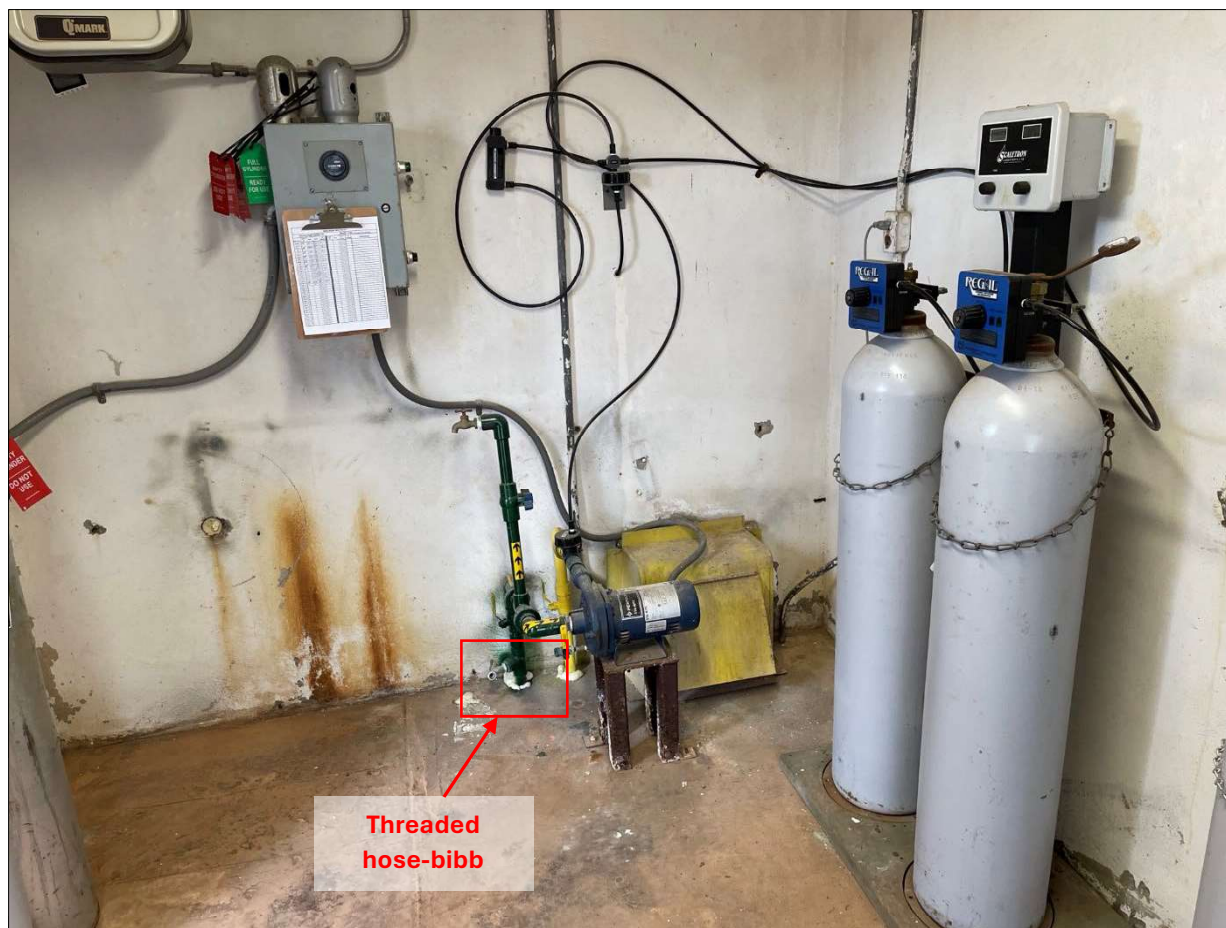
**Photograph 2. Chlorination Station 774 IMG\_3121.jpeg**

The Inspection Team observed a threaded hose-bibb on the raw water line used for chlorine gas carrier water (refer to [Appendix 1, Photographs 2 and 3](#)). System representatives stated that the hose-bibb is used to hose down the chlorination station. A hose was not connected to the hose-bibb at the time of the inspection.

**AWWA M14 Backflow Prevention and Cross-Connection Control, Chapter 6 Sample Hazards and Proper Protection, Table 6-2** describes recommended protection at fixtures and equipment found in water treatment plants. For hose-bib connections, Table 6-2 specifies a hose-bib vacuum breaker as the recommended minimum protection.

**Area of Concern 4.** The Inspection Team observed a threaded hose-bibb on the raw water line used for chlorine gas carrier water (refer to [Appendix 1, Photographs 2 and 3](#)). System representatives stated that the hose-bibb is used to hose down the chlorination station. A hose was not connected to the hose bibb at the time of the inspection.

Description: View inside the station. A threaded hose-bibb was installed on the raw water line. The System uses the hose-bibb to wash down the inside of the station.

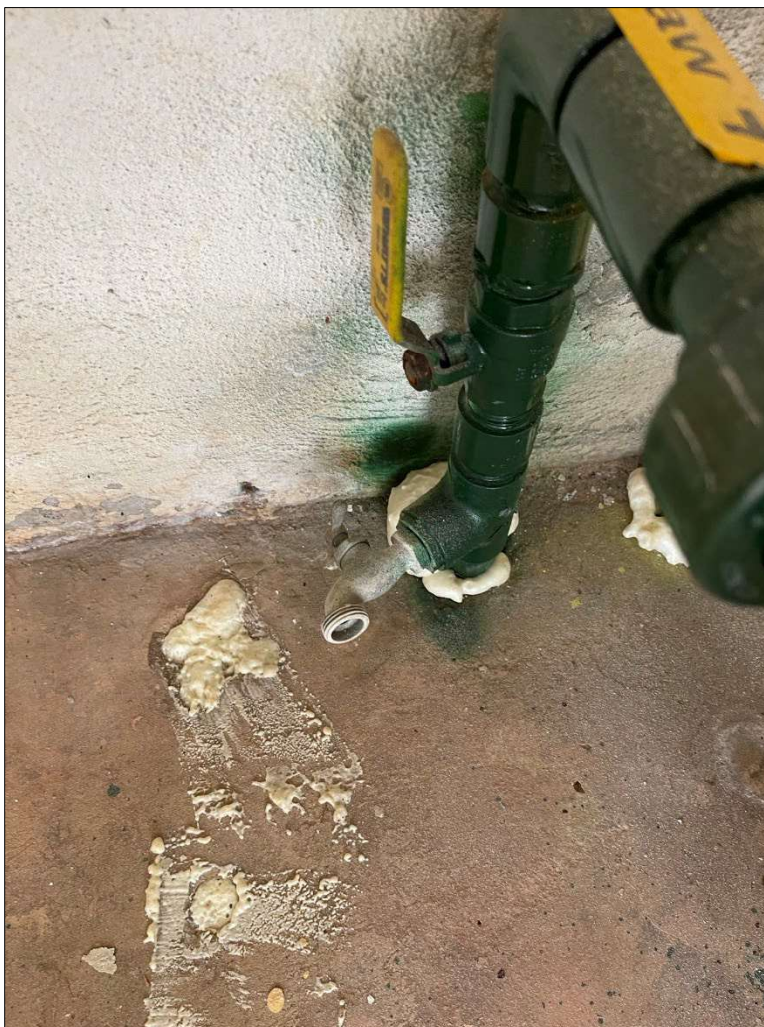
**Photograph 3. Chlorination Station 774 IMG\_3120.jpeg**

Description: View of a threaded hose-bibb on the raw water line shown in Photograph 2.

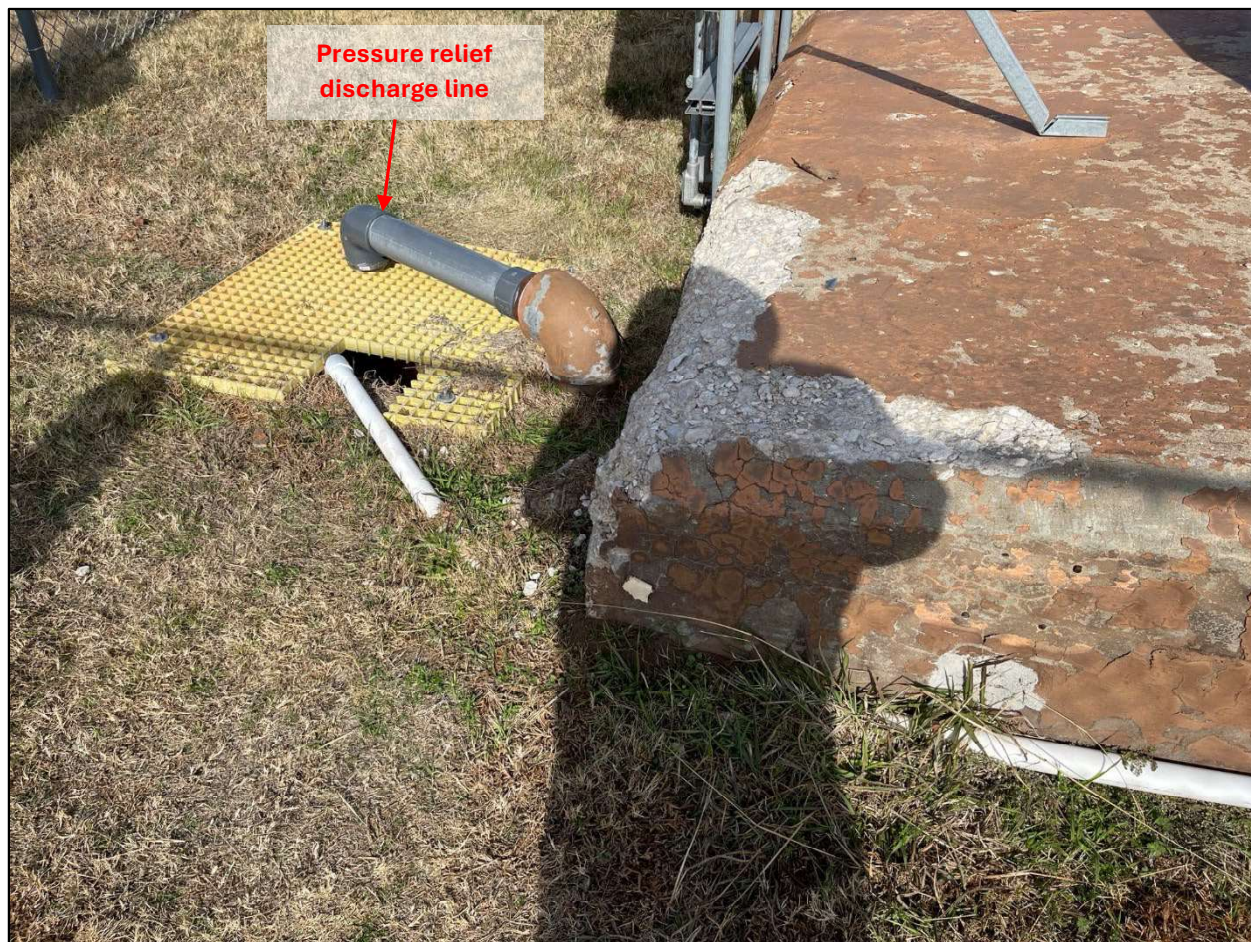
**Photograph 4. Well 5 IMG\_3129.jpeg**

The Inspection Team observed the well pressure relief drain line discharged outside the wellhouse to a catch basin. The discharge line was approximately one inch above the catch basin (refer to [Appendix 1, Photograph 4](#)).

**Recommended Standards for Water Works (Ten States Standards) (2022 Edition), Section 3.2.7** contains standards for well pumps, discharge piping, and appurtenances. **Section 3.2.7.3(a)(3)** states the discharge piping shall “Be protected against the entrance of contamination.” **Section 3.2.7.3(a)(6)** states the discharge piping shall, “Where applicable, be equipped with an air release-vacuum relief valve located upstream from the check valve, with exhaust/relief piping terminating in a downturned position at least 18 inches above the floor and covered with a 24-mesh corrosion resistant screen”

**Area of Concern 5.** At Well 5, the Inspection Team observed that the pressure relief drain line discharged outside the wellhouse into a catch basin, approximately one inch above the basin (refer to [Appendix 1, Photograph 4](#)).

Description: View of the well's pressure relief drain line that discharge outside the wellhouse to a catch basin.

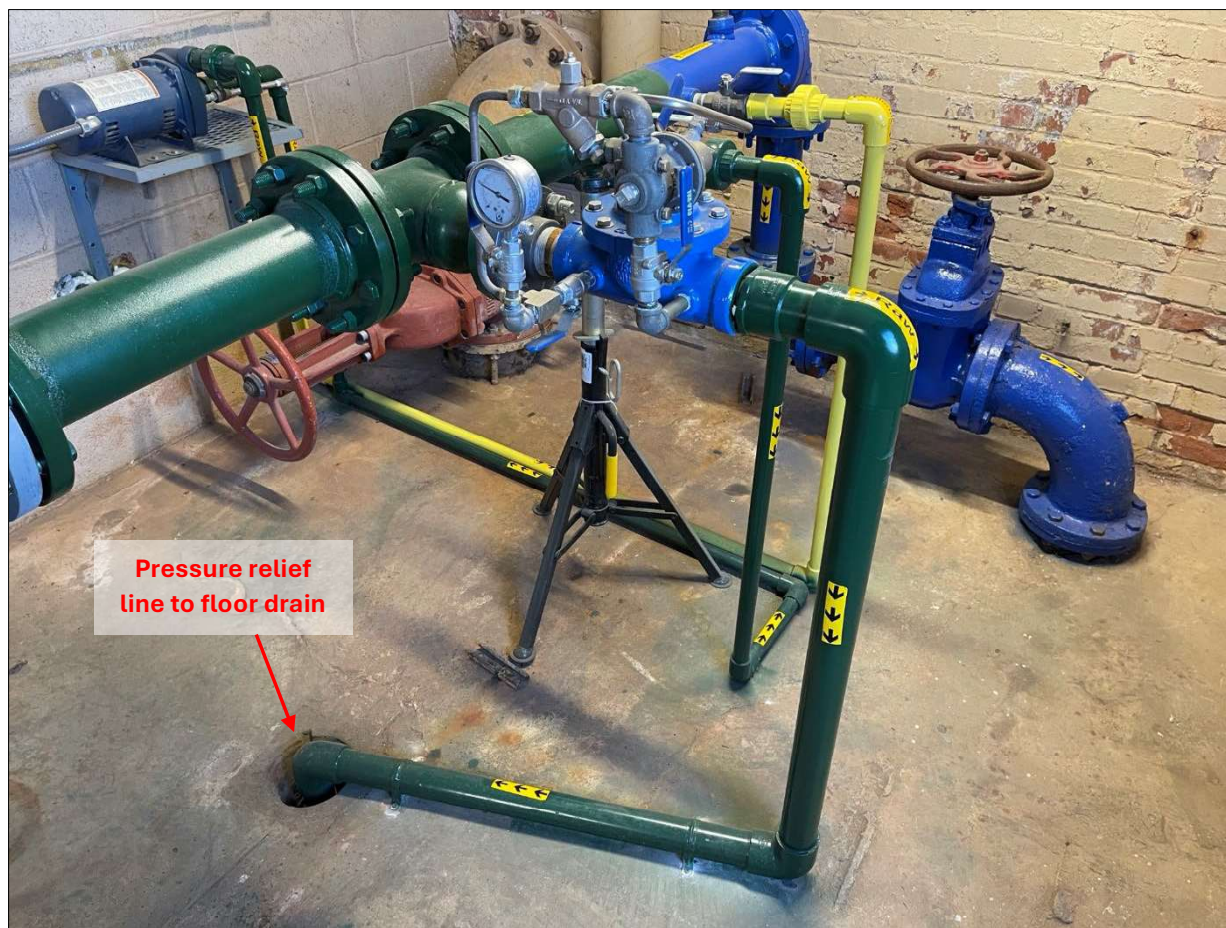
**Photograph 5. Well 21 IMG\_3143.jpeg**

The Inspection Team observed that the pressure relief drain line discharges to a floor drain (refer to [Appendix 1, Photographs 5 and 6](#)). The floor drain leads to an outside storm water catch basin (refer to [Appendix 1, Photograph 7](#)).

**Area of Concern 6.** At Well 21, the Inspection Team observed that the pressure relief drain line discharges to a floor drain (refer to [Appendix 1, Photographs 5 and 6](#)). The floor drain leads to an outside storm water catch basin (refer to [Appendix 1, Photograph 7](#)).

Description: View of the wellhead. The pressure relief line drained to a floor drain.

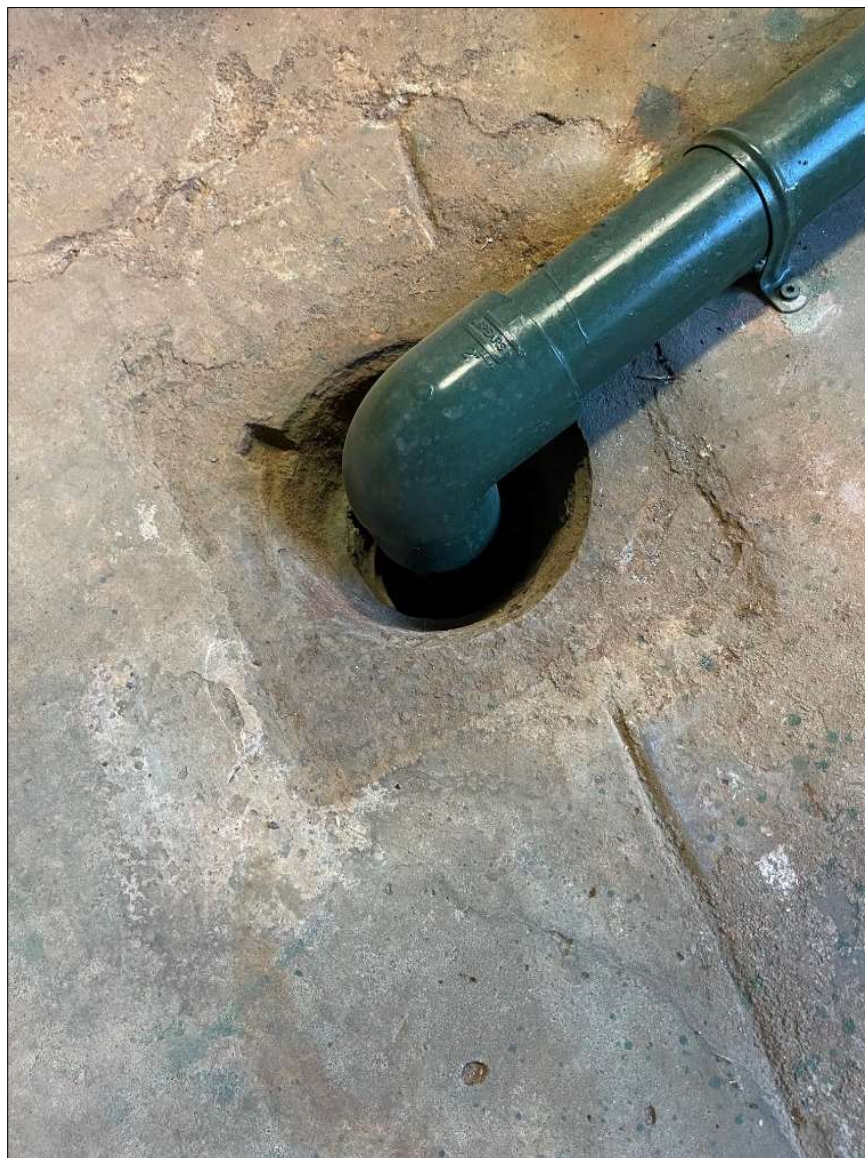
**Photograph 6. Well 21 IMG\_3147.jpeg**

Description: Close-up view of the pressure relief line and floor drain.

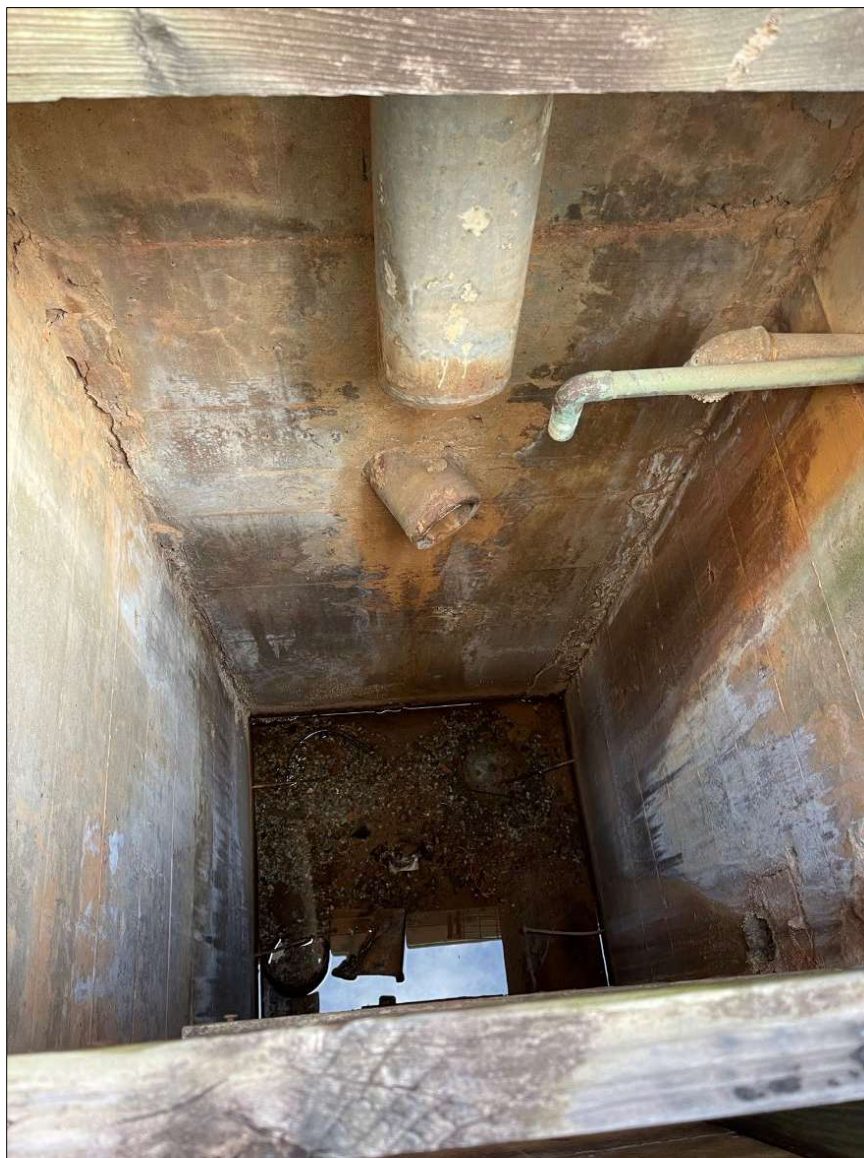
**Photograph 7. Well 21 IMG\_3146.jpeg**

Description: View of the stormwater vault to which the pressure relief line drained. The floor drain line appeared to be one of the downturned lines on the right side of the photograph. It was unclear to the Inspection Team if the vault was subject to flooding, thus posing a sanitary risk to the wellhead.

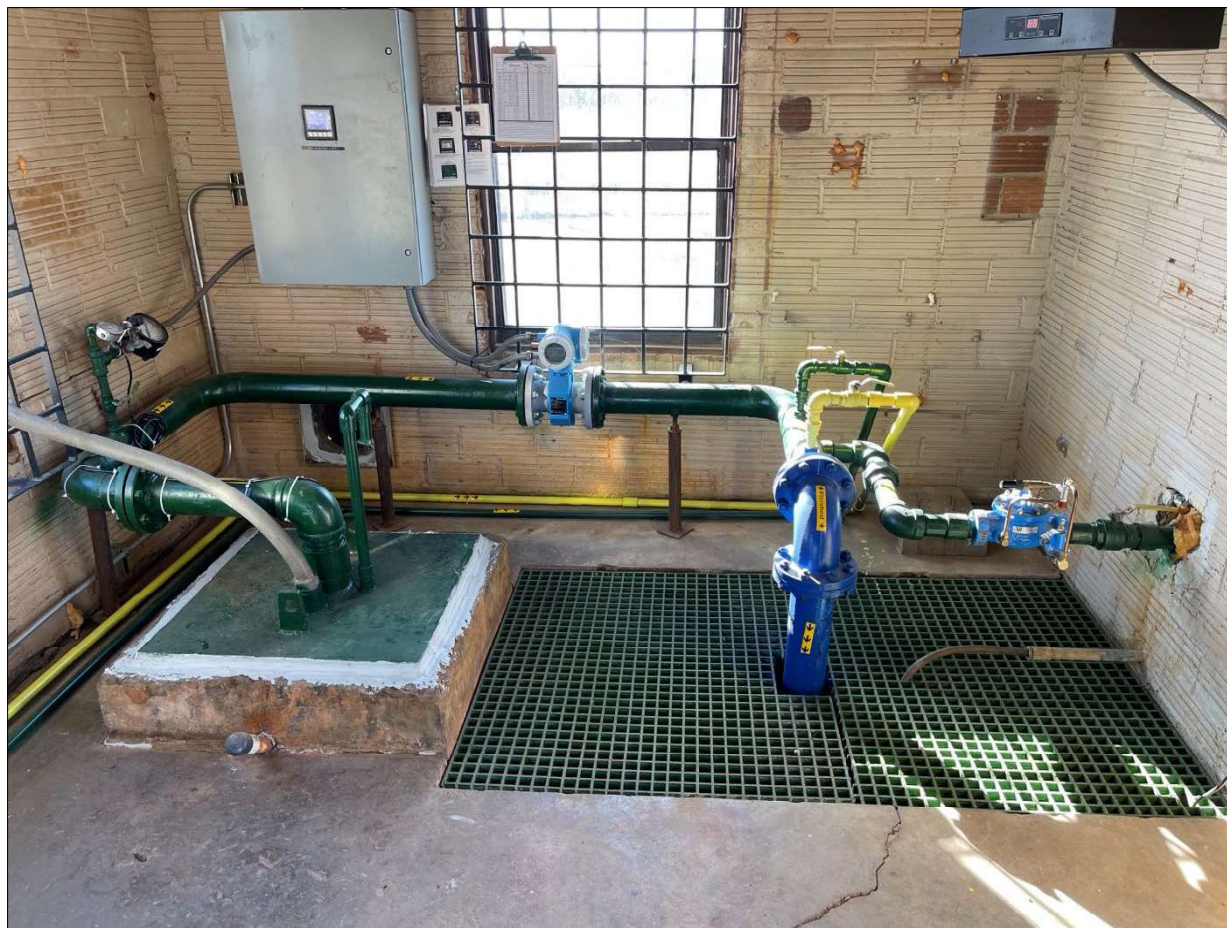
**Photograph 8. Well 24 IMG\_3172.jpeg**

**Description:** View of the wellhead. Standing water was present in the vault underneath the discharge piping (refer to Photograph 9).

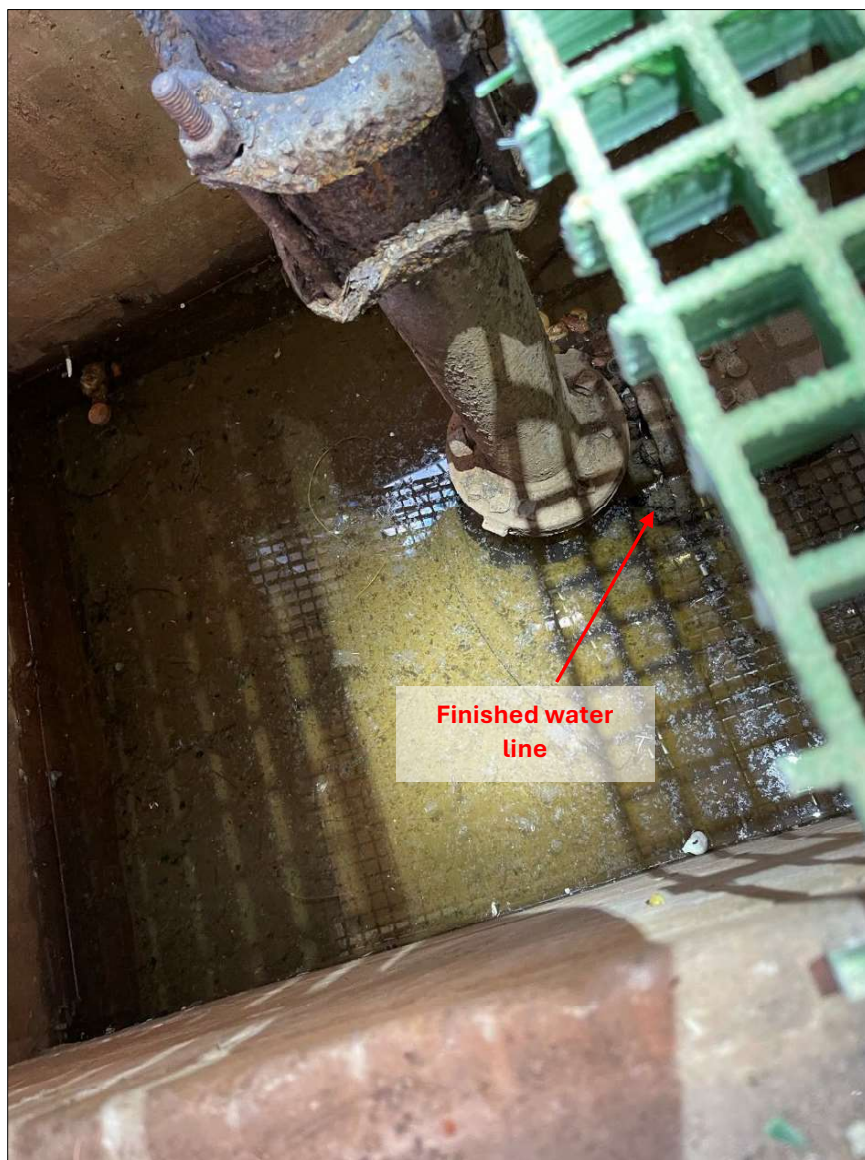
**Photograph 9. Well 24 IMG\_3173.jpeg**

Description: View of standing water in the vault underneath the wellhead piping. The finished water pipe was partially submerged. The vault had a sump pump but no sump. It was unclear to the Inspection Team if there was an issue with the sump pump or if the water level was not high enough to trigger the pump's float activator.

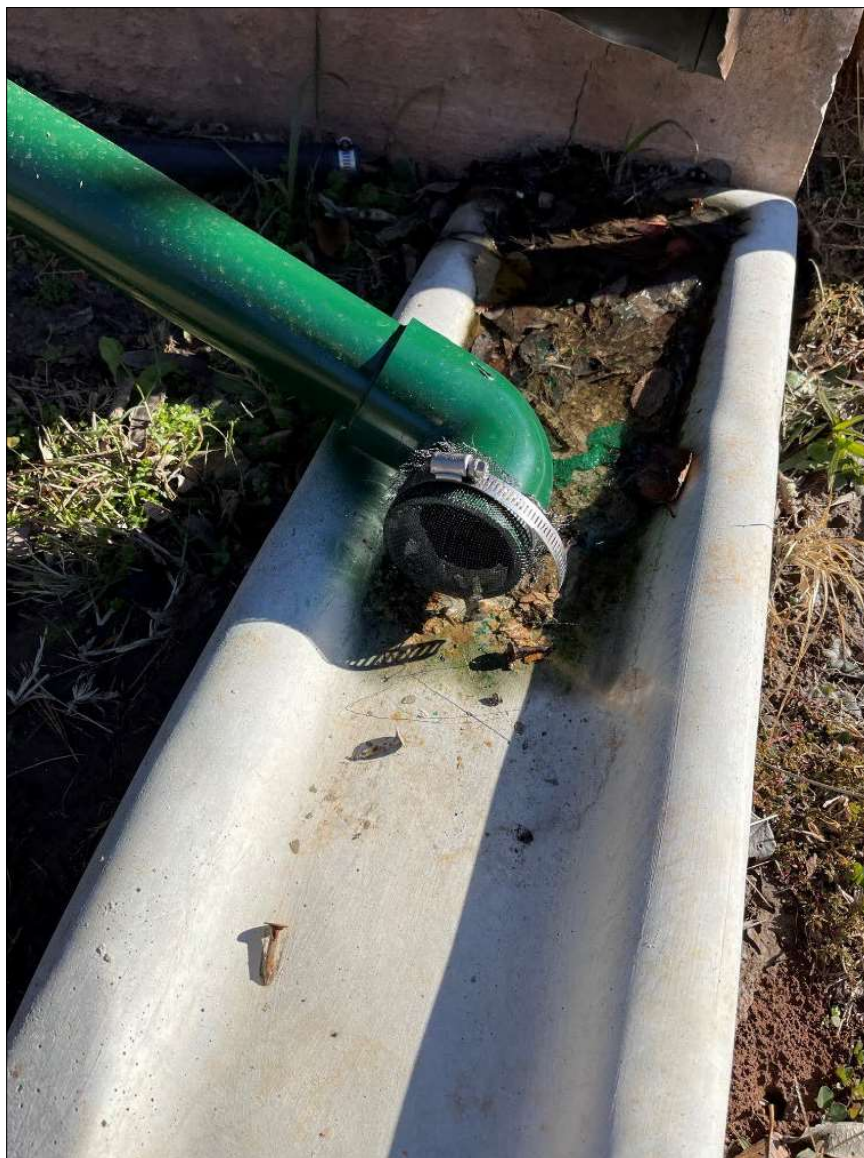
**Photograph 10. Well 25 Building 3802 IMG\_3166.jpeg**

The Inspection Team observed that the pressure relief drain line discharged outside the wellhouse. The drain line was located on a splash pad for a roof downspout (refer to Appendix 1, Photograph 10). The splash pad appeared to slope back to the wellhouse, and it appeared stormwater may accumulate in the area of the drain line.

**Area of Concern 7.** At Well 25, the Inspection Team observed that the pressure relief drain line discharged outside the wellhouse. The drain line was located on a splash pad for a roof downspout (refer to [Appendix 1, Photograph 10](#)). The splash pad appeared to slope back to the wellhouse, and it appeared stormwater may accumulate in the area of the drain line.

Description: View of the drain line for the pressure relief line. The drain line was located on a splash pad for a roof downspout. The splash pad appeared to slope back to the wellhouse, and it appeared stormwater may accumulate in the area of the drain line.

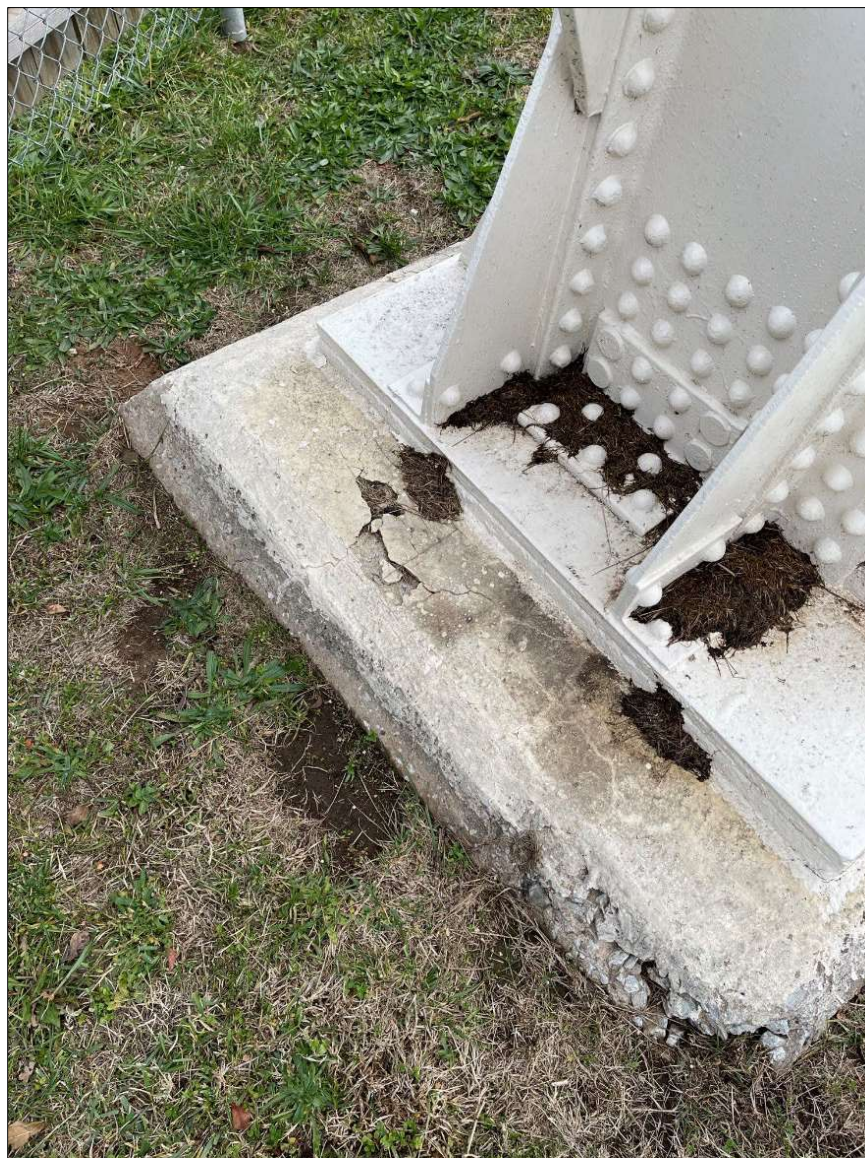
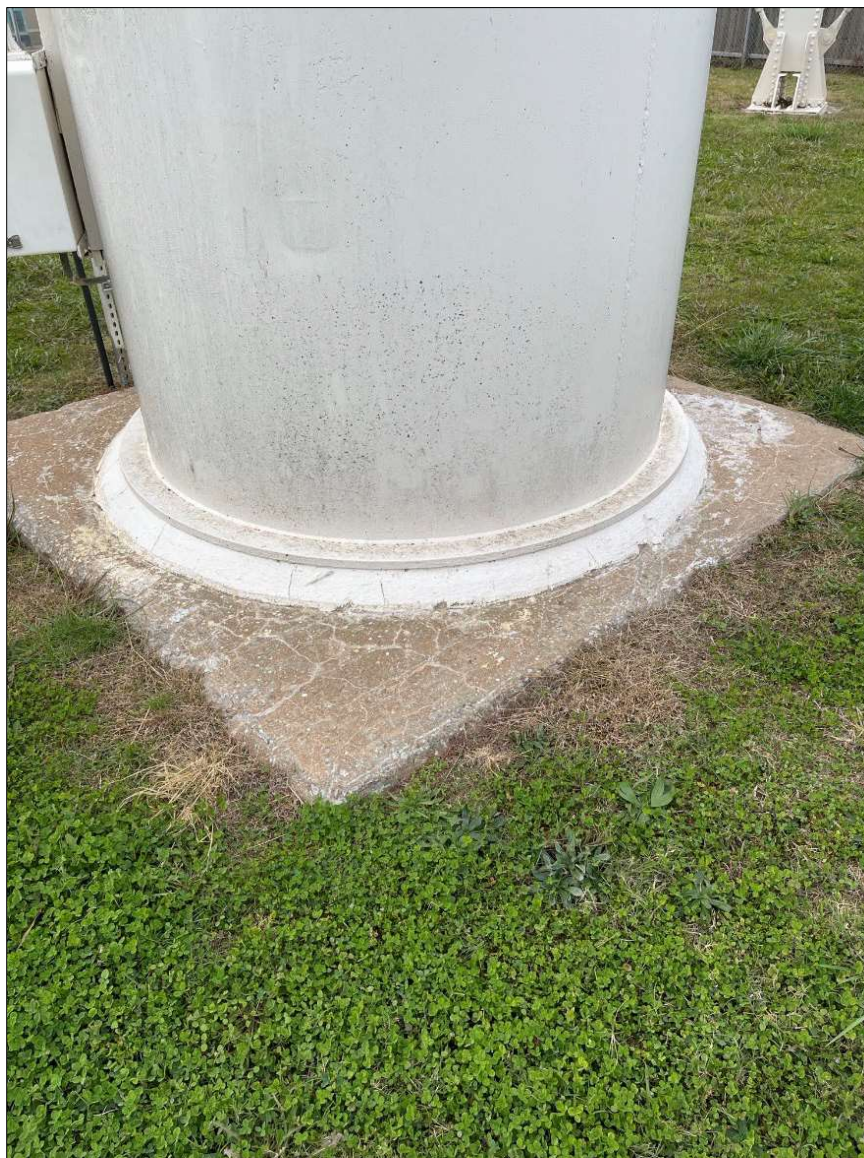
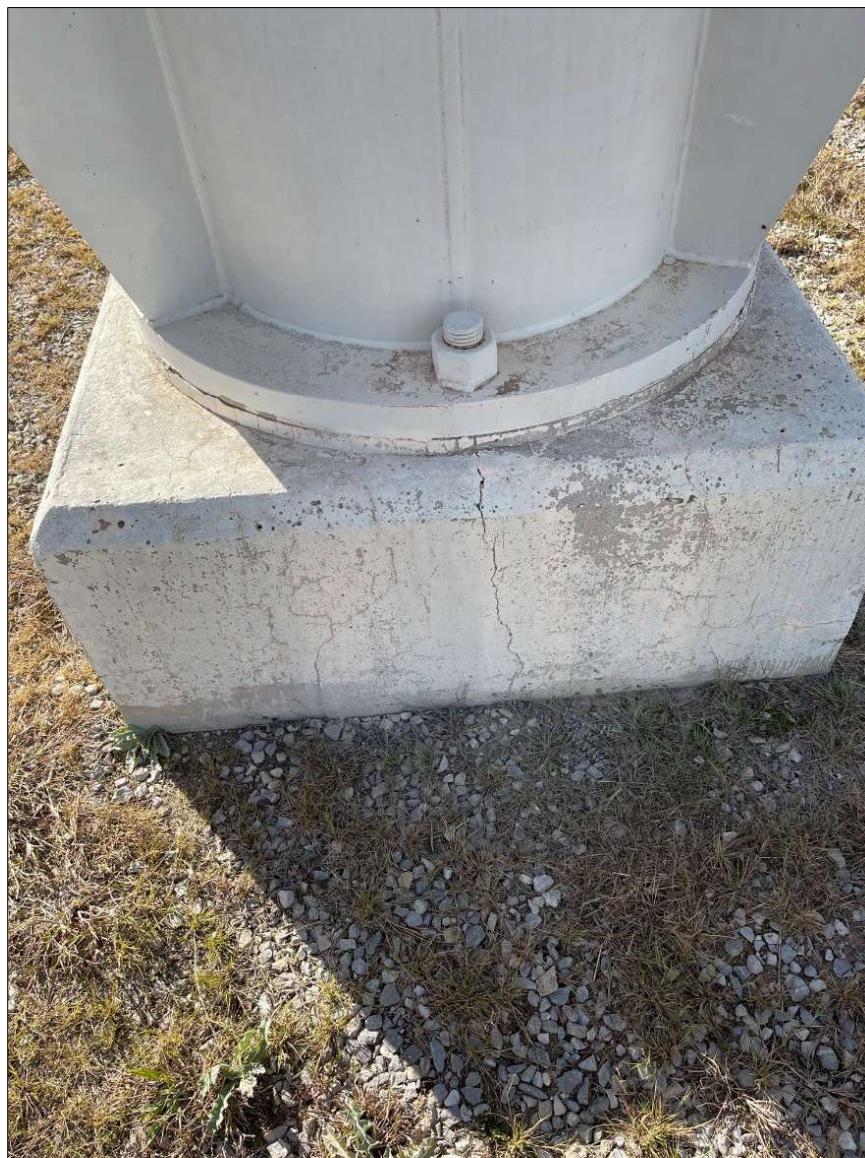
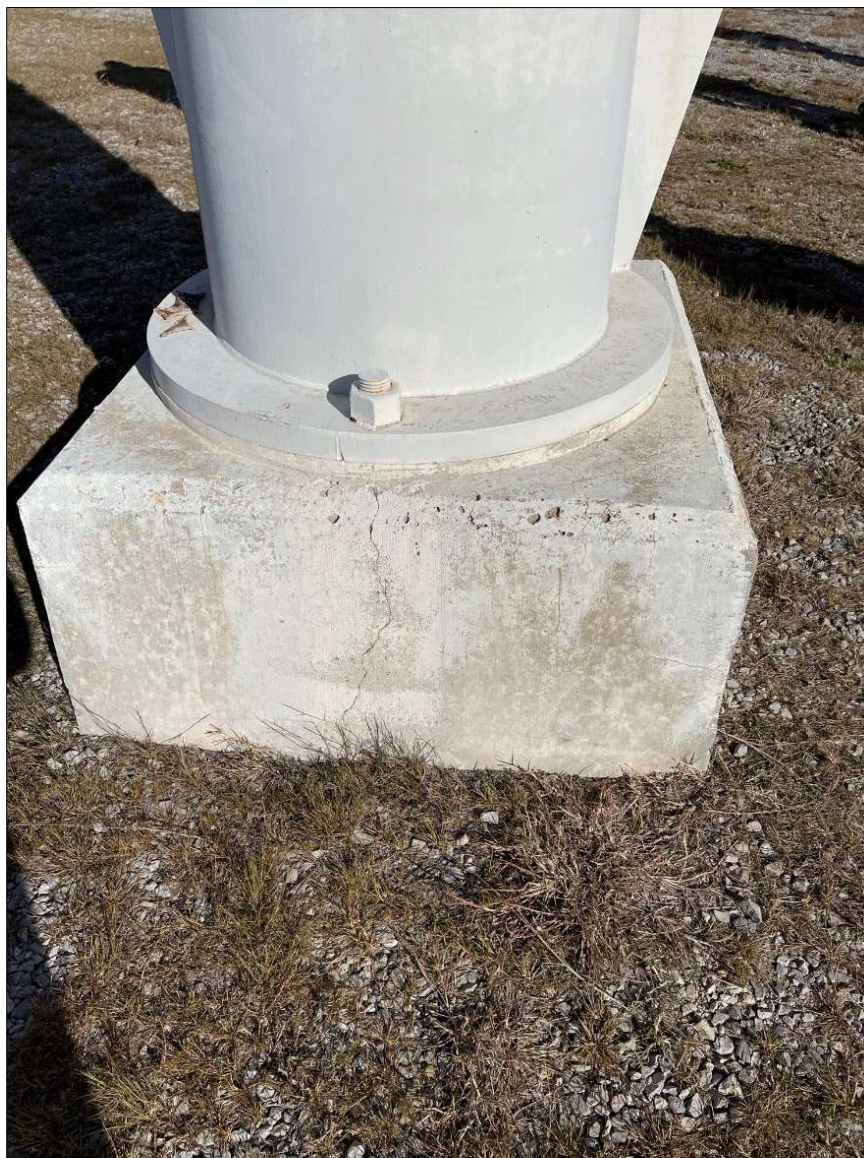
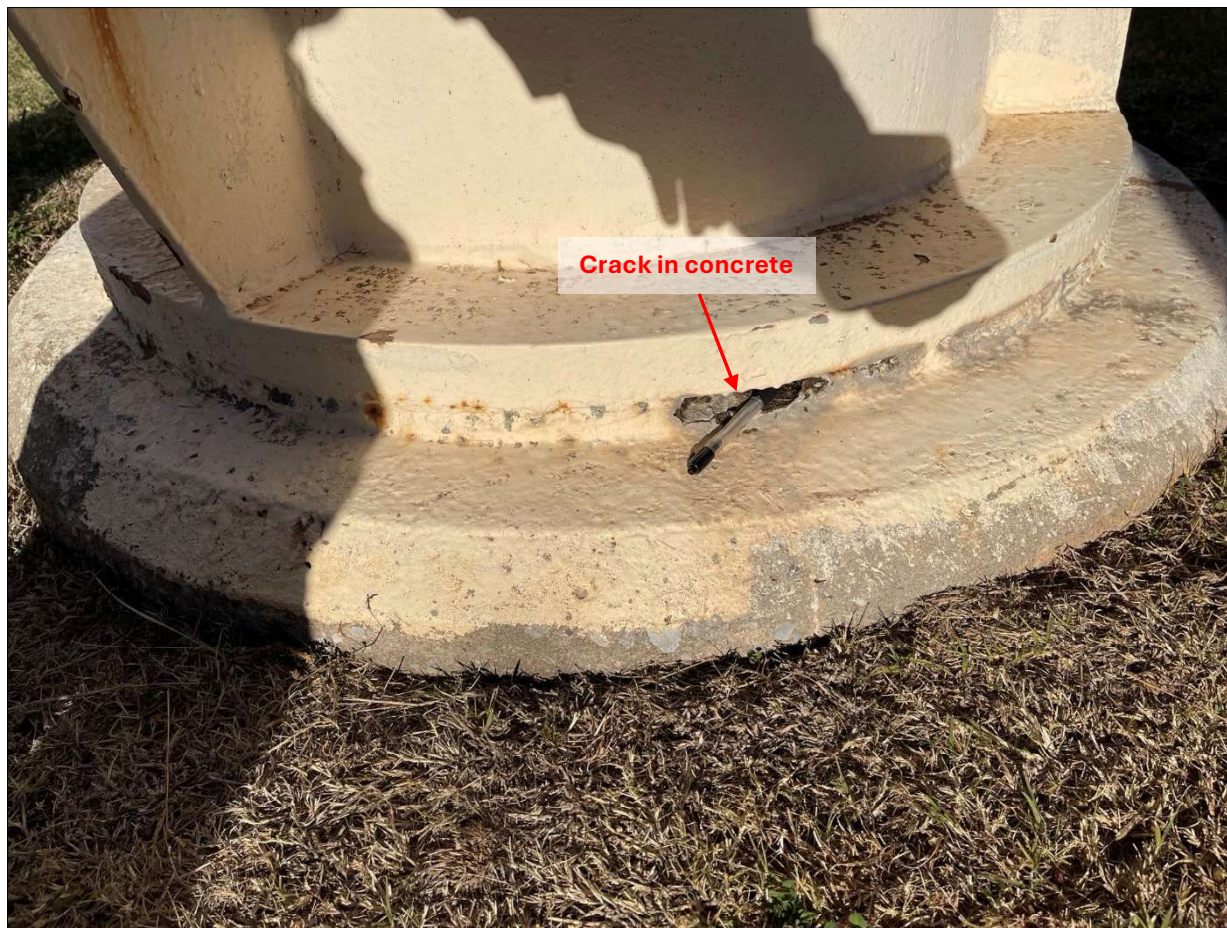
- The Inspection Team observed cracked and spalling concrete on multiple concrete support pedestals on A Tower North, Navy Tower, and Tower 3304 (refer to Appendix 1, Photographs 11–15)
- System representatives stated that the cathodic protection systems are outdated and are scheduled to be replaced (refer to Appendix 1, Photograph 16 for an example at A Tower South)
- The Inspection Team obtained the following pressure readings from tank pressure gauges:
  - Navy Tower: 53.2 psi (the tank had an electronic pressure logger)
  - Tower 3001: approximately 55 to 60 psi
  - C Tower: approximately 54 psi.

Description: View of one of the concrete support pedestals, which was cracked and spalling.

Description: View of crack/hole in one of the concrete support pedestals. One of the inspectors placed a pen inside the hole for reference.

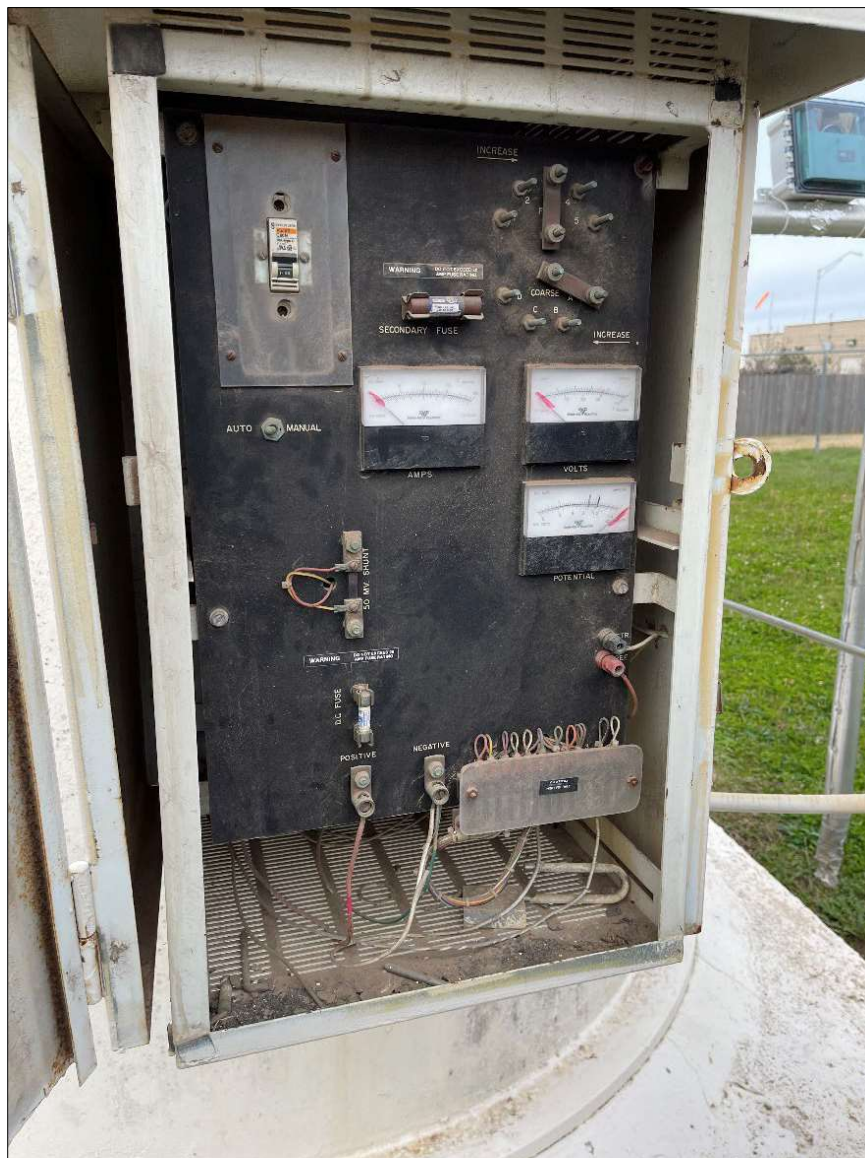
**Photograph 16. A Tower South IMG\_3112.jpeg**

**AWWA M42-13 Steel Water-Storage Tanks, Chapter 3 Cathodic Protection** states, “Annual inspection of the cathodic protection system by the manufacturer or by a qualified corrosion engineer is recommended. At a minimum, this inspection should include an overall examination of the entire cathodic protection system, replacement of all defective parts, a potential profile survey, a physical check of the anode placement, and a written report...Cathodic protection systems should be tested and inspected on a regular basis to ensure that they provide the maximum level of corrosion control to the submerged steel tank surfaces.”

**Area of Concern 9.** System representatives stated the cathodic protection systems at the finished water storage tanks are outdated and are scheduled to be replaced (refer to Appendix 1, Photograph 16 for an example at A Tower North). The Inspection Team noted the System’s ISDC scope of work includes cathodic protection systems.

Description: View inside the cathodic protection system control cabinet. System representatives stated the cathodic protection systems for the finished water storage tanks are outdated and scheduled to be replaced. The Inspection Team noted the System's ISDC scope of work includes cathodic protection systems.

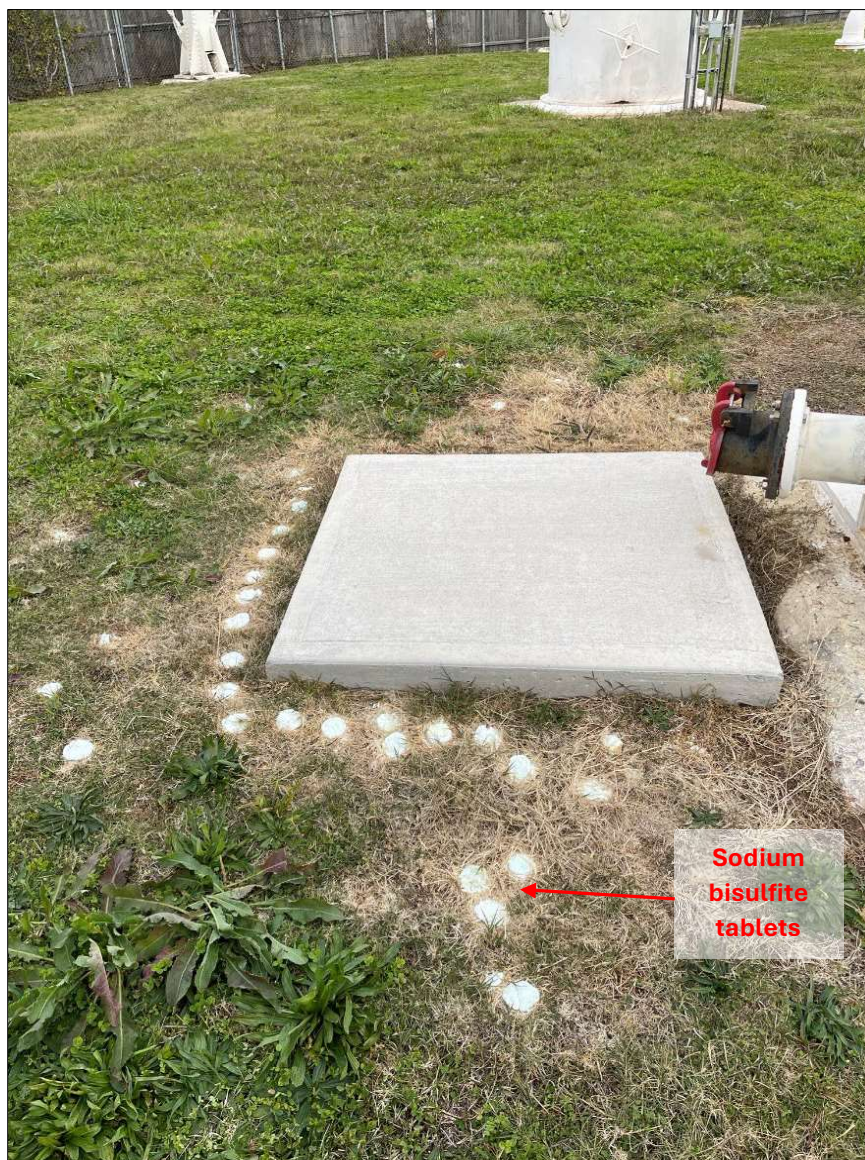
**Photograph 17. A Tower North IMG\_3109.jpeg**

System representatives stated that the tank is intentionally overflowed approximately once every 2 weeks for approximately one hour to reduce water age in the distribution system. The Inspection Team observed sodium bisulfite tables adjacent to the overflow splashpad to dechlorinate overflow water (refer to Appendix 1, Photograph 17).

**AWWA M42-13 Steel Water-Storage Tanks, Chapter 8 Routine Operation and Maintenance** states, “Overflow pipes on tanks are intended for occasional use only. Tanks should not be regularly overflowed, and the overflow should not be used as a visual control for pumps and valves. Extreme overuse of the overflow pipe may damage the pipe or brackets. Trickling overflowing water can freeze and obstruct the overflow pipe.”

**Area of Concern 8.** System representatives stated that the System intentionally overflows the A Tower North finished water storage tank, approximately once every 2 weeks for approximately one hour, to reduce water age in the distribution system. The Inspection Team observed sodium bisulfite tables adjacent to the overflow splashpad to dechlorinate water from the overflow pipe (refer to [Appendix 1, Photograph 17](#)). System representatives stated that the System is evaluating/planning system improvements to reduce water age and will cease intentional overflows.

Description: View of the overflow splash pad. The System intentionally overflows the tank to reduce water age in the distribution system. Sodium bisulfite tablets are on the ground surface adjacent to the splash pad for dechlorination.

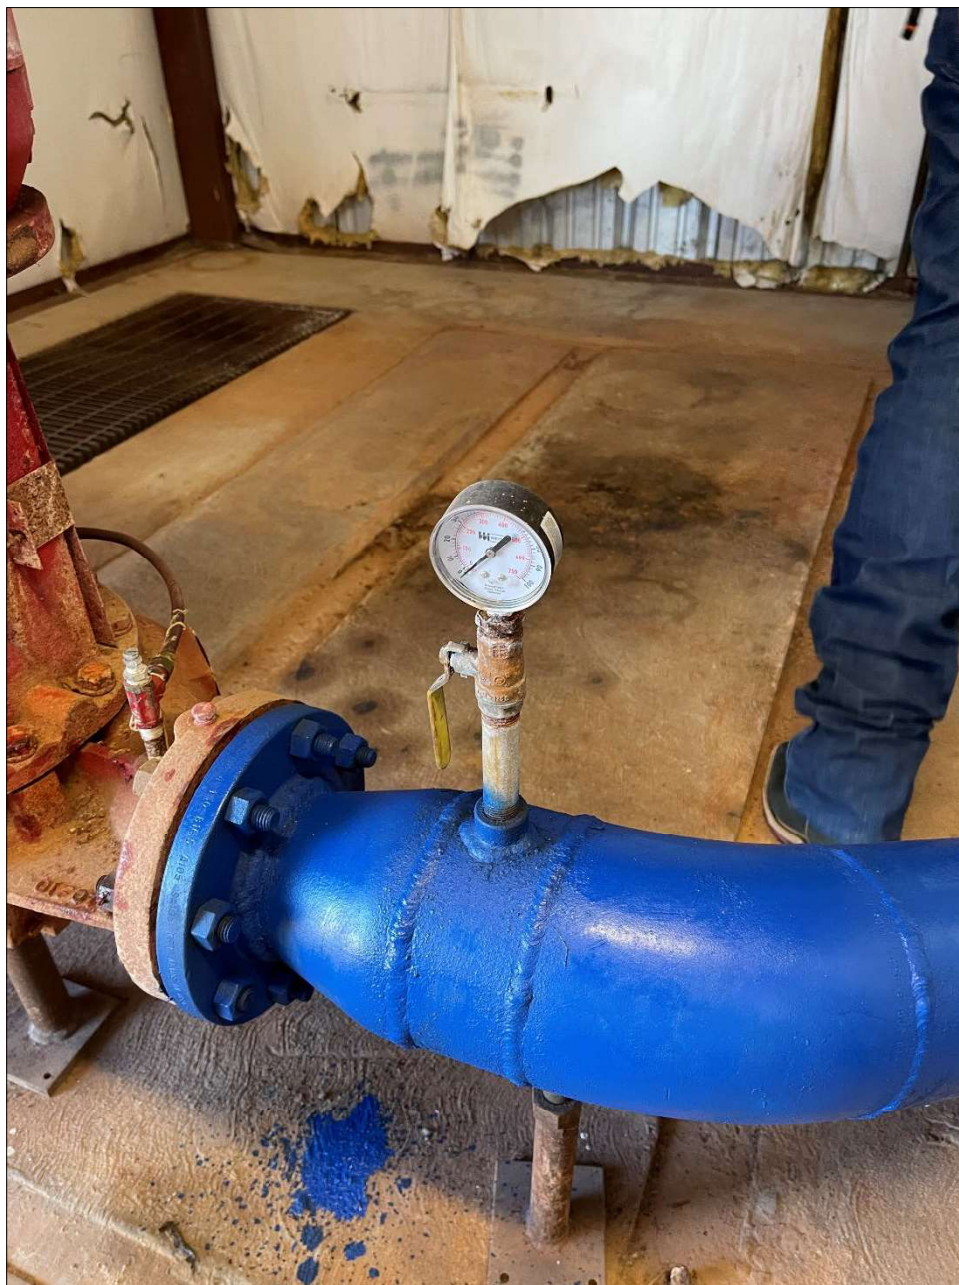
**Photograph 18. Booster Station 919 IMG\_3158.jpeg**

Description: View of the discharge pressure gauge for the North Pump. The pressure gauge read less than 0 psi. System representatives provided photographs of the replacement gauge that read approximately 55 psi.

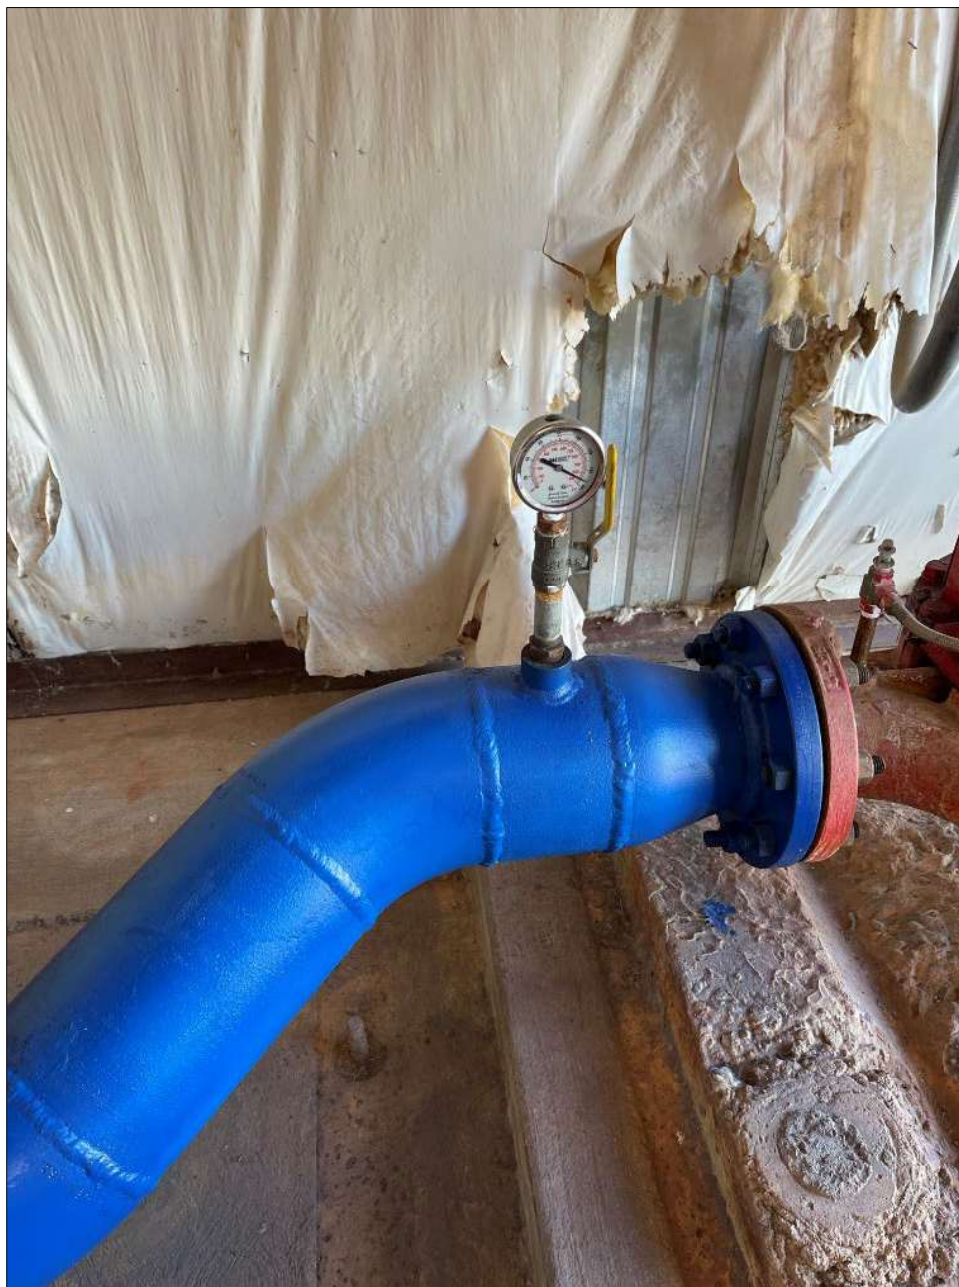
**Photograph 19. Booster Station 919 IMG\_3161.jpeg**

Description: View of the discharge pressure gauge for the South Pump. The pressure gauge read approximately 150 psi. System representatives provided photographs of the replacement gauge that read approximately 55 psi.
