**Region 6 - Enforcement & Compliance Assurance Division**  
**INSPECTION REPORT**

| <b>Inspection Date(s):</b> | 12/10/2024 and 12/11/2024 | |
| <b>System Name:</b> | Tinker Air Force Base | |
| <b>PWS ID:</b> | OK2005508 | |

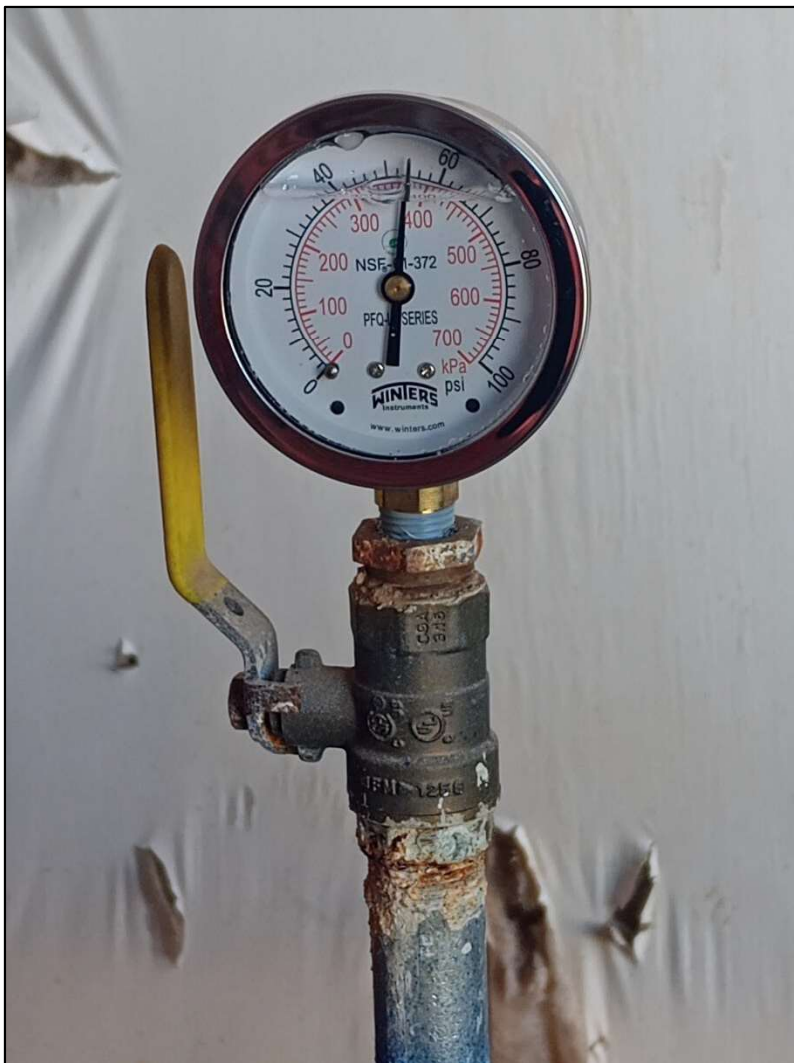
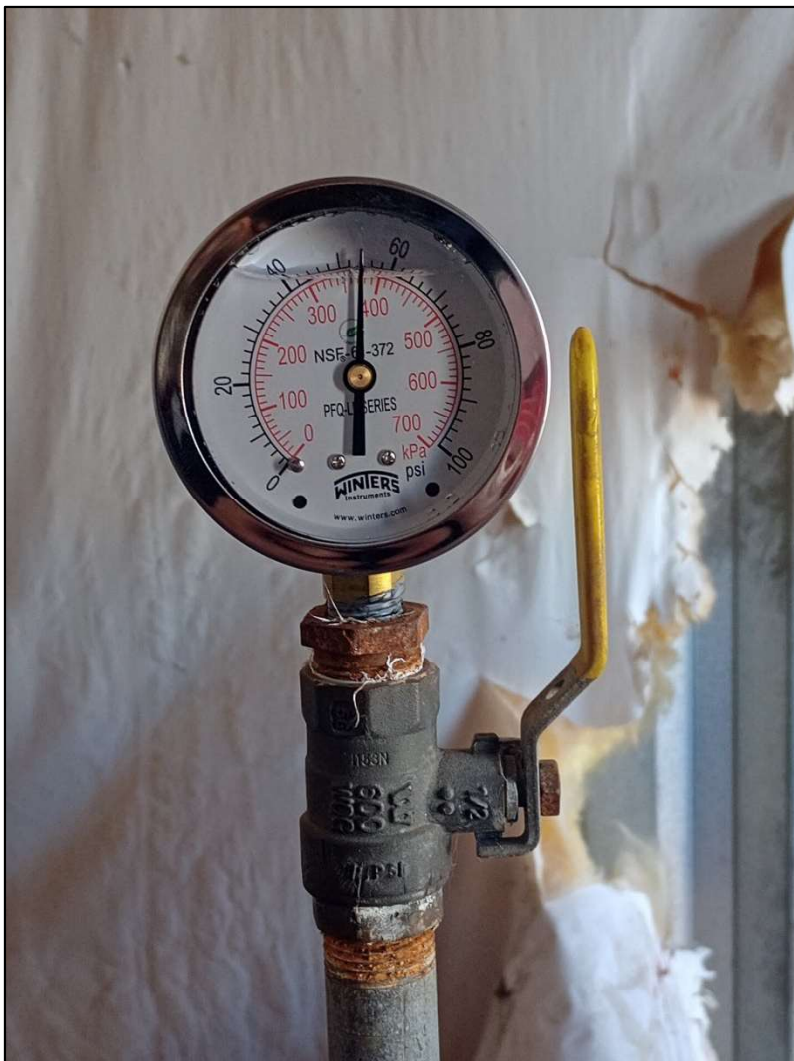
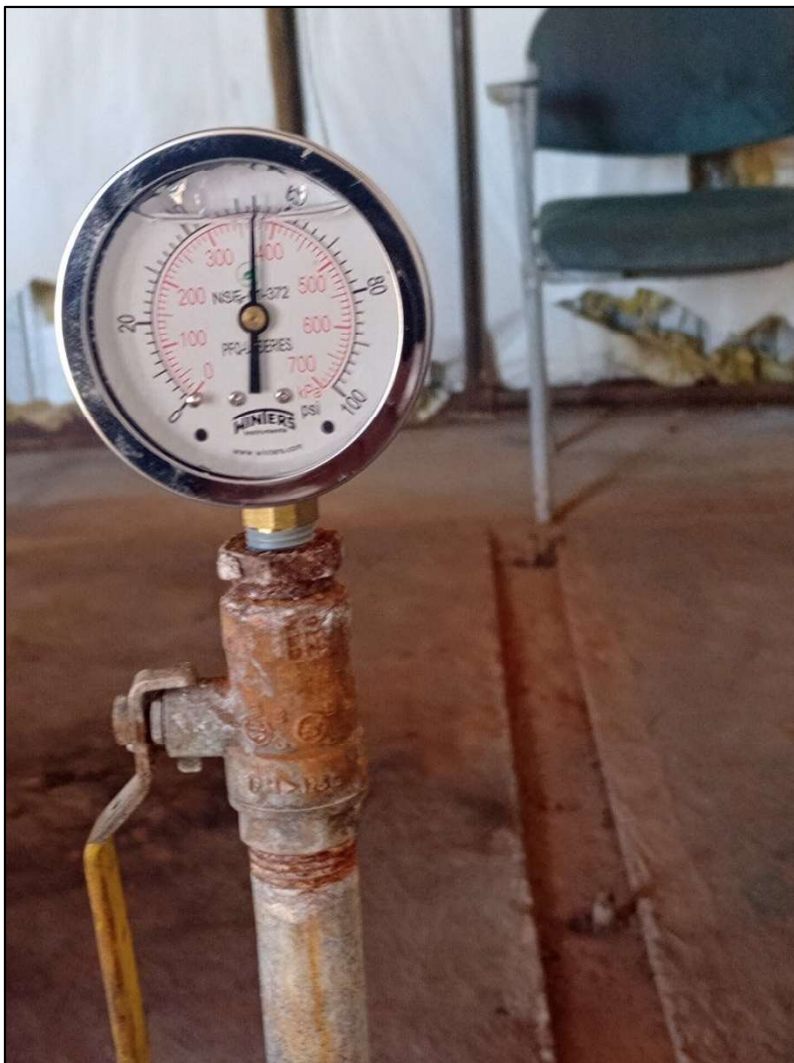
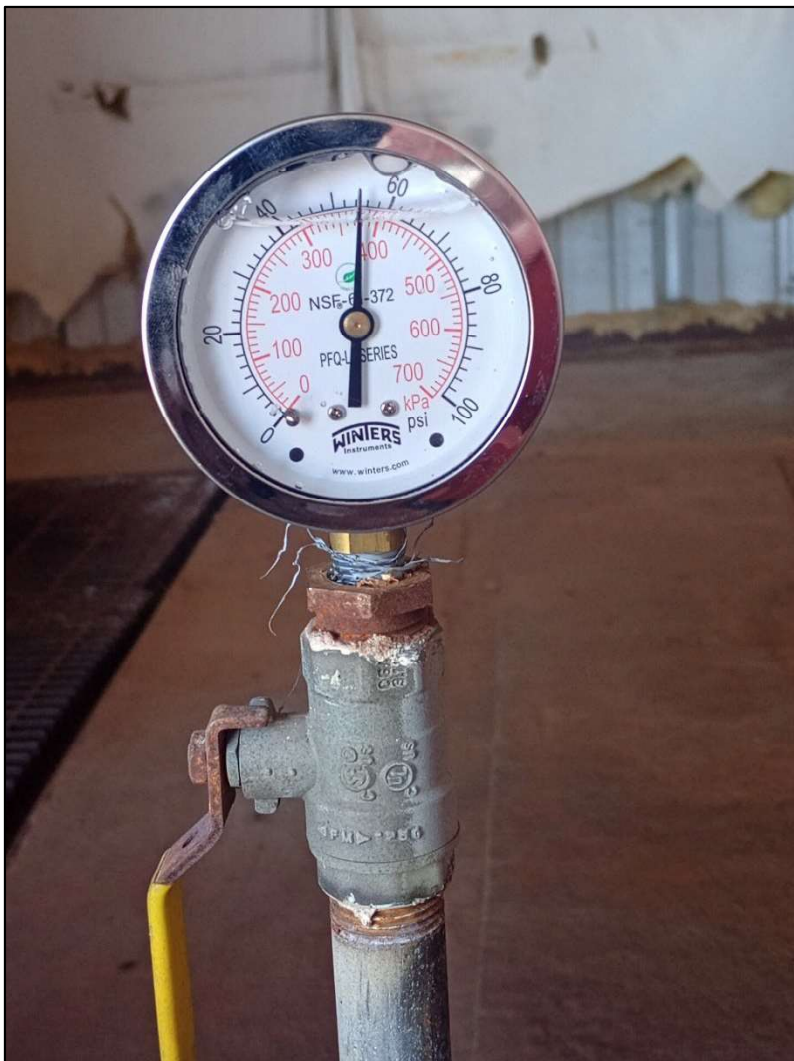
During the site visit, the Inspection Team observed that all four pressure gauges used to measure the suction and discharge pressures did not appear to be operating correctly. The North Pump's suction gauge read the gauge's maximum pressure, and the discharge pressure read below 0 psi (refer to Appendix 1, Photograph 18). The South Pump's suction gauge read approximately 100 psi, and the discharge pressure gauge read approximately 150 psi (refer to Appendix 1, Photograph 19). System representatives stated that they anticipated the discharge pressures to be approximately 50 to 60 psi, and that pressures above 100 psi were far too high. After the site visit, System representatives determined that an issue with the heater in the booster station caused the pressure gauges to fail due to cold temperatures. System representatives provided photographs of the new gauges, which read approximately 55 psi (refer to Appendix 1, Photographs 20–23).

**Area of Concern 2.** During the site visit at Booster Station 919, the Inspection Team observed that all four pressure gauges used to measure the suction and discharge pressures did not appear to be operating correctly. The North Pump’s suction gauge read the gauge’s maximum pressure and the discharge pressure read below 0 psi (refer to [Appendix 1, Photograph 18](#)). The South Pump’s suction gauge read approximately 100 psi and the discharge pressure gauge read approximately 150 psi (refer to [Appendix 1, Photograph 19](#)). System representatives stated they anticipated the discharge pressures to be approximately 50 to 60 psi, and that pressures above 100 psi were far too high. After the site visit, System representatives that an issue with the heater in the booster station caused the pressure gauges to fail due to cold temperatures. System representatives provided photographs of the new gauges, which read approximately 55 psi (refer to [Appendix 1, Photographs 20–23](#)).

Description: View of one of the four pressure gauges the System replaced. System representatives provided photographs of the replacement gauge that read approximately 55 psi.
