## REGION 10 Enforcement Division

### INSPECTION REPORT

| <b>Company Name:</b> | University of Alaska | | |
| <b>Facility or Site Name:</b> | University of Alaska Fairbanks | | |

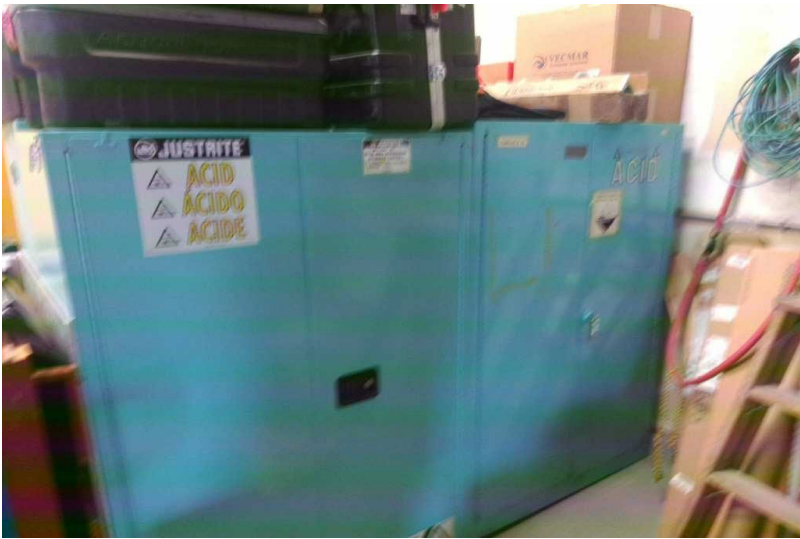
| View of the storage cabinet, showing the hazard indicator on the door of the cabinet vice marking the waste containers stored inside. | |

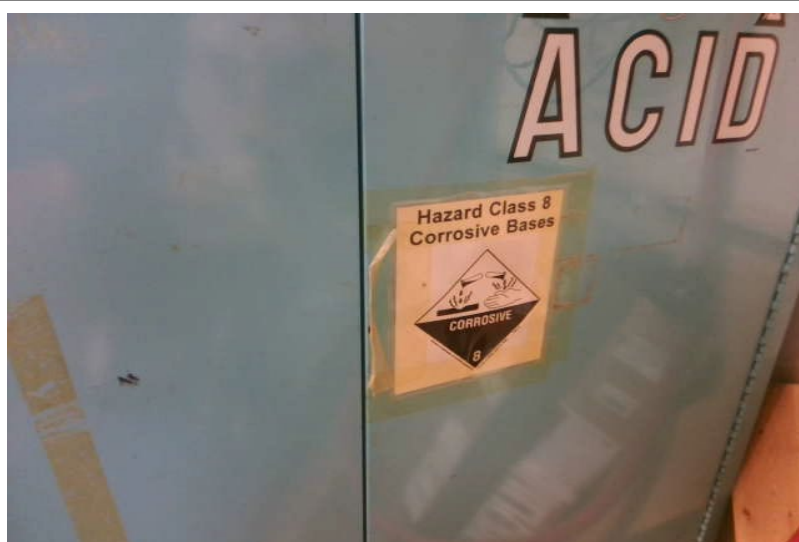
| Close-up view of the storage cabinet, showing the hazard indicator on the door of the cabinet vice marking the waste containers stored inside. |

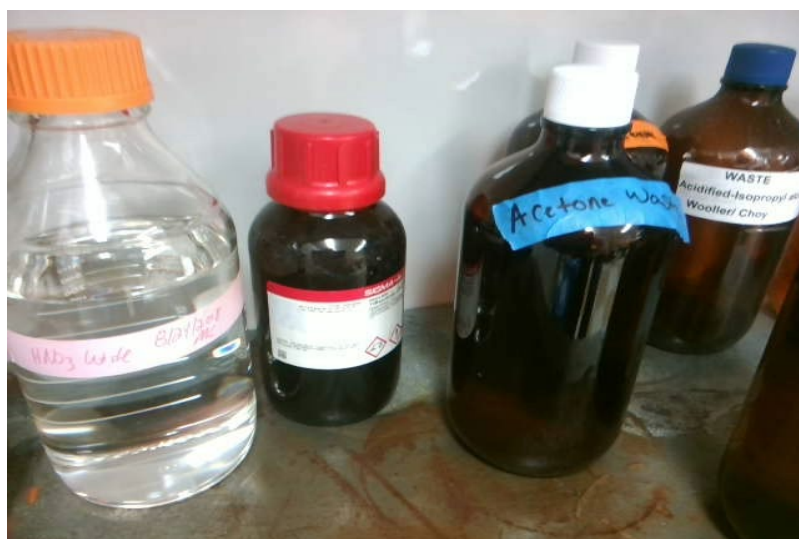
| View of SAA containers that are not labeled with the words "Hazardous Waste" or hazard indicators. |

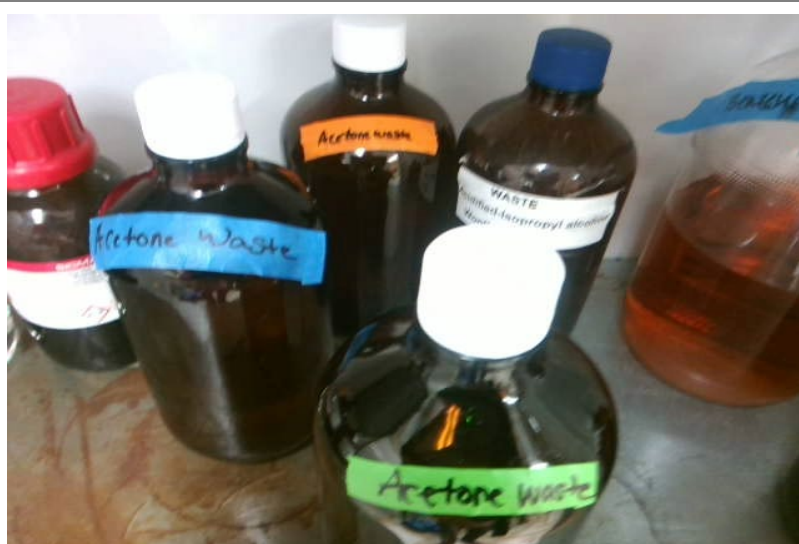
| View of SAA containers that are not labeled with the words "Hazardous Waste" or hazard indicators. |

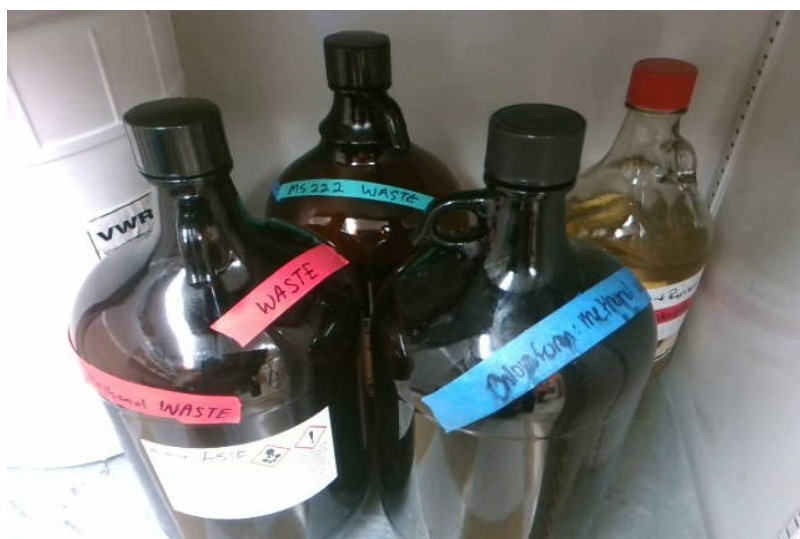
View of SAA containers that are not labeled with the words "Hazardous Waste" or hazard indicators.

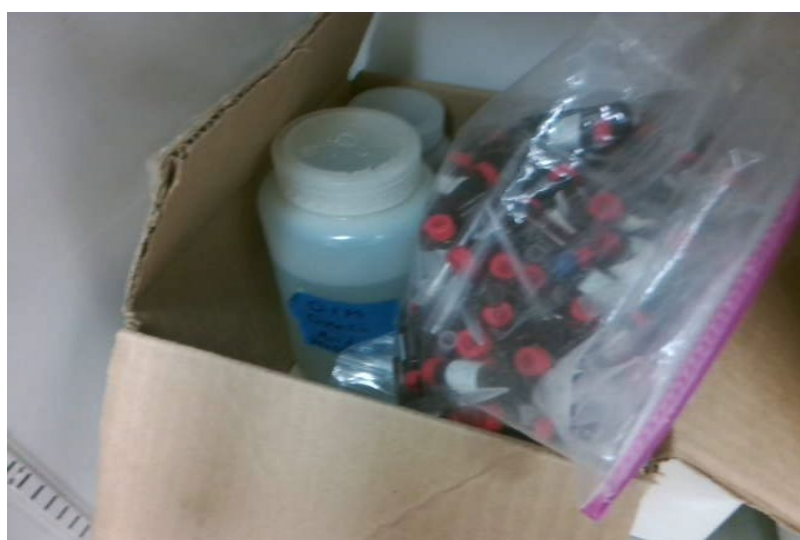
View of SAA containers that are not labeled with the words "Hazardous Waste" or hazard indicators.

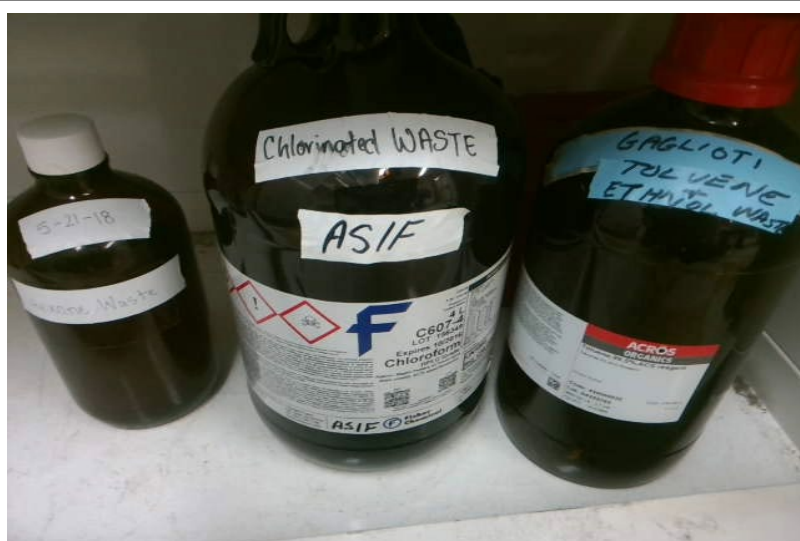
View of SAA containers that are not labeled with the words "Hazardous Waste" or hazard indicators.

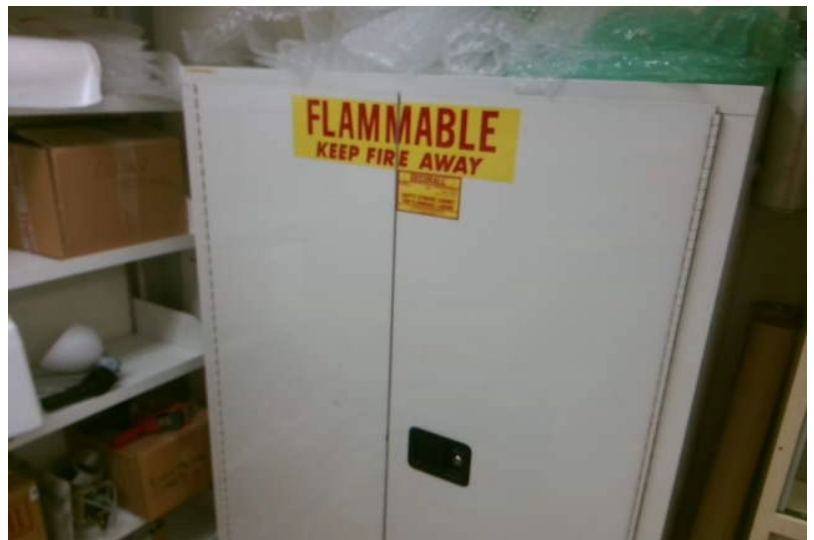
| View of the flammable storage cabinet holding the SAA containers that are not labeled with the words "Hazardous Waste" or hazard indicators. |

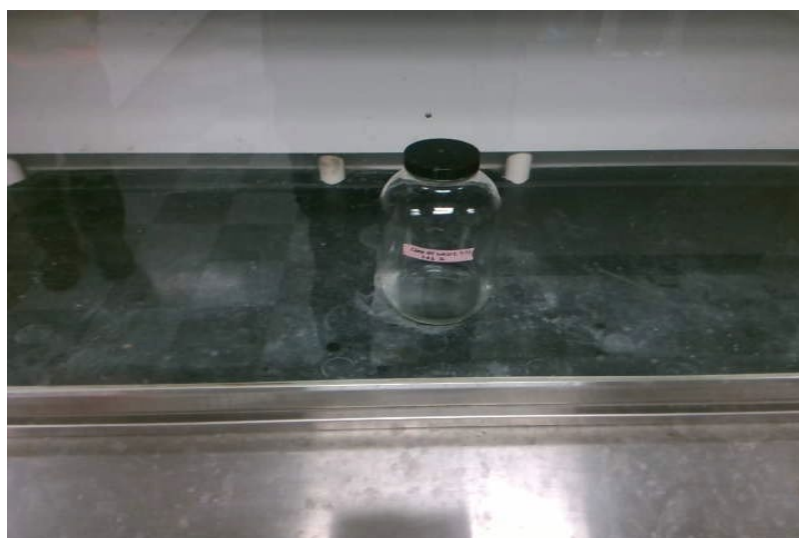
View of a SAA container not labeled with the words "Hazardous Waste" or a hazard indicator.

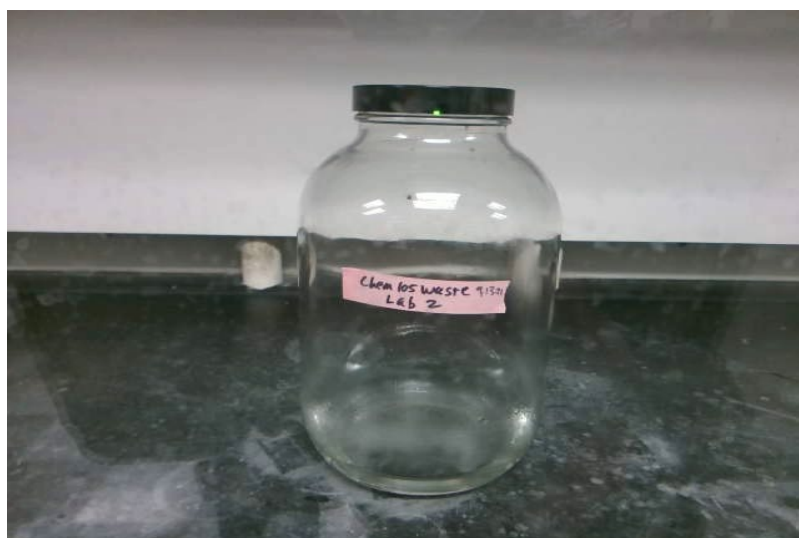
Close-up view of the same SAA container, seen in the previous photo (Ins-20210914140332332123305.jpg), not labeled with the words "Hazardous Waste" or a hazard indicator.

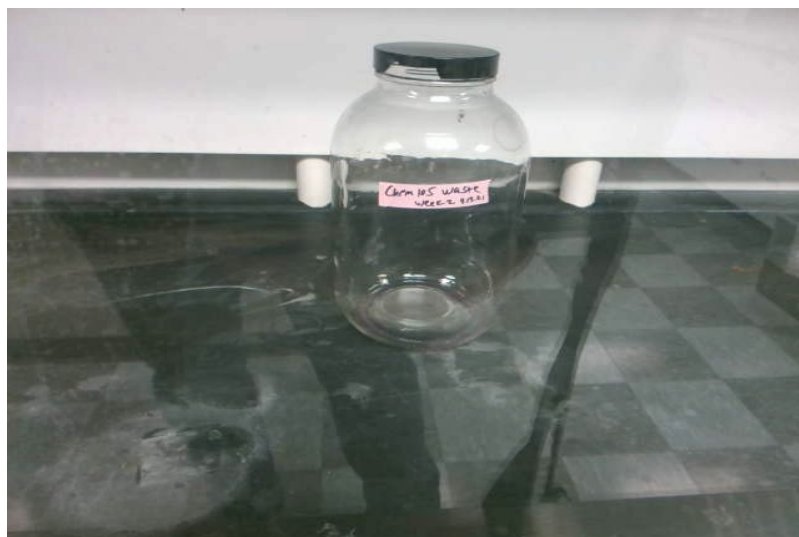
View of another SAA container not labeled with the words "Hazardous Waste" or a hazard indicator.

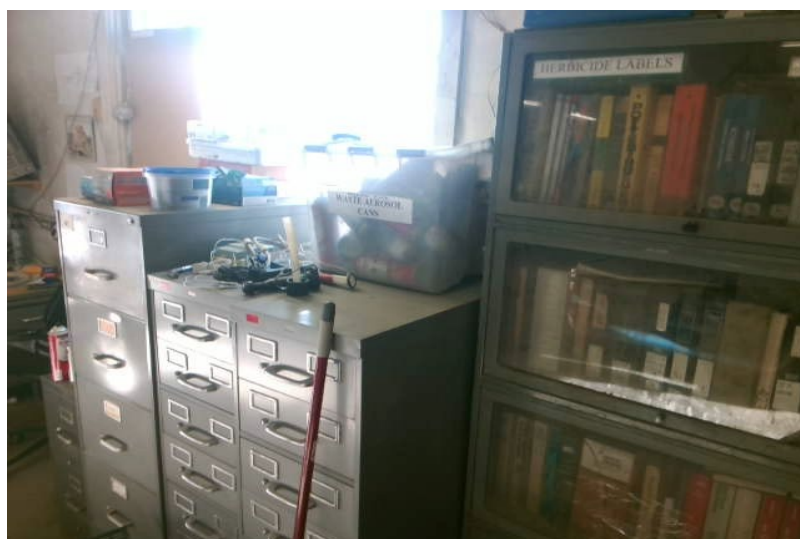
While at the AFES Maintenance Garage, I saw a clear plastic tote labeled with the words, "hazardous Waste" and "Waste Aerosol Cans" that contained waste aerosols. At the time of the inspection, the tote was not marked with a hazard indicator.

View of a clear plastic tote that contained waste aerosols. The tote is labeled with the words, "Hazardous Waste" and "Waste Aerosol Cans" but is not marked with a hazard indicator.

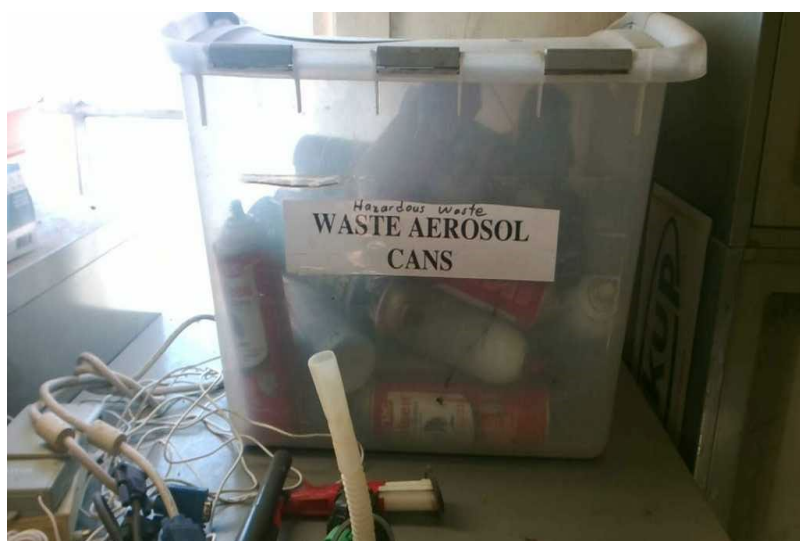
Close-up view of a clear plastic tote that contained waste aerosols. The tote is labeled with the words, "Hazardous Waste" and "Waste Aerosol Cans" but is not marked with a hazard indicator.

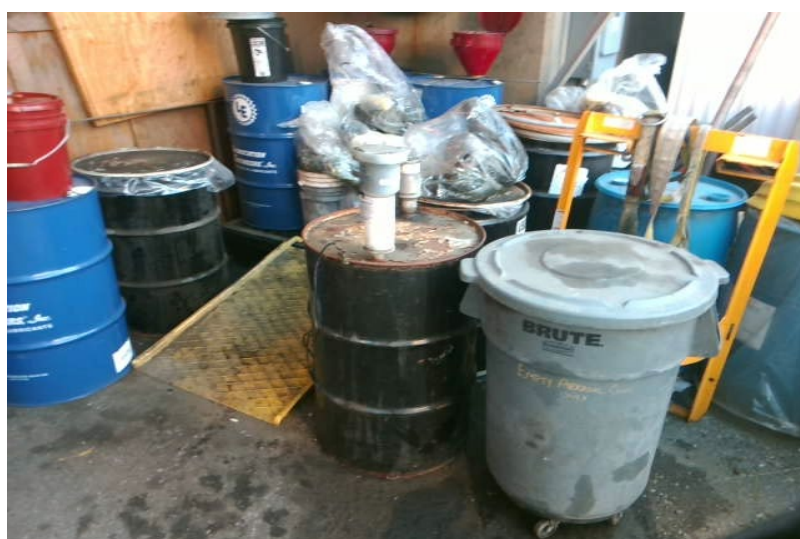
While inspecting the satellite accumulation area (SAA) near the maintenance shop, I saw a 55-gallon container with an attached aerosol can popper and filter. I asked the operator, Mr. Dean Ojala, Jr., CT3 Maintenance Mechanic Lead, about the container and he said they puncture aerosols into the container. At the time of the inspection, the container was approximately 1/6 full. The container was not labeled with the words "Hazardous Waste" and had no hazard indicator. UAF recycles the punctured aerosol cans as scrap metal.

View of a SAA container, being used to accumulate residue, from puncturing waste aerosol cans, that is not labeled with the words "Hazardous Waste" or a hazard indicator.

Following the inspection, Mr. Deck sent me an email, dated October 8, 2021, that included both written and photo documentation that the 55-gallon container had been labeled with the words labeled with the words "Hazardous Waste" and a hazard indicator.

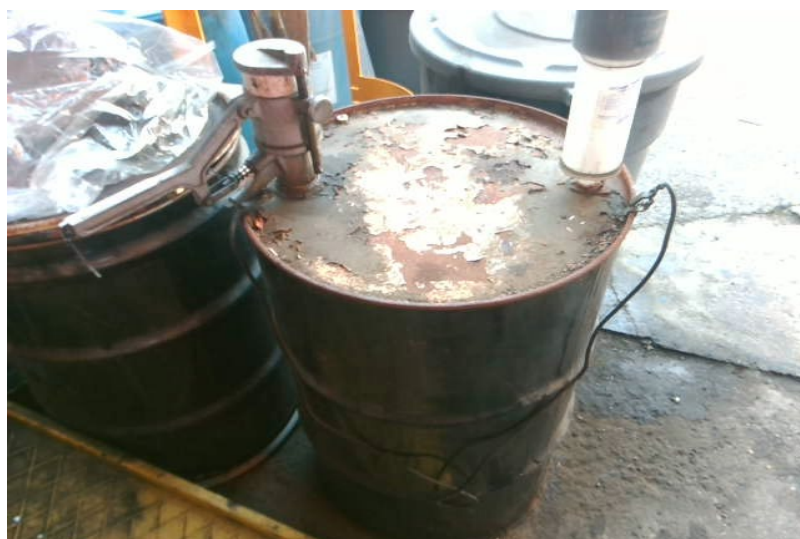
Close-up view showing the container was not labeled with the words "Hazardous Waste" or a hazard indicator.

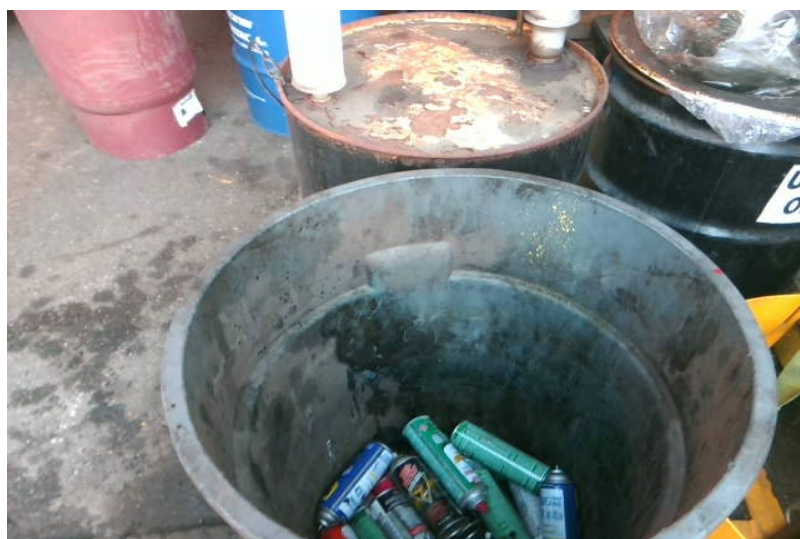
View of the punctured aerosol cans next to SAA container, being used to accumulate residue, from puncturing waste aerosol cans, that is not labeled with the words "Hazardous Waste" or a hazard indicator.

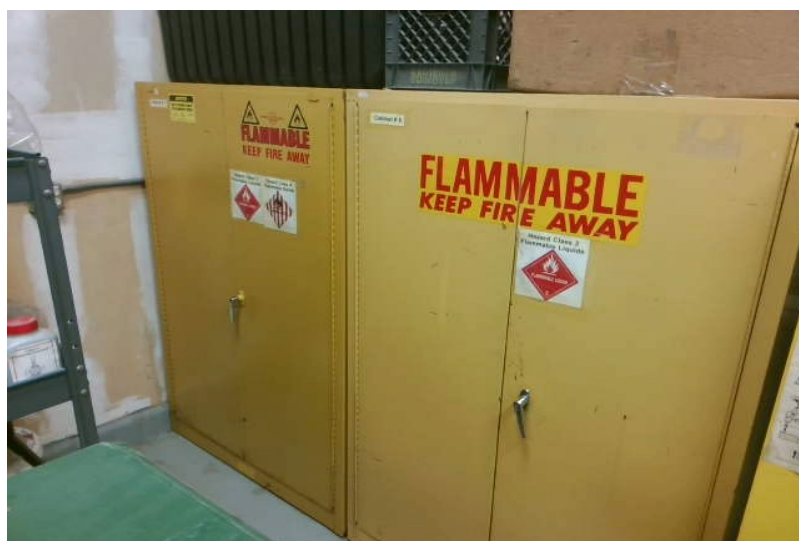
At the time of the inspection, I observed several flammable, toxic, oxidizer, and corrosive storage cabinets in Bldg. 799 HMF. The exterior of each cabinet was marked with a hazard indicator. Mr. Deck confirmed the contents in the cabinets consisted of both product and hazardous waste. The products and wastes were separated in each cabinet by either being placed on separate shelves or on opposite ends of the same shelf. I looked at the wastes inside the cabinets and saw that all the hazardous wastes were labeled with the words "Hazardous Waste", but not a hazard indicator.

View of the storage cabinets. Wastes inside the cabinets were marked with labels indicating that they were hazardous waste but did not include a hazard indicator. Each cabinet was marked with a hazard indicator.

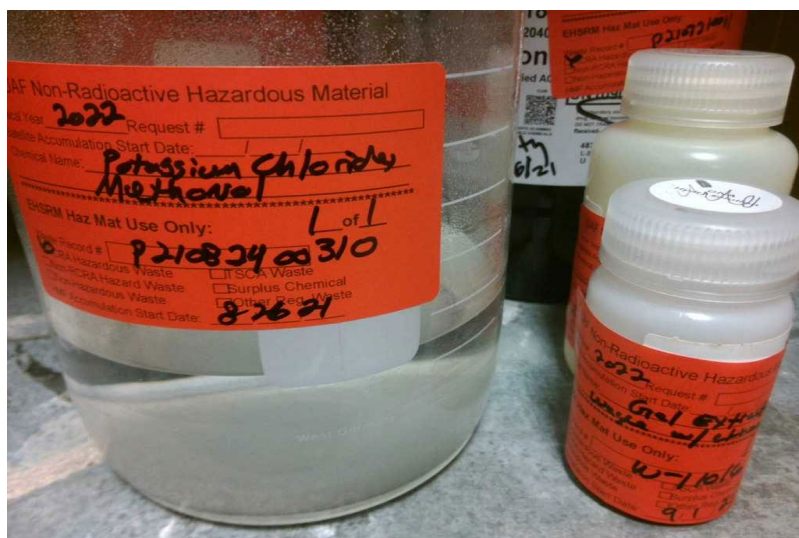
View of wastes inside the cabinets that were marked with labels indicating that they were hazardous waste but did not include a hazard indicator. Each cabinet was marked with a hazard indicator.

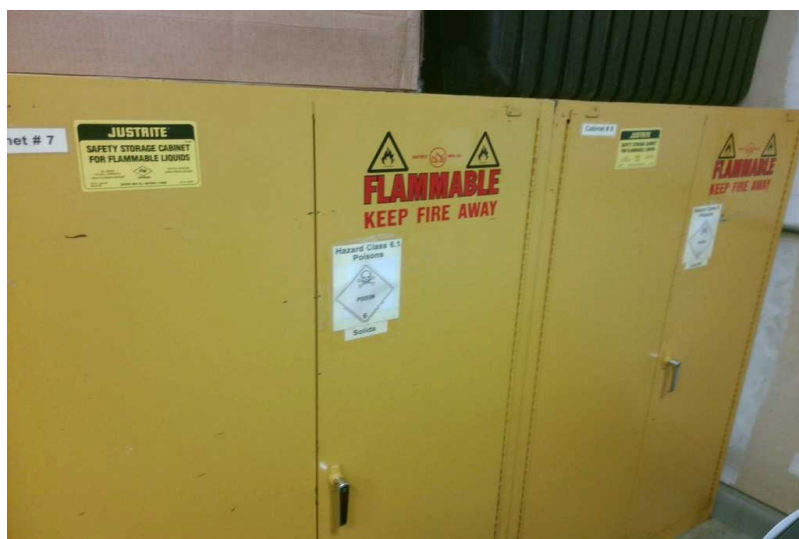
Another view of the storage cabinets that are  
marked with a hazard indicator.

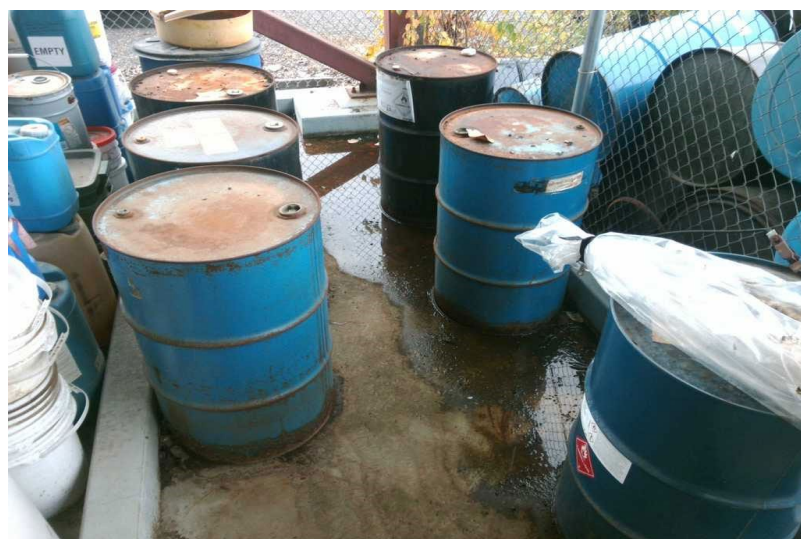
| <p>While at the HMF, I saw seven, 55-gallon containers in Cell D. I looked at the labeling on one of the containers and saw that it was labeled as containing Iso-Propyl Alcohol. The containers were in a bermed concrete containment area that held an accumulation of liquid (potentially rainwater). I could see rust around the bottoms of the containers. According to Mr. Deck, five of the containers held Isopropanol, one held Methanol, and one held Ethanol. Mr. Deck told me that the containers held product that was used in various labs across campus.</p> | |

View of seven, 55-gallon containers that according to the labels contained Isopropanol (5), Methanol (1), and Ethanol (1). The containers were sitting in an accumulation of liquid, that appeared to be rainwater, and the bottoms were rusting.

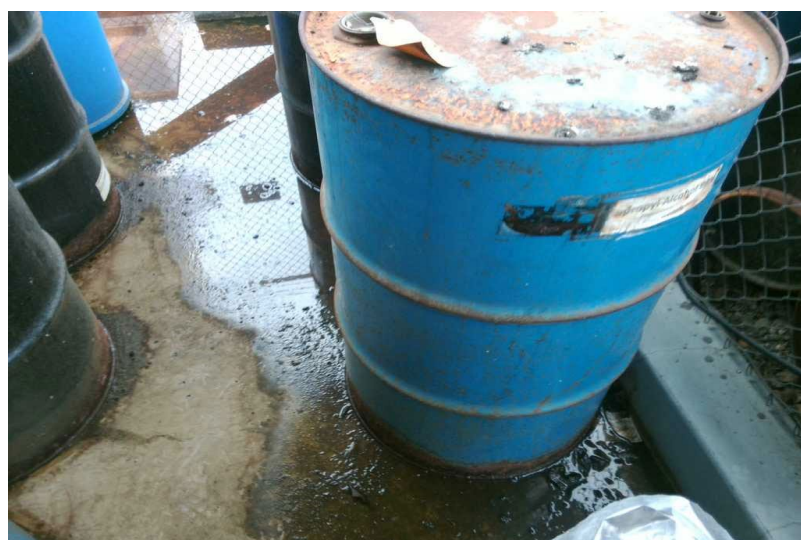
Close-up view of the rusting containers.

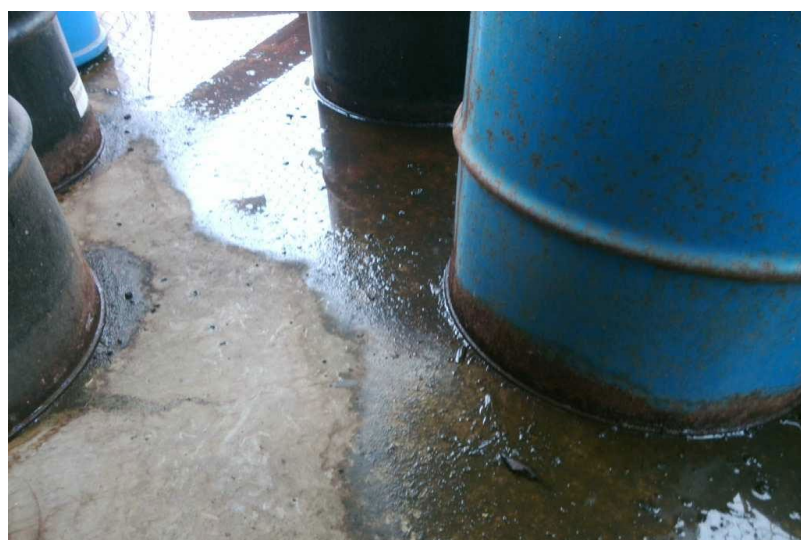
Close-up view of the rusting containers.

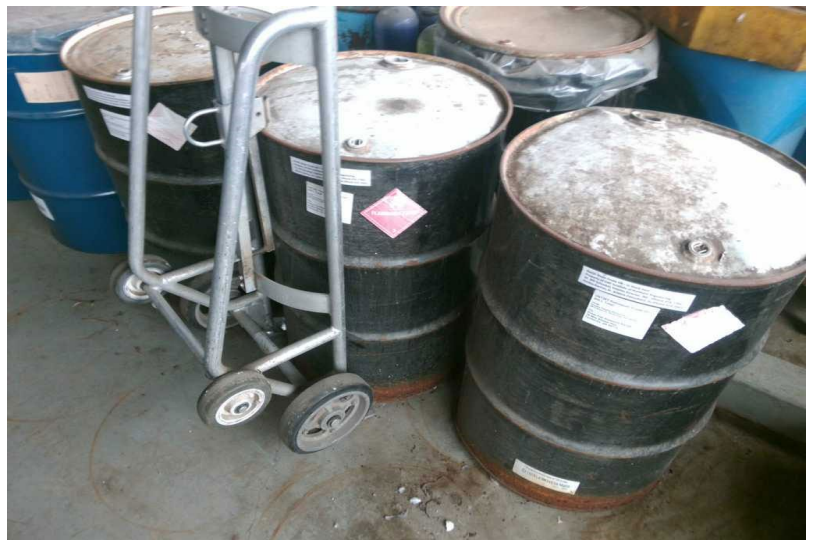
While at the covered storage area, at Bldg. 799, in Cell E, I saw several 55-gallon containers that were rusted at the bottom. According to Mr. Deck, the containers held product. According to the labels on the containers, they held North Slope Crude Oil and were marked with DOT Class 3 hazard indicators. There were three containers and two of the three were also bulging at the top and bottom of the container.

View of rusting and bulging containers that hold North Slope Crude Oil and are marked with DOT Class 3 hazard indicators.

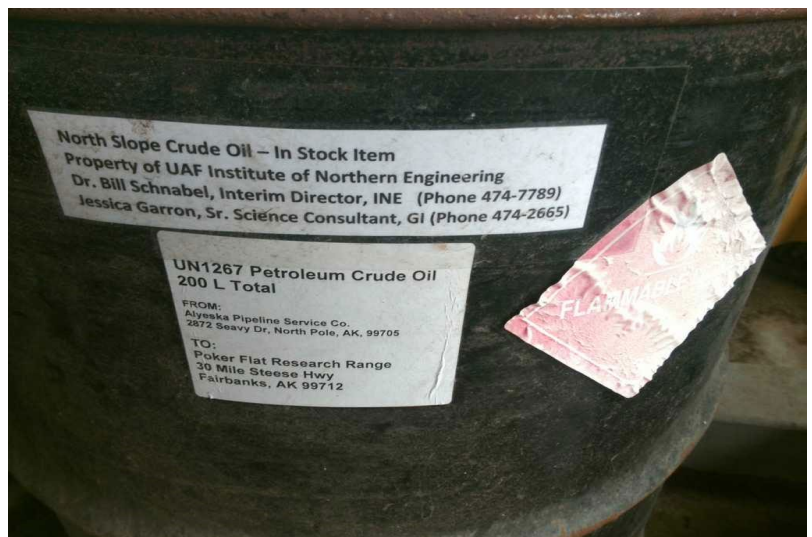
Close-up view of the labeling on the rusting and bulging containers.

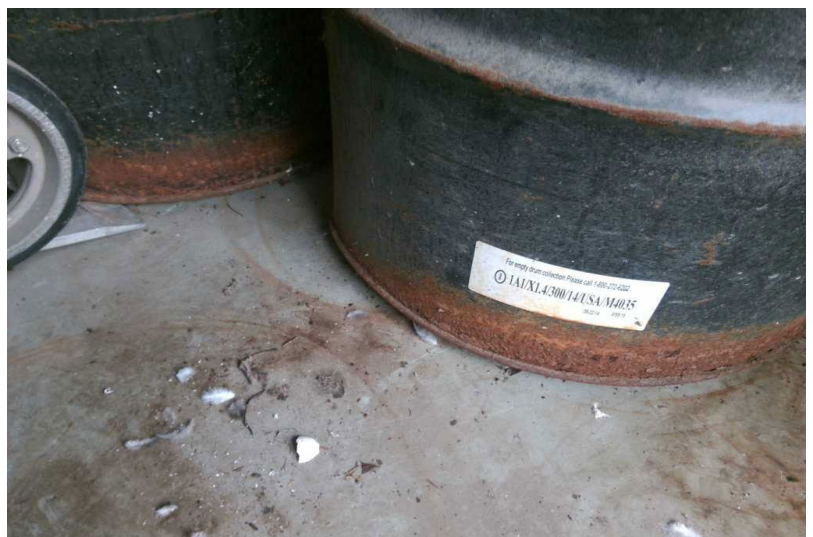
Another close-up view of the rusting and bulging containers.

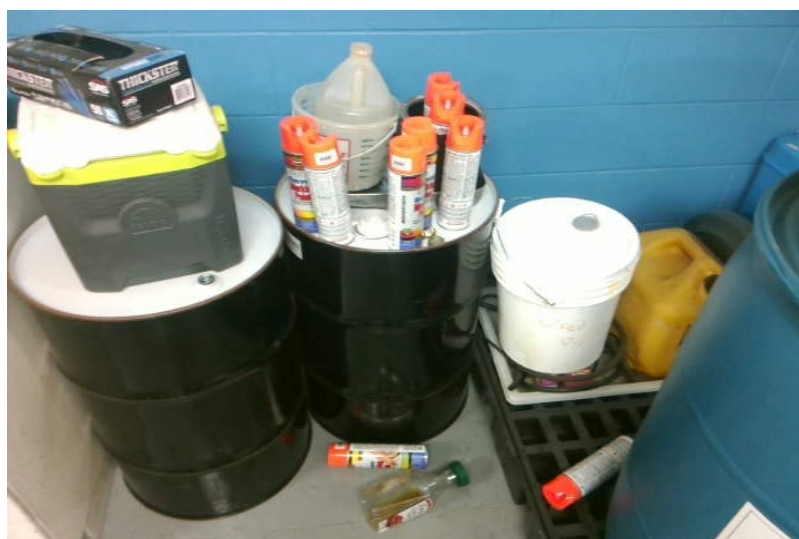
| View of nine loose waste aerosol cans that were not labeled with the words "Universal Waste - Aerosols." |

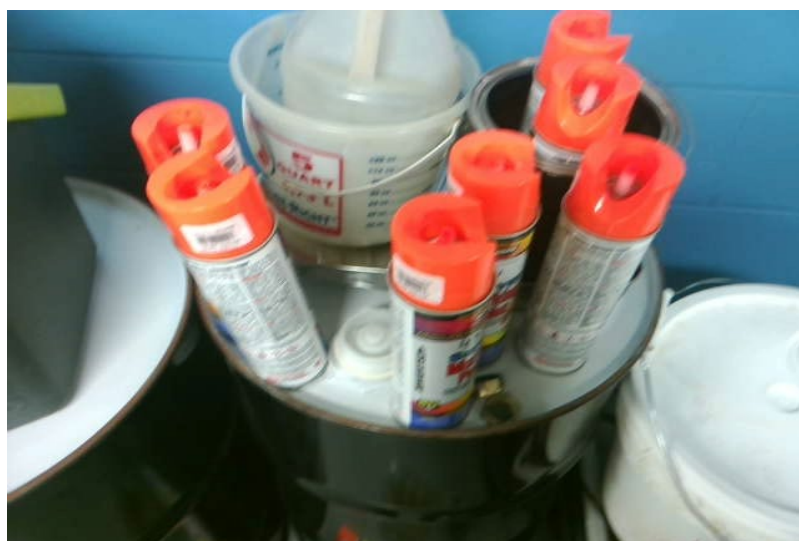
| Close-up view of seven of the nine loose waste aerosol cans that were not labeled with the words "Universal Waste - Aerosols." |

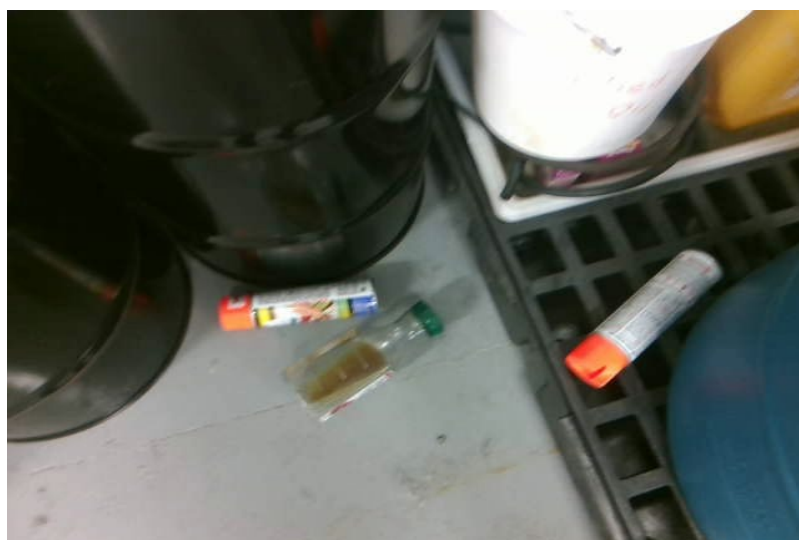
| Close-up view of the other two loose waste aerosol cans that were not labeled with the words "Universal Waste - Aerosols." |

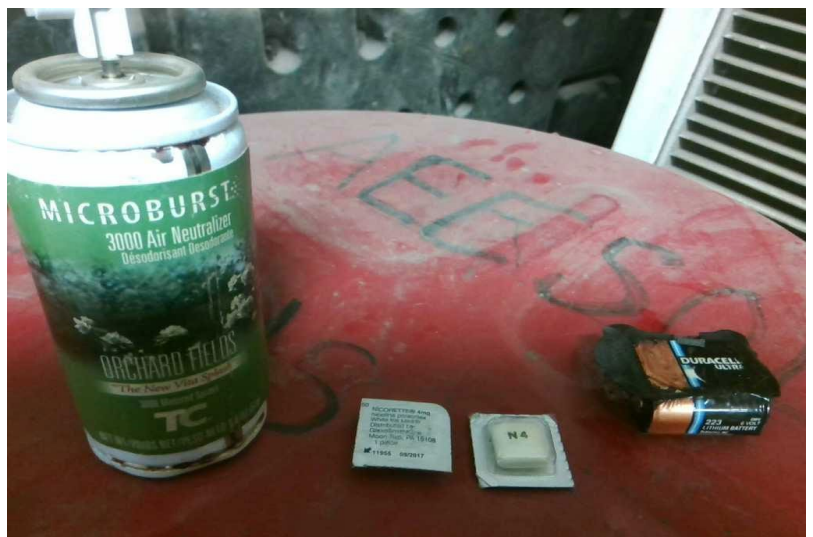
View of the contents of the step-can which include a waste aerosol can, a small, leaking lithium battery, and two pieces of "Nicorette" gum.

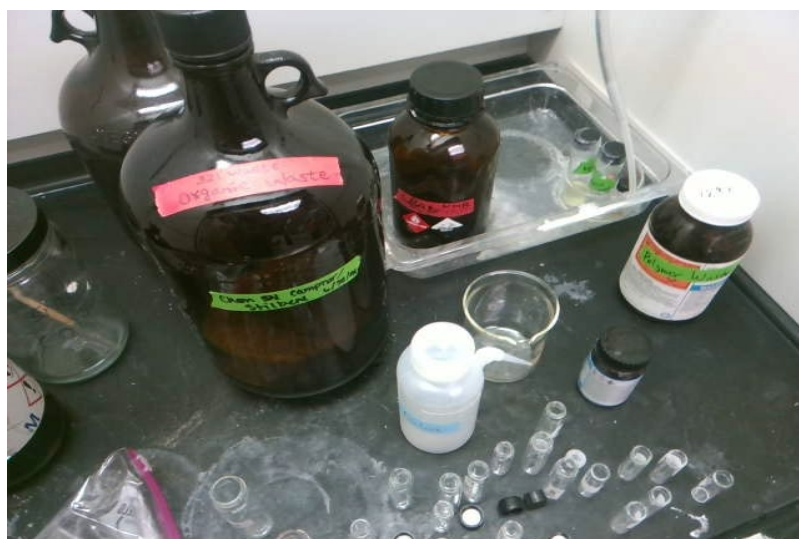
A view of SAA wastes in containers that are not labeled with the words "Hazardous Waste" or hazard indicators.

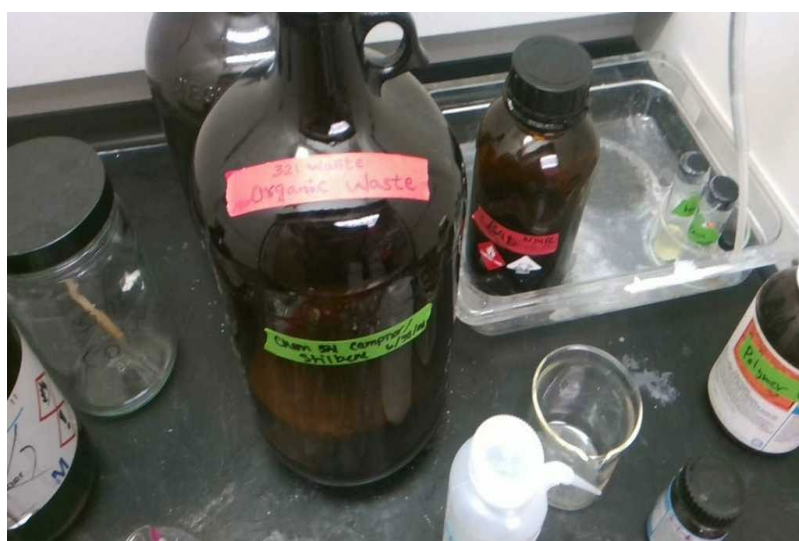
Additional view of the same SAA wastes in containers that are not labeled with the words "Hazardous Waste" or hazard indicators.

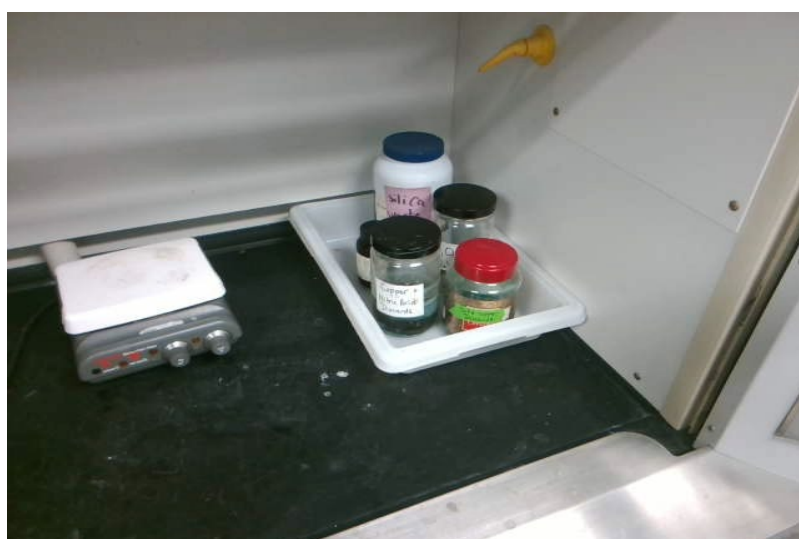
Waste containers under fume hood that are not labeled with the words "Hazardous Waste" or hazard indicators.

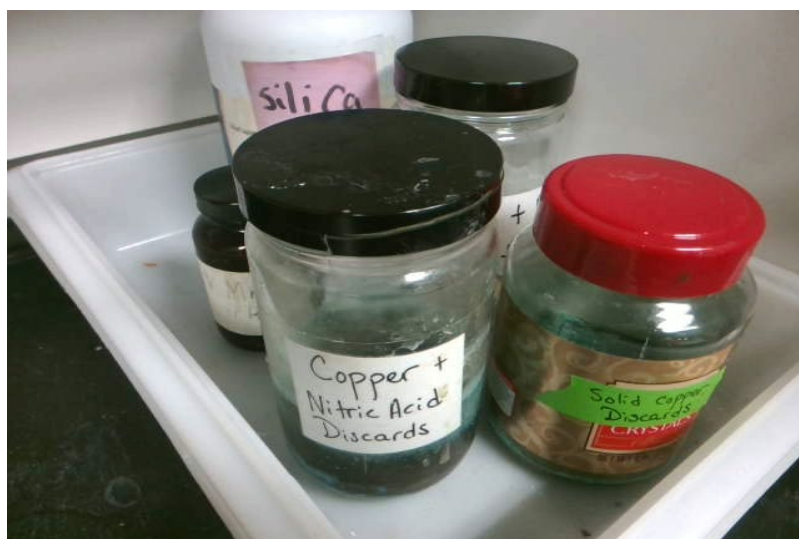
Close-up view of the same waste containers under fume hood that are not labeled with the words "Hazardous Waste" or hazard indicators.

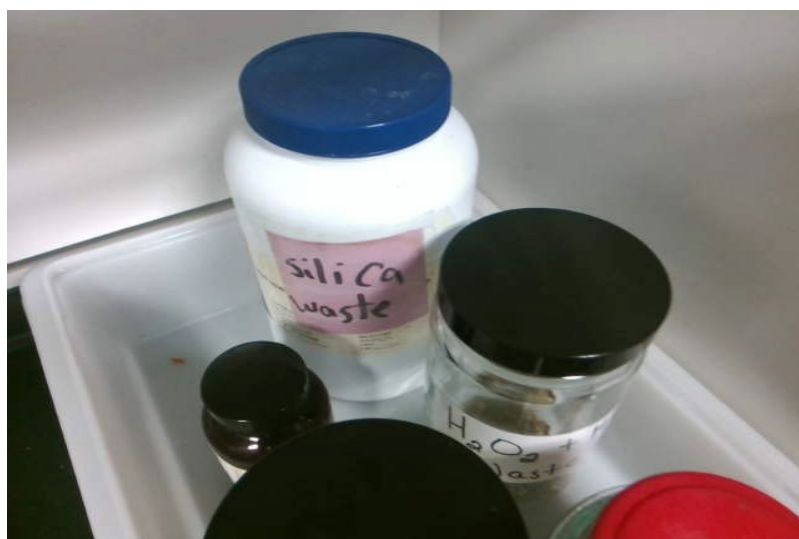
Another close-up view of the same waste containers under fume hood that are not labeled with the words "Hazardous Waste" or hazard indicators.

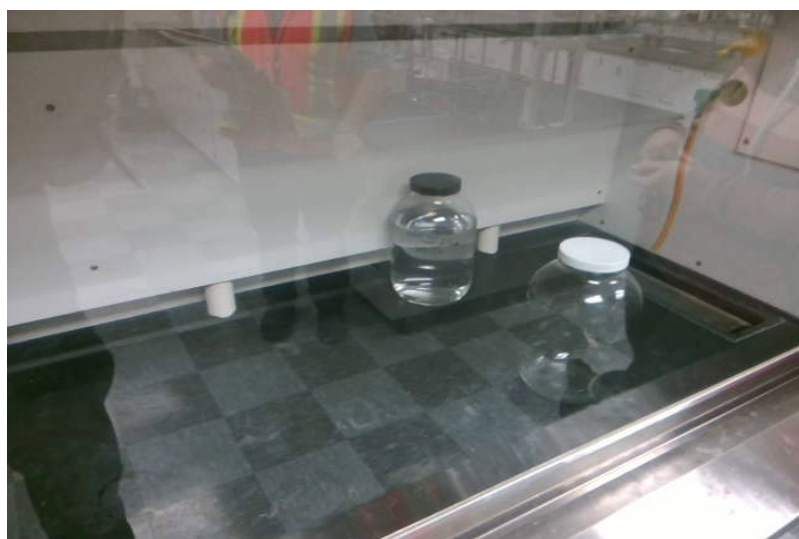
View of an unknown waste in containers under fume hood. Containers under fume hood are not labeled with the words "Hazardous Waste" or hazard indicators.

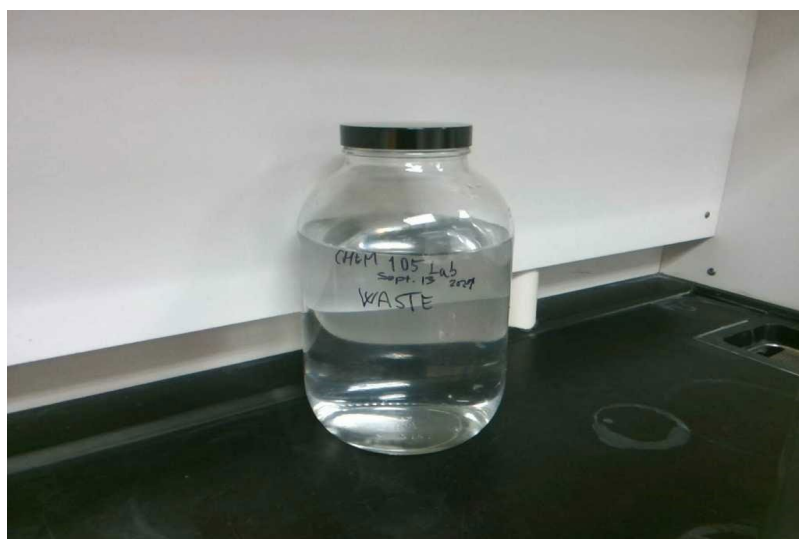
Close-up view of the unknown waste in container under vent hood. Dated 9/13/21. Containers under fume hood is not labeled with the words "Hazardous Waste" or hazard indicator.

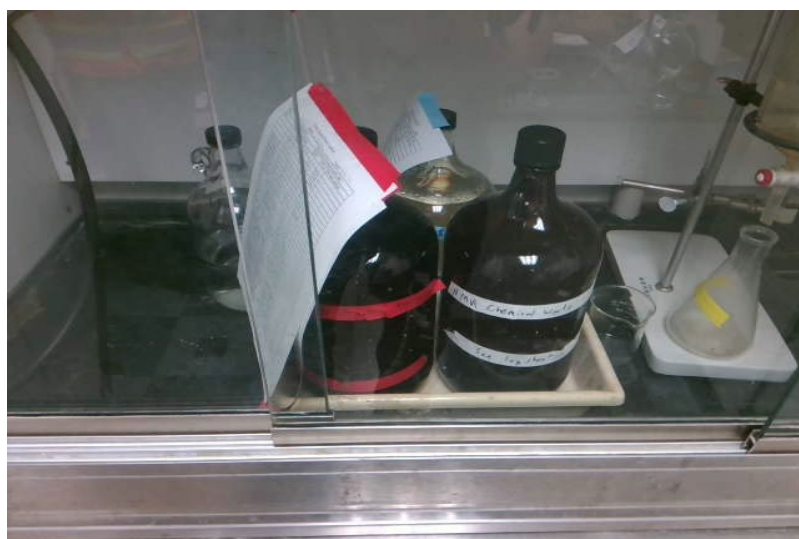
View of three waste containers under fume hood. Containers under fume hood that are not labeled with the words "Hazardous Waste" or hazard indicators.

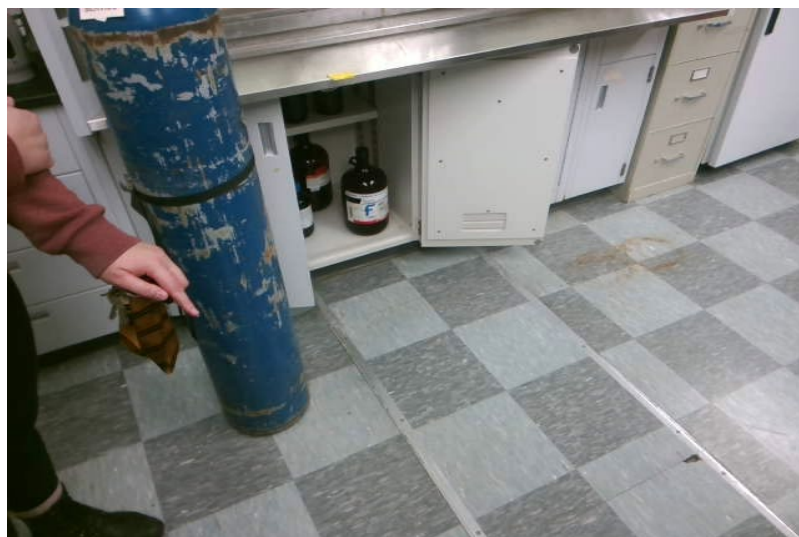
View of additional waste containers beneath  
fume hood that are not labeled with the words  
"Hazardous Waste" or hazard indicators.

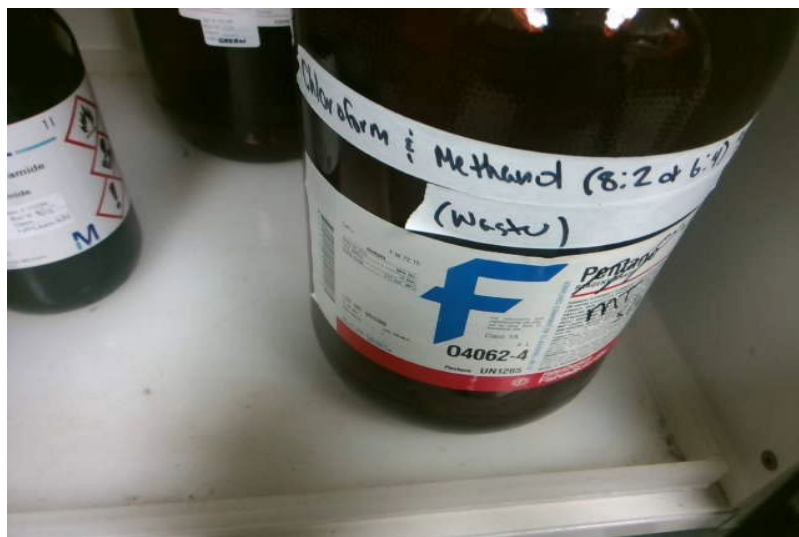
Close-up view of the additional waste  
containers beneath fume hood that are not  
labeled with the words "Hazardous Waste" or  
hazard indicators.

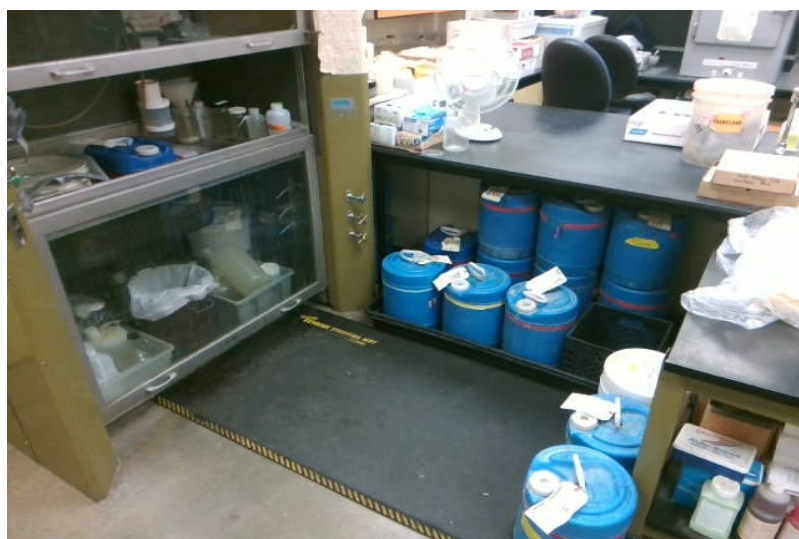
View of five, 5-gallon containers, four of which held waste Formalin and one that held waste Isopropyl alcohol. The container of waste Isopropyl alcohol was not labeled with the words "Hazardous Waste" or a hazard indicator.

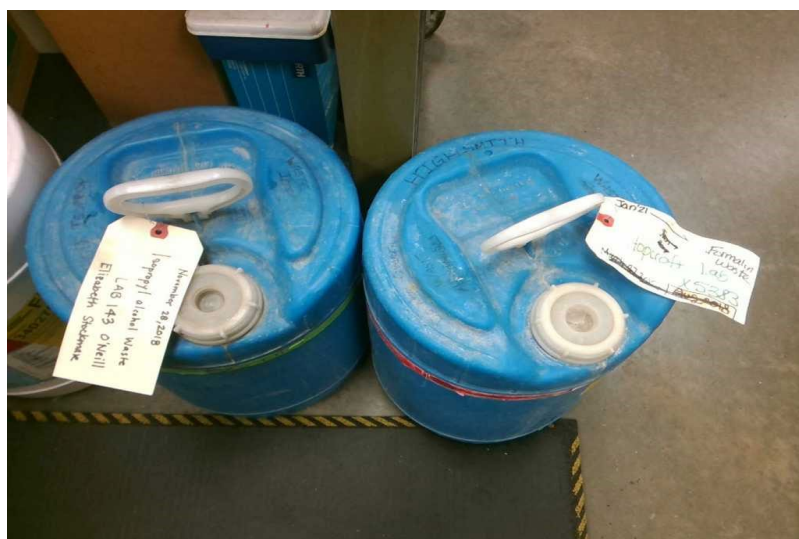
Close-up view of the container of waste Isopropyl alcohol (Seen here on the left) was not labeled with the words "Hazardous Waste" or a hazard indicator.

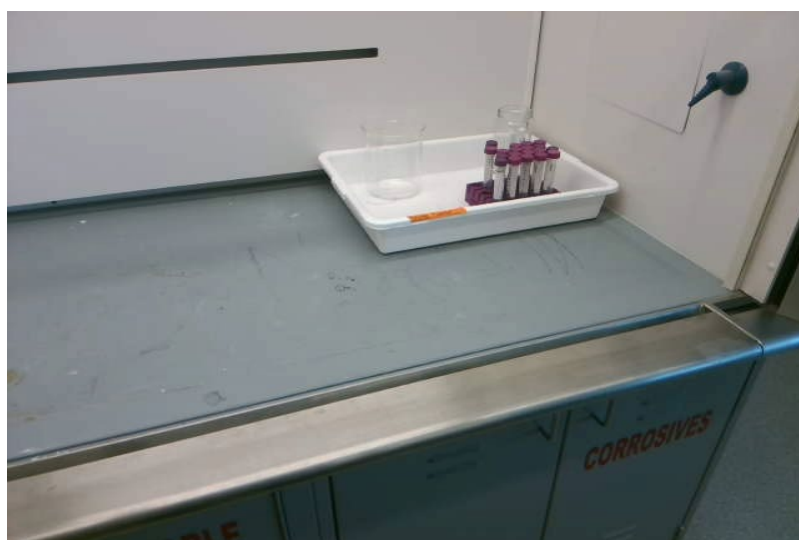
View of plastic tray under a fume hood that contained vials of waste ethanol. The vials were not labeled with the words "Hazardous Waste" or a hazard indicator.

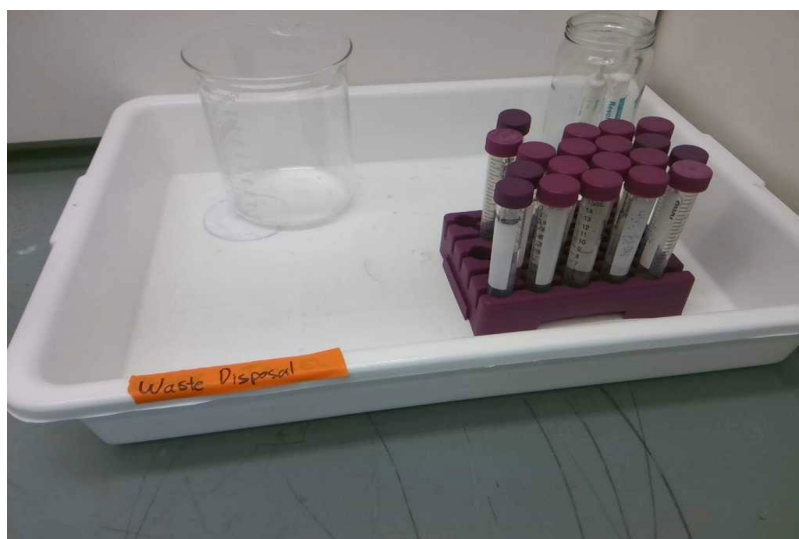
Another view of the same plastic tray under a fume hood that contained vials of waste ethanol. The vials were not labeled with the words "Hazardous Waste" or a hazard indicator.

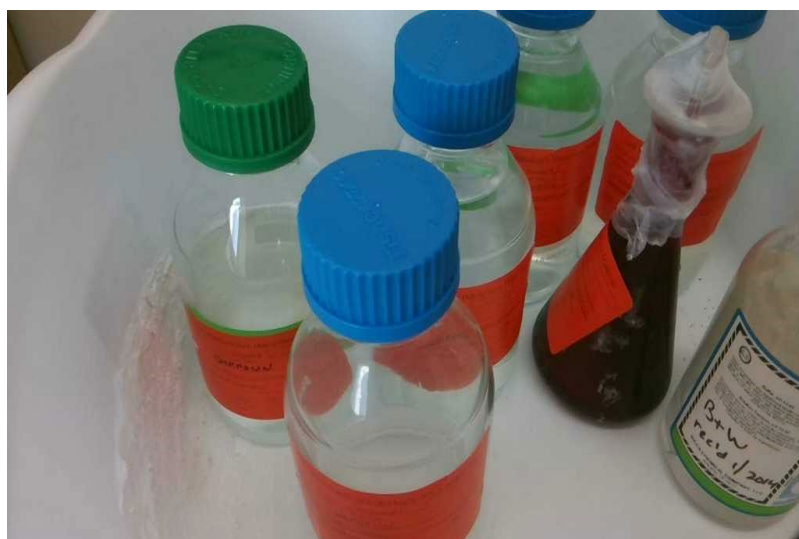
View of a plastic tub inside of a fume hood. The plastic tub held six smaller containers all labeled "Unknown" waste. The containers were not labeled with the words "Hazardous Waste" or a hazard indicator.

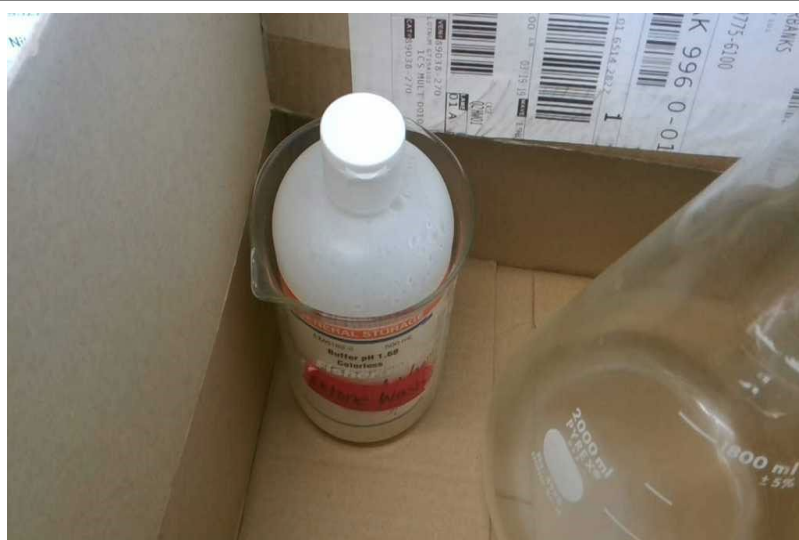
View of box containing a bottle of waste pH 1.68 buffer solution. The bottle of waste pH 1.68 buffer solution was not labeled with the words "Hazardous Waste" or a hazard indicator.

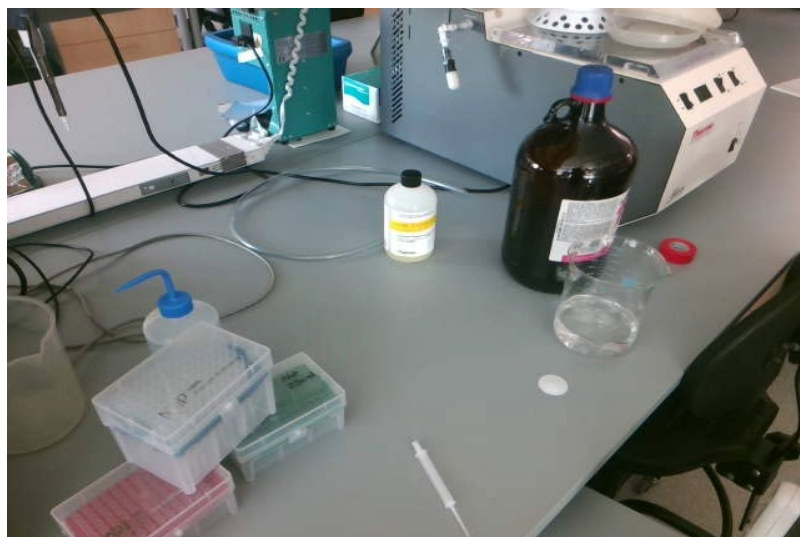
View of another waste container, seen here with a yellow label, was found across from the previous table and was not labeled with the words "Hazardous Waste" or a hazard indicator.

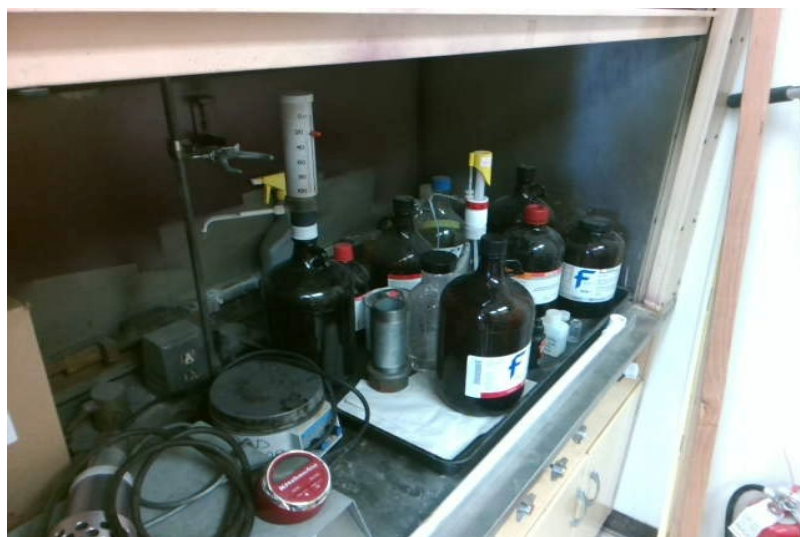
View of a fume hood containing a waste that is not labeled with the words "Hazardous Waste" or a hazard indicator.
