## REGION 10 Enforcement Division

### INSPECTION REPORT

| <b>Company Name:</b> | University of Alaska | | |
| <b>Facility or Site Name:</b> | University of Alaska Fairbanks | | |

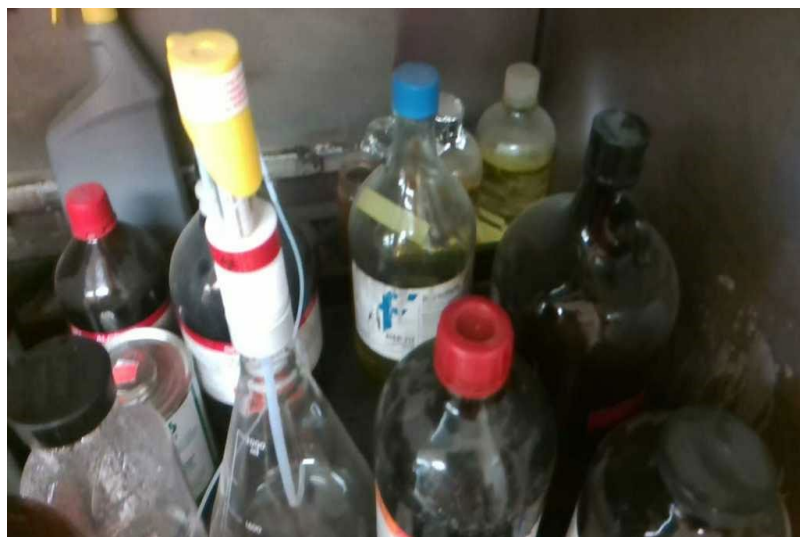
View of the container of waste HCL, seen here with the blue cap, that is not labeled with the words "Hazardous Waste" or a hazard indicator.

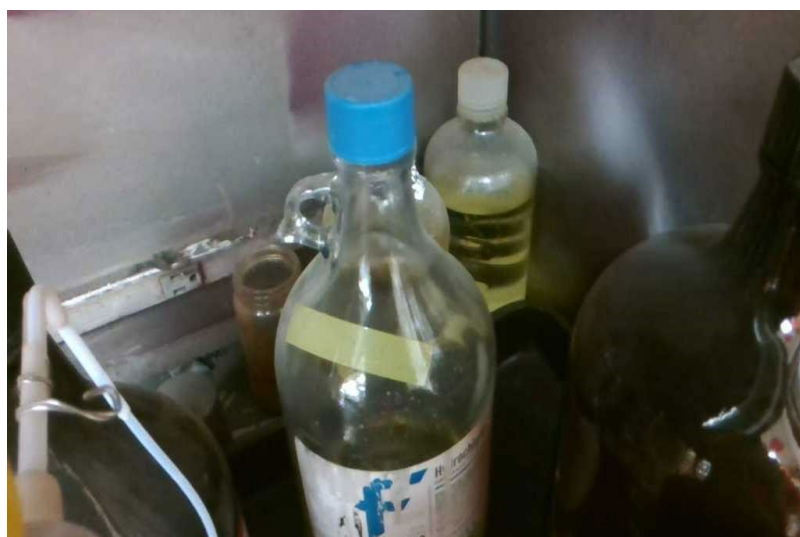
Close-up view of the container of waste HCL, seen here with the blue cap, that is not labeled with the words "Hazardous Waste" or a hazard indicator.

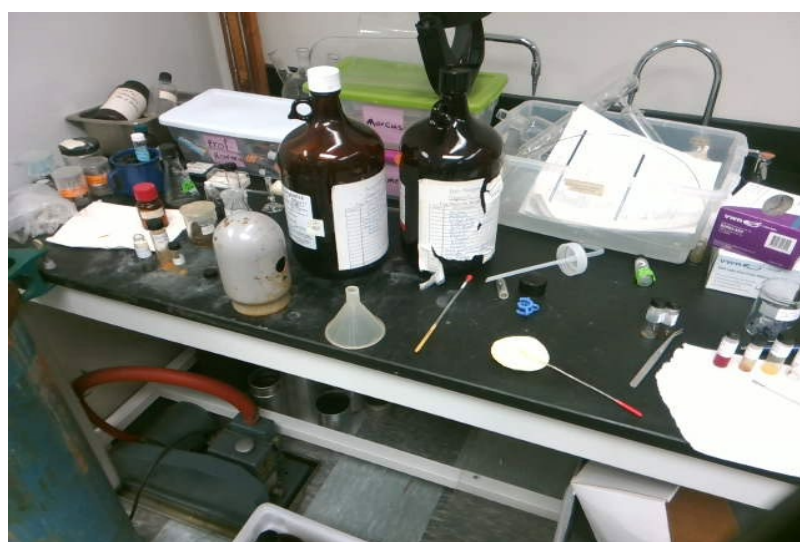
View of two four-liter containers on the table  
that contained an organic waste. The containers  
were not labeled with the words "Hazardous  
Waste" or a hazard indicator.

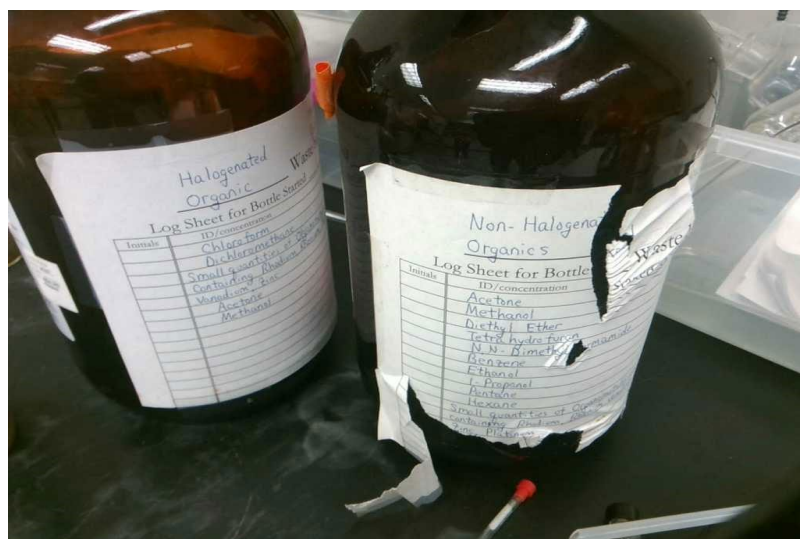
Close-up view of two four-liter containers on  
the table that contained an organic waste. The  
containers were not labeled with the words  
“Hazardous Waste” or a hazard indicator.

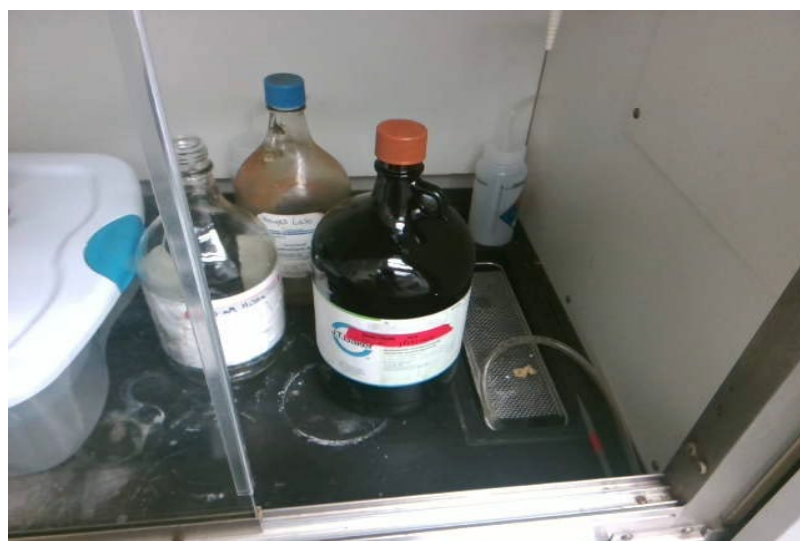
View of waste container, marked with red tape,  
that was not labeled with the words “Hazardous  
Waste” or a hazard indicator.

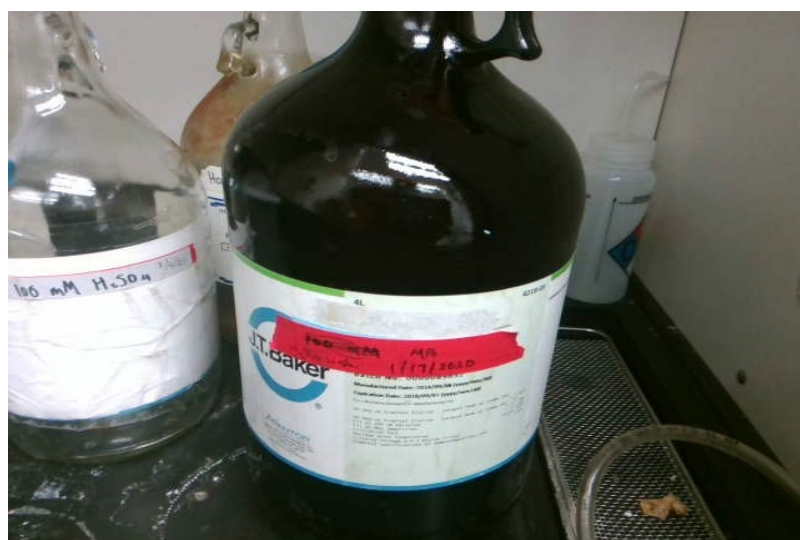
Close-up view of waste container, marked with  
red tape, that was not labeled with the words  
“Hazardous Waste” or a hazard indicator.

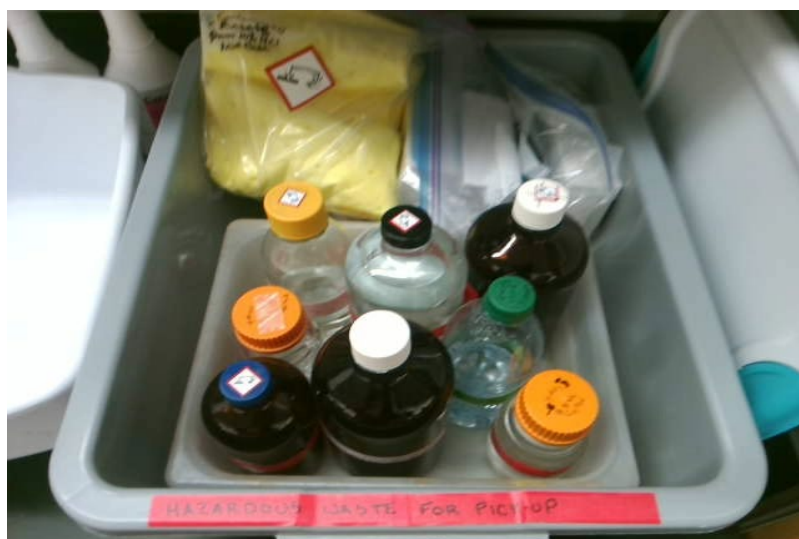
| <p>While in the ELIF Bldg. I saw a plastic container on a table in the lab on the south side of the building that was labeled as waste for pick-up. During the inspection, I requested an inventory of the plastic container. I asked that the inventory include waste type, container size and method of management. None of the wastes in the plastic container were labeled with the words "Hazardous Waste" or hazard indicators.</p> <p>Following the inspection, Mr. Deck sent me an email, dated October 8, 2021, that included both verbal and photo documentation that the containers of hazardous waste observed during the inspection were labeled with the words "Hazardous Waste" and hazard indicators. Mr. Deck also provided a copy of an inventory of the containers identified. The inventory includes the number of containers, container size, hazard determination and reference to photos taken of corrections made.</p> | |

View of a plastic tub of waste that is marked as "Hazardous waste for pick-up" on a table in the lab on the south side of the bldg. None of the containers in the tub are labeled with the words "Hazardous Waste" and not all were marked with a hazard indicator.

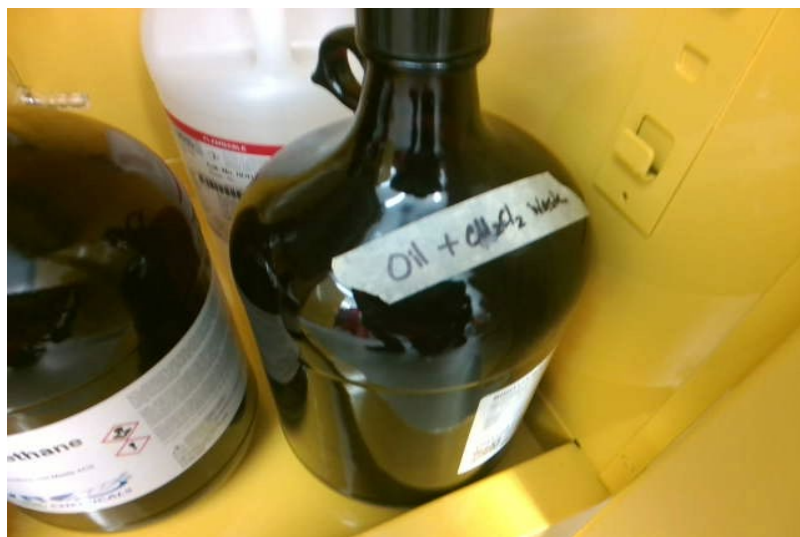
| View of additional waste containers that are not labeled with the words "Hazardous Waste" or a hazard indicator. |

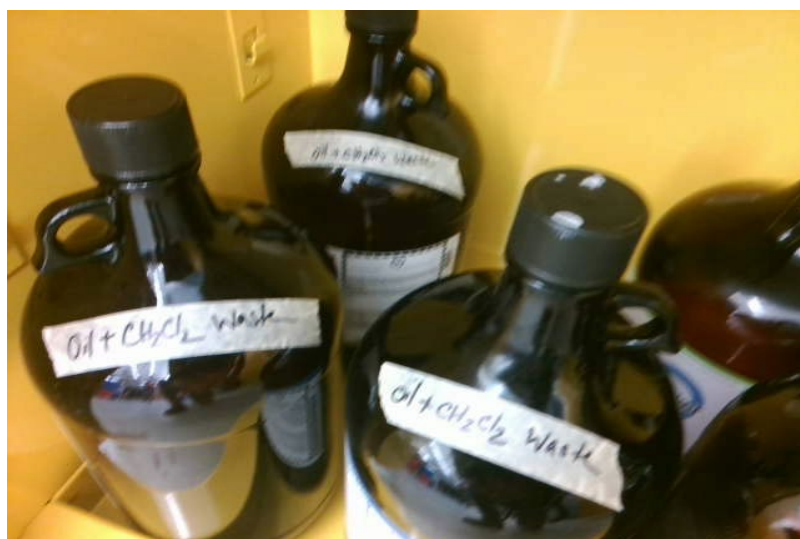
| View of additional waste containers that are not labeled with the words "Hazardous Waste" or a hazard indicator. |

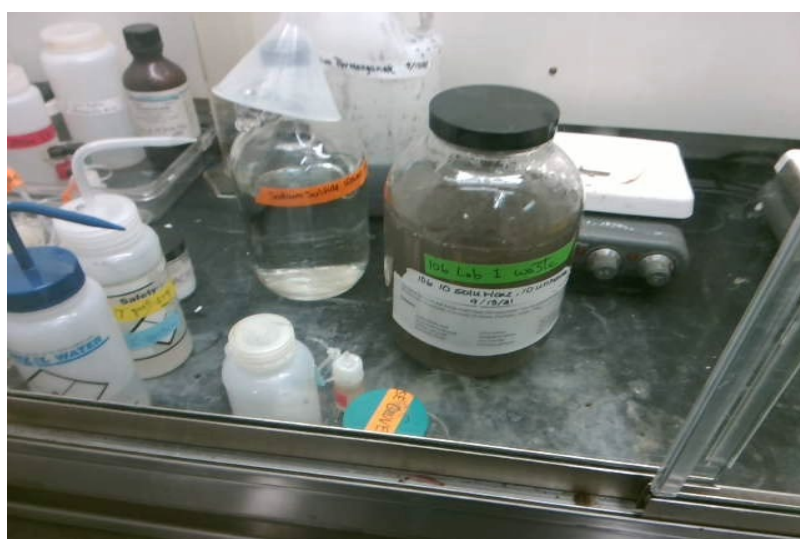
| View of waste container under the fume hood, labeled with green tape as an unknown and is not labeled with the words "Hazardous Waste" or a hazard indicator. |

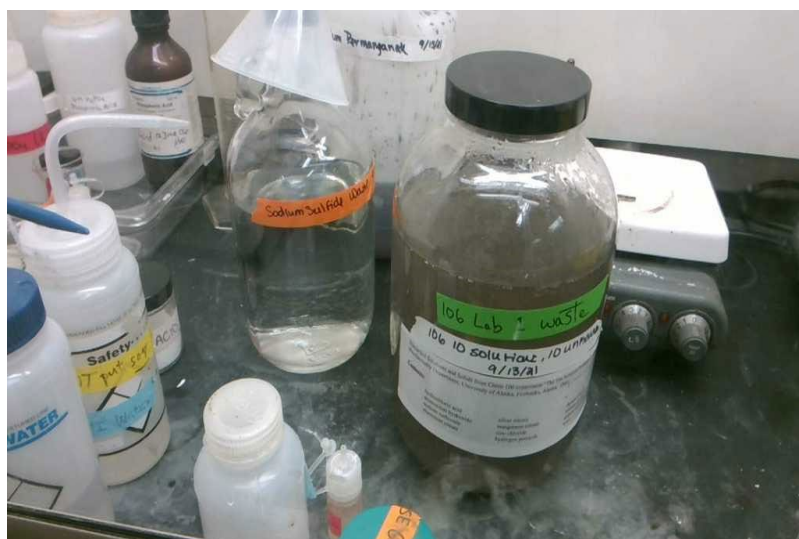
Close-up view of waste container under the fume hood, labeled with green tape as an unknown and is not labeled with the words "Hazardous Waste" or a hazard indicator.

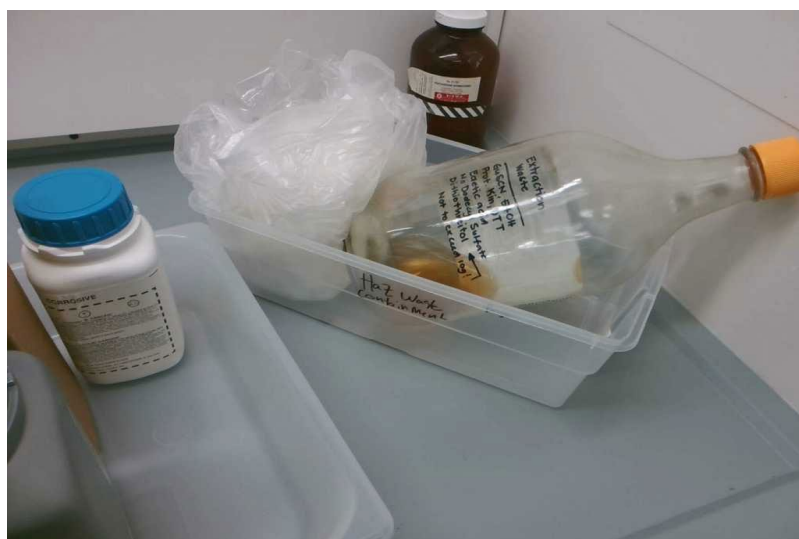
View of container under fume hood that is in another plastic tub. The plastic tub is labeled as Hazardous Waste Containment. The container in the tub is not labeled with the words "Hazardous Waste" or a hazard indicator.

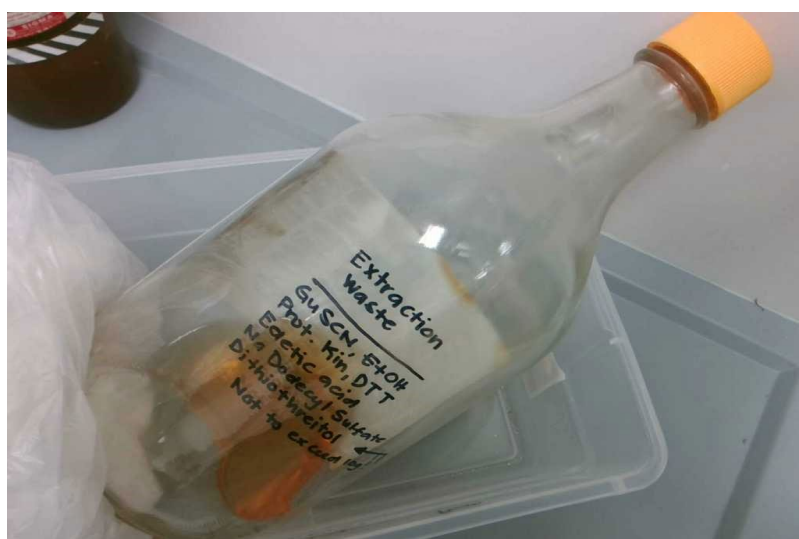
The container in the tub, seen in the previous photo, is not labeled with the words "Hazardous Waste" or a hazard indicator.

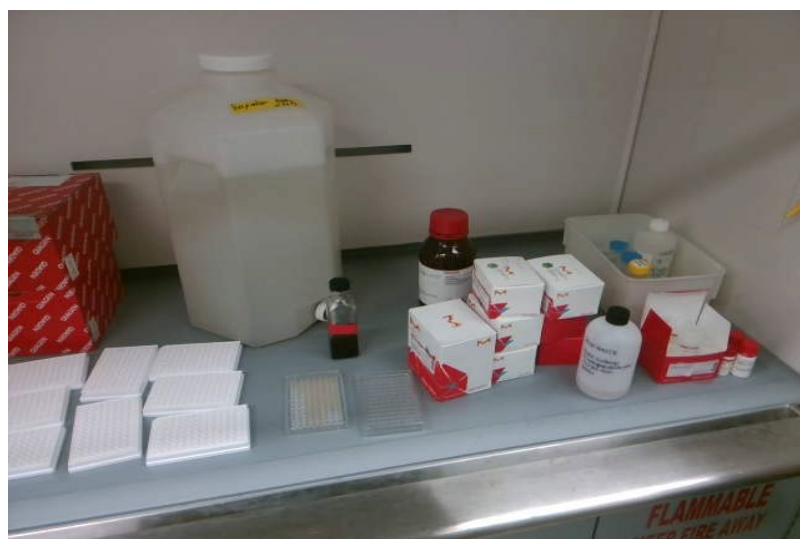
View of a second fume hood in the same room (318B) also had containers of waste that were not labeled with the words "Hazardous Waste" or a hazard indicator. The containers include the large plastic container in the rear of the fume hood, small bottle of dark liquid marked with red tape, and the small white container with the black cap.
