# NPDES Compliance Inspection Report

## Federal Cartridge Company (Speer/CCI) Lewiston, Idaho

NPDES Permit Tracking Number  
# IDR053179

Inspection Date: March 29, 2023

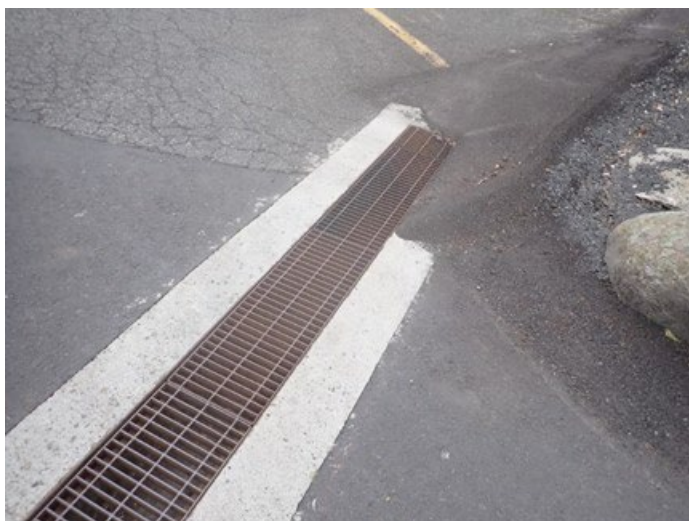
Photo #:01 (P3290004)

Description: Facing south, photo of French drain and berm on western entrance/exit of facility parking lot.

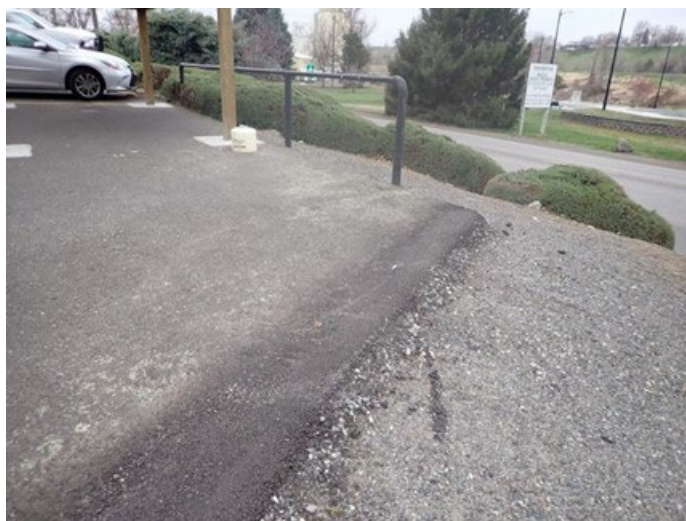
Photo #:02 (P3290006)

Description: Facing southwest, close-up photo of the berm on western entrance/exit of facility parking lot.

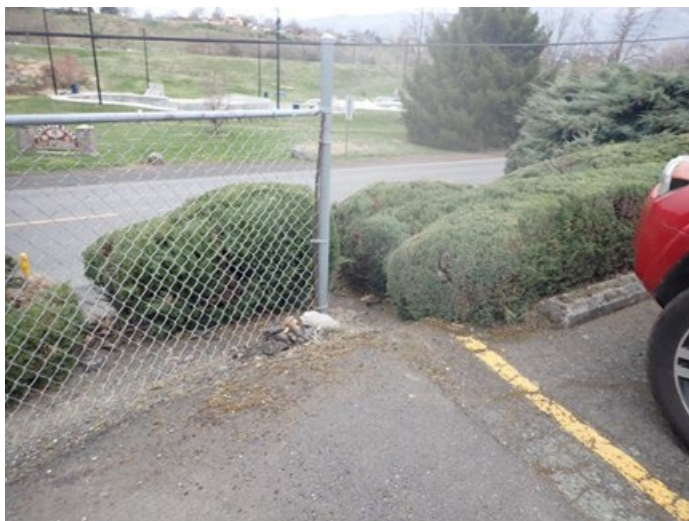
Photo #:03 (P3290009)

Description: Facing west, photo of opening where drainage leads to street in southwestern part of the facility parking lot due to slope aspect change.

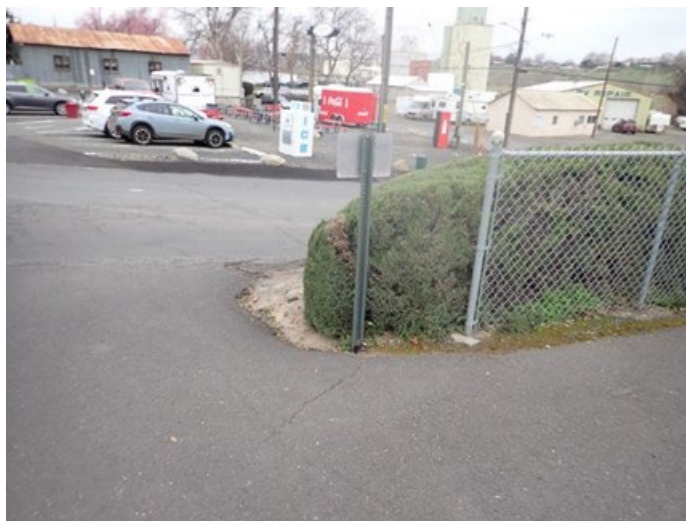
Photo #:04 (P3290011)

Description: Facing southwest, photo of the right side of the entrance/exit of facility parking lot.

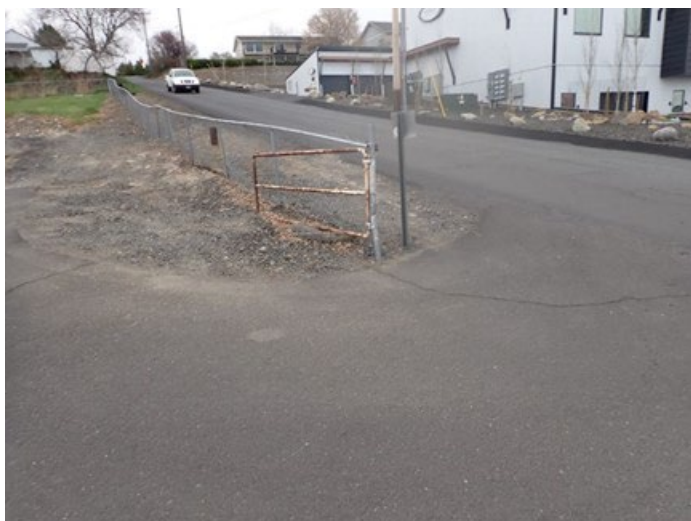
Photo #:05 (P3290014)

Description: Facing southeast, photo of the left side of the entrance/exit of facility parking lot.

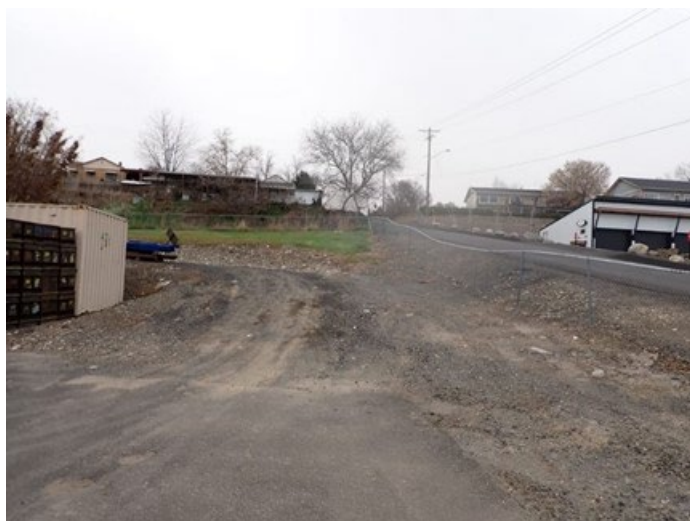
Photo #:06 (P3290017)

During the inspection, there were concerns of insufficient gravel on the pervious road and surfaces leading up to and down from the outdoor storage and staging area that can create track out of sediment from vehicle and foot traffic and discharged with stormwater out the southern entrance/exit of the Facility’s parking lot. Post-inspection, the Facility provided written documentation indicating the Facility removed materials in the staging area to an off-site storage facility. The Facility is currently working on adding more gravel to the area and designating the area as a non-storage and non-staging area.

Description: Facing east, photo of pervious (gravel) road leading up to material storage area from the southeastern part of the facility parking lot.

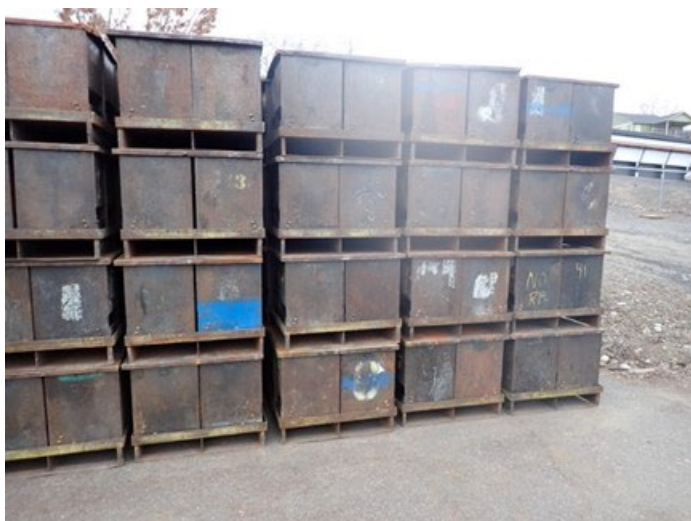
Photo #:07 (P3290019)

We continued walking to observe the eastern part of the parking lot where we observed empty ammunition boxes and active onsite contracting work being performed at the Facility (**Photo 7 & Photo 8**). We observed trash behind an equipment storage connex box next to the contractor work area (**Photo 9**). As part of the Facility's best management and housekeeping practices described in the Facility's SWPPP, trash is picked up at least twice per week by Environmental Services personnel using company owned equipment and disposed of at least once per week at the local landfill. Non-regulated recyclable materials are regularly picked up by Lewis-Clark Recyclers. Facility grounds are inspected weekly for stormwater issues by Environmental Services personnel. Bins for scrap metal are used throughout the Facility and are picked up daily. The Facility utilizes an environmental observation tool in which facility employees are instructed to address pollutants seen and properly dispose of them in marked bins. The Facility's observation tools offer metrics and employee concern tracking.

Description: Facing south, photo of ammunition boxes outside east of the facility's parking lot.

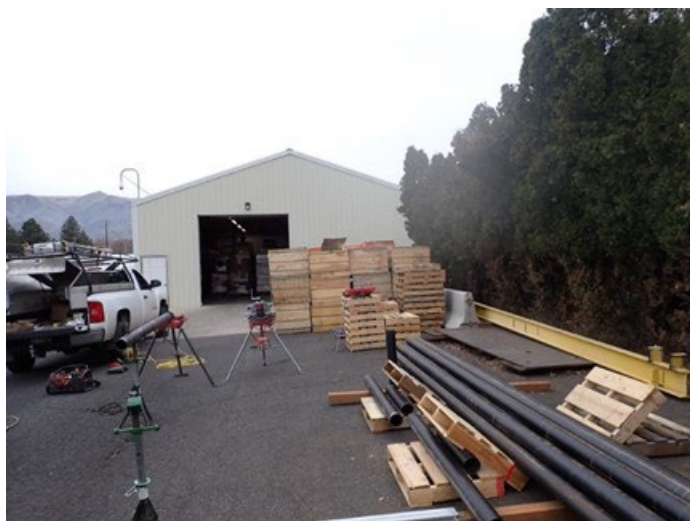
Photo #:08 (P3290024)

Description: Facing north, photo of the onsite contractor work being performed at the facility east of the parking lot.

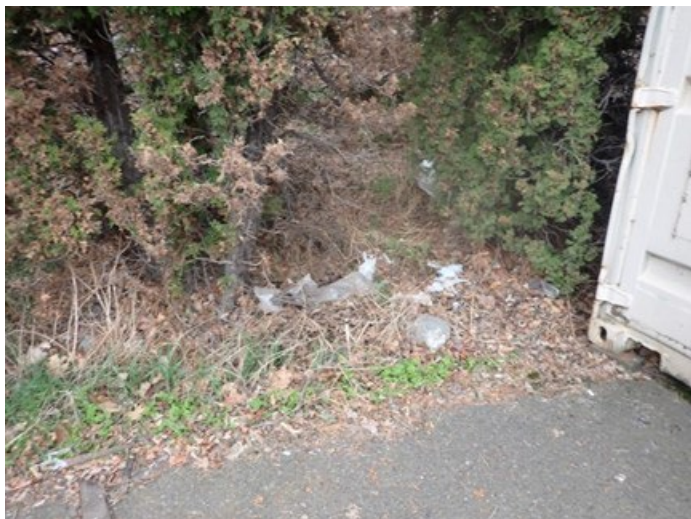
Photo #:09 (P3290026)

During the inspection I observed plastic, general trash, and other debris scattered throughout the Facility’s grounds. During the inspection, when possible, Facility representatives picked up debris. Post-inspection, the Facility provided written documentation indicating the Facility cleaned up and discarded the debris and that the importance of good housekeeping was discussed during leadership meetings. The Facility also plans to increase the frequency of the sweeper truck schedule.

Description: Facing southeast, photo of trash on the facility's grounds east of the parking lot.

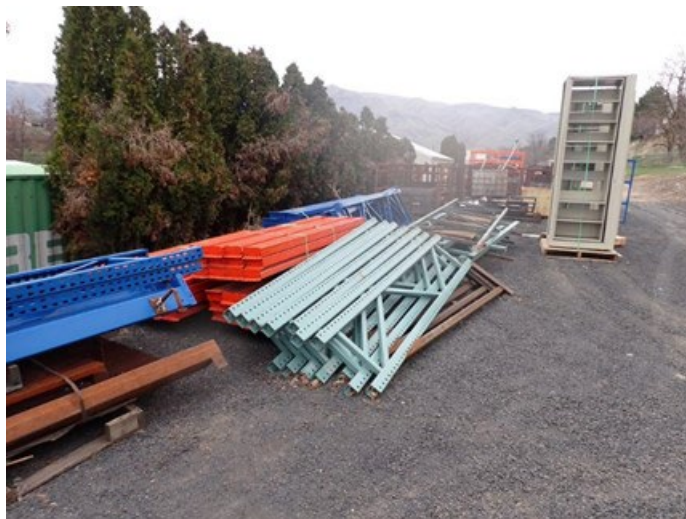
Photo #:10 (P3290038)

During the inspection, I observed what appeared to be a large outdoor storage and staging area of uncovered worn materials, such as metal racks, shelving, and bins in which stormwater could encounter pollutants from this area and drain down-slope and out the southern parking lot entrance/exit. Post-inspection, the Facility provided written documentation indicating the Facility removed materials in the staging area to an off-site storage facility, and the area was designated as a non-storage and non-staging area by Facility leadership.

Description: Facing north, photo of the facility's eastern perimeter and area that generally appears to be used for outdoor material storage and staging.

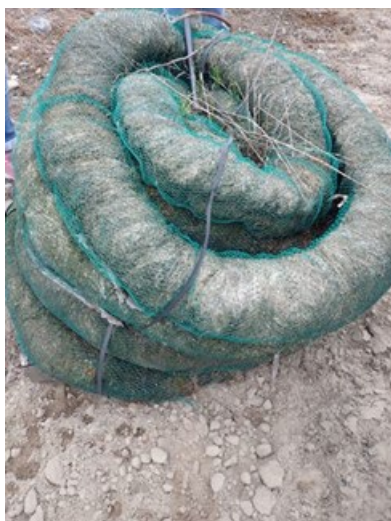
Photo #:11 (P3290057)

Description: Facing south, photo of worn straw waddle on facility's northeastern perimeter.

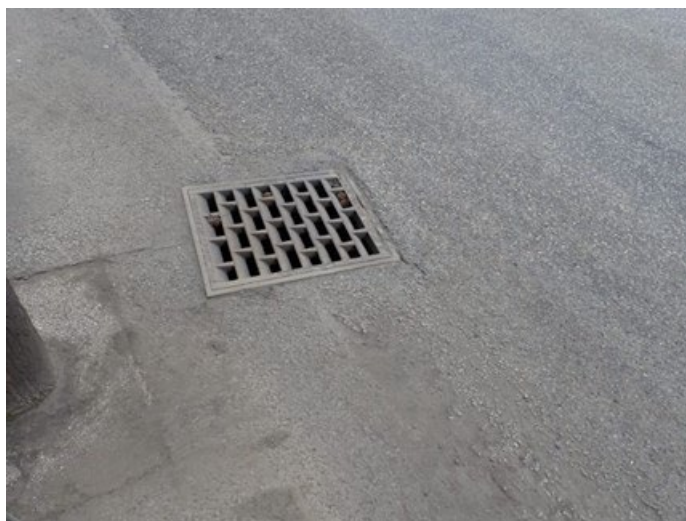
Photo #:12 (P3290072)

where we observed the Facility's ground infiltration basin in which overflow would drain out a pipe (**Photo 13**) that would then drain to the storm drain (**Photo 12**) connecting to the City of Lewiston's stormwater system. When asked if the Facility considered enhanced or additional stormwater controls and mitigation measures to minimize impacts from stormwater discharges from major storm events. The Facility indicated that it did not have such considerations documented yet. As we walked to the storm drain, we observed a loading and unloading area that did not have stormwater controls to ensure stormwater diverted into the drain (**Photo 12 & Photo 14**) given it is not listed as an outfall in the Facility's SWPPP.

Description: Facing south, photo of the facility's only storm drain located west of the western parking lot entrance/exit that discharges to the City of Lewiston stormwater system.

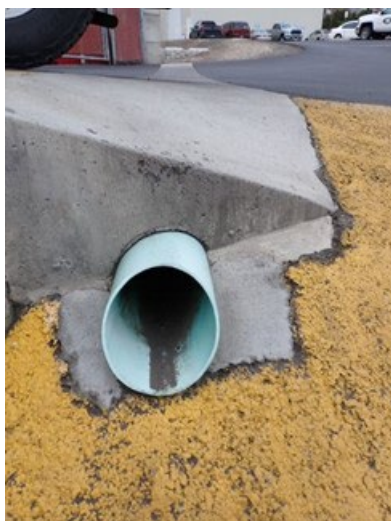
Photo #:13 (P3290074)

Description: Facing east, photo of underground infiltration basin overflow pipe that discharges to facility's storm drain.

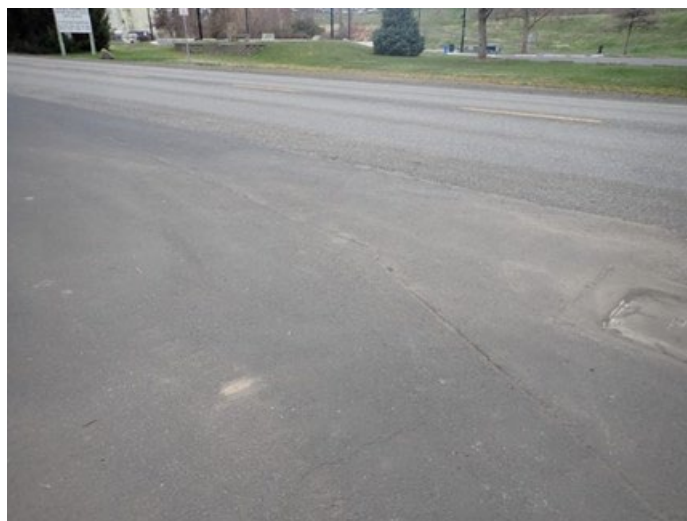
Photo #:14 (P3290075)

Description: Facing southwest, photo of the impervious surface and street (Snake River Avenue) where loading and unloading activity occurs; located to the left of the main storm drain by the western entrance/exit of the facility's parking lot.

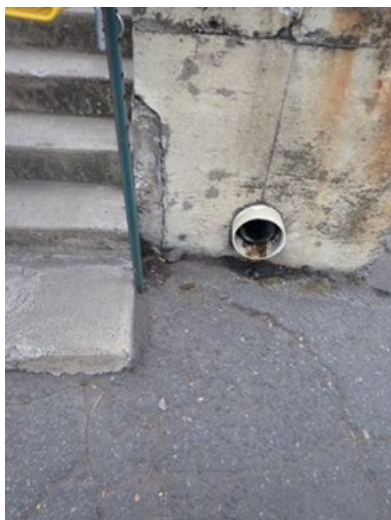
Photo #:15 (P3290077)

Description: Facing east, photo of downspout conveyance outflow pipe next to loading/unloading area on western side of facility that collects roof runoff and discharges to facility's storm drain.

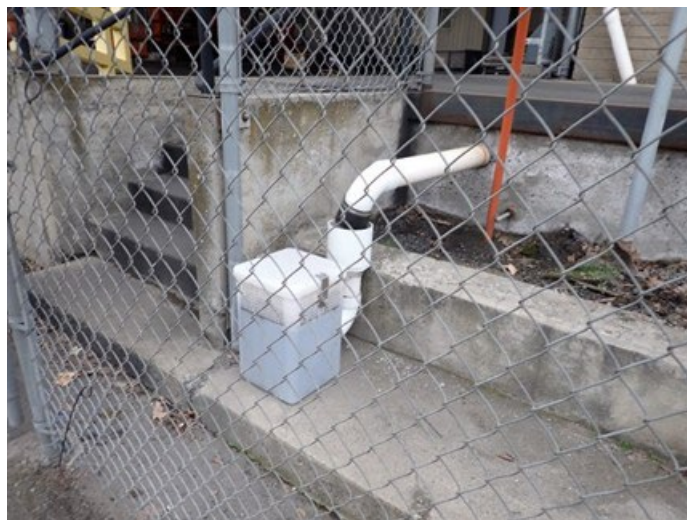
Photo #:16 (P3290078)

Description: Facing northeast, photo of treatment control and filtration system on facility's western perimeter used to remove metals from stormwater.

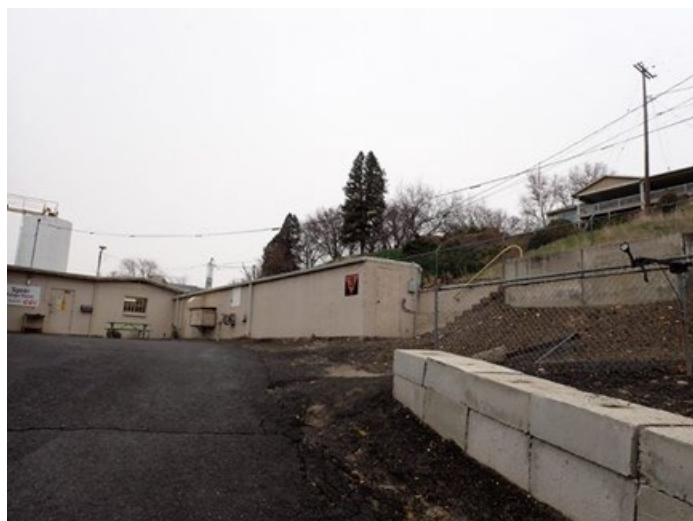
Photo #:17 (P3290090)

Description: Facing northeast, photo of the impervious area in front of the firing range building contributing to drainage area 1 as labeled on facility's SWPPP.

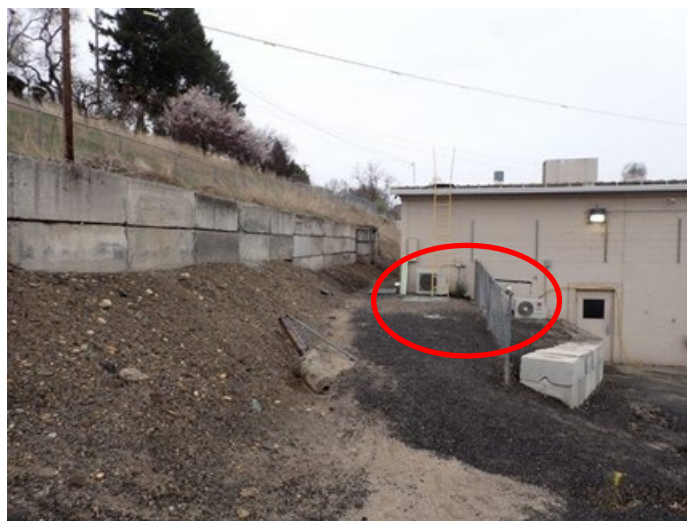
Photo #:18 (P3290091)

Description: Facing south, photo looking at building 1023 and where new cooling unit installation is planned in drainage basin 1.

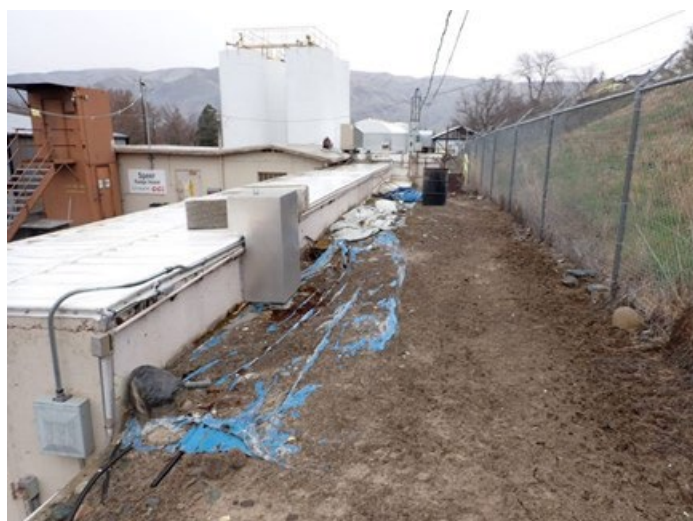
Photo #:19 (P3290097)

We continued up the hill to the western perimeter and walked to the northwestern-most part of the Facility above the quality assurance building where we observed worn plastic tarps and an unlabeled barrel of unknown contents (**Photo 19 & Photo 20**).

Description: Facing northeast, photo of the northeastern perimeter for the facility above the test firing range building with worn tarps on the ground.

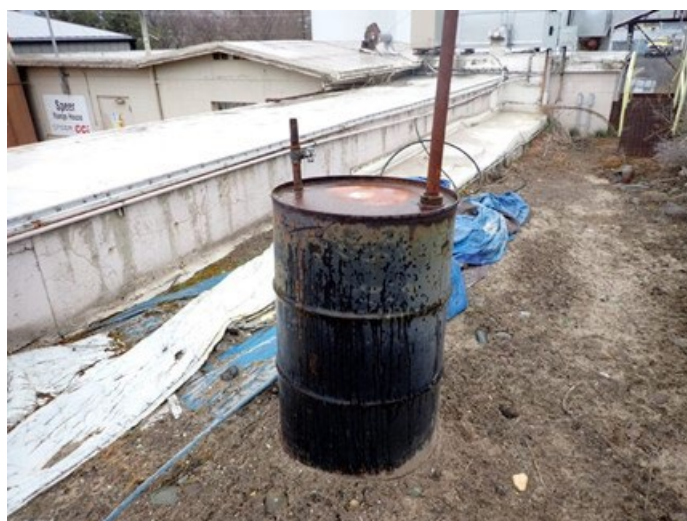
Photo #:20 (P3290099)

During the inspection, there was an unmarked and unlabeled rusted drum of unknown contents with a pipe connection on the northwestern corner of the Facility along the western perimeter fencing and above the quality assurance and test firing building. Post-inspection, the Facility provided written documentation indicating the Facility removed and properly disposed of the drum.

Description: Facing northwest, photo of an unlabeled barrel with unknown contents on the northeastern part of the facility above the test firing range building.

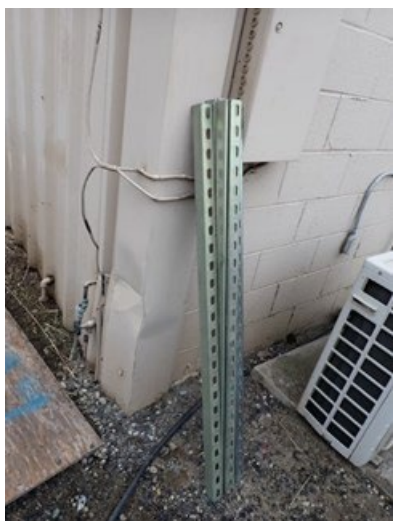
Photo #:21 (P3290102)

Description: Facing southwest, photo of where a new cooling unit is to be installed on building 1023 in northern part of the facility.

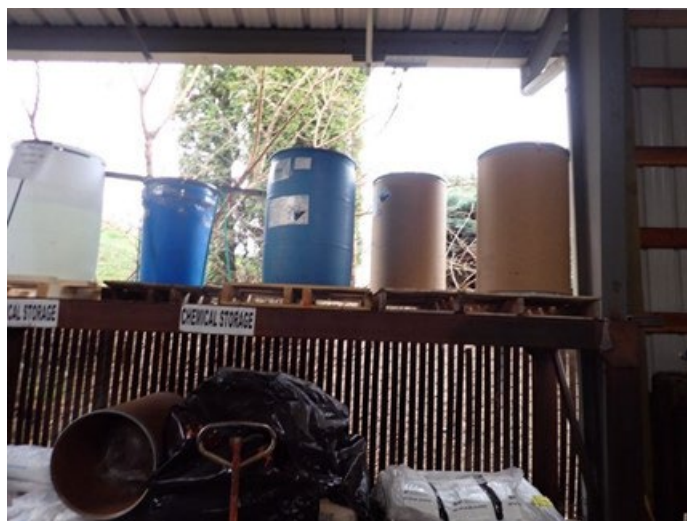
Photo #:22 (P3290116)

During the inspection, I observed inadequate secondary containment of chemical

Description: Facing southwest, photo of the chemical storage area in building 1023.

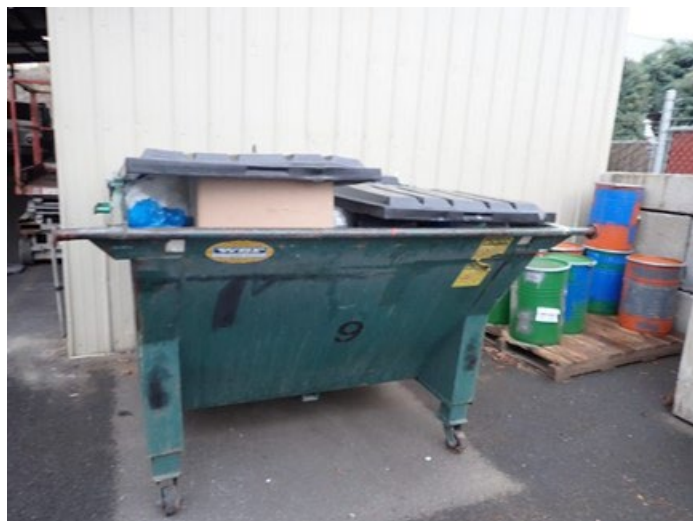
Photo #:23 (P3290124)

Description: Facing east, photo of a facility trash dumpster next to building 1023.

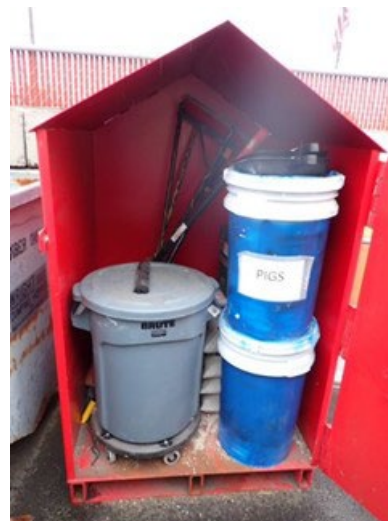
Photo #:24 (P3290130)

Description: Facing south, photo of the facility's spill kit.
