## Region 6 Compliance Assurance and Enforcement Division

### INSPECTION REPORT

| Company Name: | Jamie Oil Inc. | | |
| Facility Name: | Ezzell B-2 | | |

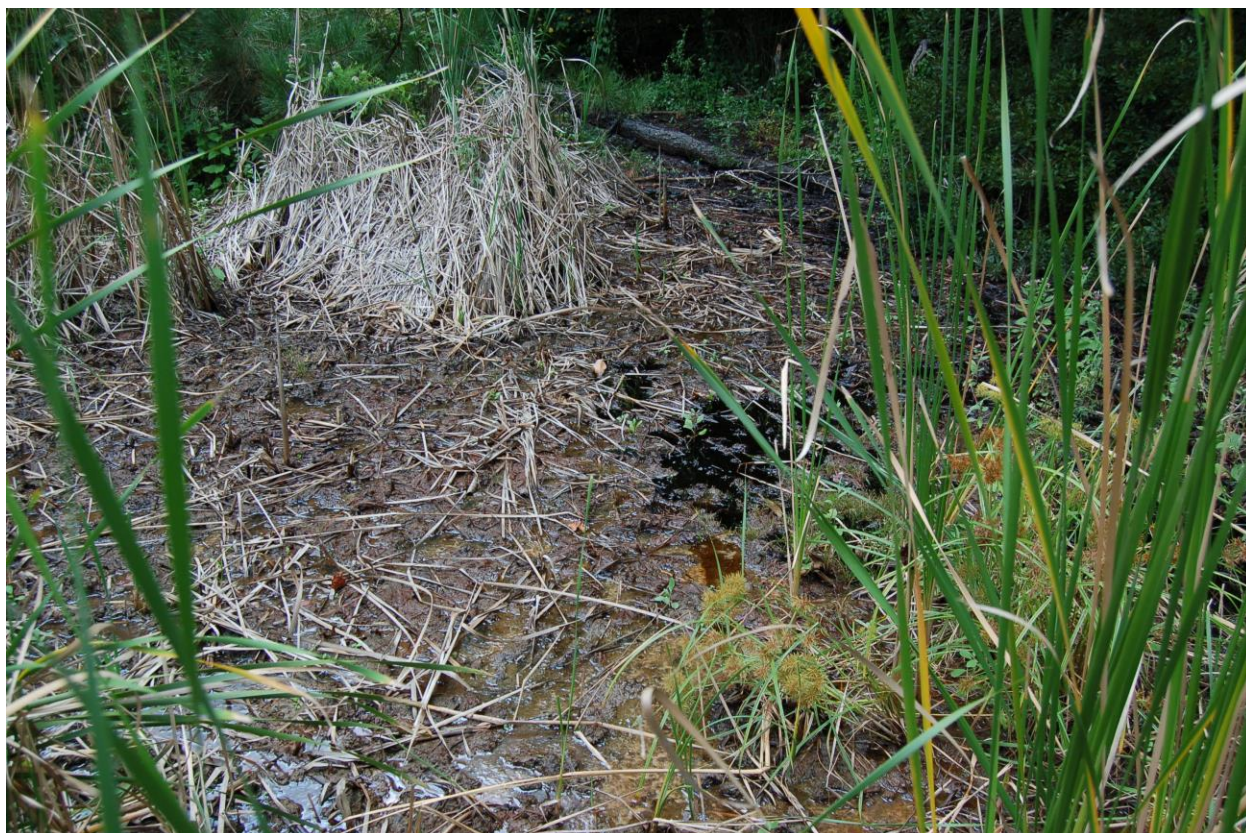
Photo File Name: Photo 12 taken west.

Description: Shows that oil and brine that has been discharged into the creek and marsh.

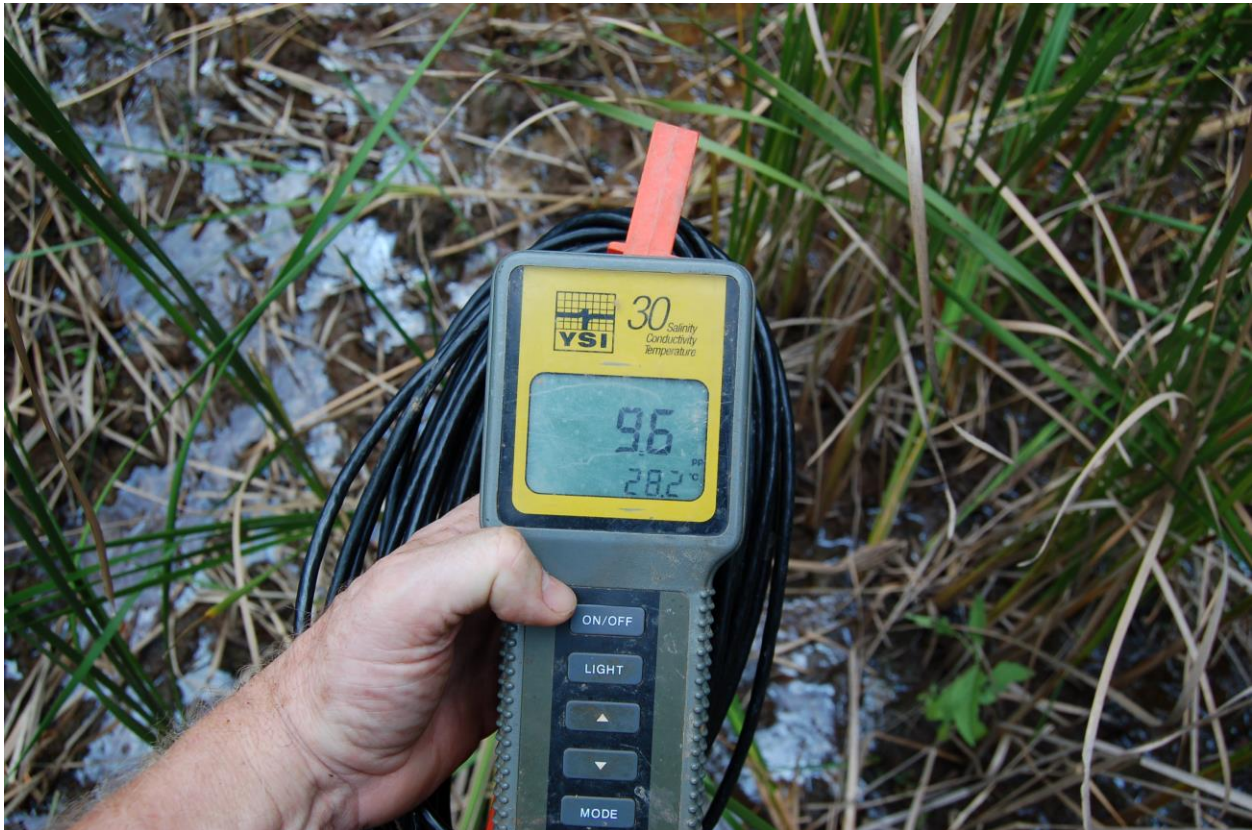
Photo File Name: Photo 15 taken west.

Point of entry to the tributary of Salt Creek: Latitude 33.2328N, Longitude -92.5948W. TSS is 9600 ppm.

Description: Shows a YSI meter reading of 9600 ppm TSS in the creek and marsh.
