**Deer Park Plant**  
**NARRATIVE REPORT**

**Power Failure and Zebra Poly Relief Valve VCM Release**

**July 14, 1997**

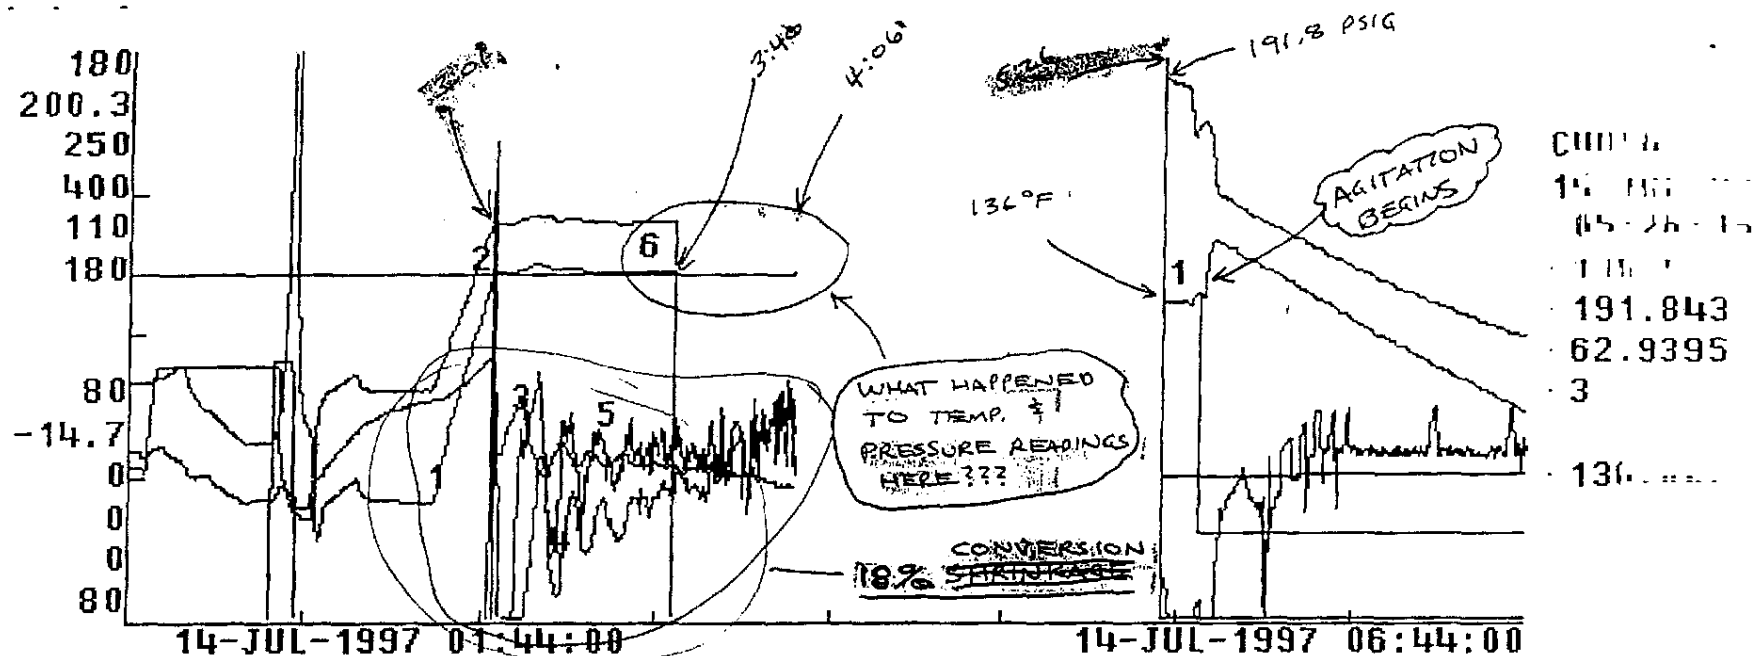
Zebra Poly Trend

9. Instrumentation was unavailable for approximately 1 hour and 20 minutes.
10. Zebra is equipped with 3 temperature probes – each showed a significantly different temperature after the agitator was restarted.

11. Zebra was not burped after the initial R/V lift.
12. The R/V for slurry or residual VCM at 0615.
13. The AMS pots fired immediately.
14. Calculations show that we had enough residual agitation to properly mix the AMS and subsequently kill the reaction.
