## TRIP OR CONFERENCE REPORT

| COMPANY VISITED<br>MARATHON OIL | | S.O. NO.<br>7339R1 | |
| OBJECT OF TRIP OR CONFERENCE<br>OBSERVE TURBINE SPEED VARIATION AND TROUBLE<br>SHOOT AS REQUIRED | | G.O. NO. | |

MARATHON OIL  
ROBINSON, ILLINOIS  
S.O. 7339

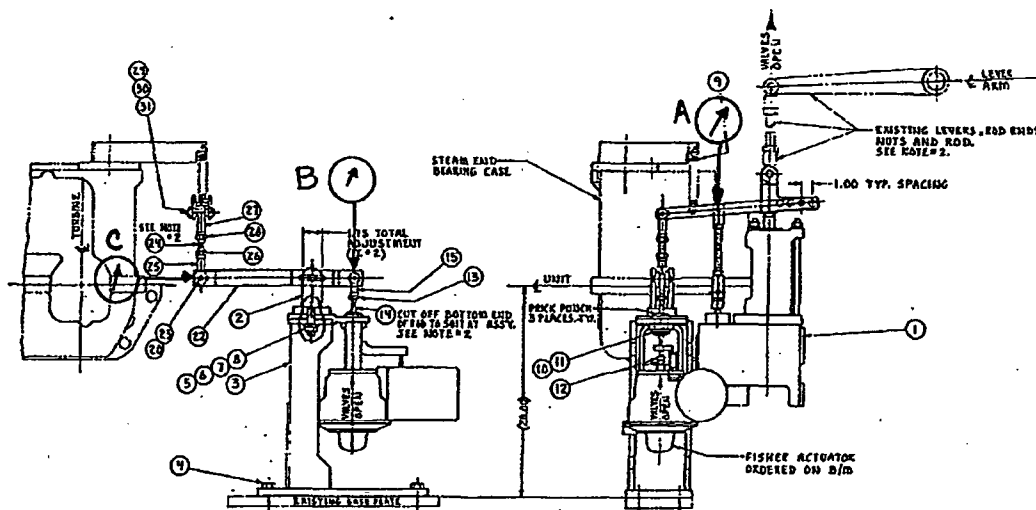
After arrival at site and meeting with Messrs. Stone and Jungen, proceeded up to the unit. Three dial indicators were obtained and mounted to monitor various parts of the servo motor linkage. The locations are as indicated below:

Operations lowered the speed of the unit to get the unstable region of operation. This region was entered several times. Each with a duration of 4-6 cycles then the unit would stabilize out. Each cycle lasted approximately 5 seconds with speed changes of about 50 rpm. During each cycle the dial indicators cycled as follows:

| DIAL INDICATOR | TIR RANGE (MILS) |
| A | 98 - 01 |
| B | 95 - 04 |
| C | 96 - 98 |

The indicator movement was steady and smooth (other than the inherent vibration). No sticking or binding was found.

- 1) Speed variation exhibited is approximately 50 rpm with current system.
- 2) Dial indicators mounted in the following locations:
  - A) Actuator vertical travel.
  - B) Actuator lever horizontal travel.
  - C) Pilot valve vertical travel.

Do not indicate any binding or sticking linkages are present. Movements are clean and exhibit no discontinuities.
