## Clean Water Act Section 404: Site Visit/Case Development

| Inspector Name(s) | Seika Robinson | Time In | 11:15 AM | Start Date | June 11, 2024 |
| Site Name | Hotel Media Luna | | | | |
| Site Address* | Tax Parcel 196-000-009-39 | | | | |

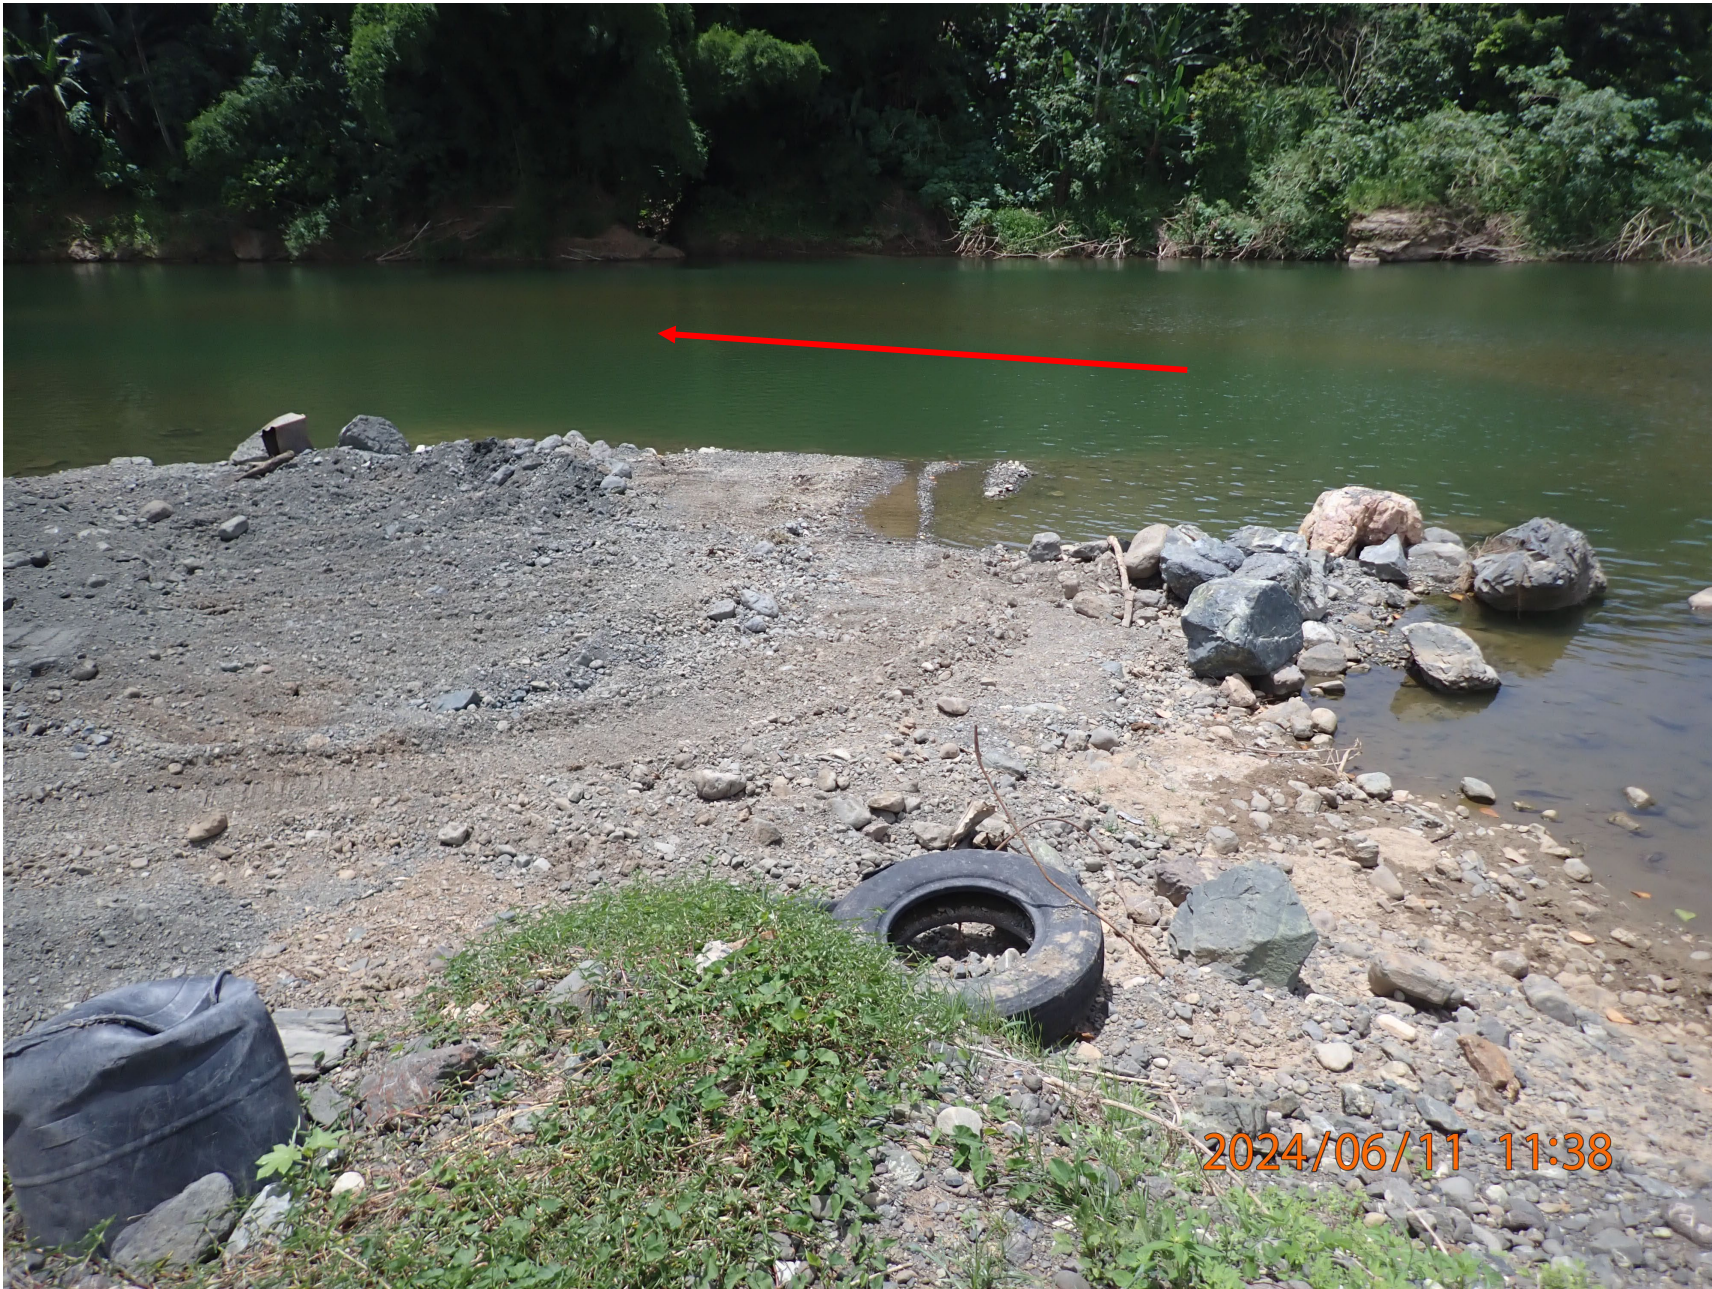
**Photo ID:** P6111005

**Description:** Within the bank, below ordinary high water of the Rio de la Plata, earth moving work and fill material was observed along with trash debris.

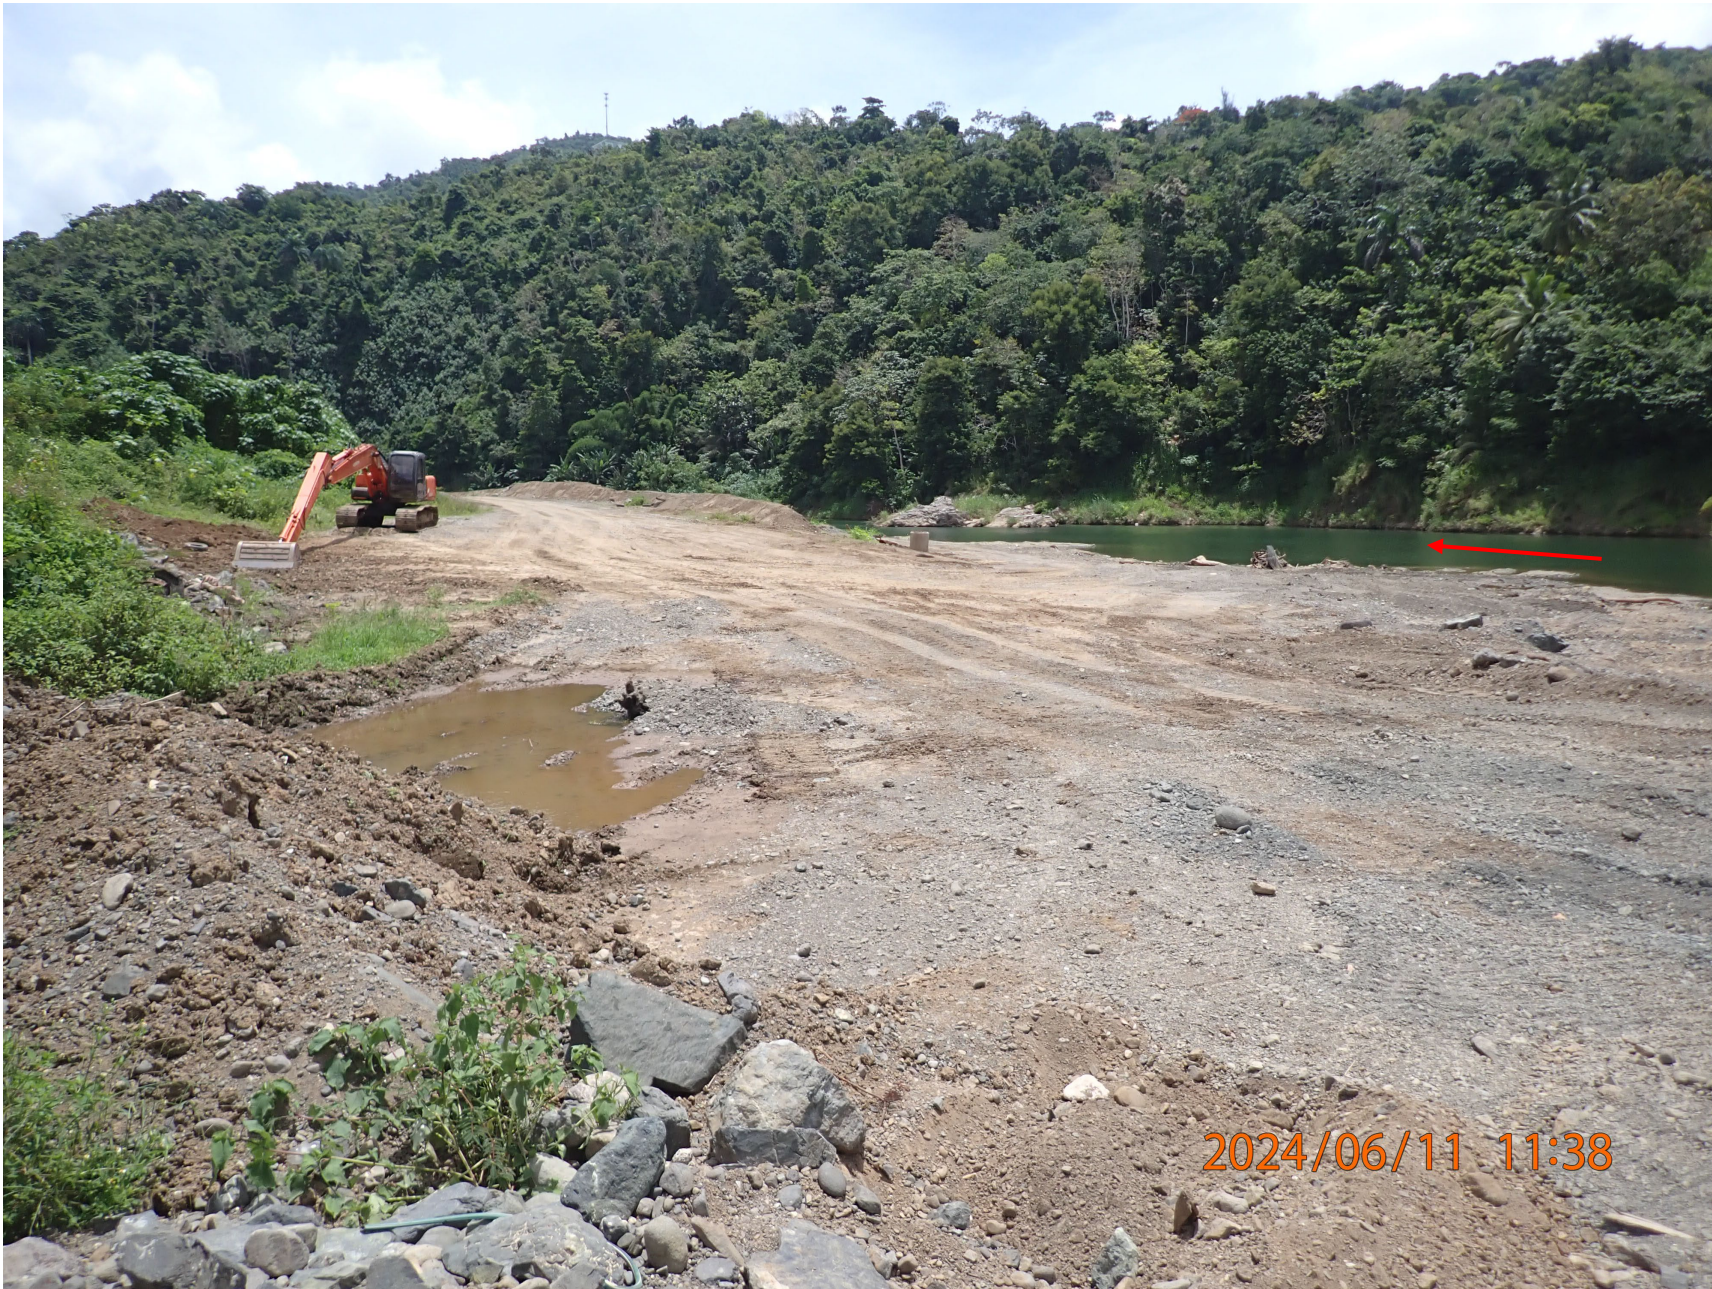
**Photo ID:** P6111007

**Description:** Earth moving work and fill material was observed. Construction machinery was observed parked within the area where earth moving work had occurred.

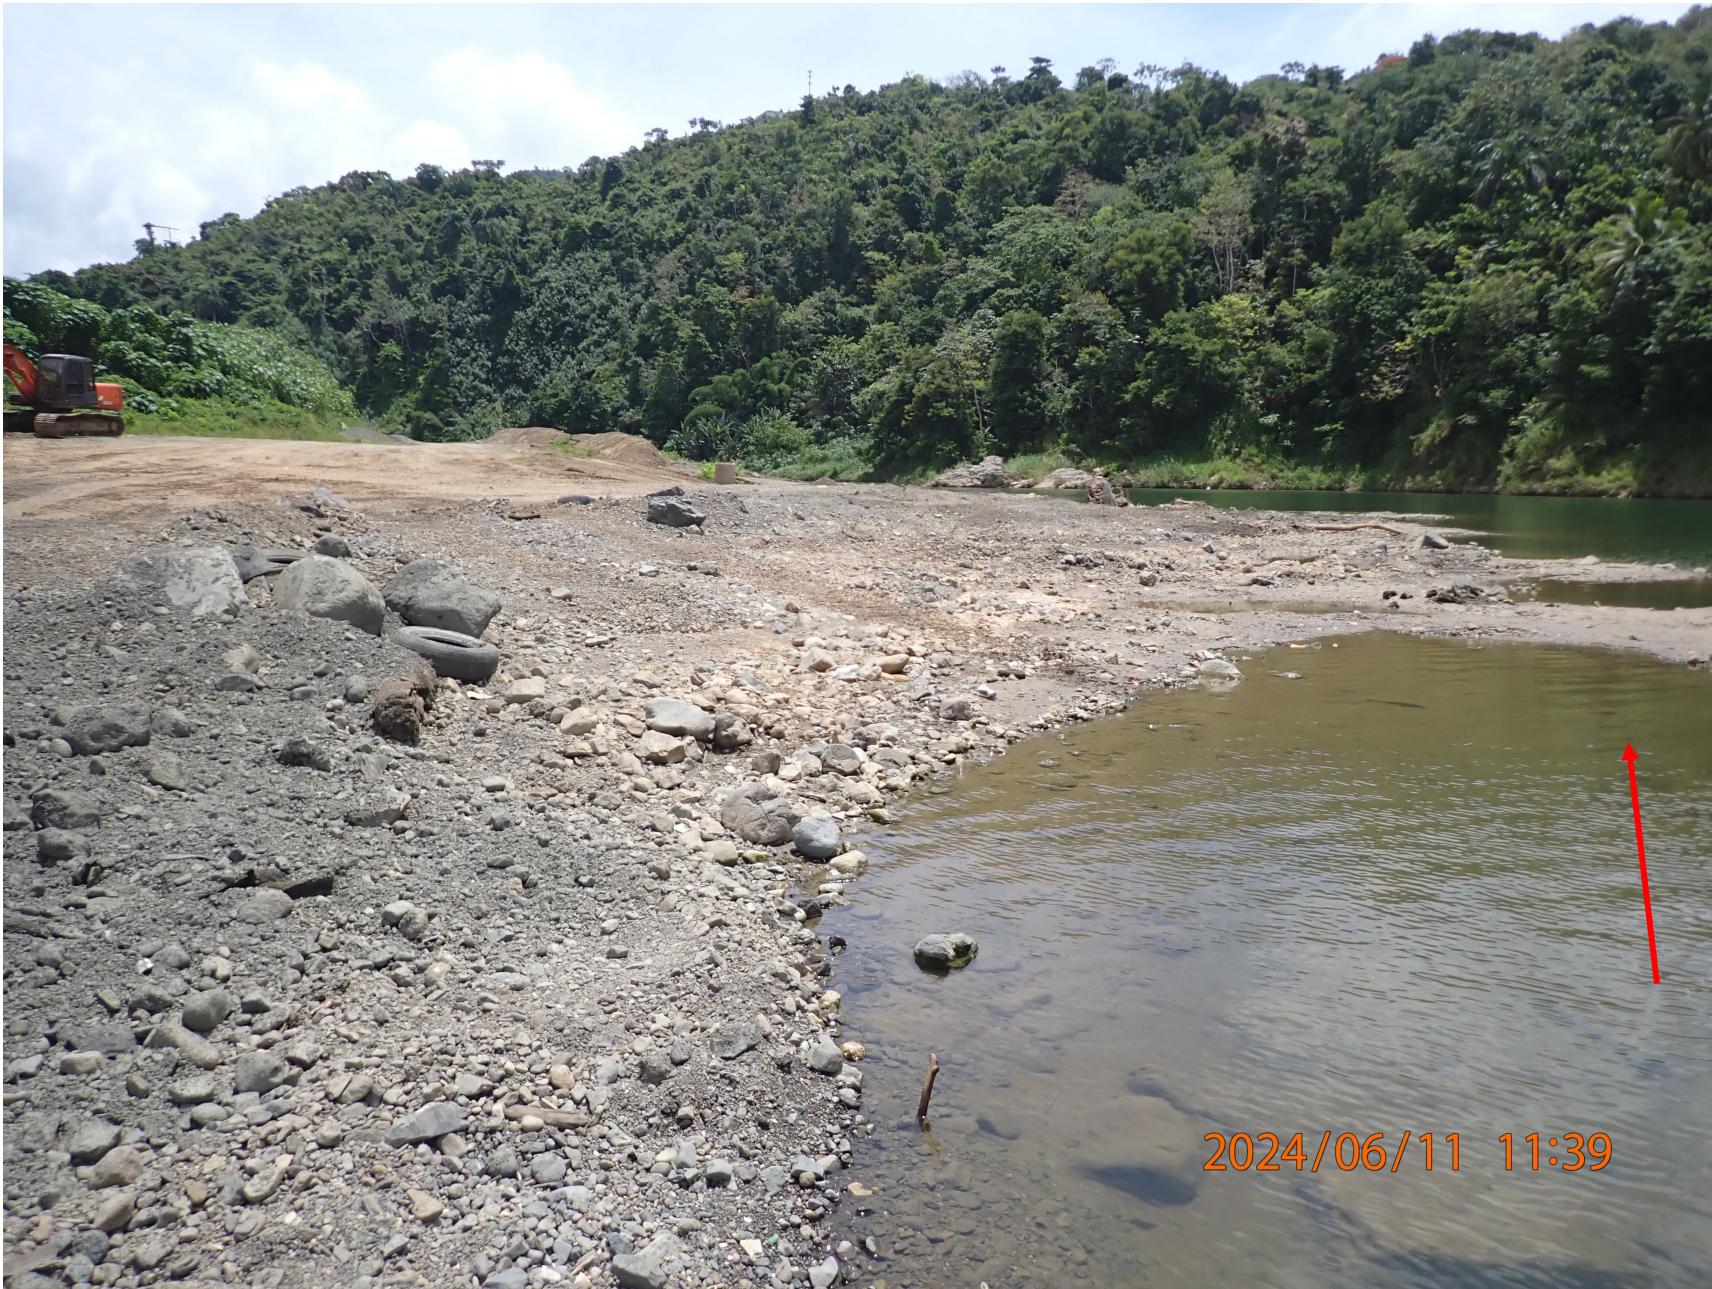
**Photo ID:** P6111010

**Description:** Within the bank of the Río de la Plata, earth moving work and fill material was observed. Construction machinery was observed parked within the area where earth moving work had occurred.

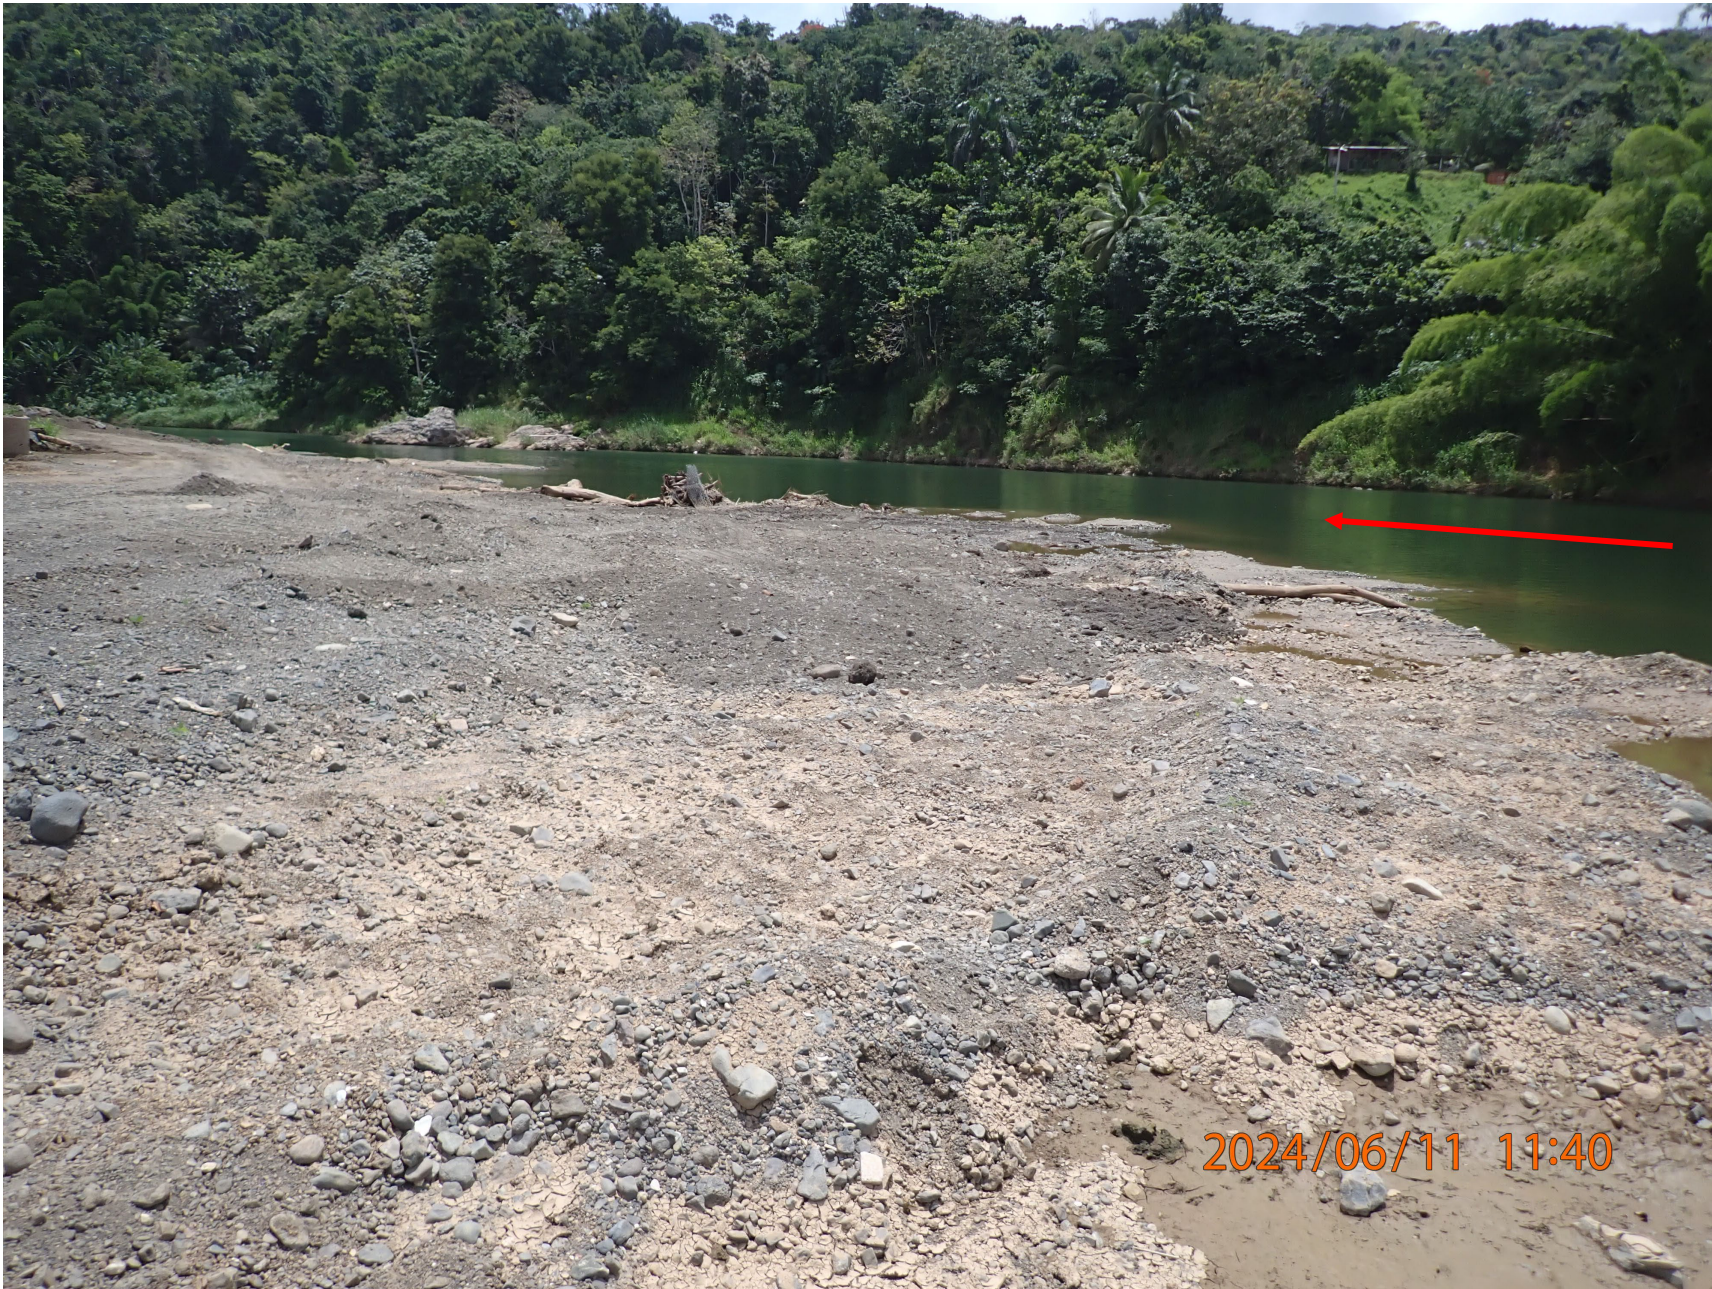
**Description:** Within the bank of the Río de la Plata, earth moving work and fill material was observed.

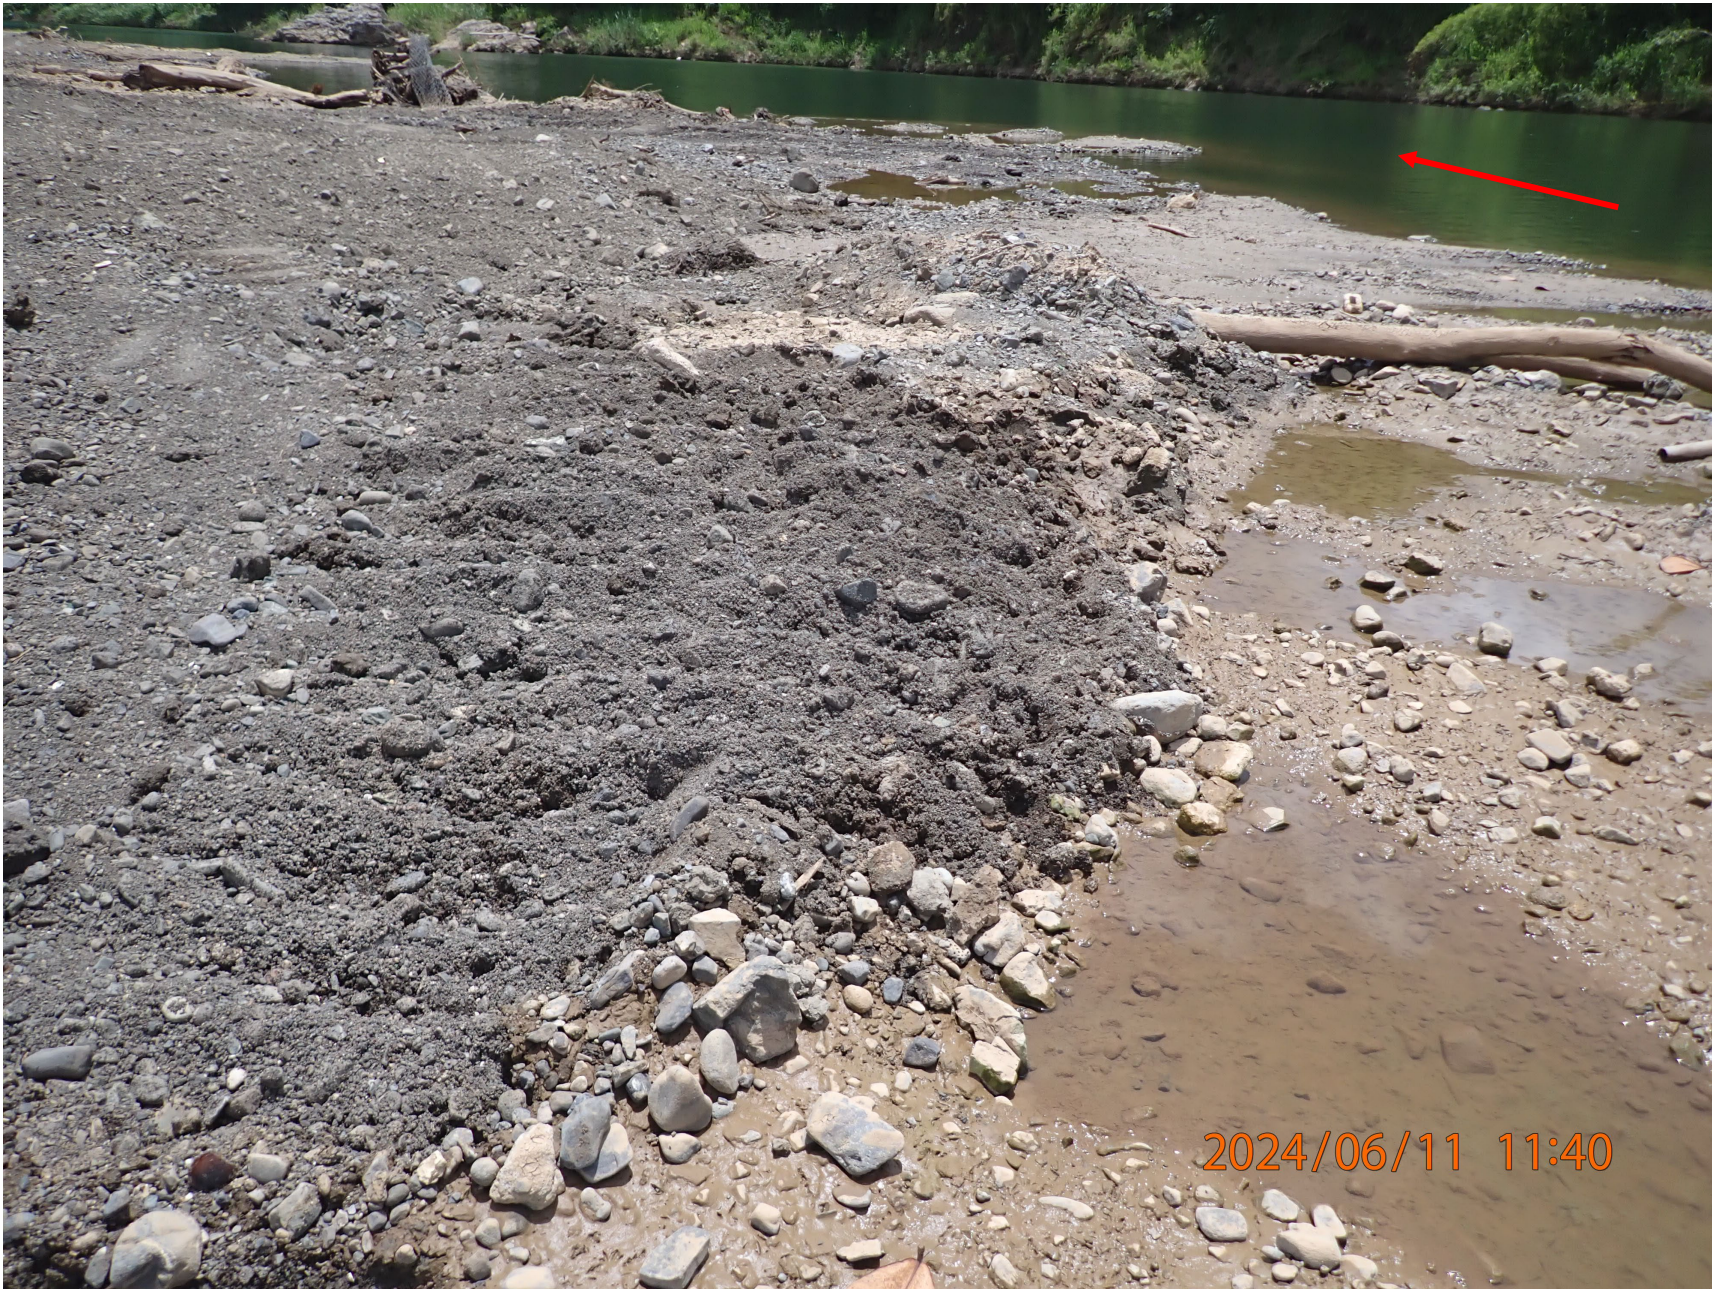
**Photo ID:** P6111013

**Description:** Within the bank of the Río de la Plata, earth moving work and fill material was observed.

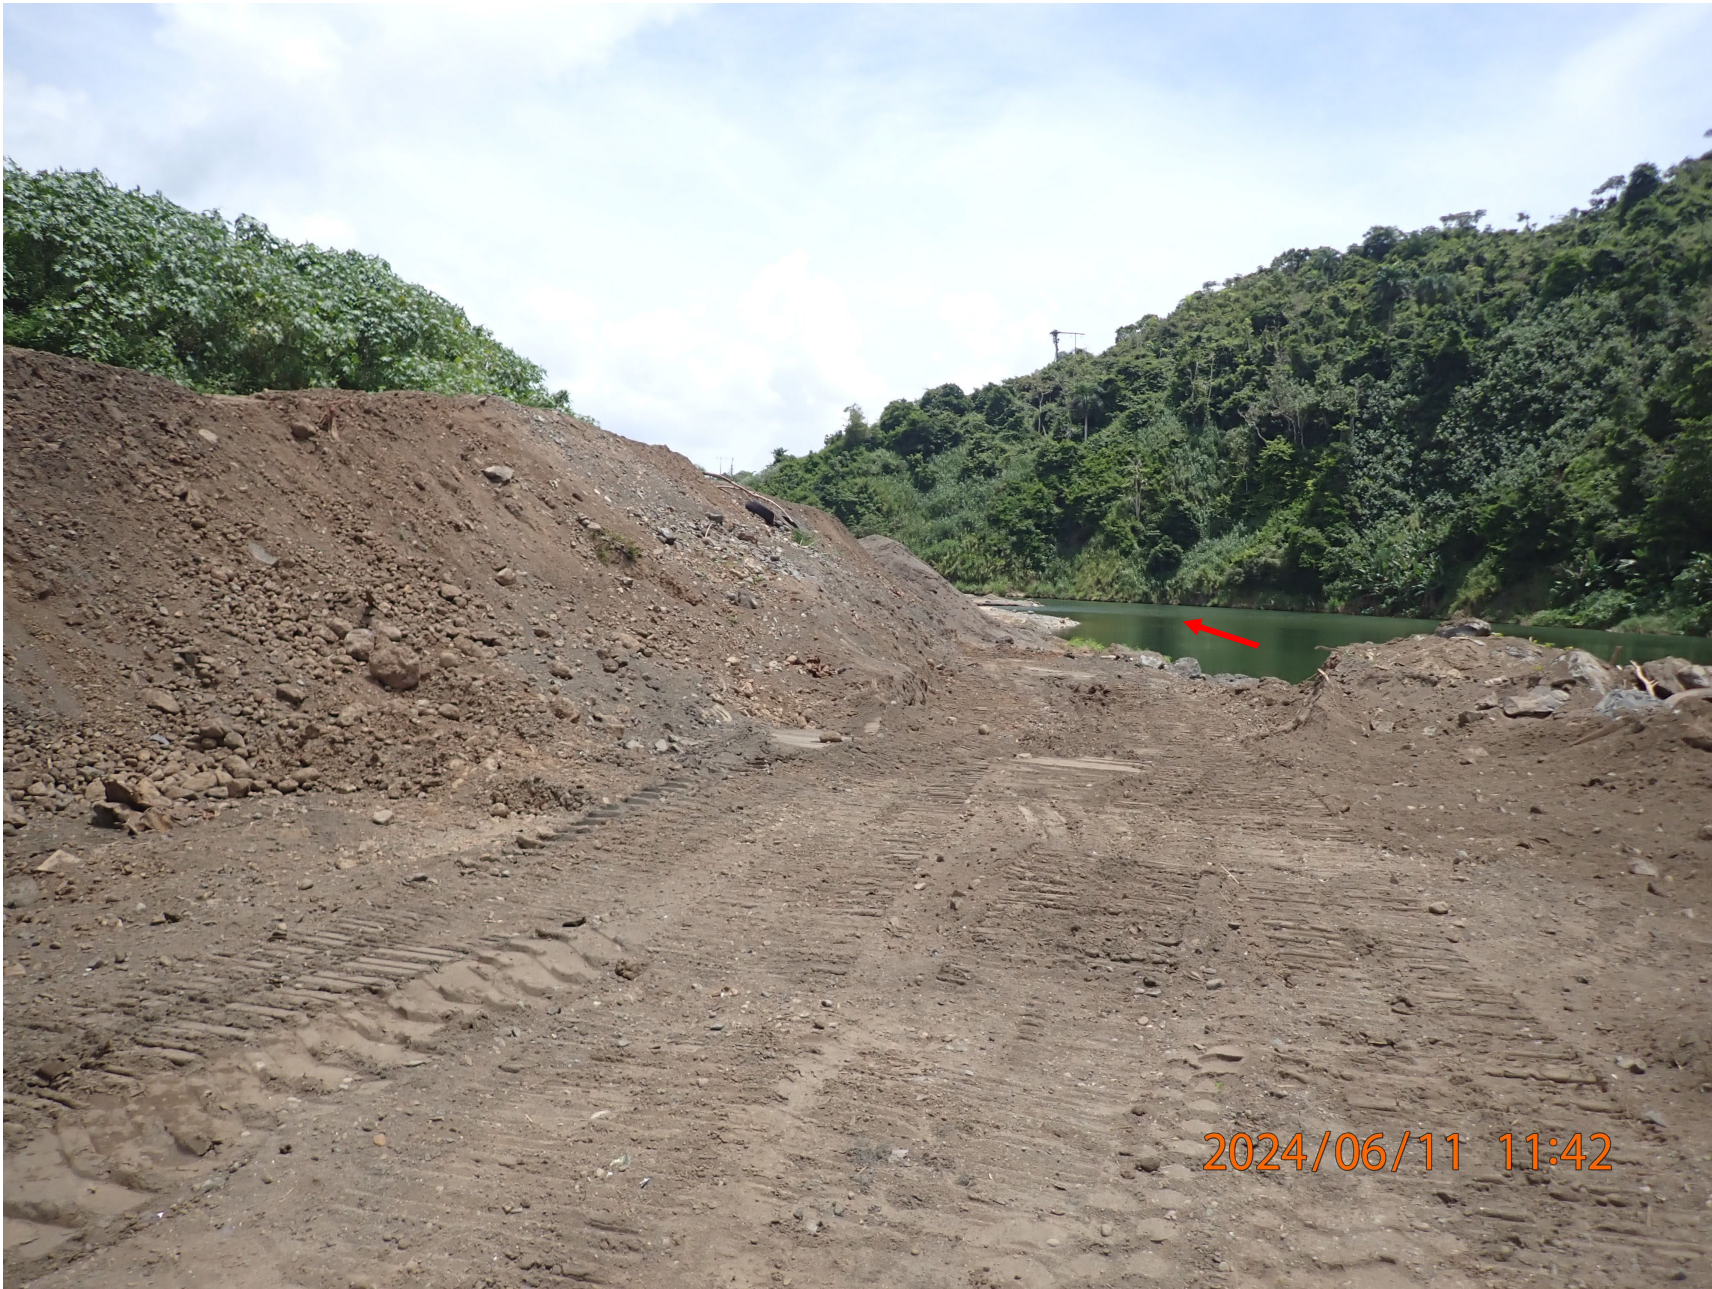
**Photo ID:** P6111016

**Description:** Within the bank of the Rio de la Plata, earth moving work and fill material was observed.

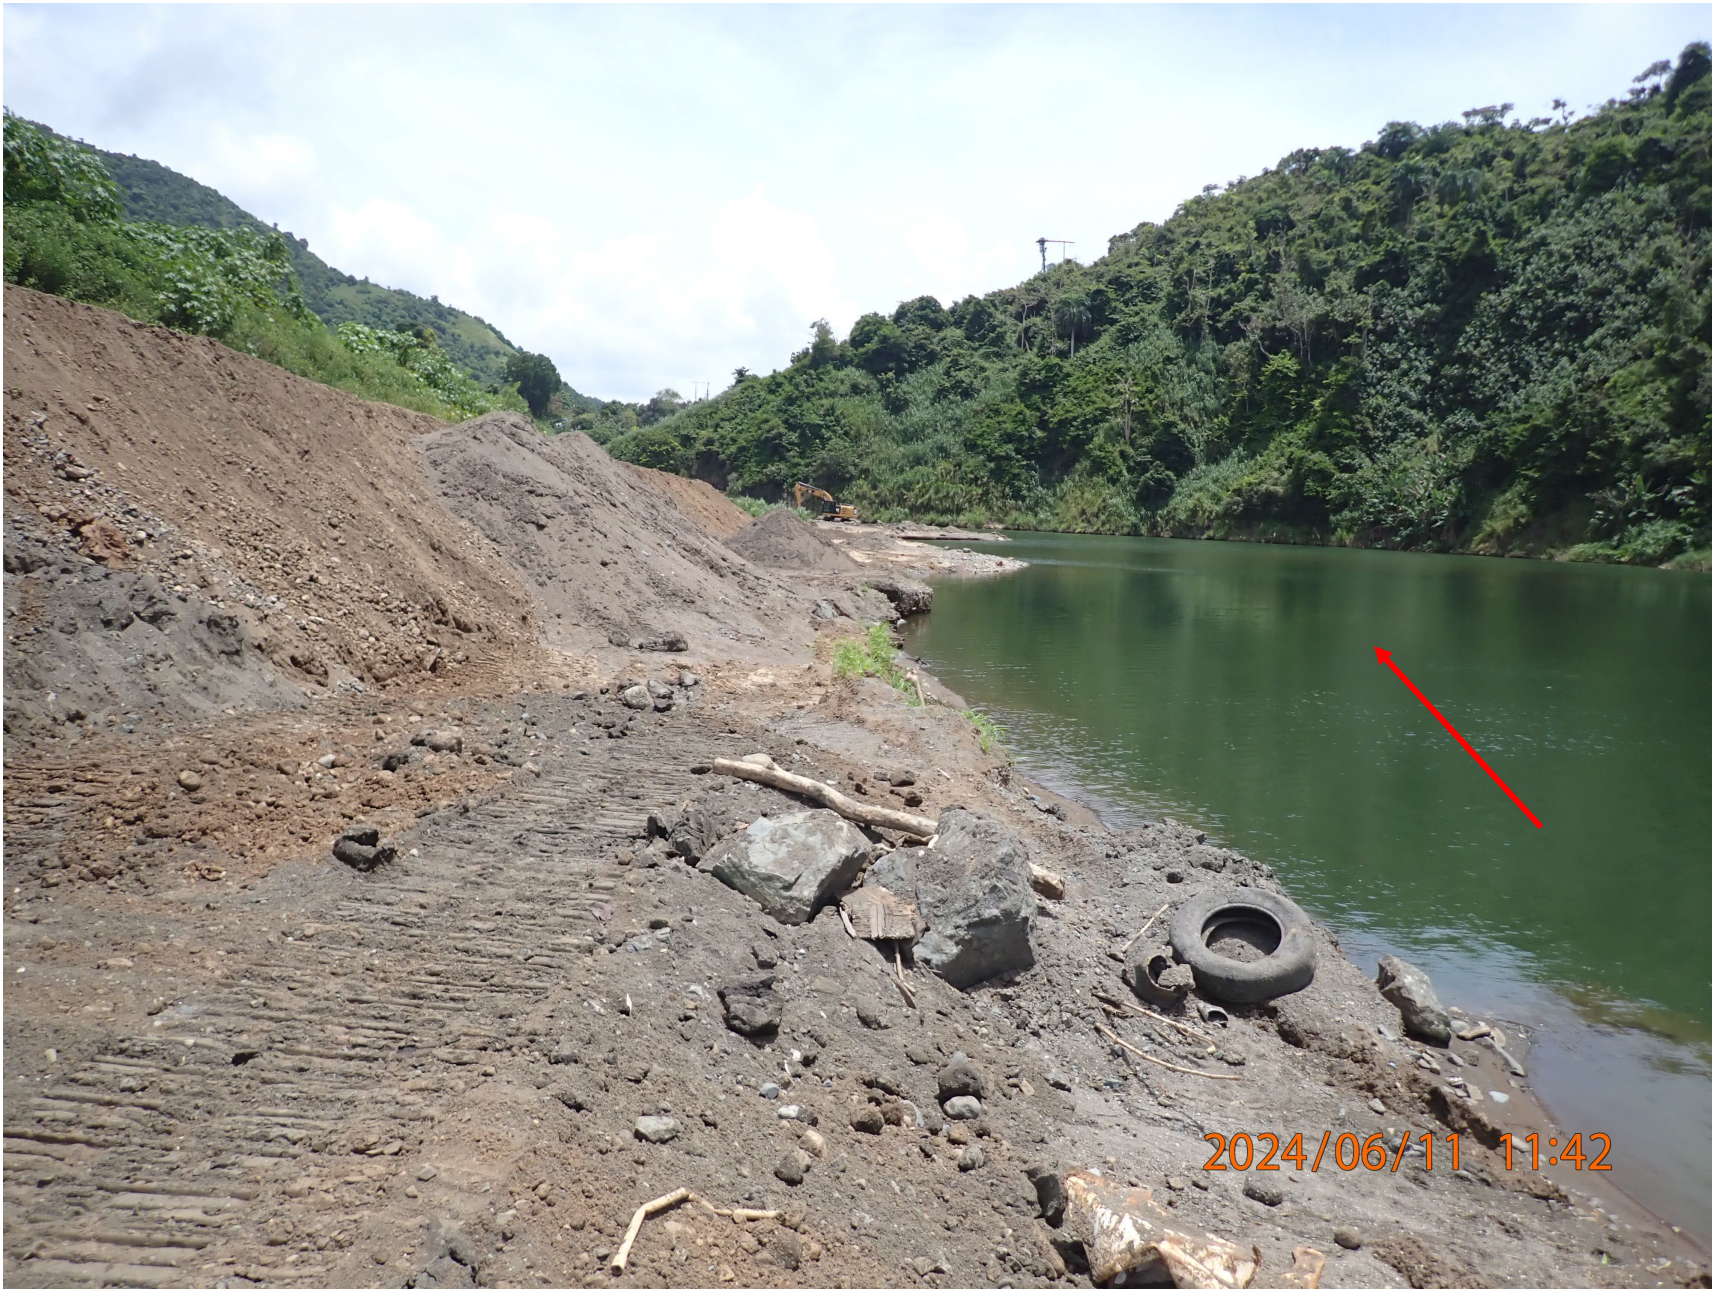
**Description:** Within the bank of the Río de la Plata, earth moving work and fill material was observed along with trash debris. Construction machinery was observed parked within the area where earth moving work had occurred.

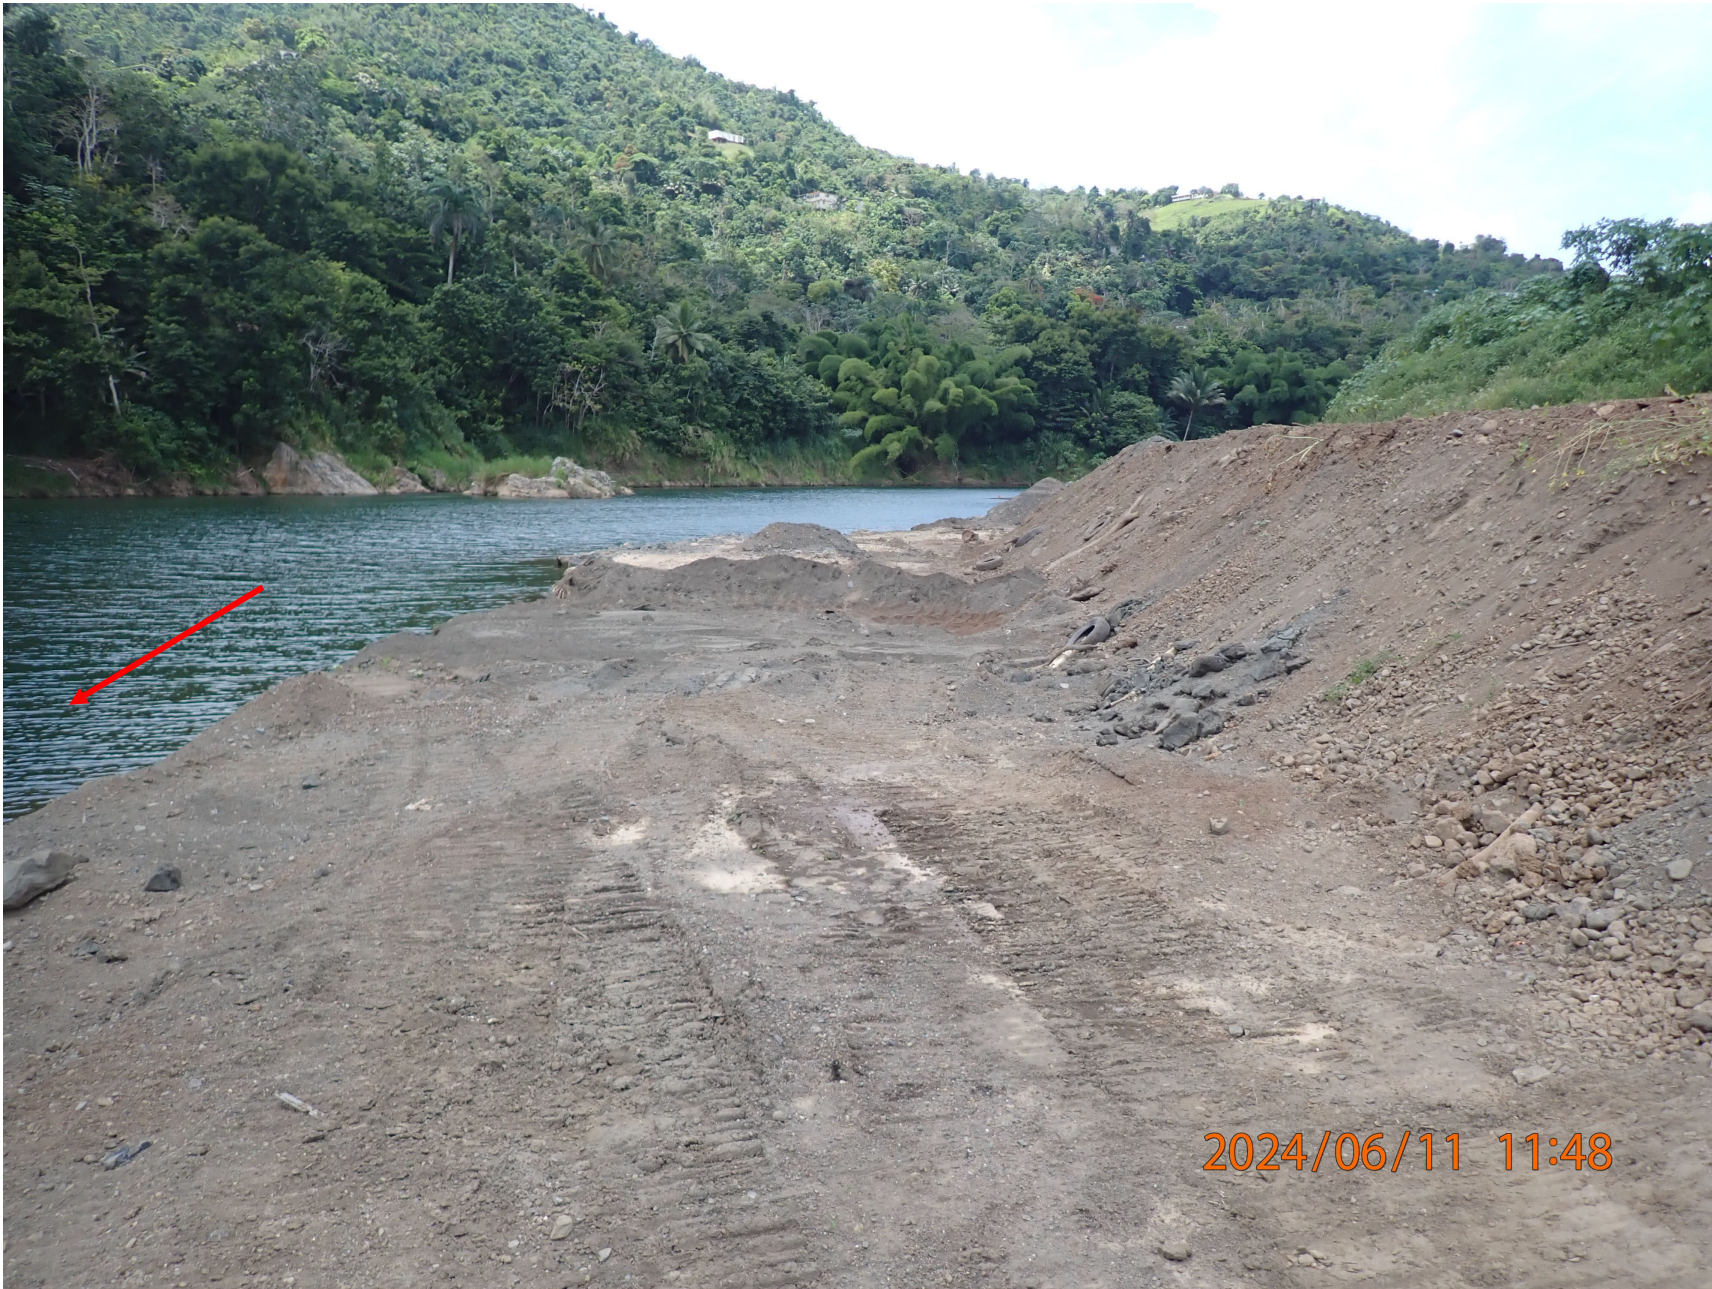
**Photo ID:** P61110018

**Description:** Within the bank of the Río de la Plata, earth moving work and fill material was observed.

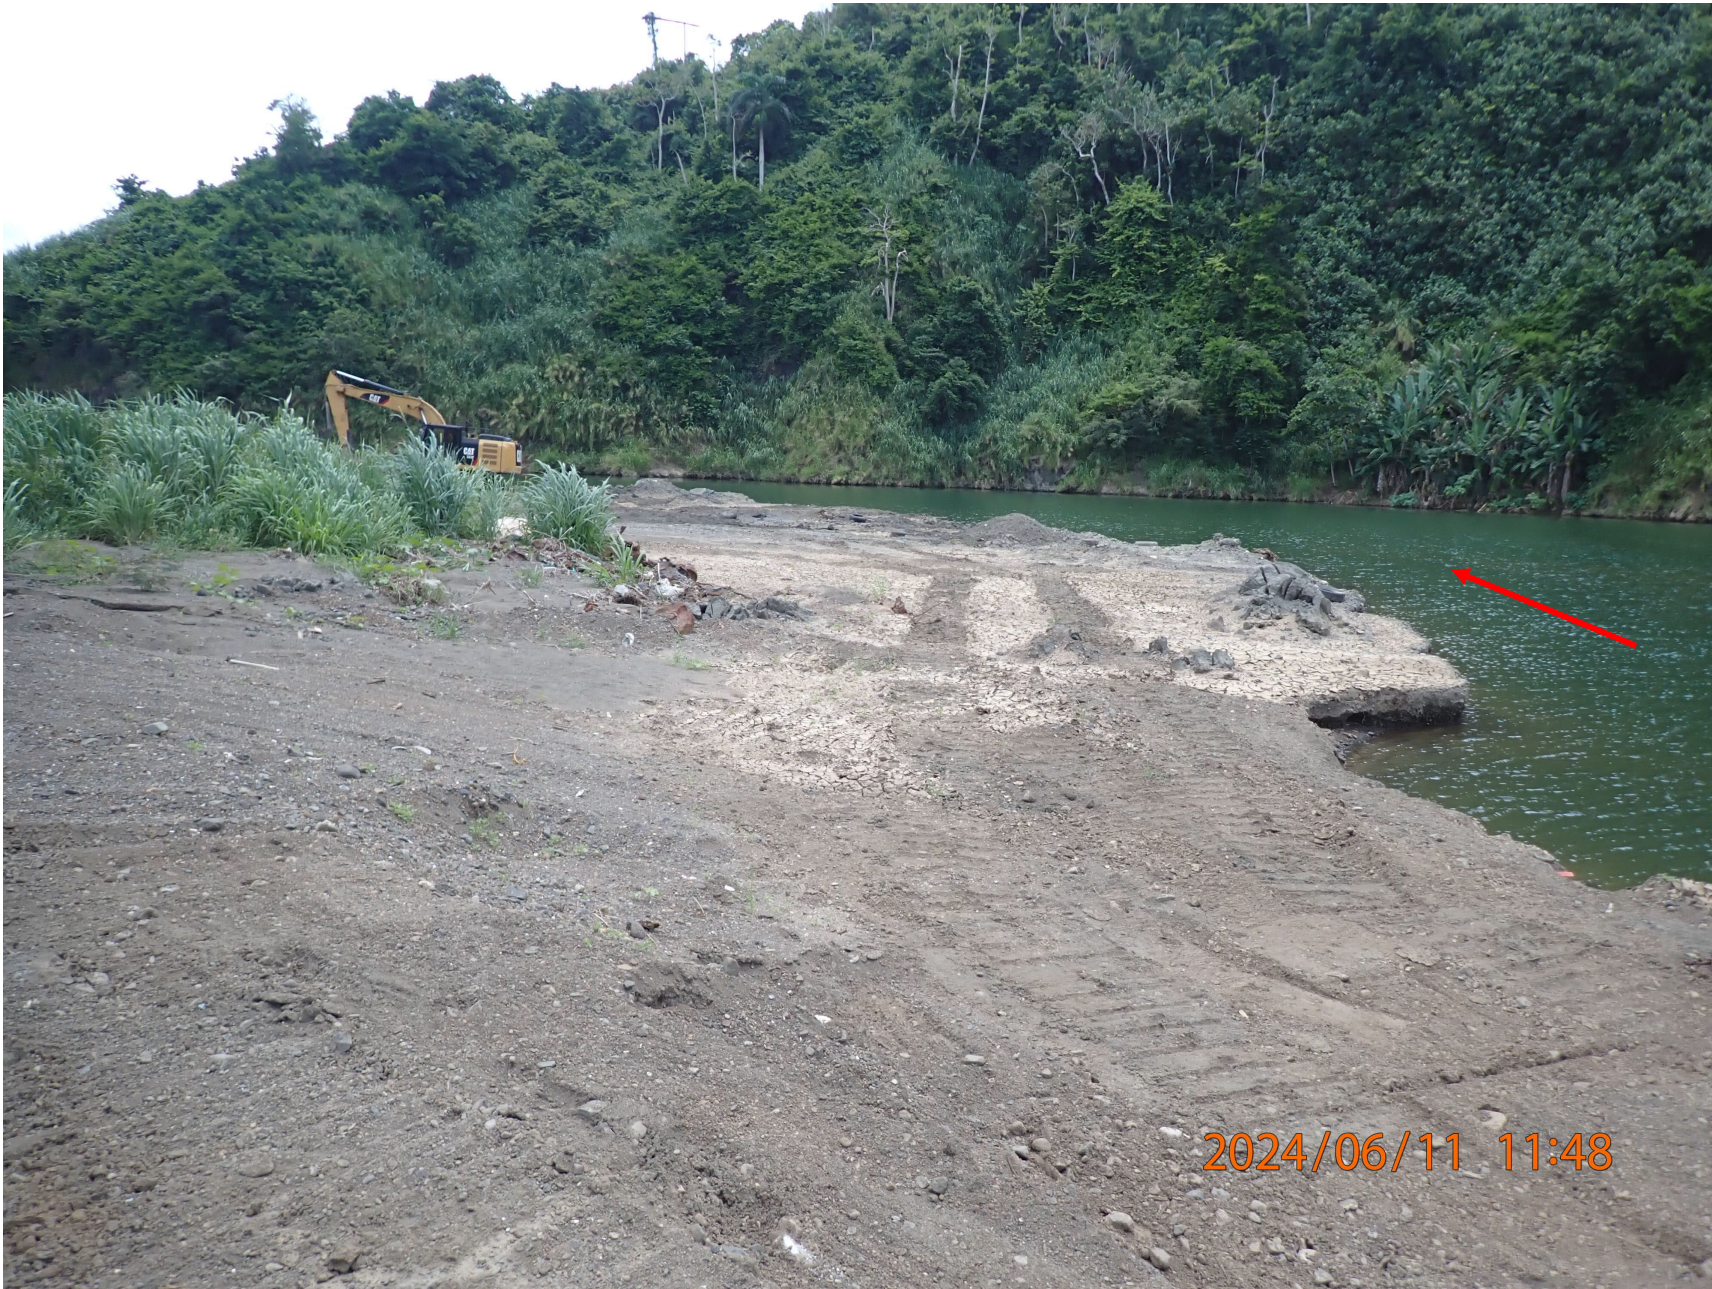
**Photo ID:** P6111019

**Description:** Within the bank of the Río de la Plata, earth moving work and fill material was observed. Construction machinery was observed parked within the area where earth moving work had occurred.

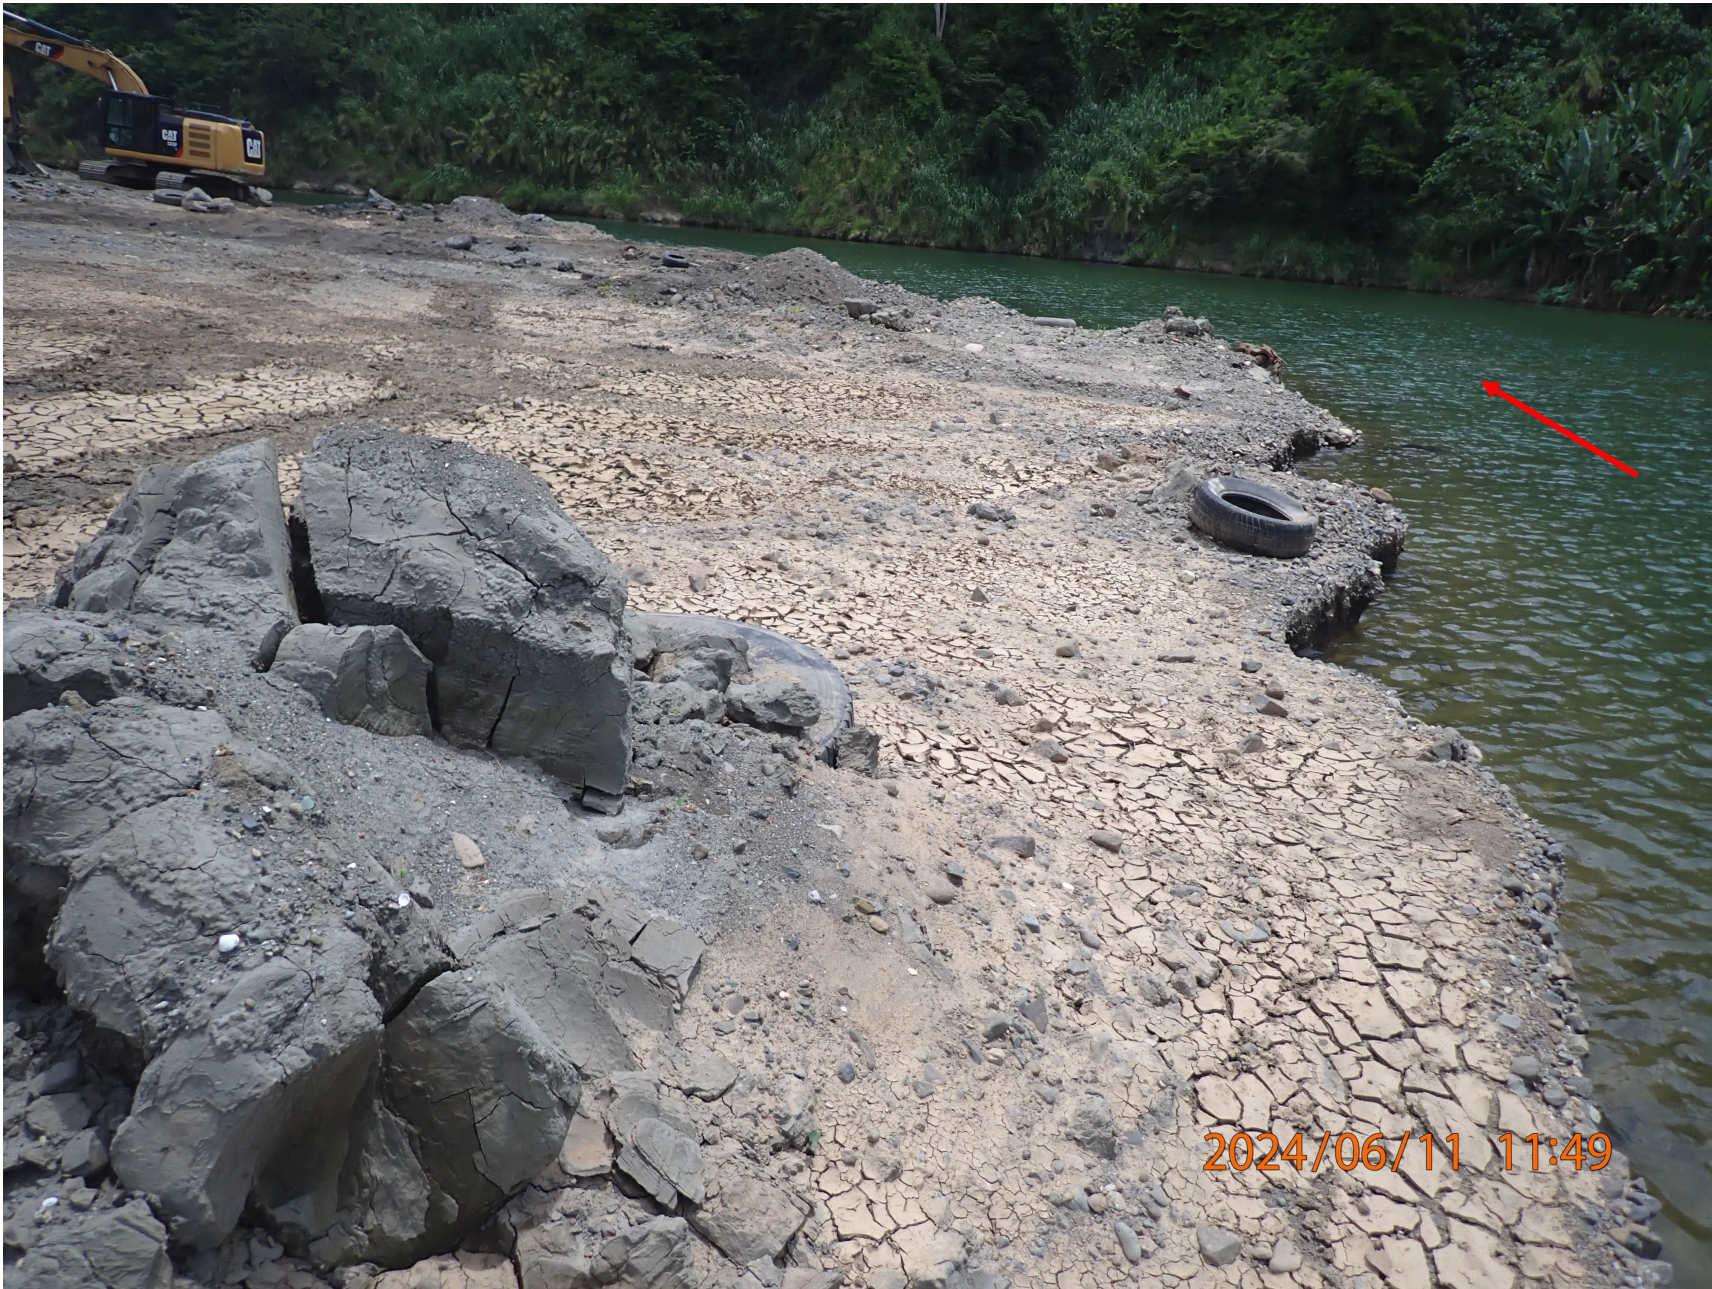
**Photo ID:** P6111020

**Description:** Within the bank of the Río de la Plata, earth moving work and fill material was observed along with trash debris. Construction machinery was observed parked within the area where earth moving work had occurred.

Mud cracks were observed within the area of work.
